# **Fence Construction & Hot Mixed Asphaltic Concrete Cover Repair Letter Report**

**Rockwool Industries, Inc. Federal  
Superfund Site 1741  
Taylors Valley Road, Belton, Bell  
County, Texas**

**Texas Commission on  
Environmental Quality**

**February 3, 2015**

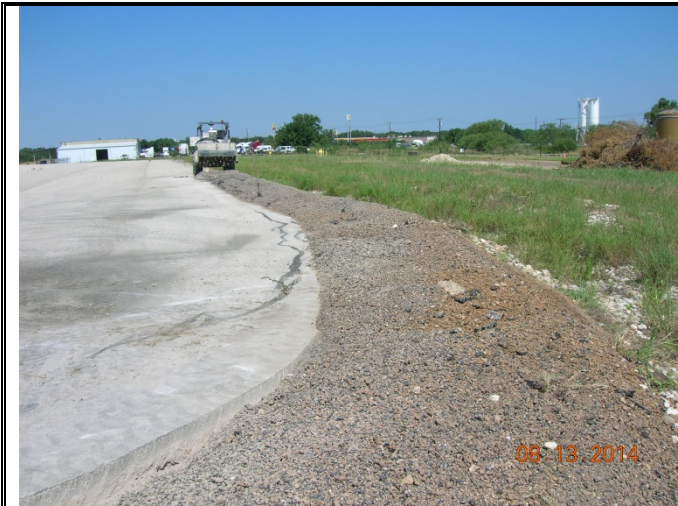
Photo 19: Facing northwest on north-side as contractor mills the 7-foot apron surrounding the HMA cover.

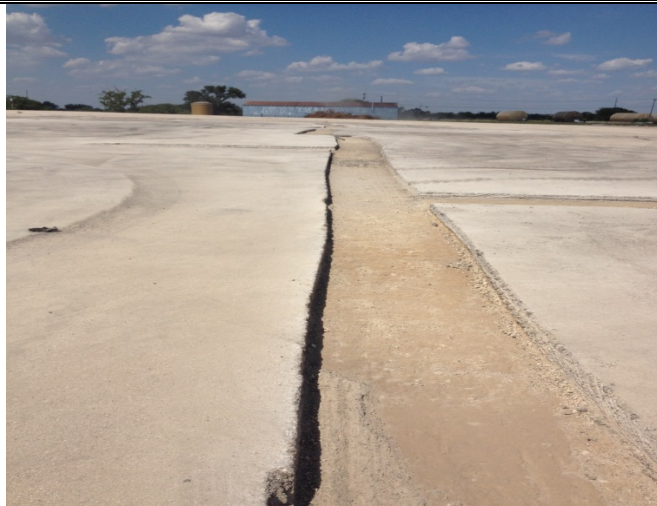
Photo 25: Facing north at milled and swept crack areas located on the HMA cover.

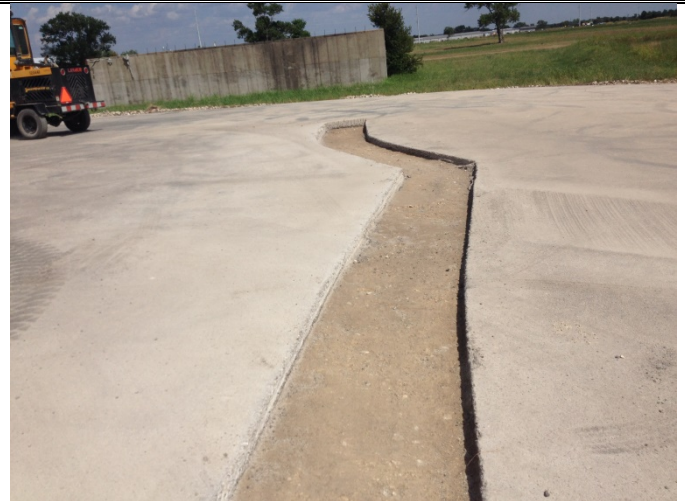
Photo 26: Facing east at milled and swept crack areas located on the HMA cover.

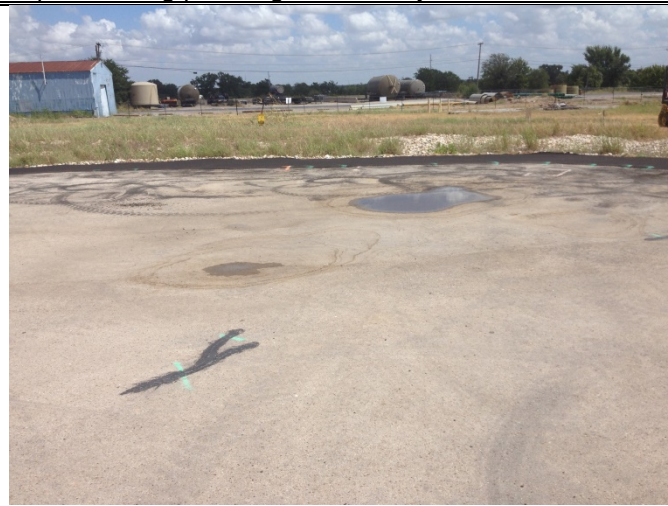
Photo 33: Facing northeast. View of depression on northeast corner of the HMA cover.

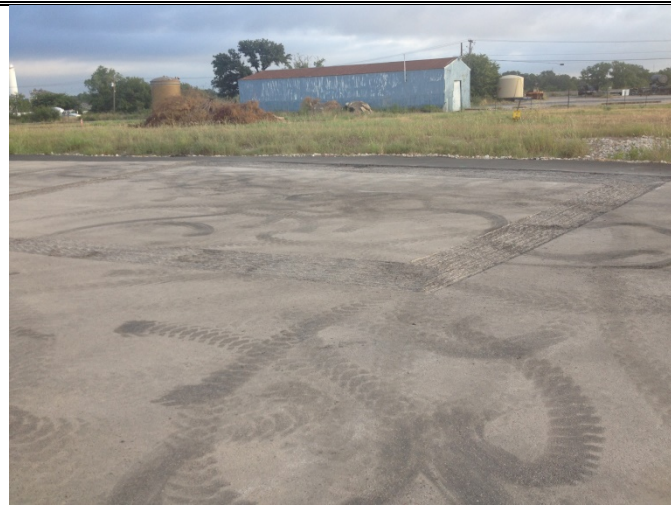
Photo 34: Facing northwest looking at milled depression on northeast corner of the HMA cover.

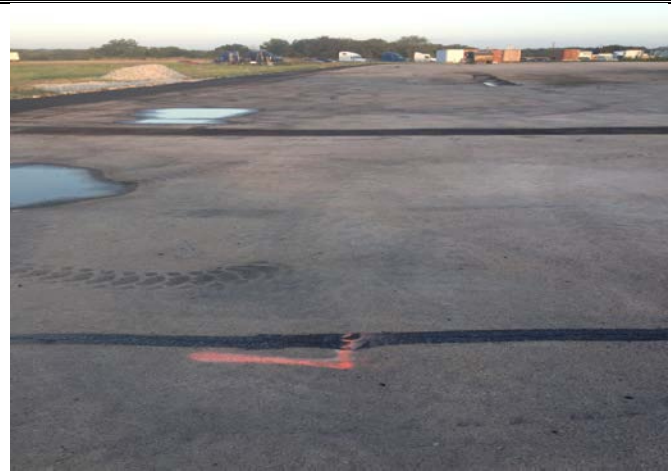
Photo 36: Facing west at depression on the southern side of the HMA cover.

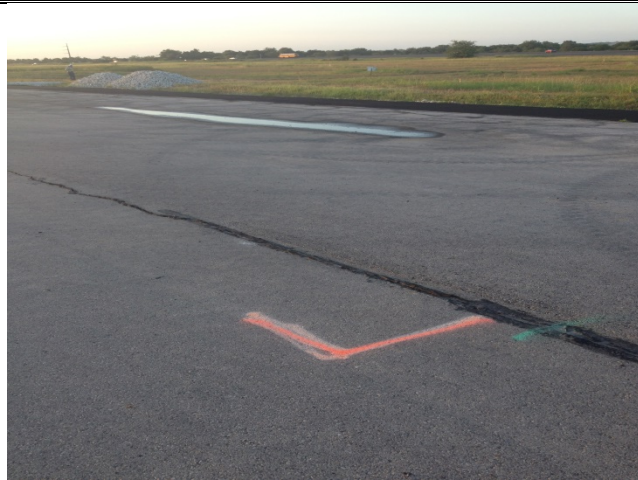
Photo 37: Facing southeast at depression on the southern side of the HMA cover.

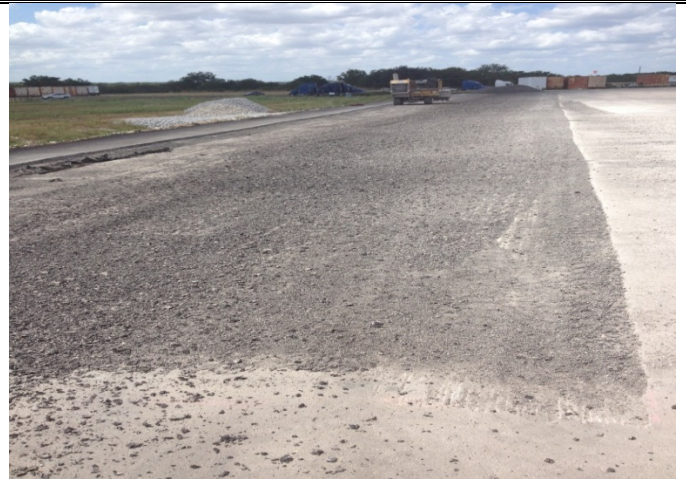
Photo 38: Facing southwest at southern depression being milled.

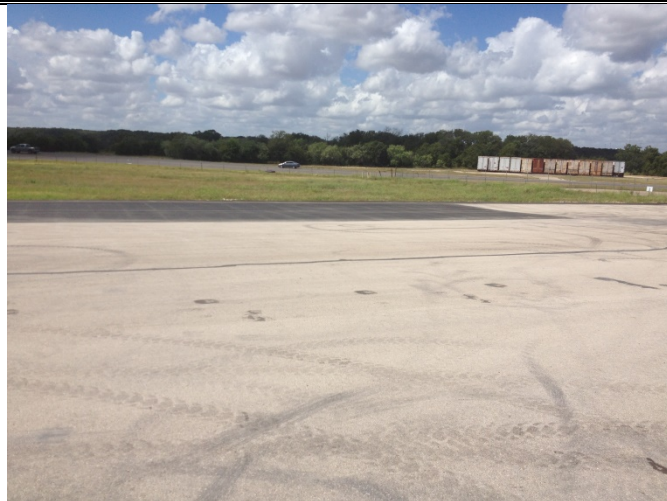
Photo 39: Facing southwest at newly patched and compacted area located on the southern side of the cover.

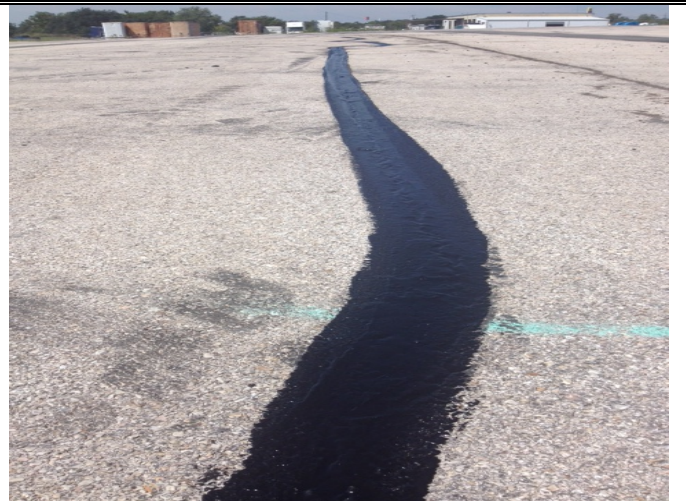
Photo 40: Facing west at a sealed crack.

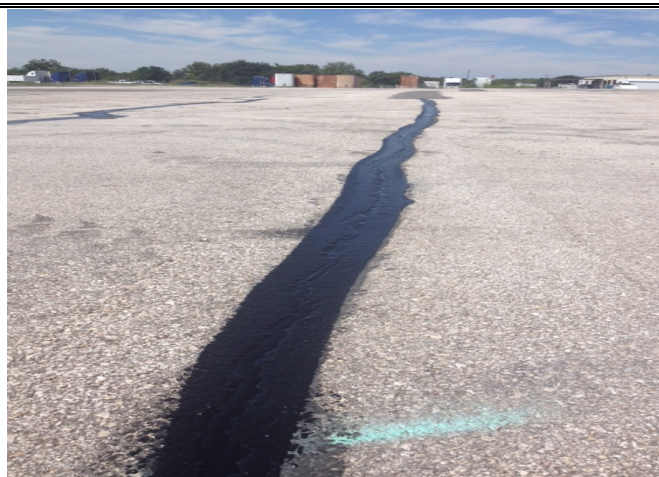
Photo 41: Facing west at a sealed crack

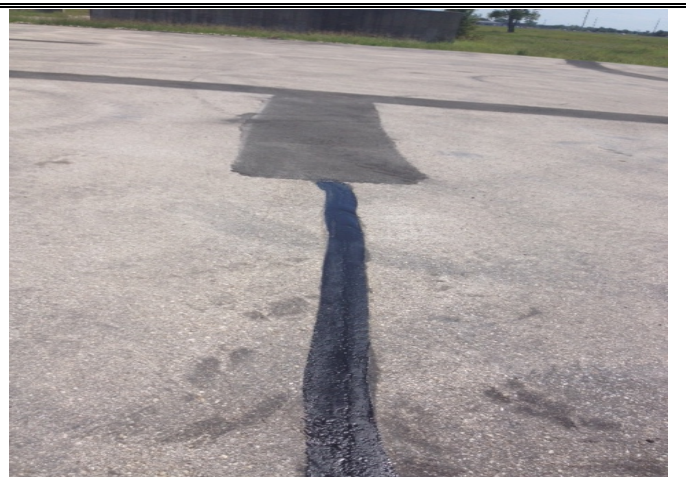
Photo 42: Facing east at a sealed crack.

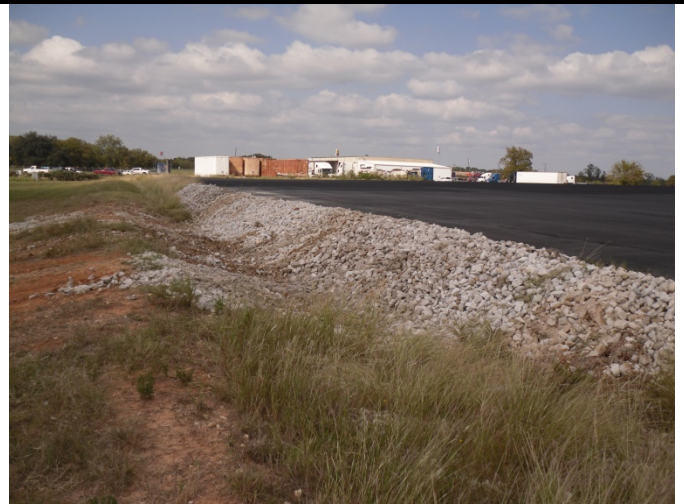
Photo 50: Facing west. View of constructed and re-enforced rip-rap located on the southern side of the HMA cover.

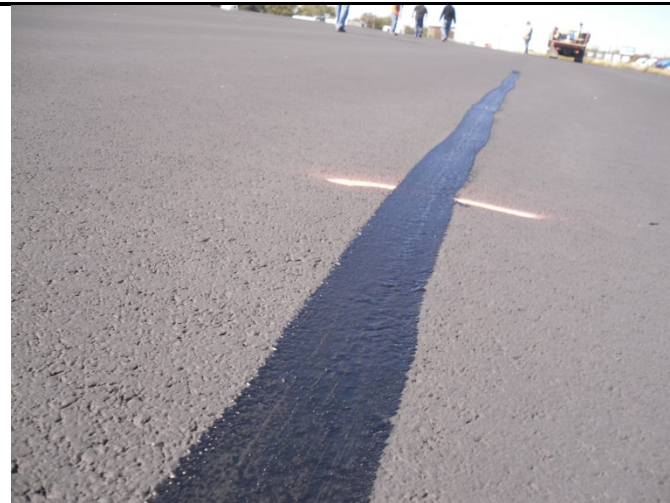
a pressure feed nozzle to penetrate the joint and completely fill each crack so that the top of sealant was not more than 1/8-inch above the pavement surface. Crack sealing material experienced settling in certain areas which required the repair contractor to reapply the crack seals to ensure that the seal was to grade, but not more than 1/8-inch above the pavement surface.

Photo 51: View of crack sealant applied to existing crack after settling occurred.

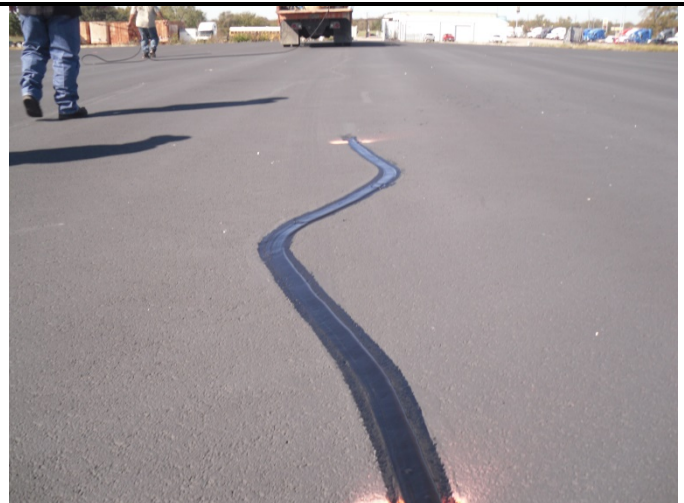
Photo 52: View of crack sealant applied to existing crack after settling occurred.
