**Initial Site Visit Report
Rockwool Industries, Inc.
Superfund Site
1741 Taylors Valley Rd
Belton, Texas 76513**

**Texas Commission on
Environmental Quality**

January 7, 2011

**Contract No.
582-10-91051
Work Order No.
248-0019**

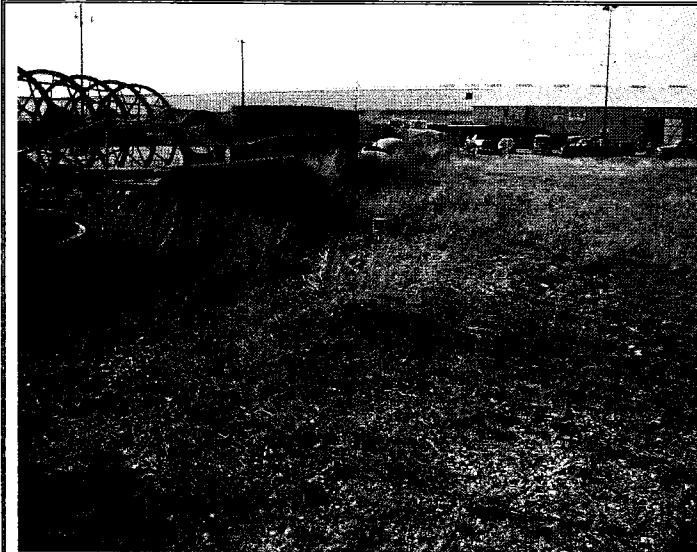
Photo #1

Description: Looking SSE at MW-21. Note fence damage.

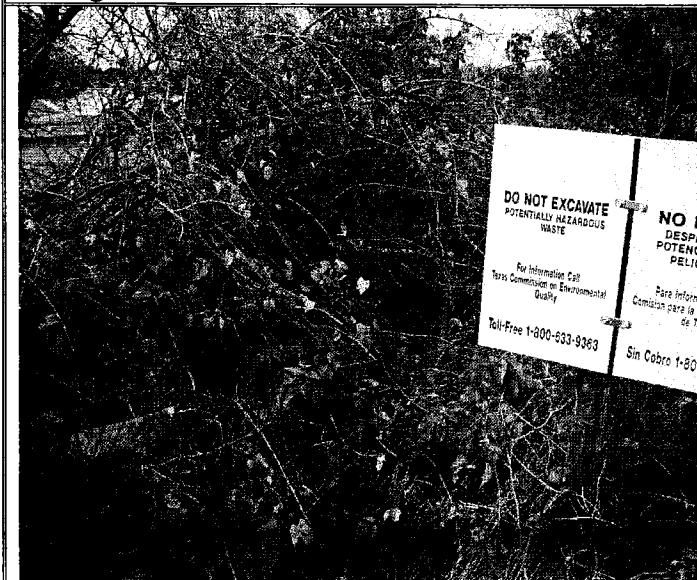
Photo #3

condition, however, MW-20 was found to be overgrown with a tree and brush (see photo #3) which will have to be removed in order to access the well.

Description: MW-20 with heavy vegetative growth on it.

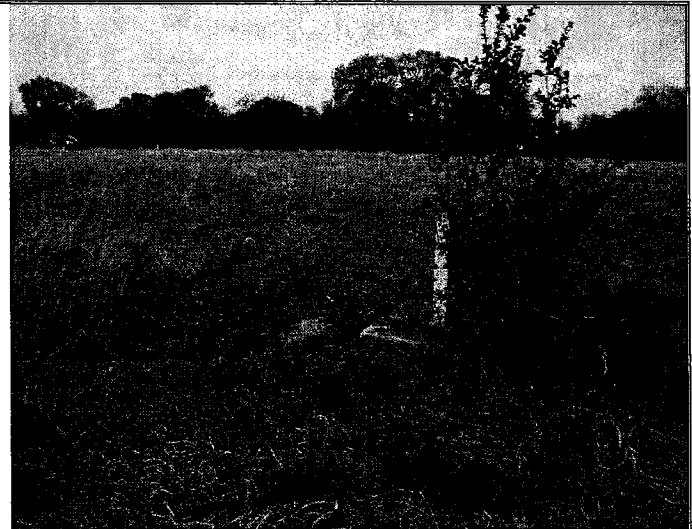
The North Property section of the site was the first portion of the property to be inspected, the area around the former evaporation lagoon was found to be fairly well maintained with grass/weeds dominating the vegetation (see photos #4 through #9). Monitoring wells MW-21, MW-22, MW-35-90, MW-36-90, MW-37-90, and MW-38-90 were found to be accessible and in good surface condition. MW-35-90, MW-36-90, MW-37-90, and MW-38-90 did not have protective pipe/bollards around their stub ups and MW-38-90 had a small brush/tree that needed to be removed (see photo #6).

Photo #6
Date: November 23, 2010
Description: MW-38-90 Looking north. Note vegetative growth

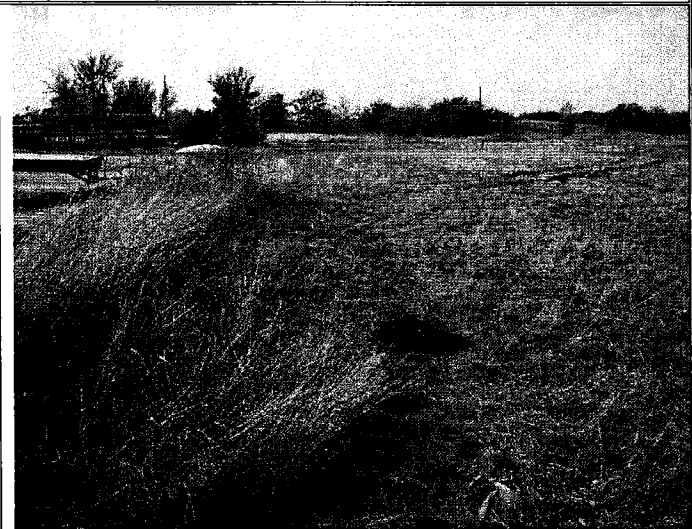
The fence is completely missing south of the former evaporation lagoon area on the north side of an asphalt parking lot used mainly by large trucks. Truck tracks are evident which cross into the North Property and extend to near the Leon River Embankment (see photos #8 and #9)

Photo #8
Date: November 23, 2010
Description: Boundary between asphalt parking area and North Property (S of former Evap. Lagoon). Note that fence is missing and truck tracks are evident onto site.

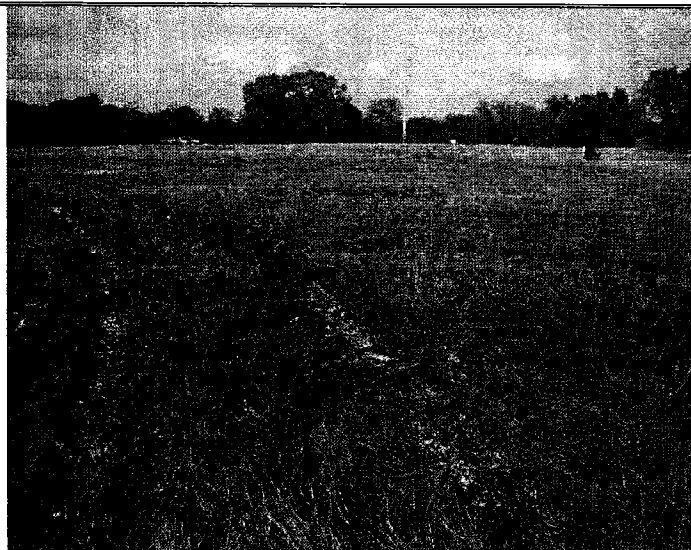
Photo #9

Description: Truck tracks across North Property site from asphalt parking lot.

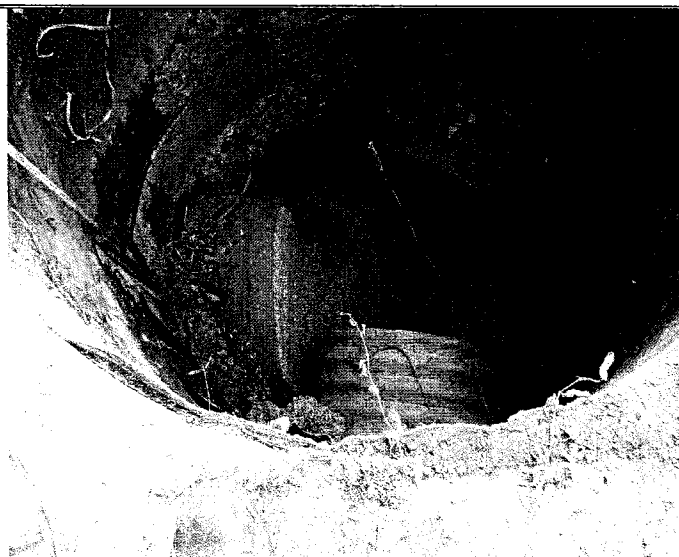
Photo #10

Description: Inside of culvert junction box. Note culvert from the east is plugged.

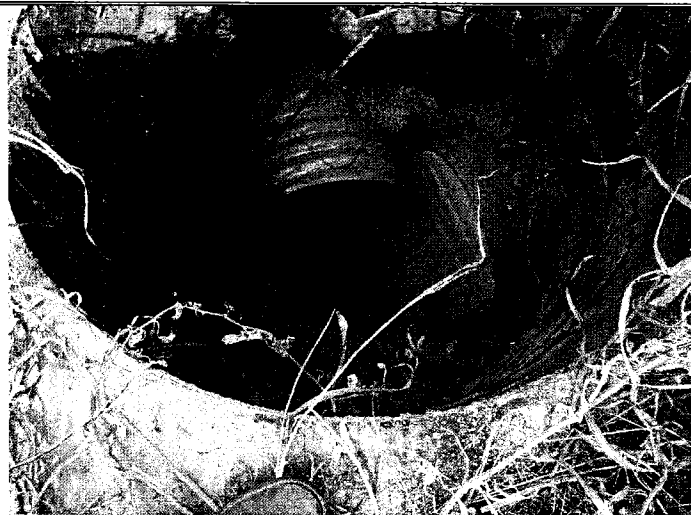
Photo #11

Description: Inside of culvert junction box. Note culvert from the east is plugged.

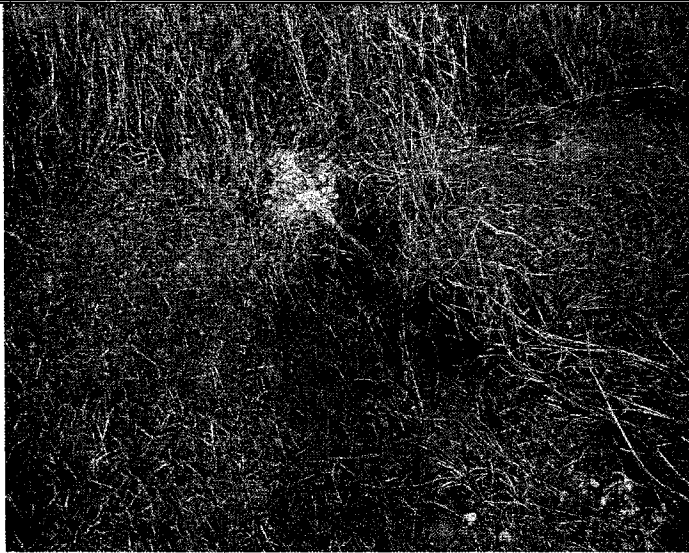
Photo #13

Erosion is evident between the former evaporation lagoon and north shot pile. An erosion channel approximately 3 feet wide and 3 feet deep has formed approximately 40 feet west of MW-35-90 running due north to the Leon River embankment (see photos #13 and #14). The erosion channel runs parallel to the existing underground drainage pipe. The underground drainage pipe was inspected and the outfall is full of trash and debris and needs to be cleaned out. No obvious erosion of the concrete blocks placed on the Leon River embankment were identified although significant vegetative growth prevented a detailed inspection.

Description: Erosion at the end of drainage swale west of former evap. lagoon on North Property. Looking north.

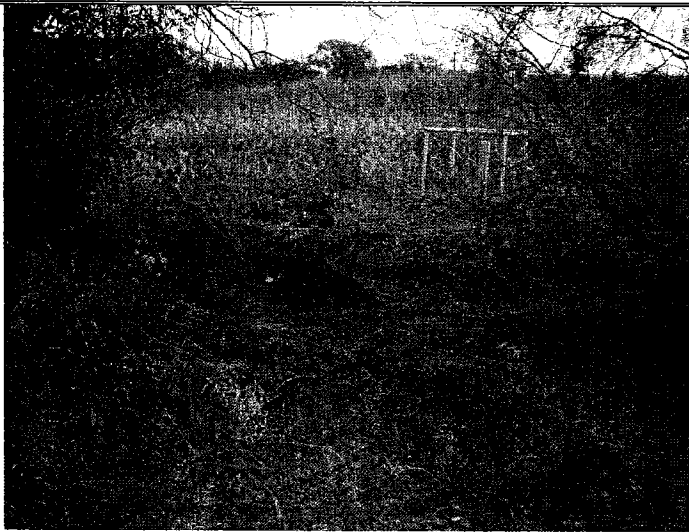
Photo #21

The fence is down near MW-15 between the North Shot Pile and the cemetery. (see photo #21)

Description: From Cemetery looking ENE at MW-15. Note downed fence.

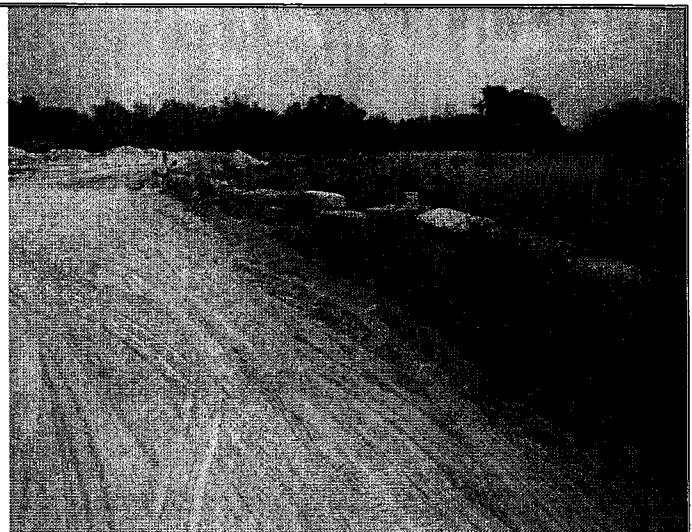
Photo #22

Description: From Concrete Plant looking NNE across landfill. Note signage and possible landfill encroachment.

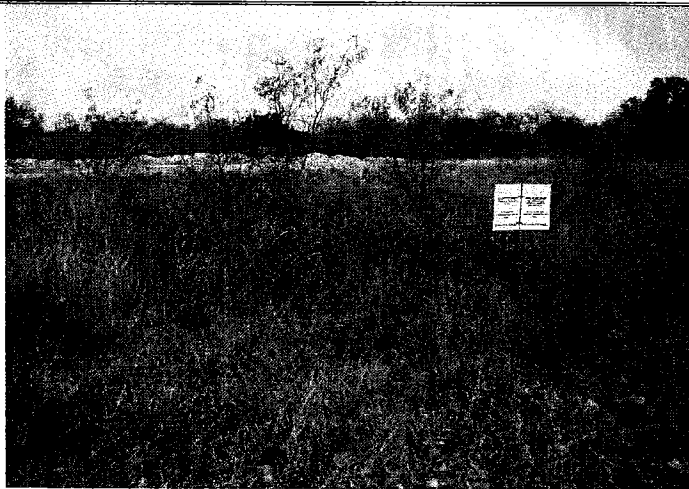
Photo #23

Description: From Cemetery looking NNW across landfill w/ cement facility disturbance in background.

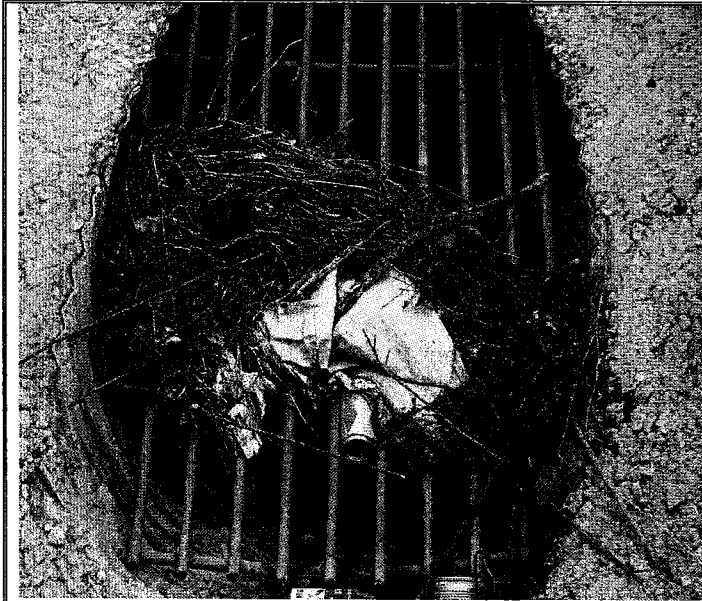
Photo #25

Description: Drainage inlet under landfill between cemetery and concrete plant. Note trash/debris.

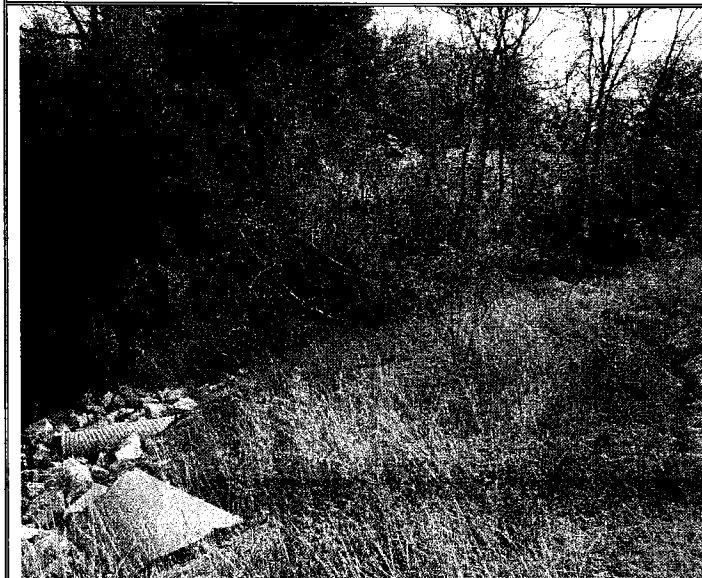
Photo #27

Description: Discharge to drainage culverts under landfill between cemetery and concrete plant. Note hay bales on slope above discharge.

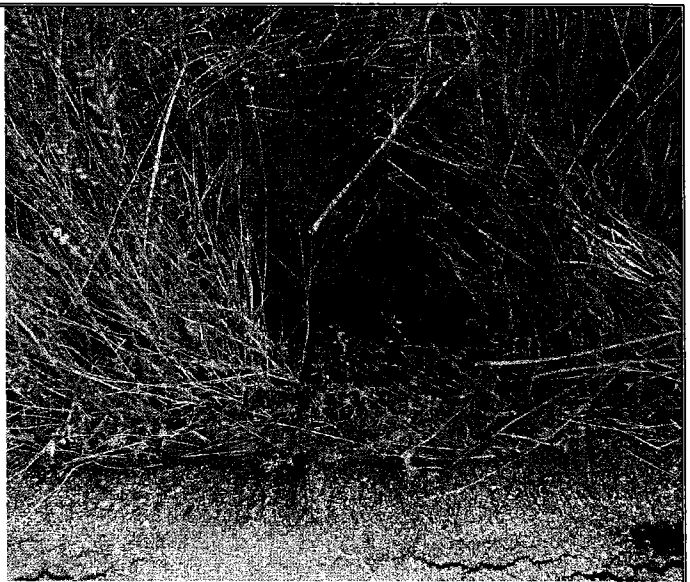
Photo #30

The containment cell cover (asphalt) appears to be in good shape with little to no cracks in the asphalt evident on the main cell. The boundary asphalt (last ~10 feet of the edge) is cracked

and some edge erosion was noted. Vegetative growth (mainly grasses) has been established in most of the cracks in the edge asphalt. A drainage berm surrounds the containment cell which directs runoff into a stormwater detention basin. Several small trees and brush vegetation has been established in the berms and drainage basin.

Description: Erosion along the edge of containment cell cap with erosion control netting exposed.

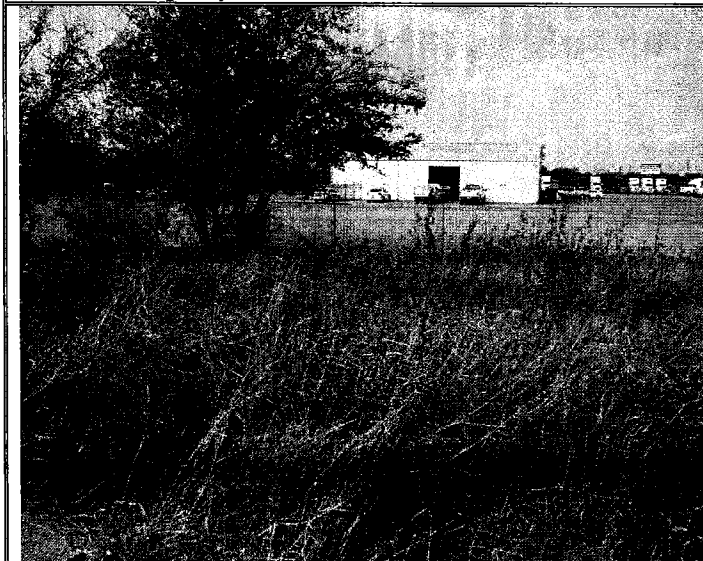
Photo #31

The perimeter fence is down/missing in sections along the western boundary, particularly in the southwest corner.

Description: Looking west from central edge of MATCON cover. Note fence is damaged/non existent.

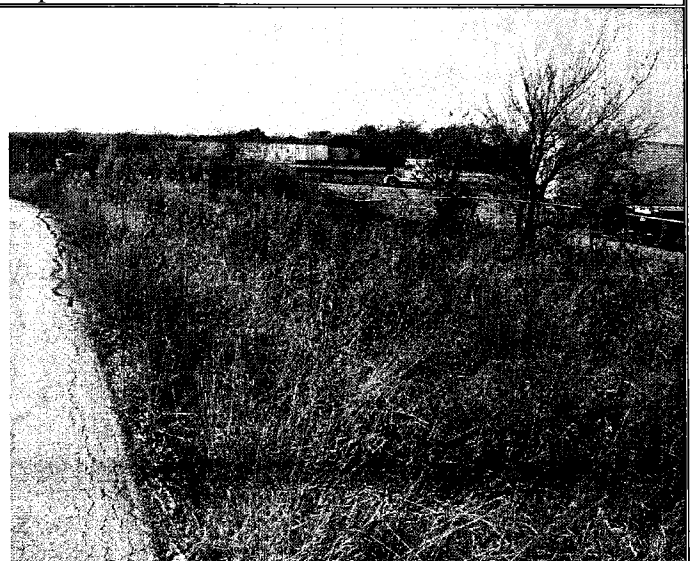
Photo #32

Description: Looking SW from central edge of MATCON cover. Note fence damaged.

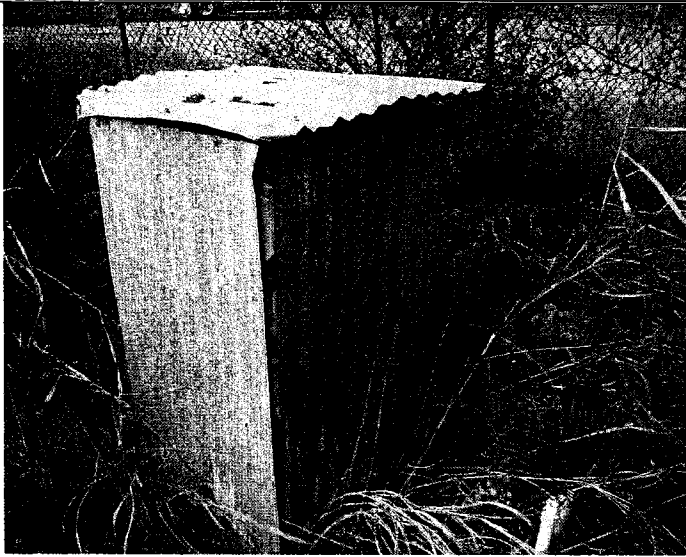
Monitor wells MW-27-90, MW-28-90, MW-29-90, MW-30-90, MW-33-90, MW-34-90, MW-7, MW-9, MW-10, MW-11, MW-16, and MW-17 were located around the containment cell. All of the monitor wells appeared to be in good condition and accessible, although some will require vegetative control measure (brush/tree removal). MW-7 appears to be an old domestic well and has a tin box covering that has a hinged roof. Access to MW-7 may be an issue during monitoring and MW-9 may be damaged.

Photo #33
Date: November 23, 2010
Description: MW-7 tin covered housing.

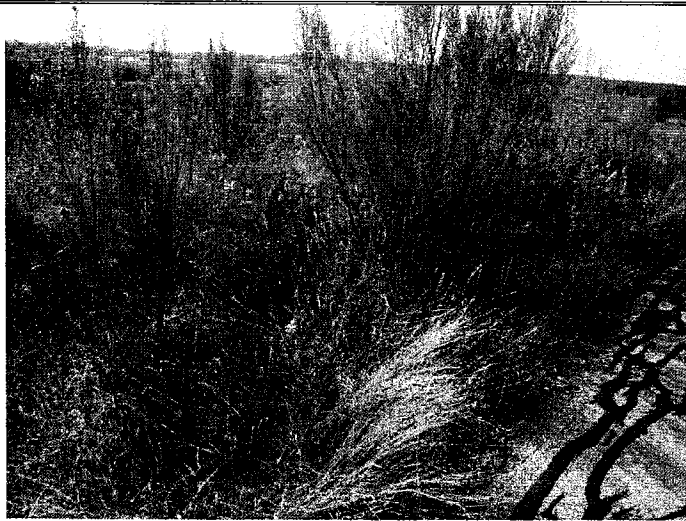
Photo #35
Date: November 23, 2010
Description: Salt Cedar and other vegetative growth in berm along southern edge of MATCON cover.

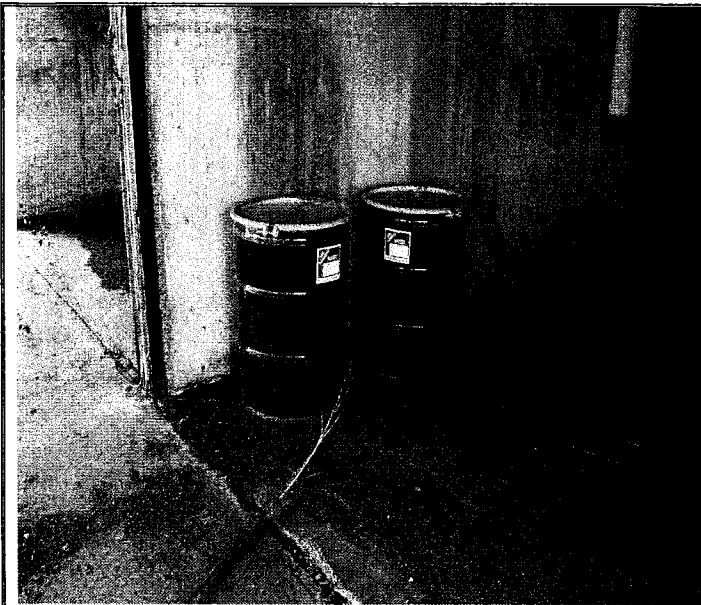
Photo #36

An existing building (former brick plant) is adjacent to the containment cell to the east and four drums with what appeared to be common trash was discovered in the building.

Description: Non-Haz Waste labeled drums in former brick plant building.

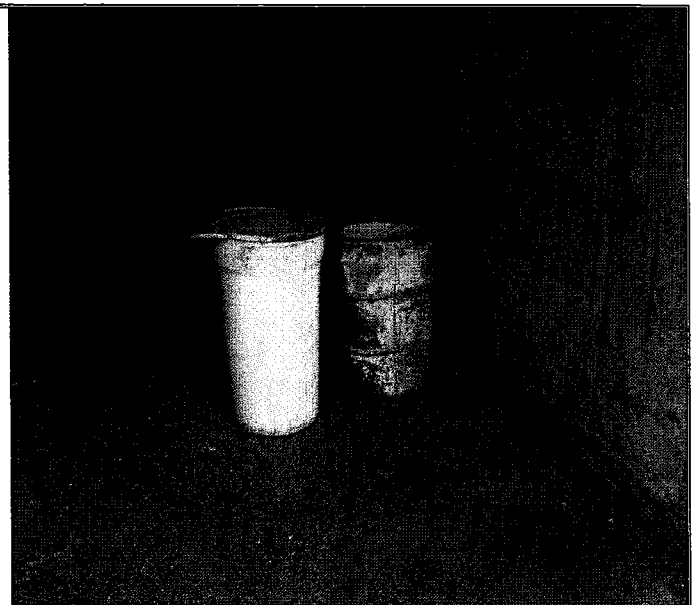
Photo #37

Description: Trash drums in former brick plant building.

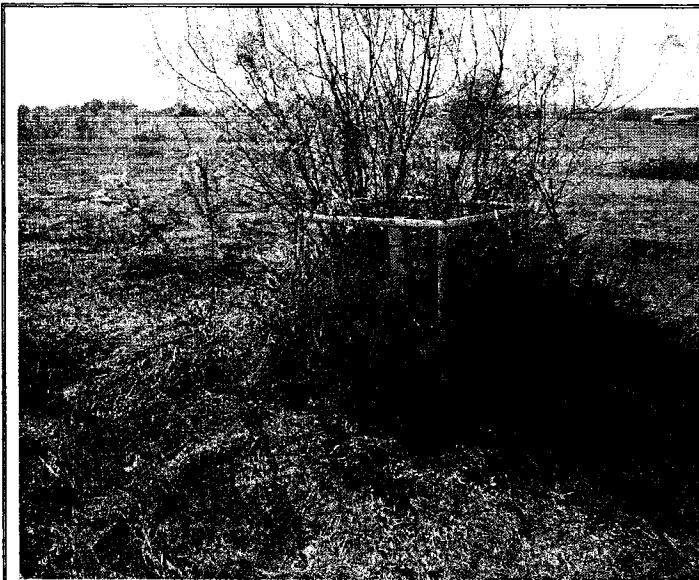
Photo #40

Description: MW-17 on the Central Property. Note mesquite and other vegetative growth.

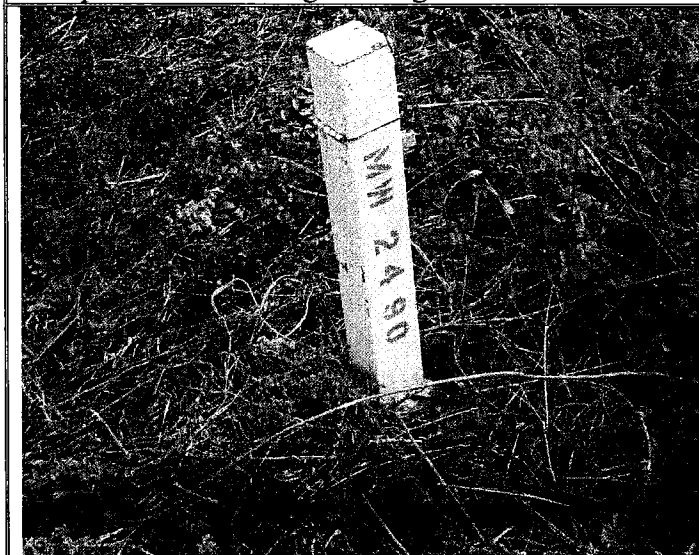
Photo #42

Description: MW-24-90 on the Central Property. Note lack of protective bollards/guard rail.

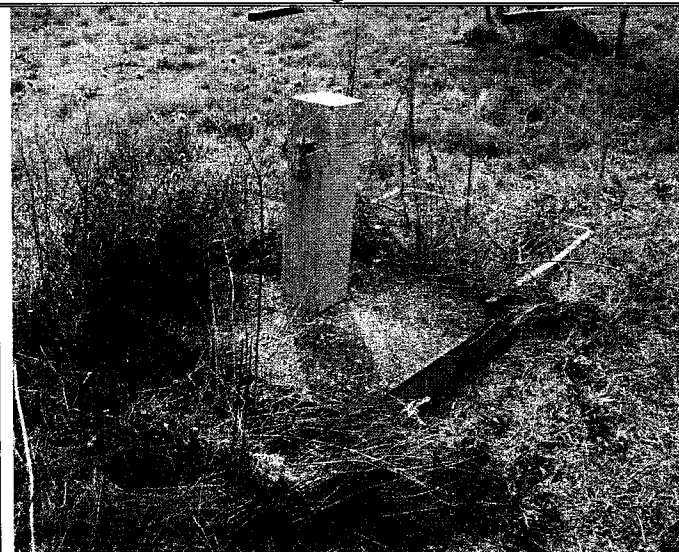
Photo #47

Description: MW-9 with possible damaged
wellhead.

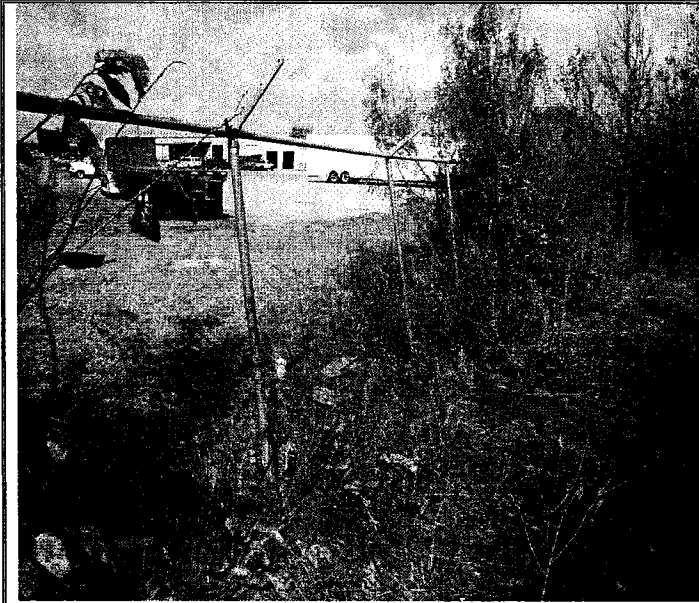
Photo #48

Description: From SW corner of Central Property looking NNW. Note missing fence chain links.

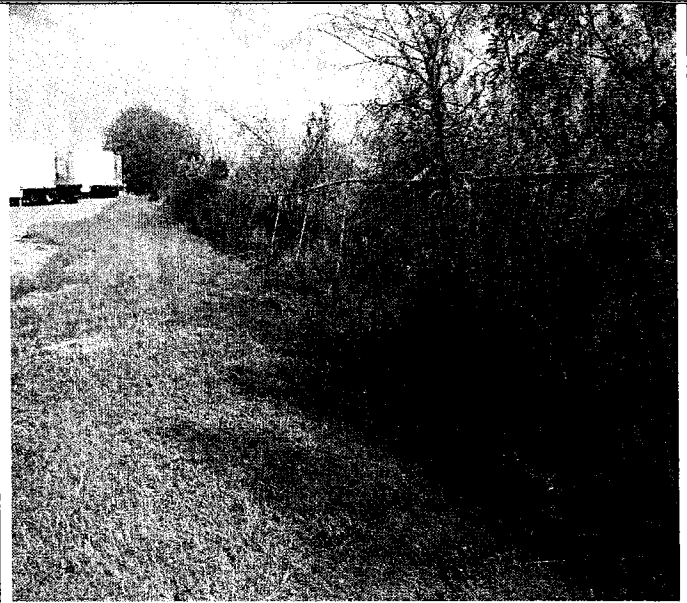
Photo #49

Description: From Adjacent property west of Central Property looking NNE. Note damaged fence.
