Meeting Date: 11/14/2023	NB #1
Agenda Item: Air Quality Testing Report for Town Hall	
Informational:	
Sevee & Maher Engineers was hired to do an air quality test on all three floors of the Town Hall. The Report shows that nothing was found to be at an unhealthy level despite the lack of air handling systems. Recommendations were also made in the report.	
Town Manager's Recommendation:	
To make a motion to accept the report from Sevee & Maher Engineers, for the air quality report the Town Hall.	
Requested Action:	
To make a motion to accept the report from Sevee & Maher Engineers, for the air quality report the Town Hall.	
Vote

Town Hall

180 Main Street, South Berwick, Maine

INDOOR AIR QUALITY/MOLD ASSESSMENT
SOUTH BERWICK TOWN HALL
180 MAIN STREET, SOUTH BERWICK, MAINE

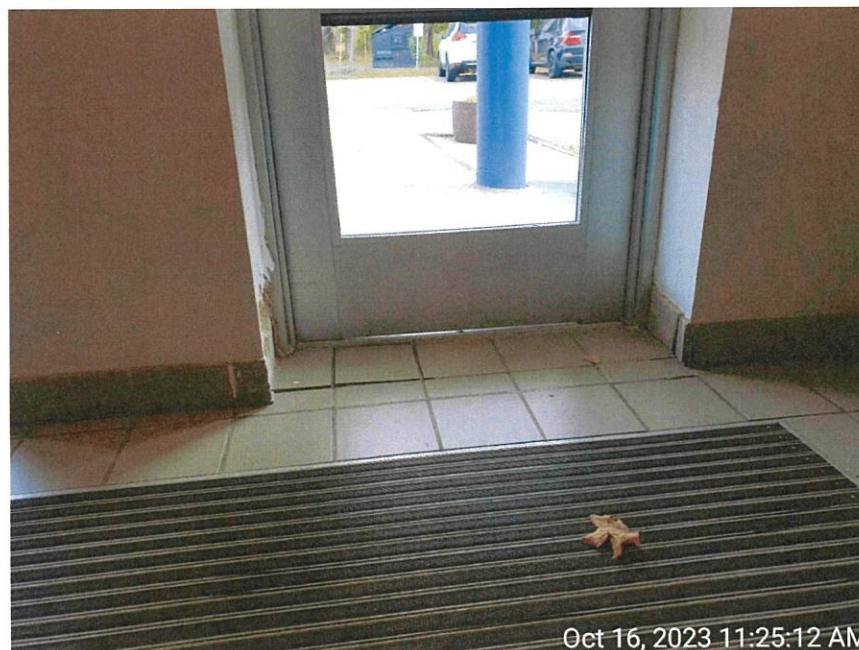
Water intrusion point for improperly sealed door threshold at first floor entry to elevator lobby area.

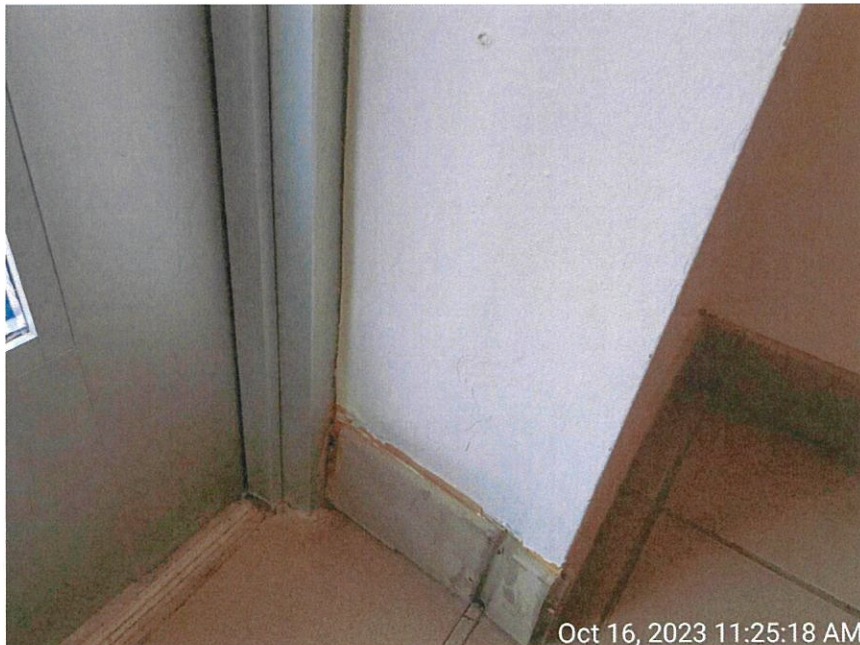
Water damaged lower wall plaster due to improperly sealed door threshold at first floor entry to elevator lobby area.

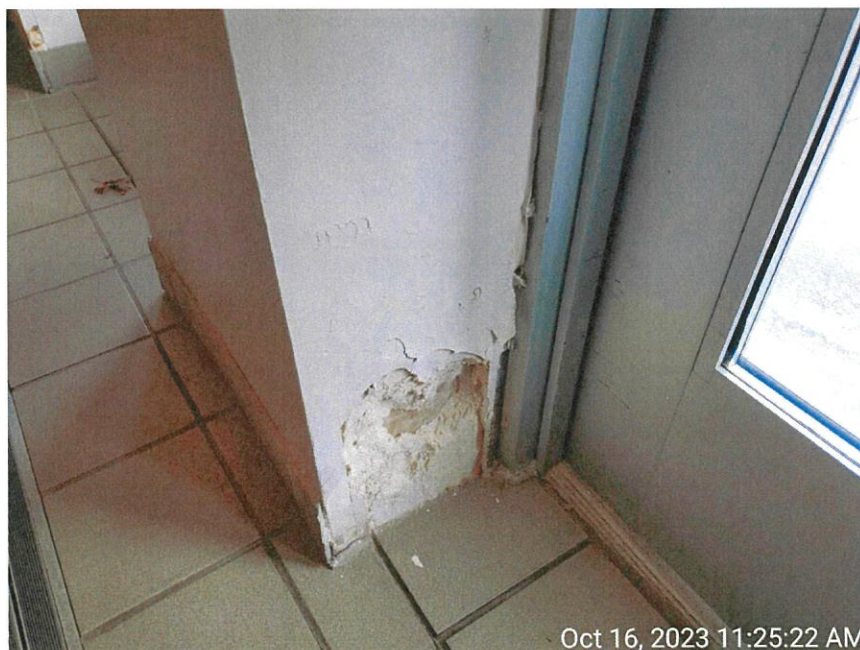
Water damaged lower wall plaster due to improperly sealed door threshold at first floor entry to elevator lobby area.

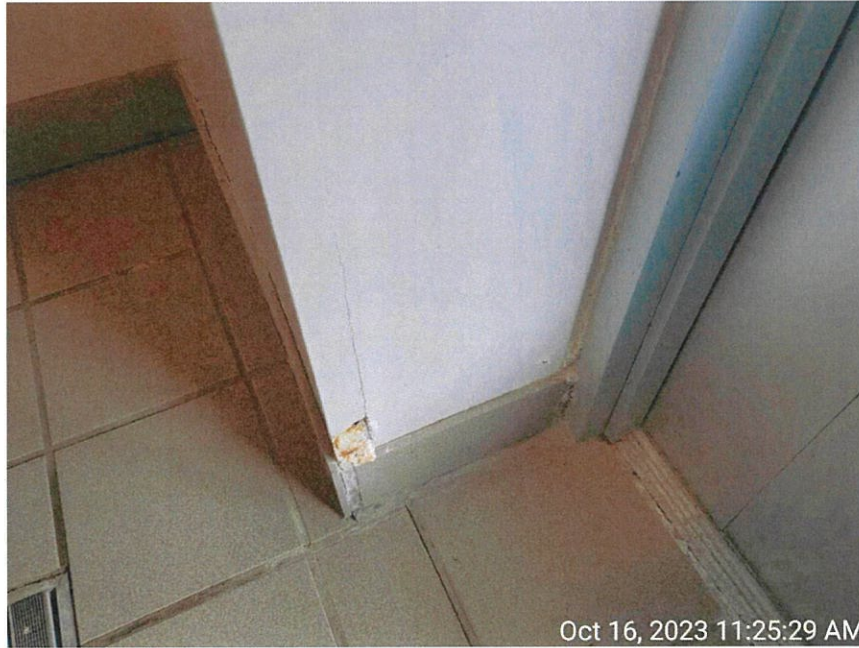
Water damaged lower wall plaster due to improperly sealed door threshold at first floor entry to elevator lobby area.

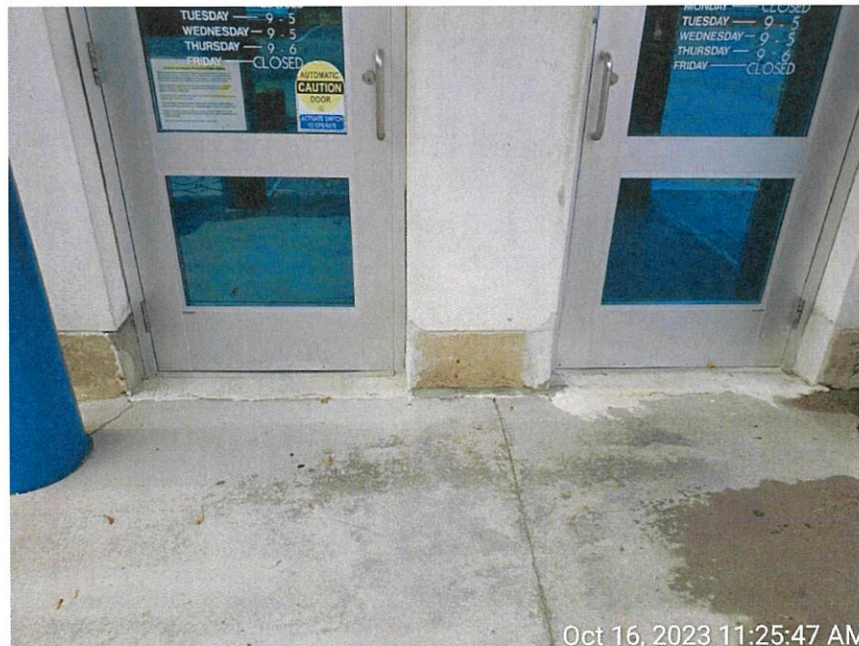
Water intrusion point for improperly sealed door threshold at first floor entry to elevator lobby area.

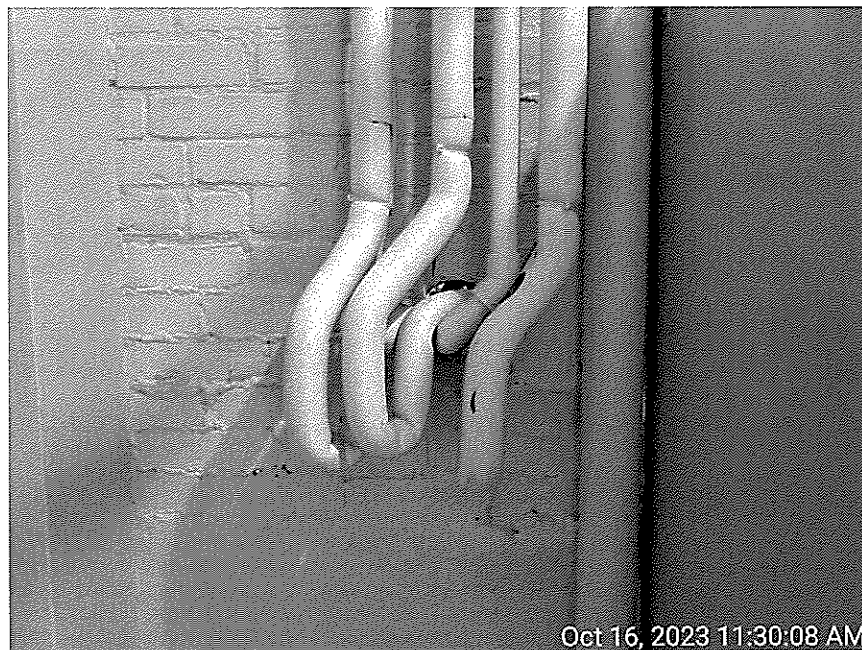
Improperly sealed penetrations in first floor former Police locker room.

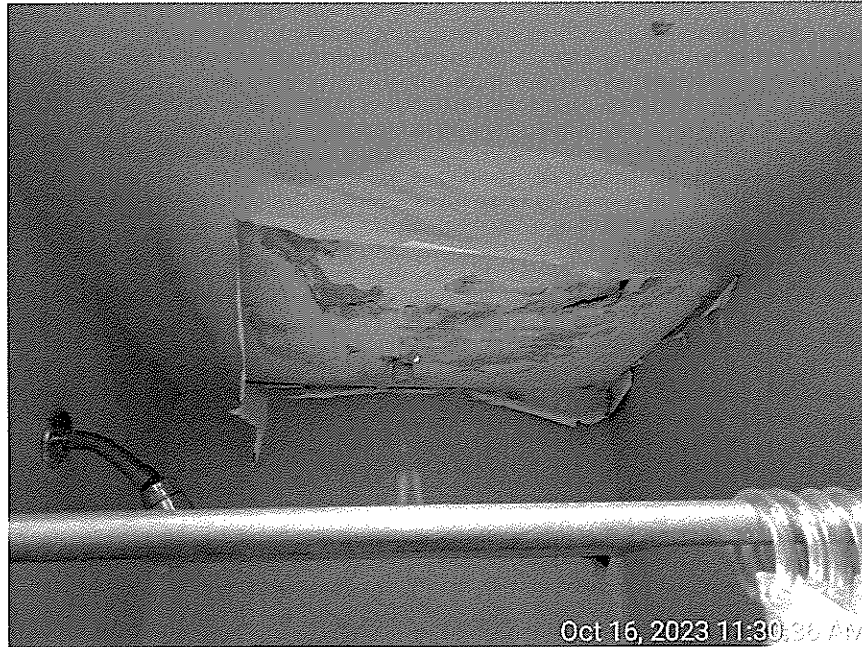
The former locker room has visual indications of historical moisture issues in the form of insect activity and the damaged drywall ceiling in the shower area.

Water damage ceiling in shower unit in first floor former Police locker room.

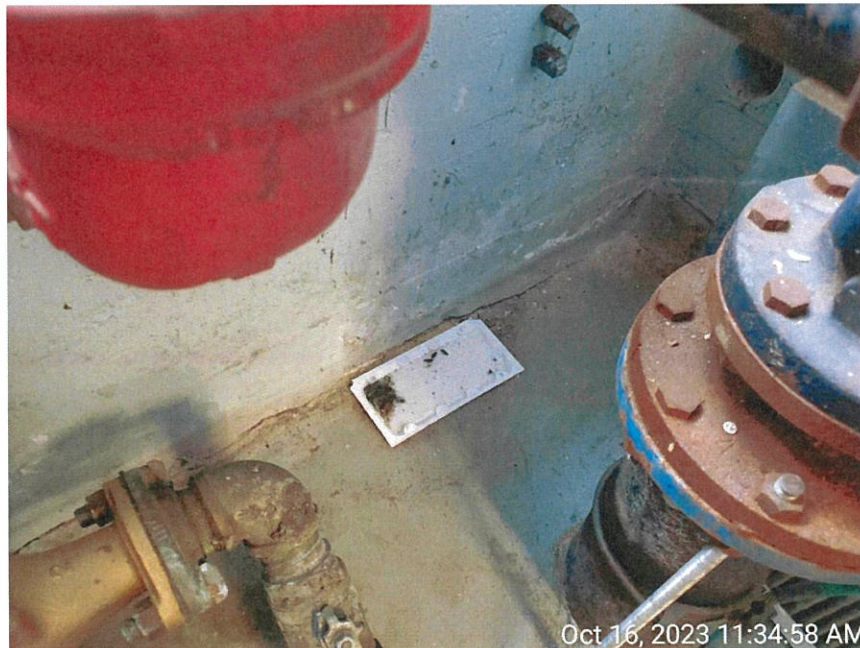
Dead rodents are present in the sprinkler utility room and appear to be entering via unsealed perimeter penetration. Additionally, the indications of elevated moisture levels for this building level are also supported by the insect activity observed.

Rodent carcass in first floor sprinkler room.

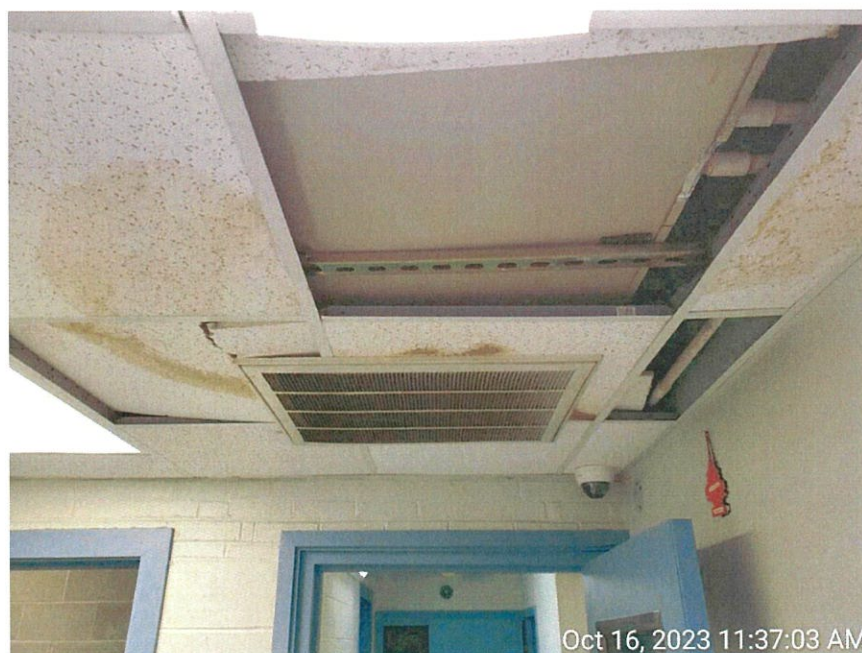
The air handler unit in the hallway adjacent to the former dispatch office has some significant ceiling tile staining and appears to be due to the air handling unit above the ceiling either having condensation issues or the drain pan line is clogged resulting in overflow.

Moisture damaged ceiling tiles due to air handler unit in ceiling on first floor outside former Police Dispatch Office.

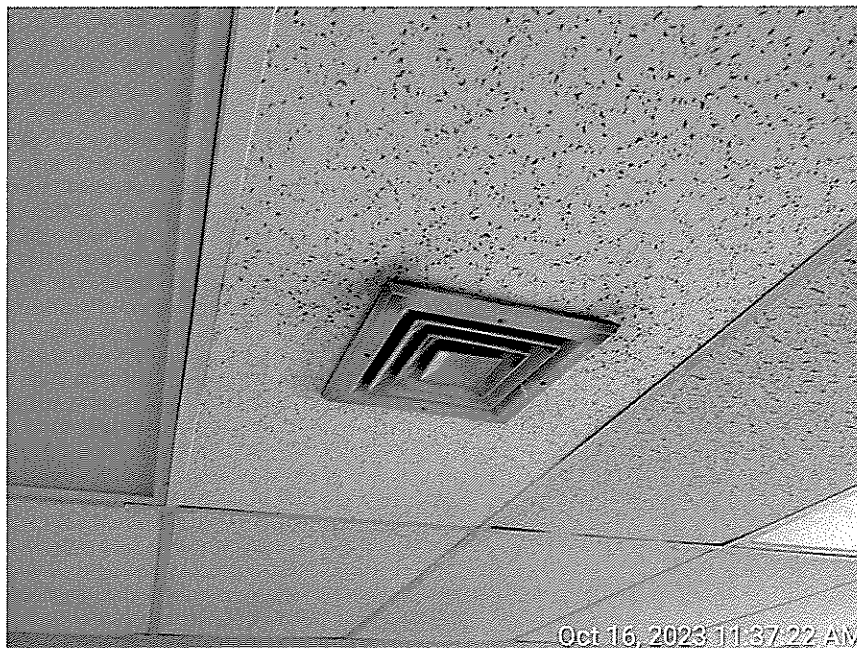
Dirty supply diffuser and ductwork on first floor in former Police Patrol Office.

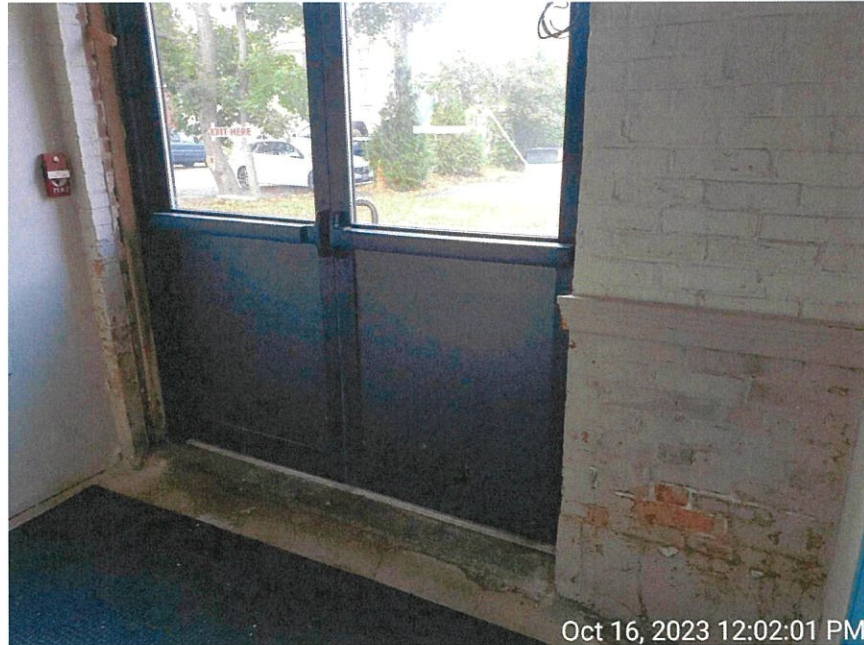
Moisture influences in first floor area causing peeling paint conditions.

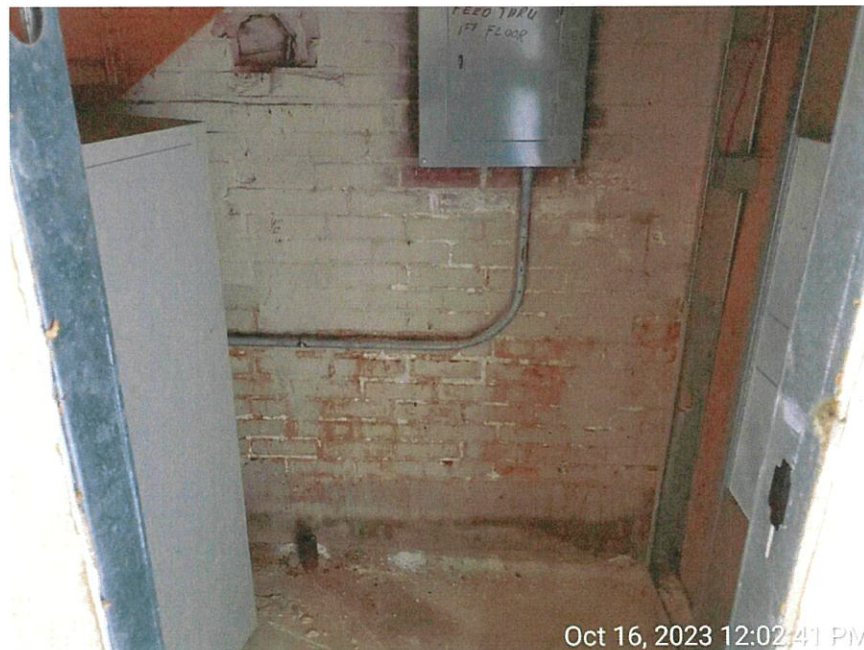
Moisture influences in first floor area causing peeling paint conditions.

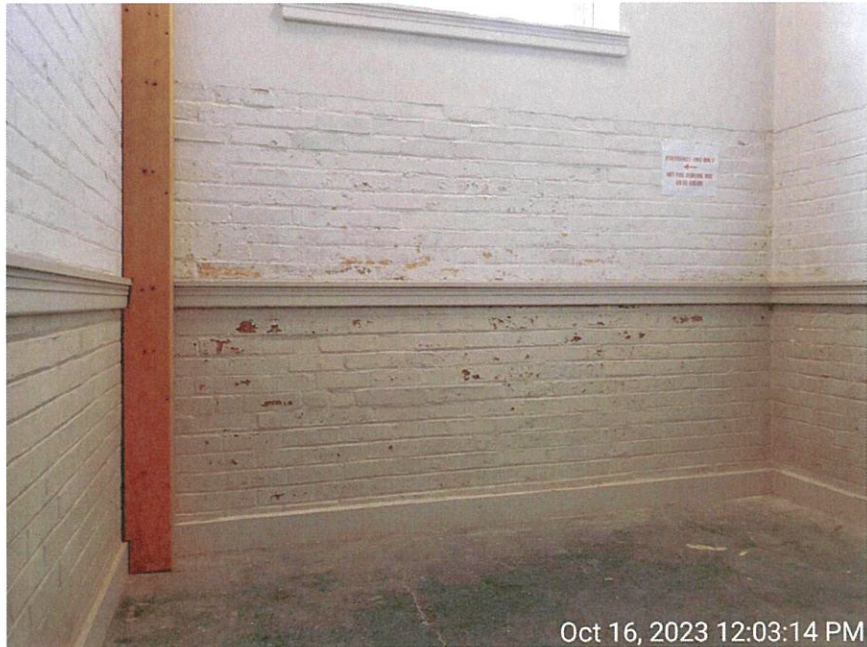
Moisture influences in first floor area causing peeling paint conditions.

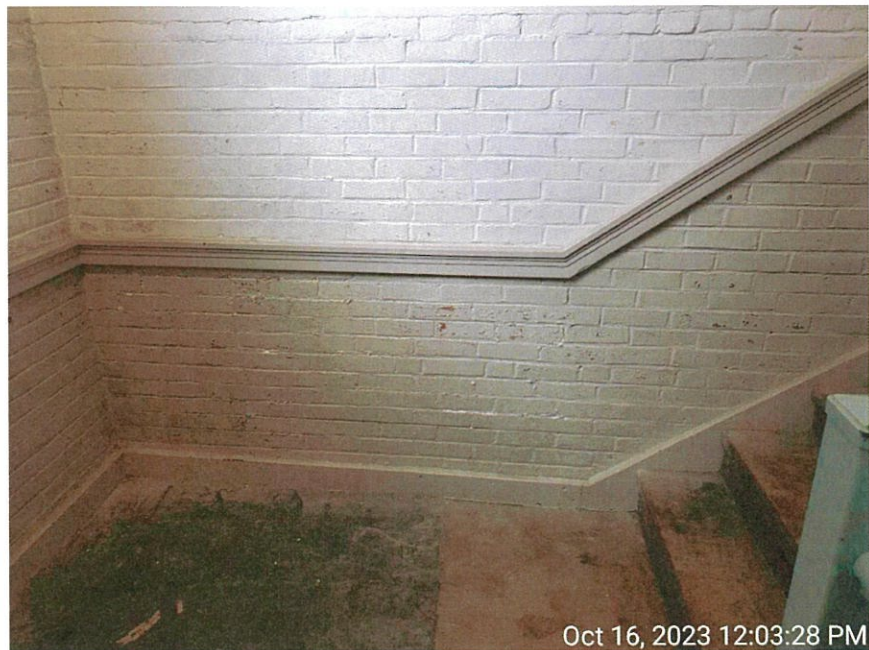
Moisture influences in first floor area causing peeling paint conditions.

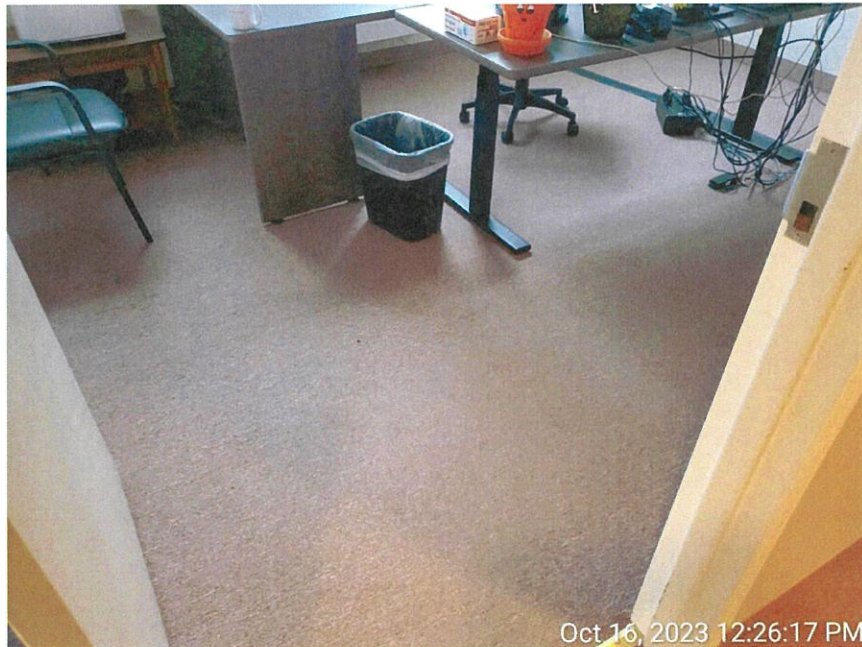
All carpeting on the second-floor areas were found to be worn and dirty. Particulate air sampling data indicates that this is resulting in elevated skin cells and miscellaneous fiber activity.

Worn/dirty carpeting on second floor in General Assistance Office.

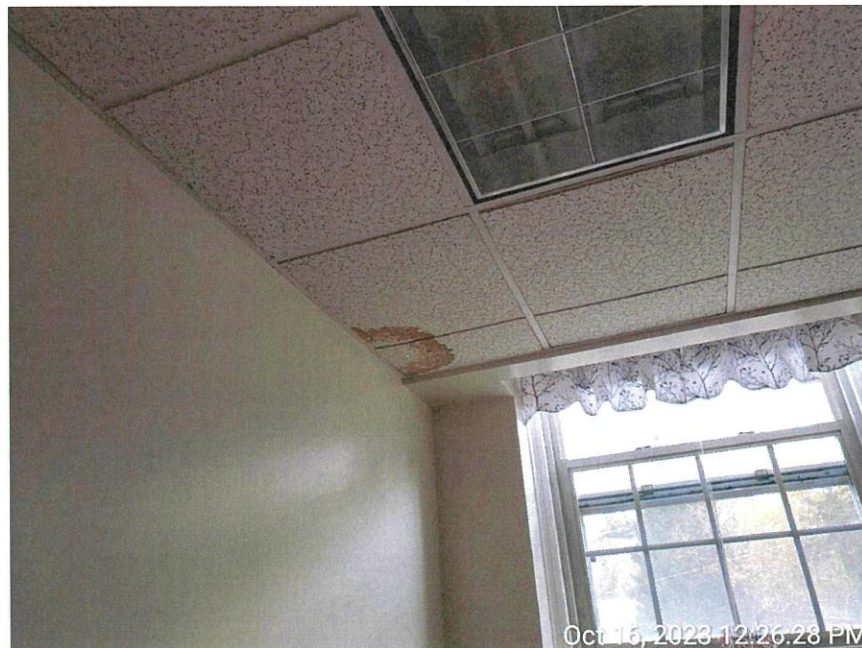
Water damaged ceiling tile on second floor in General Assistance Office.

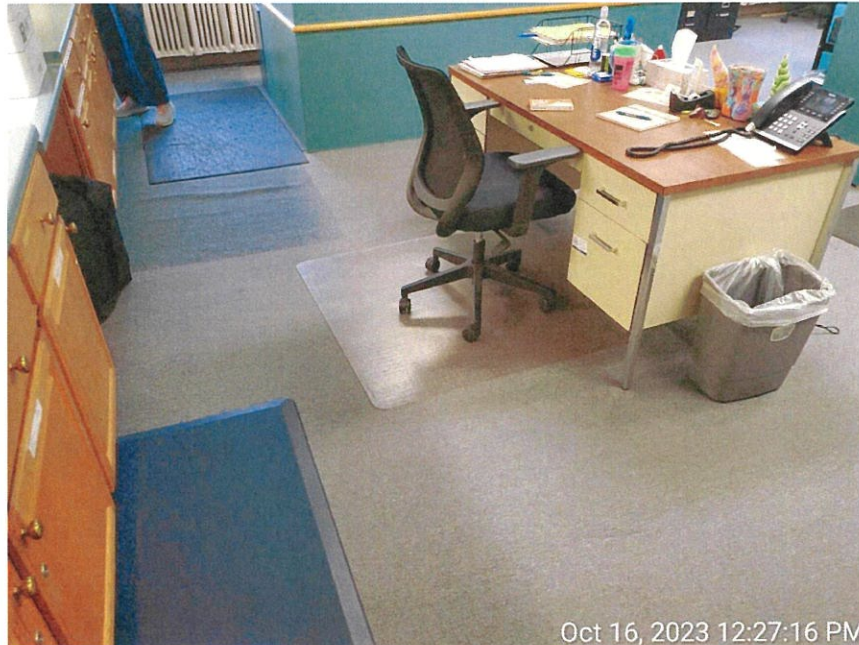
Worn/dirty carpeting on second floor in Town Clerk Offices.

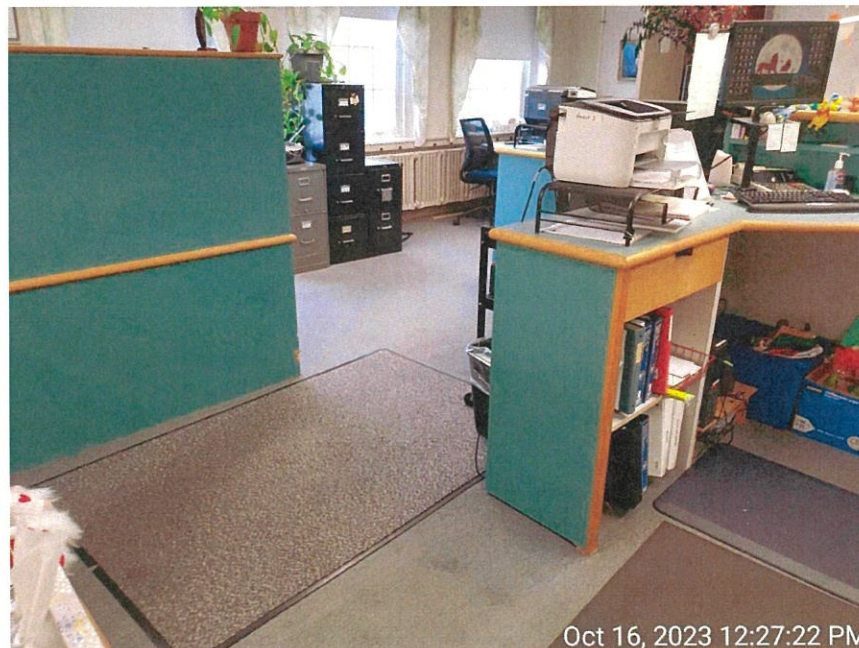
Worn/dirty carpeting on second floor in Town Clerk Offices.

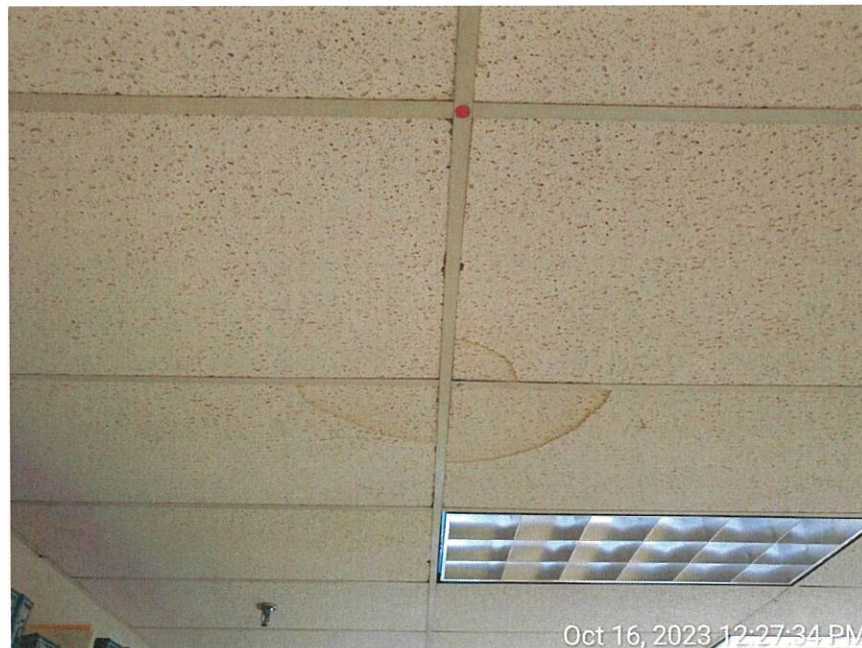
Water-stained ceiling tiles dirty return diffuser and ductwork on second floor in Town Clerk Offices.

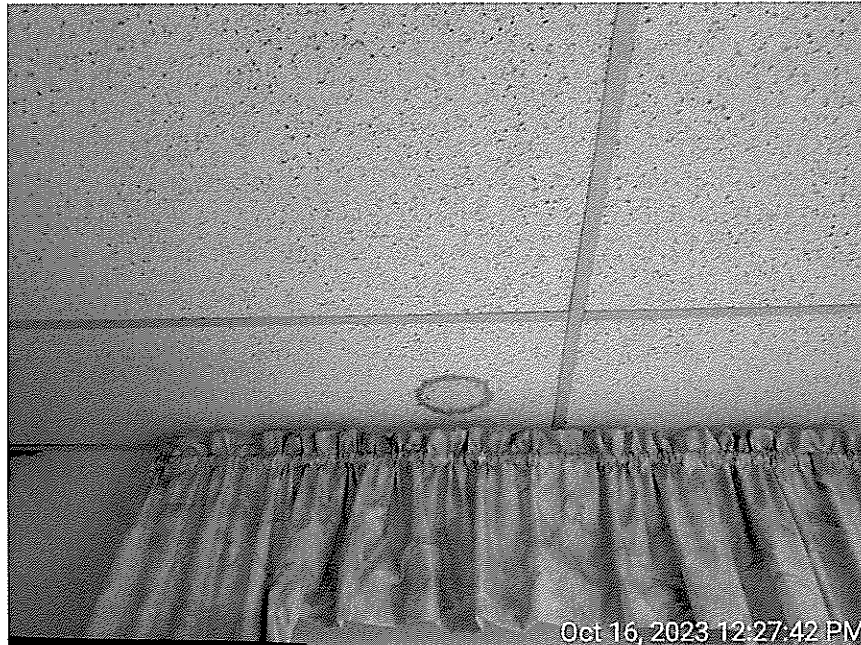
Water-stained ceiling tile on second floor in Town Clerk Offices.

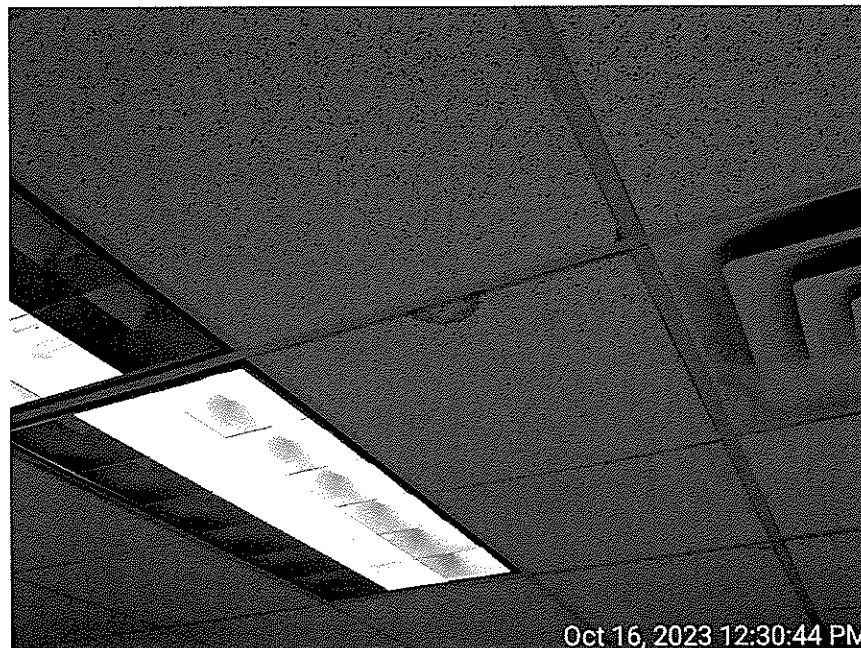
Water-stained ceiling tile on second floor in Assessing Offices.

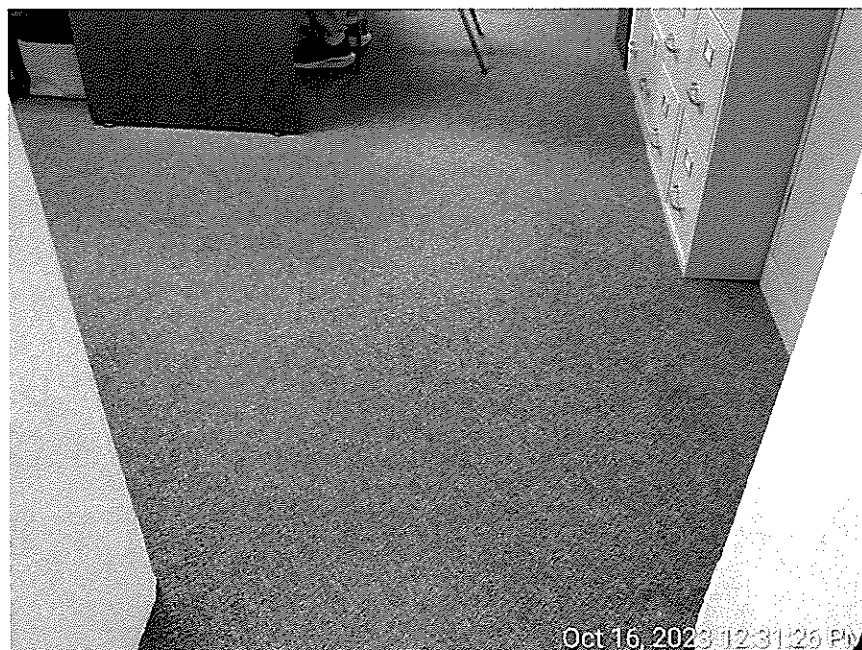
Worn/dirty carpeting on second floor in Asst. Town Mgr./HR/Finance Offices.

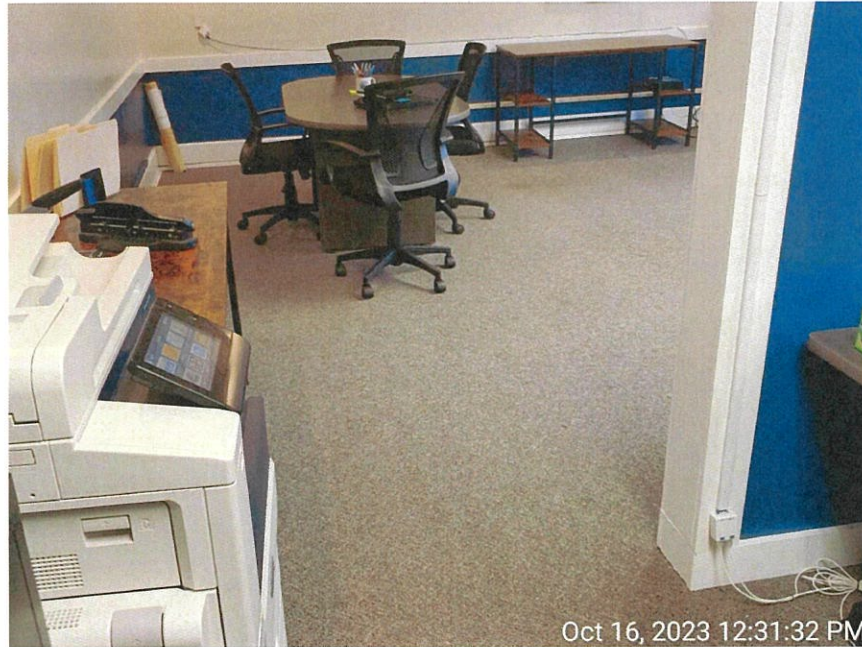
Worn/dirty carpeting on second floor in Asst. Town Mgr./HR/Finance Offices.

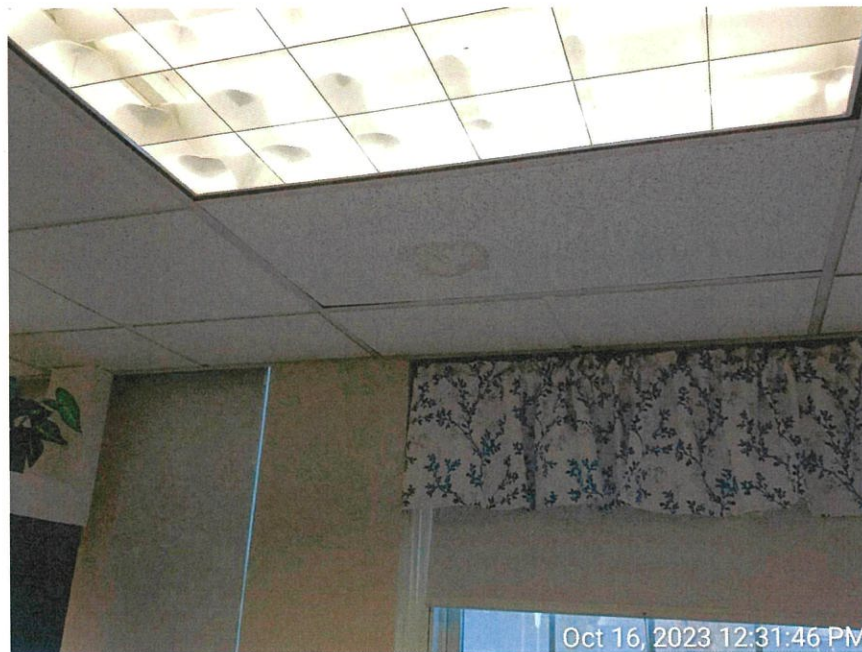
Water-stained ceiling tile on second floor in Asst. Town Mgr./HR/Finance Offices.

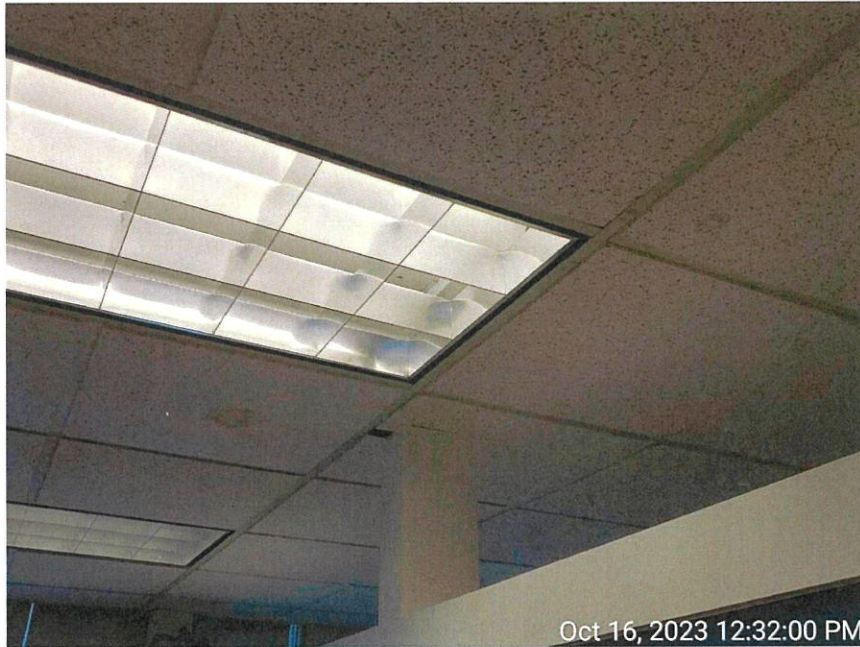
Water-stained ceiling tiles on second floor in Asst. Town Mgr./HR/Finance Offices.

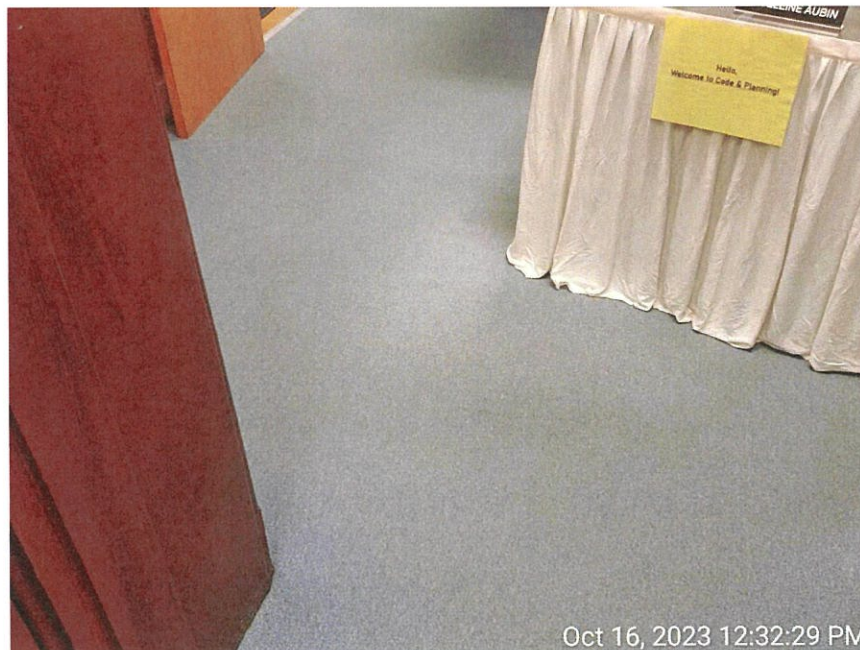
Worn/dirty carpeting on second floor in Codes/Planner Offices.

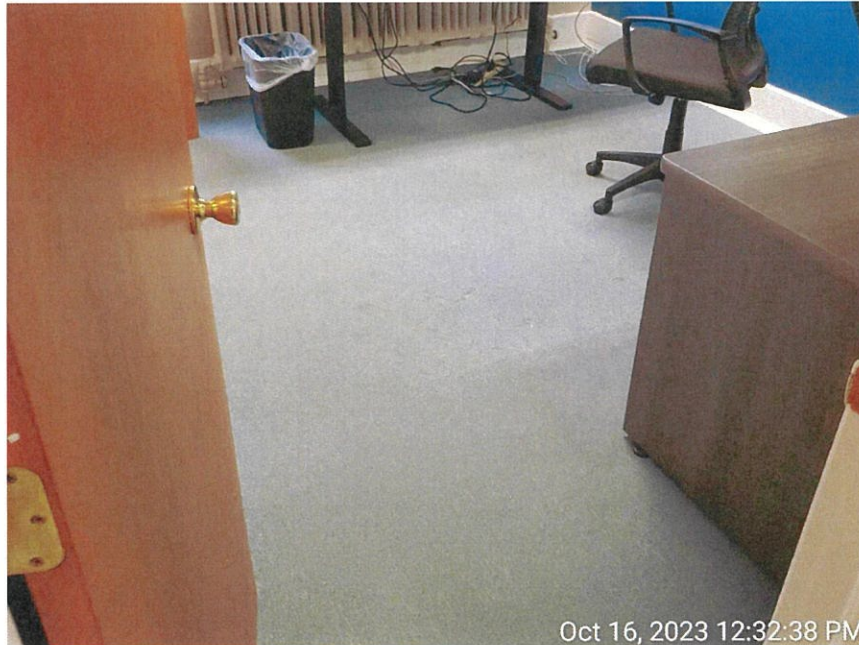
Worn/dirty carpeting on second floor in Codes/Planner Offices.

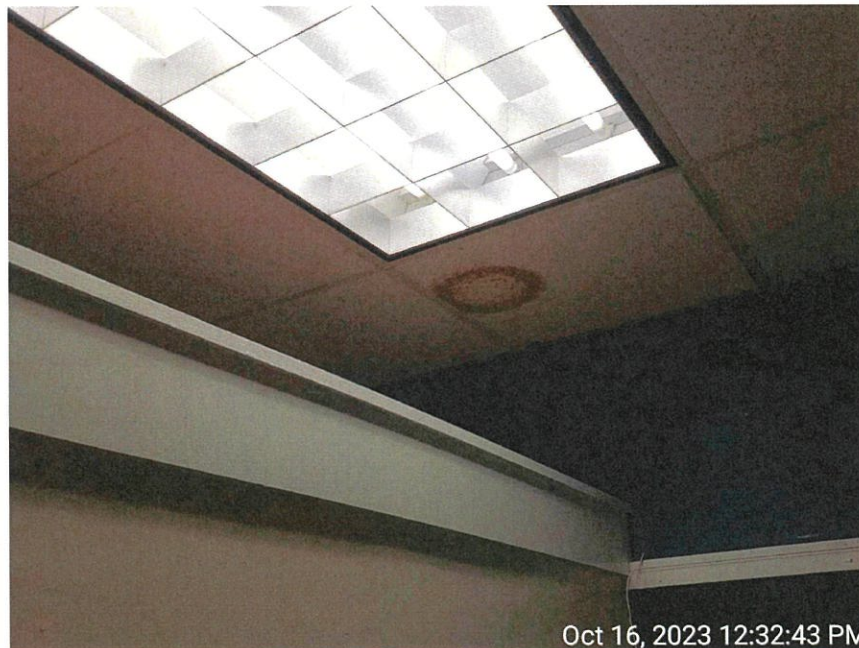
Water-stained ceiling tile on second floor in Codes/Planner Offices.

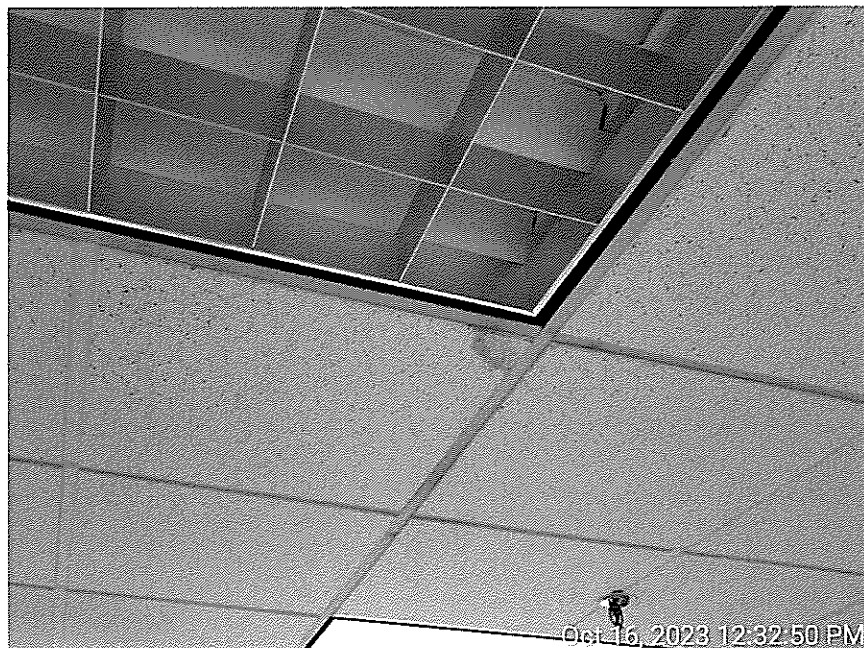
Water-stained ceiling tile on second floor in Codes/Planner Offices.

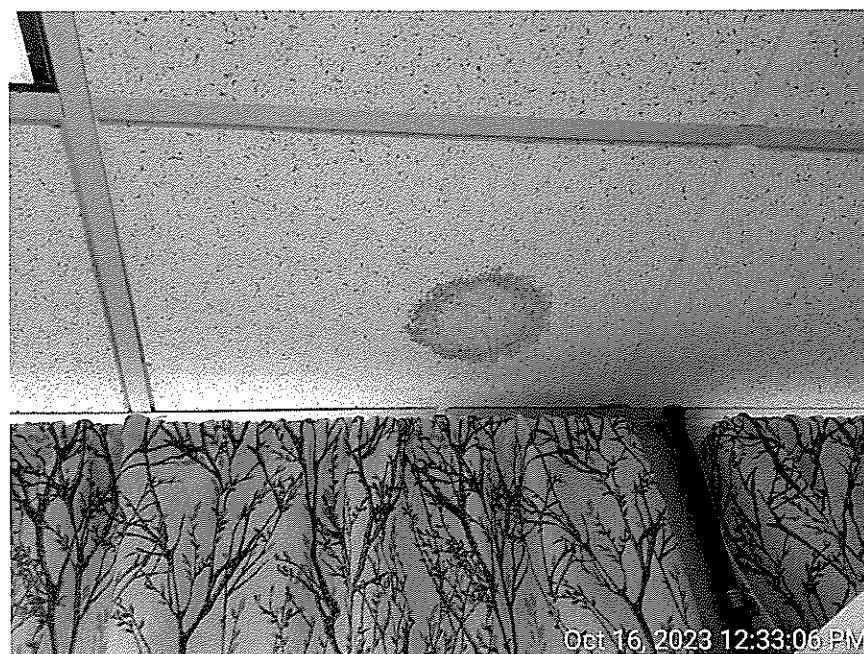
Water-stained ceiling tile on second floor in Codes/Planner Offices.

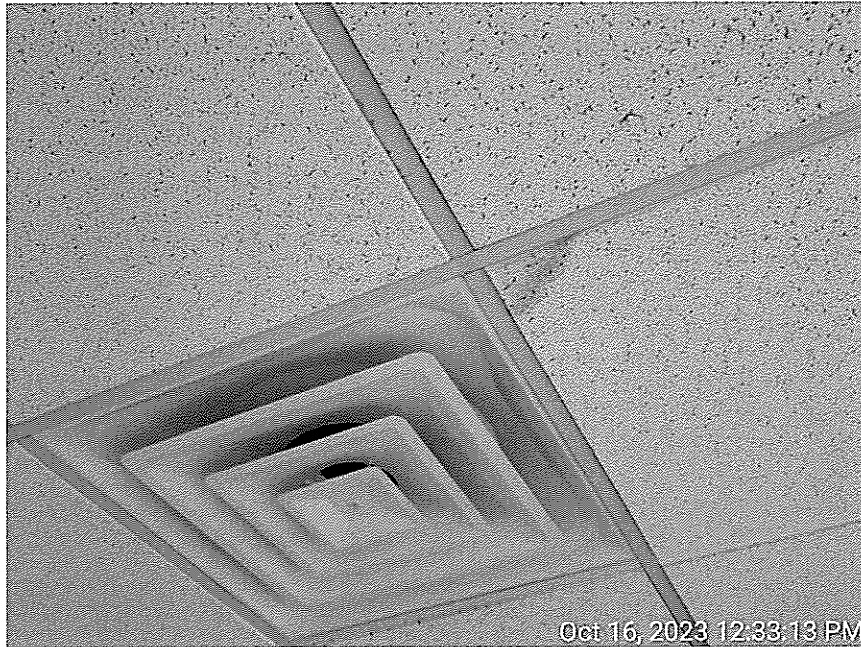
Water-stained ceiling tile on second floor in Codes/Planner Offices.

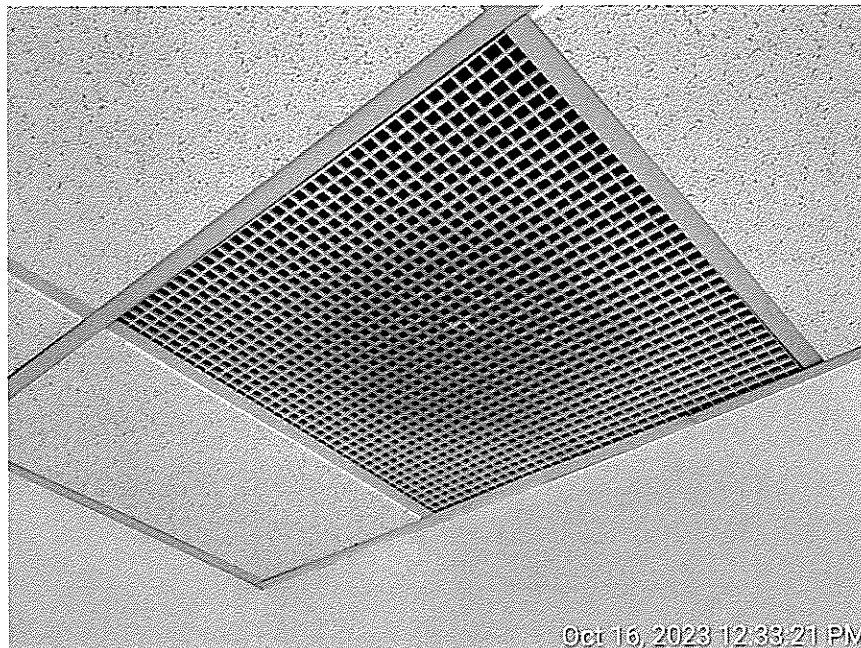
Dirty return diffuser and ductwork on second floor in Codes/Planner Offices.

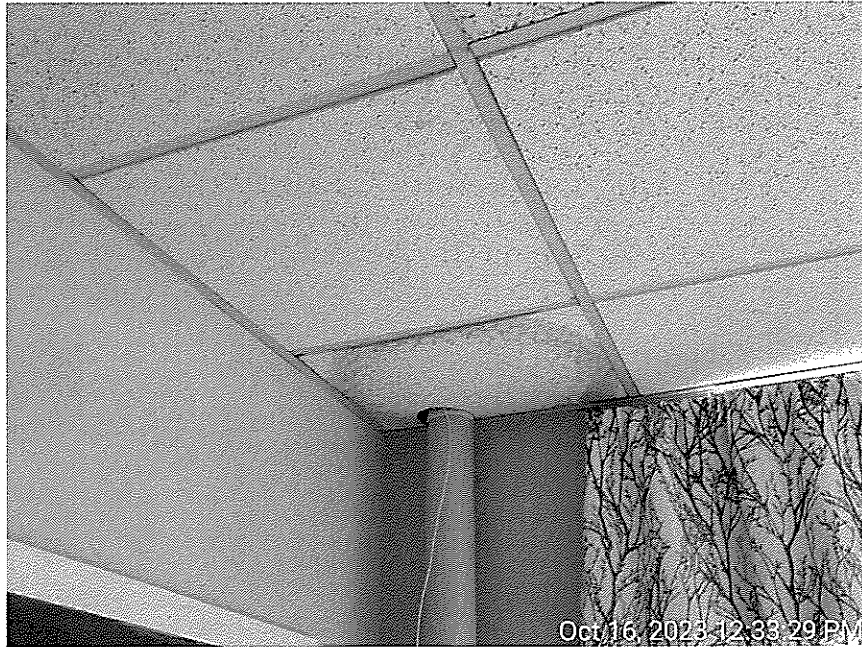
Water-stained ceiling tile on second floor in Codes/Planner Offices.

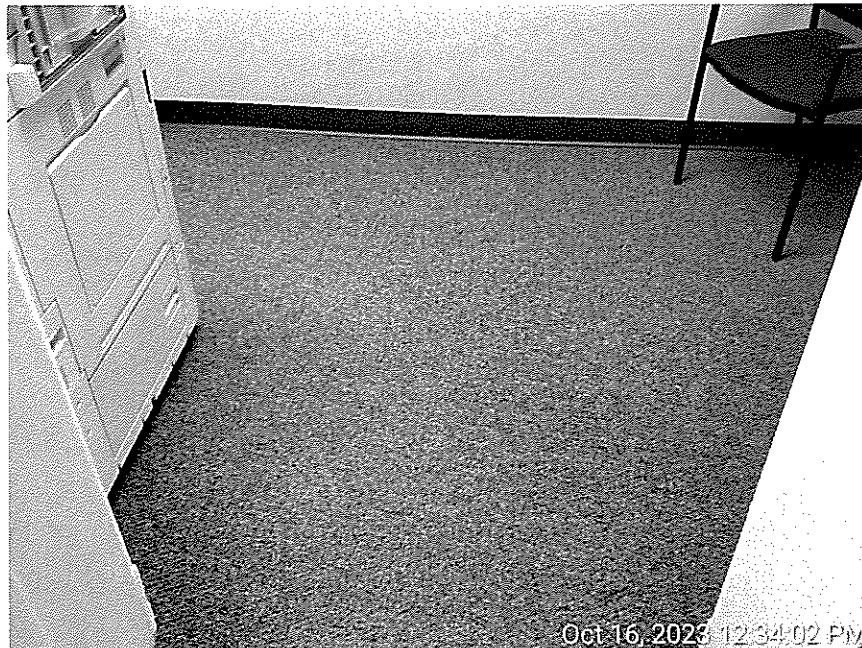
Worn/dirty carpeting on second floor in Twon Manager Offices.

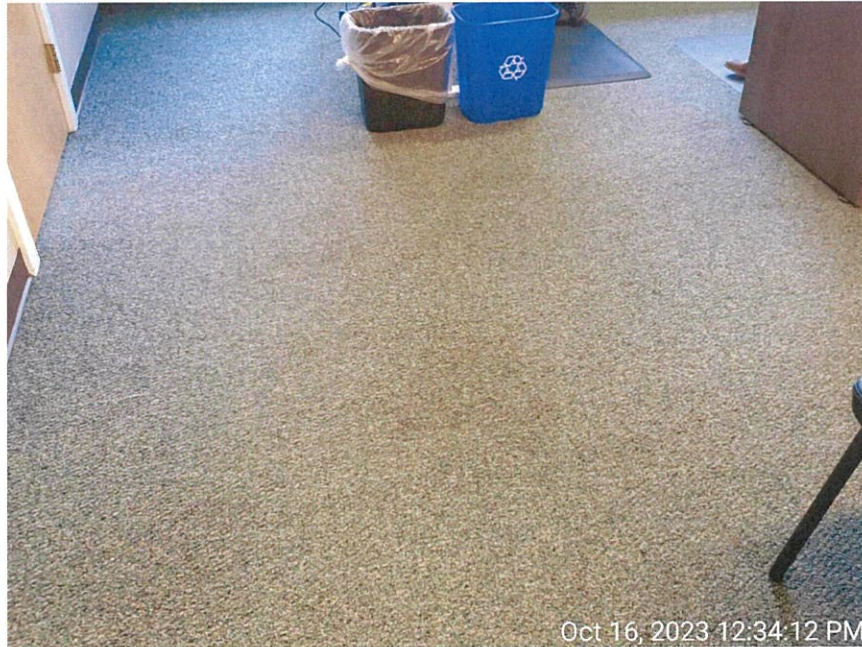
Worn/dirty carpeting on second floor in Twon Manager Offices.

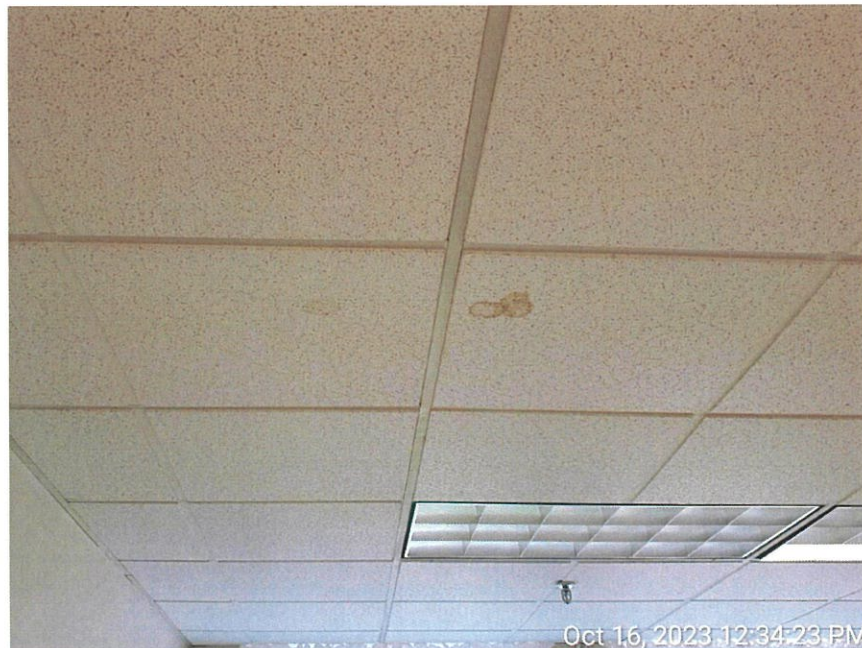
Water-stained ceiling tiles on second floor in Twon Manager Offices.

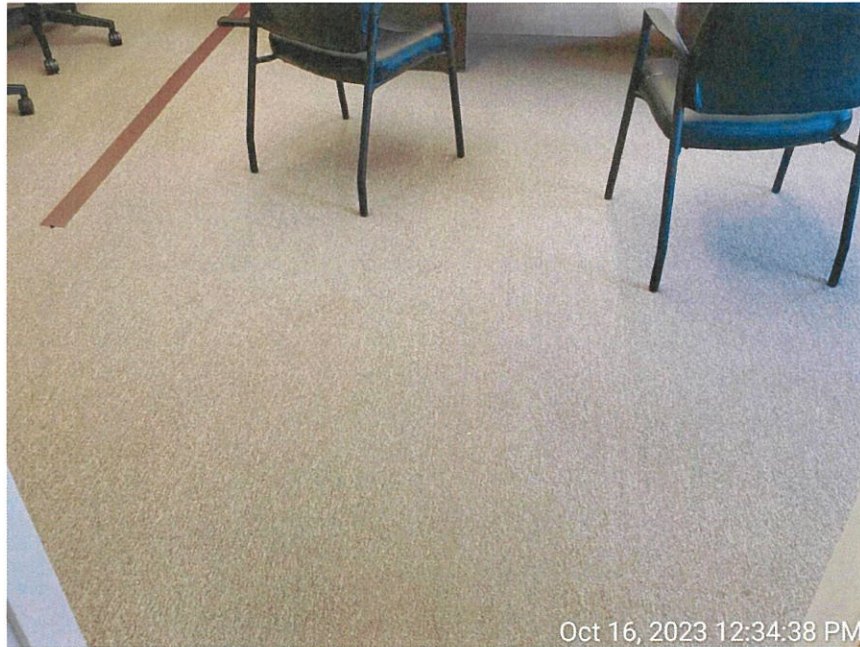
Worn/dirty carpeting on second floor in Town Manager Offices.

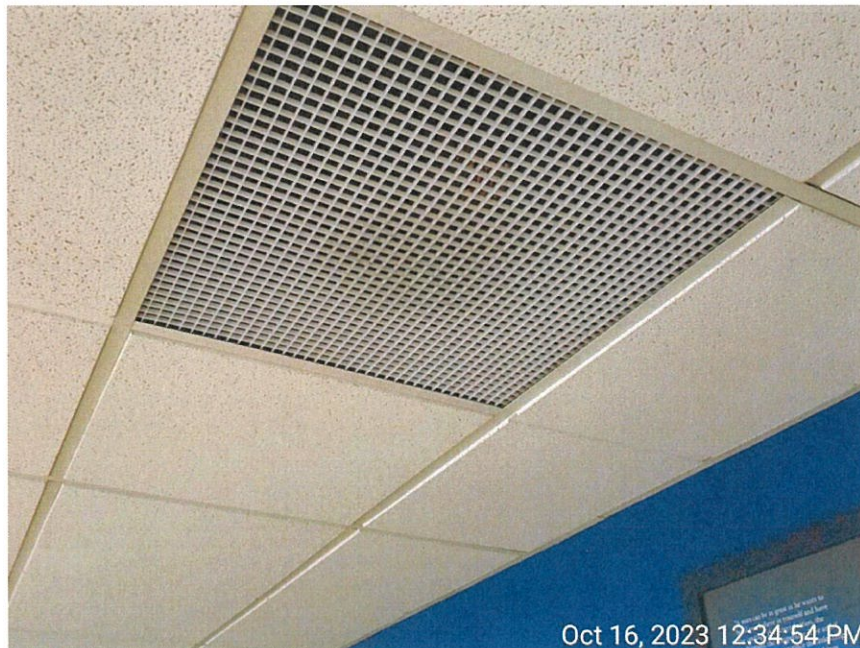
Dirty return diffuser and ductwork on second floor in Town Manager Offices.

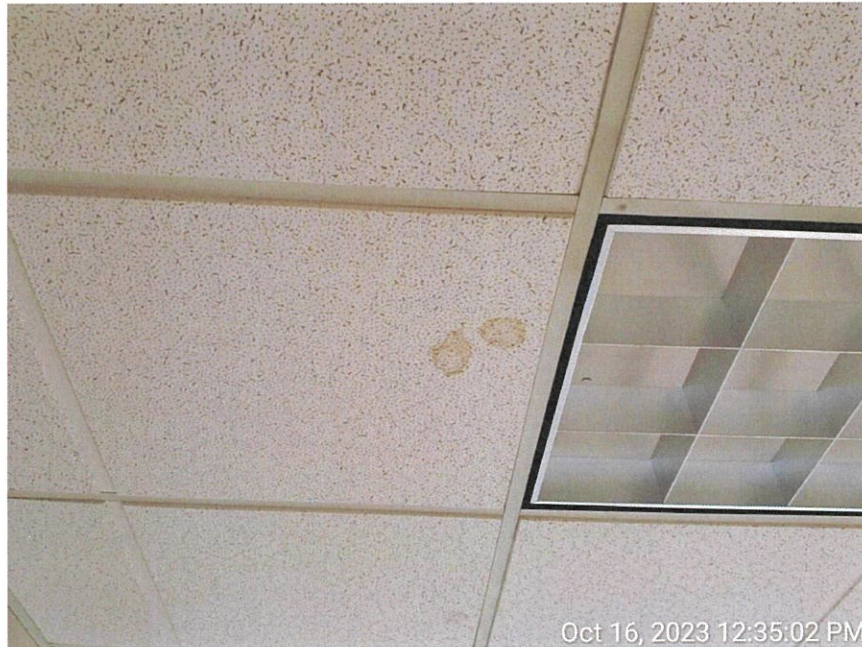
Water-stained ceiling tiles on second floor in Twon Manager Offices.
