Meeting Date: 11/14/2023	NB #1
Agenda Item: Air Quality Testing Report for Town Hall	
Informational:	
Sevee & Maher Engineers was hired to do an air quality test on all three floors of the Town Hall. The Report shows that nothing was found to be at an unhealthy level despite the lack of air handling systems. Recommendations were also made in the report.	
Town Manager's Recommendation:	
To make a motion to accept the report from Sevee & Maher Engineers, for the air quality report the Town Hall.	
Requested Action:	
To make a motion to accept the report from Sevee & Maher Engineers, for the air quality report the Town Hall.	
Vote

Town Hall

180 Main Street, South Berwick, Maine

INDOOR AIR QUALITY/MOLD ASSESSMENT
SOUTH BERWICK TOWN HALL
180 MAIN STREET, SOUTH BERWICK, MAINE

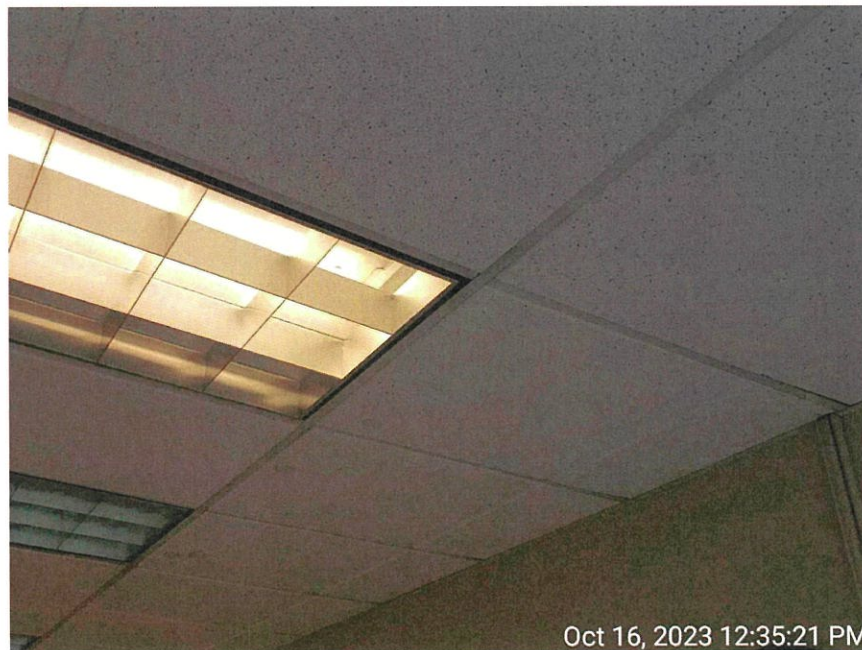
Water-stained ceiling tiles on second floor in Twon Manager Offices.

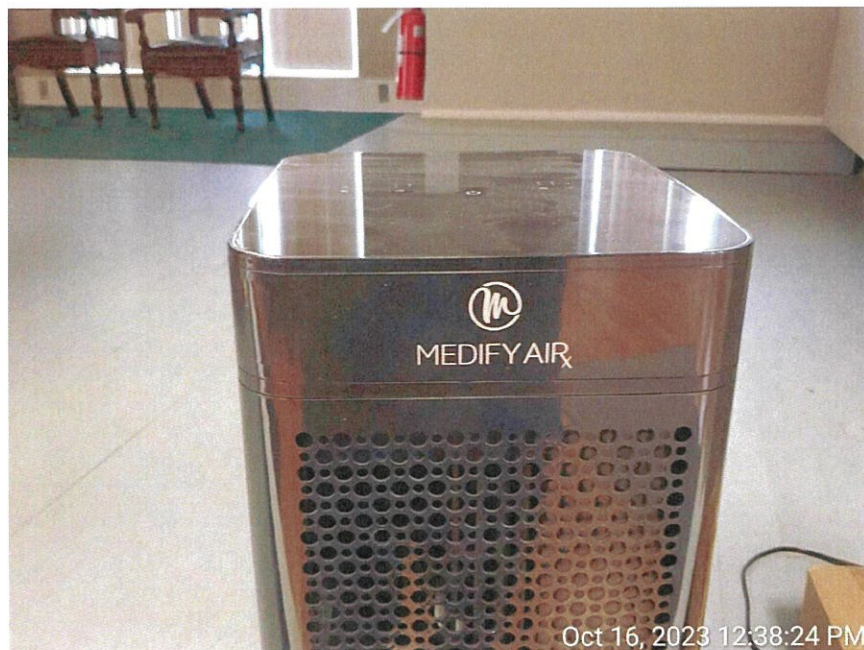
Four (4) portable air purifier units were observed in the auditorium space that have ion generation capability. Ion generation produces Ozone (O₃) a poisonous gas that is a severe upper respiratory irritant. These units, if used, should only be operated in the HEPA filter mode only.

Air purifier on third floor with ionizing setting - Ozone producing.

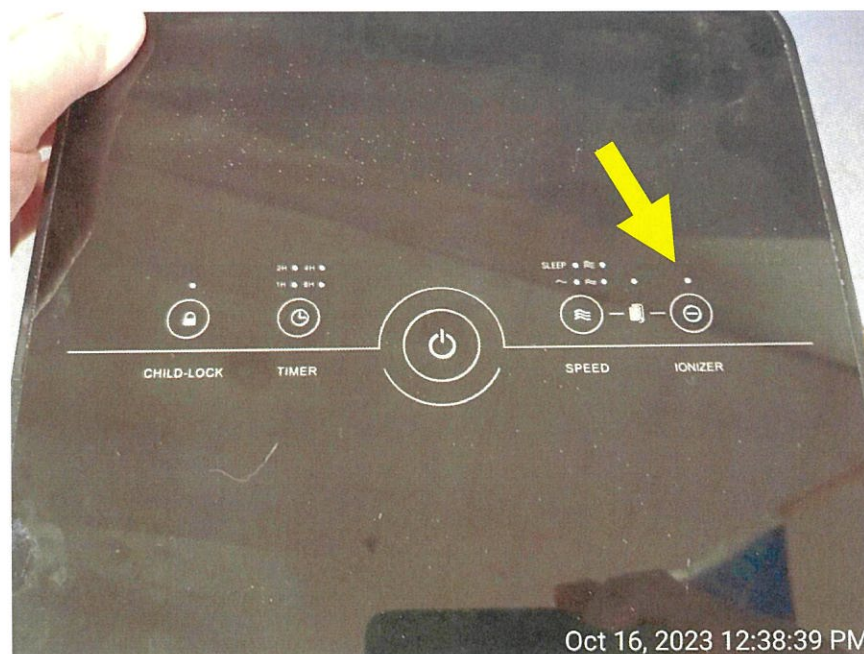
Air purifier on third floor with ionizing setting - Ozone producing.

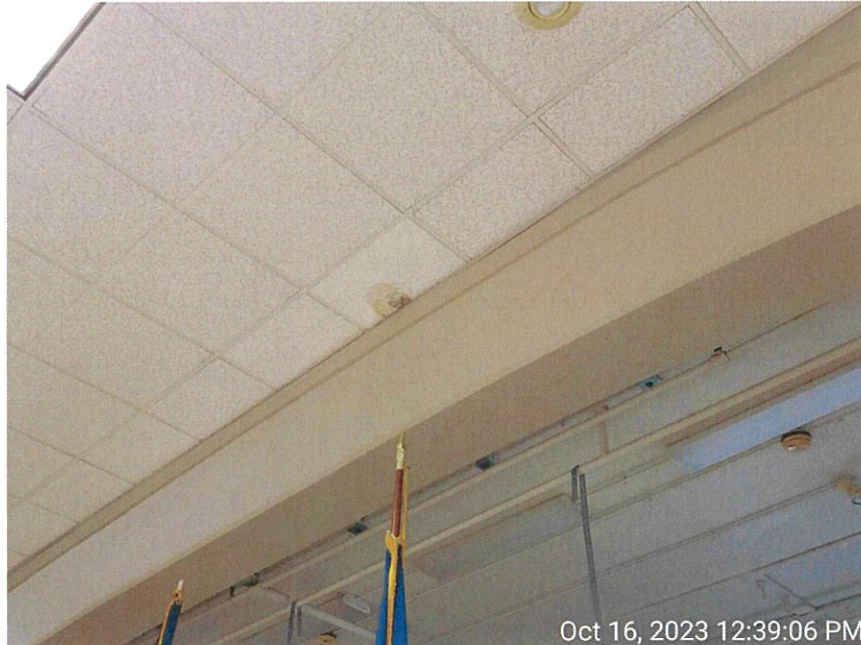
Numerous suspended ceiling tiles have evidence of past water impact, but most were simply water-stained with no observable mold growth, except for one ceiling tile near the stage with visible mold growth of either *Cladosporium* or *Stachybotrys*. Direct sampling was not feasible as the ceiling height was extremely elevated.

Water-stained ceiling tile on third floor in Auditorium/Stage area.
Possible Cladosporium or Stachybotrys mold growth – inaccessible for direct sampling.

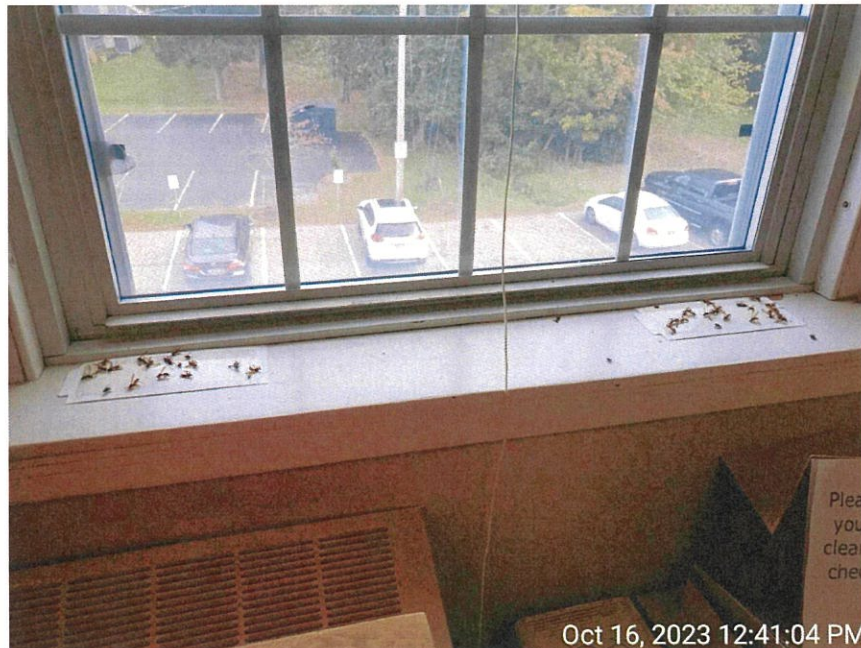
Insect infestation on third floor in election storage room.

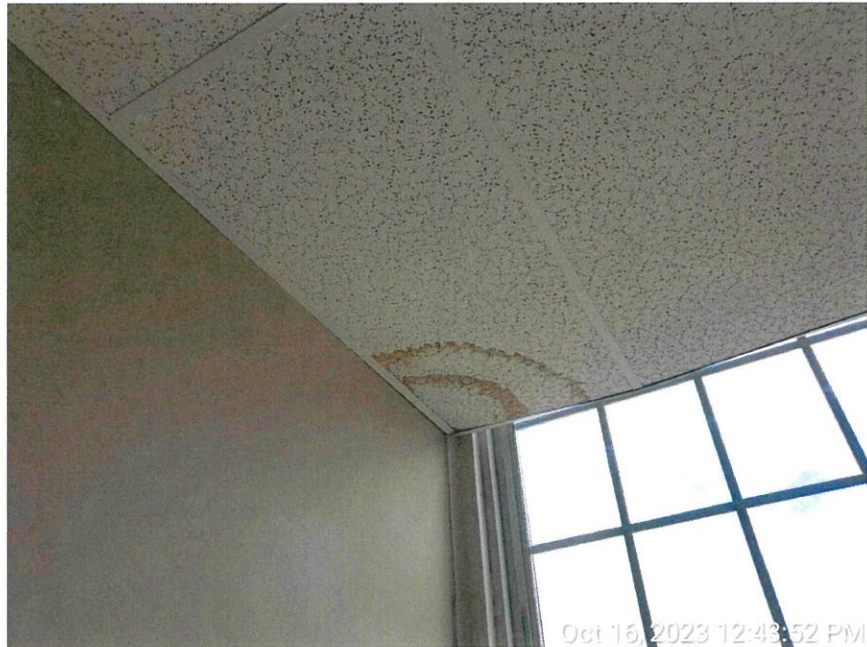
Water damaged ceiling tile on third floor in janitors' storage room.

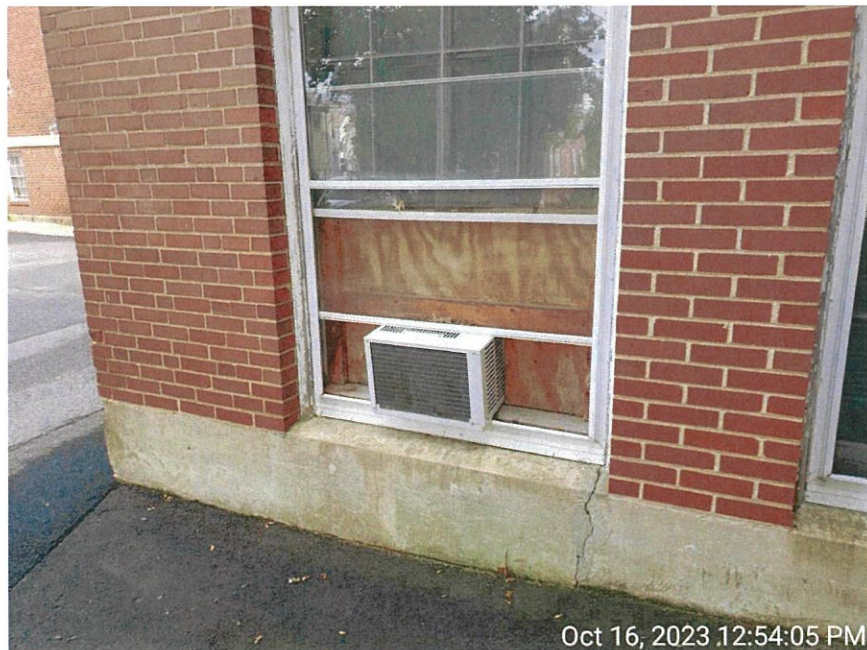
Water intrusion point for window area.

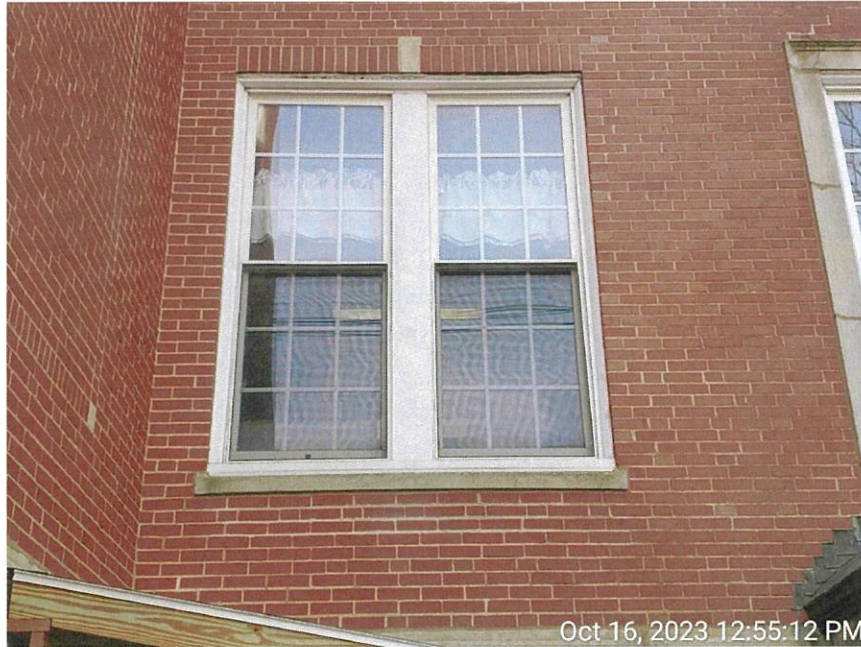
All lintel areas for the window units were observed to have shrunken and/or deteriorating caulking that are not only potential pathways for drain plane water intrusion, but also insect and rodent pathways.

Shrinking/cracking window caulking for header area is rainwater intrusion point.

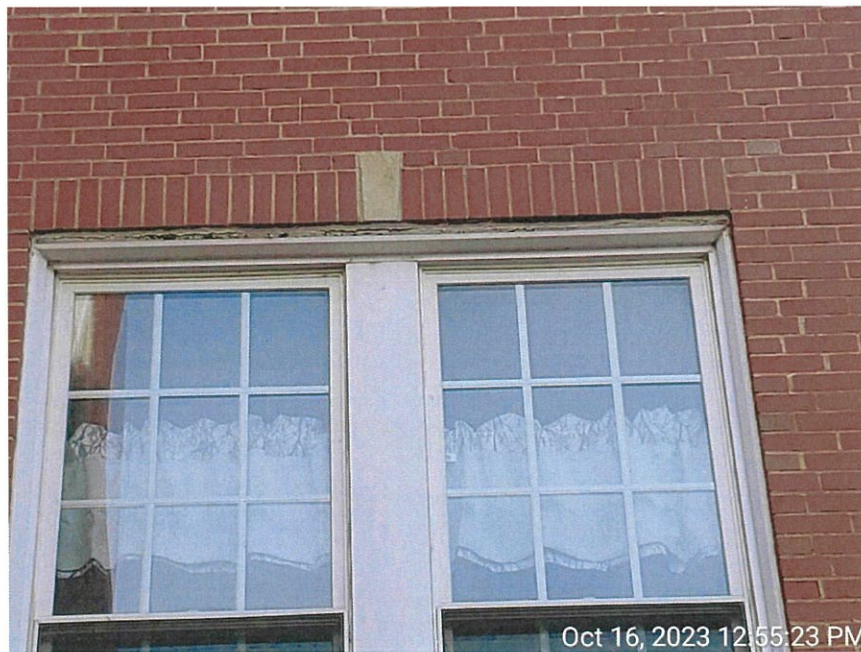
Shrinking/cracking window caulking for header area is rainwater intrusion point.

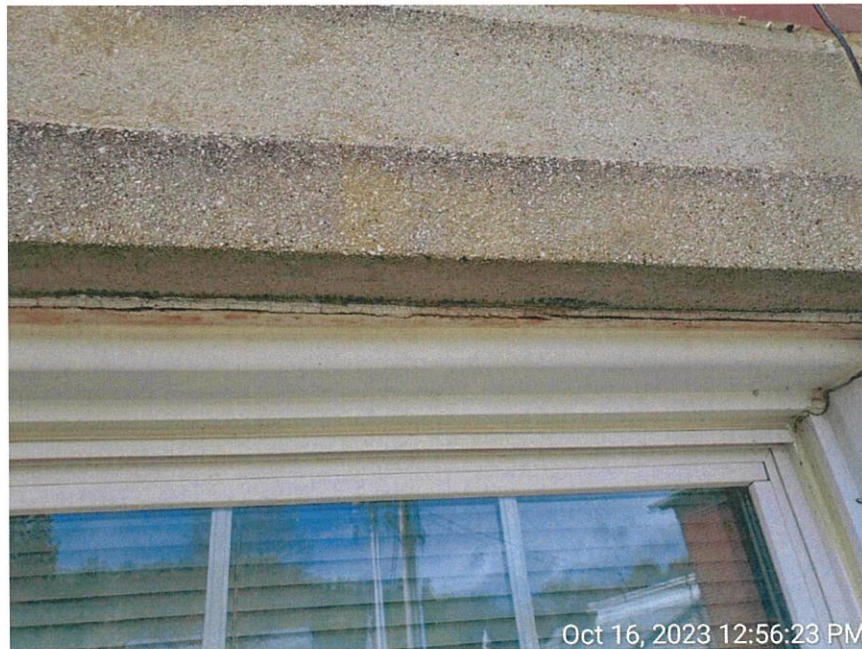
Shrinking/cracking window caulking for header area is rainwater intrusion point.

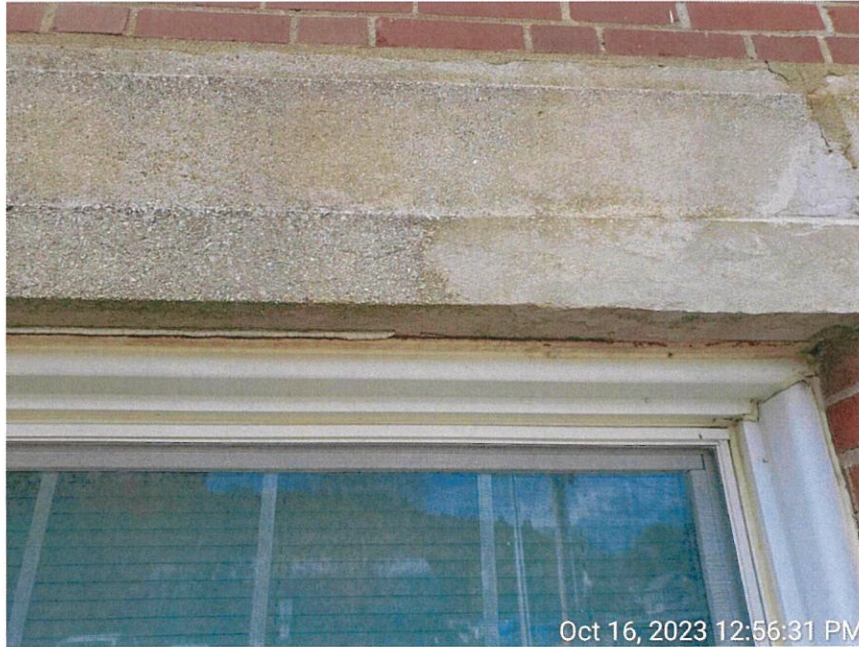
Shrinking/cracking window caulking for header area is rainwater intrusion point.

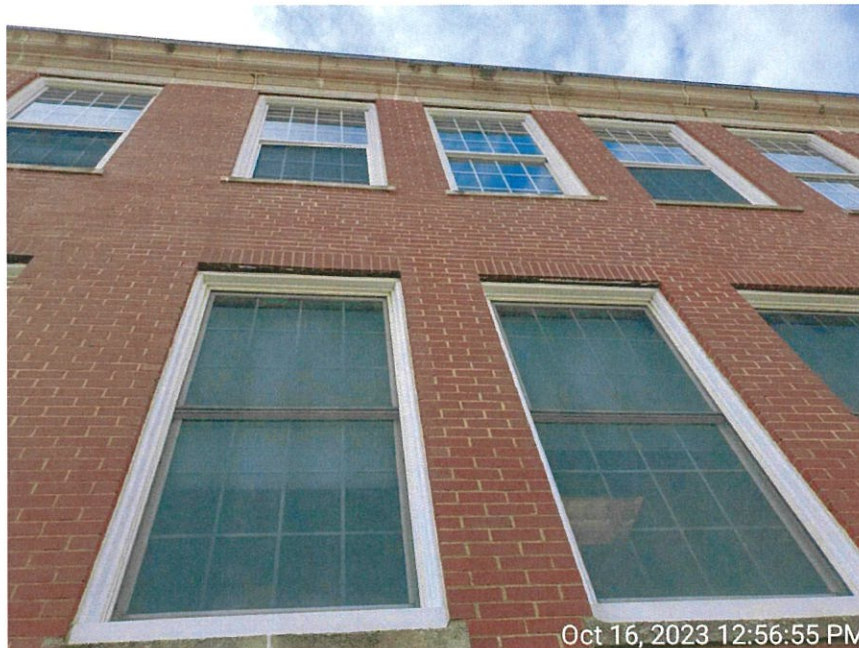
Shrinking/cracking window caulking for header area is rainwater intrusion point.

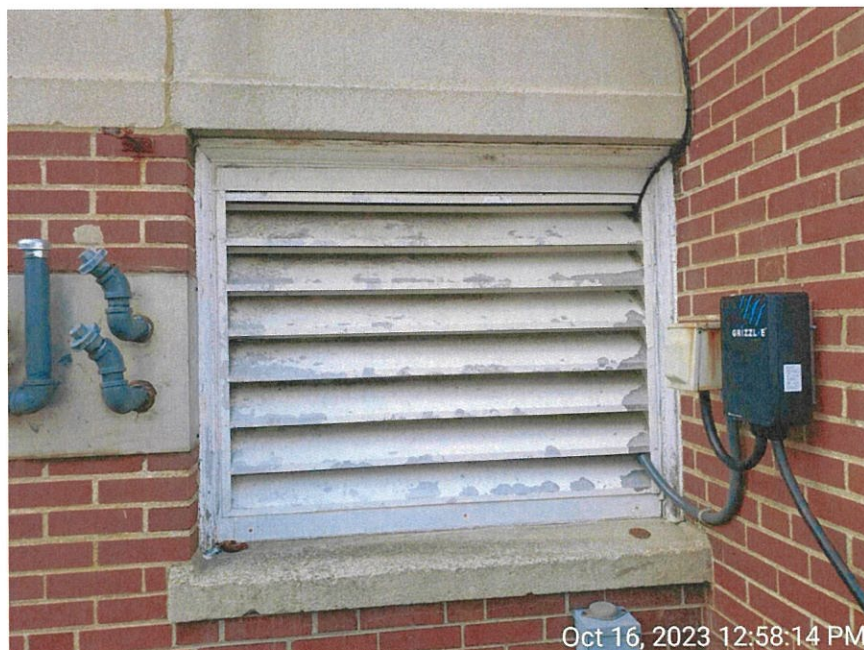
Possible lead-based paint for uncladded wood trim.
