Alpha Home & Commercial Building Inspections

Property Inspection Report

180 Main St, South Berwick, ME 03908
Inspection prepared for: Perry Ellsworth
Real Estate Agent: -

Date of Inspection: 2/23/2021 Time: 10:00 AM
Order ID: 12304

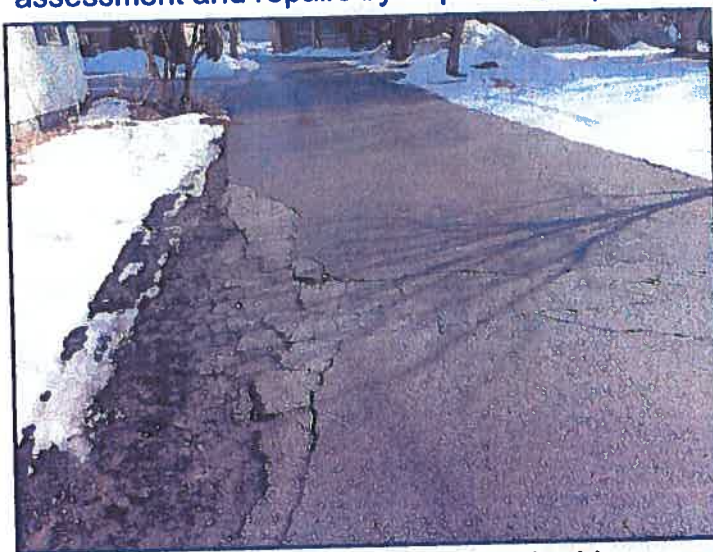
1.3. Excessive deterioration and cracking was observed at the asphalt surfaces. Recommend assessment and repairs by a qualified asphalt contractor.

Damaged asphalt surface at left side driveway.

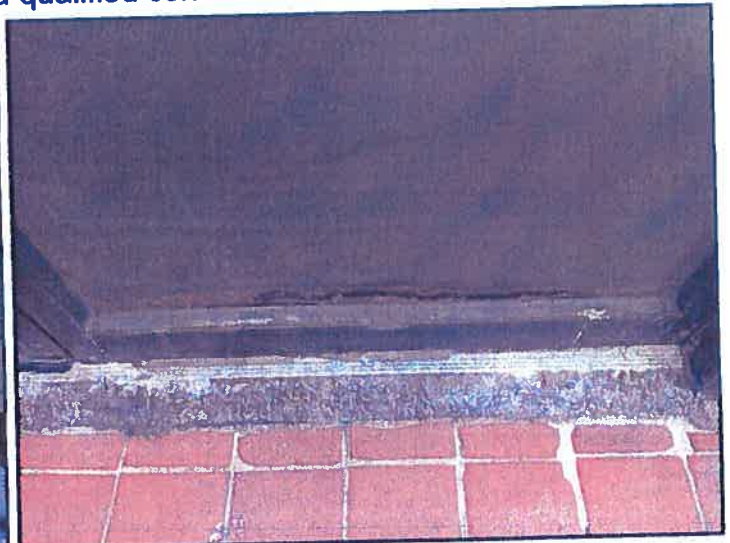
1.2. One or more exterior door has damage to door, frame or trim, recommend full assessment of all doors and repairs by a qualified tradesman as needed.

Corrosion/damage at front door

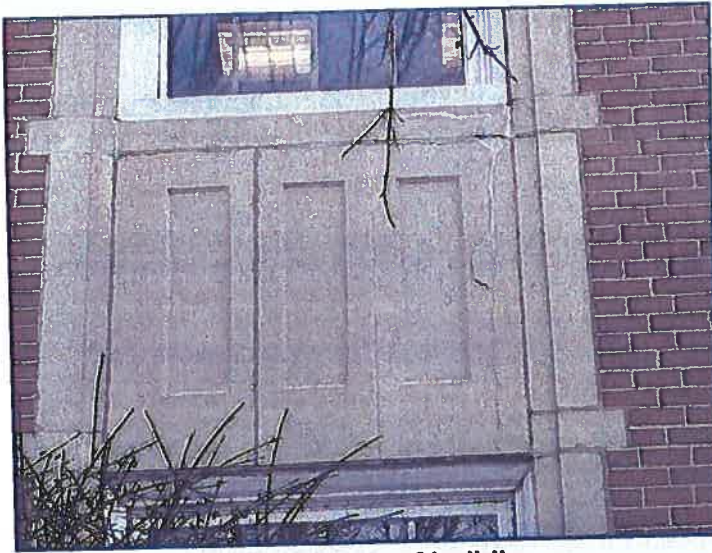
Crack at front of building

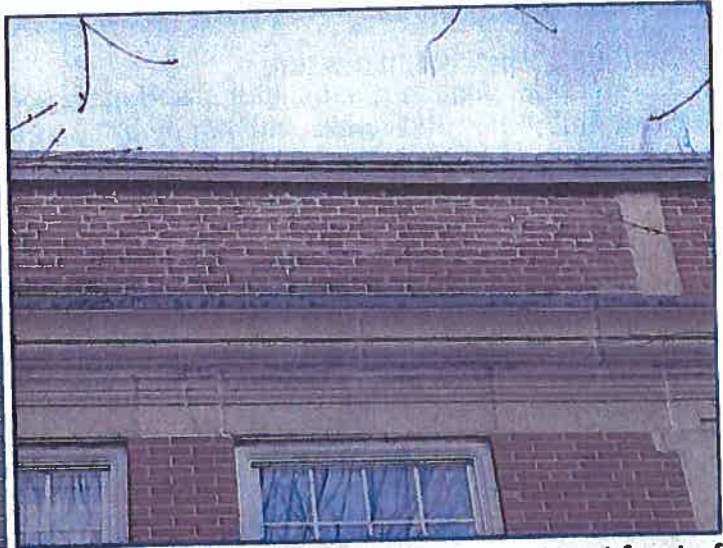
Areas of damage/deterioration to mortar at front of building.

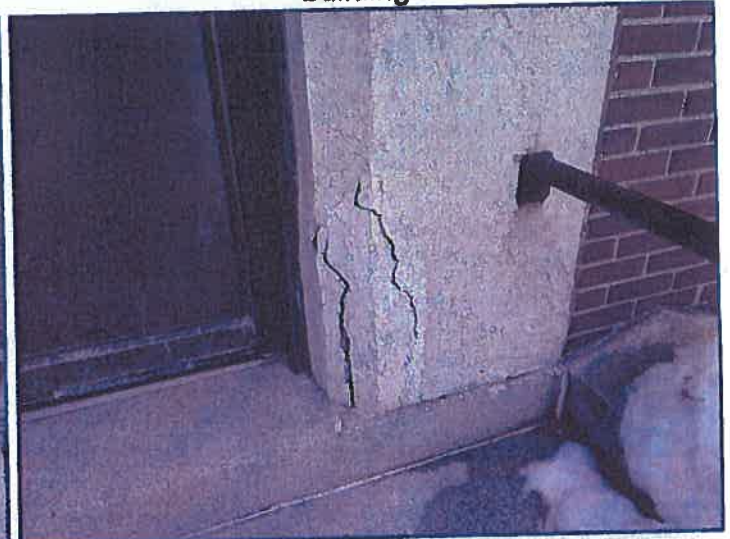
Damage at front of building

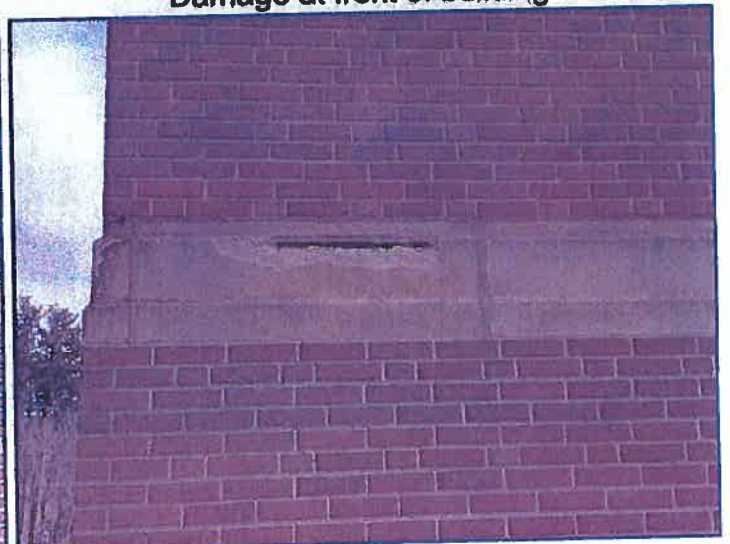
Damage surface at left side

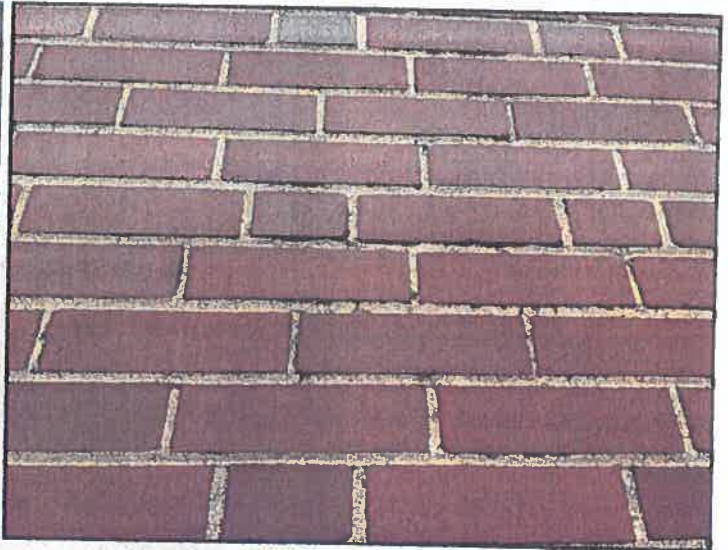
2.3. The exterior brick and stone masonry walls are in fair to poor condition. There are many areas of loose and receding grout, there are several areas of vertical and/or step cracks in walls. Recommend full inspection and repairs by a qualified masonry contractor.

Areas of damage/receding mortar.

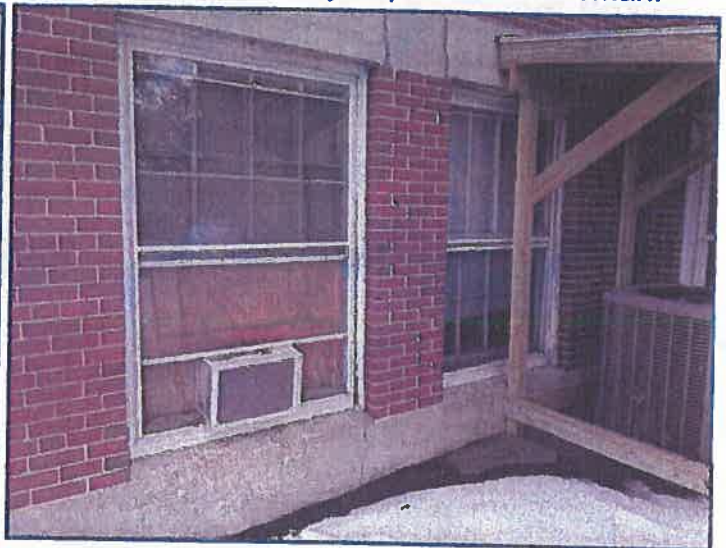
3.2. Deterioration of glazing and caulking at one or more window. Recommend assessment and repairs by a qualified contractor.

Older single pane wood windows with peeling paint and glazing

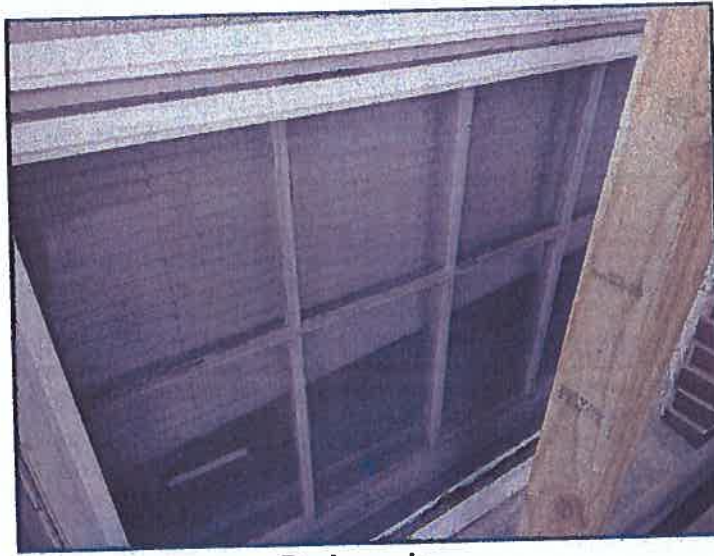
3.3. There is broken glass at one or more window, recommend repairs by a qualified tradesman.

Broken glass

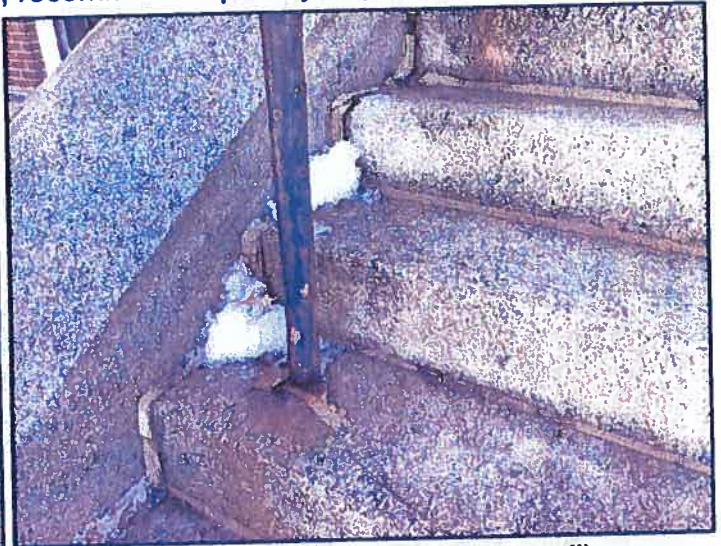
Corrosion/damage at front stair railing.

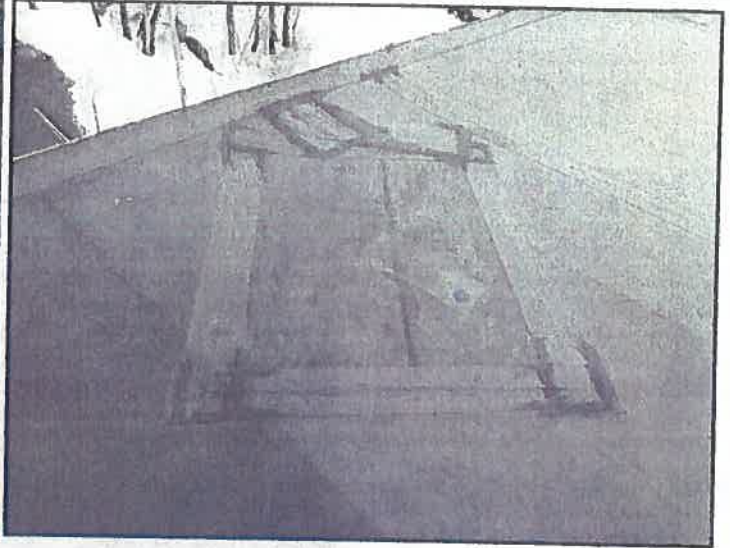
1.2. Roof surface has a few areas of prior repair, recommend monitor for further deterioration and water intrusion and repairs or replacement as needed by a qualified roofing contractor.

Prior repair

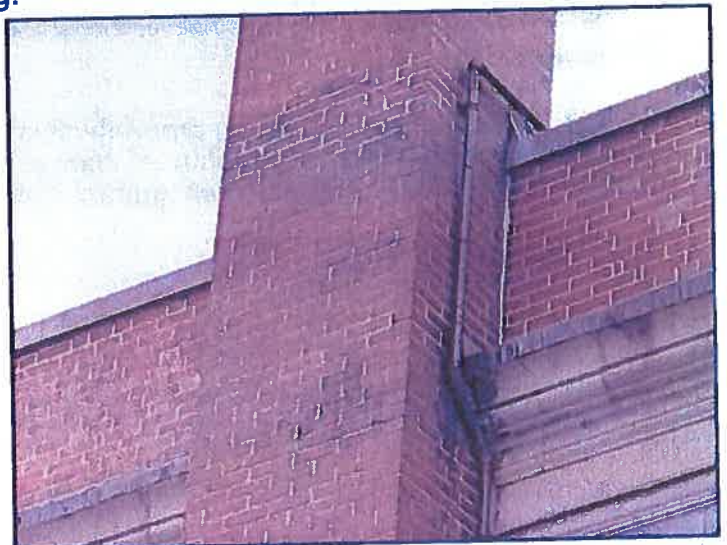
Rear chimney

Areas of damage/deterioration to mortar.

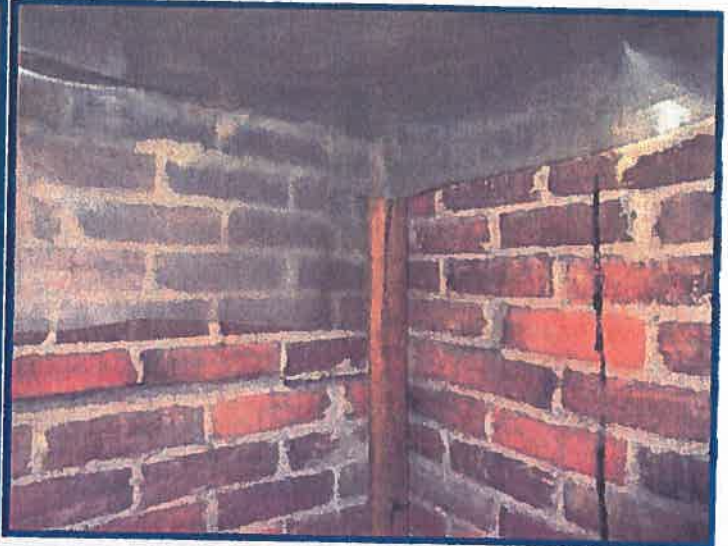
2.5. The exterior brick masonry walls have areas of horizontal cracking and step cracking on walls. Recommend full inspection and repairs by a qualified masonry contractor.

Horizontal cracks and step cracks

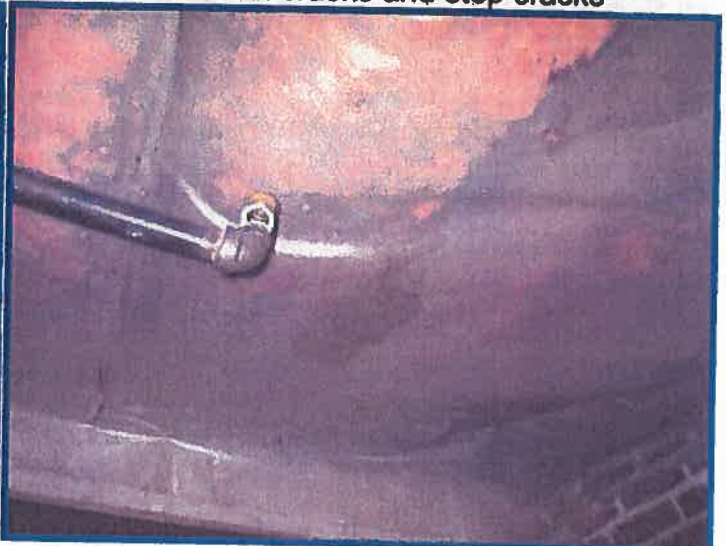
2.4. Stains were found in one or more attic surface areas, no elevated levels of moisture were found. The stain(s) may be due to past or present roof and/or plumbing leaks. Recommend asking the property owner about history of water intrusion and or assessment of any affected areas by a qualified contractor and repairs as necessary.

water staining above vapor barrier, dry at the time of inspection

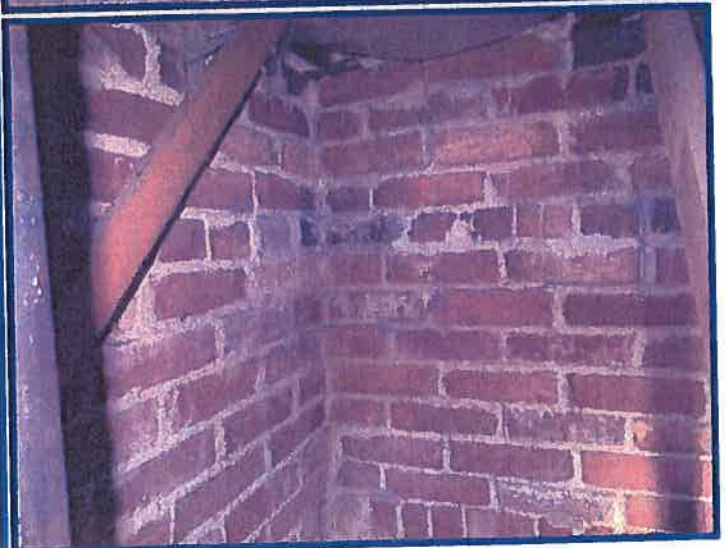
horizontal cracks and step cracks

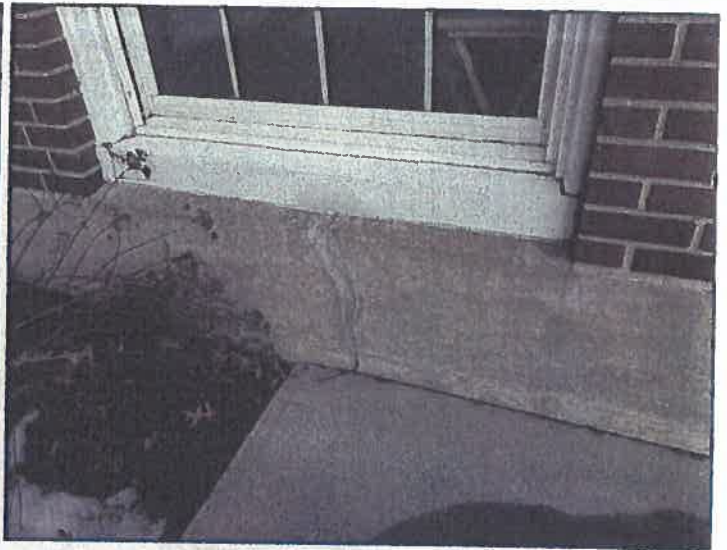
1.8. Vertical cracks noted on foundation wall at one or more location, recommend monitor for further movement and or water intrusion and sealing / repairs as needed.

Vertical crack at right side

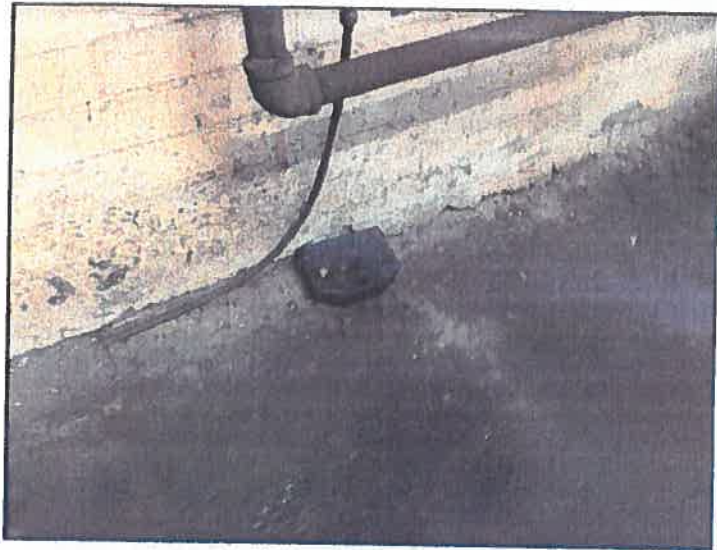
Animal treatment in basement.

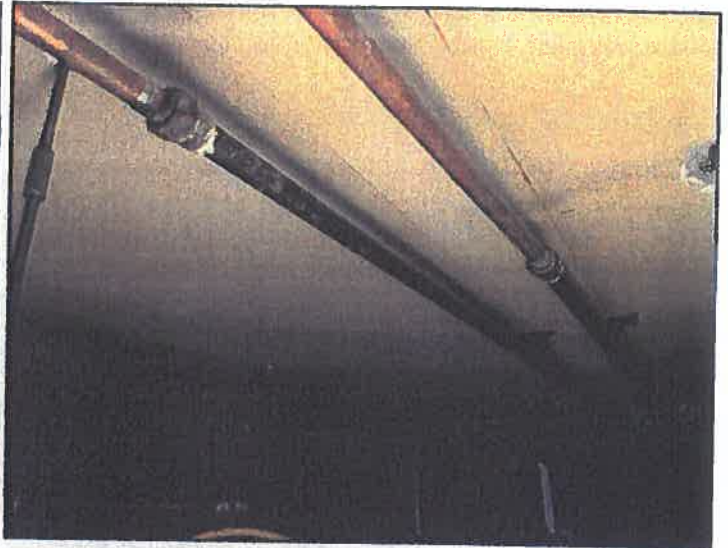
1.3. There is corrosion on one or more plumbing line or fitting in basement, recommend monitor for any further corrosion and leaking and have repairs by a licensed plumber as needed.

Corrosion on plumbing above drop ceiling at second floor conference room.

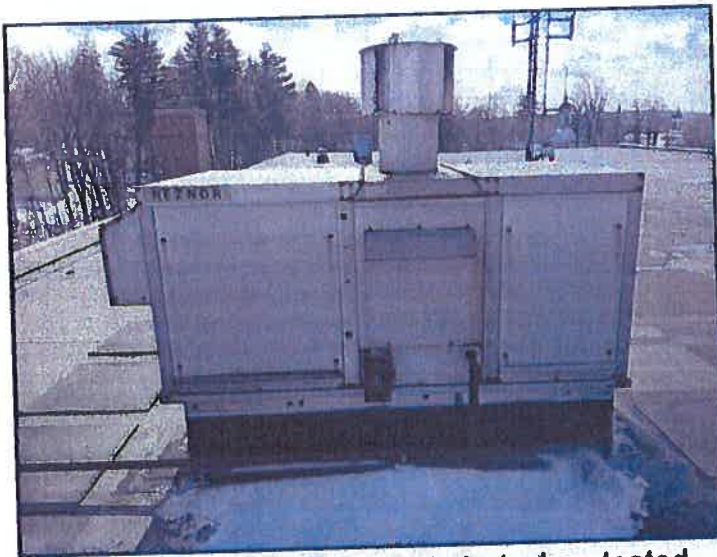
- 1.8. One or more HVAC component would not start using normal controls, recommend full inspection and repairs if needed by a qualified HVAC contractor.

Rooftop heating unit did not start when tested.
Age not determined, but unit appears to be beyond design life.

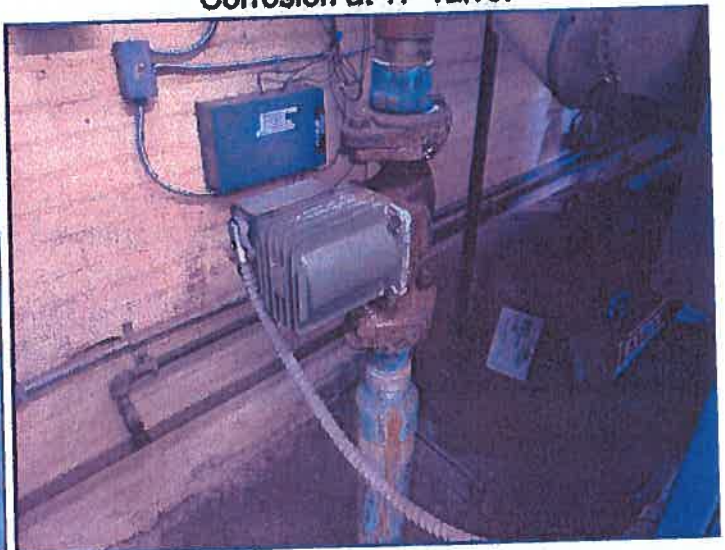
Corrosion at circulator pump.

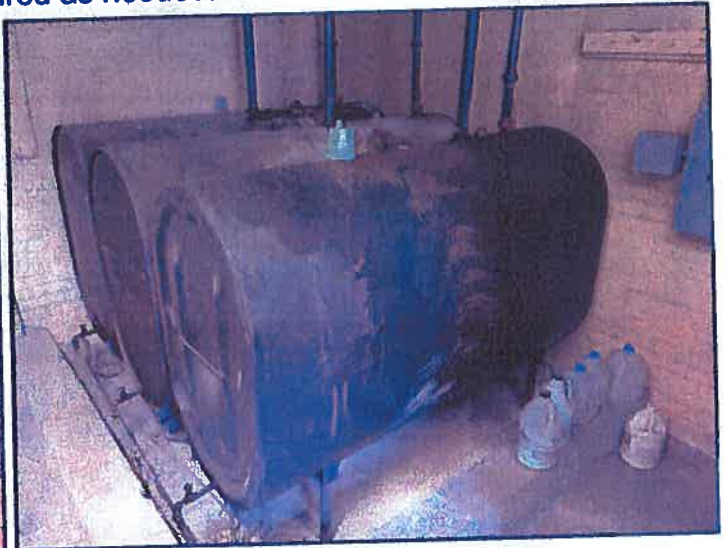
Oil staining on oil tanks

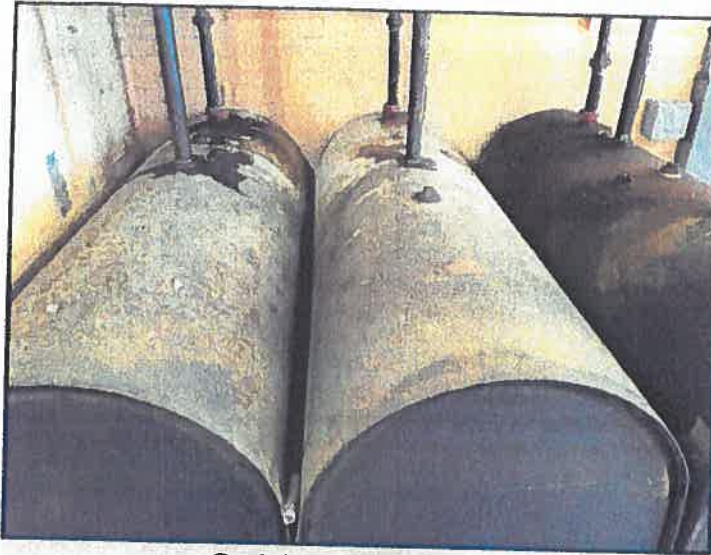
Staining on oil tanks.

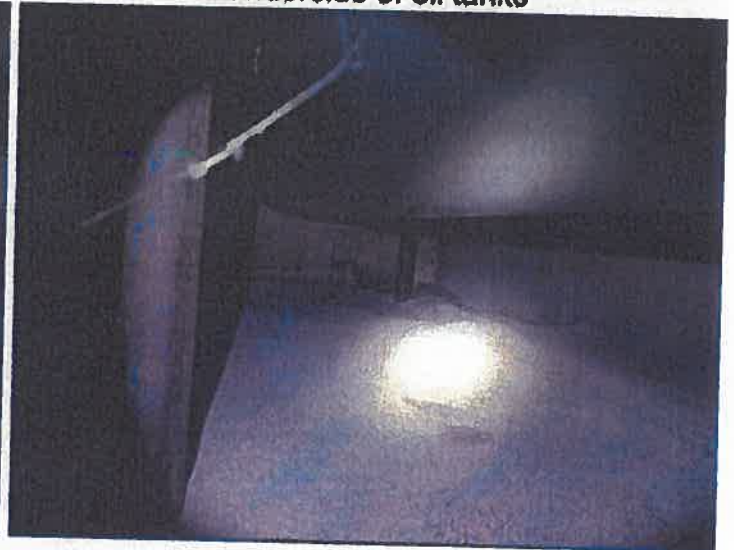
Oil leak / wet oil staining on tank and floor below oil tank.

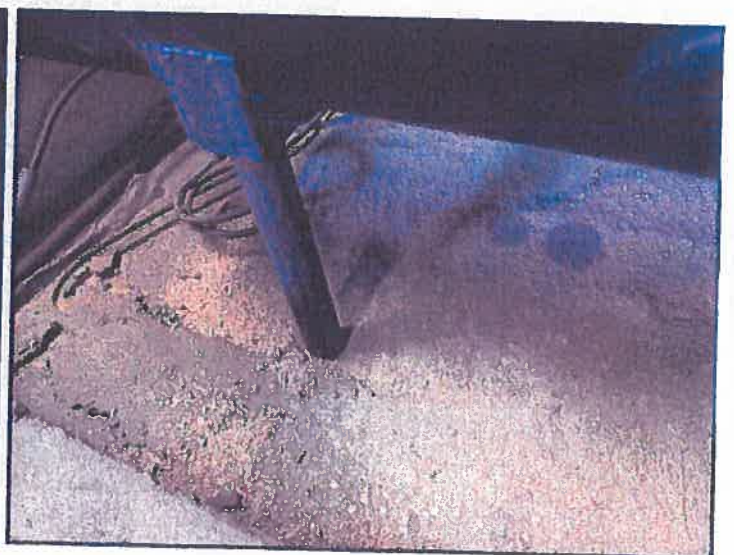
Oil leak / oil drips on floor

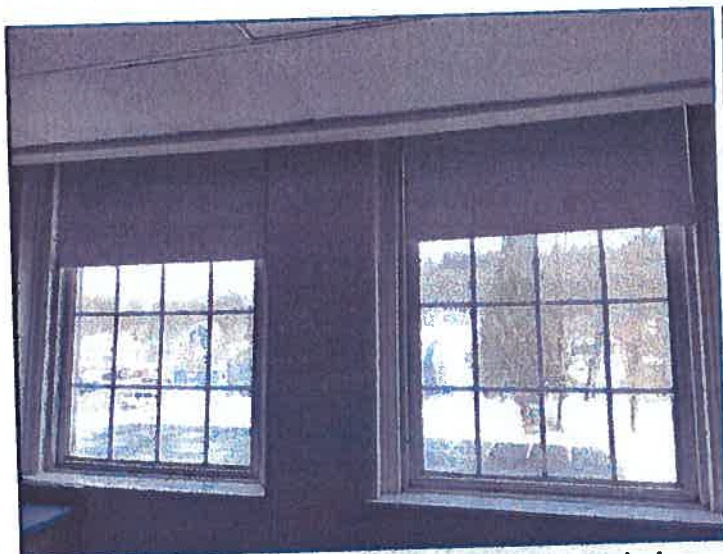
Several windows reported to not open and close properly.

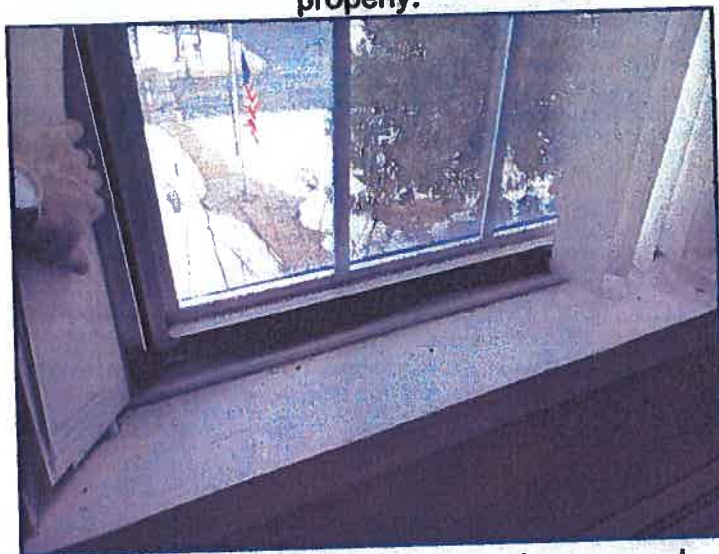
Third floor front window does not close properly.

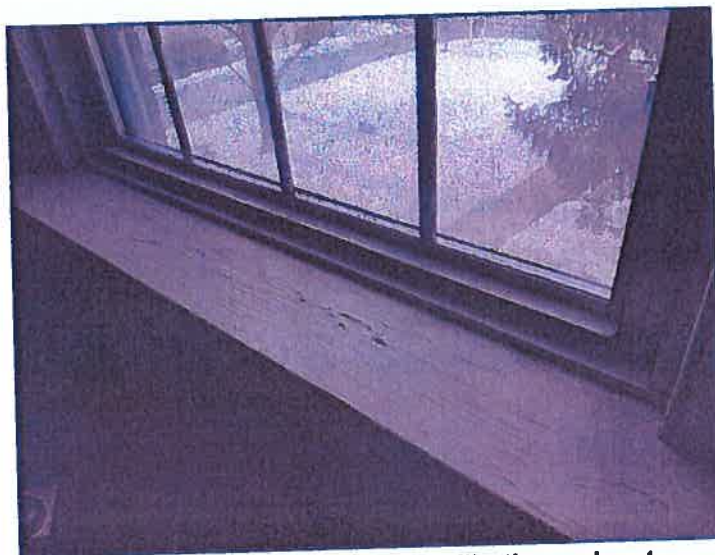
Water staining at window sills throughout.

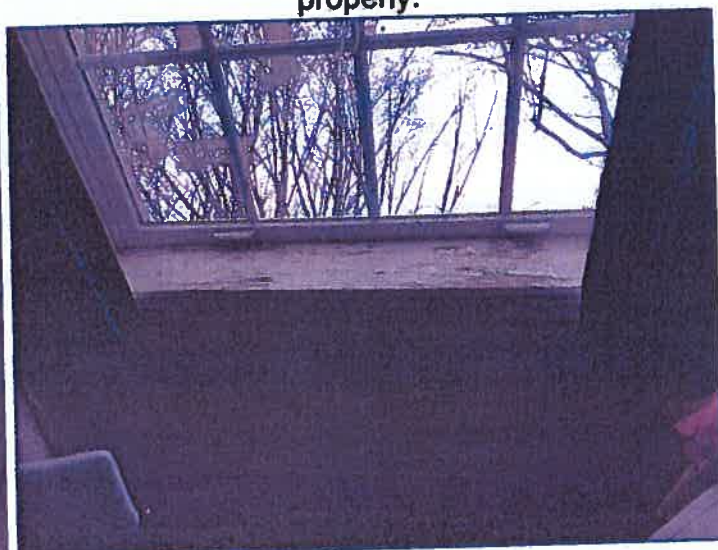
Water staining and peeling paint at many window sills.

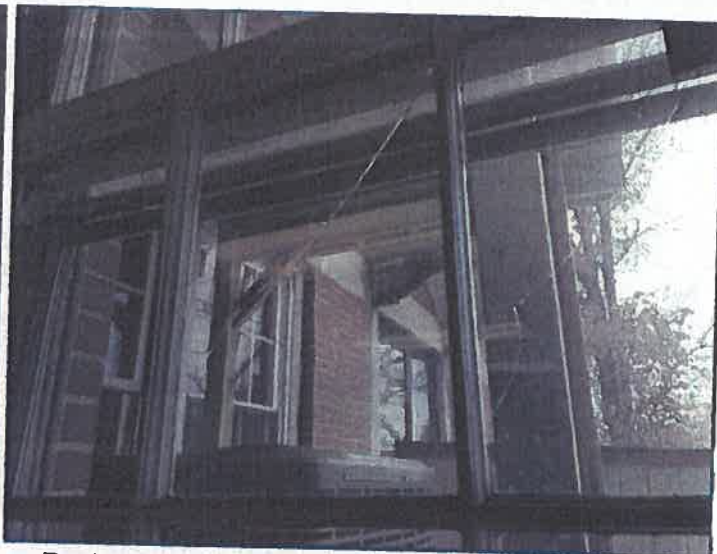
Broken glass at former police station window
patrol room

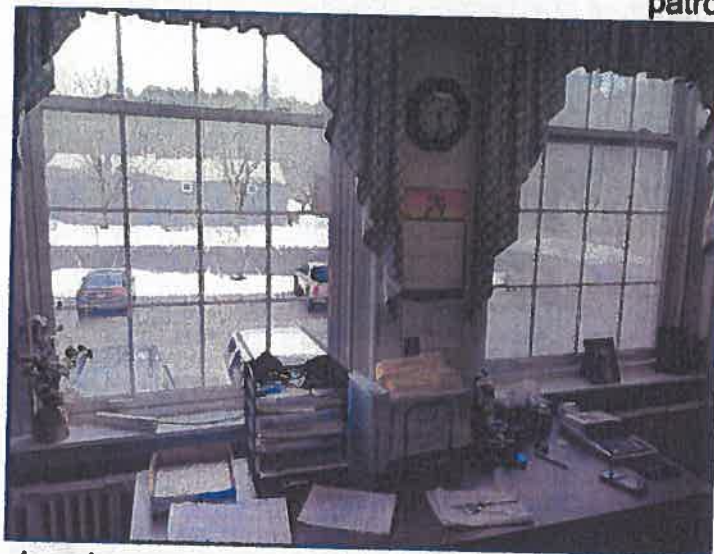
Finance room window does not close properly and windows are reported to be drafty.

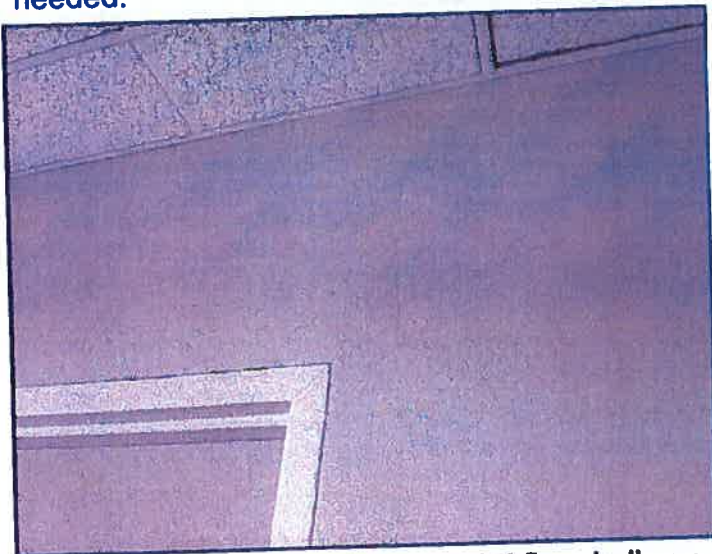
Typical settlement cracking at third floor hallway.

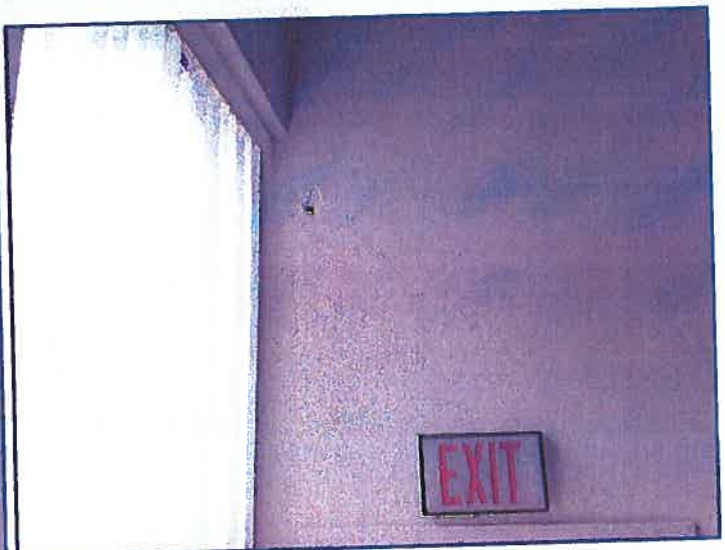
Damaged wall / settlement cracking at stage.

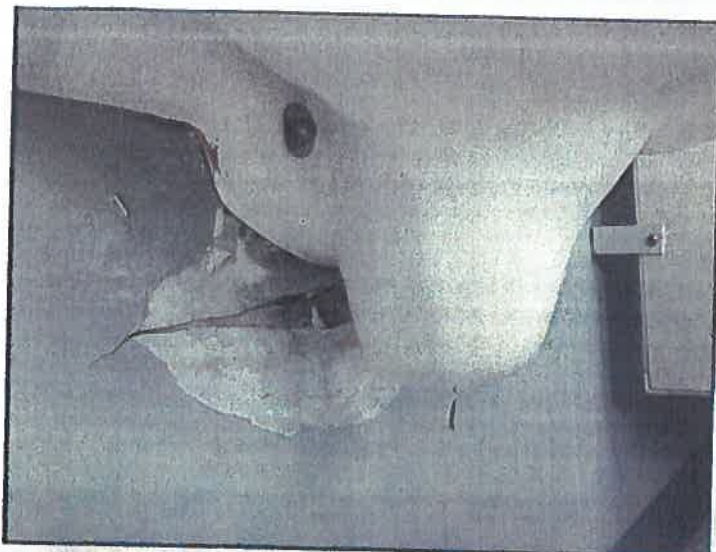
Damaged wall and suspected mold staining at third floor men's room. Area tested dry.

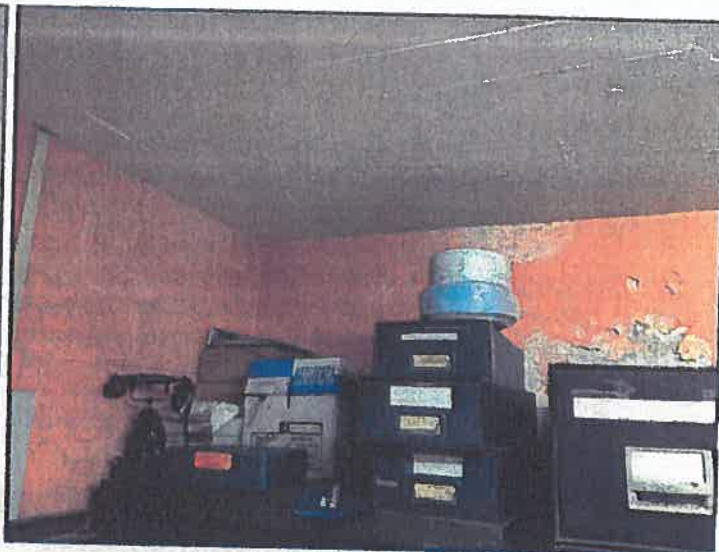
Efflorescence/water staining at vault wall.

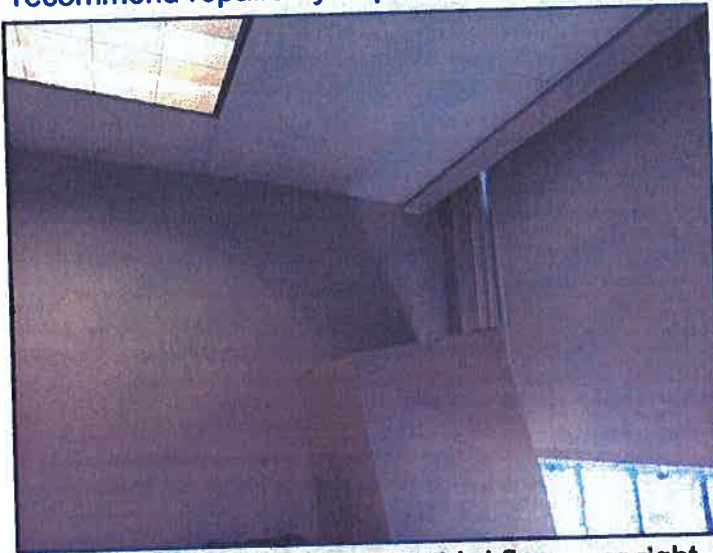
Water staining on ceiling at third floor rear right room.

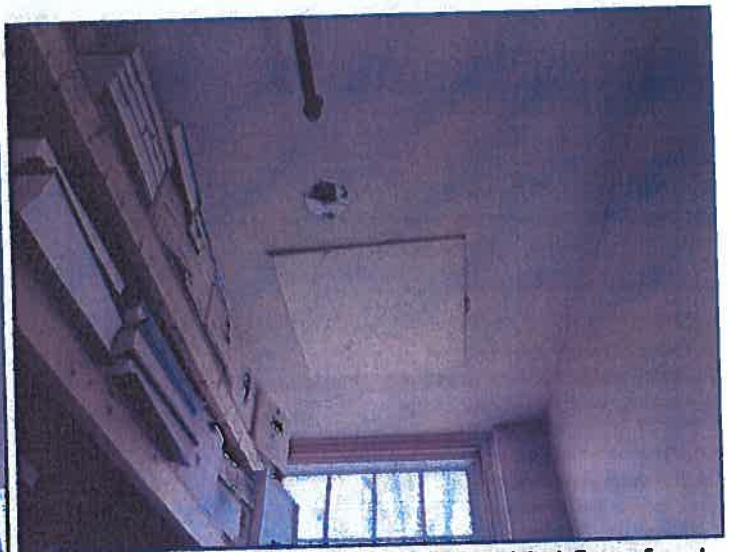
Damaged ceiling/patch ceiling at third floor front right storage closet.

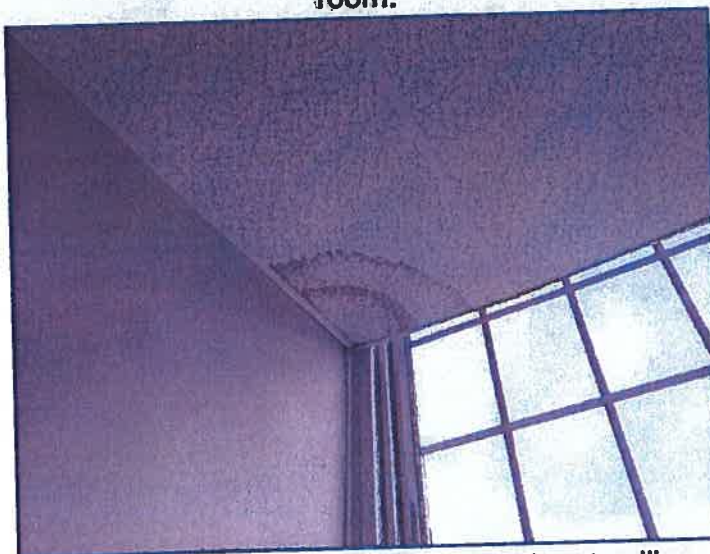
Water staining at third floor janitor closet ceiling.

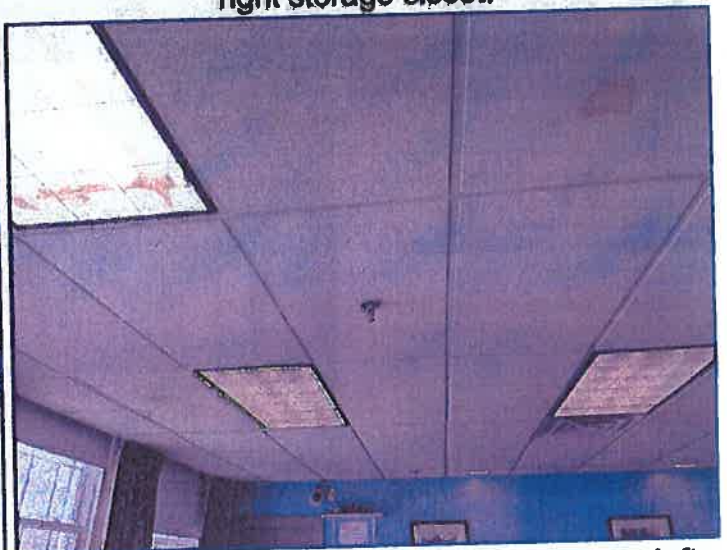
Numerous water stains at second floor rear left room / conference room ceiling.

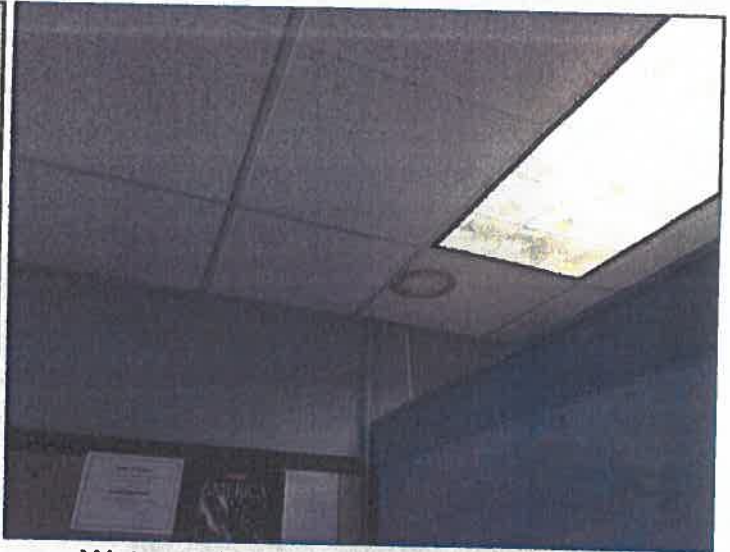
Water staining throughout second floor.

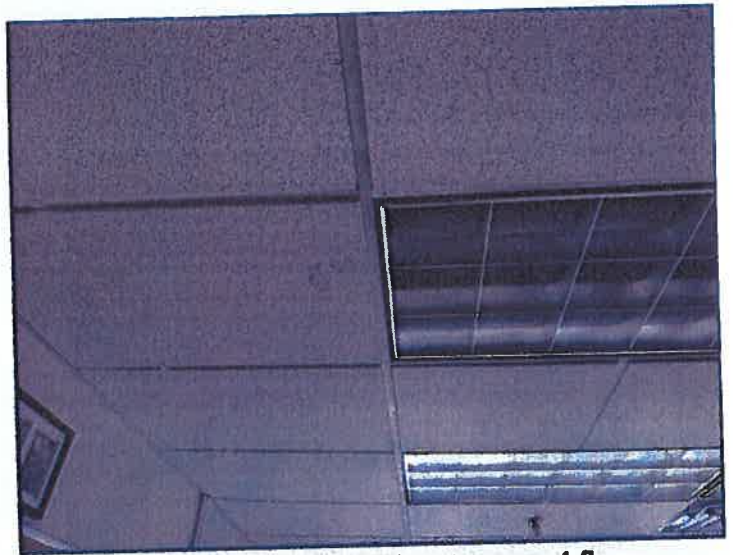
Water staining throughout second floor.

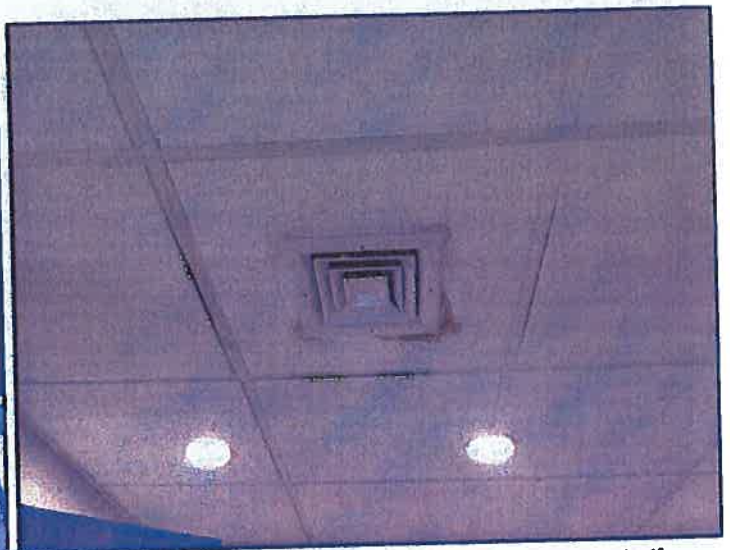
Water staining throughout former police station tested dry.

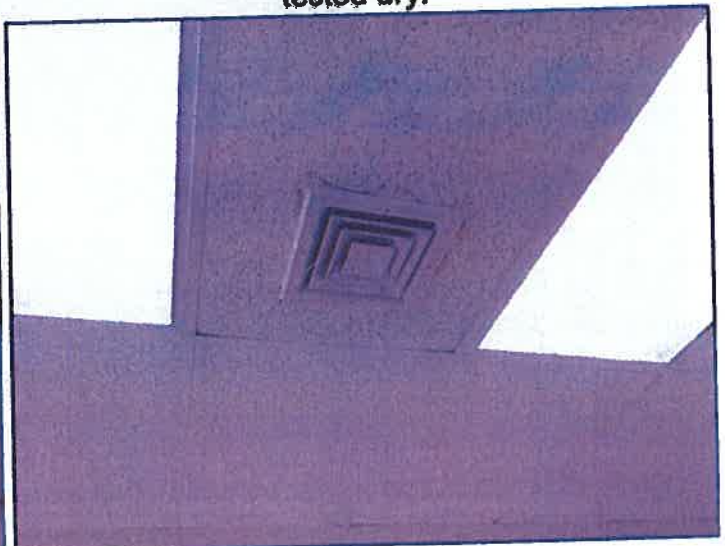
Water staining throughout former police station tested dry.

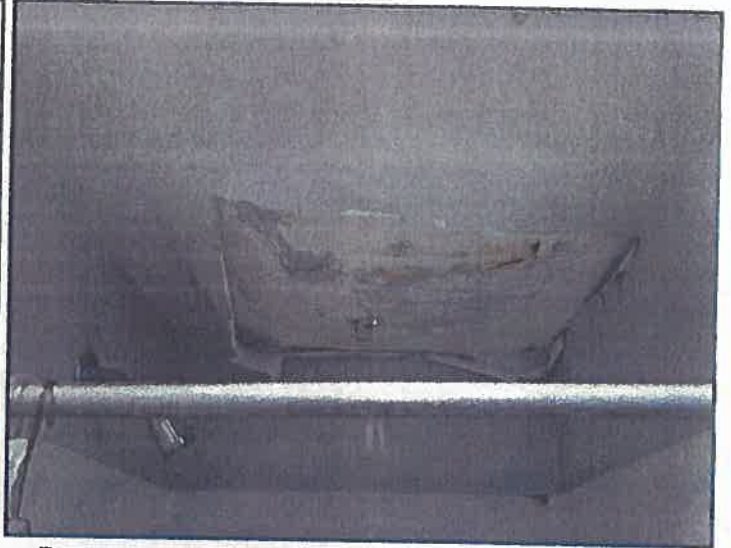
Damaged ceiling / suspected mold staining at shower in former police station bathroom.

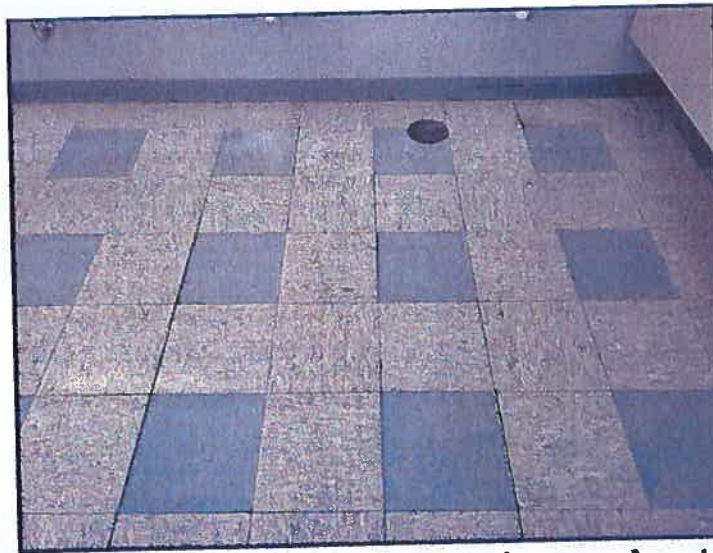
Lifting tiles / worn flooring at third floor man's room. Area tested dry.

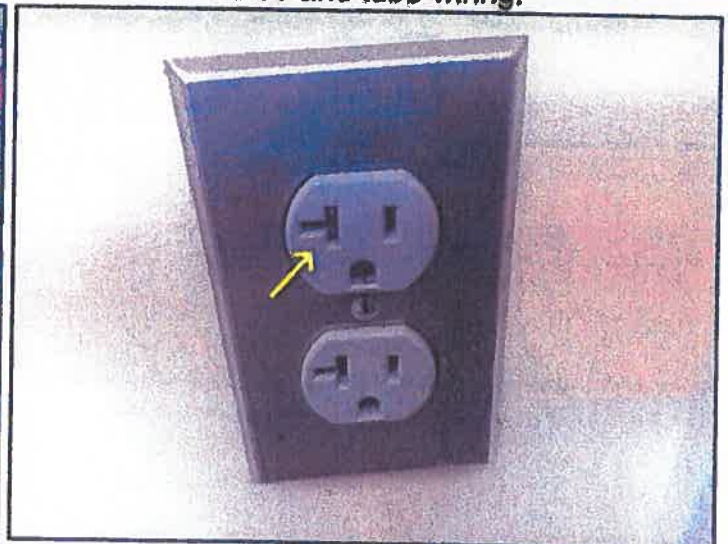
Damaged outlet/ prong stuck in outlet at general assistance office.

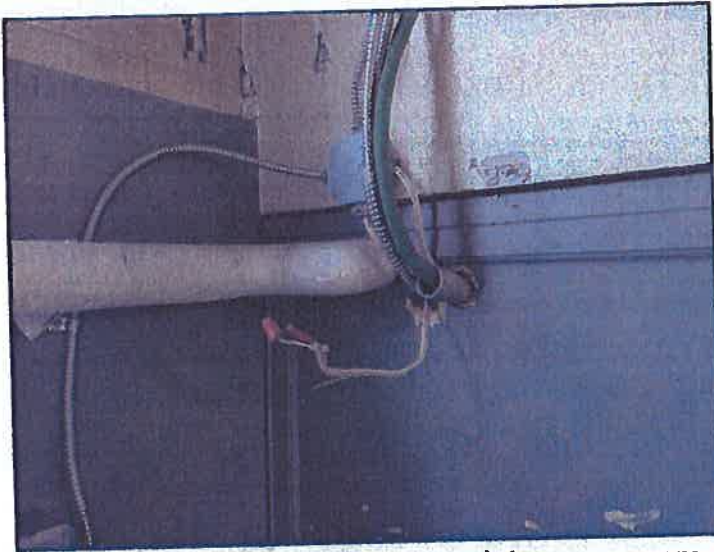
In properly terminated wire at maintenance room / work room.

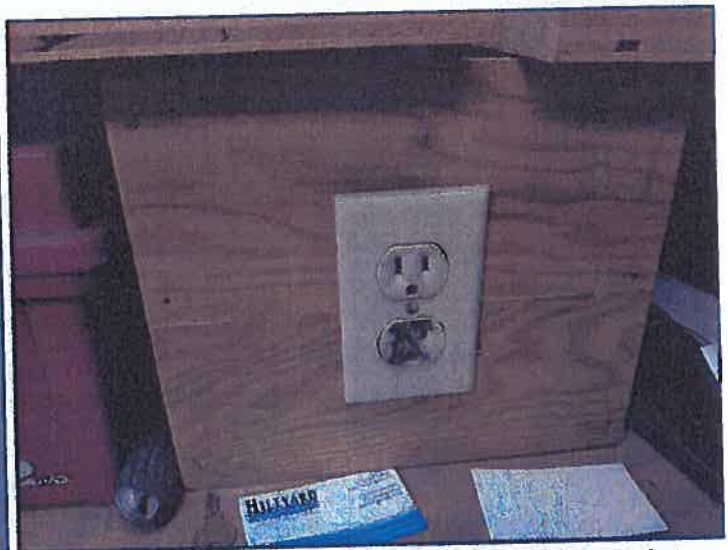
Arching stains at work bench electrical outlet.

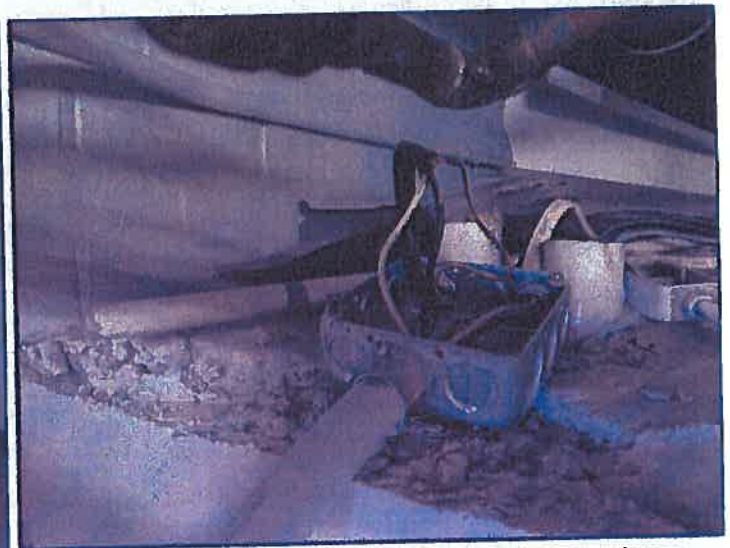
Open junction box at former police station

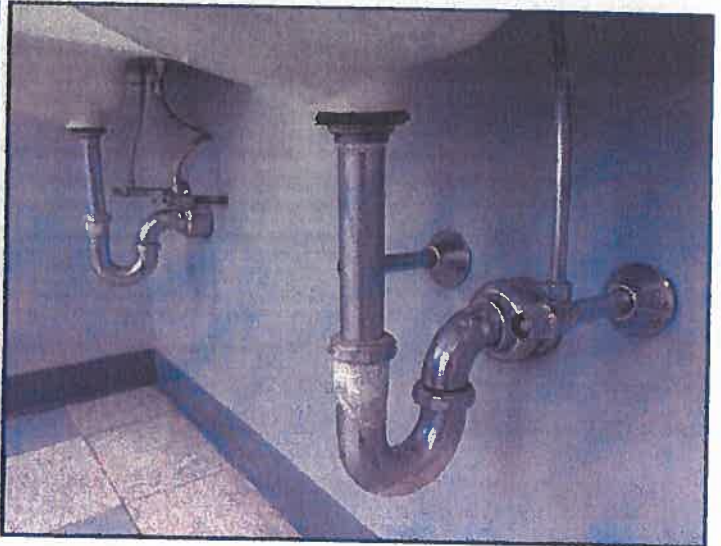
Corrosion of plumbing pillow sinks at third floor men's room.

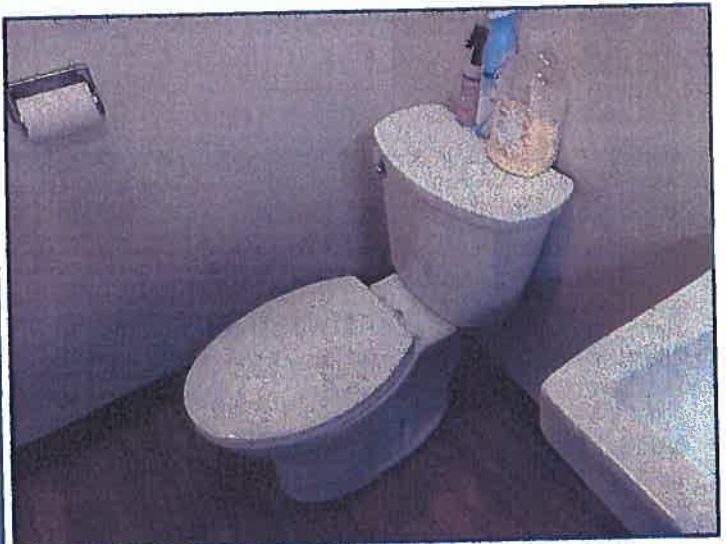
Loose toilet at second floor men's room.

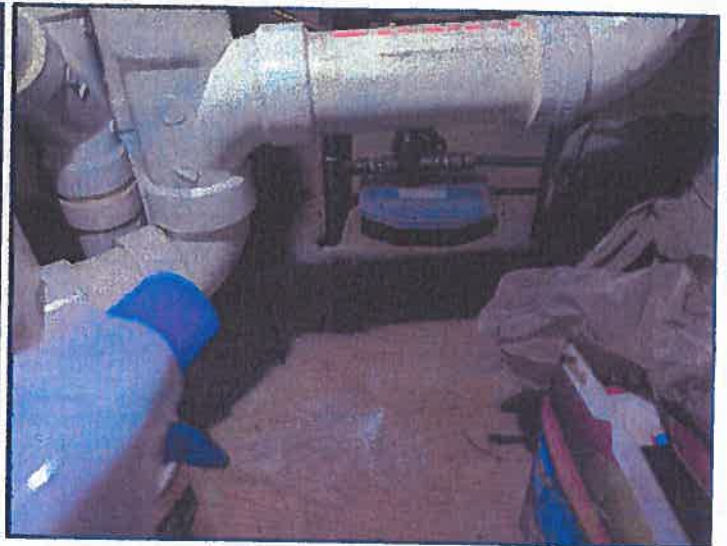
Water staining and cabinet below 3rd floor kitchen sink tested dry. Rodent activity / treatment present.

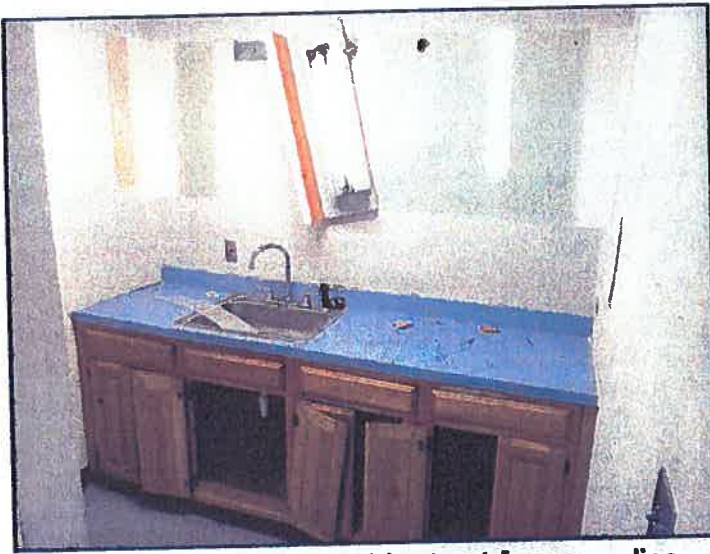
Damaged / missing cabinets at former police station.

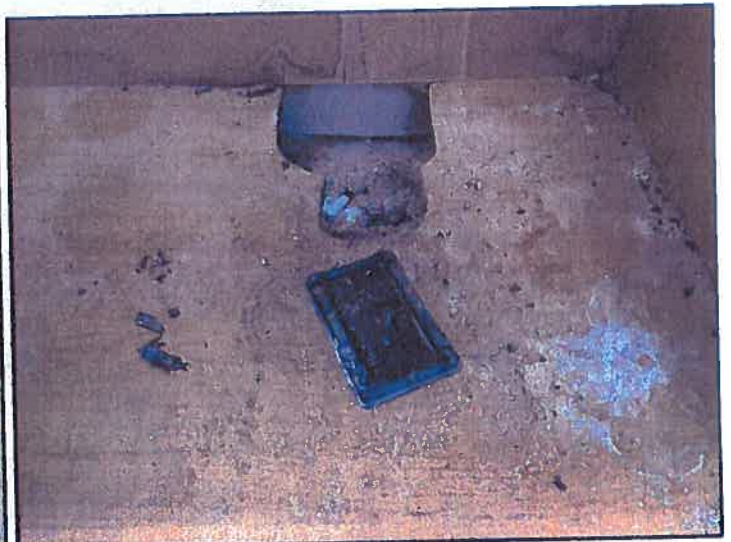
Rodent activity and water staining below sink at former police station.
