South Berwick Town Hall Evaluation and Recommendations

August 20, 2023

Port City Architecture and their consultants have been commissioned to provide a facility assessment for the existing South Berwick Town Hall building including physical condition; structural integrity; mechanical, electrical, and plumbing system; site conditions; overall appearance; overall function; and code compliance. As part of our inspection, we highlighted any workplace safety issues, potential hazard, and building functionality pertaining to a modern-day town hall administration that incorporates current technology and practices.

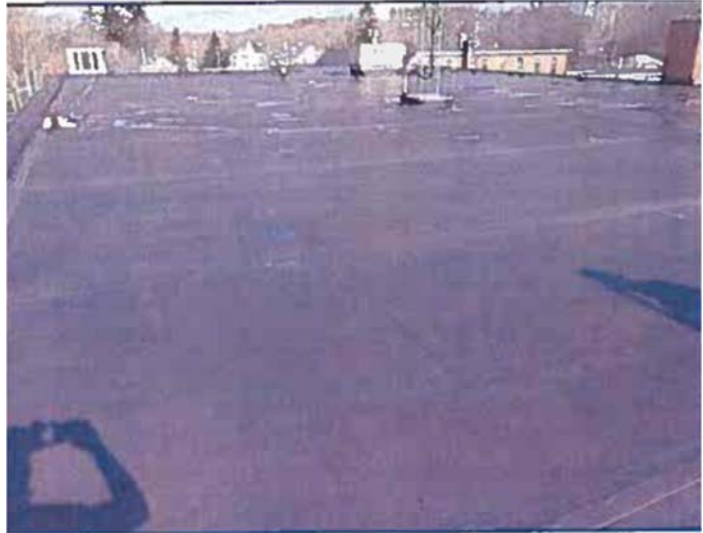
EPDM Roof:

- Typically, an EPDM has a 30-year life expectancy. The Town Hall's roof is showing significant wear and tear. It will need to be replaced in the next five years. If the building is renovated, this will experience additional wear and tear from the construction process and will need to be replaced during renovation since it is near the end of life.

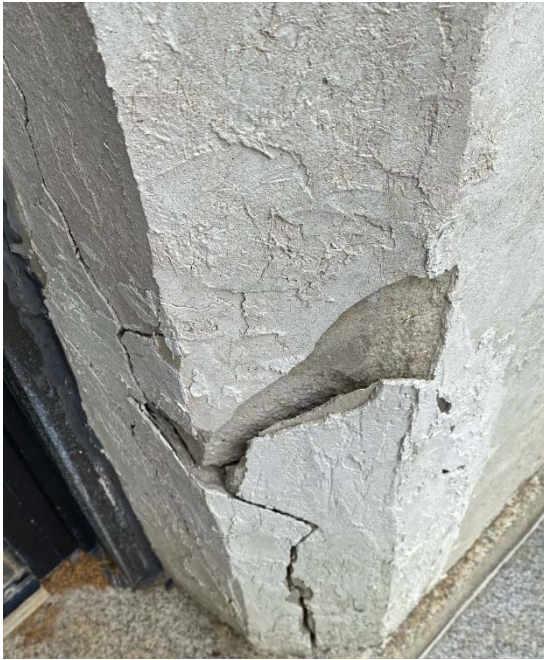
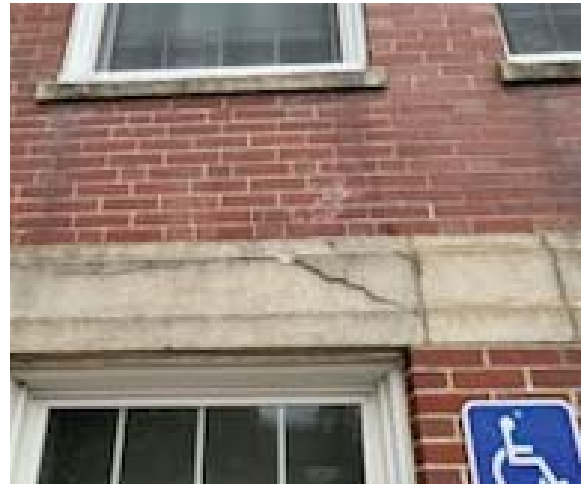
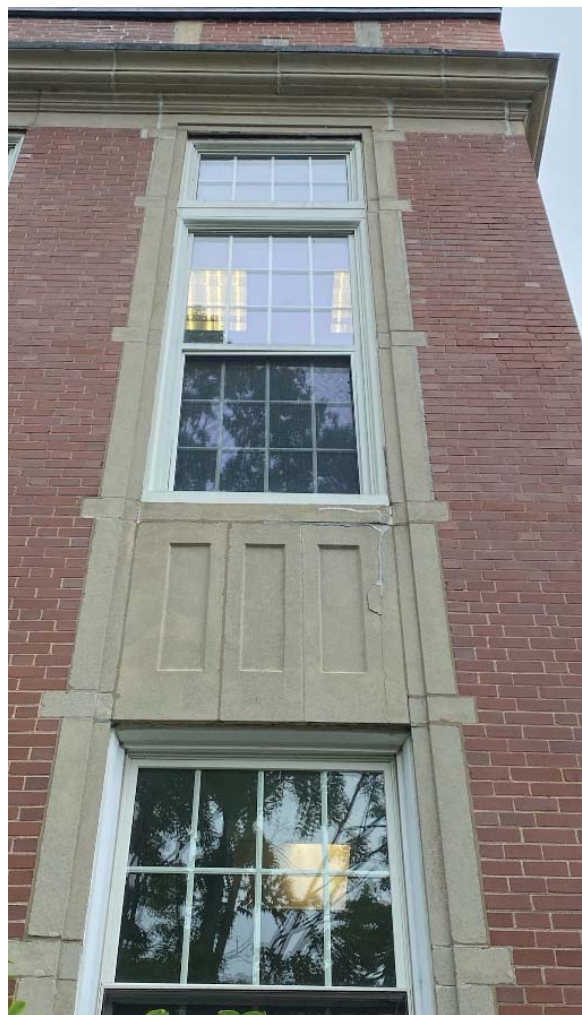
General Precast Concrete:

- There is precast concrete throughout the exterior façade and the precast concrete is starting to fail in many locations. Refer to the next few pages for specific examples of failure at the windows, tablets, and pediment. This issue needs to be addressed now before an injury occurs.
- Refer to in Appendix A for more information.

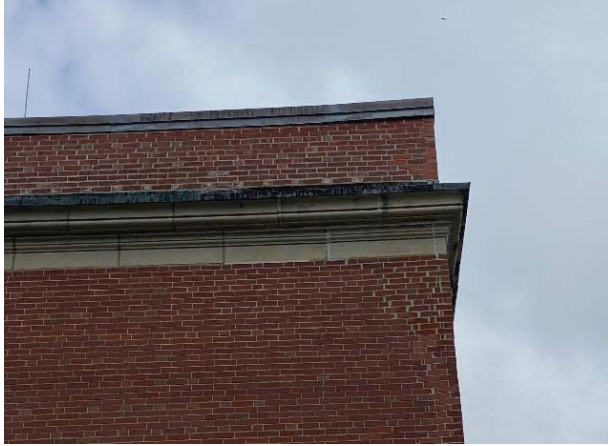
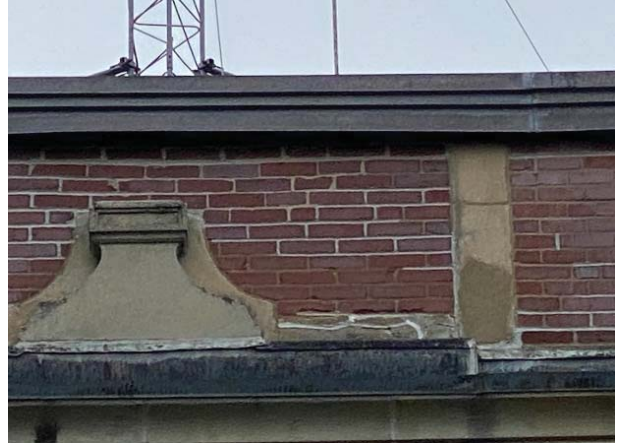
General Precast Concrete:

- Upon visual assessment of the building's exterior it is evident that pieces of the precast concrete have fallen off. To date there has been no bodily harm. However, all the precast concrete needs to be inspected by a qualified mason and repaired or removed before somebody is hurt.

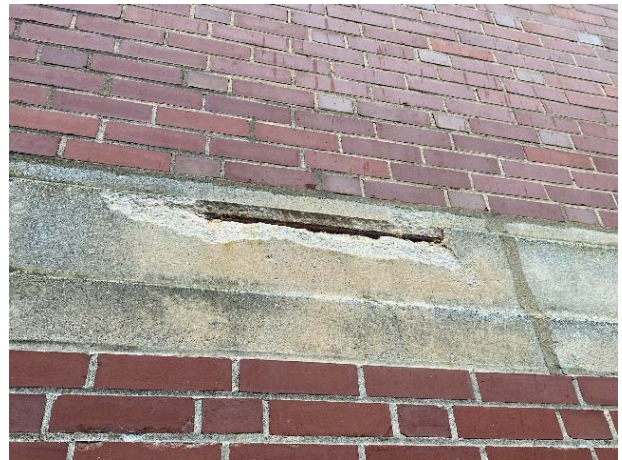
- A piece of concrete sill that has fallen and can be seen on the sidewalk below.

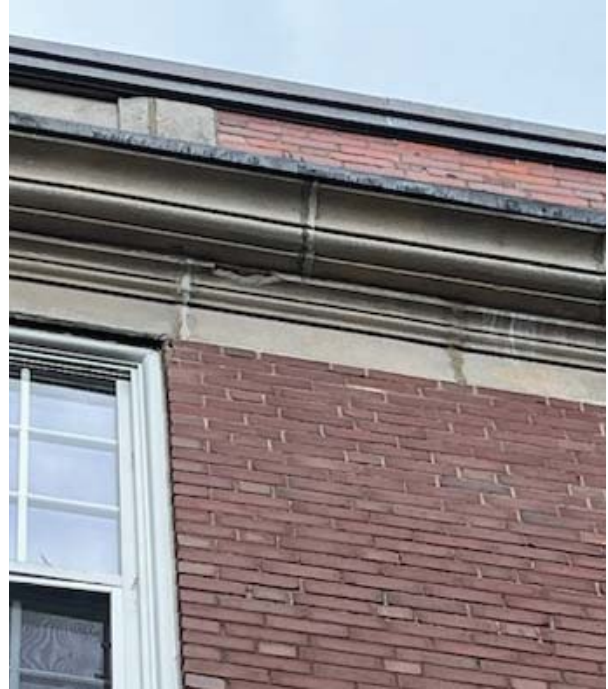
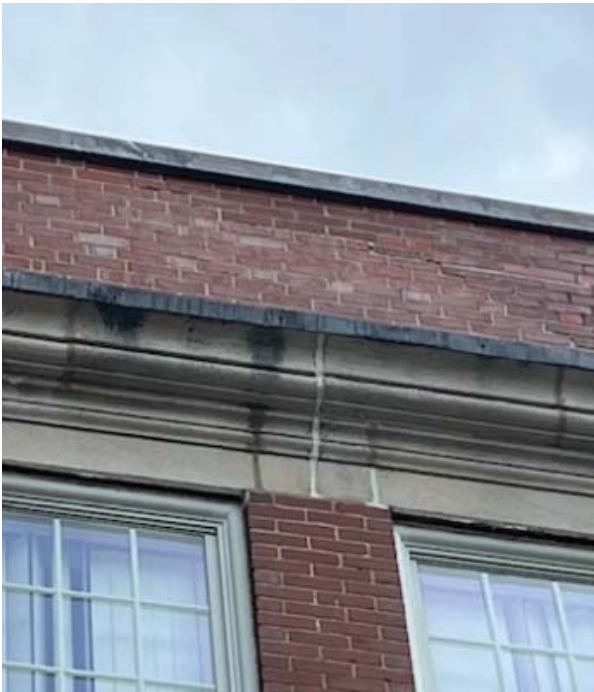
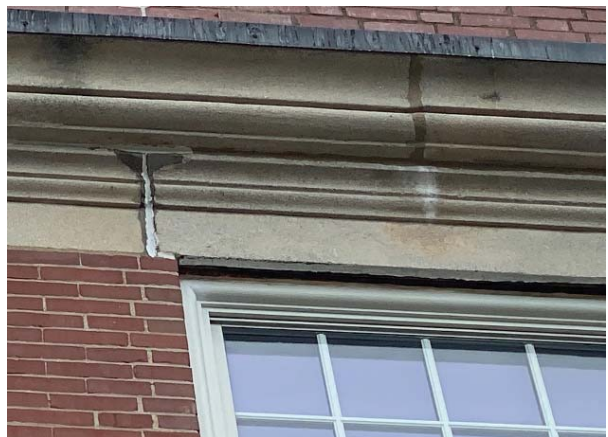
Precast Concrete Pediment:

- The pediment is starting to deteriorate, and a small portion of precast concrete has fallen.
- After further inspection from the ground, there was limited cracking but a large quantity of staining. From the ground and without selected demolition, we are unable to inspect if the break-metal cap is allowing water into the building's masonry facade, but we suspect that it might be. If it is, this will greatly accelerate the deterioration process. Either way, the pediment needs to be thoroughly inspected and remediated as soon as possible.

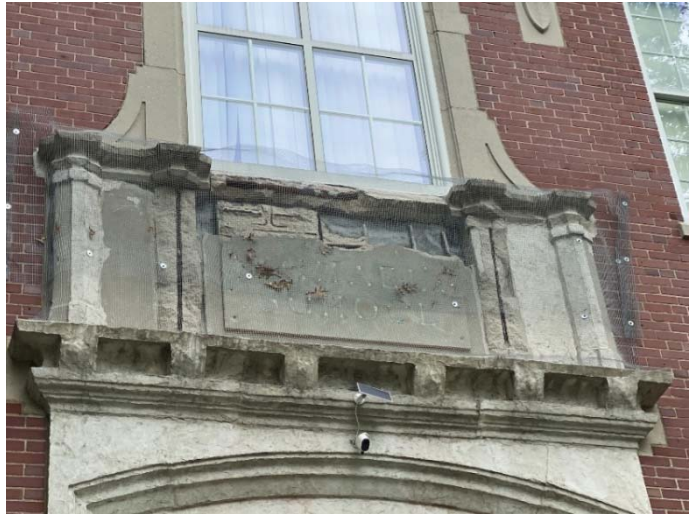
Precast Concrete Entry Tablet:

- The large piece over the main entry is in significant disrepair and has crumbled. A metal mesh screen has been installed to contain the fragments. This poses a safety risk.
- As this concrete deteriorates, it allows water into the precast and the brick wall which will accelerate the cracking of the precast, along with damaging the brick system. This should be treated now to prevent additional water infiltrating the brick and causing additional damage to the building.

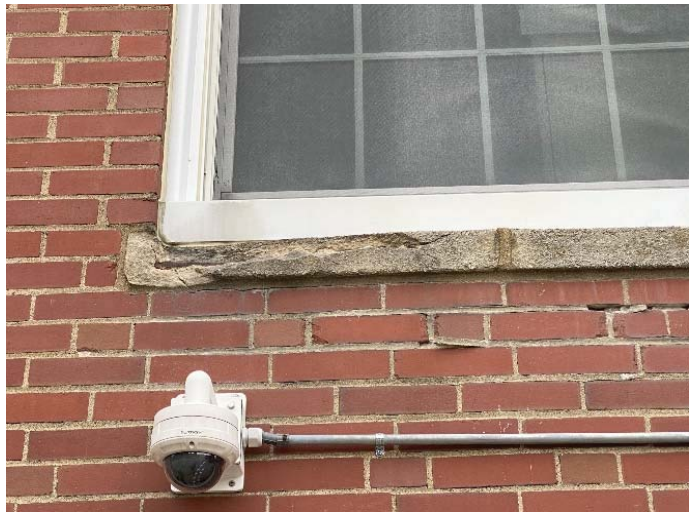
Windowsills:

- The existing windowsills are precast concrete and do not have flashing or other material to prevent water from sitting on them; subsequently water penetrates into the concrete sill and causing extensive cracking.
- Many sills are cracked, and some have pieces that have broken off.
- We were only able to inspect the windowsills on the ground floor. Not all sills could be inspected from the ground level, and we were not able to open windows to look at the sills on the second and third floors because the windows are failing and thus inoperable. A further inspection should be made with a lift bucket to ensure that there are not more significantly damaged sills that may have lose concrete that we were not able to assess from the ground level.

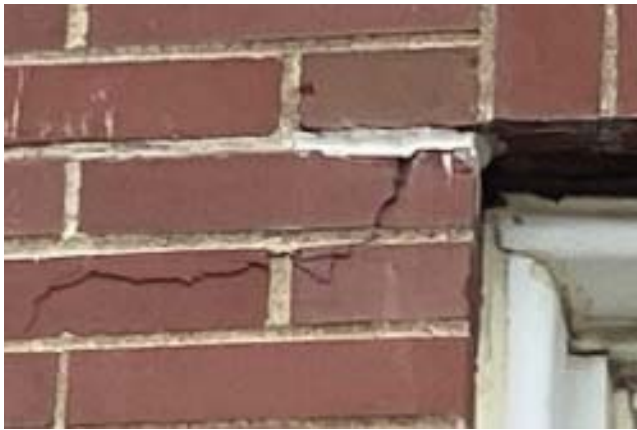
Window Lintels:

- The steel windows are rusting. Though this is normal, they should be regularly scraped and painted.
- At some point, somebody caulked between the brick and the lintel blocking water from draining properly. The blocked water is freezing and expanding causing damage to the brick. This caulk needs to be removed.

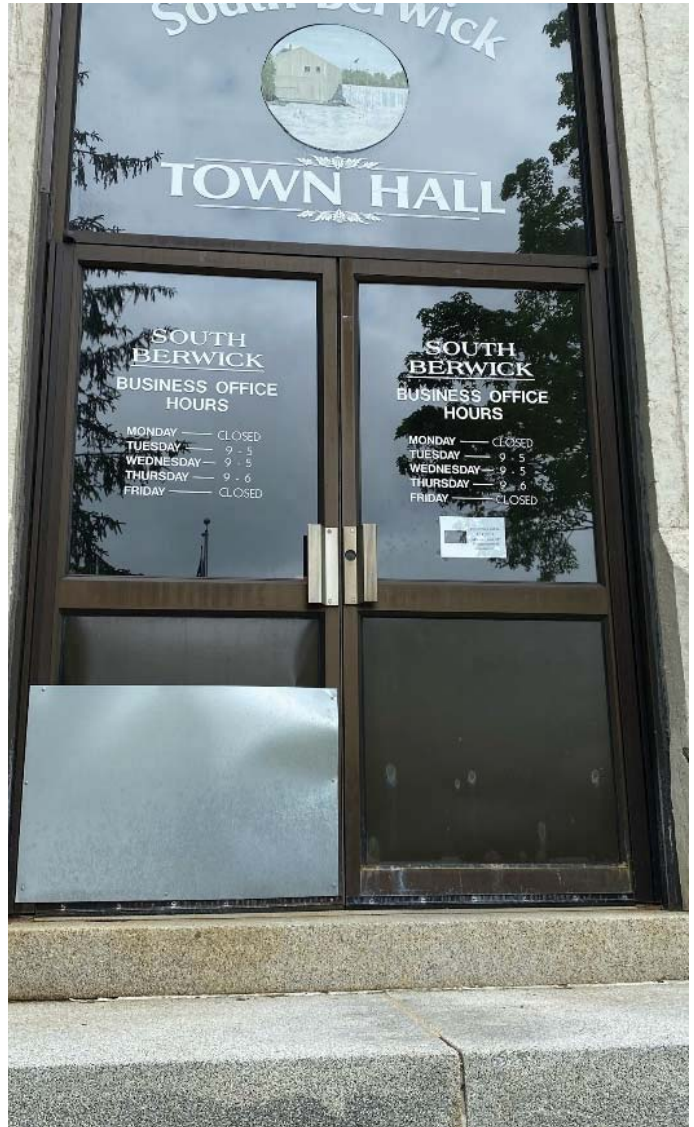
- The exterior doors are a combination of hollow metal and aluminum storefront.
- Most exterior doors are older and worn, impacting their thermal value and their overall appearance. These should be replaced for a more attractive look and better insulated / weather stripping.
- The thresholds at the exterior aluminum storefront doors do not meet ADA requirements and may be letting water in due to wear. These should be replaced.
- The door pull weight exceeds ADA code requirements at the stairs and must be addressed by adjusting the closer or adding an automatic door opener.

- The aluminum storefront front doors are deteriorating, a panel has corroded, and the door should be replaced.

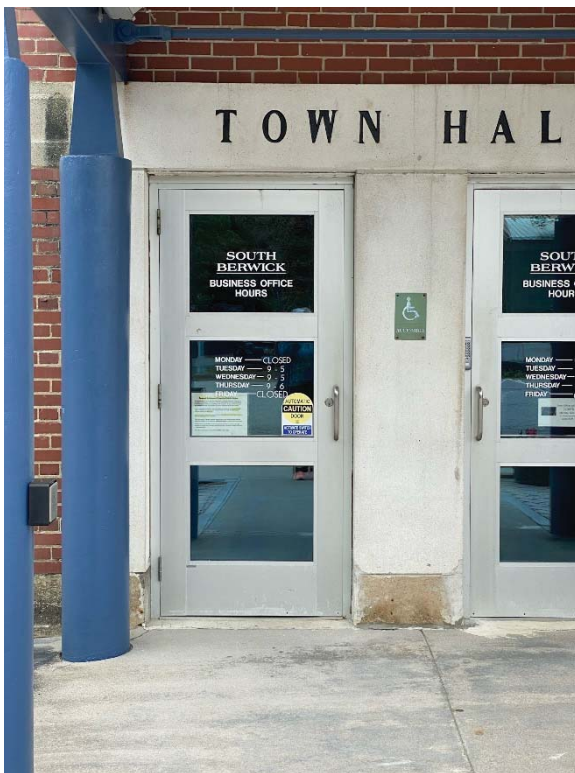
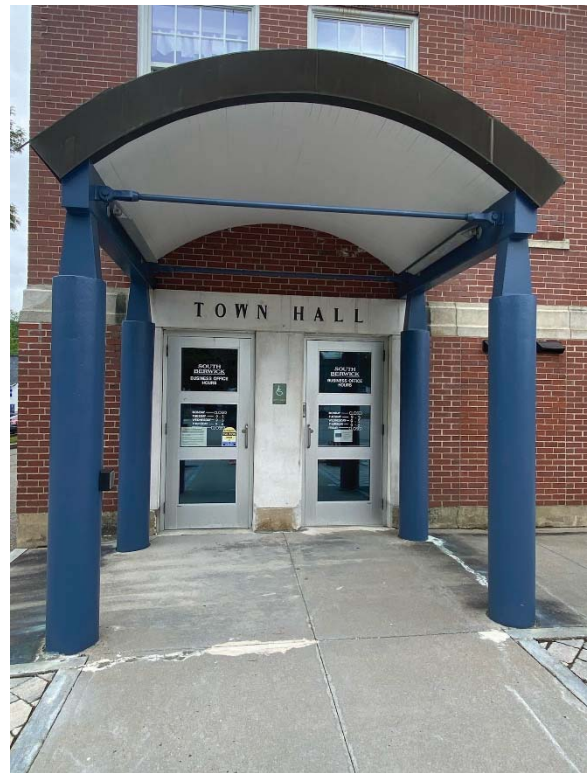
- The entrance canopy funnels rainwater to the side and the water is damaging the building. Gutters or other water control should be added.
- The rear entry doors are ADA and have an automatic door opener. However, the thresholds are starting to curl and should be replaced. See Threshold note above.

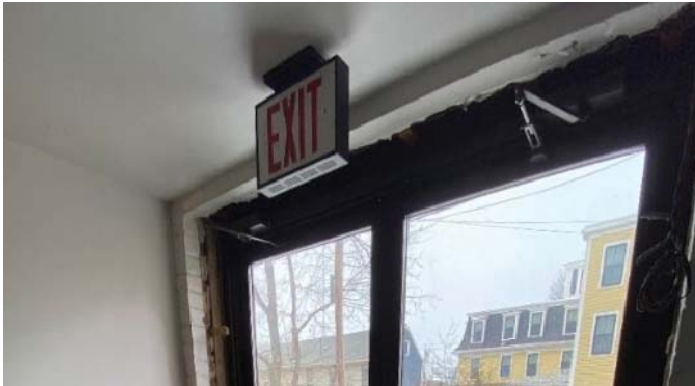
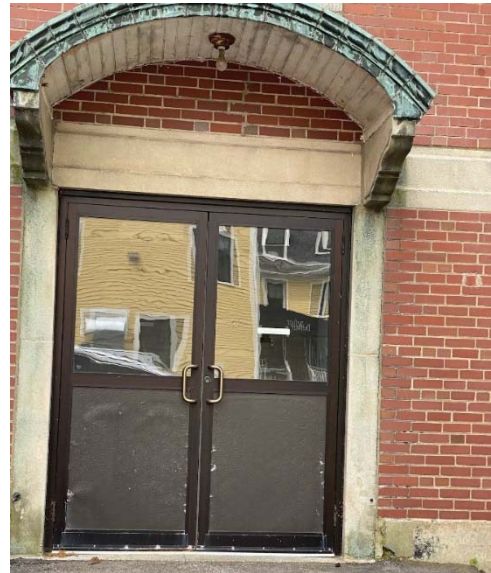
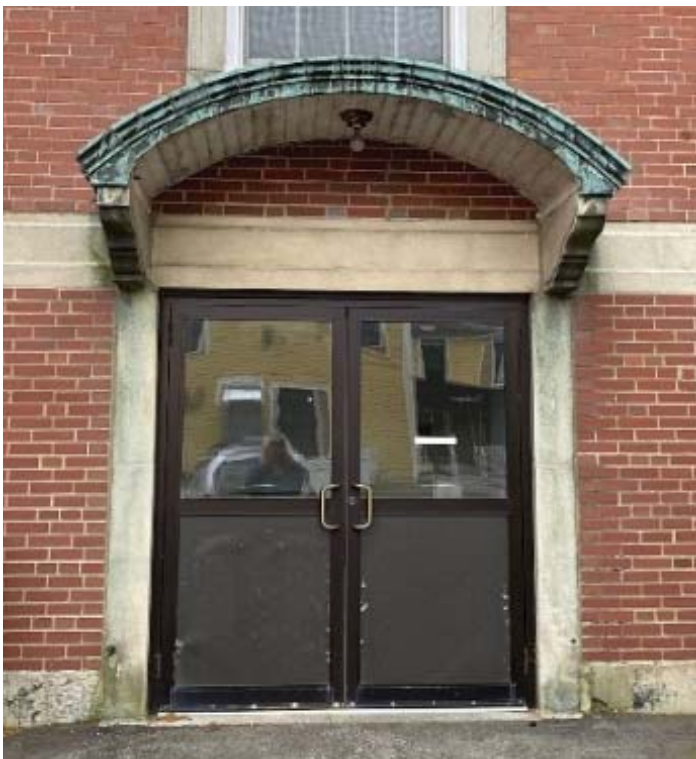
Aluminum Storefront Stair Doors:

- The side stair doors are starting to fail as indicated by all the rivets added to them. They need to be replaced.
- The interior jambs of one of the doors is missing which is negatively affecting the buildings appearance.

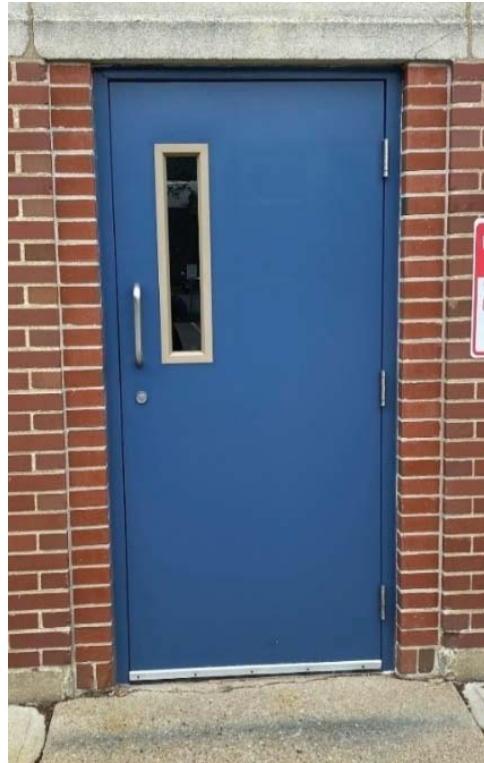
Hollow Metal Rear Doors:

- The two hollow doors at the rear of the building have recently been replaced and are in good shape.

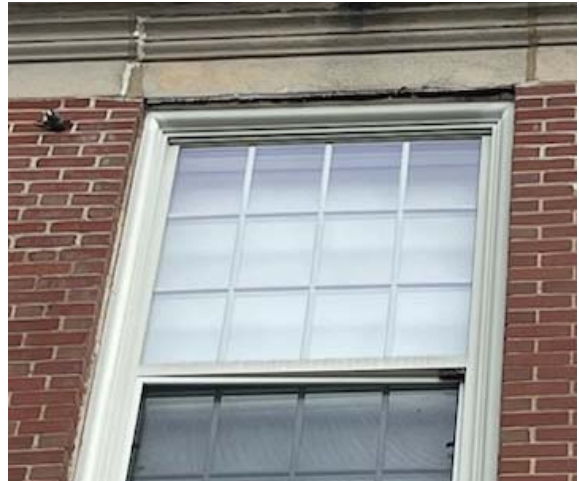
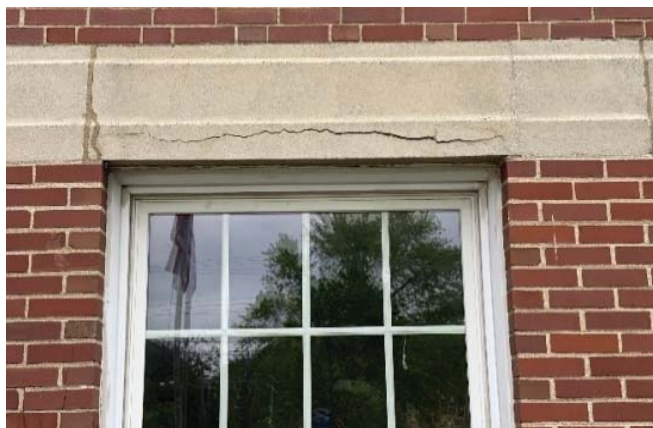
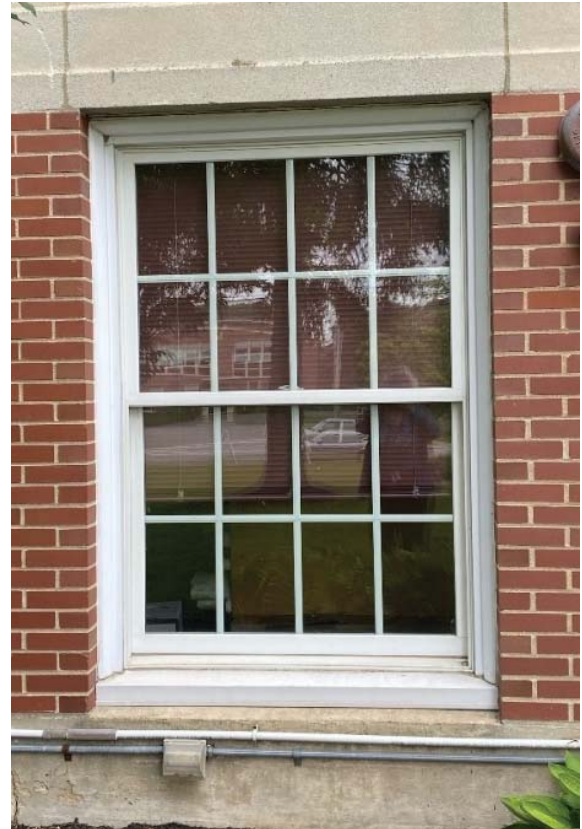
Windows:

- Windows were replaced approximately 25 years ago and vinyl windows of this size have a lifespan of ten years. Many of the windows are failing. These need to be stabilized now and replaced in the next year.
- In our exploration, we encountered the window sashes are falling out and the top sashes will not stay up in many locations. Both issues pose a significant risk for personal injury and need to be addressed now. Please see Port City's letter of June 14, 2023, refer to **Appendix C – Letter to South Berwick about Windows and Precast** for the full letter.

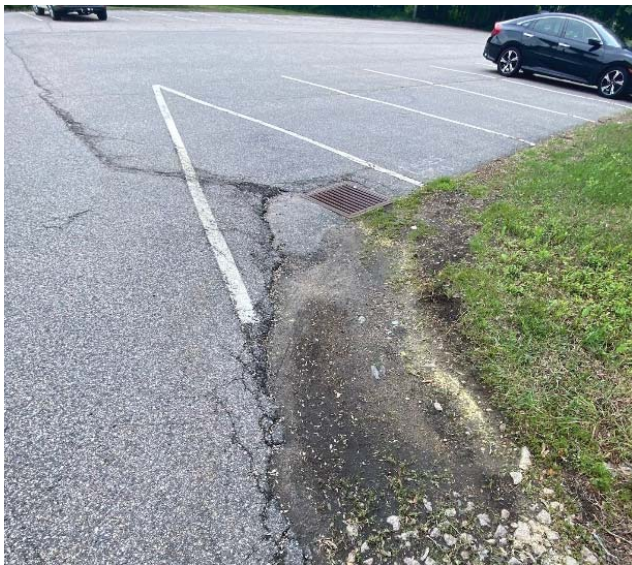
General Parking Lot

- There is ponding and broken areas of pavement indicating the subbase is failing. The parking lot should be regraded and paved.
- The parking lot needs to be restriped.
- The entrance and exit could use better signage.

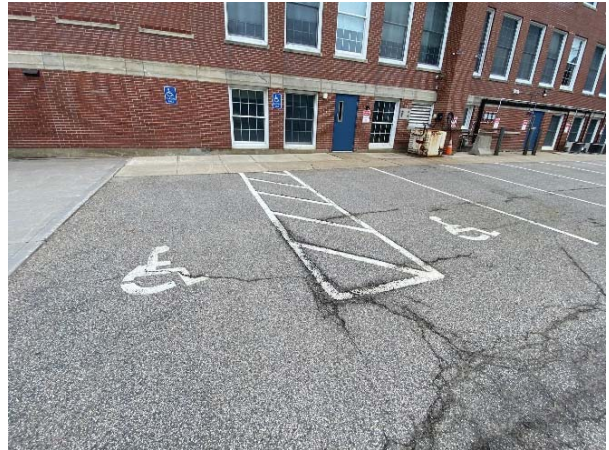
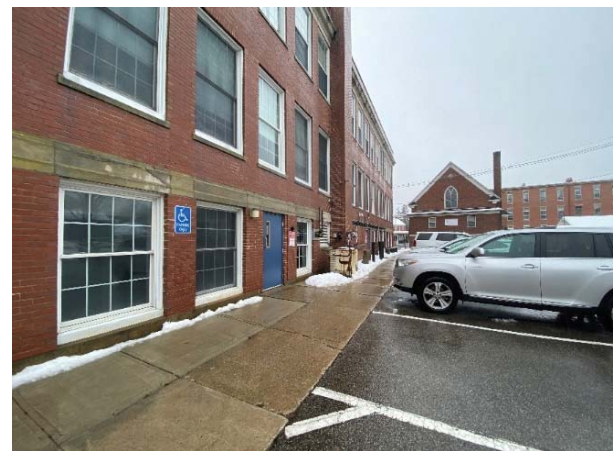
- ADA Parking spots do not meet the current code. While they meet the 2% grade, the van spaces are too small. Also, once the parking spaces are renovated, the tilt downs need to be reevaluated and renovated to provide convenience to the new spaces.

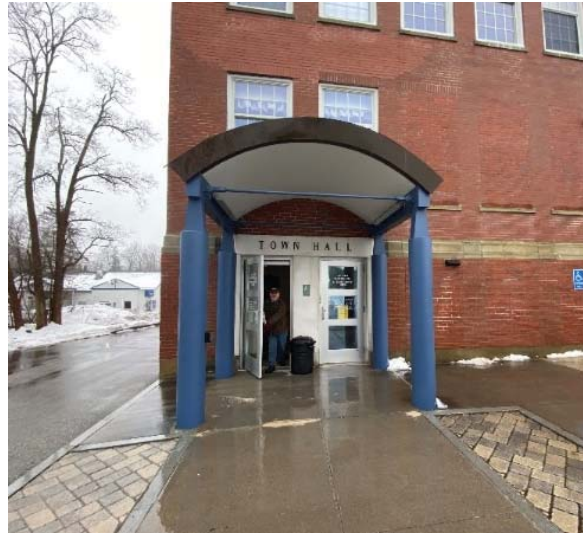
Entry Sidewalk

- The planting beds at the main entry were filled in creating a tripping hazard since the pavers shifted / sunk. These need to be repaired.

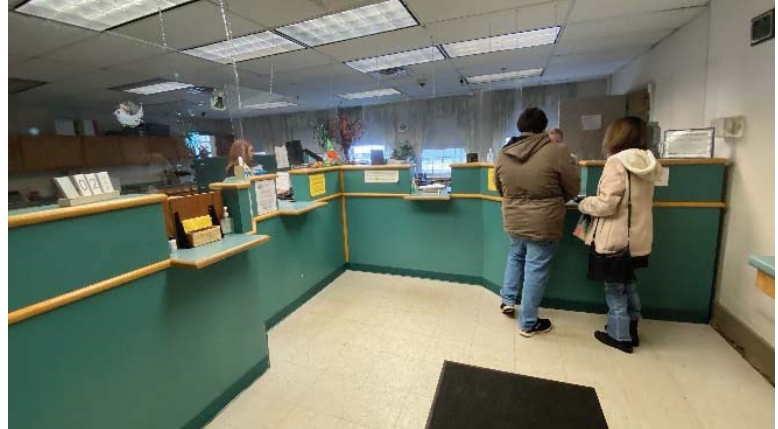
Clerk's Counter:

- Finishes are starting to fail in some places and are dated. See finishes for more information.
- The counter is not ergonomic and could be causing staff issues.
- The department is set up to keep the public on one side of counter and staff on the other side of the counter. They are able to lock the department off from the hallway.
- Because the two stations are in a corner, there is not room for people at both counters without the likelihood of touching each other. This creates privacy and comfort issues.

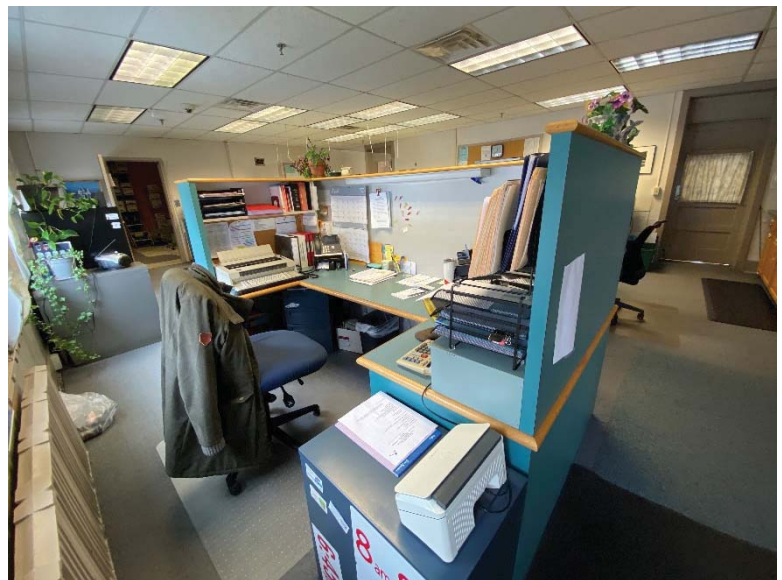
- The clerk's desk is too small, is not ergonomic, and the walls are not full height. This is a substandard desk and needs to either be replaced or modified.

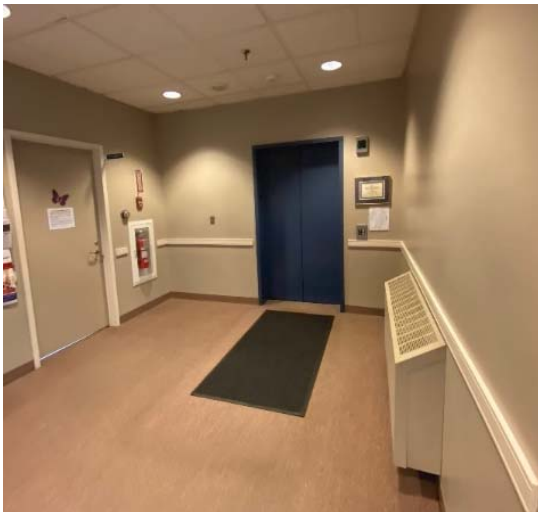
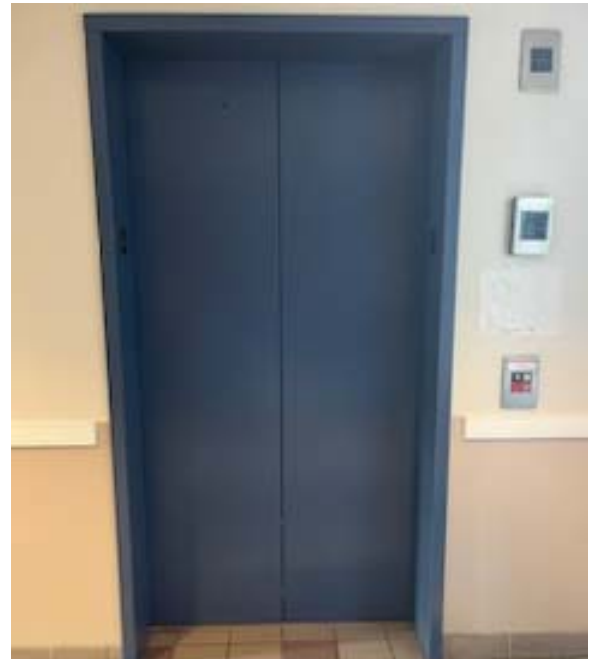
Elevator:

- The elevator has been in existence for many years and is reaching the end of life on several components.
- The leveler is failing so the elevator does not always line up with each floor. It is anticipated that the elevator will need to be replaced in the near future. It is possible that the elevator will fail its next annual state inspection and will need to be replaced at that time.
- The existing elevator shaft should be grandfathered and not need to be made larger. However, that is up to the local jurisdiction, and they may require the town to enlarge the elevator shaft to meet current code requirements.
- The flooring appears to be class A, and this meets code.

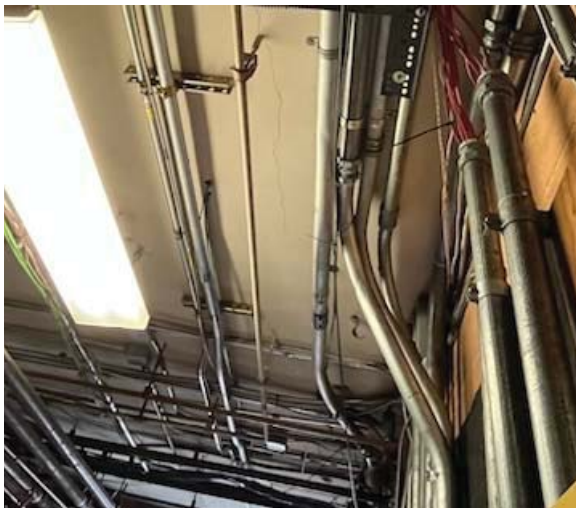
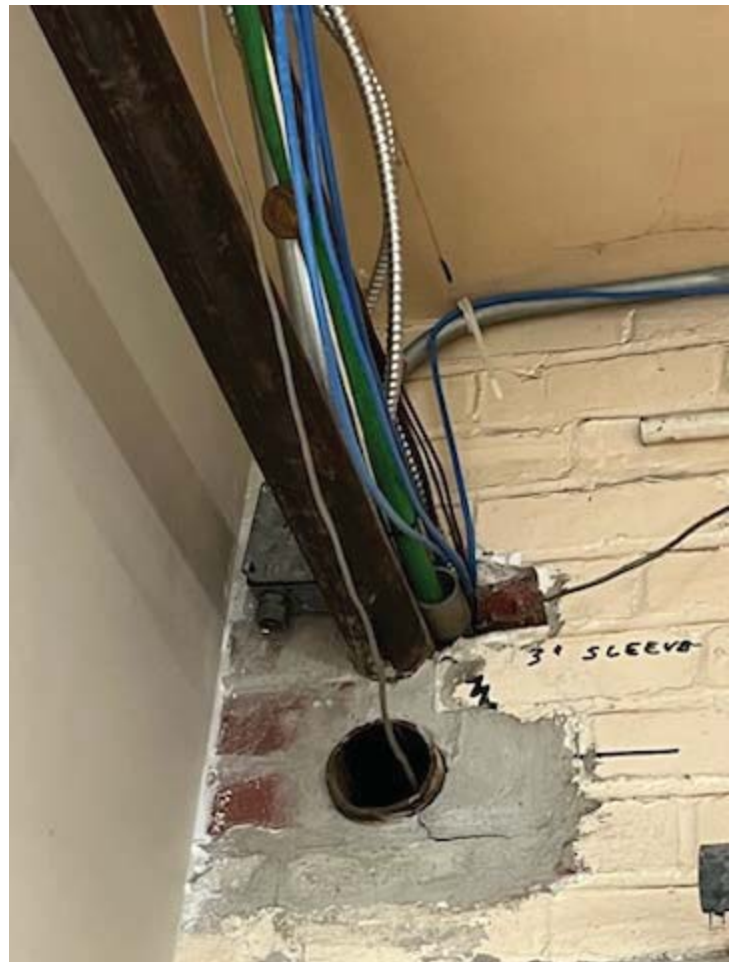
- The MEP has been retrofitted over the years. The walls are in disarray from renovations. There are scattered equipment, pipes, and wires, as well as holes and dents in the walls. These need to be repaired.
- All hard walls and ceilings with cuts need to be patched and all penetrations in fire walls need fire caulk to provide fire rated systems as required by code.
- Electrical wires when exposed should be in conduit to make sure they are not damaged.

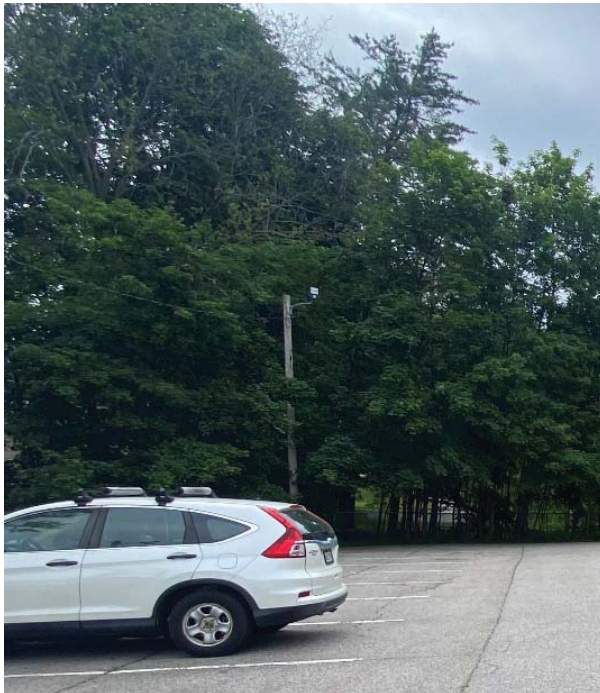
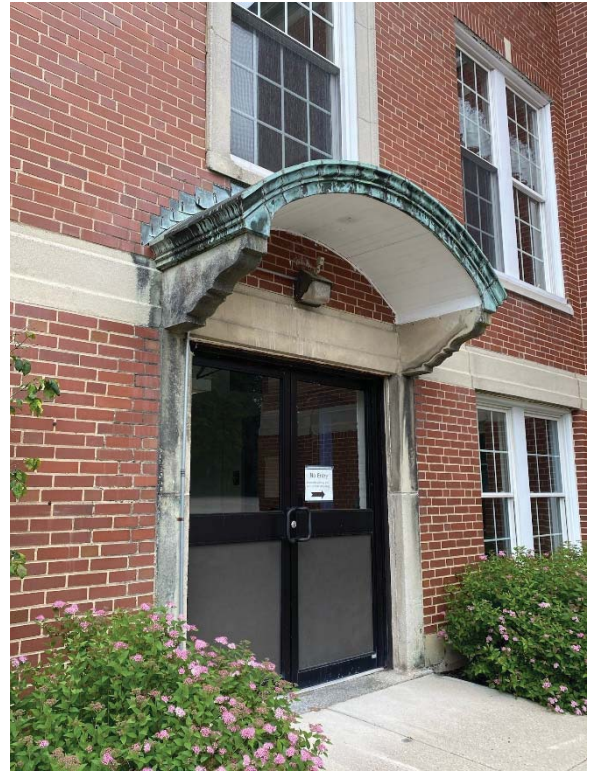
Existing Exterior Lighting:

- All exterior egress doors are required to have emergency lights that operate on a battery. The existing emergency lights are old and likely have expired batteries. These need to be tested and faulty lights need to be replaced.
- There are both wall mounted and pole mounted site lighting. Due to the age, the fixtures are not LED and will not have the best cut-off lenses. These should be replaced to provide more cost-effective lighting and to make sure there is not excessive light spilling over the property line.

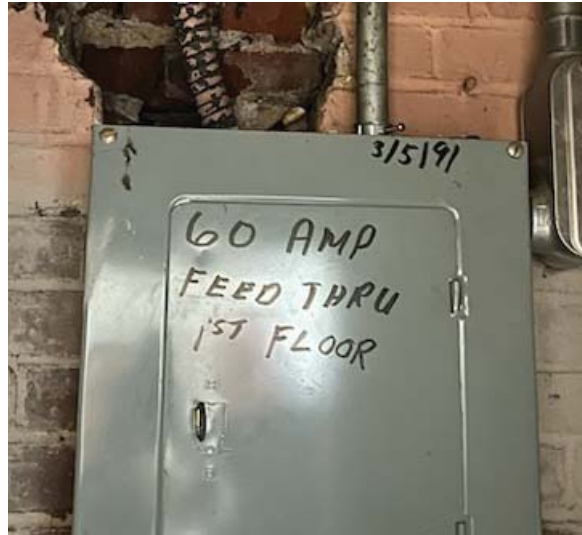
Electrical Systems:

- The electrical boxes are scattered throughout the building and are not arranged in an organized fashion. One electrical box is in a stairwell which is a code violation and needs to be removed as soon as possible (see stair review above).

- Some breakers are permanently tripped indicating there is an electrical supply issue.
- Open splices of electrical wires were noticed, and these are required to be placed in electrical boxes by code. These are throughout the building. In some cases, it might be more cost effective to just replace the wires instead of providing multiple boxes.

- As stated above, the wires are disorganized and loose. These should be placed in conduits to prevent someone accidentally cutting a wire and electrocuting them self.

- There is some knobs and tube wiring exposed in the attic and there is probably additional knobs and tube within the existing walls that we are not able to see without doing selective demolition. This wiring needs to be removed and replaced.

- The extensive issues with the electrical system need to be addressed by having a master electrician remove / replace / relocate the sub panels, repair / replace the faulty wiring, and provide adequate electrical infrastructure as soon as possible. However, if the building is going to be renovated, the electrical issues are so severe, the electrical system should be removed and replaced throughout.

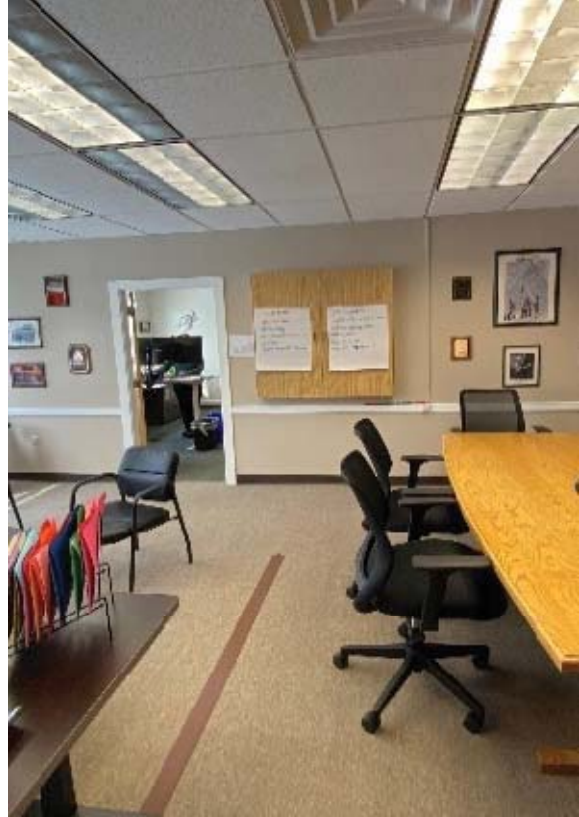
- Carpet is ripped in several places with tape holding it together. Though unattractive, the most important issue is that it poses a trip hazard and should be replaced now.

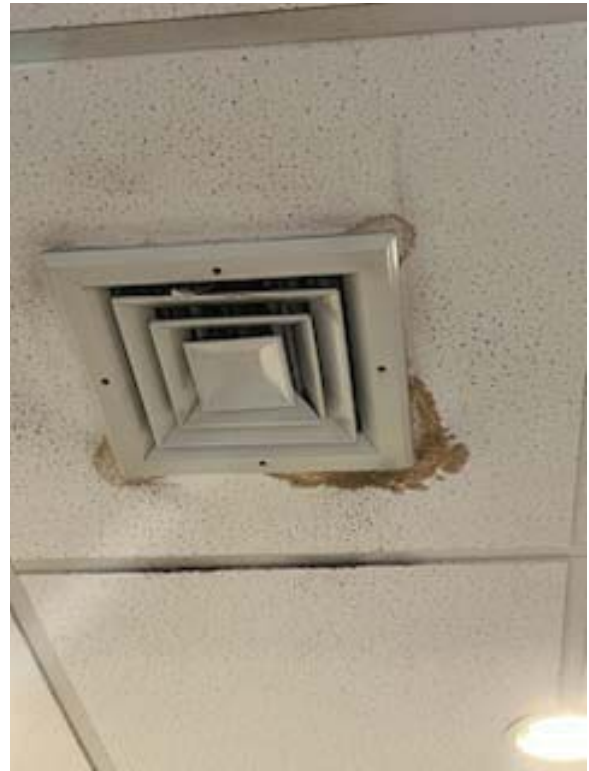
Ceilings:

- Ceilings throughout are dated, worn, and water damage is present throughout.
- In many places the ceiling frame is starting to turn yellow from age. These should be replaced.
- The ceilings systems need to be replaced throughout the building.

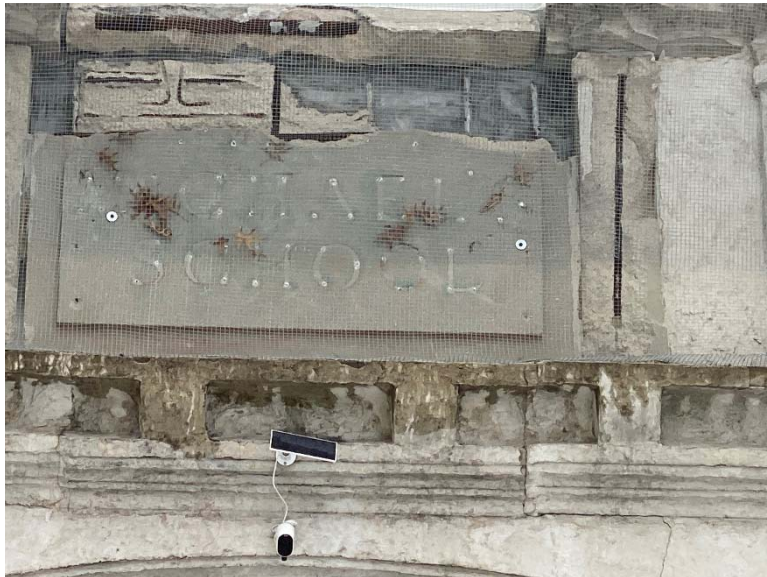
Entry Tablet:

- The large piece over the main entry is in the worst shape and has totally crumbled to the point somebody has provided a protective screen around it to prevent people being hit by pieces of falling pieces of concrete. As this concrete deteriorates, it allows water into the precast and the brick wall which will accelerate the cracking of the precast and potentially the brick system.

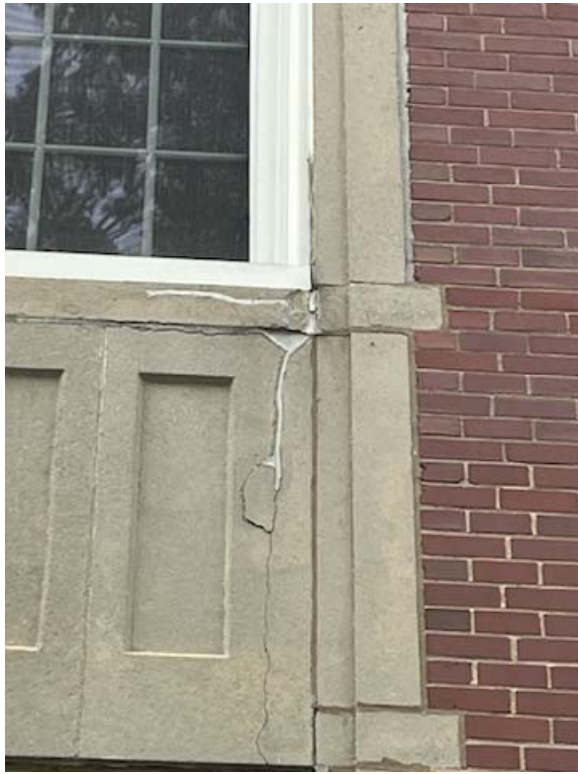
Tablet at the stair towers:

- While pieces have not fallen yet, the large cracks are allowing water into the wall / precast system, and it will continue to crack until it also fails.

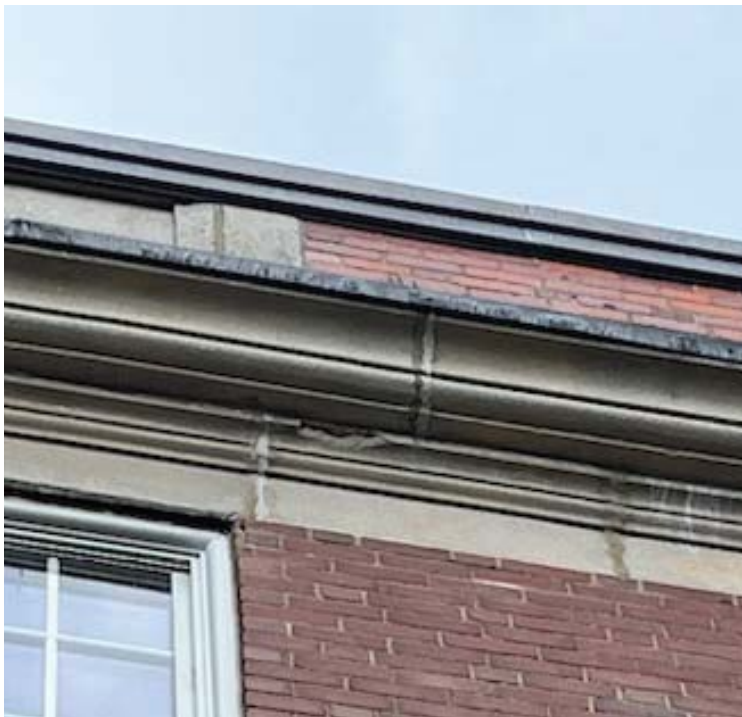
Pediment:

- The pediment is starting to deteriorate and a small portion of precast concrete has fallen.
- After further inspection from the ground, there was limited cracking but a large quantity of staining. From the ground, we were unable to inspect if the break-metal cap is allowing water into the building's masonry facade, but we suspect that it might be. If it is, this will greatly accelerate the deterioration process. Either way, the pediment needs to be thoroughly inspected and remediated ASAP.

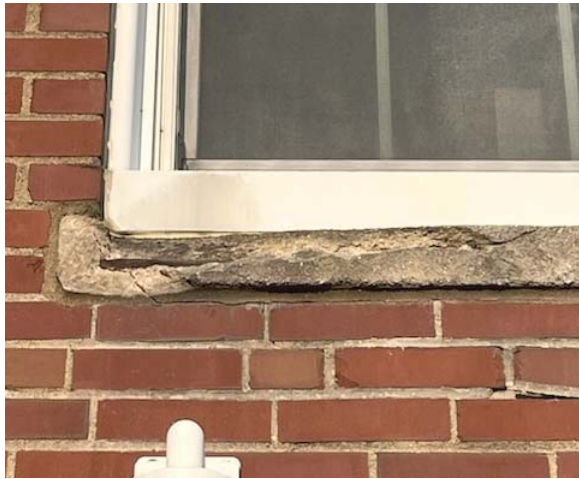
Windowsills:

- The water has infiltrated some of the sills and caused it to deteriorate to the point where large chunks of precast have fallen off and the rebar is exposed. Once rebar is exposed, the rusting of the rebar will accelerate causing the rebar to expand which in turn will cause more cracking and deterioration of the precast. This will also allow water to infiltrate the wall system causing damage there too.

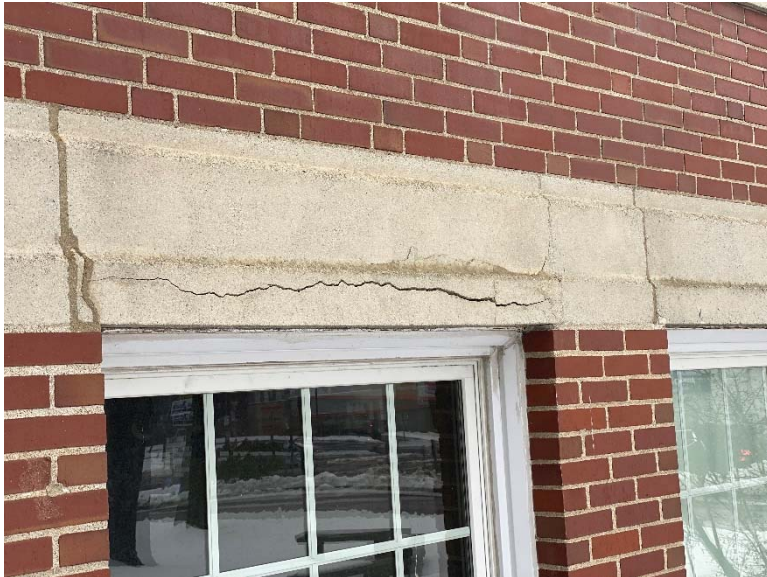
Window headers:

- Water has infiltrated the window header in several places and the rebar has started to rust and expand creating a long, continuous crack. This situation will continue to get worse unless some sort of remediation is done.

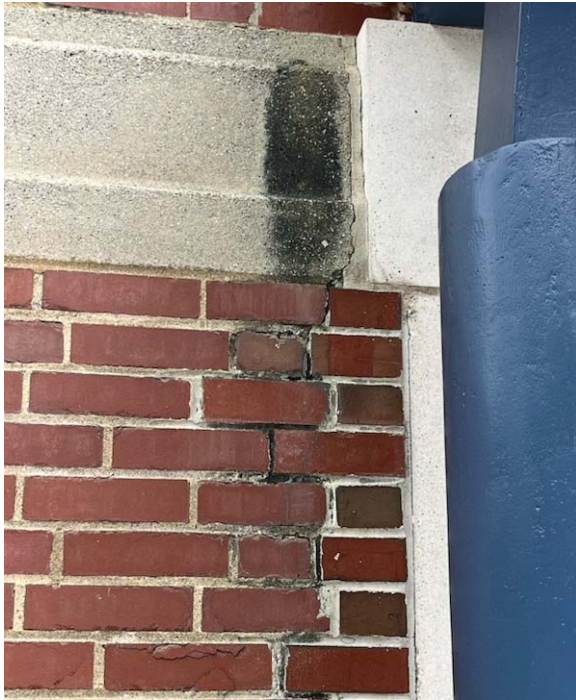
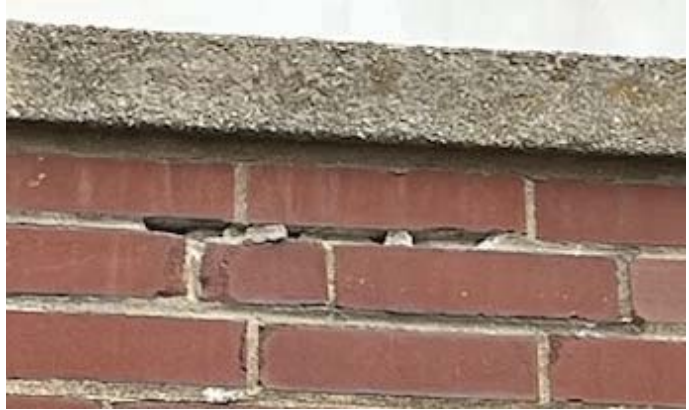
Brick deterioration:

- At places, water has infiltrated the precast concrete and has started to weep through the brick causing the mortar joints to deteriorate. When the precast concrete is stabilized, any places where the mortar is failing will need repointed.

- Unfortunately, the true extent of the damage to the precast and masonry cannot be determined without a more in-depth investigation and possible selective demolition of the precast and the surrounding materials. The Town needs to address the deteriorating precast before someone is seriously hurt (or worse) by falling concrete. A further investigation will determine the extent of the damage and will inform the Town of what kind of remediation is required. At a minimum, the Town should provide some sort of reinforcement and/or protection system to prevent the deteriorating precast from falling on pedestrians. If South Berwick desires, we will be happy to help locate a company who specializes in masonry investigation and repairs.
