## CIVIL CONSULTANTS MEMORANDUM

**SUBJECT: South Berwick Town Hall – Exterior Masonry Inspection**

**DATE: OCTOBER 3, 2023**

**PROJECT: EXTERIOR REVIEW – TOWN HALL / COMMUNITY CENTER**

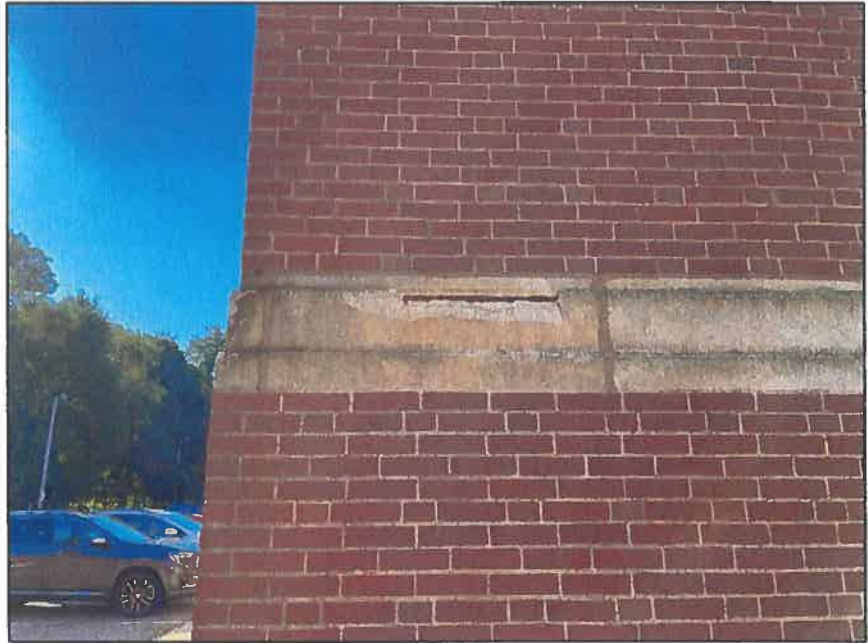
The current issues center around the decay and deterioration of the concrete façade pieces that are showing their age. Moisture intrusion and general aging seem to be causes for the deterioration.

*Photograph 1 – Concrete Banding Deterioration*

The concrete decorative façade pieces around the building (Photograph 1) are showing their age from exposure over the years. The attached photograph indicates a typical situation. These areas can be repaired by a competent mason or concrete contractor. The repair method involves removal of all loose concrete, cleaning the exposed steel reinforcing, sealing the reinforcing and application of new

concrete surfacing. This new surface can be formed to match the original profile of the concrete. The adjacent areas may need to be cleaned to reveal hidden damage not visible for the on the ground observations.

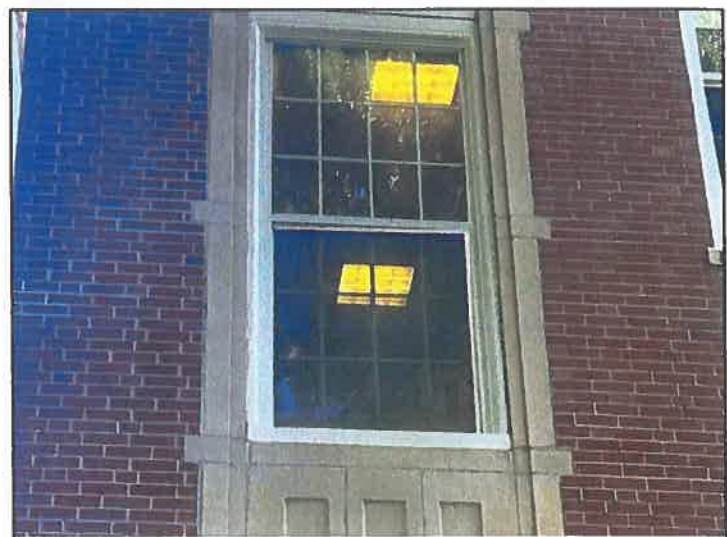
*Photograph 2 – Window Concrete Deterioration*

This repair strategy can also be applied to the large decorative concrete window surrounds as seen in Photograph 2. The damaged concrete will be removed, the area cleaned and repaired. The repair materials can have a similar texture to the existing to blend in with the surrounding location.

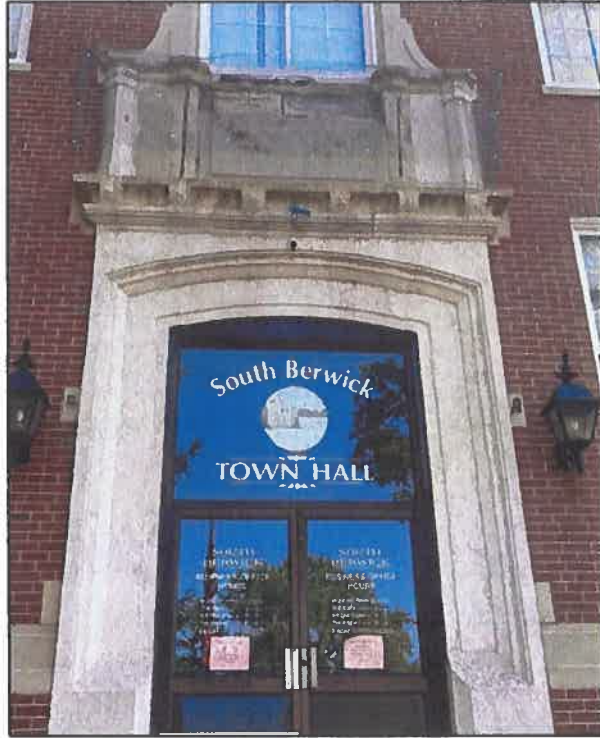
Photograph 3

The repair to the main entry detail above main door will require more than a surface repair. The head sign detail has degraded to a condition that a majority of the face needs to be removed and replaced. If desired by the Town the existing detail can be recreated to have the pillars and signage above the door.

The front door decorative concrete surround appears to have had a plaster type of repair (unknown age) that does not match the remainder of the building. It is possible that this coating could be removed to restore the original appearance. A restoration contractor would need to be consulted to address this area further.

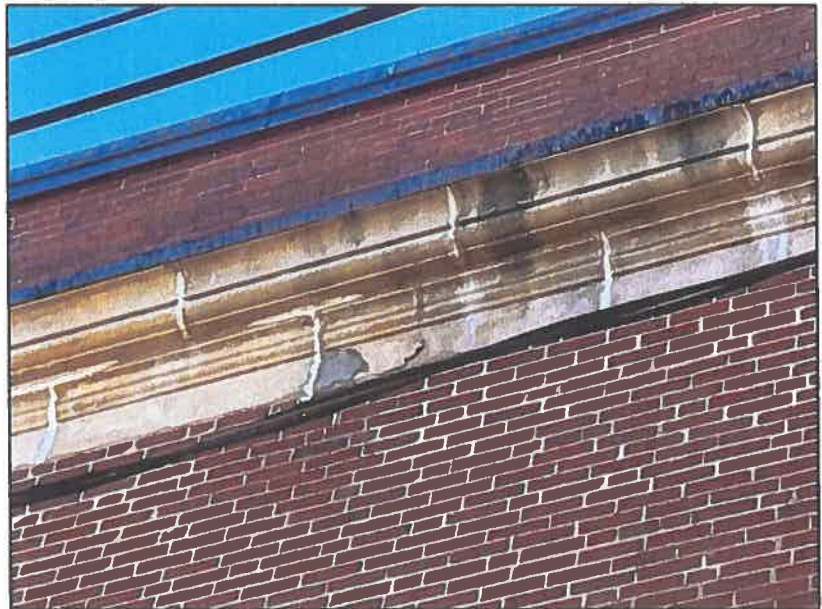
Photograph 4

The top band of the building along the roof parapet should be investigated as part of any exterior renovation project. The top side of the parapet was not visible during the inspection from the ground, but no major areas were observed that needed to be repaired. The inspection process will involve reviewing the metal flashing and connection to the masonry.

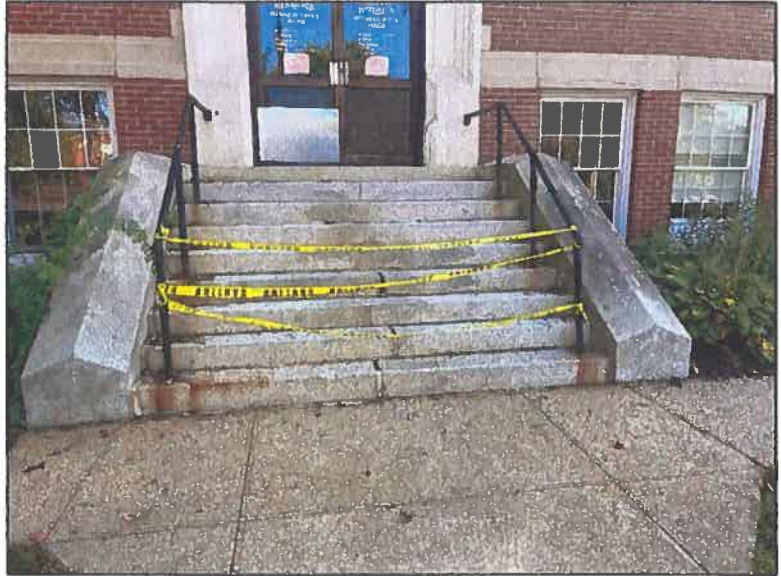
*Photograph 5*

The front entry stairs are in need of repair. In order to properly repair this area, the granite slab treads would need to be removed and supports investigated. It appears that most of the existing treads could be reused.

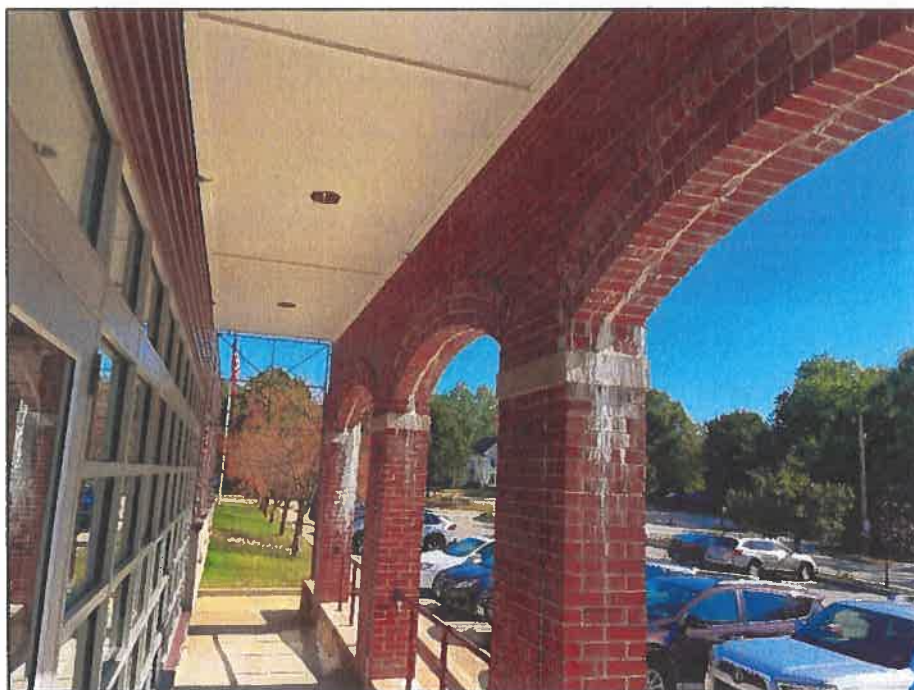
*Photograph 6*

At the community center water is entering the brick arch entranceway covering and has caused significant damage to the masonry. As a result of the moisture intrusion, significant amounts of efflorescence and scaling is visible due to the water and moisture moving through the masonry.

arch is supported by concrete block masonry. The block details were designed by the project architect during the renovation, not the project structural engineer. The details on the plan do not indicate how the arch of brick veneer is supported. It is our recommendation that some destructive testing and removal of finishes be completed to determine the damage to the existing masonry support. The work should be conducted by a mason with engineering oversight. Moisture is entering the brick veneer and causing the leaks and staining. The investigation will reveal if there is damage to the veneer supports. We recommend that this be completed sooner rather than later.
