Geotechnical Evaluation

Mills Canyon Sewer Access Road Repairs

City Project No. 85090

February 19, 2018 | Project No. 403150001

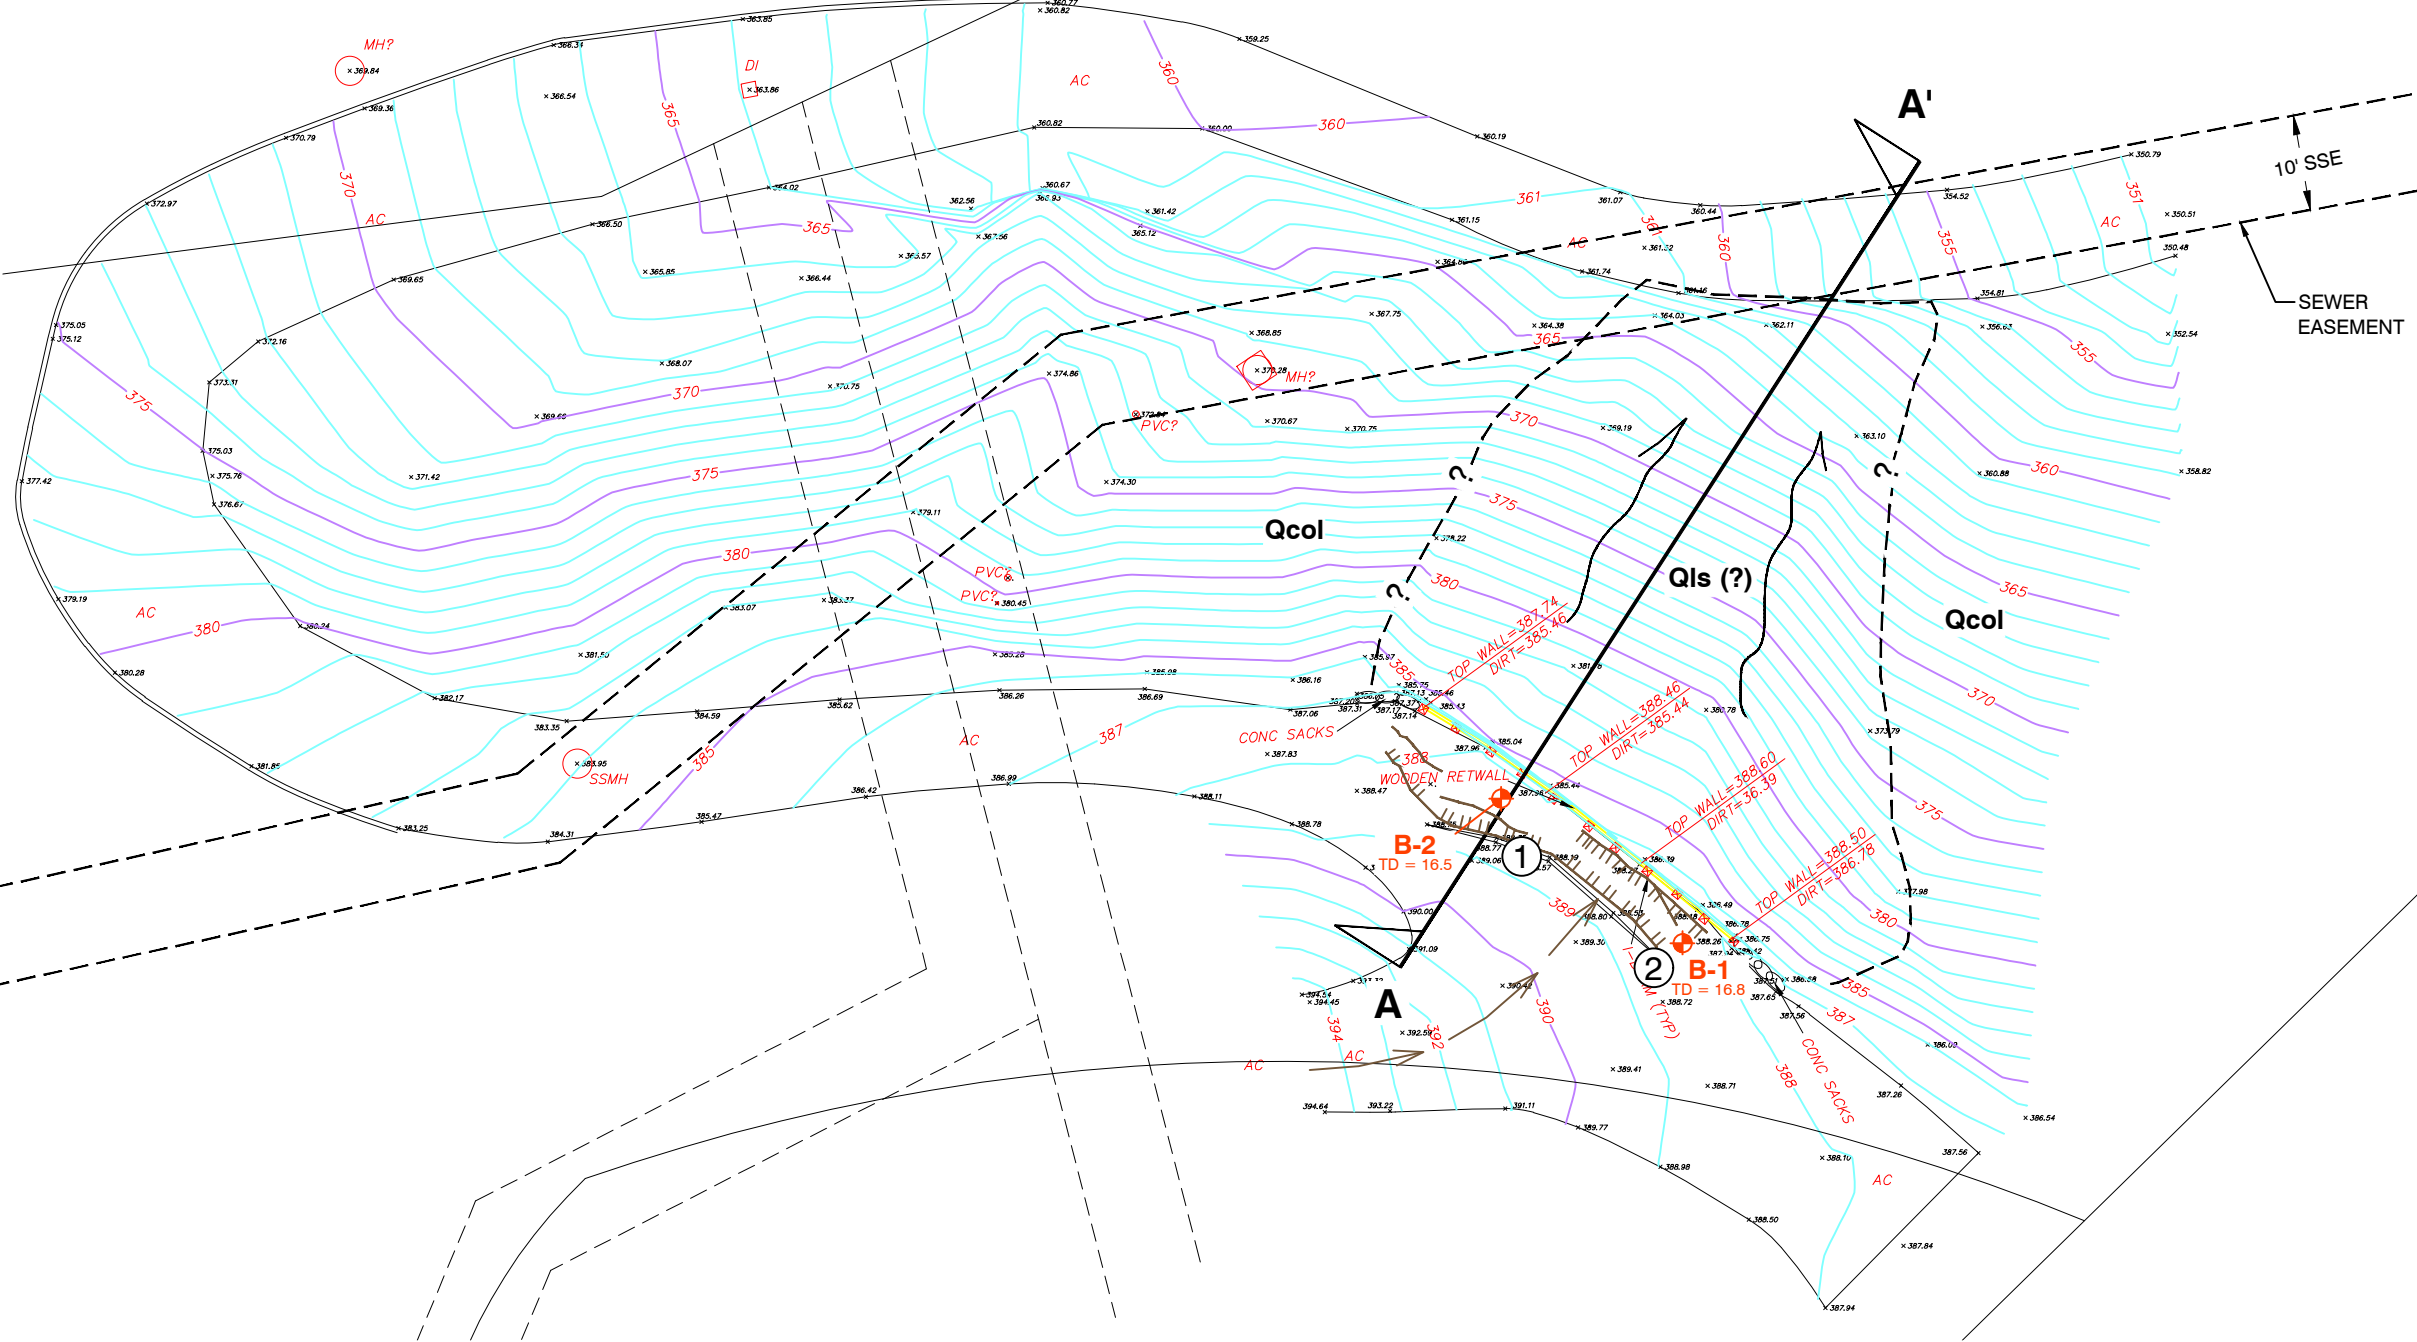
FIGURE 4

Surface flow from the ascending portion of the access road flows directly toward the wall. Two distinct settlement cracks with vertical displacements of up to 6 inches run parallel to the top of the wall through the asphalt pavement. A separation of about 14 inches was observed between the bottom of the timber lagging and the soil ground surface.

6" OF VERTICAL DISPLACEMENT
(11/29/2017)
- ②

1/2" OF VERTICAL DISPLACEMENT
(11/29/2017)

- At Area 1, based on the results of our site observations and slope stability evaluation, the soil movement and cracks in the road are caused by inadequate lagging embedment, in combination with poor control of surface drainage, which flows directly at the wall from the ascending roadway. A separation of about 14 inches was observed between the bottom of the timber lagging and the soil ground surface. Water flow has resulted in soil migration from beneath the lagging and progressive loss of material causing removal of support beneath the roadway. Other contributing factors could include inadequate embedment depth of the soldier piles for the existing retaining wall. Based on the need to significantly extend the lagging depth, a new retaining wall with longer soldier piles is recommended for this area.

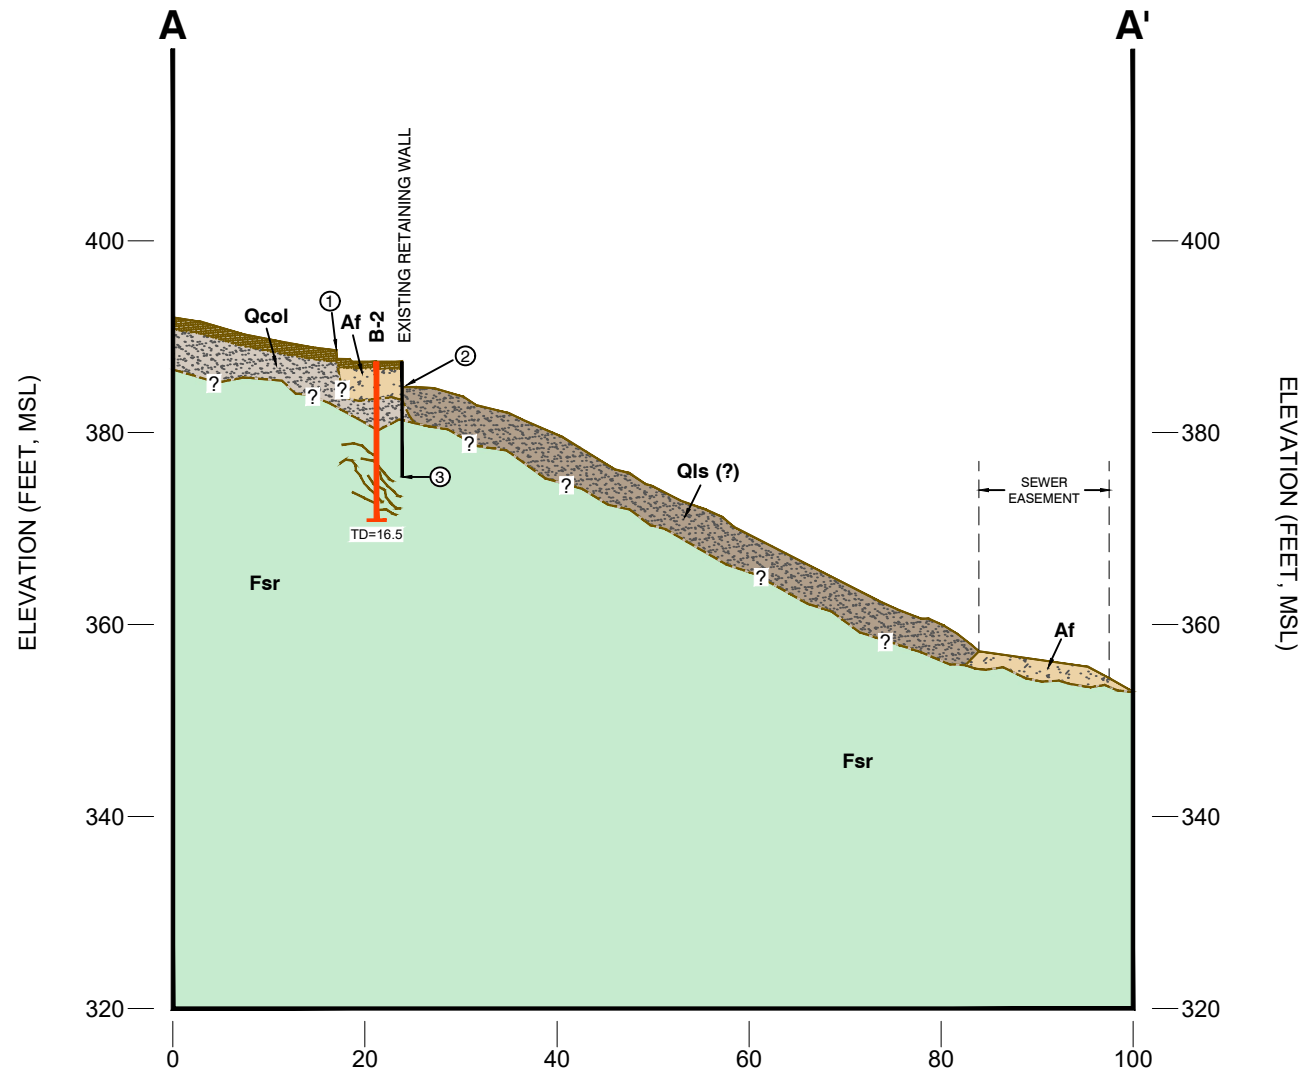
FIGURE 5

The sewer line is located at the toe of a natural slope that descends from the wall toward the creek (Figure 5). The slope is about 30 feet in height and inclined at about 26 degrees from horizontal (slope ratio of 2:1 – horizontal to vertical). Features suggestive of recent slope movement were not observed on the slope; however, the surface of the slope is hummocky, suggesting that older landslide events may have occurred on the slope.

The results of our slope stability evaluation indicate that the existing slope and retaining wall in cross-section A-A' has an adequate (more than 1.5) factor of safety against instability under static and pseudo-static loading conditions. However, the results for our slope stability evaluation in cross-sections B-B' and C-C' indicate that the existing slopes do not have factors of safety of 1.5 or more under static condition for instability. Based on these results, mitigation measures consisting of a retaining wall element were considered for Sections B-B' and C-C'. The pile elements representing a retaining wall were included as vertical reinforcement strips, 20-feet deep with 6-foot on-center spacing. The shear force of the pile was increased until a factor of safety of 1.5, or more, was obtained. Pseudo-static slope analyses were then conducted to evaluate the yield acceleration of the slope, with the retaining wall shear force from the static analyses included. The results of our analyses are summarized below in Table 2.

- ① 4" OF VERTICAL DISPLACEMENT.
- ② 12" GAP BELOW BOTTOM OF TIMBER LAGGING AND GROUND.
- ③ TOTAL LENGTH OF PIERS 12 FEET, EMBEDDED 10 FEET.

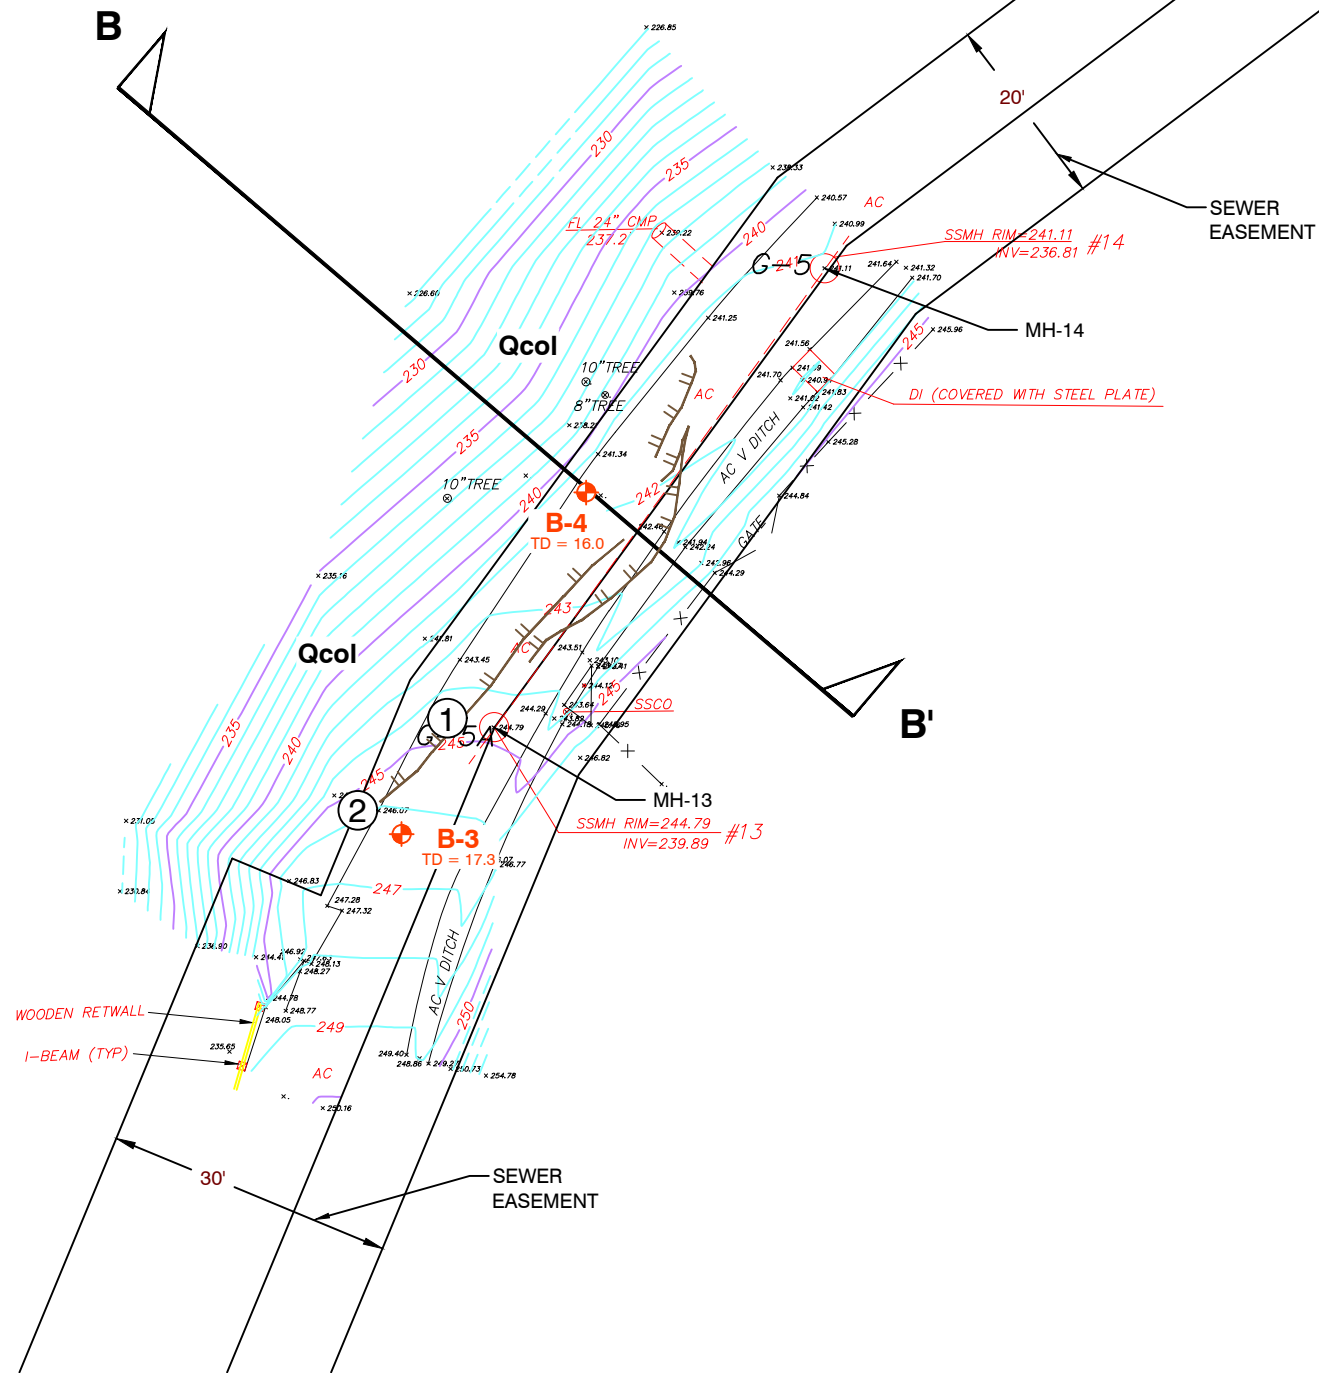
Area 2 is located about $\frac{1}{4}$ mile along the roadway, adjacent to Sewer Manhole No. 13 (Figures 2 and 6). The area of damaged road extends about 60 linear feet parallel to the roadway and includes several ground cracks through the asphalt with vertical displacements of up to 6 inches. Horizontal separations across the cracks are up to 8 inches wide. One of the prominent cracks overlies the sewer line and extends approximately 30 feet. The cracks were observed in the asphalt section, but were not observed in the adjoining slope that descends to Mill Creek (Figure 7). The descending natural slope is about 30 feet high with a slope ratio of about 1.5:1 (horizontal to vertical). The slope surface was generally comprised of vegetation and surficial soil. We did not observe indications of significant soil movement on the slope.

- At Area 2, soil movement beneath the access road has caused an area of damaged road that is about 60 linear feet parallel to the roadway and includes several ground cracks through the asphalt with vertical displacements of up to 6 inches and horizontal separations across the cracks up to 8 inches wide. Based on the results of our site observations and slope stability evaluation, we recommend construction of a new soldier pile and wood lagging retaining wall along the outboard edge of the roadway.

- NOTES:**
- ① 8" OF LATERAL DISPLACEMENT (01/22/2018)
 - ② NO GROUND CRACKS BEYOND PAVEMENT

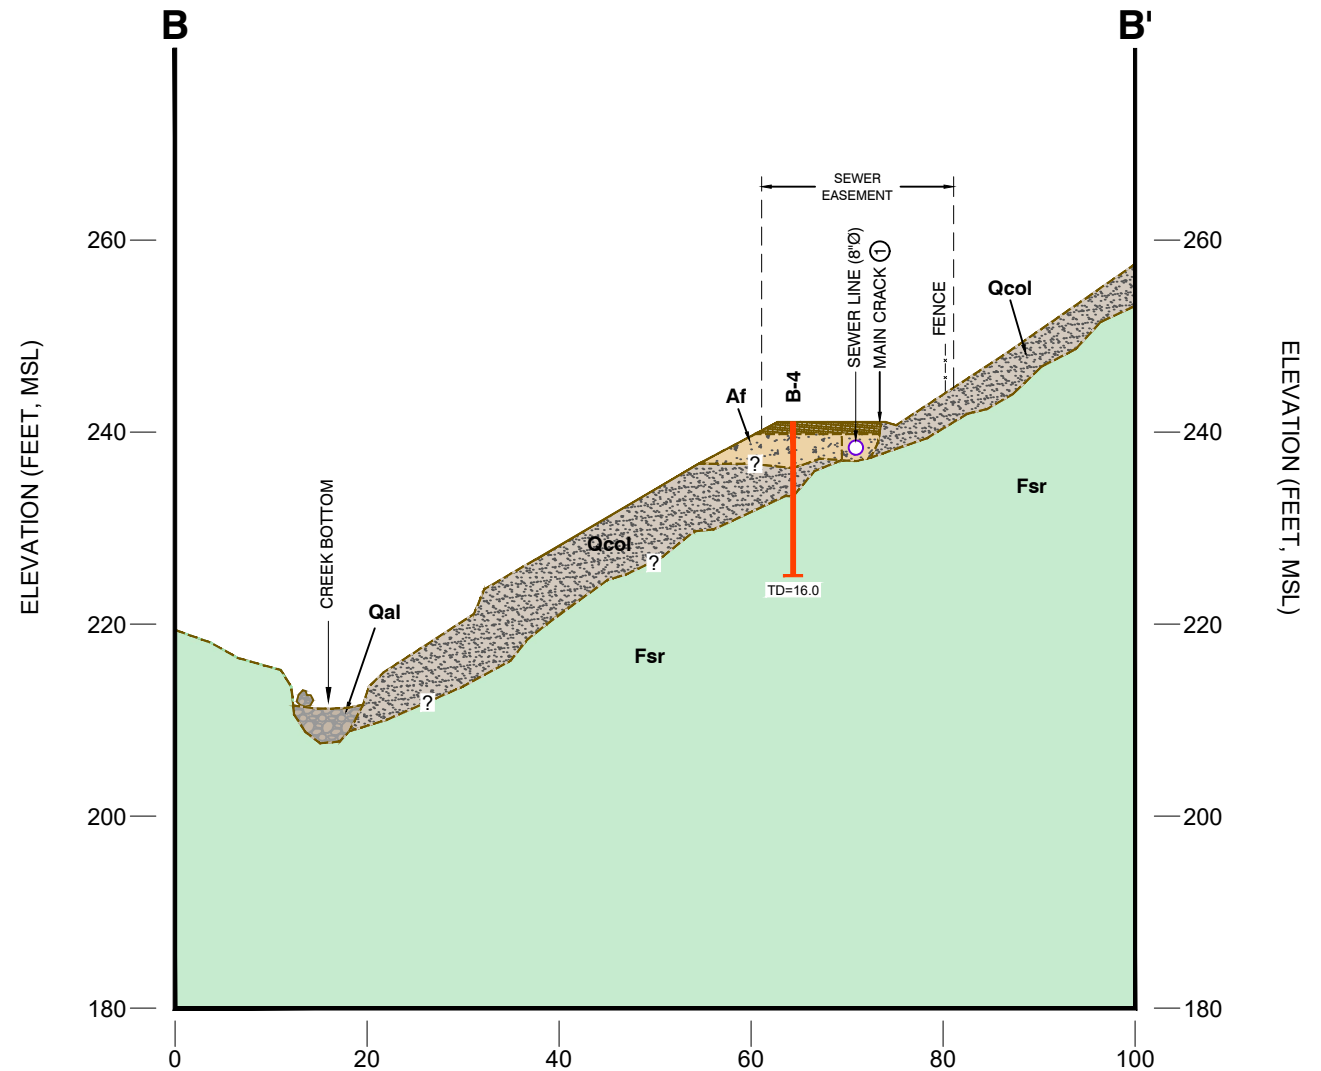
FIGURE 7

- ① HORIZONTAL SEPARATION UP TO 5",
BUT ONLY ~1/2" OF VERTICAL SEPARATION.

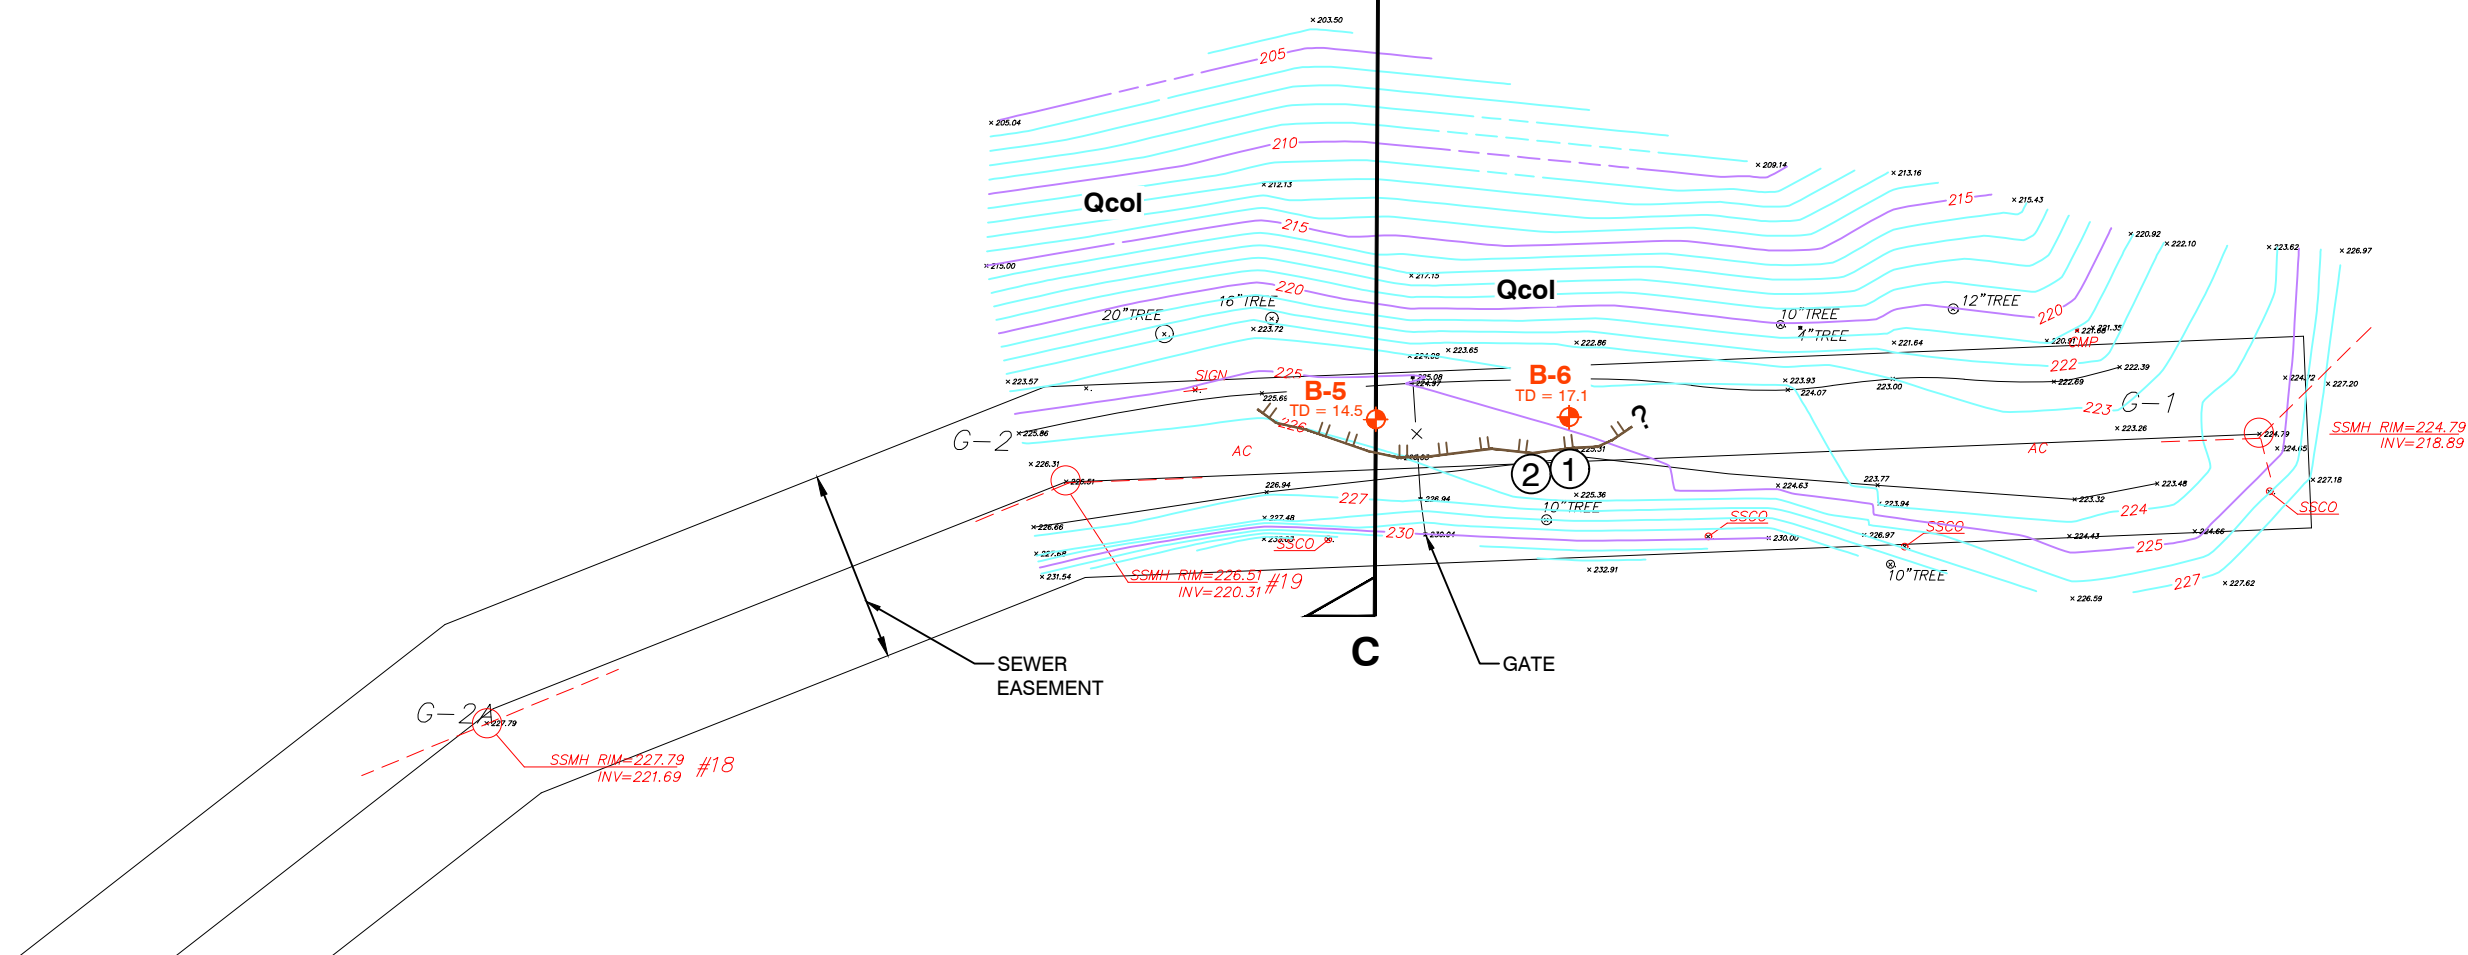
Area 3 is located at the eastern end of the roadway, about 0.4 miles from the La Mesa Court entrance (Figures 2 and 8). The area of damaged road at Area 3 extends about 40 linear feet parallel to the roadway and includes a few main ground cracks through the asphalt with vertical displacements of up to 8 inches. Horizontal separations across the main crack are up to 9 inches. The cracks were observed in the asphalt section but were not observed in the adjoining slope that descends to a tributary to Mill Creek (Figure 9). The descending natural slope is about 45 feet high with a slope ratio of about 1.5:1 (horizontal to vertical). The slope surface was generally comprised of vegetation and surficial soil. We did not observe indications of significant soil movement on the slope.

- At Area 3, soil movement beneath the access road has caused an area of damaged road that is about 40 linear feet parallel to the roadway and includes ground cracks through the asphalt with vertical displacements of up to about 8 inches and horizontal separations up to about 9 inches. Based on the results of our site observations and slope stability evaluation, we recommend construction of a new soldier pile and wood lagging retaining wall, or other slope improvement system, along the outboard edge of the roadway.

- NOTES:**
- ① (1/22/18) - 10" HORIZONTAL DISPLACEMENT; ~1" TO 2" VERTICAL DISPLACEMENT
 - ② (1/22/18) - ~8" HORIZONTAL DISPLACEMENT; ~8" VERTICAL DISPLACEMENT

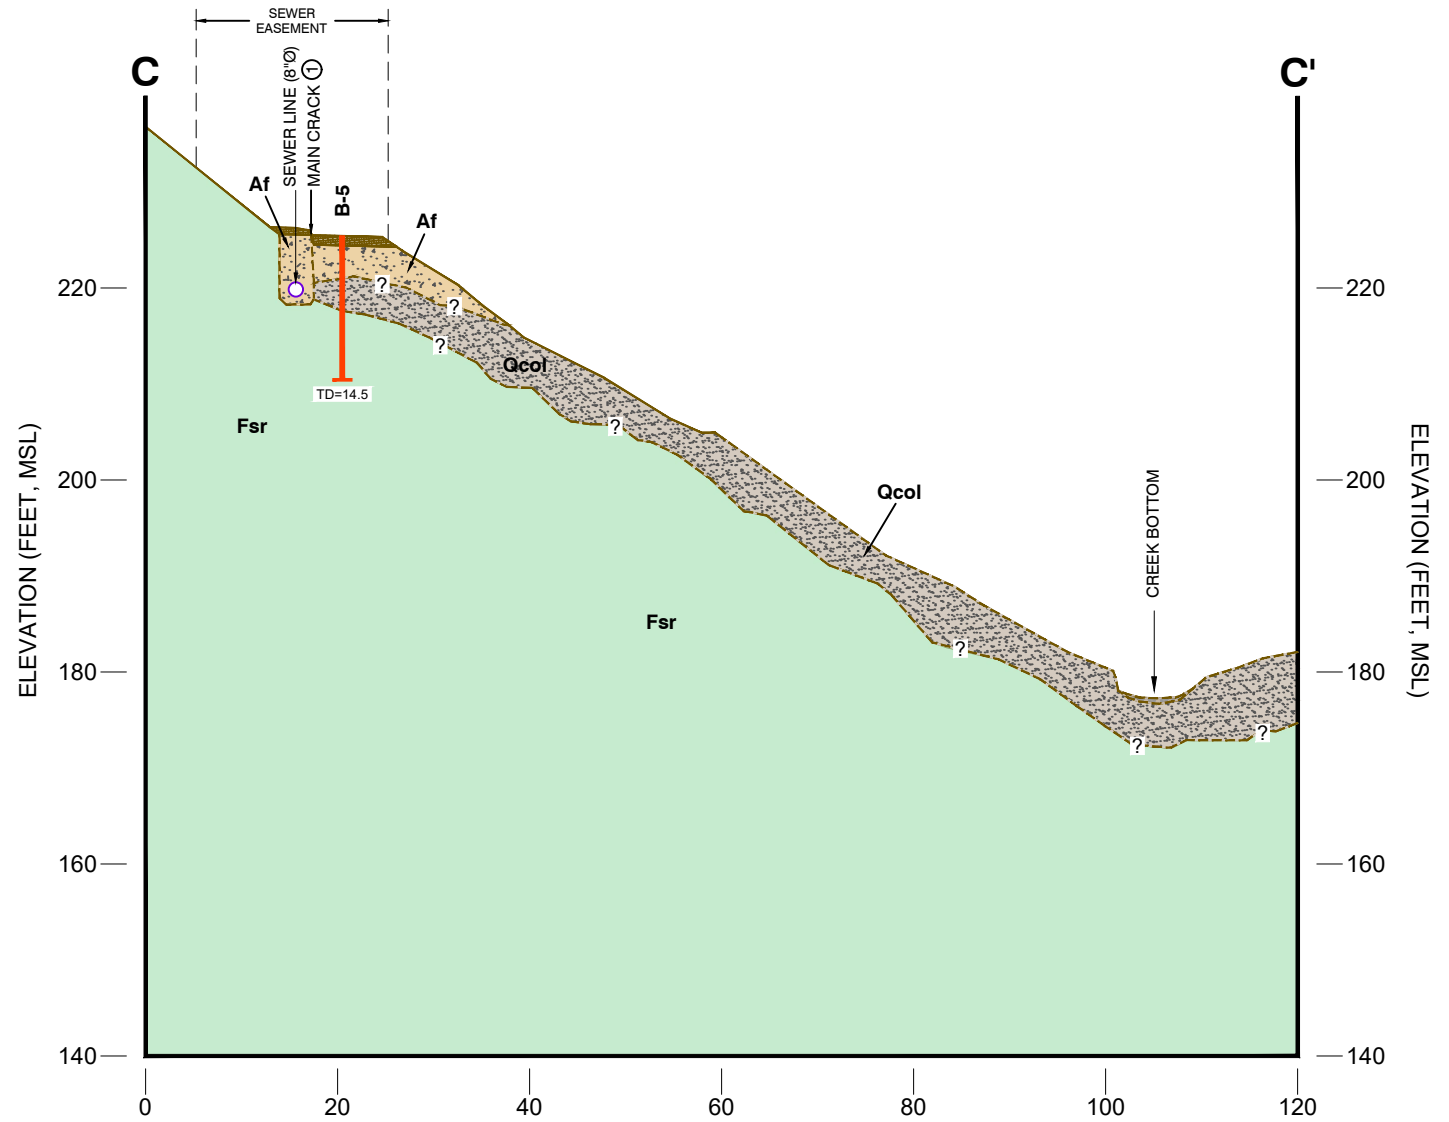
FIGURE 9

HORIZONTAL SEPARATION UP TO 5";
VERTICAL SEPARATION UP TO 7".
