# Tionesta Borough – Elm Street

## Forest County

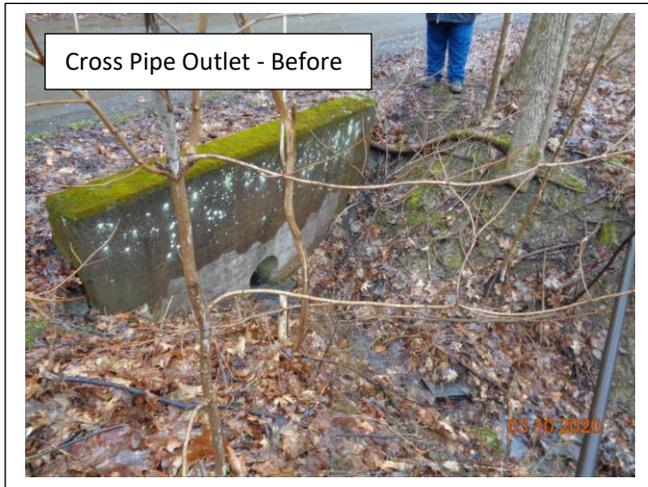
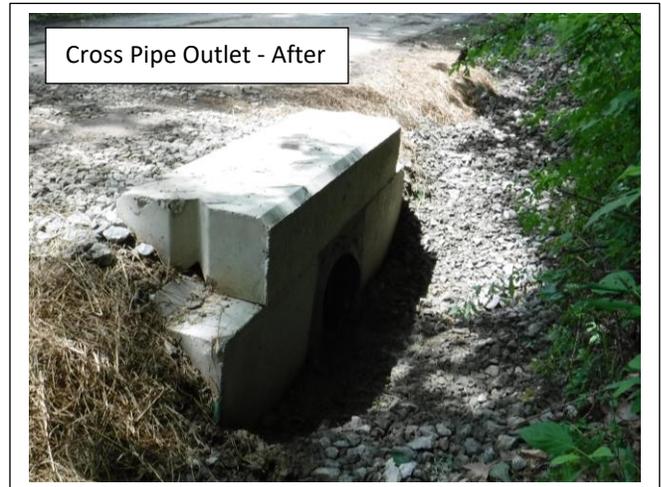
**Problem:** The existing cross pipes were too small. The existing end walls were crumbling and falling into the outlets. Erosion was occurring at the outlets of the existing cross pipes. Some of the inlets needed stabilized.

**Solution:** Four existing 10-inch diameter cross pipes were replaced with 18-inch diameter cross pipes. The crumbling end walls were rebuilt. An inlet box was installed. The inlets were stabilized with #1 stone to help filter out any sediment. R4 stone was installed at the outlets to help slow water down and prevent erosion.
