Exhibit 1: Inspection Report and Cover Letter,
sent to Respondent on Oct. 17, 2019

Enclosed is the inspection report for EPA's Clean Water Act compliance inspection of the City of San Juan Bautista Wastewater Treatment Plant (NPDES Permit No. CA0047902/WDR Order No. R3-2009-0019) conducted on June 24, 2019.

Inspection Date(s):	June 24, 2019		
Time:	Entry: 9:30 AM	Exit: 2:00 PM	
Media:	Water		
Regulatory Program(s)	Clean Water Act NPDES		
<small>City of</small>			
Company Name:	City of San Juan Bautista		
Facility or Site Name:	City of San Juan Bautista Wastewater Treatment Plant		
Facility/Site Physical Location:	1300 Third Street San Juan Bautista, CA 95054 San Benito County		
Geographic Coordinates:	Latitude: 36°50'52.86"N Longitude: 121°32'40.00"W		
Mailing address:	PO Box 1420 San Juan Bautista, CA 95045		
Facility/Site Contact:	Miles Farmer	Title: Operator of Record	
	Phone: 831-601-9367	Email: miles@cypresswaterservices.com	
Facility/Site Identifier:	NPDES Permit No. CA0047902 WDR Order No. R3-2009-0019		
Facility/Site Personnel Participating in Inspection:			
Name	Affiliation	Title	Email
Aaron Slusher	Cypress Water Services	Wastewater Operator	slusher.aaron@gmail.com
Nicho

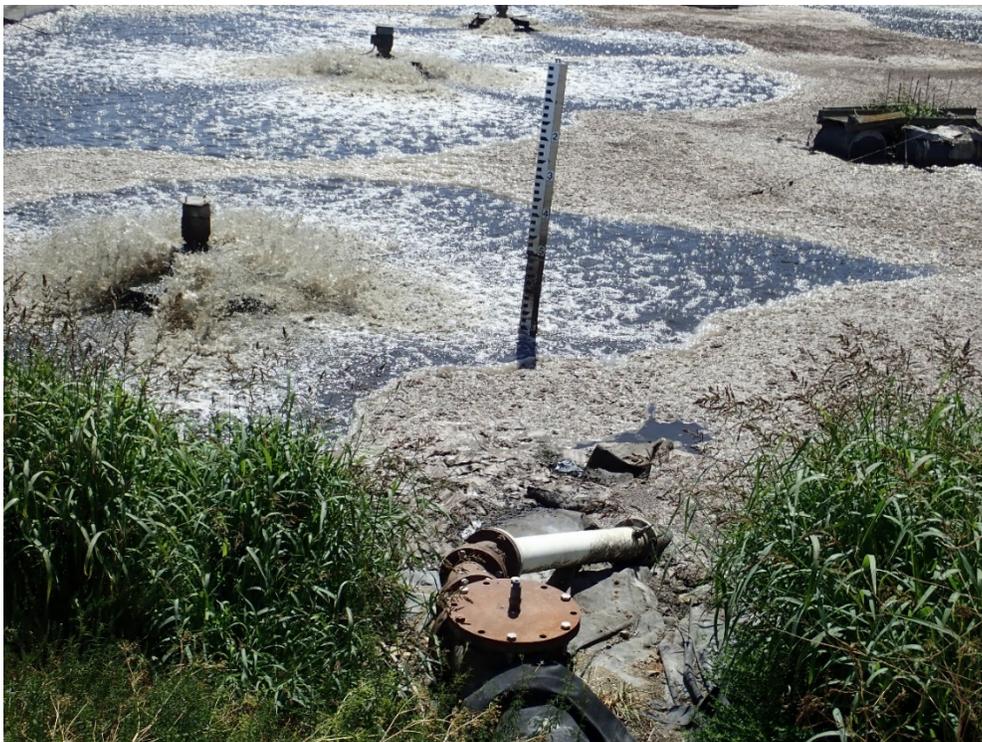
Photo 6 : Pond 1 with level indicator. Note watermark approximately 1.5ft above current level.

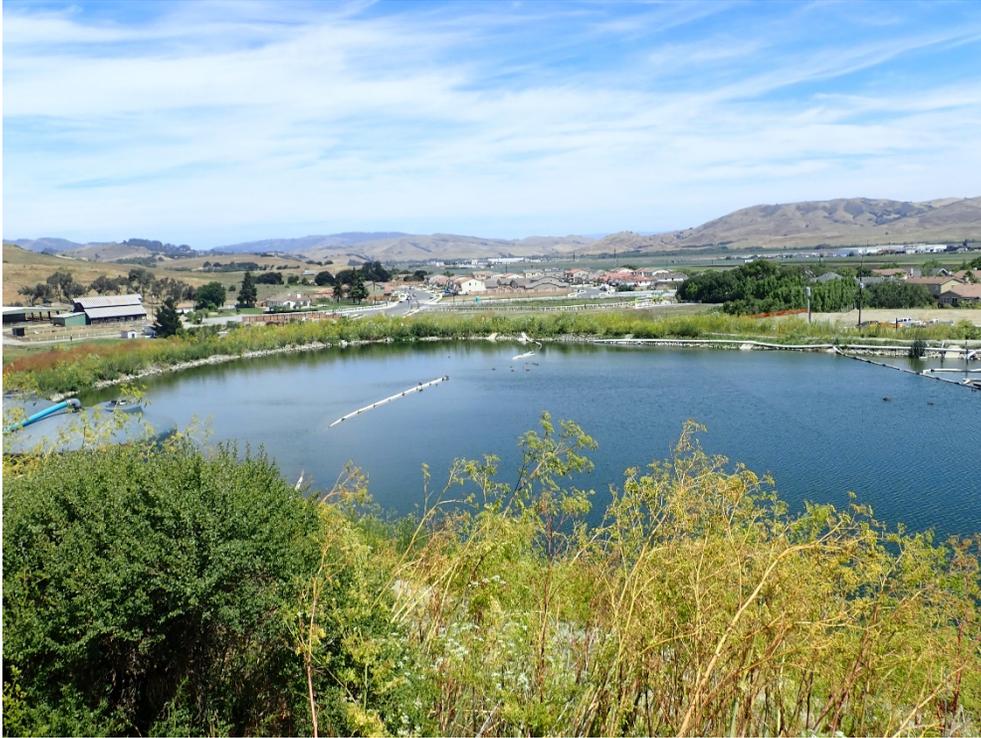
- The baffles in Pond 2 no longer extend to the surface in several areas (Photos 9, 10, and 12).
- Floating media in Cell 2C no longer floats at the surface. Aaron Slusher (Wastewater Operator) stated that they sank when disturbed by Synagro's sludge removal operations in late 2018. He said that Cypress Water Services had attempted to right them, but they were too heavy with sludge.

Photo 9 : Looking North from above Pond 2.

- 1) Pond 2 may not be providing full treatment because of gaps in the baffles; some flows may be bypassing the treatment cells and this could reduce treatment effectiveness.

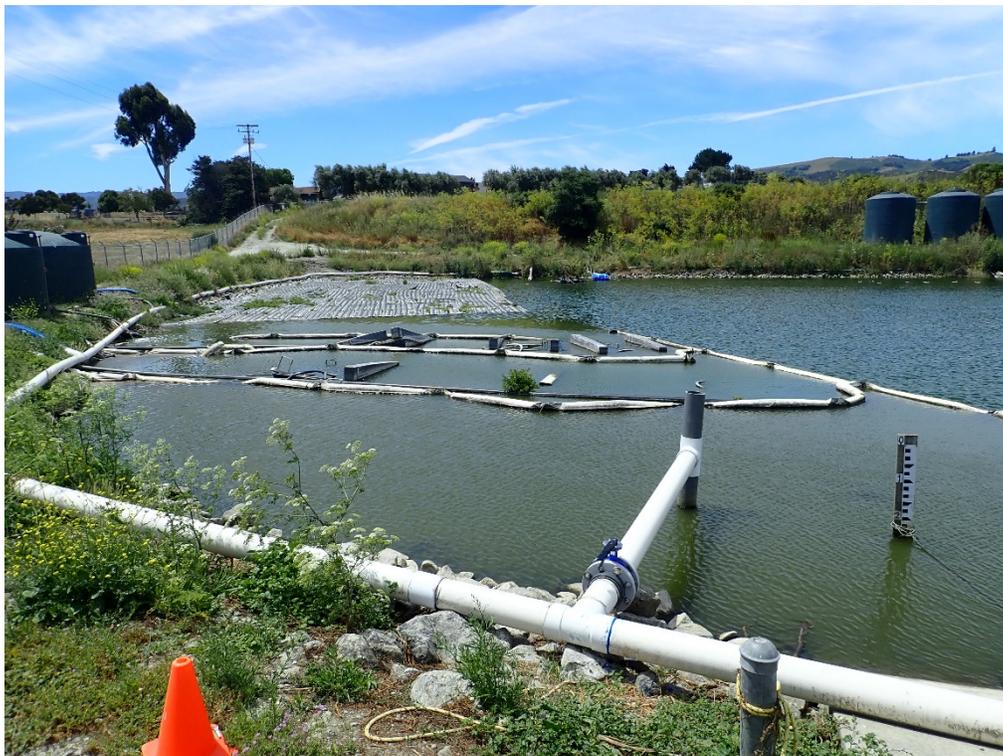
Photo 10 : Pond 2 seen from the North. Cell 2C on the left and 2B on the right.

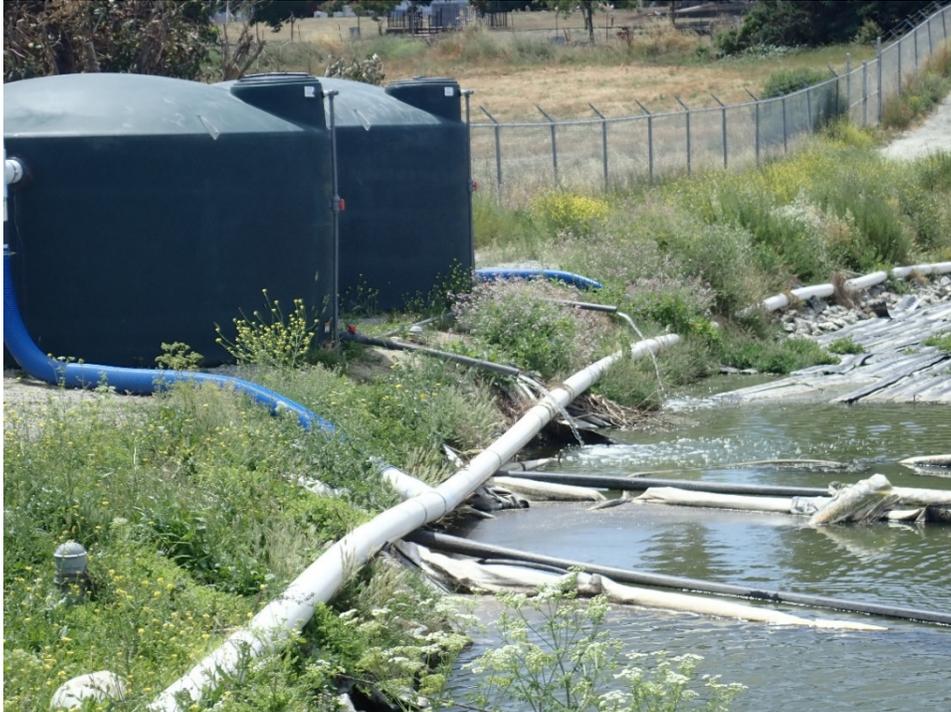
- The Facility is no longer operated in accordance with the process flow diagram in the permit, included as Attachment 3. For example, the diagram does not show the two new 5,000 gallon equalization tanks adjacent to Pond 2.

Photo 11 : Two 5,000 gallon equalization tanks discharging into Cell 2C from the East bank of Pond 2.

- 2) The floating media in Cell 2C is likely no longer doing what it was designed to do, presumably nitrogen reduction.
- 3) Cypress Water Services has made changes to the flows at the plant that should be communicated to the permit writer and documented in a permit modification.

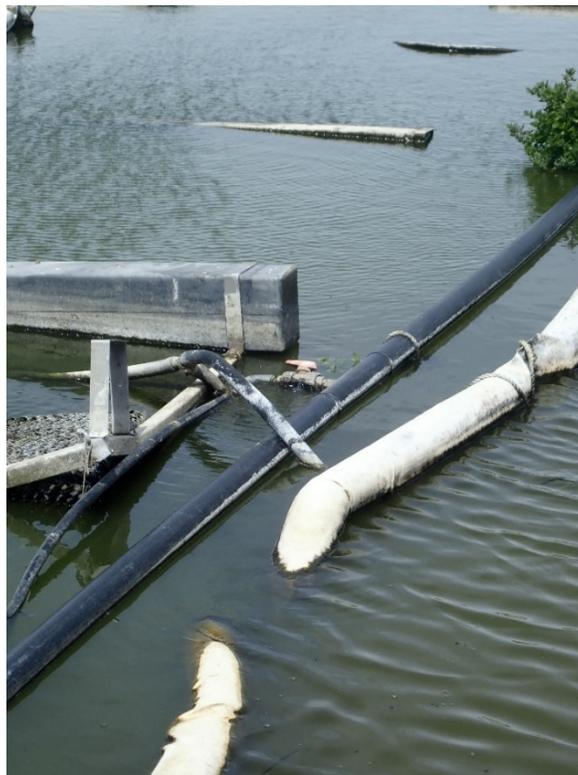
Photo 12 : Baffle in Cell 2C with gap at surface.

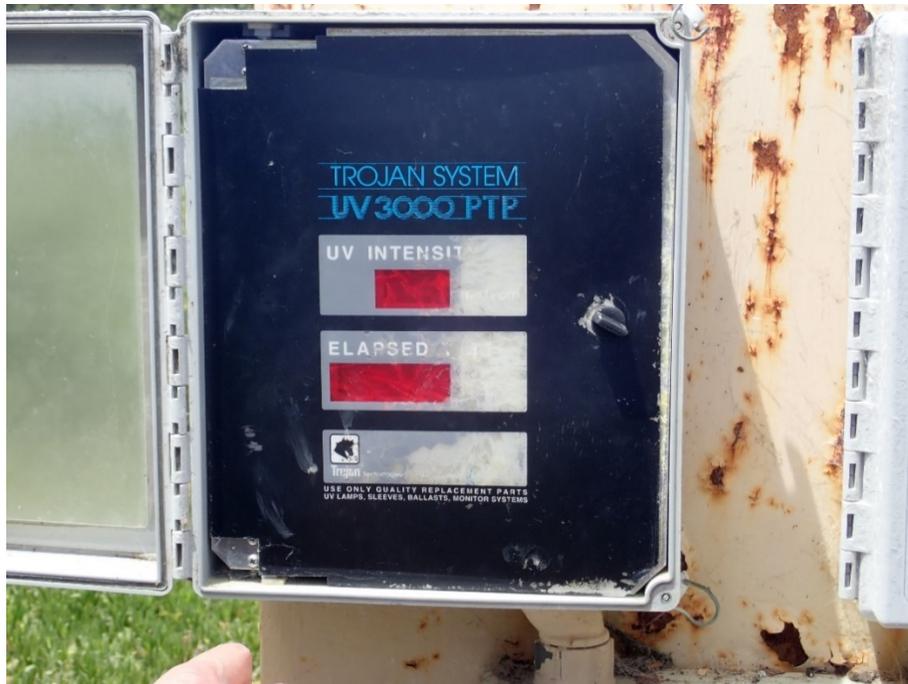
- The UV information panel's (Photo 16) intensity and run time displays were unreadable.
- No calibration records were available for the turbidimeter, dissolved oxygen or pH meters in the onsite lab or for the flowmeter.

Photo 16 Unreadable UV system information panel.

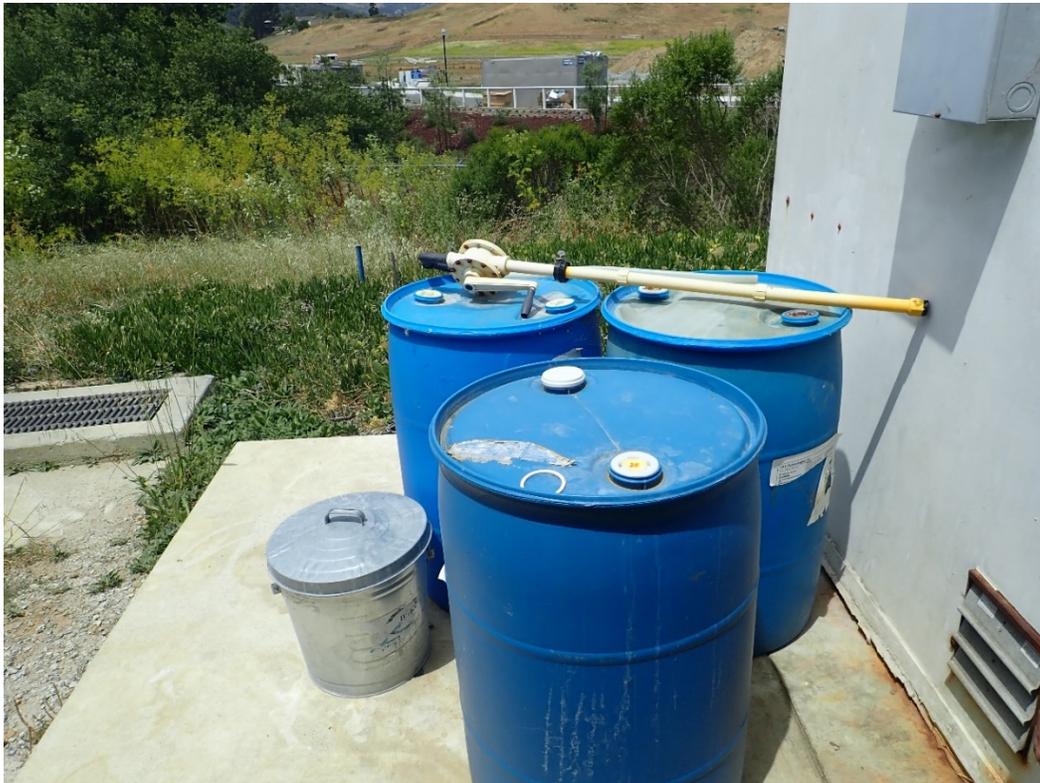
- There were three full 55-gallon drums behind the structure housing the polymer injection system (Photo 25). One drum was labelled Sodium Bisulfate, one labelled polymer, and one had an unreadable label. There was an additional full unlabeled 55-gallon drum behind the shed housing the composite sampler. None of the drums were covered or had secondary containment.

Photo 25 : Full 55 gallon drums stored outside without secondary containment.

- 7) Unlabeled and unused chemicals in drums need to be disposed of in accordance with all applicable regulations.
- 8) Chemicals which remain stored onsite should have secondary containment and/or be stored in a location where a spill would not reach the discharge drainage. The Facility should develop and implement a Spill Prevention and Response Plan.
