INDOOR AIR QUALITY/MOLD ASSESSMENT SOUTH BERWICK TOWN HALL 180 MAIN STREET, SOUTH BERWICK, MAINE

October 2023

John M. Boilard, RIHT, CMC Senior Industrial Hygiene & Safety Specialist

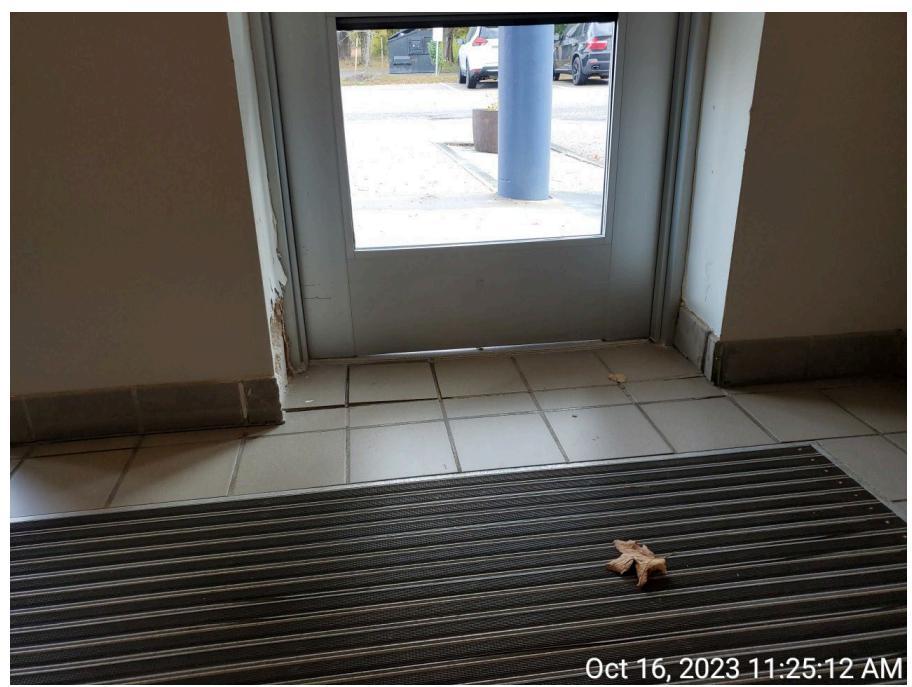
Water intrusion point for improperly sealed door threshold at first floor entry to elevator lobby area.

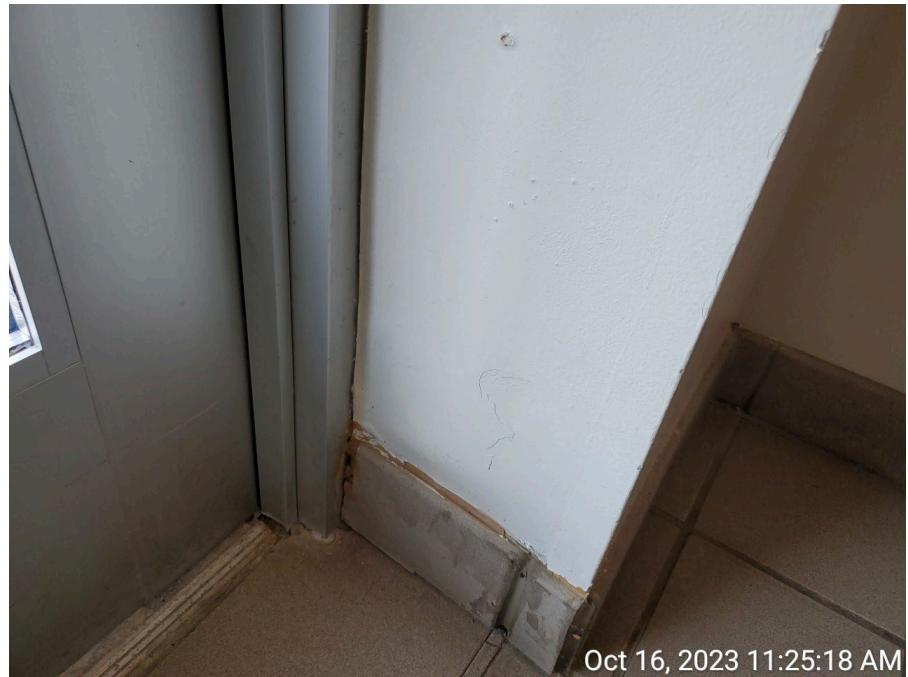
Water damaged lower wall plaster due to improperly sealed door threshold at first floor entry to elevator lobby area.

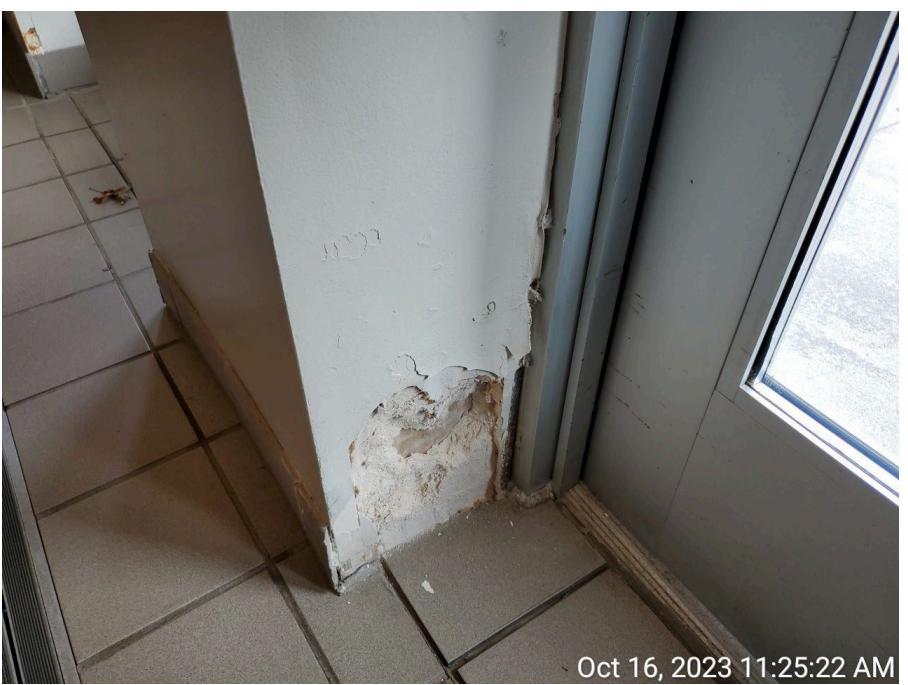
Water damaged lower wall plaster due to improperly sealed door threshold at first floor entry to elevator lobby area.

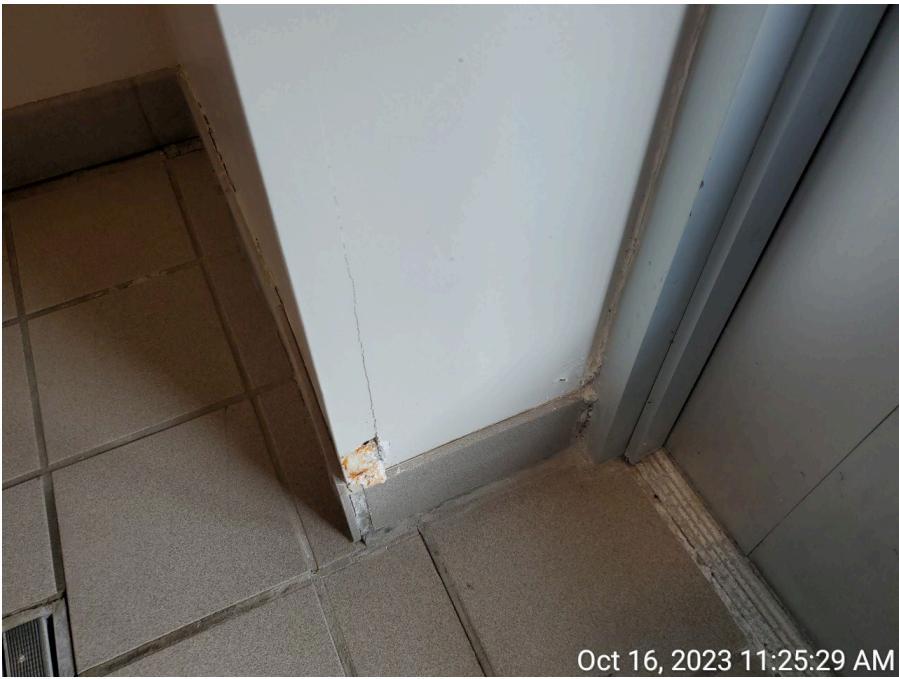
Water damaged lower wall plaster due to improperly sealed door threshold at first floor entry to elevator lobby area.

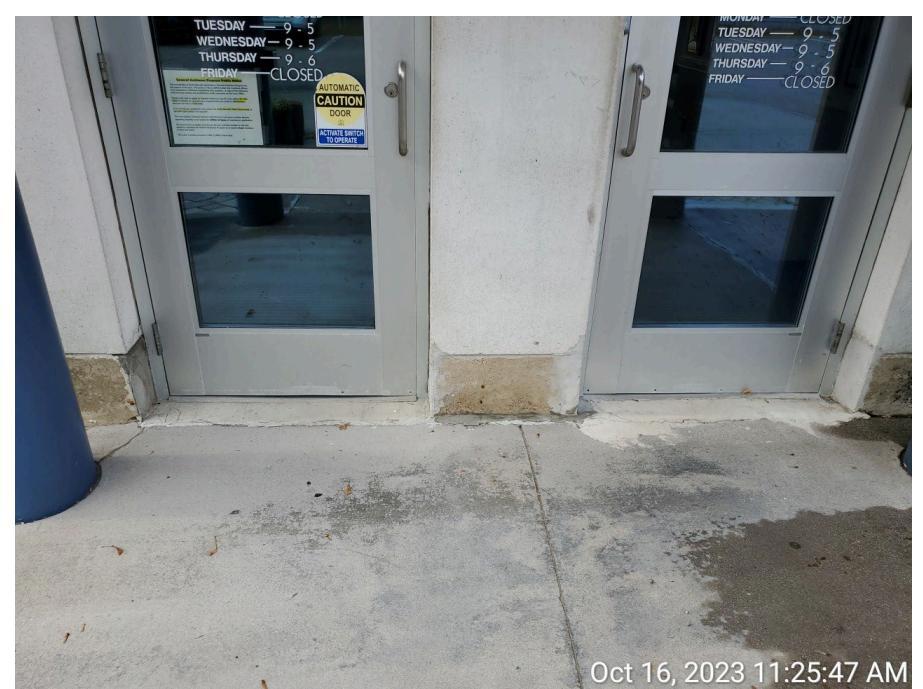
Water intrusion point for improperly sealed door threshold at first floor entry to elevator lobby area.

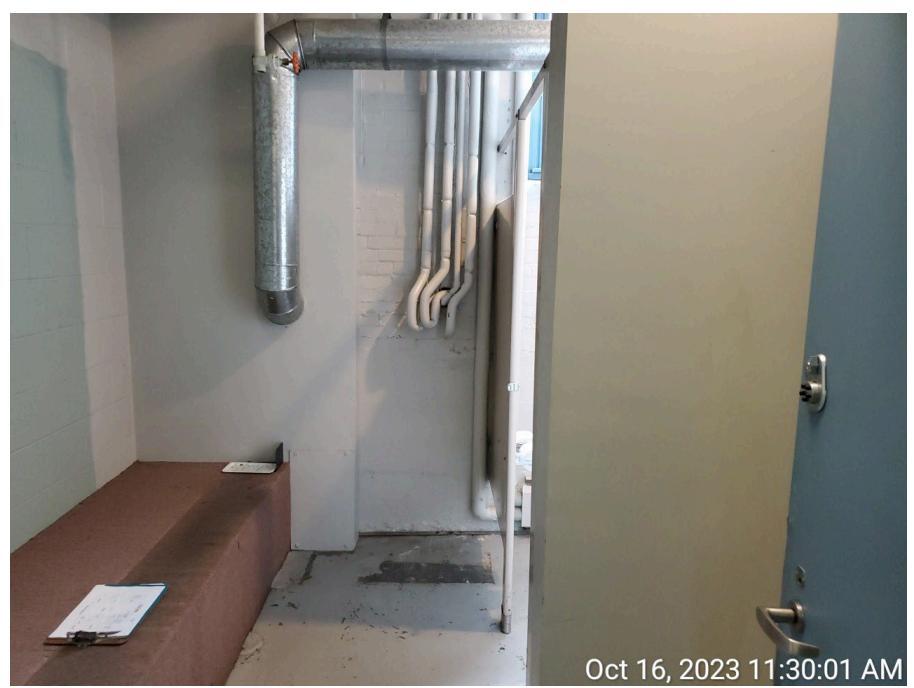
The former locker room has visual indications of historical moisture issues in the form of insect activity and the damaged drywall ceiling in the shower area.

Insect infestation in first floor former Police locker room.

- A properly certified and licensed pest control entity should be contracted with to provide insect and rodent control actions at the site.
- All water-stained ceiling tiles and the mold compromised ceiling tile in the auditorium area need to be removed and replaced. Replacement not only aids in aesthetics for occupants, but helps identify when new leaks or water impact occurs so it can be properly addressed.
- All unsealed perimeter penetrations and foundation cracks need to be properly sealed.
- All shrinking/failing exterior caulking for windows and doors needs to be removed and replaced.

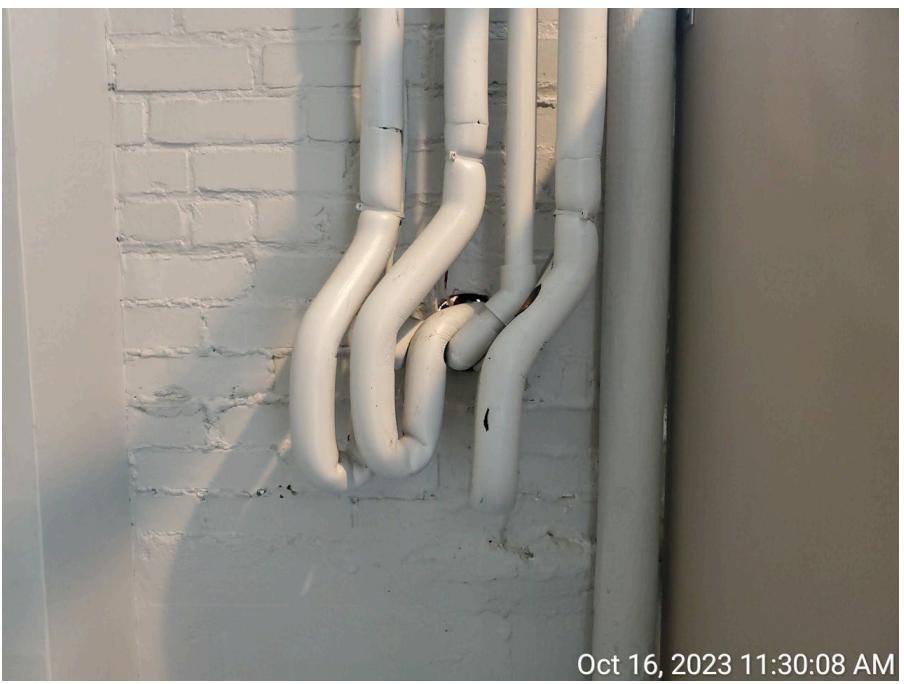
Improperly sealed penetrations in first floor former Police locker room.

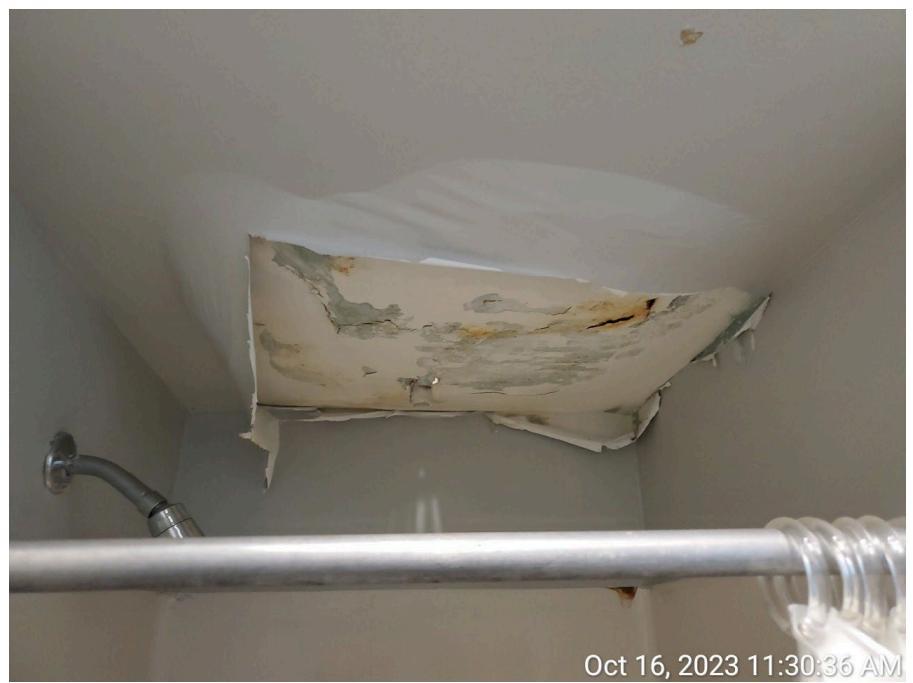
Water damage ceiling in shower unit in first floor former Police locker room.

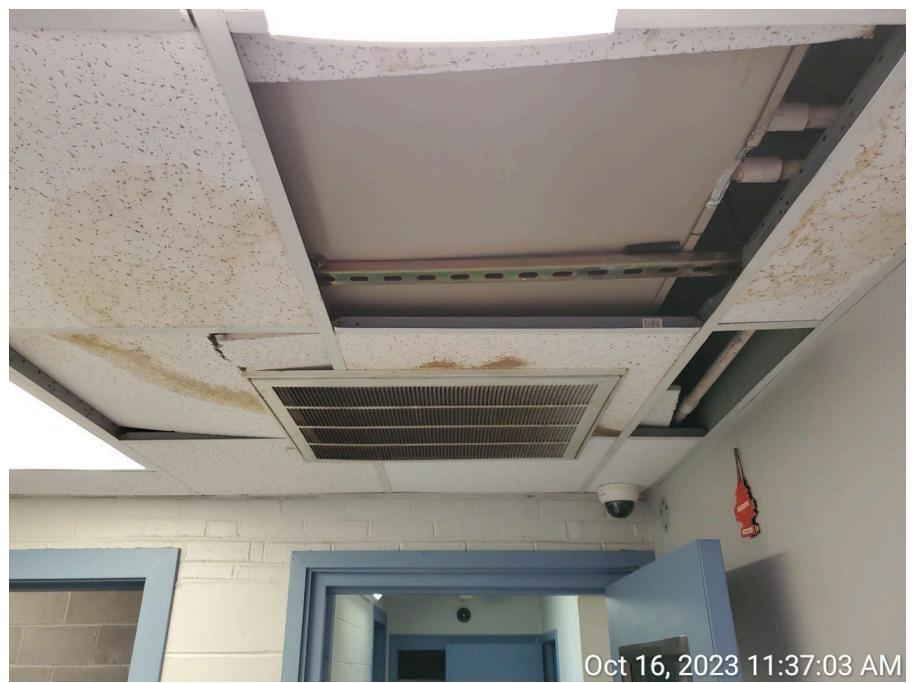
The air handler unit in the hallway adjacent to the former dispatch office has some significant ceiling tile staining and appears to be due to the air handling unit above the ceiling either having condensation issues or the drain pan line is clogged resulting in overflow.

Moisture damaged ceiling tiles due to air handler unit in ceiling on first floor outside former Police Dispatch Office.

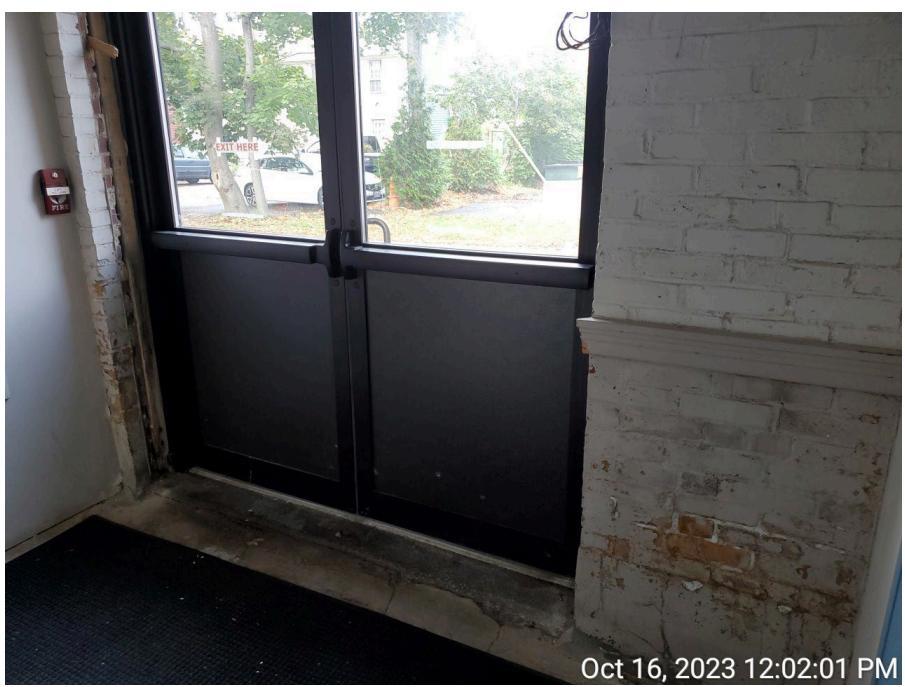
Moisture influences in first floor area causing peeling paint conditions.

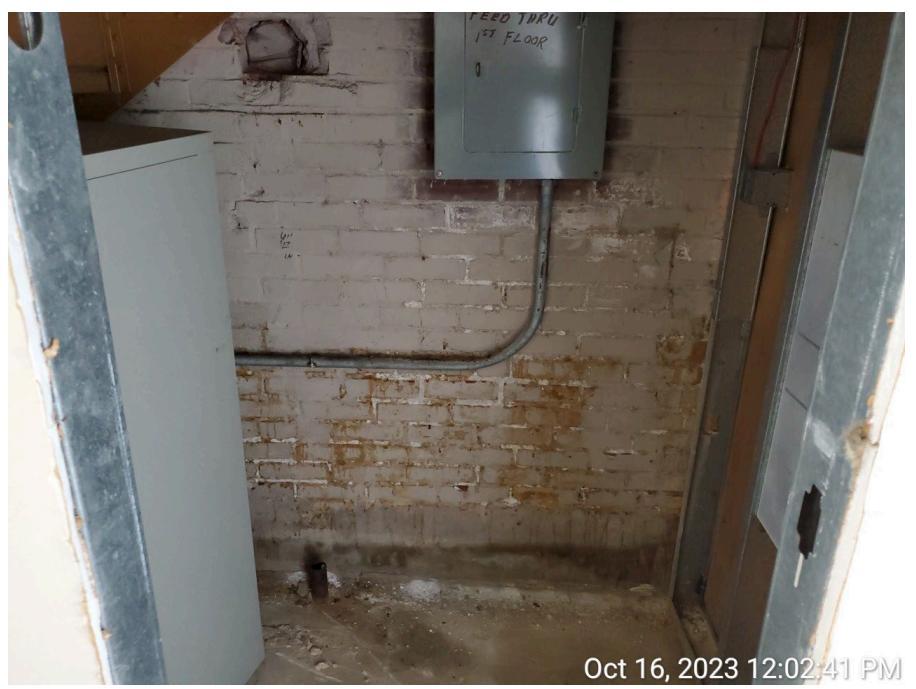
Moisture influences in first floor area causing peeling paint conditions.

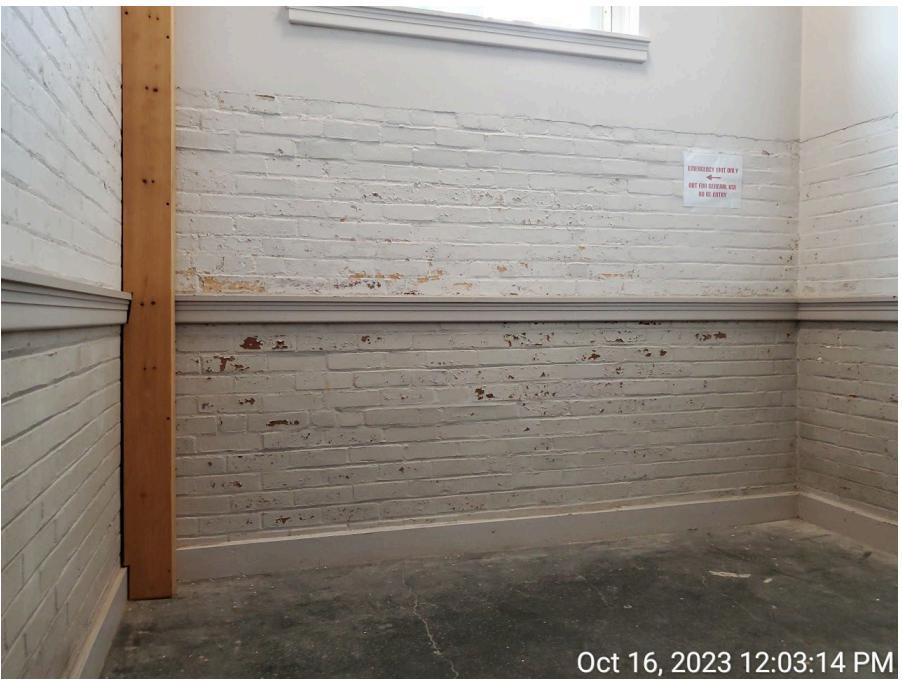
Moisture influences in first floor area causing peeling paint conditions.

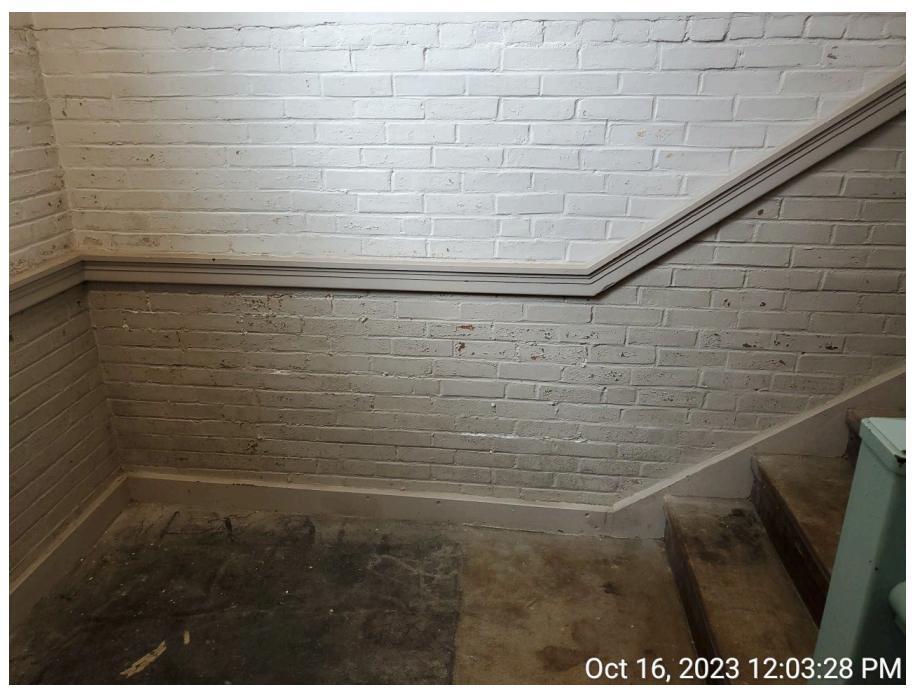
Moisture influences in first floor area causing peeling paint conditions.

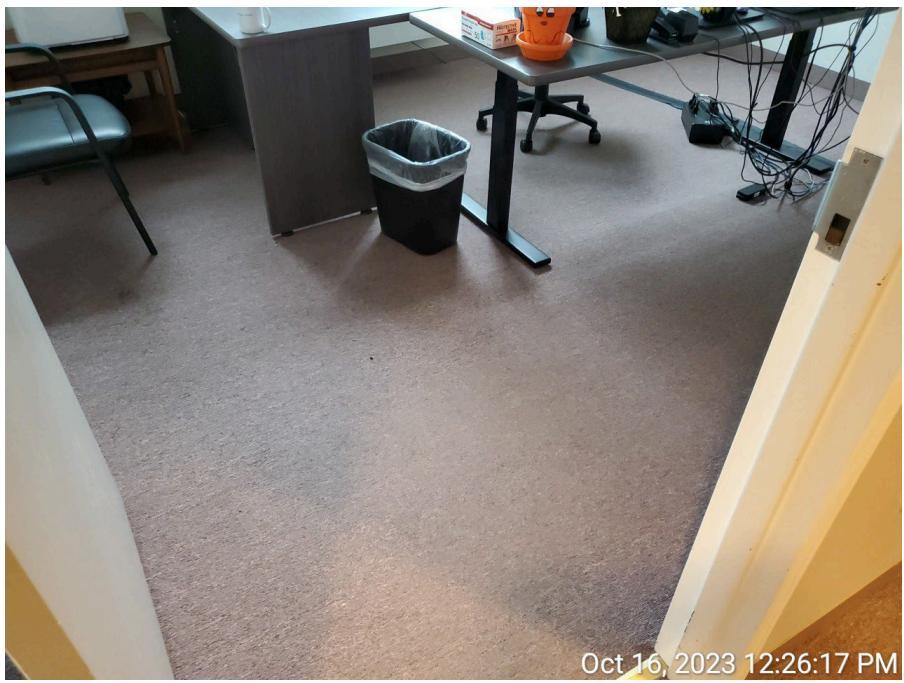
All carpeting on the second-floor areas were found to be worn and dirty. Particulate air sampling data indicates that this is resulting in elevated skin cells and miscellaneous fiber activity.

Worn/dirty carpeting on second floor in General Assistance Office.

• Worn/dirty carpeting needs to be removed. Replacement with carpeting is not recommended unless frequent HEPA vacuuming, and periodic shampooing/cleaning is performed. Hard flooring surfaces are much easier to clean and maintain and do not trap settled debris matter that then become re-entrained through foot traffic.

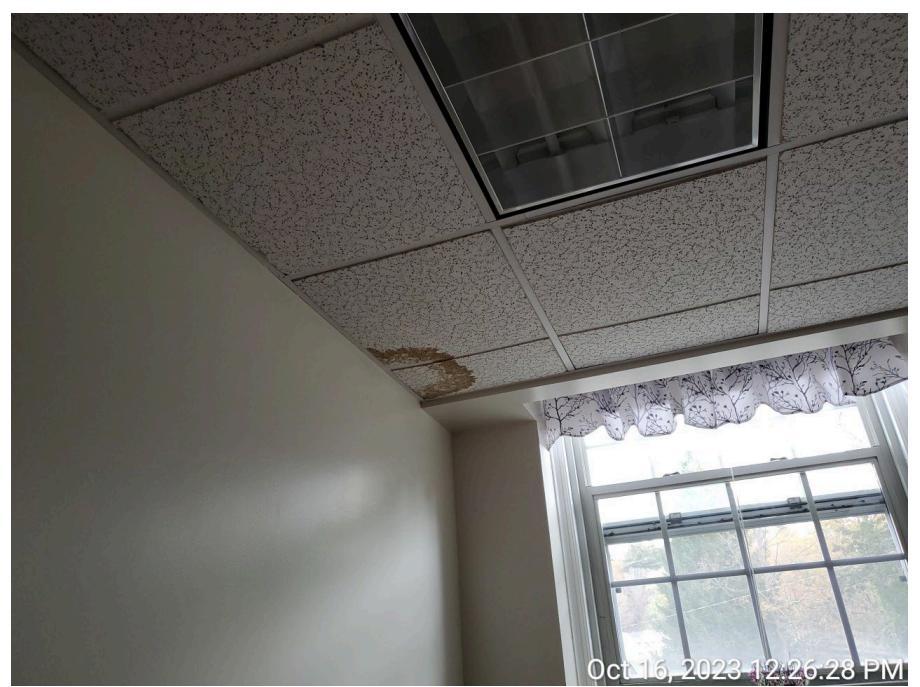
Water damaged ceiling tile on second floor in General Assistance Office.

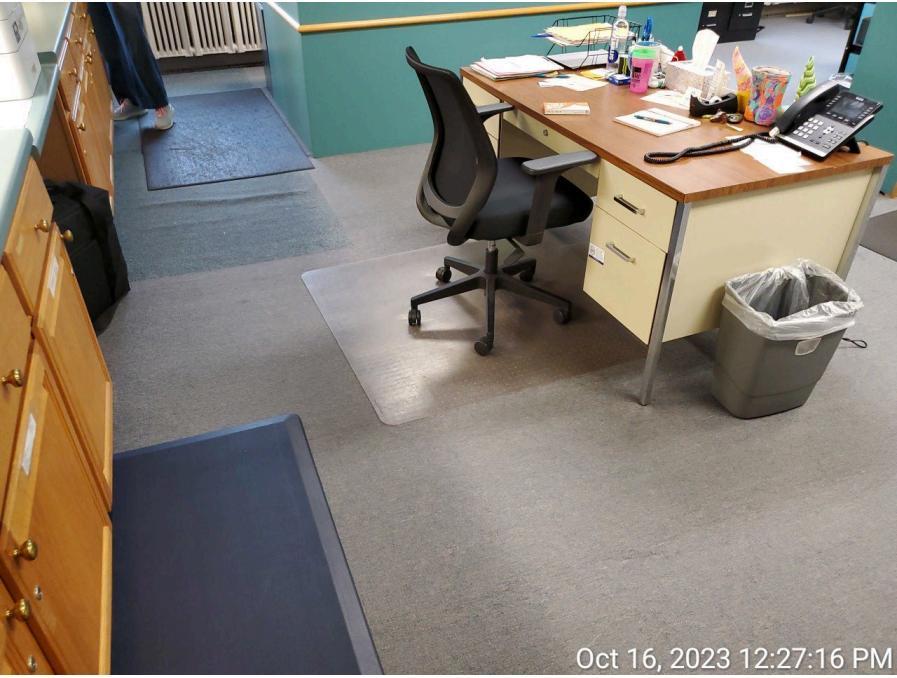
Worn/dirty carpeting on second floor in Town Clerk Offices.

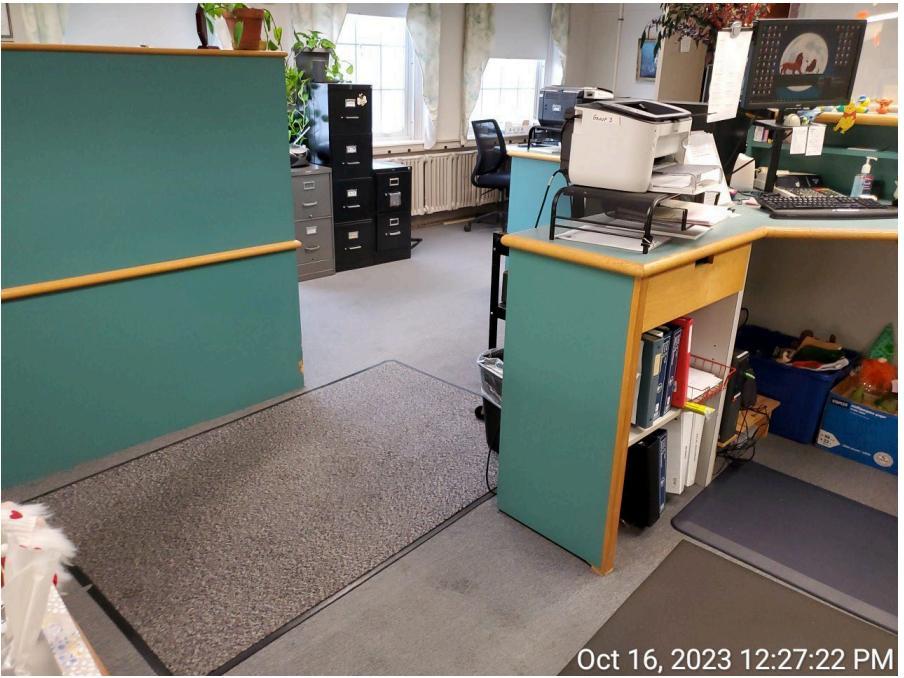
Worn/dirty carpeting on second floor in Town Clerk Offices.

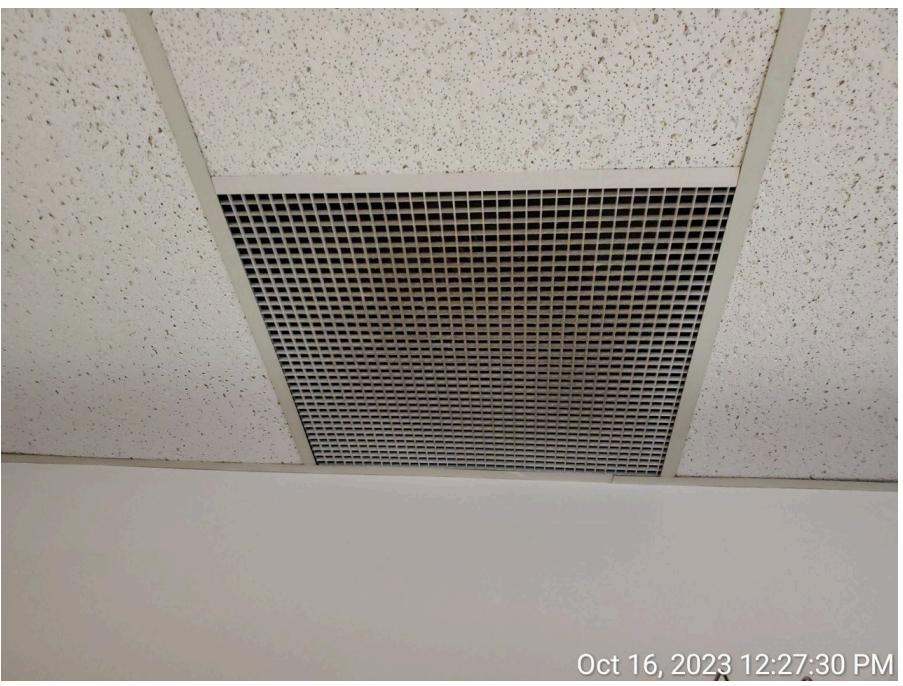
Dirty return diffuser and ductwork on second floor in Town Clerk Offices.

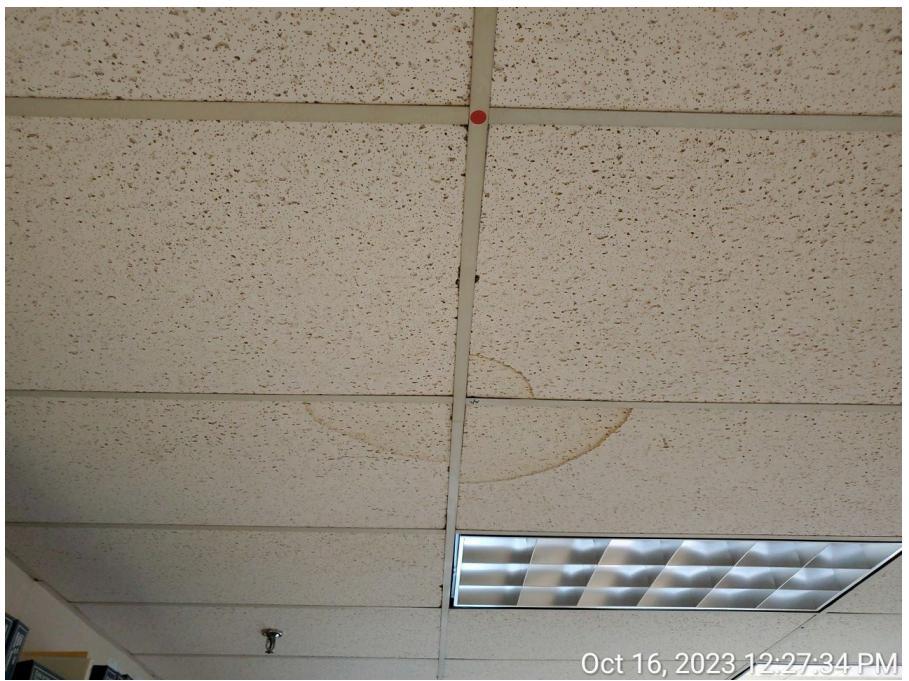
Water-stained ceiling tiles dirty return diffuser and ductwork on second floor in Town Clerk Offices.

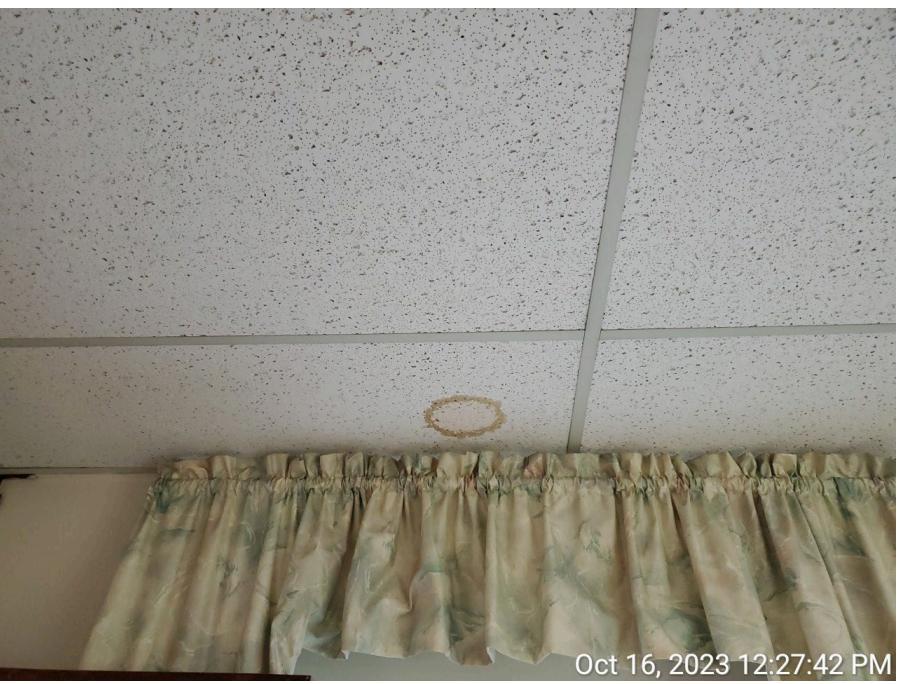
Water-stained ceiling tile on second floor in Town Clerk Offices.

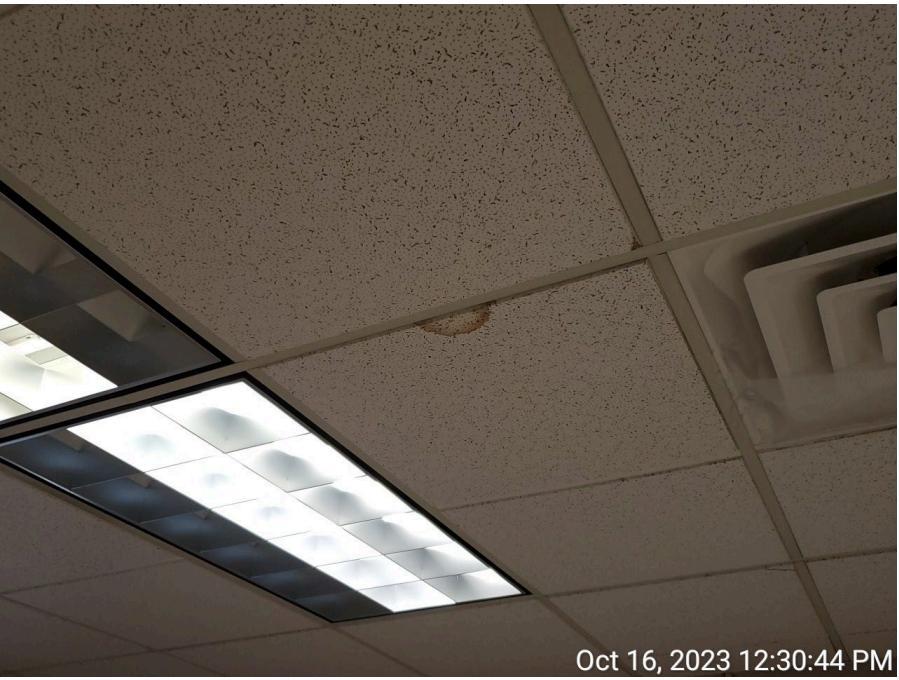
Water-stained ceiling tile on second floor in Assessing Offices.

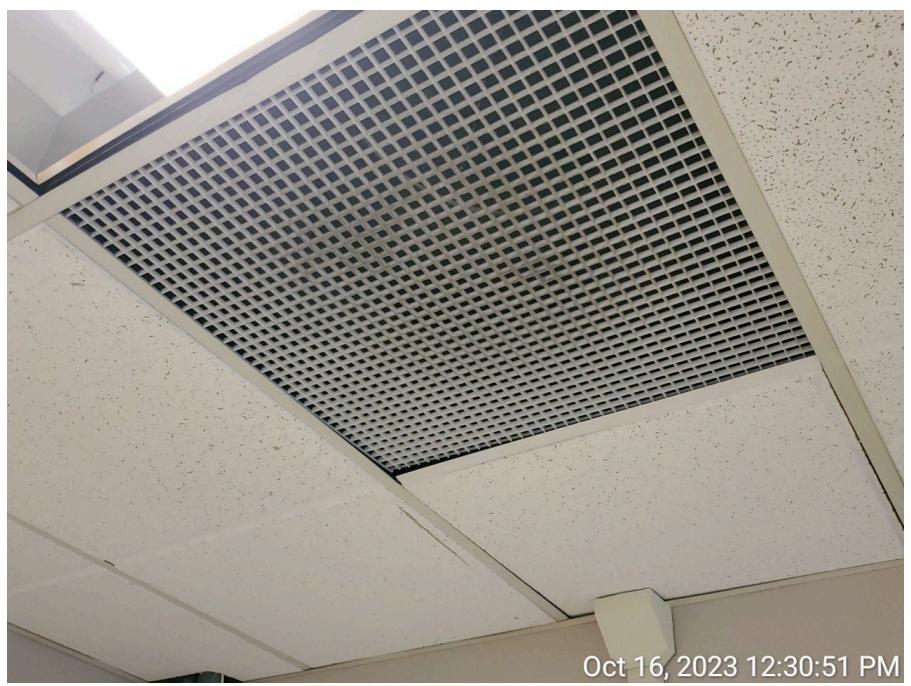
Dirty return diffuser and ductwork on second floor in Assessing Offices.

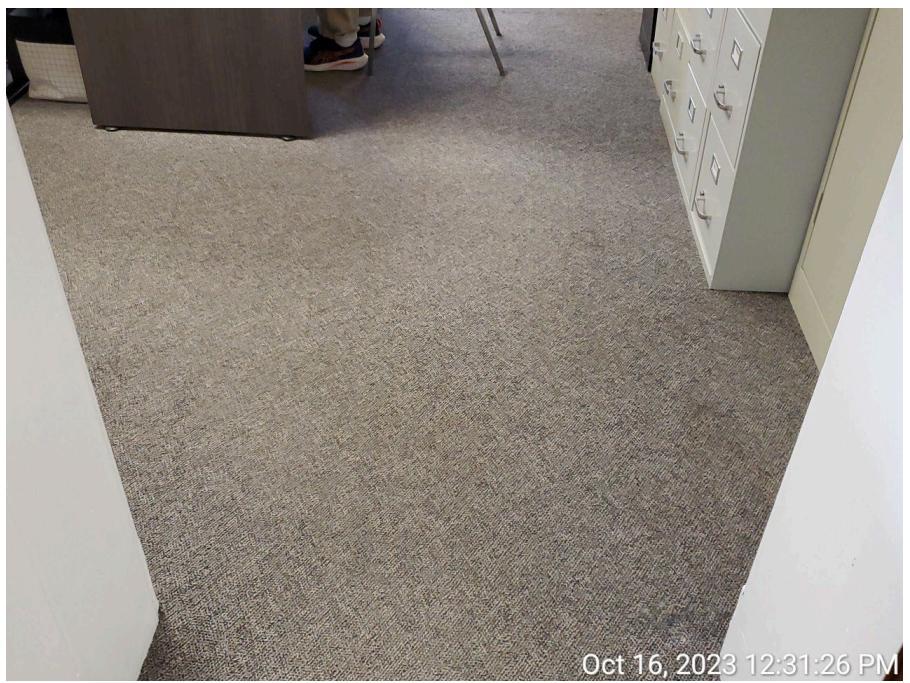
Worn/dirty carpeting on second floor in Asst. Town Mgr./HR/Finance Offices.

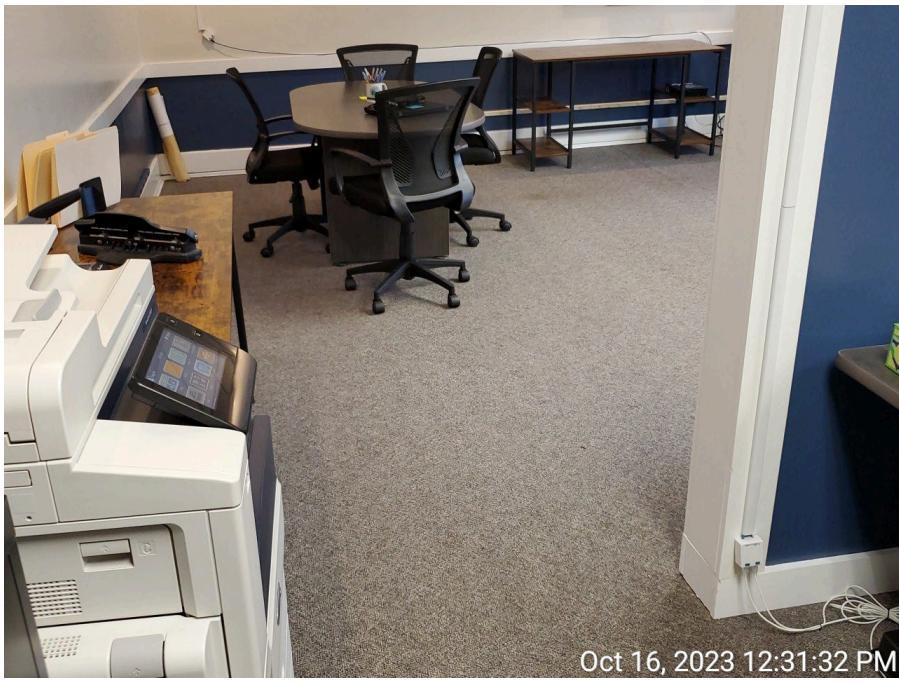
Worn/dirty carpeting on second floor in Asst. Town Mgr./HR/Finance Offices.

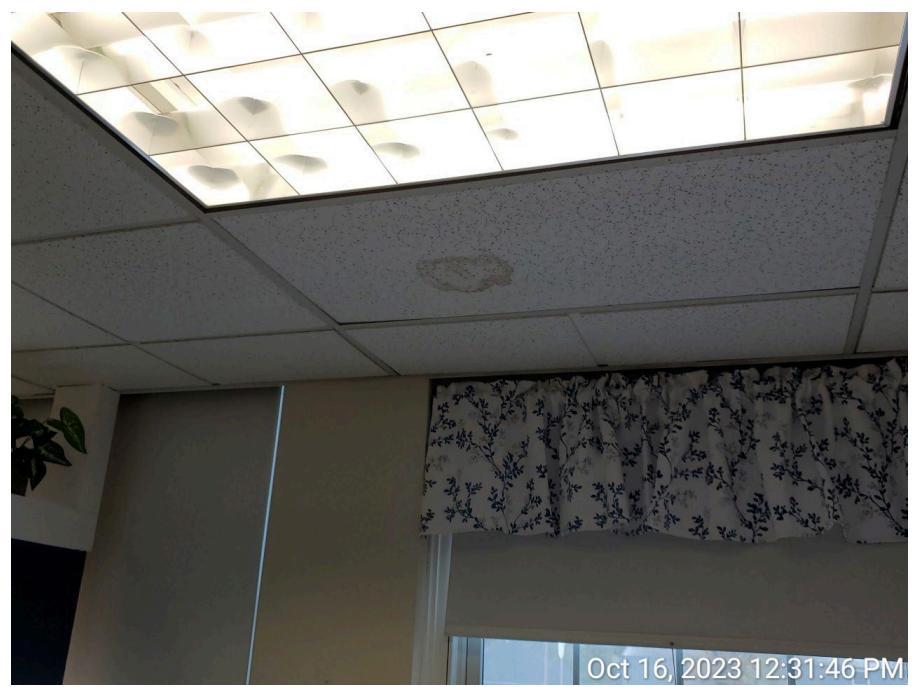
Water-stained ceiling tile on second floor in Asst. Town Mgr./HR/Finance Offices.

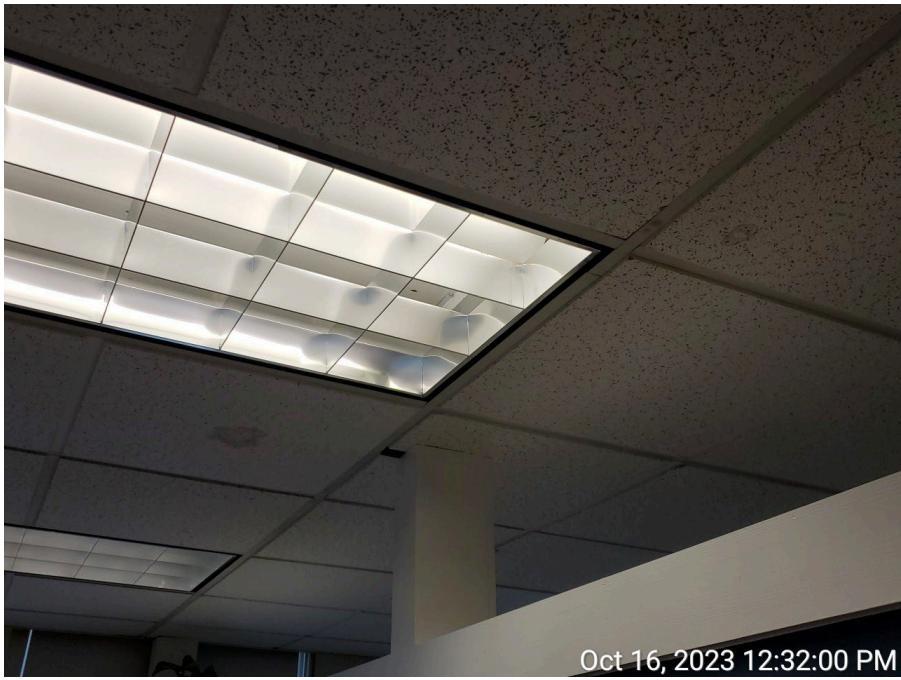
Water-stained ceiling tiles on second floor in Asst. Town Mgr./HR/Finance Offices.

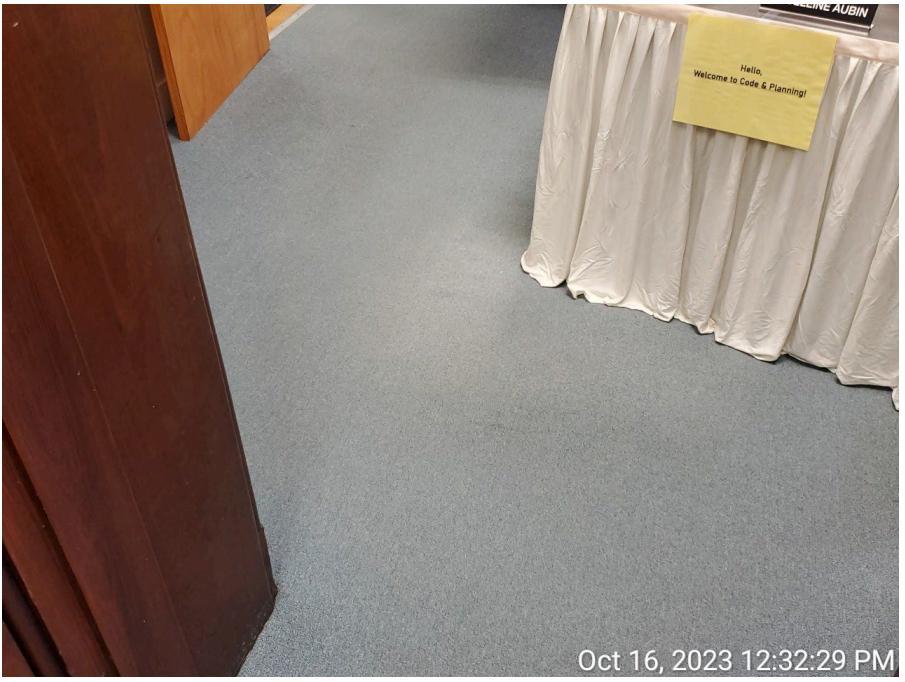
Worn/dirty carpeting on second floor in Codes/Planner Offices.

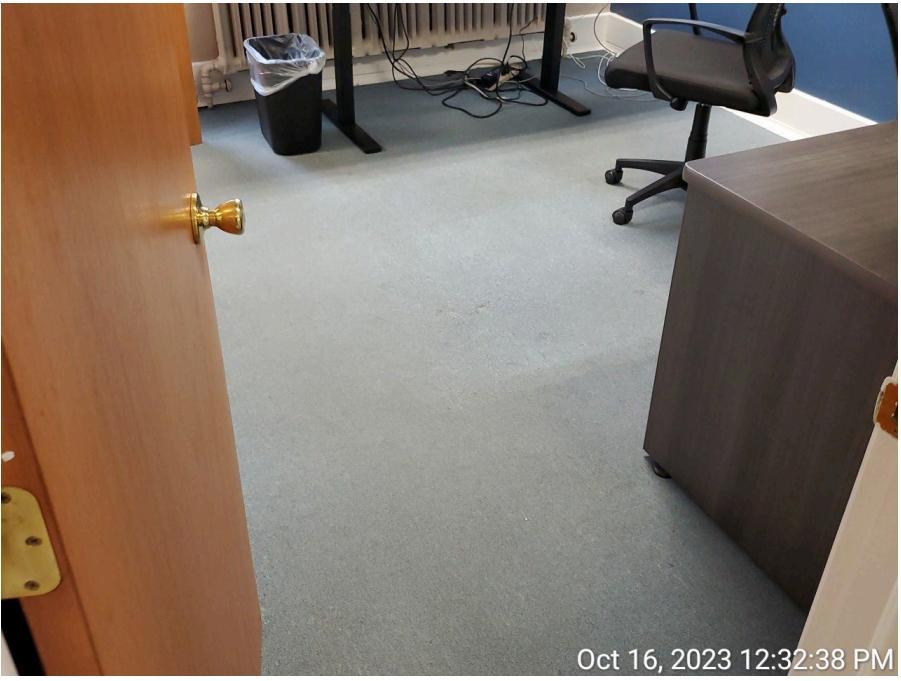
Worn/dirty carpeting on second floor in Codes/Planner Offices.

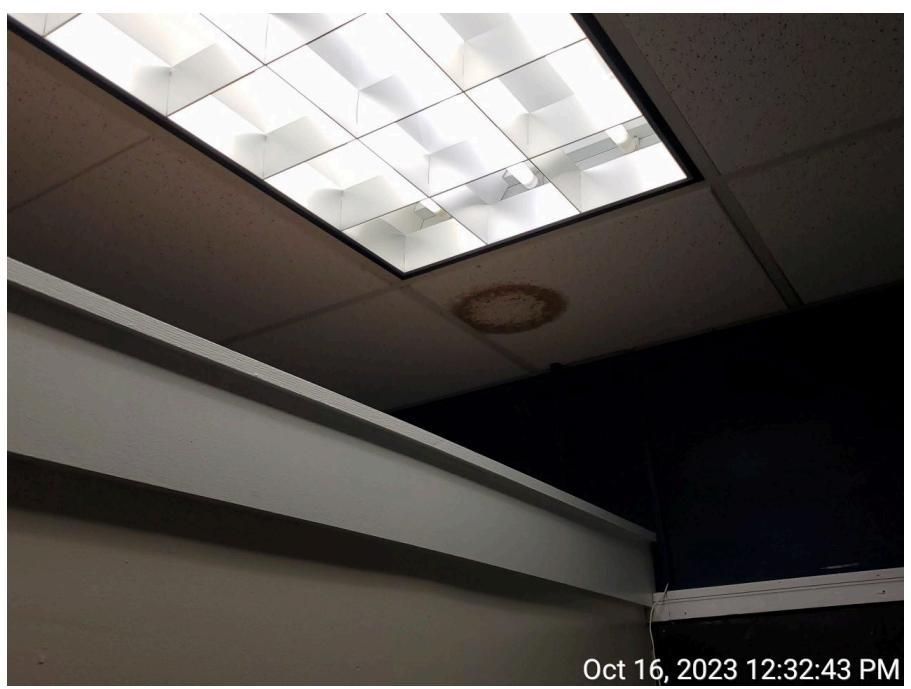
Water-stained ceiling tile on second floor in Codes/Planner Offices.

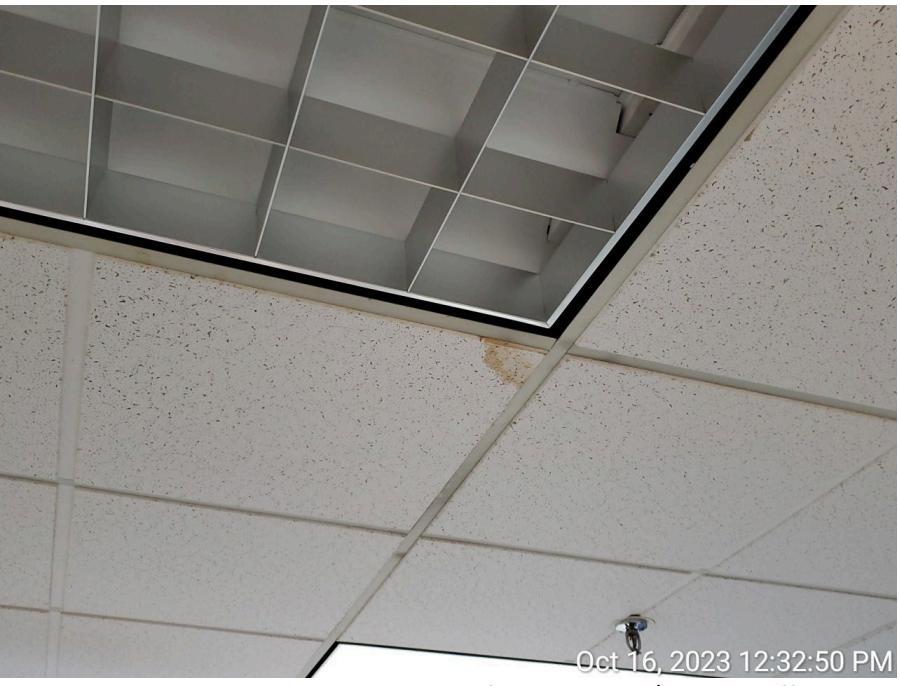
Water-stained ceiling tile on second floor in Codes/Planner Offices.

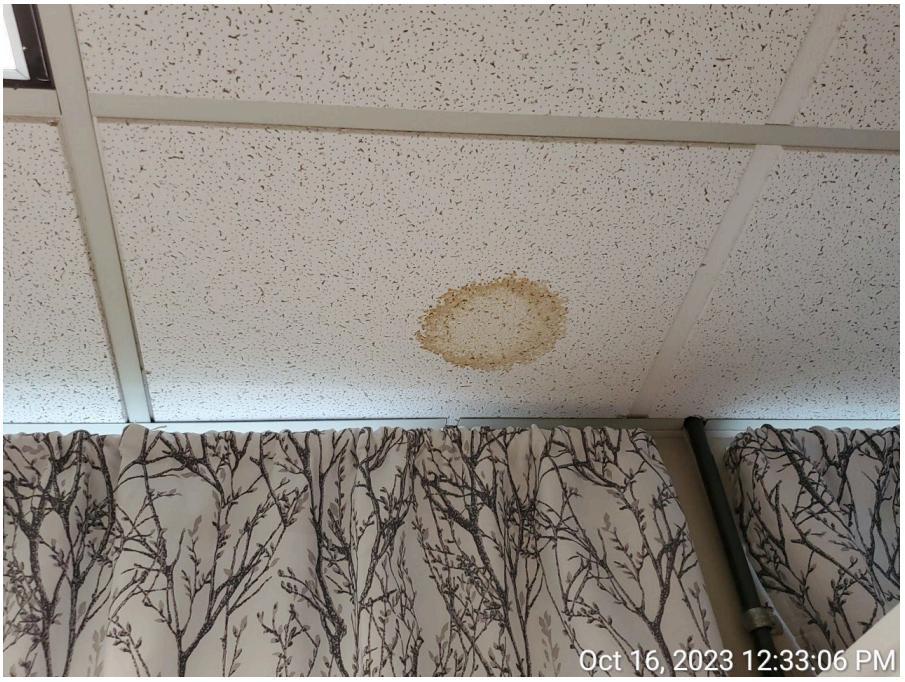
Water-stained ceiling tile on second floor in Codes/Planner Offices.

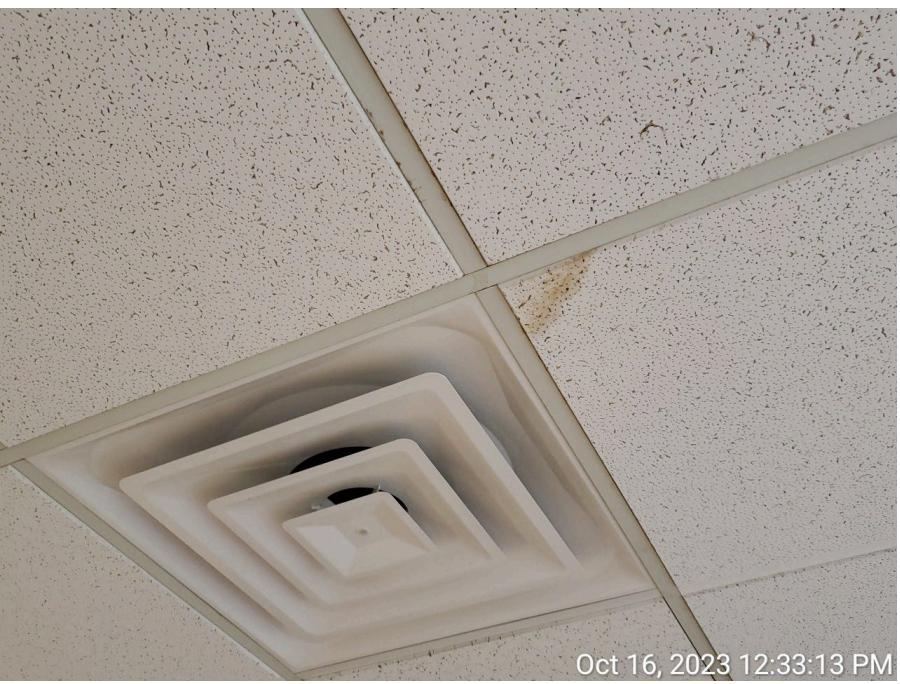
Water-stained ceiling tile on second floor in Codes/Planner Offices.

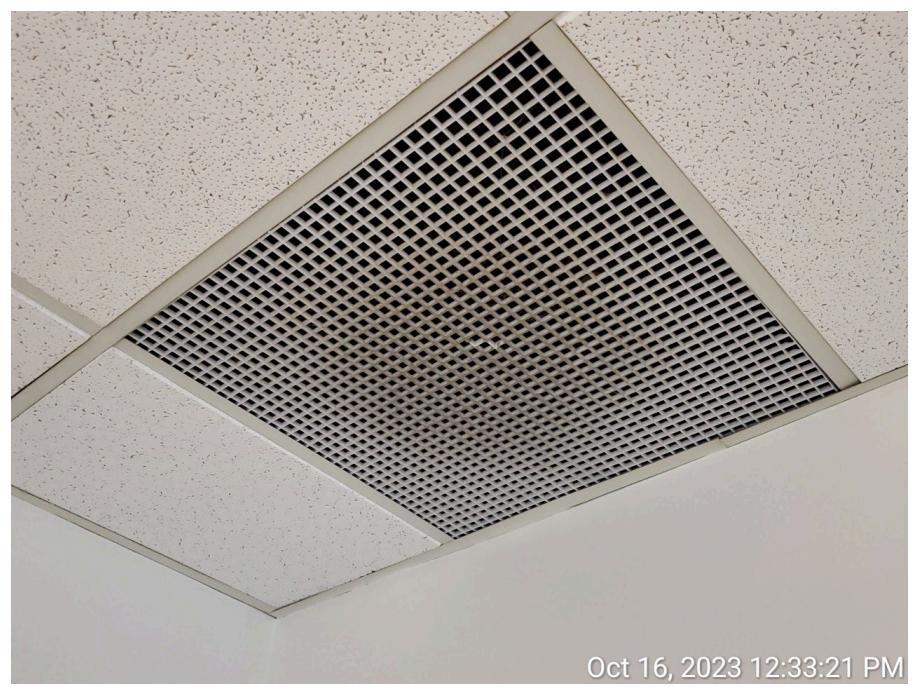
Dirty return diffuser and ductwork on second floor in Codes/Planner Offices.

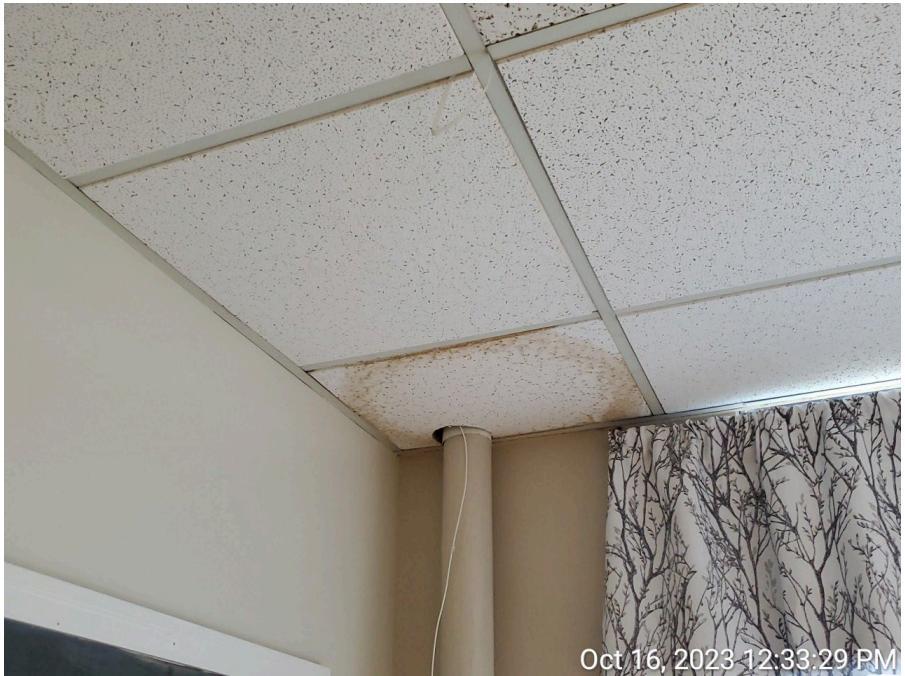
Water-stained ceiling tile on second floor in Codes/Planner Offices.

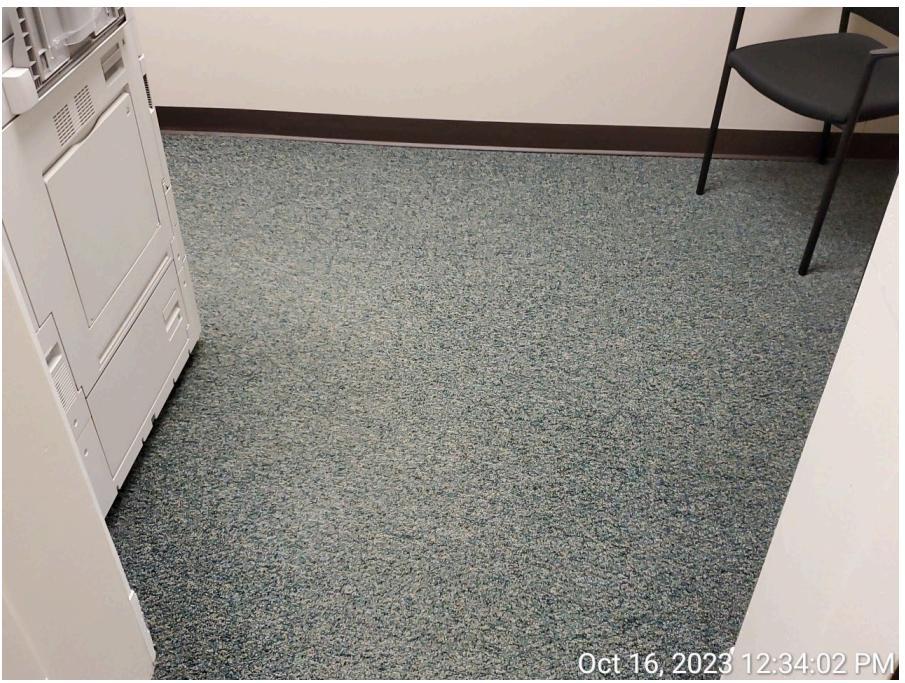
Worn/dirty carpeting on second floor in Twon Manager Offices.
