INDOOR AIR QUALITY/MOLD ASSESSMENT SOUTH BERWICK TOWN HALL 180 MAIN STREET, SOUTH BERWICK, MAINE

October 2023

John M. Boilard, RIHT, CMC Senior Industrial Hygiene & Safety Specialist

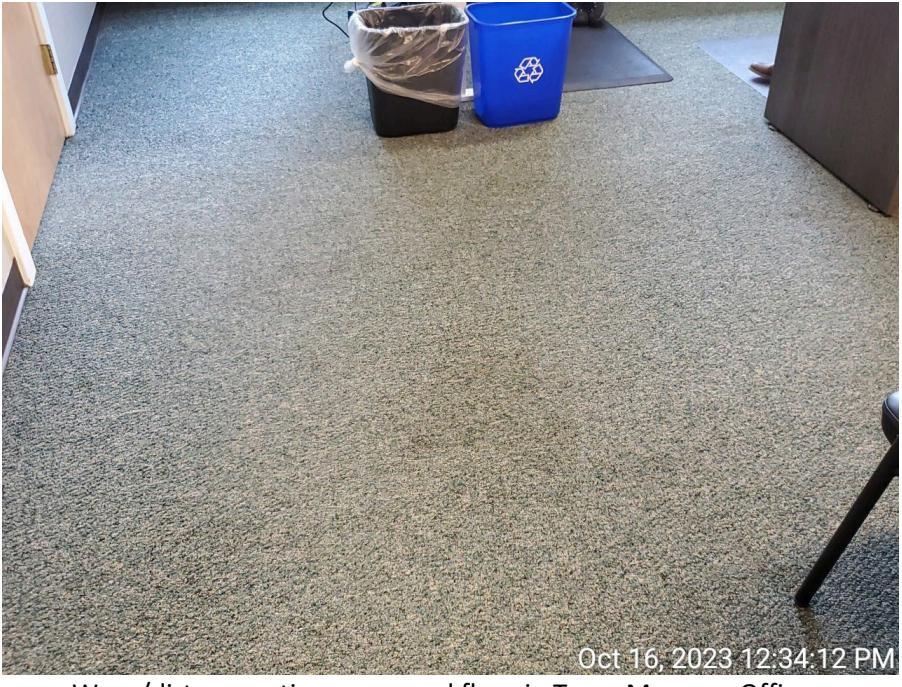
Worn/dirty carpeting on second floor in Twon Manager Offices.

• Worn/dirty carpeting needs to be removed. Replacement with carpeting is not recommended unless frequent HEPA vacuuming, and periodic shampooing/cleaning is performed. Hard flooring surfaces are much easier to clean and maintain and do not trap settled debris matter that then become re-entrained through foot traffic.

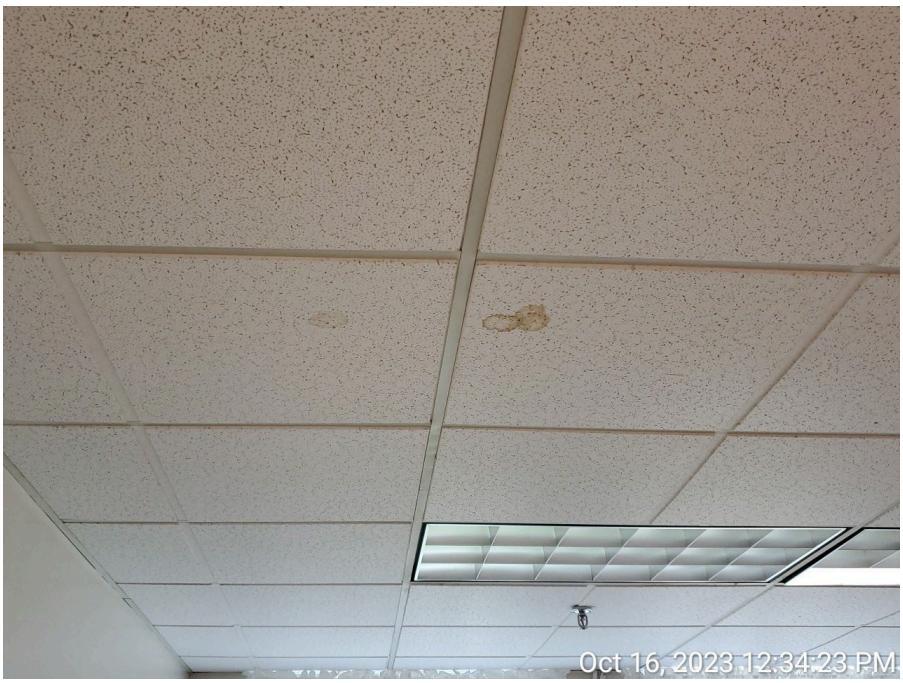
Water-stained ceiling tiles on second floor in Twon Manager Offices.

- A properly certified and licensed pest control entity should be contracted with to provide insect and rodent control actions at the site.
- All water-stained ceiling tiles and the mold compromised ceiling tile in the auditorium area need to be removed and replaced. Replacement not only aids in aesthetics for occupants, but helps identify when new leaks or water impact occurs so it can be properly addressed.
- All unsealed perimeter penetrations and foundation cracks need to be properly sealed.
- All shrinking/failing exterior caulking for windows and doors needs to be removed and replaced.

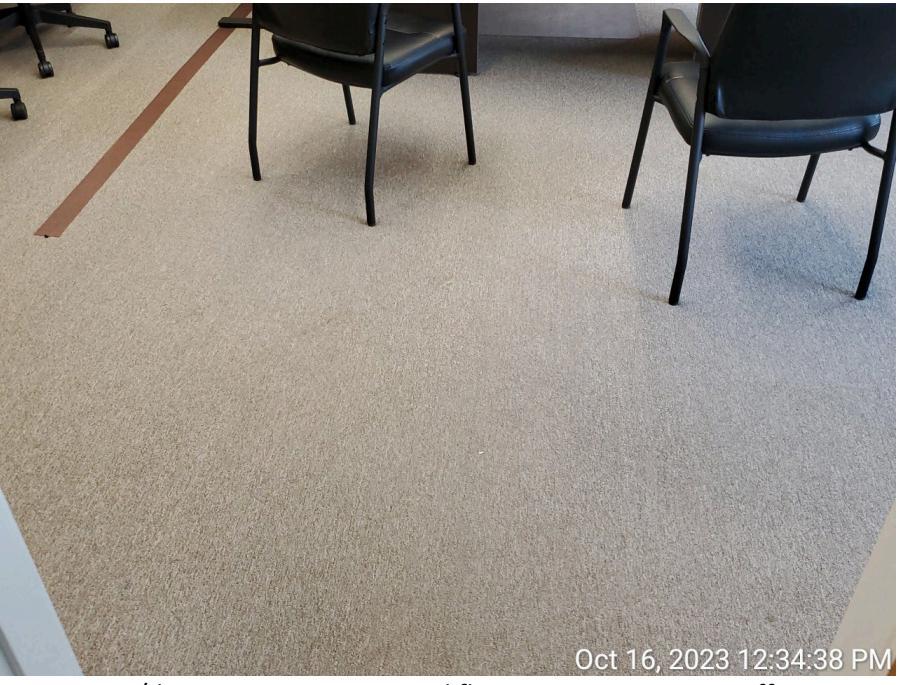
Worn/dirty carpeting on second floor in Twon Manager Offices.

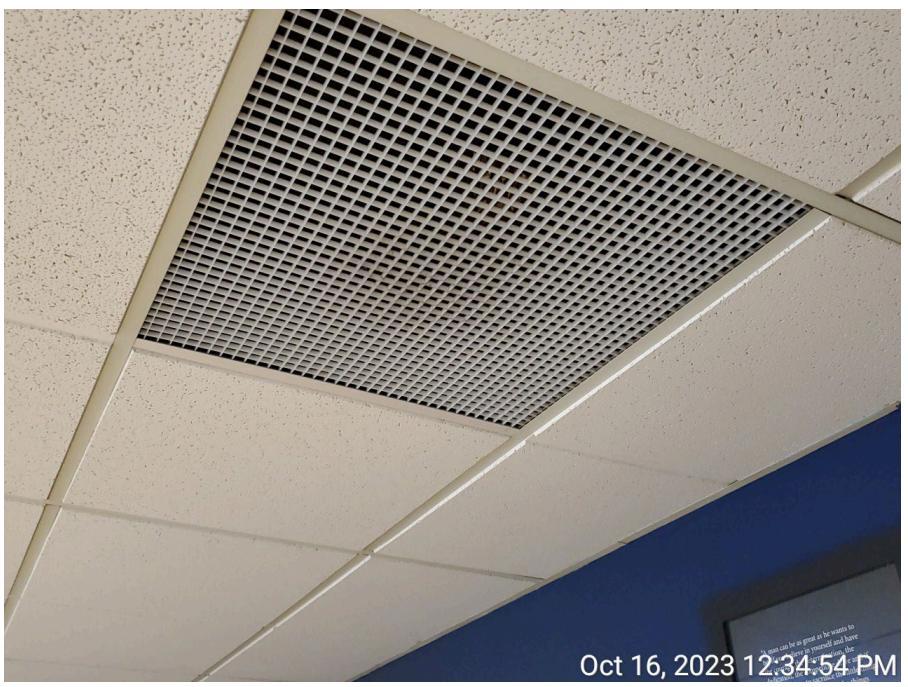
Dirty return diffuser and ductwork on second floor in Town Manager Offices.

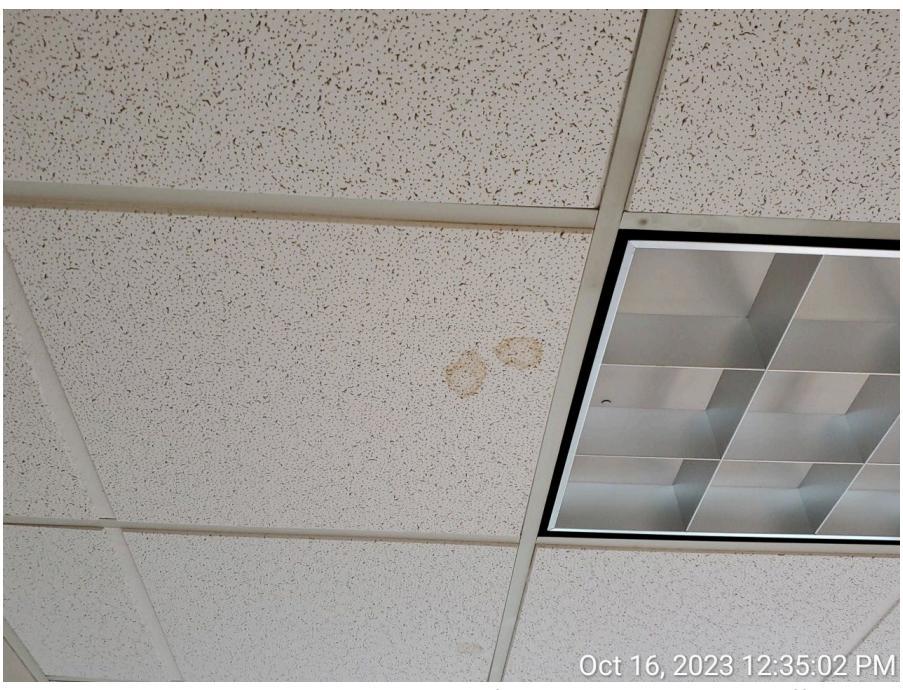
Water-stained ceiling tiles on second floor in Twon Manager Offices.

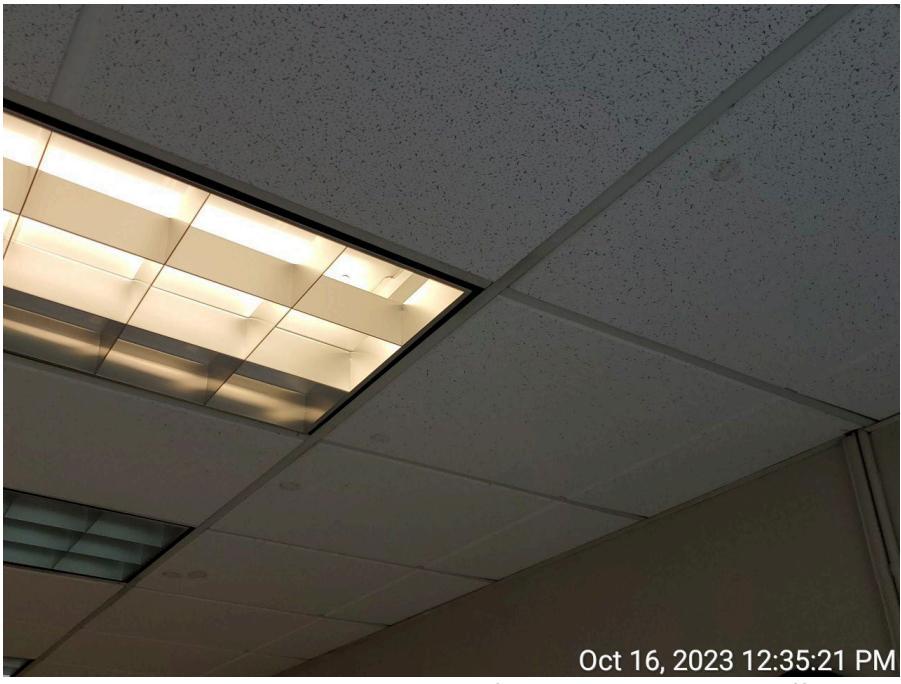
Water-stained ceiling tiles on second floor in Twon Manager Offices.

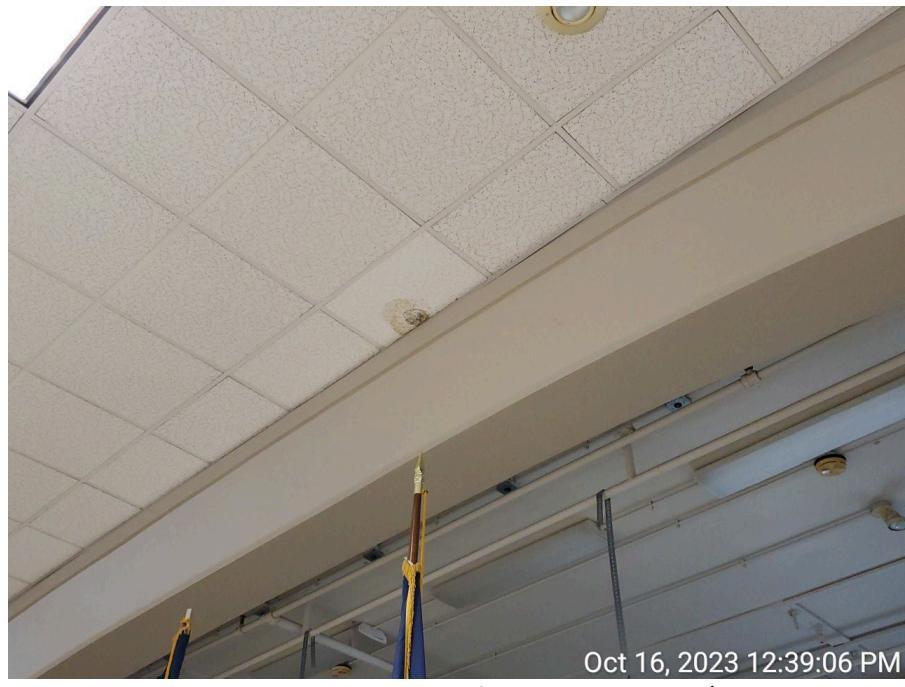
Water-stained ceiling tile on third floor in Auditorium/Stage area. Possible Cladosporium or Stachybotrys mold growth – inaccessible for direct sampling.

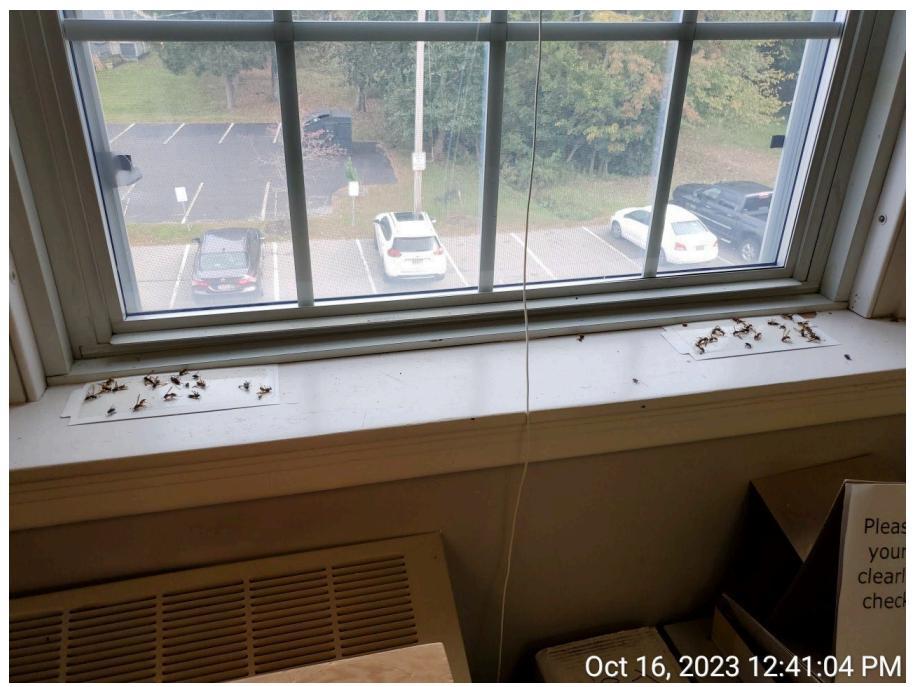
Insect infestation on third floor in election storage room.

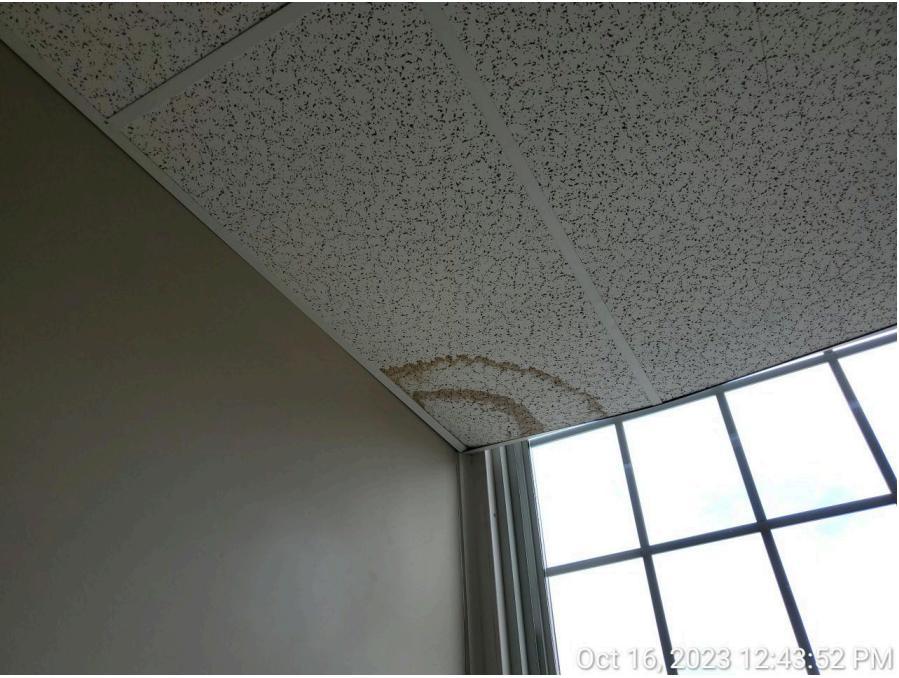
Water damaged ceiling tile on third floor in janitors' storage room.

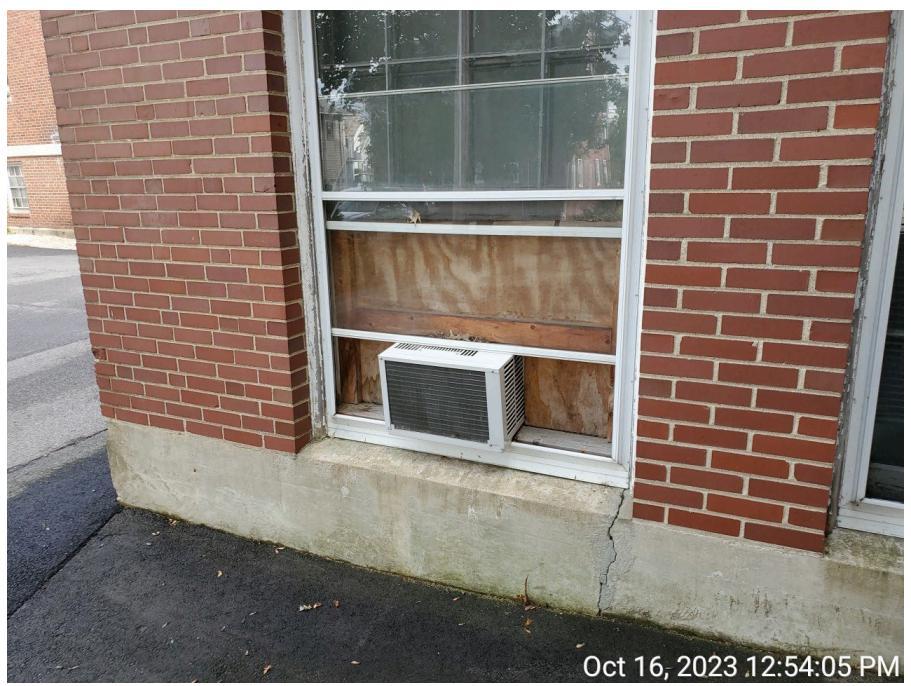
Water intrusion point for window area.

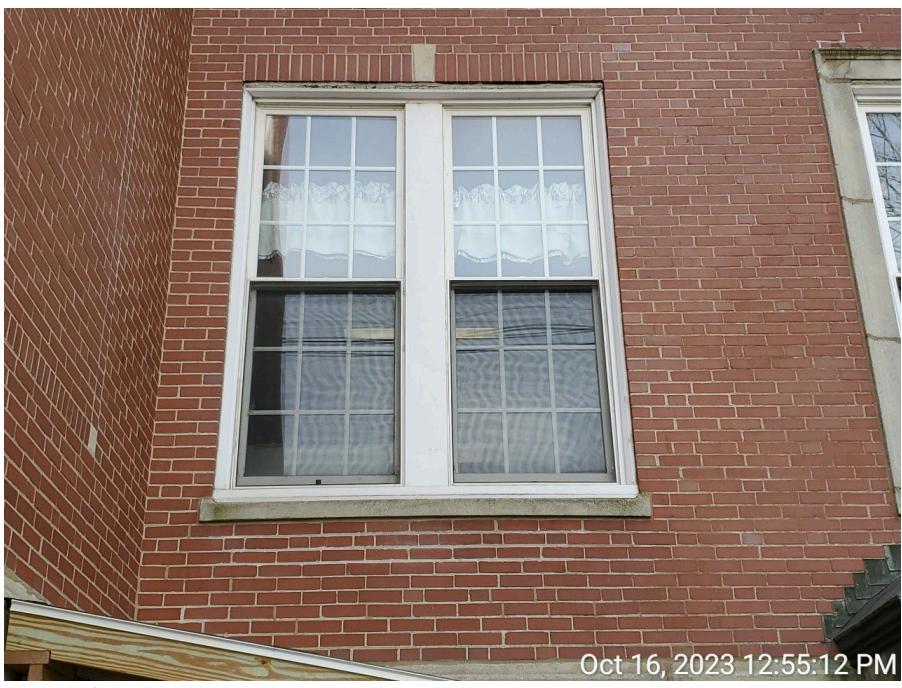
All lintel areas for the window units were observed to have shrunken and/or deteriorating caulking that are not only potential pathways for drain plane water intrusion, but also insect and rodent pathways.

Shrinking/cracking window caulking for header area is rainwater intrusion point.

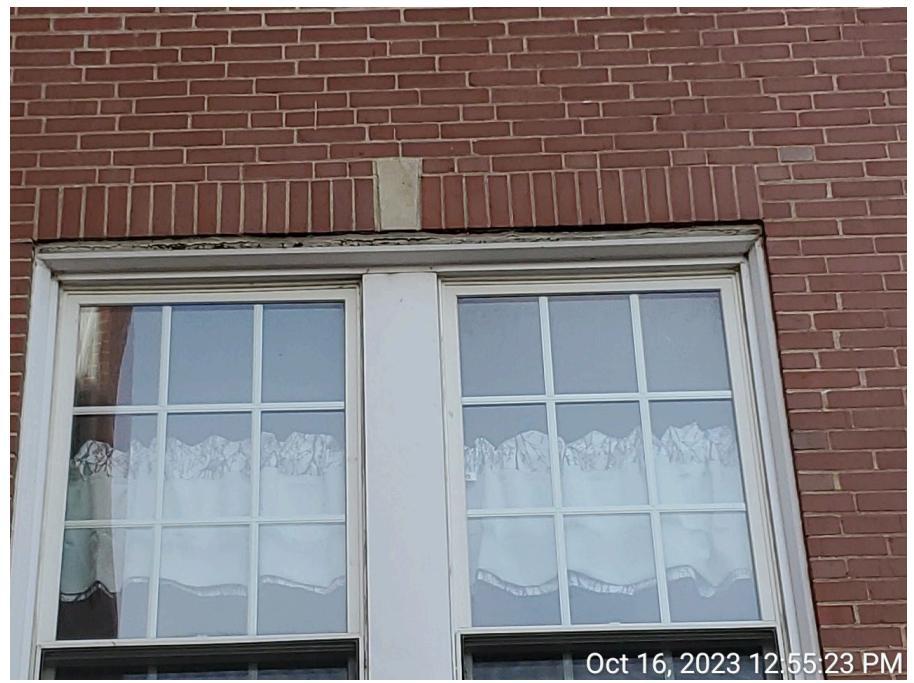
Shrinking/cracking window caulking for header area is rainwater intrusion point.

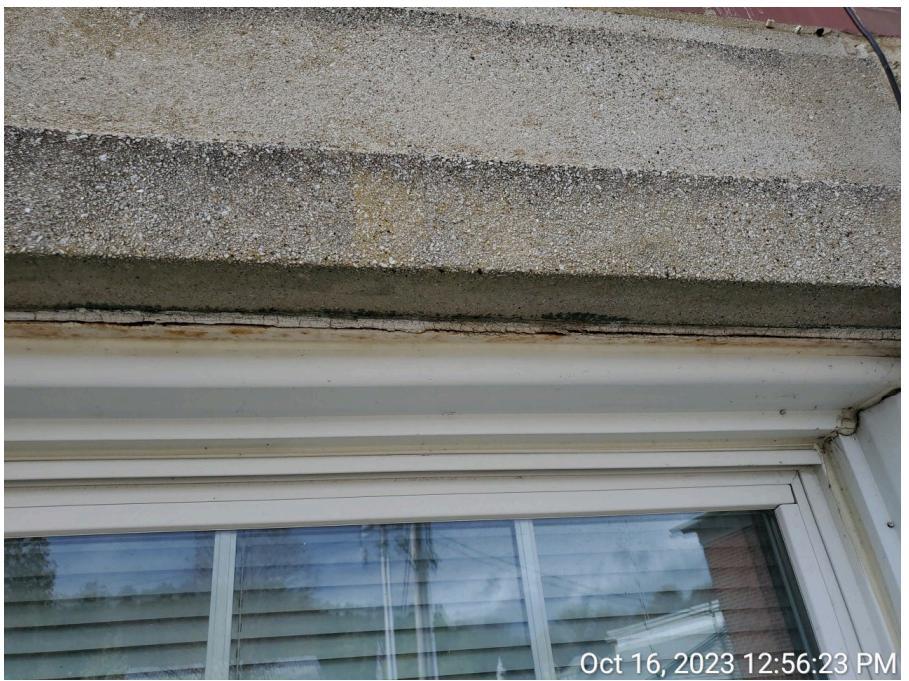
Shrinking/cracking window caulking for header area is rainwater intrusion point.

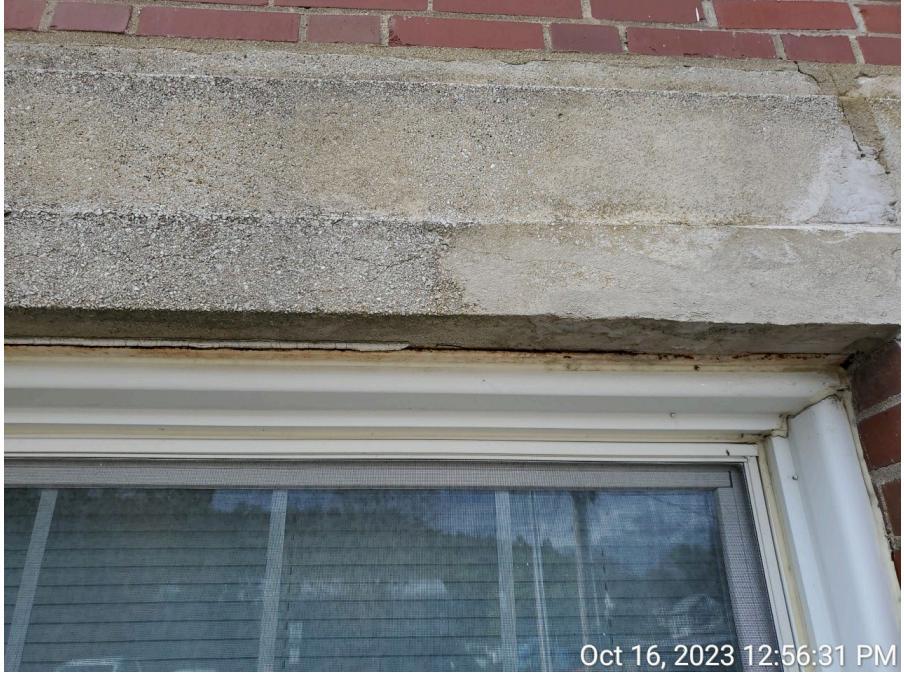
Shrinking/cracking window caulking for header area is rainwater intrusion point.

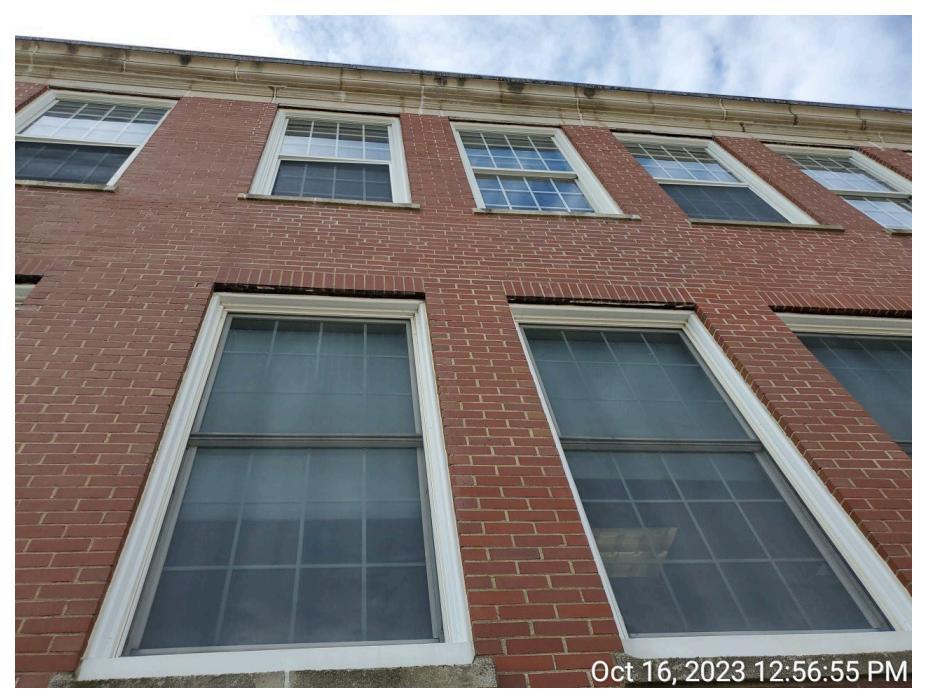
Shrinking/cracking window caulking for header area is rainwater intrusion point.

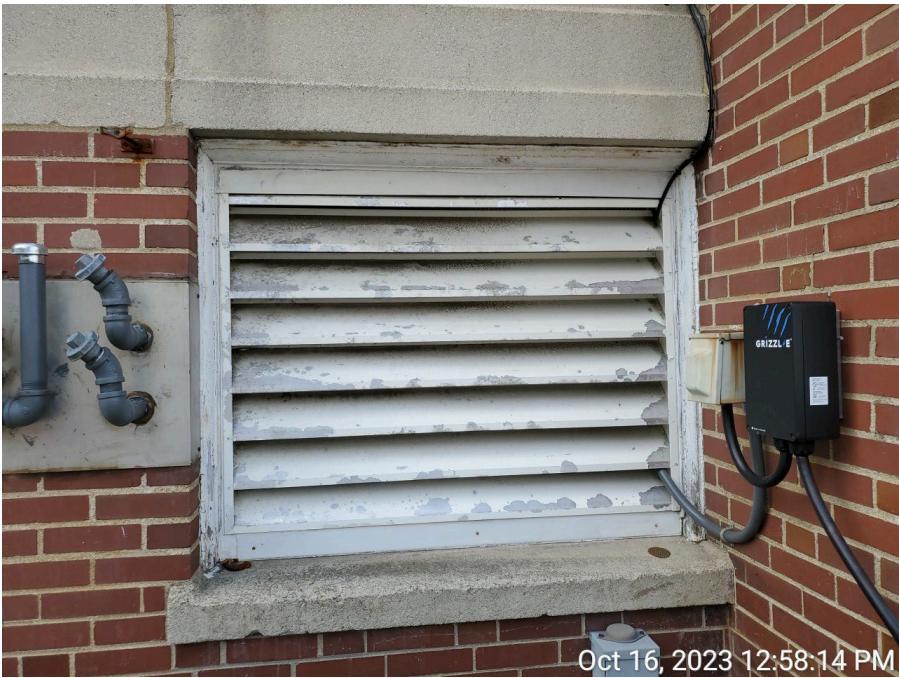
Possible lead-based paint for uncladded wood trim.
