## **PEER REVIEW**

Prepared By: Cornerstone Earth Group

Date: June 9, 2014

Re: Carolan Avenue and Rollins Road Residential Development  
Burlingame, California 94010

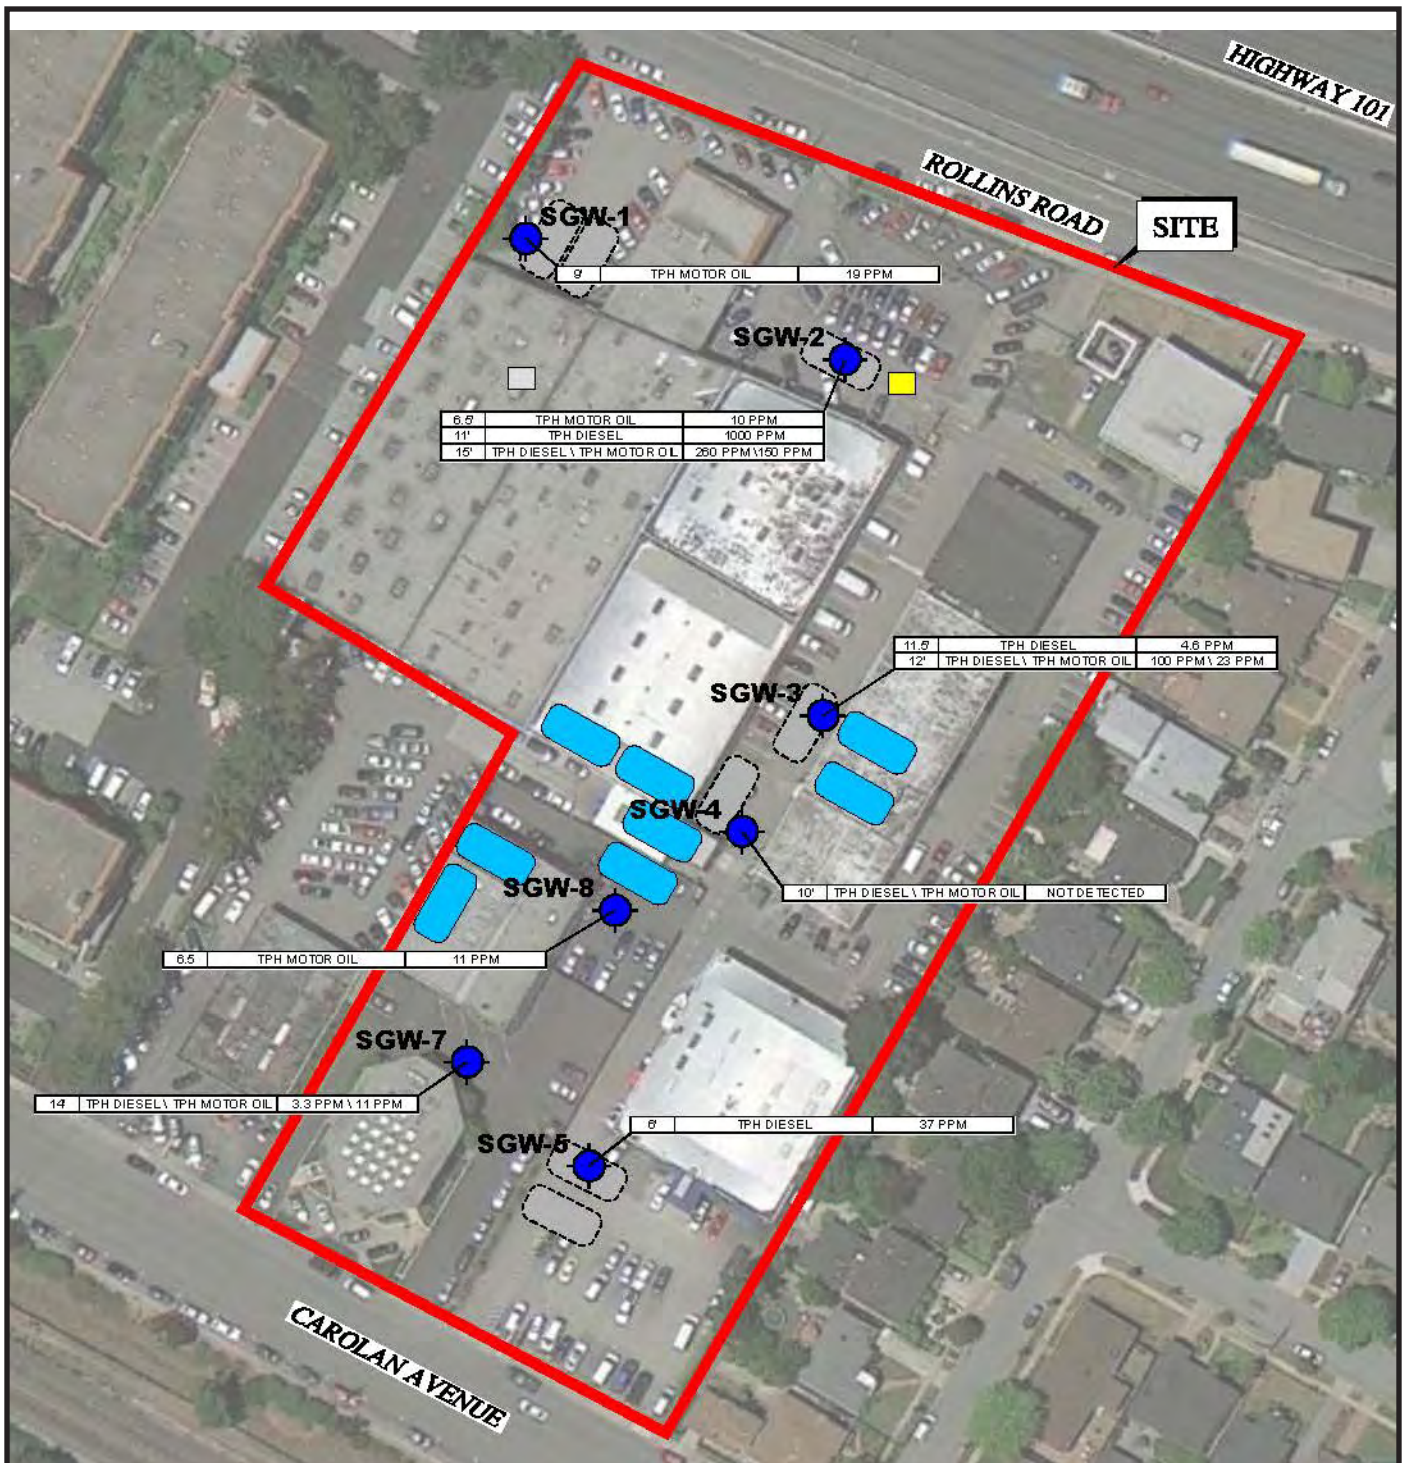
The soil and ground water analytical data are summarized below and on Figures 3 and 4:

- One soil sample collected at an approximate depth of 9 feet in the former UST locations at 1025 Rollins Road (SGW-1) revealed 19 mg/kg of TPH as motor oil with no reported visual evidence of impacts from TPH during field activities. The residential ESL<sup>1</sup> for TPH as motor oil is 100 mg/kg. It appeared that the tank backfill soil extended to a depth of about 11 feet before the sampling probe encountered native soil.

- Sampling of the former UST and sump locations at 1017 Rollins Road (SGW-2) encountered stained and odoriferous soil at approximate depths of 11 to 15 feet. Analytical testing of soil collected at approximate depths of 6½, 11 and 15 feet detected TPH as diesel at 1,100 mg/kg at approximately 11½ feet<sup>2</sup> and 260 mg/kg at approximately 15 feet. TPH as motor oil was detected at 10 and 150 mg/kg at approximately 6½ and 15 feet, respectively. The residential ESL for TPH as motor oil and TPH as diesel is 100 mg/kg.

- Boring SGW-3 was located in the area of a former UST west of the automobile service building at 1007 Rollins Road. TPH as diesel was detected at concentrations of 4.6 and 100 mg/kg at an approximate depth of 11½ and 12 feet, respectively. TPH as motor oil also was detected at 23 mg/kg at an approximate depth of 12 feet. The residential ESL for TPH as motor oil and TPH as diesel is 100 mg/kg.

- A soil and ground water sample were collected at the former UST location in front of the Enterprise Rental at 1008 Carolan Avenue (SGW-5). Analytical testing of the ground water detected TPH as gasoline at 910 µg/L and TPH as diesel at 680 µg/L. Analytical testing of the soil sample detected TPH as diesel at 37 mg/kg in soil (6 foot depth). The ground water ESL for TPH as gasoline and TPH as diesel is 100 µg/L; the residential soil ESL for TPH as diesel is 100 mg/kg.

- Analytical testing of soil samples collected from 1028 Carolan Avenue (SGW-7 at 14 feet and SGW-8 at 6½ feet) detected TPH as motor oil at 11 mg/kg in both samples and TPH as diesel at 3.3 mg/kg IN SGW-7). It should be noted that these sampling locations were

<sup>2</sup> Figure 3 shows a data discrepancy with 1,000 mg/kg shown on the figure and 1,100 mg/kg presented in the ENGEO report.

- Soil contamination above residential ESLs and RSLs and ground water contamination above ESLs have been documented in past sampling events. We recommend establishing the extent of contamination exceeding these screening criteria through

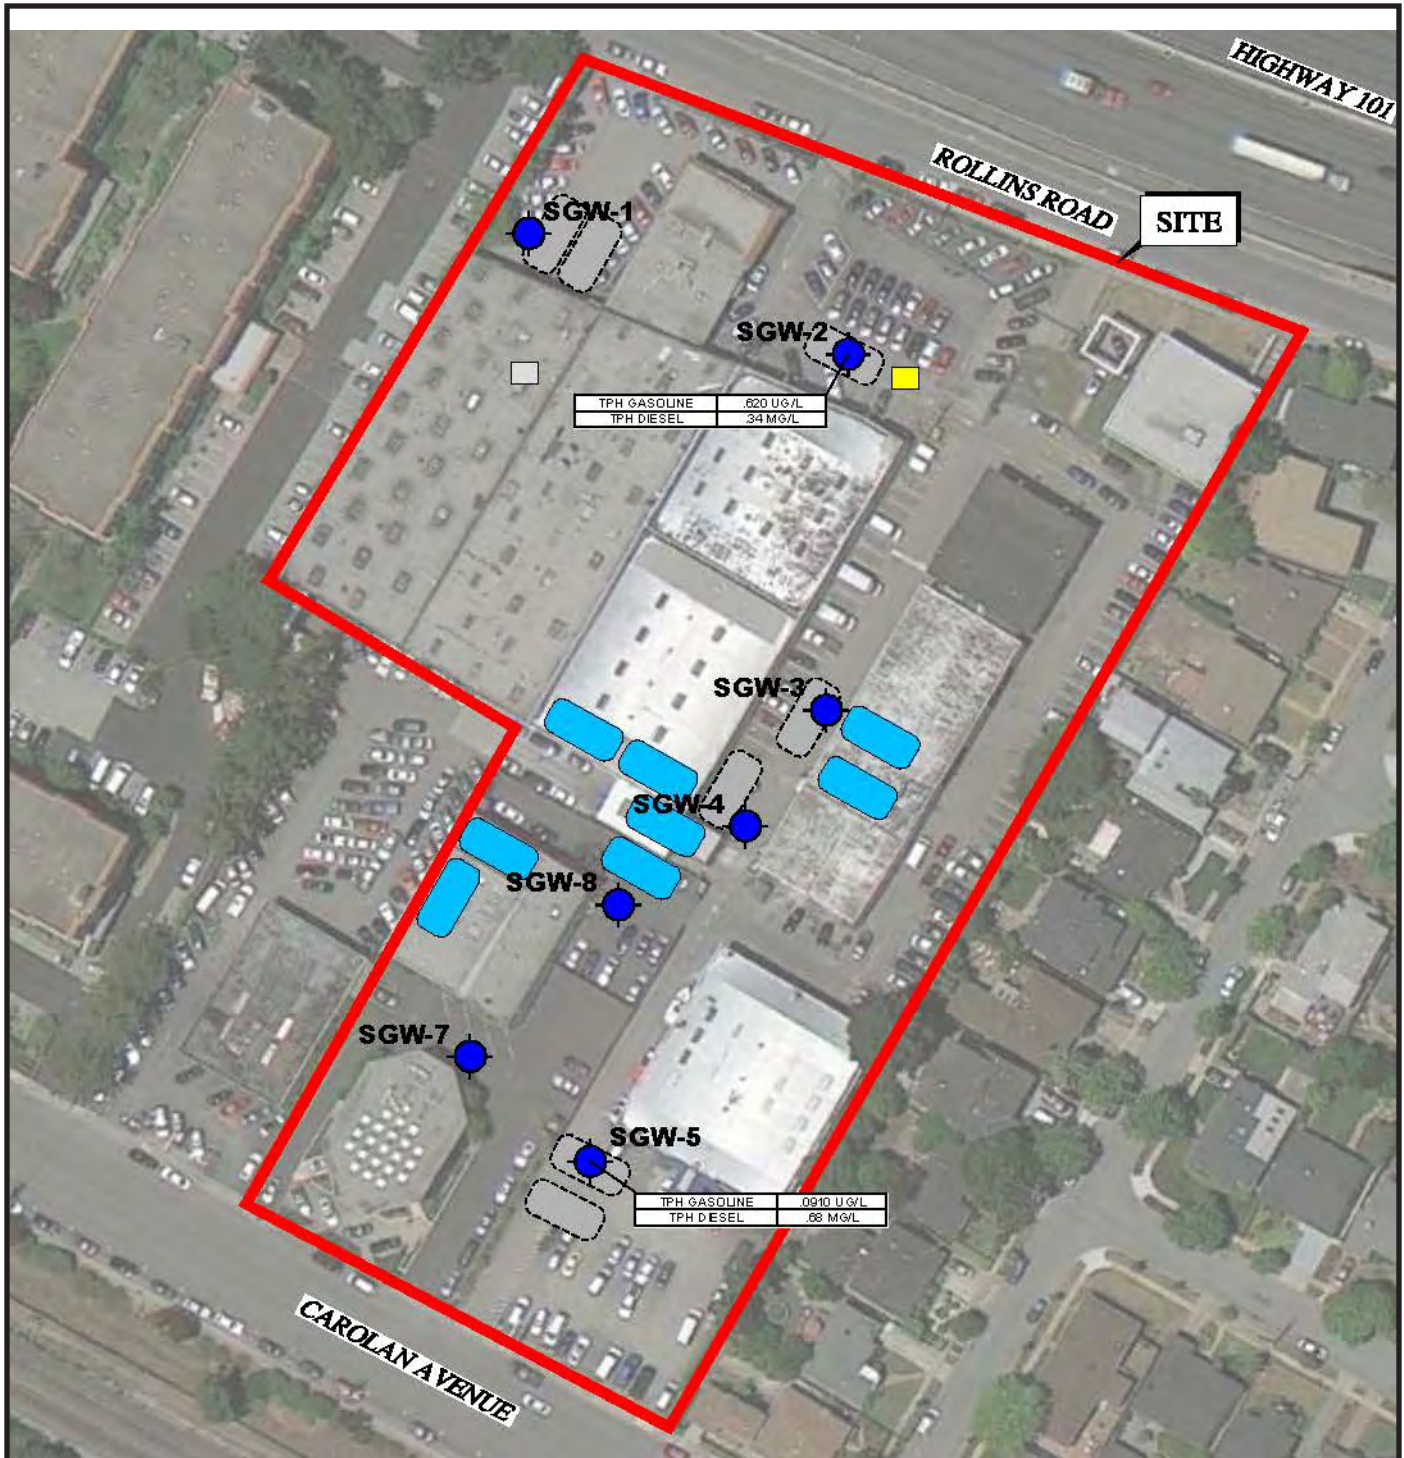
Figure 4

TPH as diesel was detected in ground water at 340 µg/L. The ground water ESL is 100 µg/L.
