LANDMARK COMMISSION REPORT

APPLICATION FOR COMPREHENSIVE EXTERIOR POST STORM RENOVATIONS TO 125 E WATER STREET

Reference Number: LC-09-18

REPAIR NARRATIVE

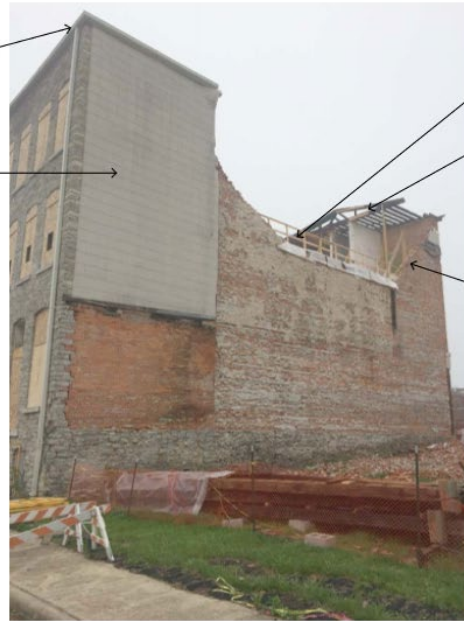
CURRENT CONDITION

TEMPORARY ROOF STABILIZATION
MEASURES TO BE REMOVED

EXISTING TRUSS AND ROOF
FRAMING TO REMAIN

REMOVE UN-STABLE
MASONRY AS REQ'D

REMOVE EXISTING GUTTERS
AND DOWNSPOUTS. REPLACE
WITH NEW TO MATCH

REMOVE EXISTING EIFS
FROM WALL

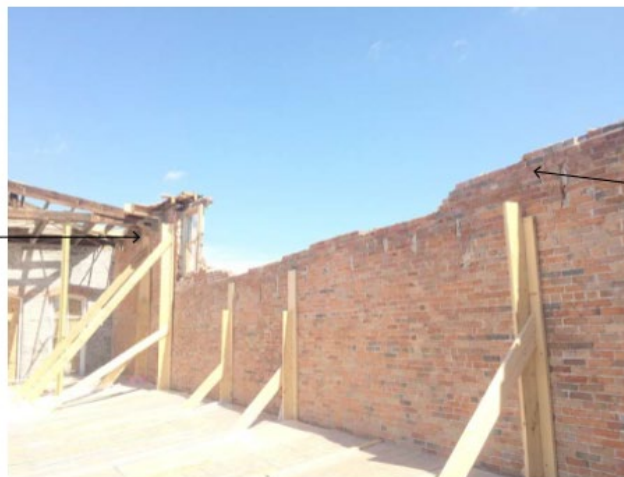
CURRENT CONDITION - EAST ELEVATION INTERIOR VIEW

LOCATIONS OF
ANGLES
AND ANCHOR BOLTS
TO BE REPLACED
SEE PLAN KEYNOTE 5

REMOVE UN-STABLE
MASONRY AS REQ'D
DOWN TO EXISTING
STABLE HEADER
COURSE

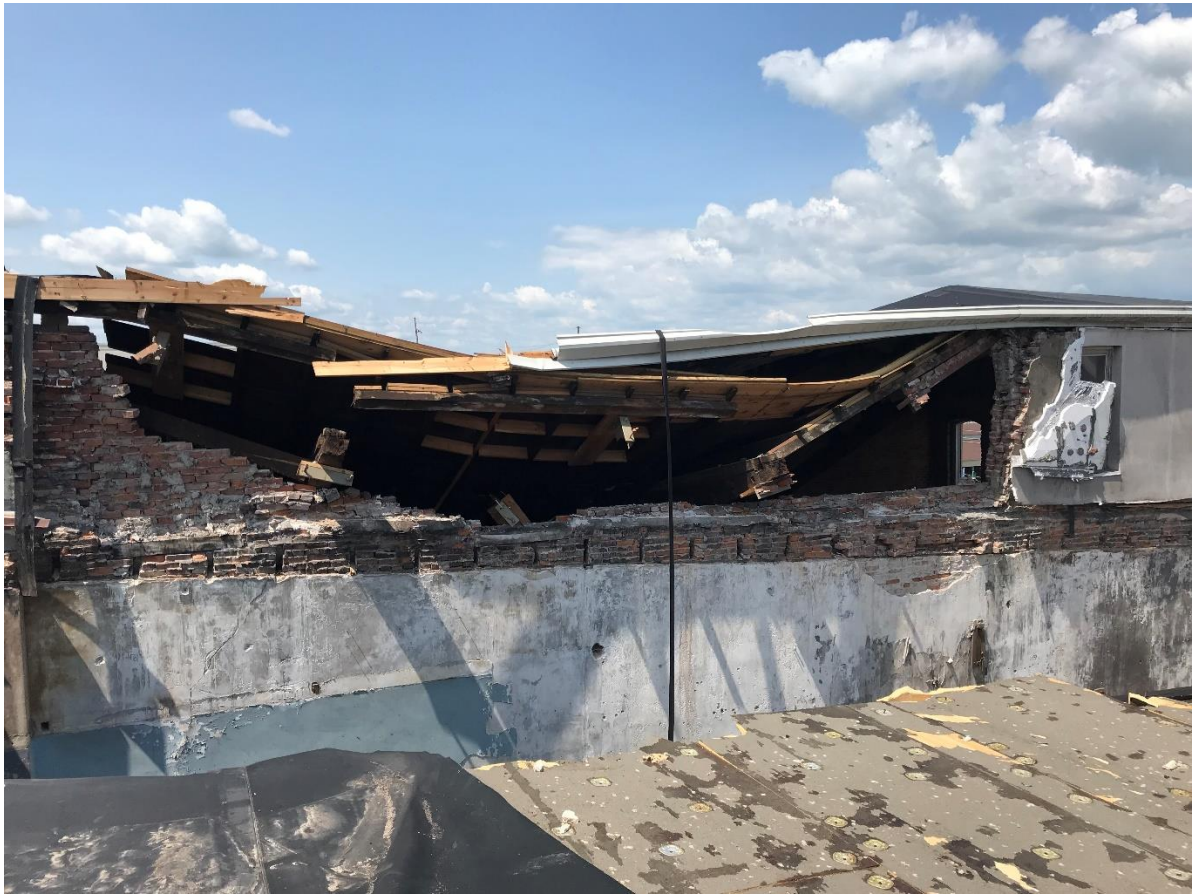
East Wall Storm Damage (before cleanup)
(Note roof missing on adjacent building in foreground)

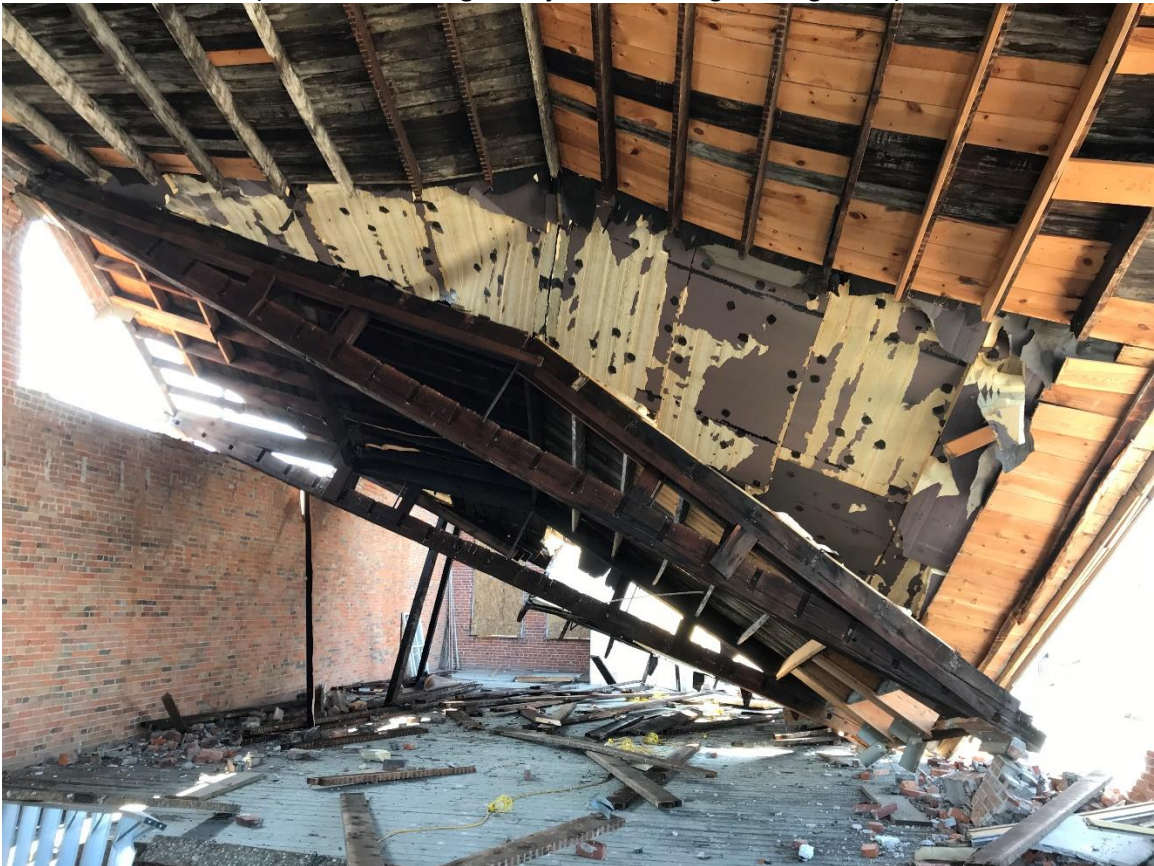
Roof Structure resting on third floor (before cleanup)
Note east wall damage with truss ends resting on remaining wall

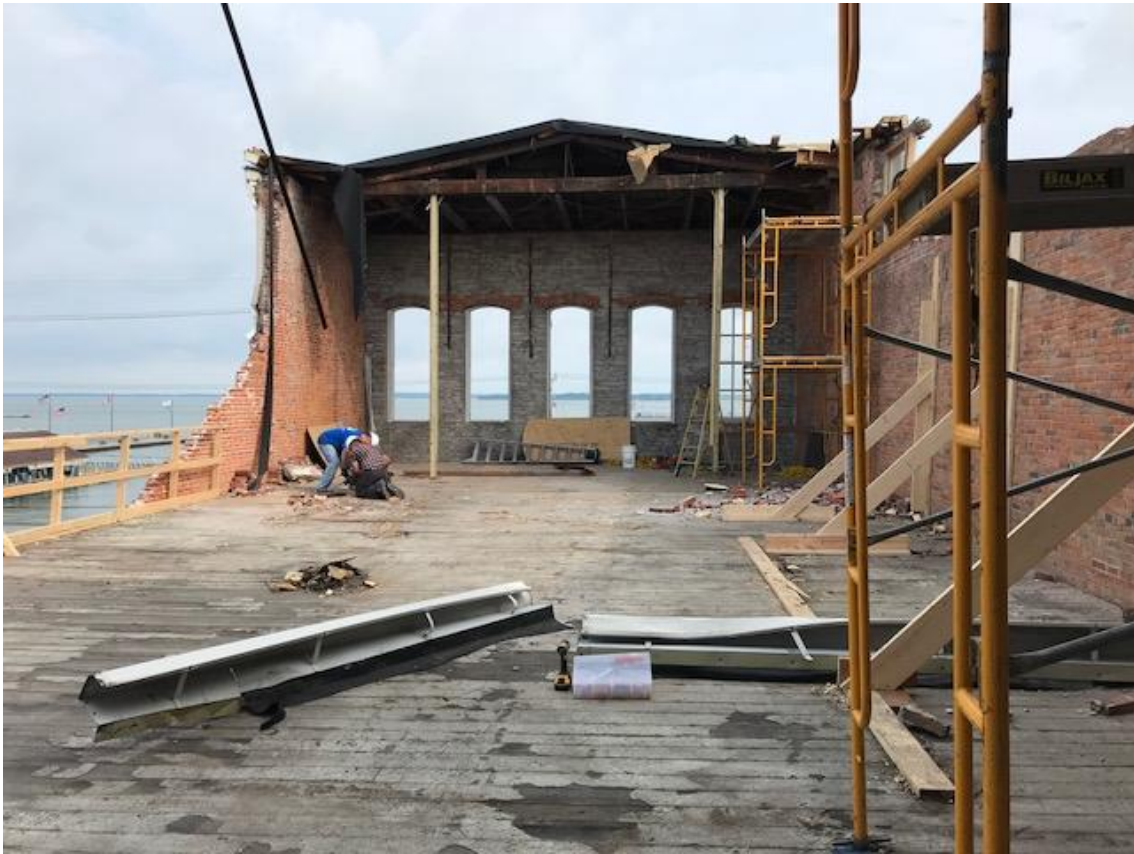
Third floor after damage cleanup
Note extent of damage to west wall compared to east wall

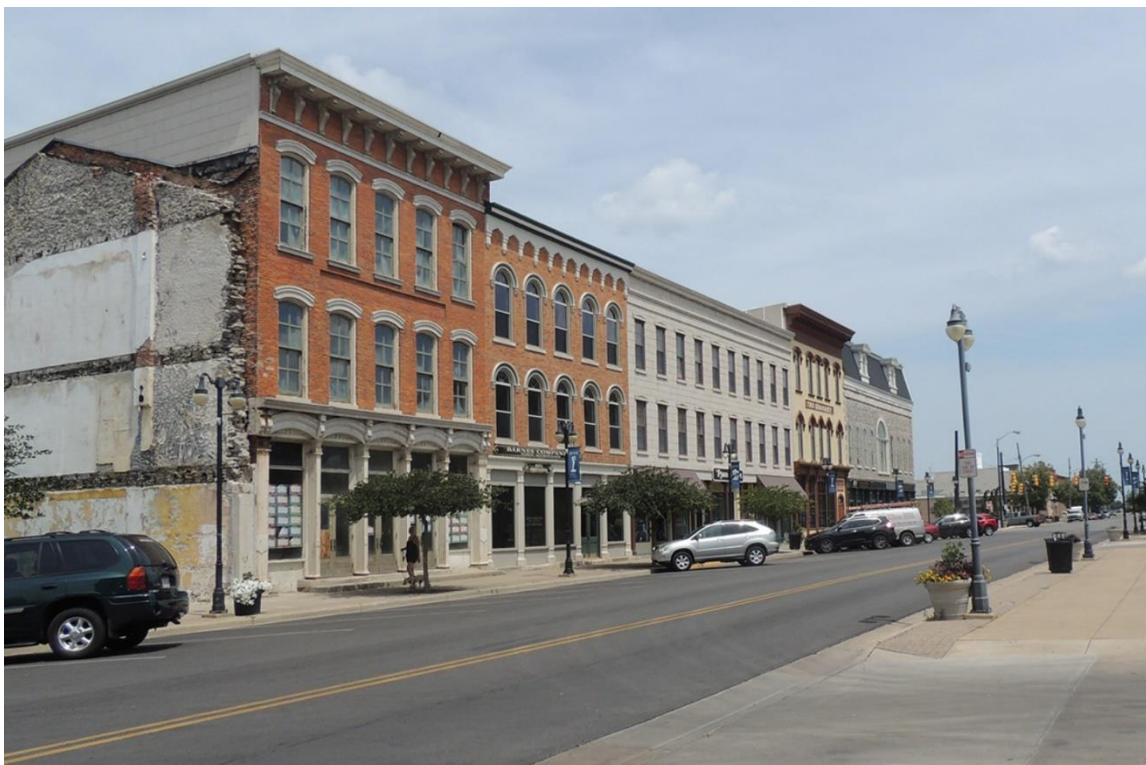
Building view 2014 after demolition of adjacent building
Note significant masonry wall present at west wall

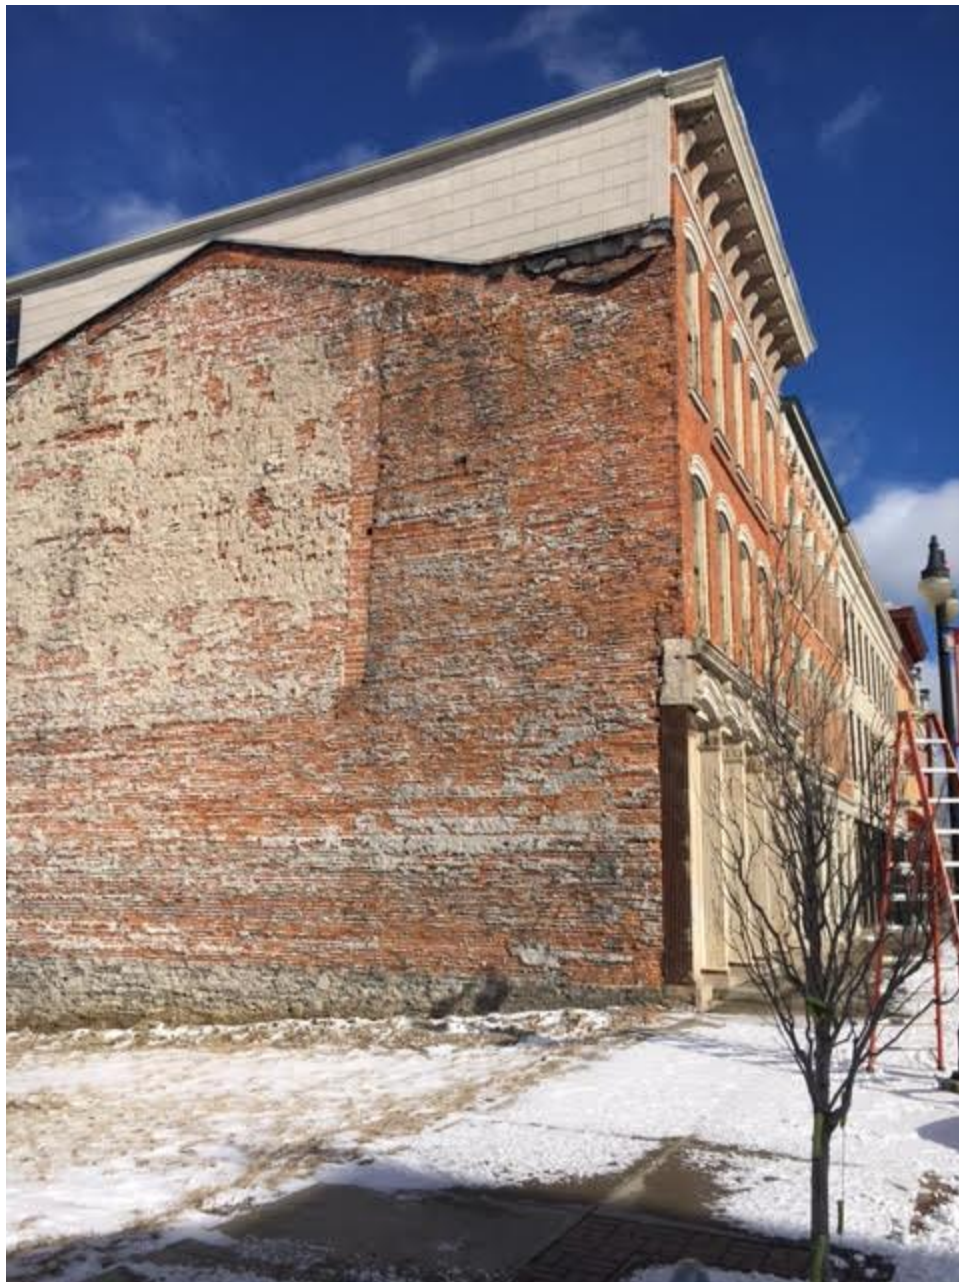
West wall exposed after adjacent building wall demolished
Note variation in brick

In recent years, the building to the west was demolished due to neglect, thus exposing what was never intended to be, and is not capable of being a wall exposed to the elements. The wall was constructed with bricks that do not have a severe or moderate (SW or MW) facing, making them excessively porous for single or double wythe construction. By leaving these exposed, the interior of the building becomes susceptible to the negative effects of moisture infiltration as well as freeze thaw conditions. With the wall not having any insulating properties and the wall varying between 2 and 3 wythes of thickness, it does not have enough mass to allow for the dew point to land outside the interior space, thus creating a condensation issue within the building.

As noted above, the existing west wall is also not consistent in its thickness and dimension. The thickness varies from 2 to 3 wythes thick along its length. Thus the repairs are limited to a width dimension of 2 brick wythes or 8" nominally, to accommodate the necessary reinforcing and anchoring. This thickness does not allow for the exterior application of a veneer brick face.

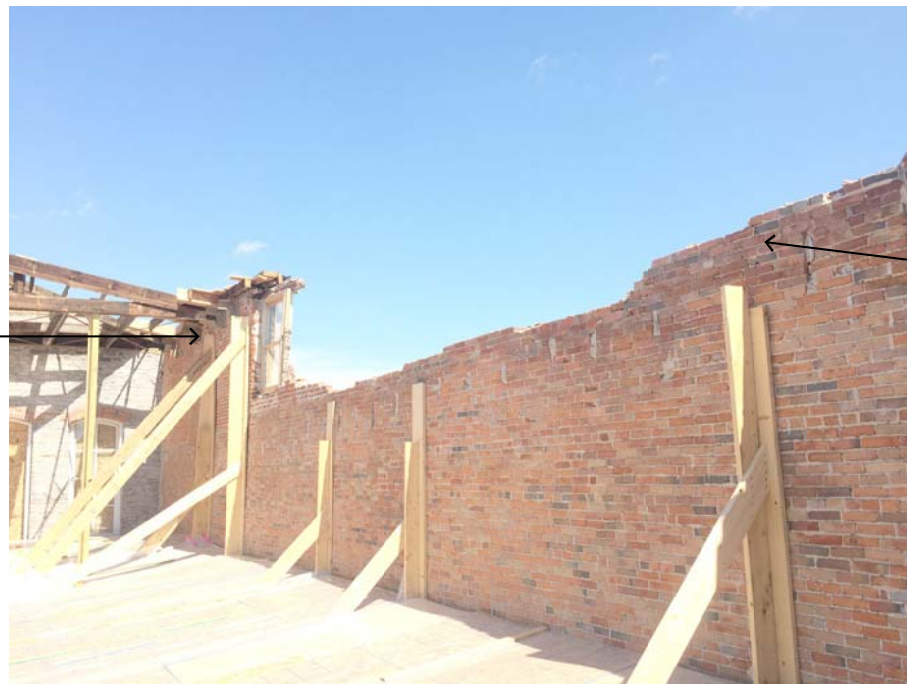
CURRENT CONDITION - EAST ELEVATION INTERIOR VIEW

LOCATIONS OF ANGLES AND ANCHOR BOLTS TO BE REPLACED SEE PLAN KEYNOTE 5

REMOVE UN-STABLE MASONRY AS REQ'D DOWN TO EXISTING STABLE HEADER COURSE

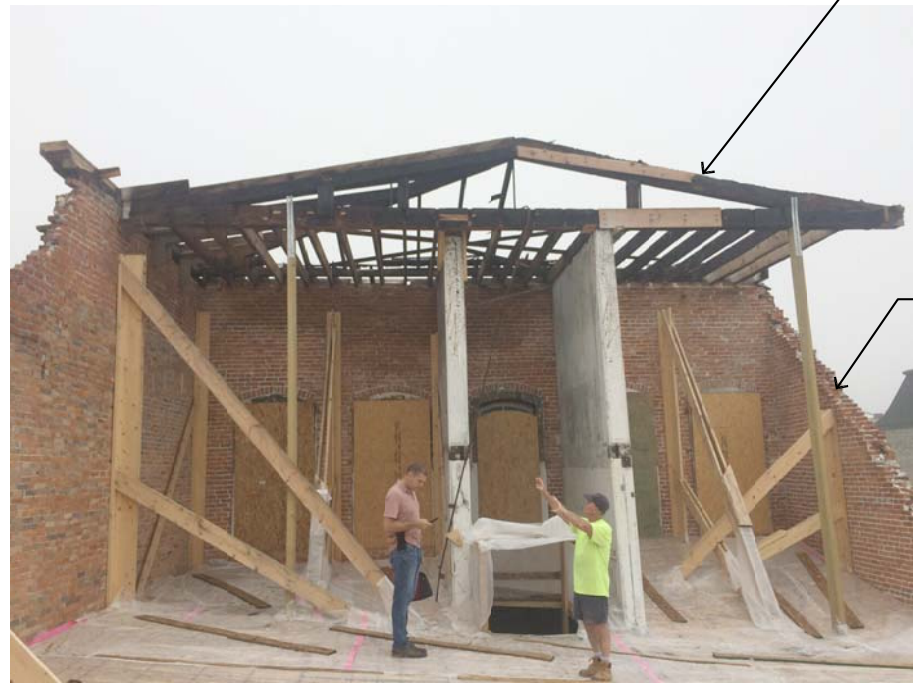
CURRENT CONDITION - FRONT OF THIRD FLOOR

EXISTING TRUSS AND FRAMING TO REMAIN SEE ADDITIONAL WORK NOTED ELSEWHERE

REMOVE UN-STABLE MASONRY AS REQ'D

LOCATIONS OF ANGLES AND ANCHOR BOLTS TO BE REPLACED - SEE PLAN KEYNOTE 5

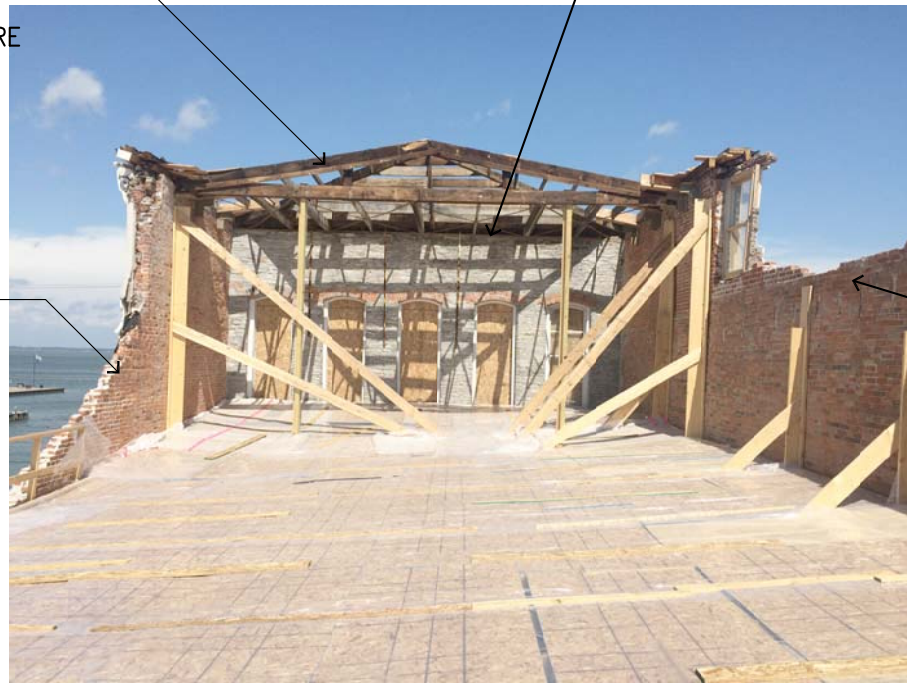
CURRENT CONDITION - REAR OF THIRD FLOOR

REMOVE UN-STABLE MASONRY AS REQ'D

REMOVE EXISTING GUTTERS AND DOWNSPOUTS. REPLACE WITH NEW TO MATCH

REMOVE EXISTING EIFS FROM WALL

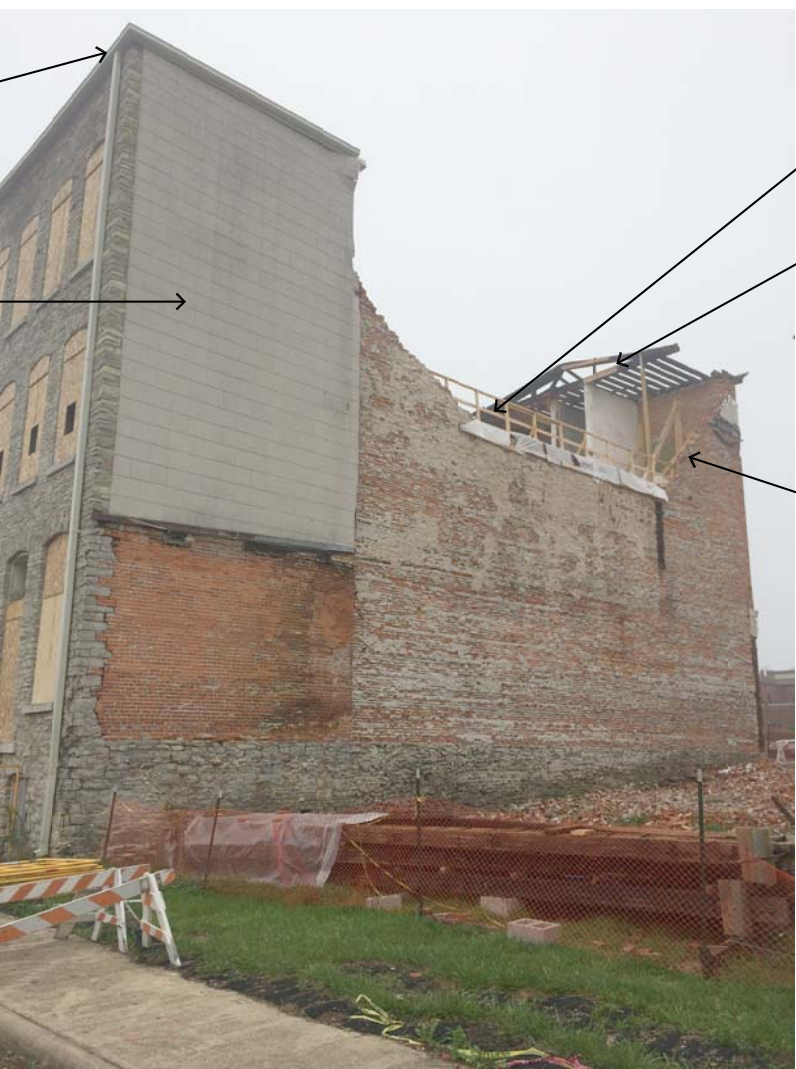
CURRENT CONDITION

TEMPORARY ROOF STABILIZATION MEASURES TO BE REMOVED
