Landmark Commission

**September 18th, 2019
4:30 P.M.
City Commission Chamber
AGENDA**

The Cooke Building Conditions and Project Summary

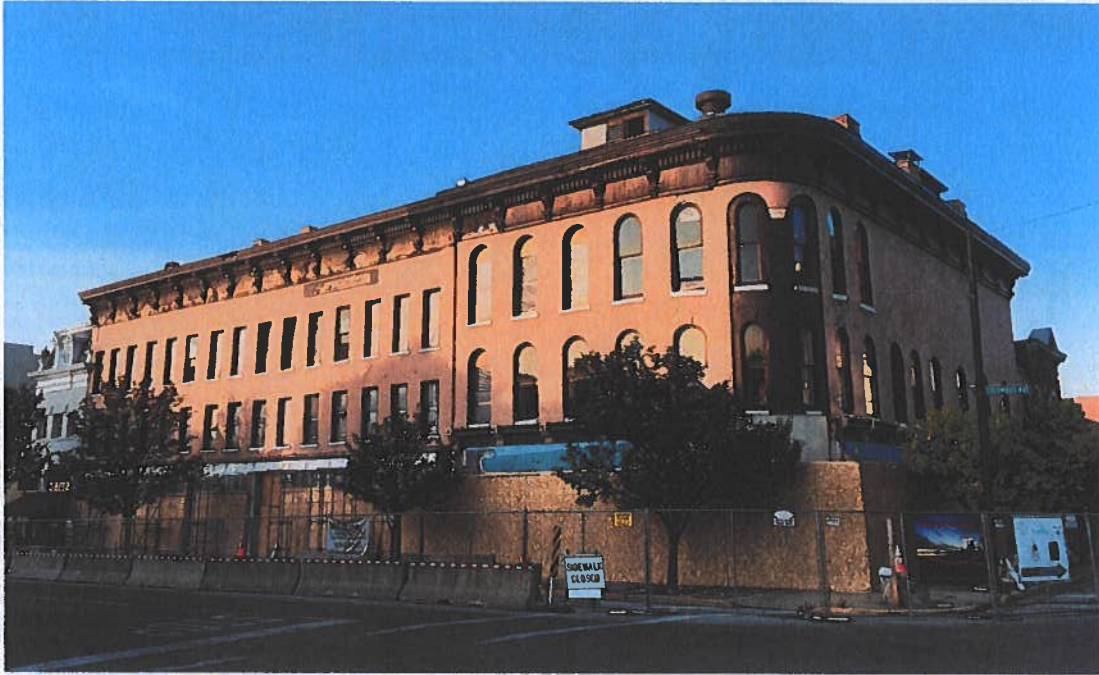
Cooke Building as of September 9, 2019

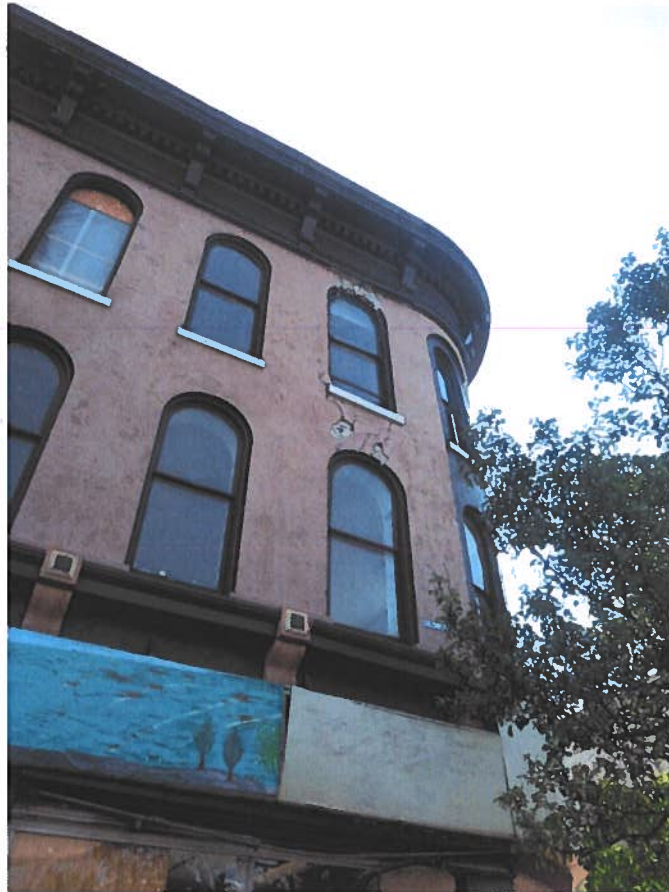
The masonry bearing walls are in various states of deterioration. Bricks and mortar are missing or have deteriorated throughout the structure. Some of the masonry has been deliberately removed to create chases

Failing Masonry

The exterior masonry walls are in poor structural condition. The complete extent of deterioration won't be identified until the stucco is removed. Extensive bracing and repairs will be required just from the observation that have be made. Replacement of large portions of the walls, if not total replacement, is anticipated.

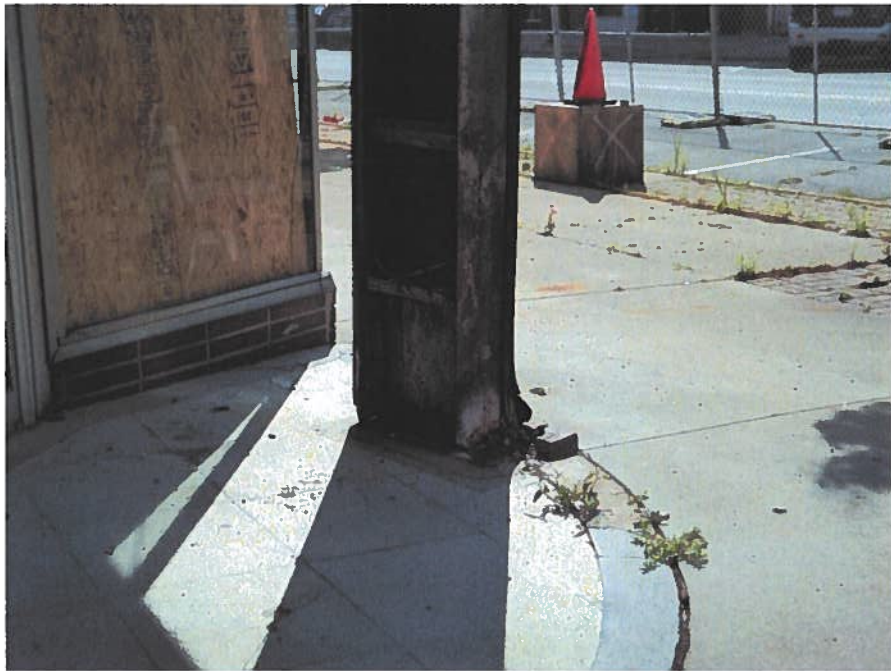
The corner building constructed in 1866 used steel and iron for some of the structural support. The beams over the first floor windows are steel and are supported at the corner by two steel columns. The columns were covered with a plywood box. During renovations, the plywood was removed. We were informed the corner of the building settled approximately 1½" over the lunch hour after the plywood was removed. The base of the columns have rusted and have failed. The base of one of the columns supporting the corner has shifted approximately 1" – 1½" off its base plate.

Failed Column

The steel columns at the corner of Columbus Ave. and Market St. have failed. New columns are required. The floors above will require jacking into place and may require replacement. We did not directly view the steel beams above the storefront windows. We anticipate they will also require replacement or reinforcement.

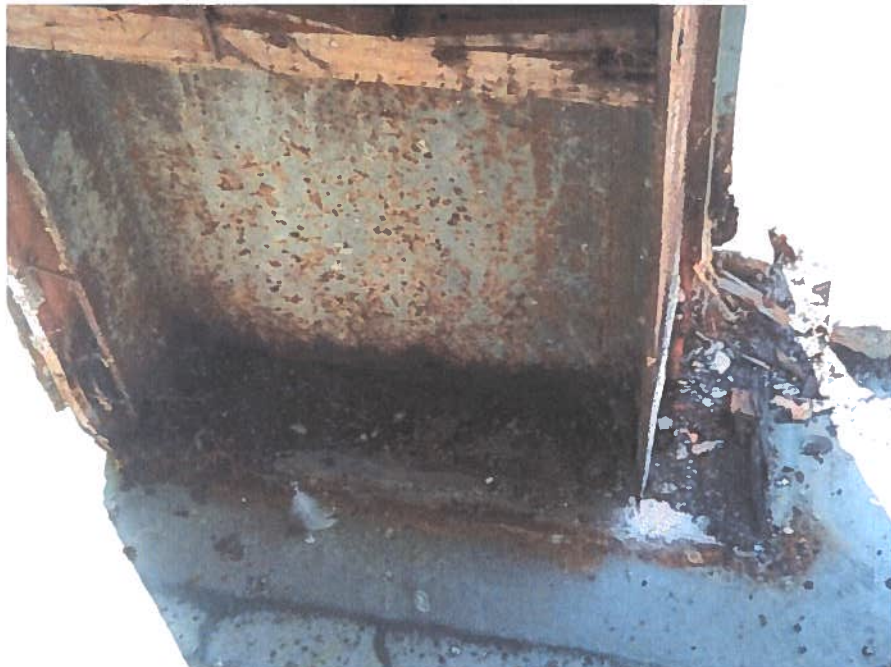
Failed Column Base

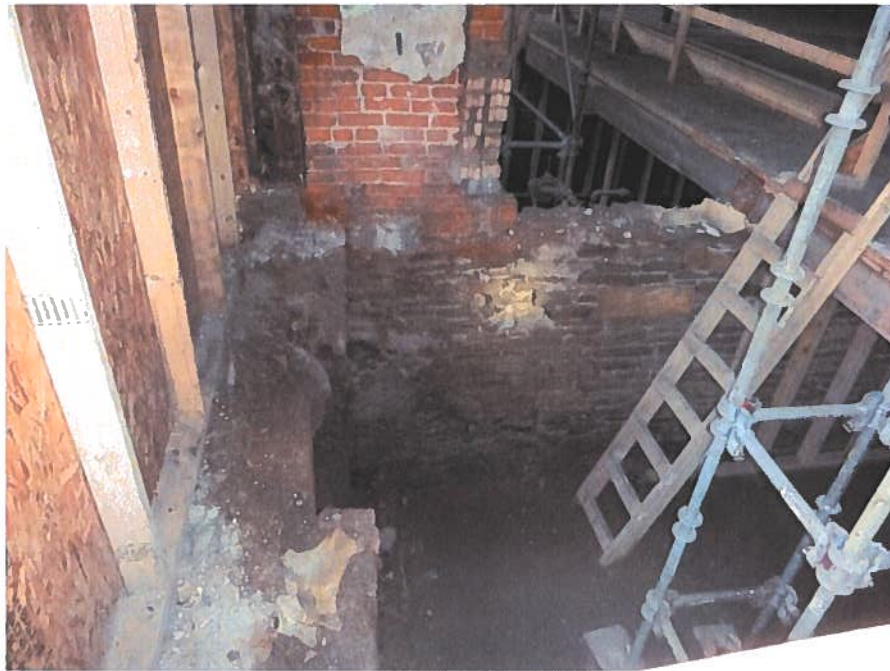
Failing Bearing Wall

The masonry bearing walls are failing or have already failed. The walls would require replacement, bracing, or supplemental framing to support any new floor and roof structures. The foundation and basement walls would require replacement, bracing, or reinforcing. One proposal has new concrete walls formed against the existing brick to support and stabilize the existing basement and foundation walls.

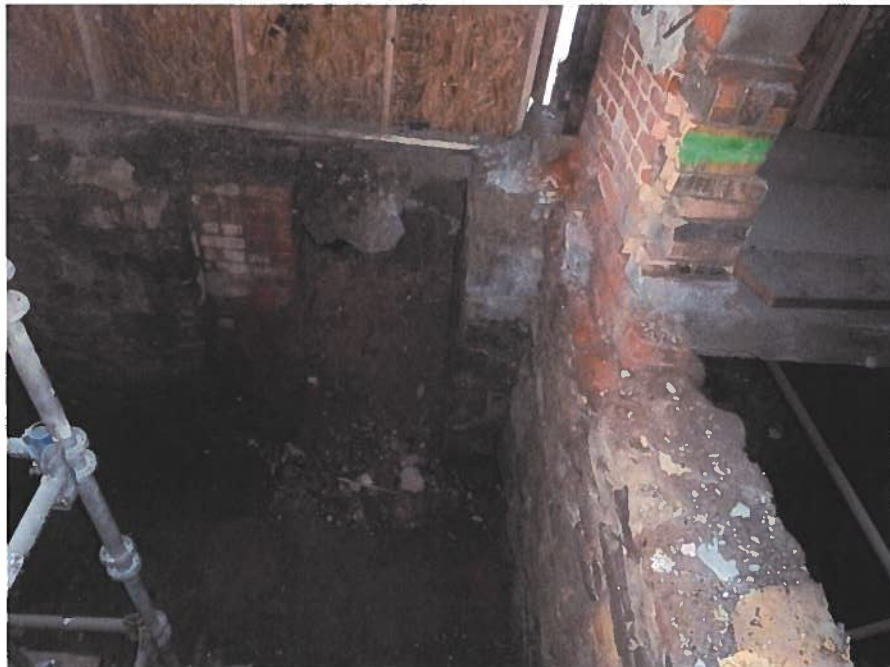
Most areas of the basement walls are deteriorating. The wall along Columbus Ave. has visible areas where the masonry has crumbled and fallen to the ground. The bearing walls supporting the first floor and upper levels are showing signs of deterioration and failure. The joist bearings are deteriorated as well as the masonry in general. Years of moisture and the lack of maintenance have contributed to the general deterioration.

Failing Basement Retaining Wall

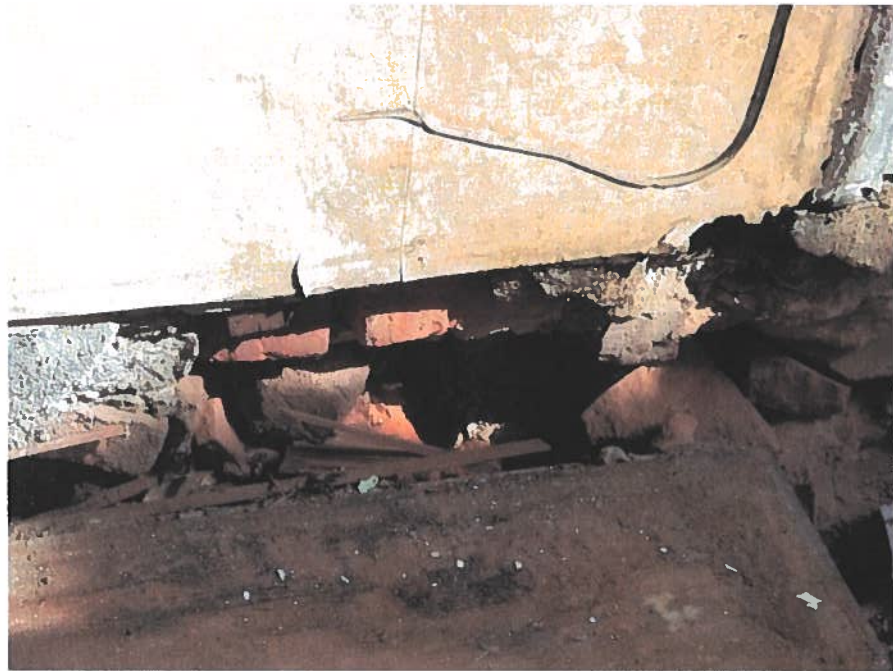
Failing Masonry Walls

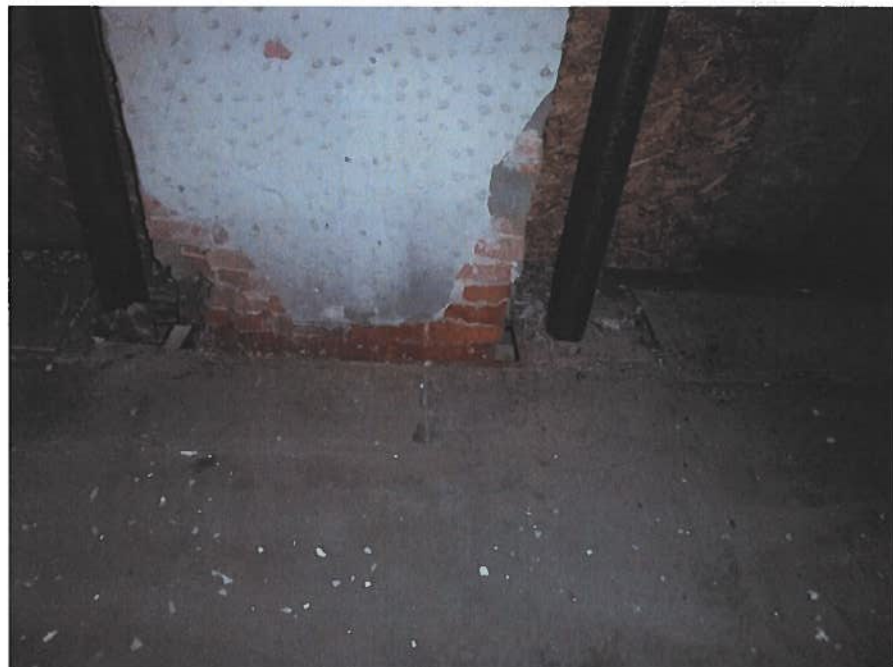
Deteriorating Masonry

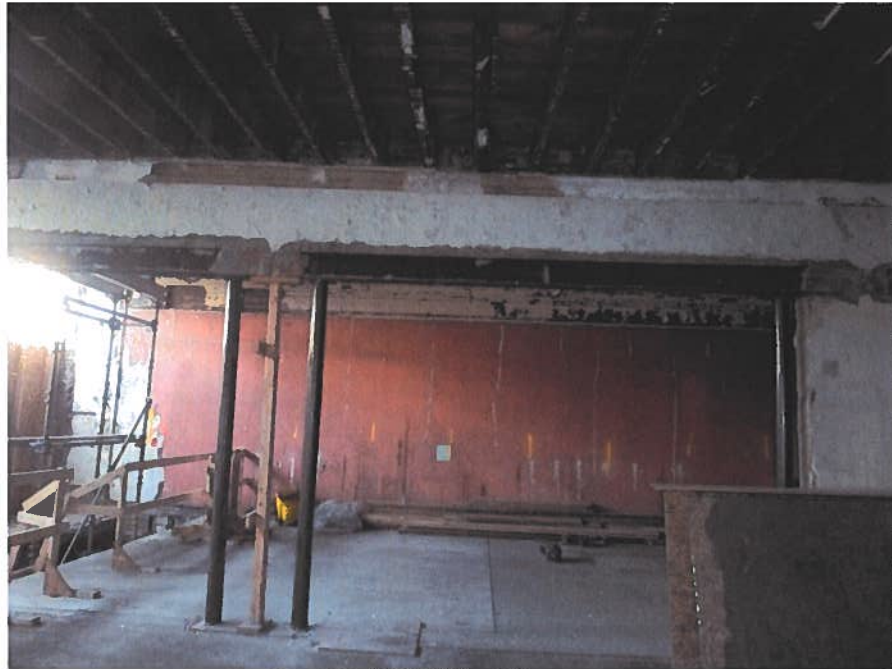
Removed Masonry Bearing Wall Location

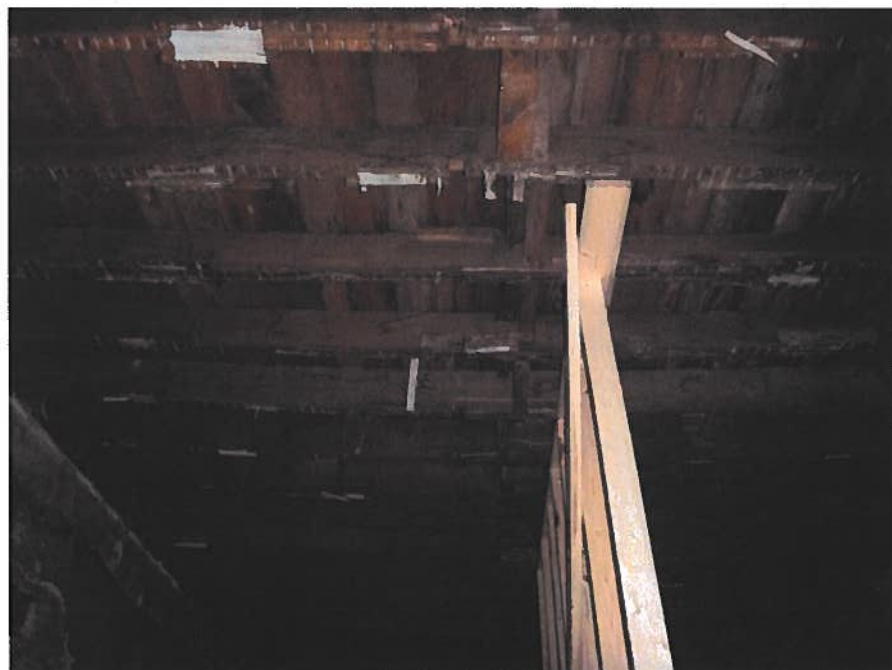
Temporary Floor Joist Support

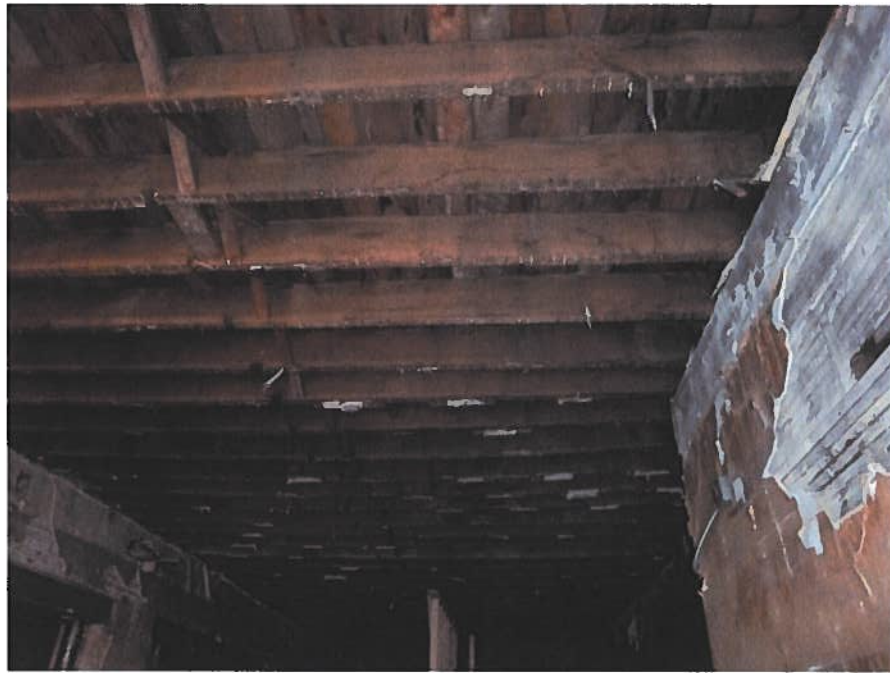
There are locations where the floor joists have failed or were notched on the bottom at the middle of the span and now are being temporarily supported by wood studs. There are locations where water damage has occurred from leaks over the years and damaged the joists. Many locations of failed joists on the first and second floors.

Notched Floor Joists

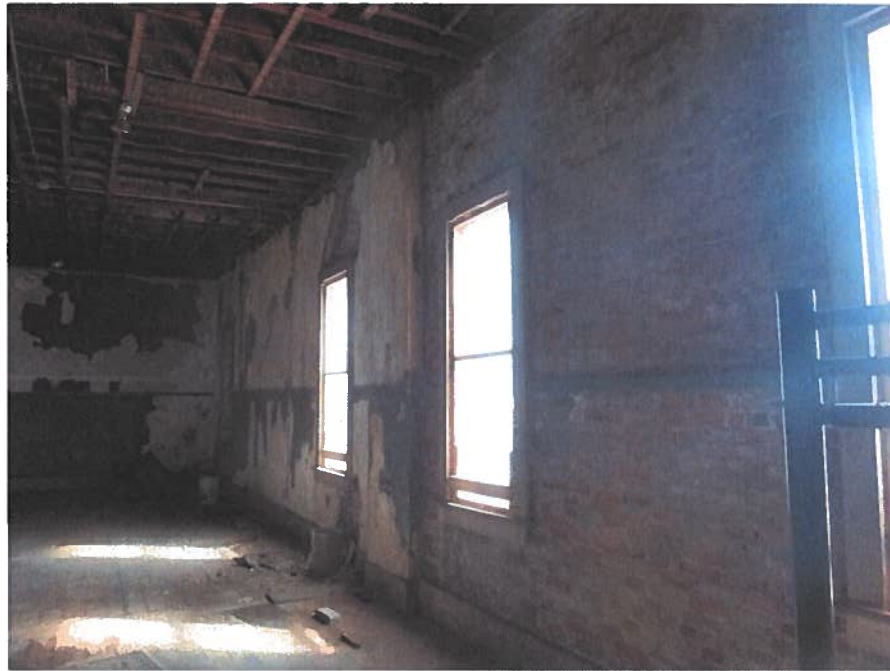
Deteriorating Masonry Wall

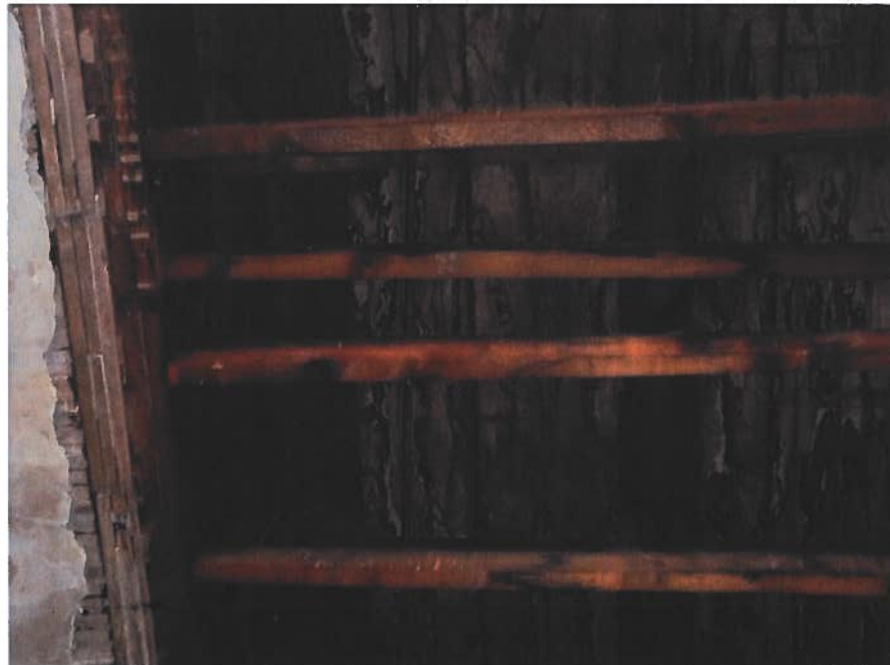
Water Damage to Roof Structure

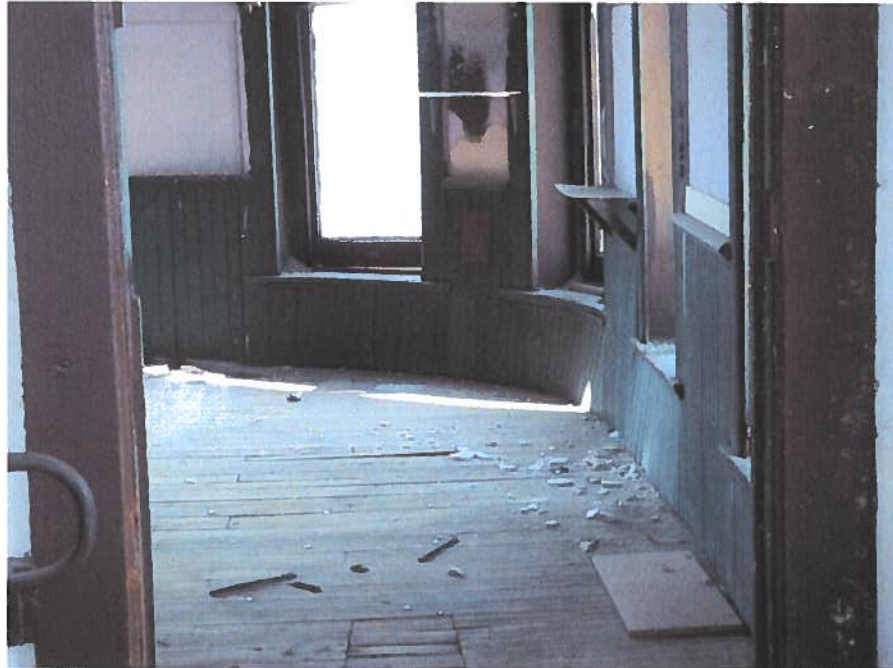
Buckling Wood Wall Slats

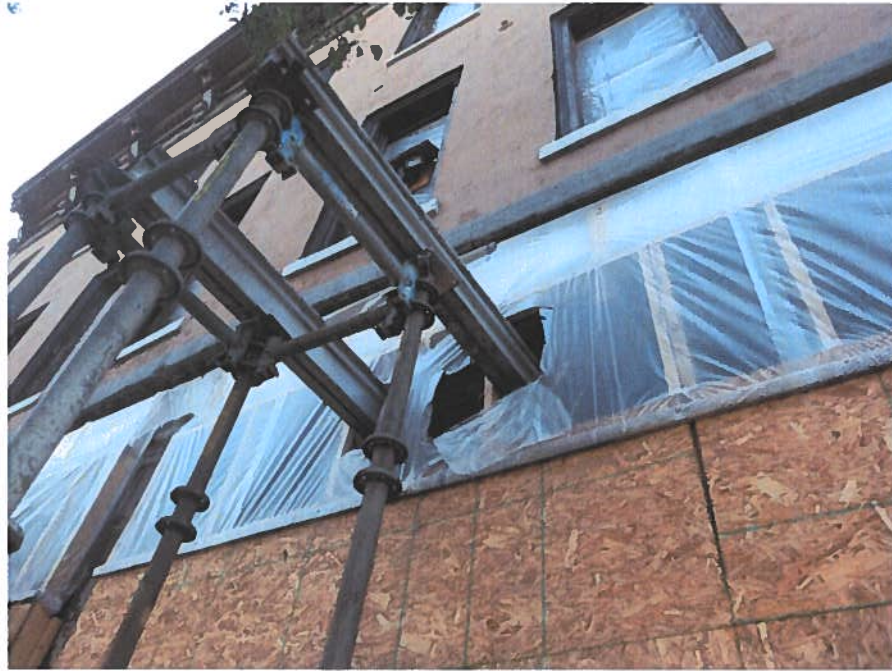
The original building constructed in 1850 was built with wood beams supporting the masonry walls above the storefront windows at the first floor. The beams are in various states of decay and are presently being supported with temporary shoring. The masonry walls above are exhibiting various signs of deterioration. The stucco is cracked and delaminating from the brick in some areas. Cracks through the stucco and probably through the brick walls are evident. The window frames on the first and second floors all appear to be deteriorating.

Temporary Wood Beam Support

The wood beams supporting the masonry walls above the first floor are deteriorating. The beams would require replacement. Supplemental support to remove the load from the masonry walls would be required.

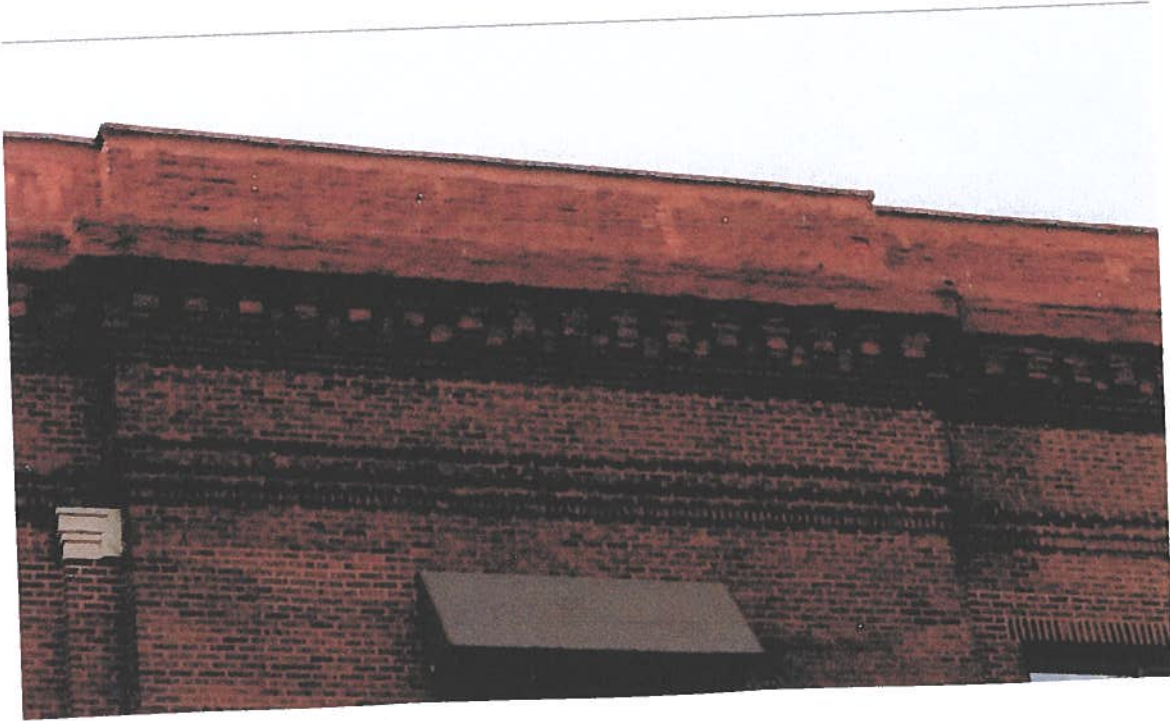
CURRENT CONDITION:

- Leakage into below units
- Loose bricks held with only a layer of foam surfacing.
- Support steel wet and deteriorating holding up the brick work in question.

Support steel needs the moisture to dry up to stop the deterioration and where the damage is severe surface cleaning of rust must be done and surface primed and sealed.

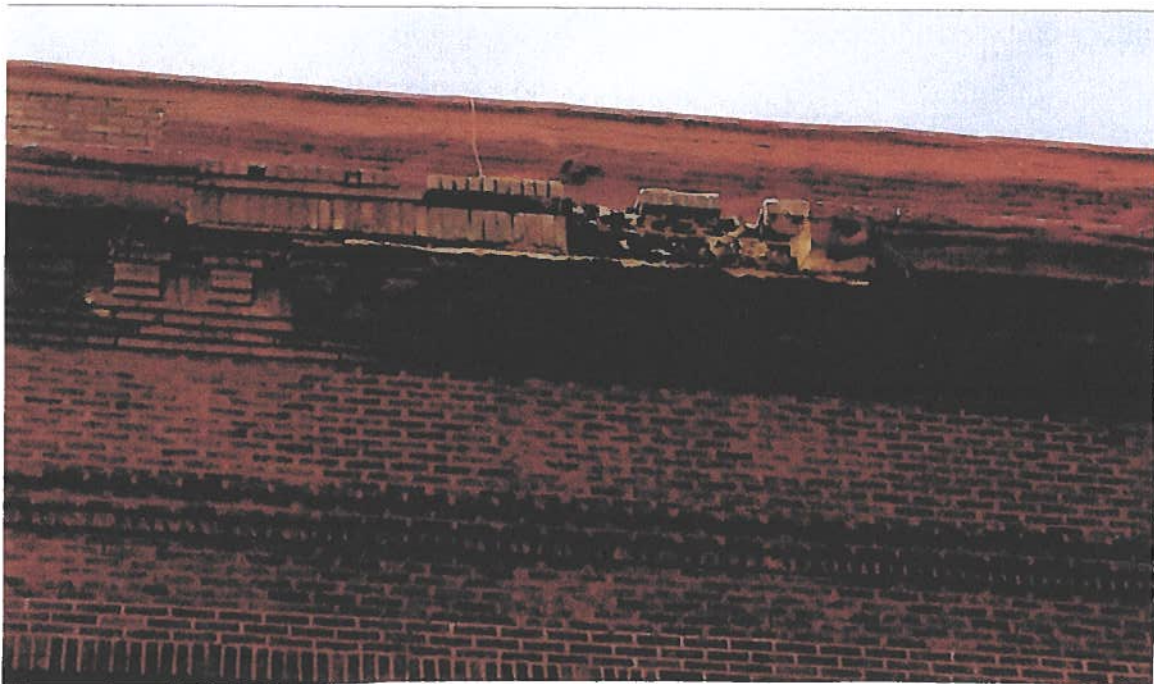
RECENT SECTION OF FOAM REMOVAL AND BRICK REPAIR:

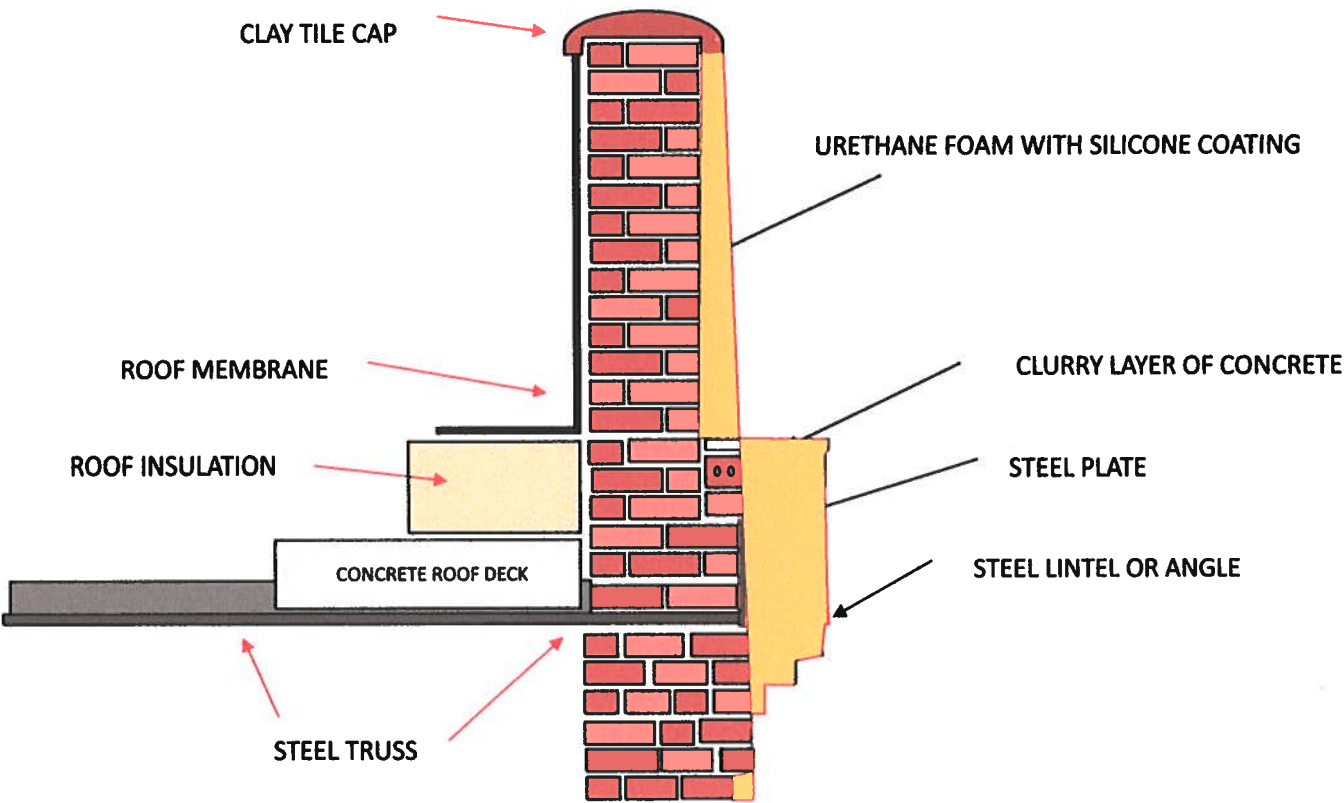
EXISTING CONDITION

The area of the building near the parapet is currently facing some structural issues that require attention before significant damage is caused. The applicant submitted building evaluation and scope of work summaries prepared by R.L. Seiler & Associates, a roofing firm based in Doylestown, Ohio. According to the report, there are three areas of concern: 1) Water leakage into residential units, 2) Loose bricks held together with only a layer of foam surfacing, and 3) The support steel holding up the brick work is deteriorating due to water damage.
