Semi-Annual Operations & Maintenance Report

**Rockwool Industries, Inc.
Federal Superfund Site
1741 Taylors Valley Road
Belton, Bell County, Texas**

**Texas Commission on
Environmental Quality**

August 15, 2011

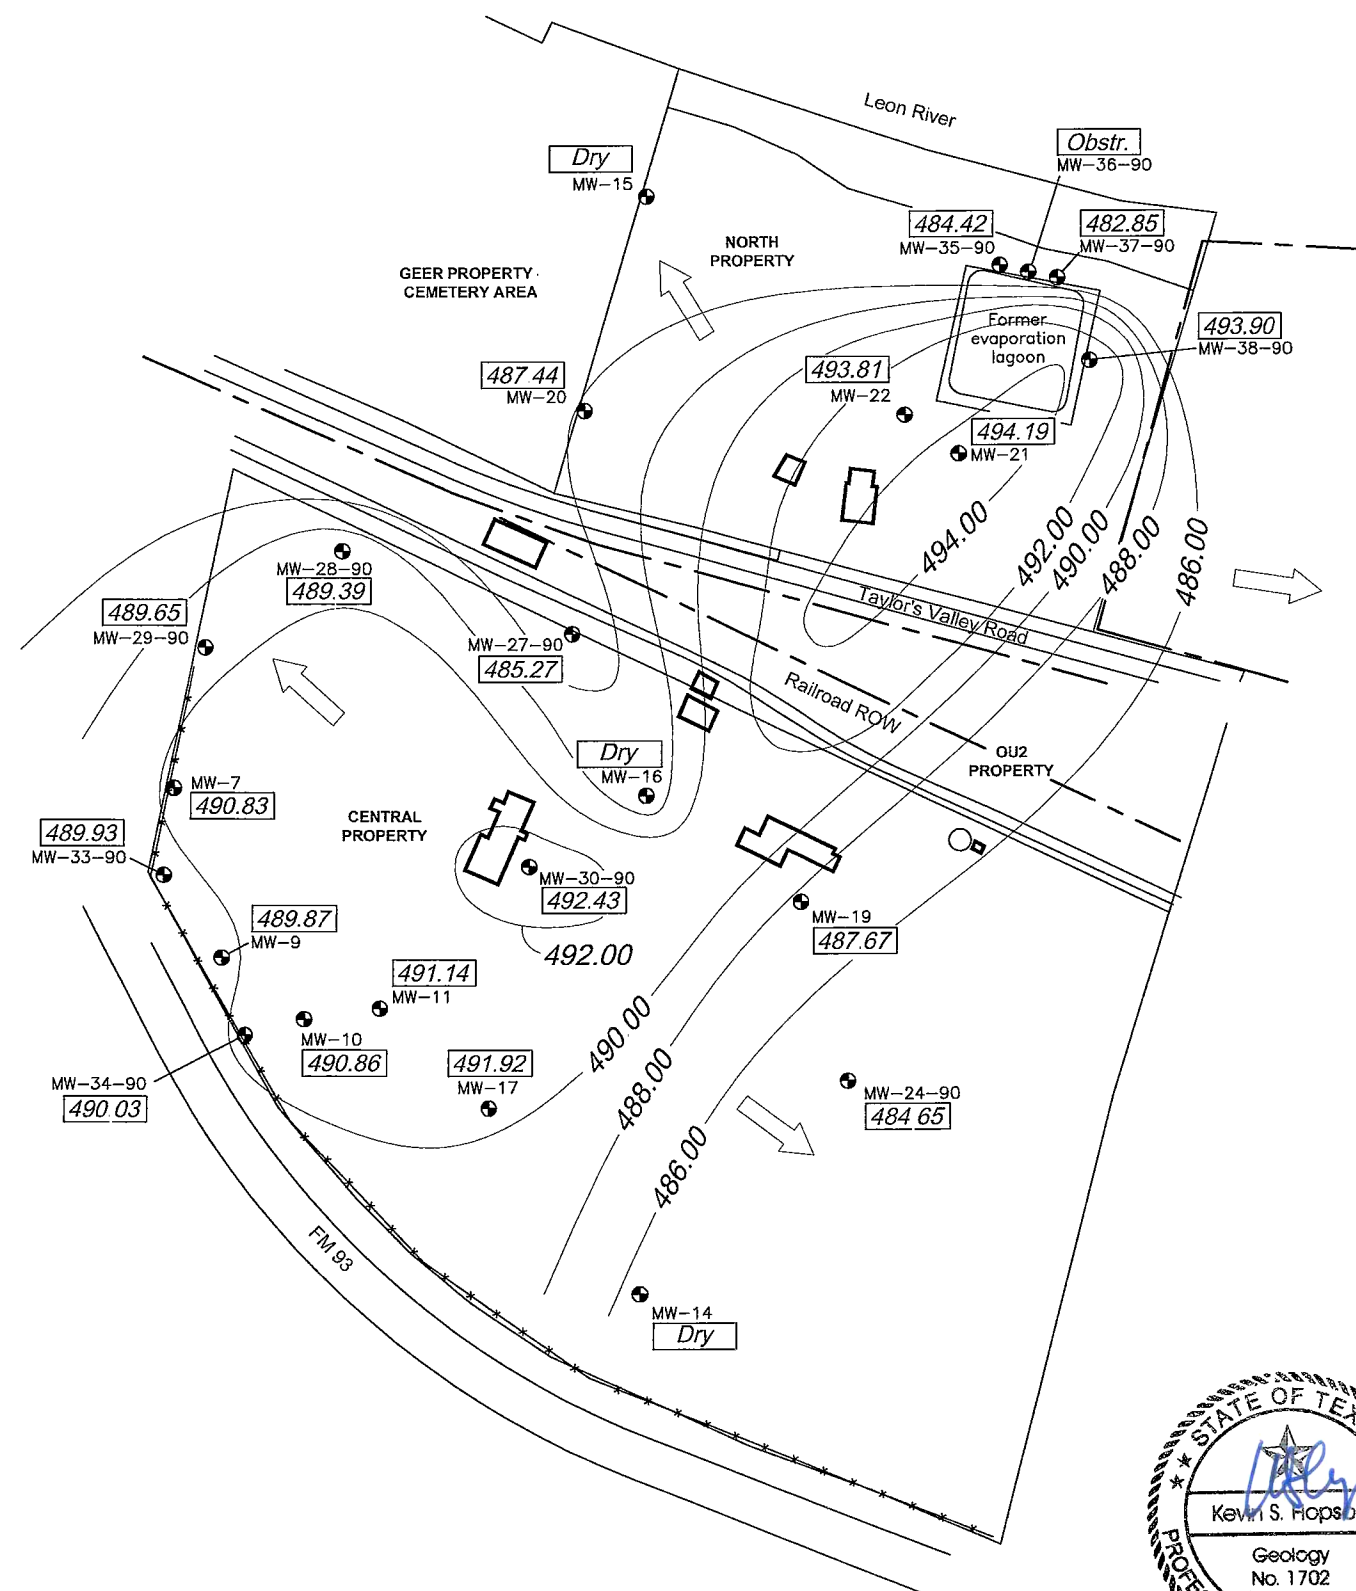
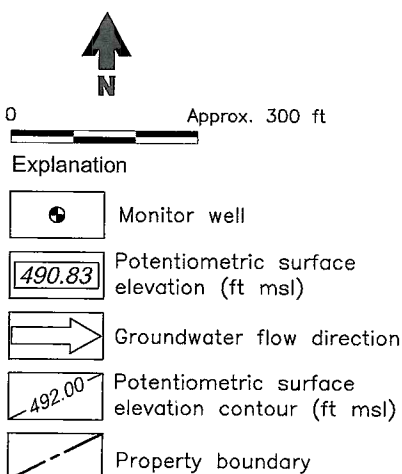
Figure 3

Rockwool Industries Superfund Site
1741 Taylor's Valley Rd
Belton, Texas
Potentiometric Surface Elevations
May 2, 2011

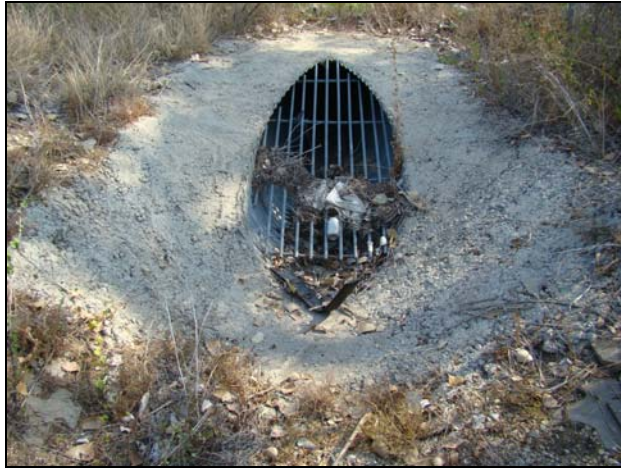
Photo #1
Date: August 2, 2011
Description: Looking South at Inlet of Drainage Culvert Located on the West Side of the Cemetery Property.

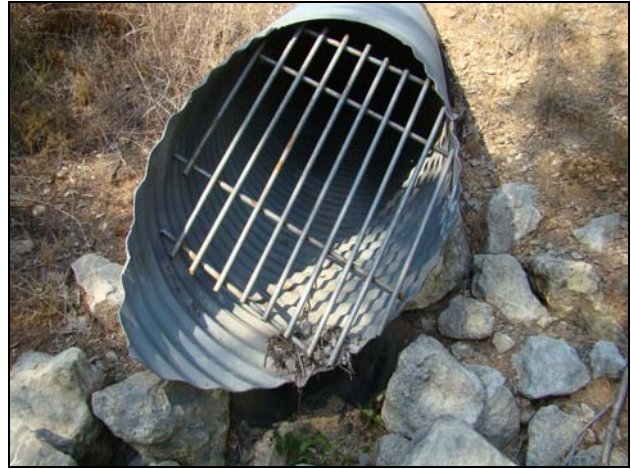
Photo #1
Date: August 2, 2011
Description: Looking South at Discharge of Drainage Culvert Located on the West Side of the Cemetery Property.

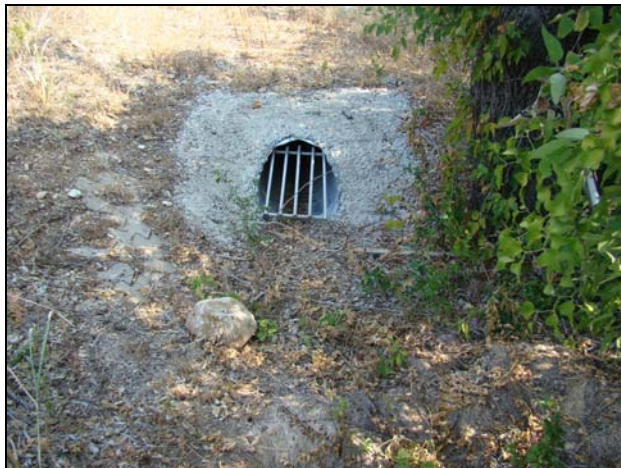
Photo #3
Date: August 2, 2011
Description: Looking South at Inlet of Drainage Culvert Located on the West Side of the Cemetery Property.

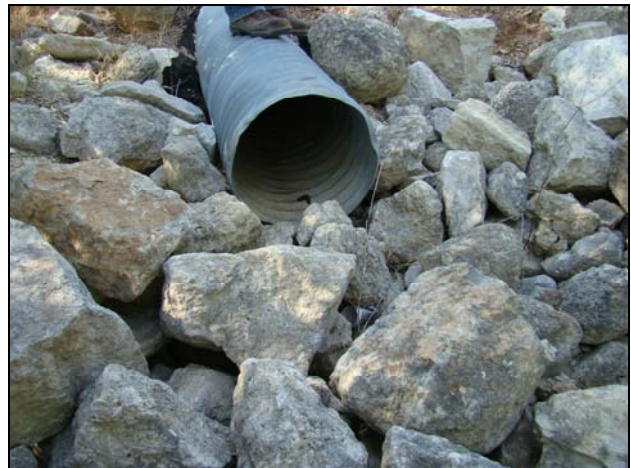
Photo #4
Date: August 2, 2011
Description: Looking South at Discharge of Drainage Culvert Located on the West Side of the Cemetery Property.

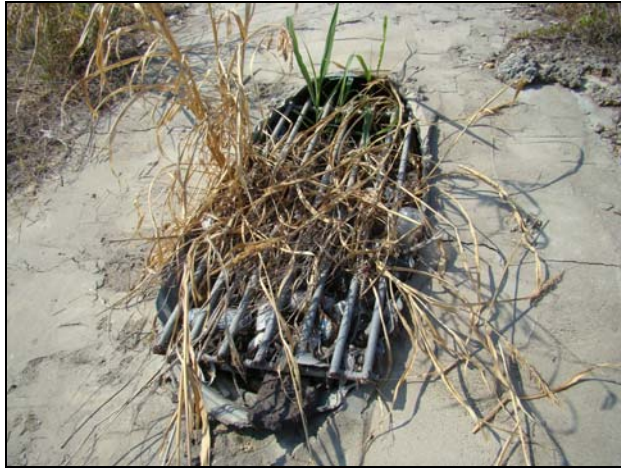
Photo #5
Date: August 2, 2011
Description: Looking South at Discharge of Drainage Culvert Located on the North Property Prior to Cleaning.

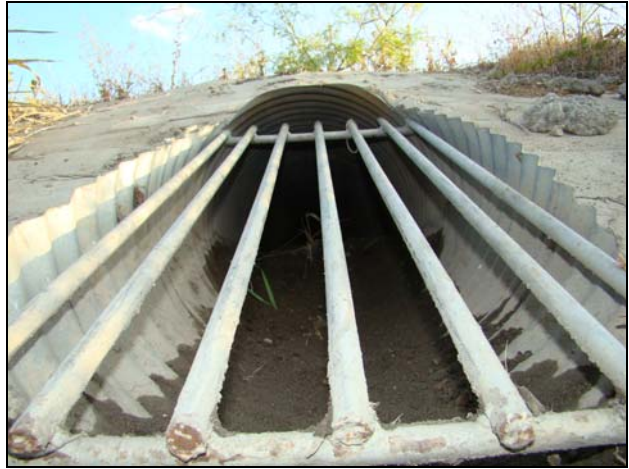
Photo #6
Date: August 2, 2011
Description: Looking South at Discharge of Drainage Culvert Located on the North Property After Cleaning.

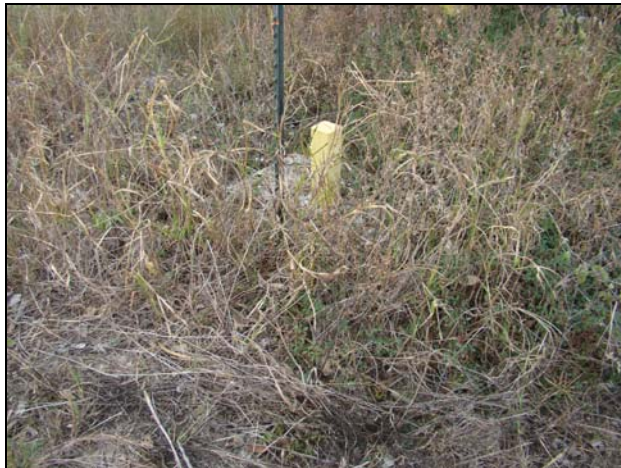
Photo #7
Date: November 23, 2010
Description: Looking Northeast at MW-16 on the Central Property Prior to Bollard Installation and Vegetation Removal.

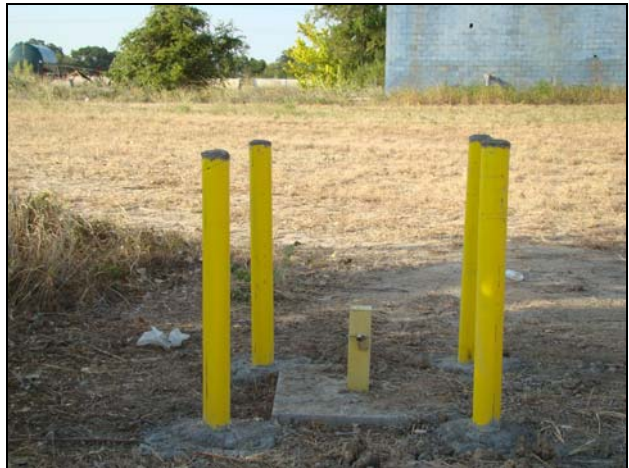
Photo #8
Date: August 3, 2011
Description: Looking North at MW-16 on the Central Property with Bollards Installed and Vegetation Removed.

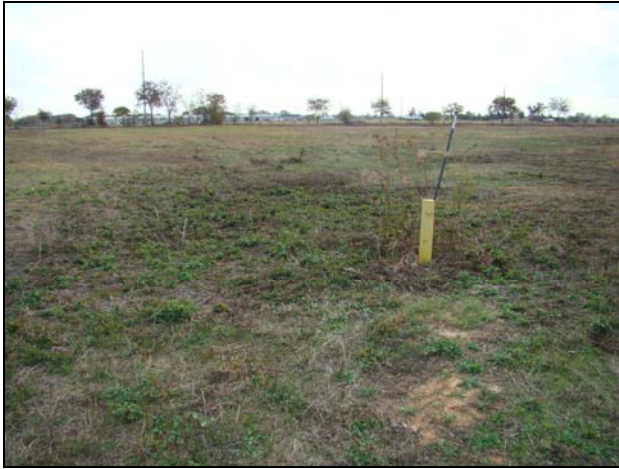
Photo #9
Date: November 23, 2010
Description: Looking East-Southeast at MW-24-90 on the Central Property Prior to Bollard Installation and Vegetation Removal.

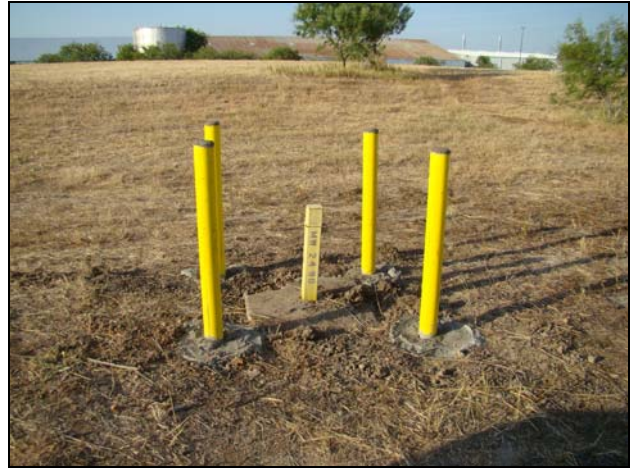
Photo #10
Date: August 3, 2011
Description: Looking North at MW-24-90 on the Central Property with Bollards Installed and Vegetation Removed.

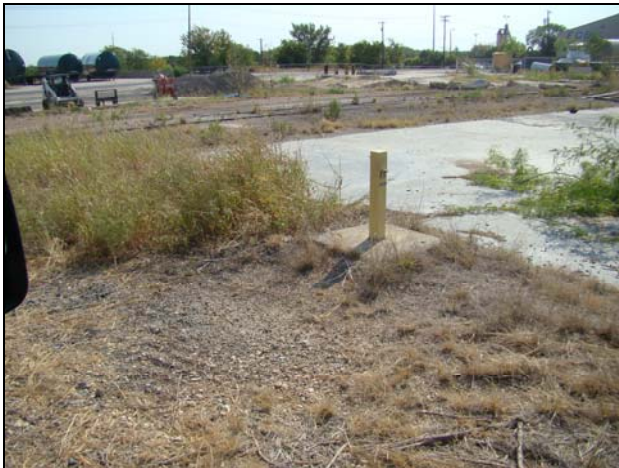
Photo #11
Date: August 3, 2011
Description: Looking Northeast at MW-27-90 on the Central Property Prior to Bollard Installation and Vegetation Removal.

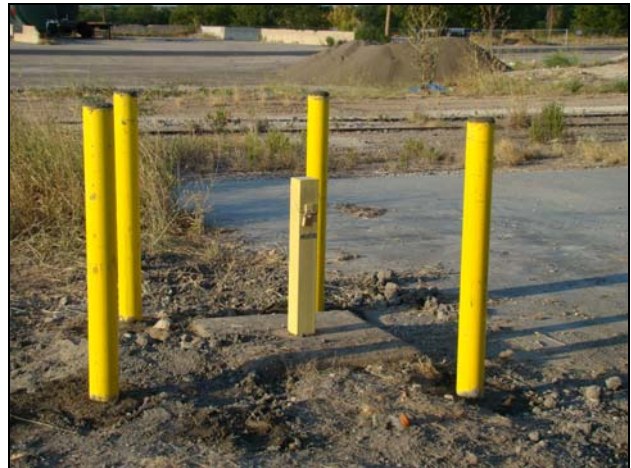
Photo #12
Date: August 3, 2011
Description: Looking Northeast at MW-27-90 on the Central Property with Bollards Installed and Vegetation Removed.

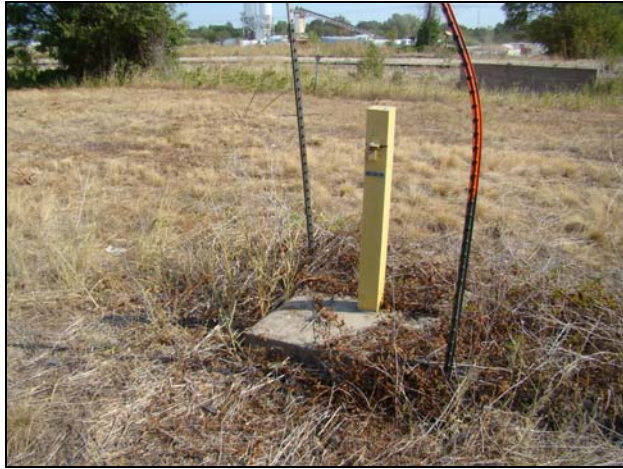
Photo #13
Date: August 3, 2011
Description: Looking Northwest at MW-28-90 on the Central Property Prior to Bollard Installation and Vegetation Removal.

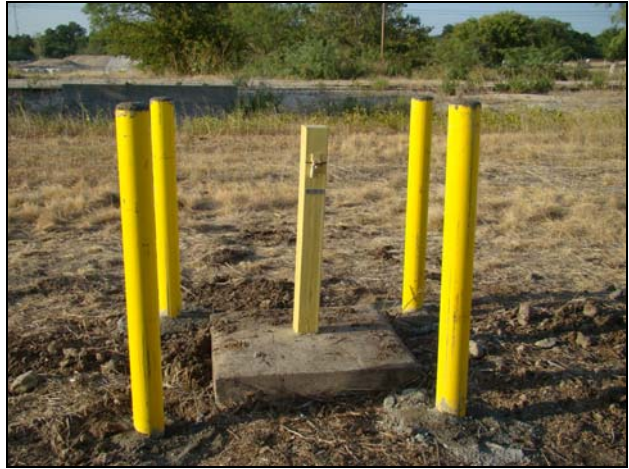
Photo #14
Date: August 3, 2011
Description: Looking North at MW-28-90 on the Central Property with Bollards Installed and Vegetation Removed.

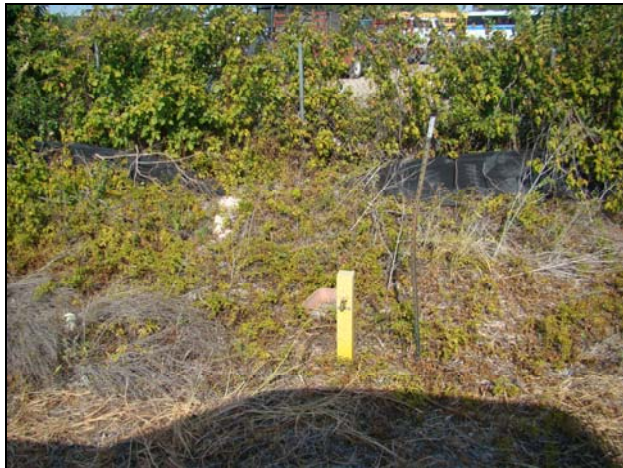
Photo #15
Date: August 3, 2011
Description: Looking West at MW-29-90 on the Central Property Prior to Bollard Installation and Vegetation Removal.

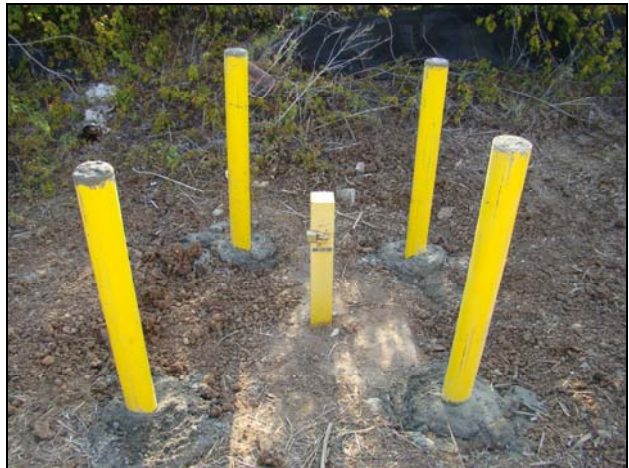
Photo #16
Date: August 3, 2011
Description: Looking West at MW-29-90 on the Central Property with Bollards Installed and Vegetation Removed.

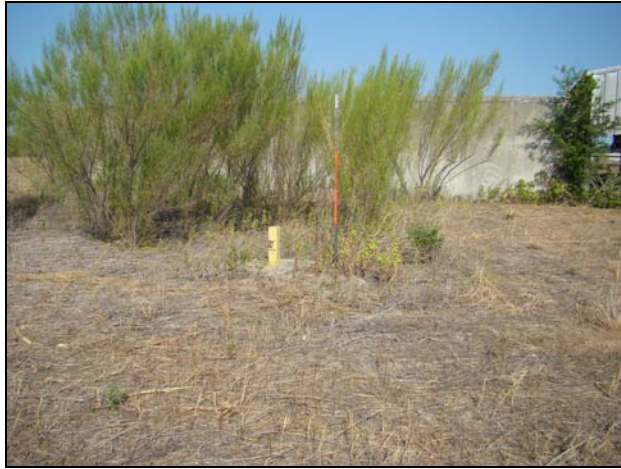
Photo #17
Date: August 3, 2011
Description: Looking West at MW-30-90 on the Central Property Prior to Bollard Installation and Vegetation Removal.

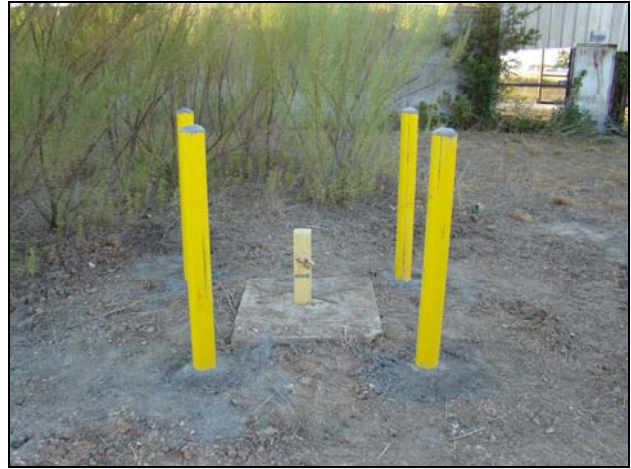
Photo #18
Date: August 3, 2011
Description: Looking West at MW-30-90 on the Central Property with Bollards Installed and Vegetation Removed.

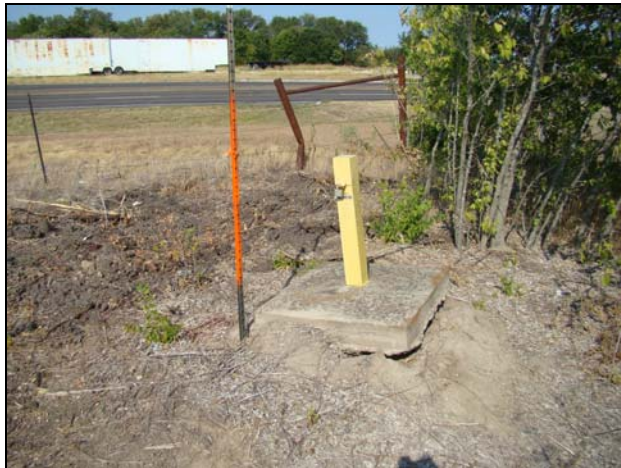
Photo #19
Date: August 3, 2011
Description: Looking Southwest at MW-33-90 on the Central Property prior to Bollard Installation and Vegetation Removal.

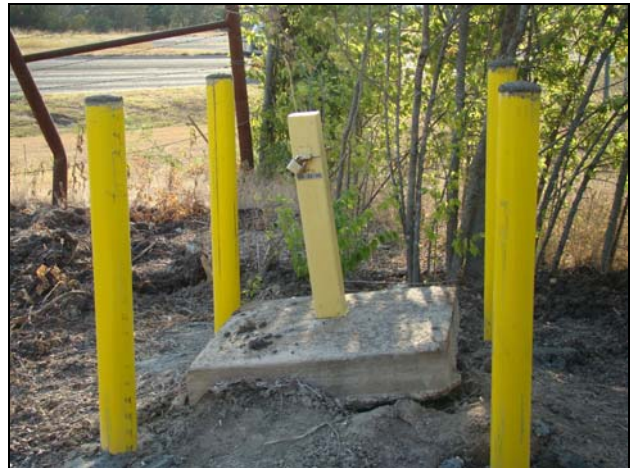
Photo #20
Date: August 3, 2011
Description: Looking Southwest at MW-33-90 on the Central Property with Bollards Installed and Vegetation Removed.

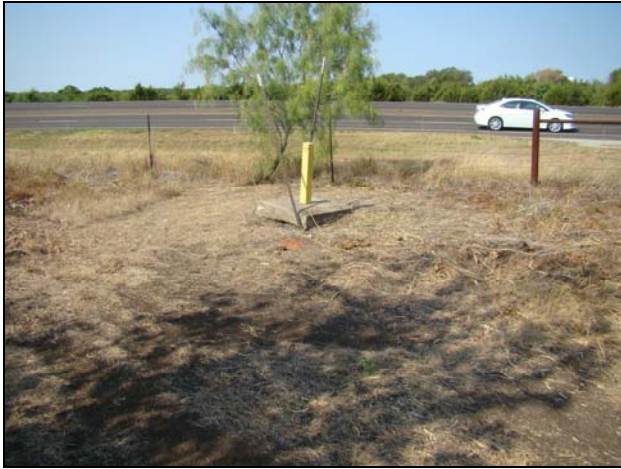
Photo #21
Date: August 3, 2011
Description: Looking South at MW-34-90 on the Central Property Prior to Bollard Installation and Vegetation Removal.

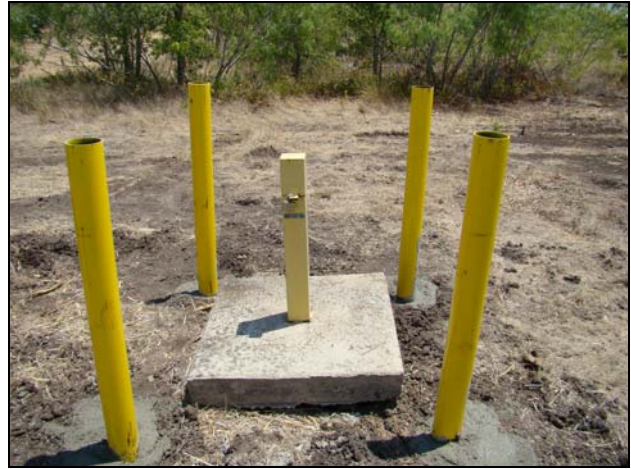
Photo #22
Date: August 3, 2011
Description: Looking Northeast at MW-34-90 on the Central Property with Bollards Installed and Vegetation Removed.

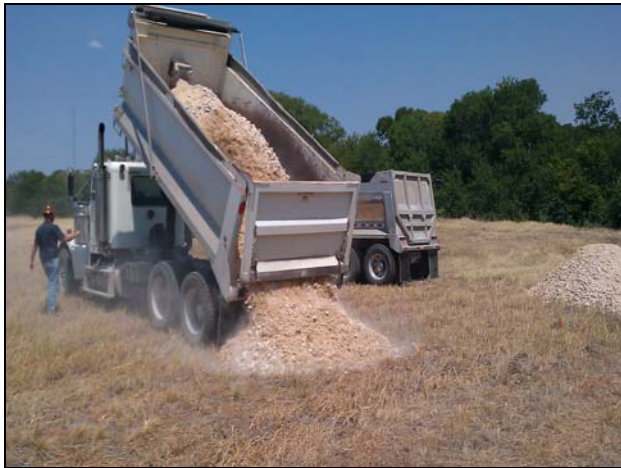
Photo #23
Date: August 3, 2011
Description: Looking Northwest at North Property Coarse Gravel Installation for Runoff and Erosion Control.

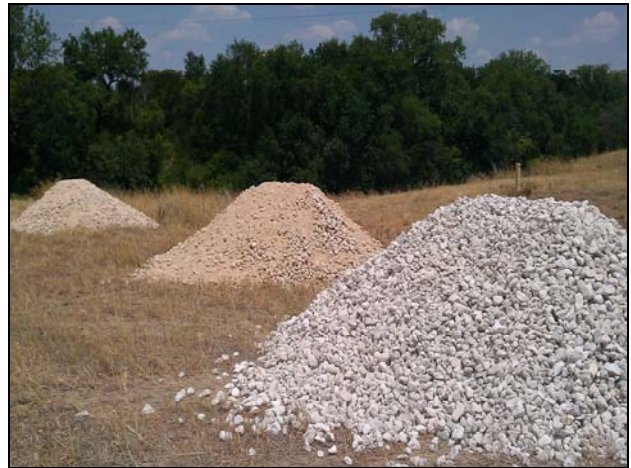
Photo #24
Date: August 3, 2011
Description: Looking Northeast at North Property Coarse Gravel Installation for Runoff and Erosion Control.

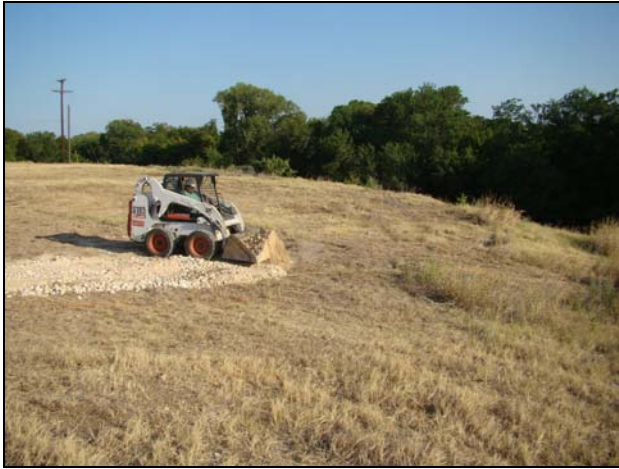
Photo #25
Date: August 3, 2011
Description: Looking Northwest at North Property Coarse Gravel Installation for Runoff and Erosion Control.

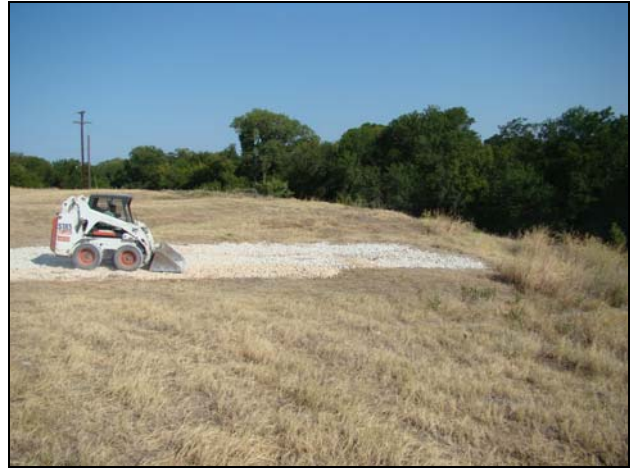
Photo #26
Date: August 3, 2011
Description: Looking Northwest at North Property Coarse Gravel Installation for Runoff and Erosion Control.

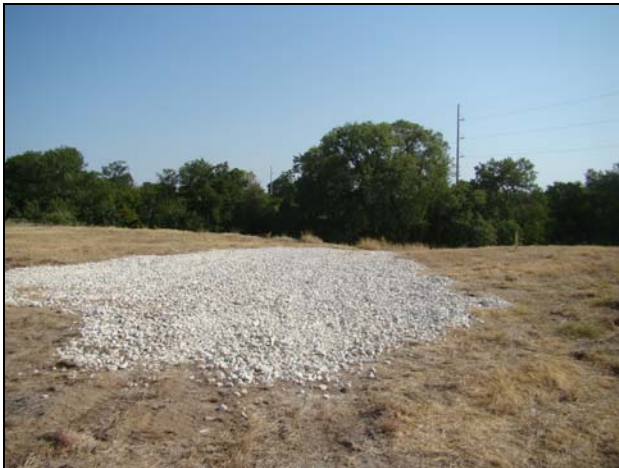
Photo #27
Date: August 3, 2011
Description: Looking North at North Property Coarse Gravel Installation for Runoff and Erosion Control.

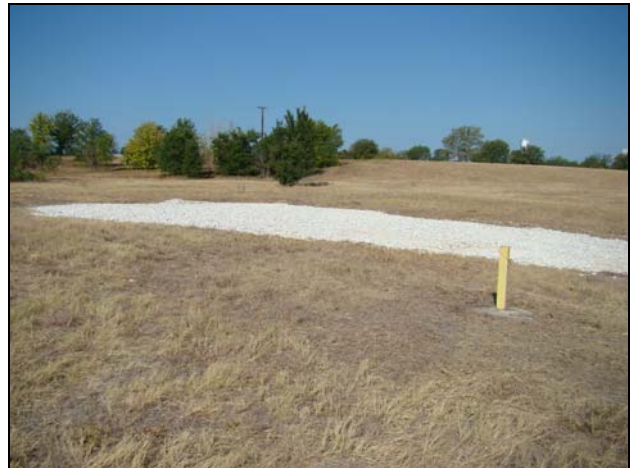
Photo #28
Date: August 3, 2011
Description: Looking Southwest at North Property Coarse Gravel Installation for Runoff and Erosion Control.

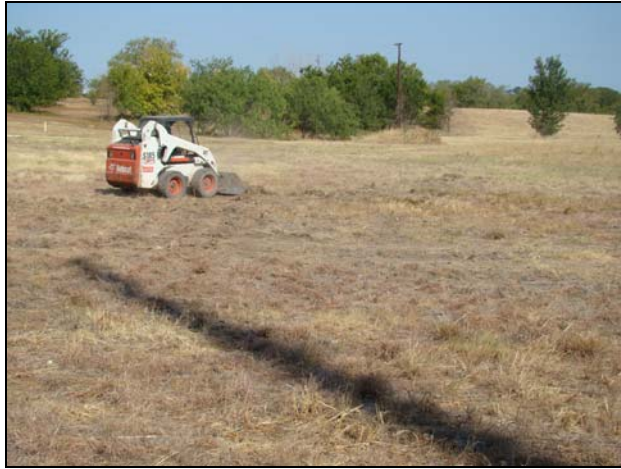
Photo #29
Date: August 3, 2011
Description: Looking West at North Property
Soil Cover Furrow Repair.

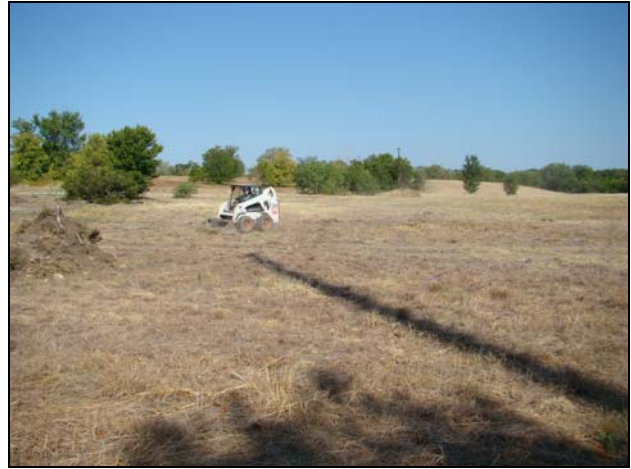
Photo #30
Date: August 3, 2011
Description: Looking West at North Property
Soil Cover Furrow Repair.

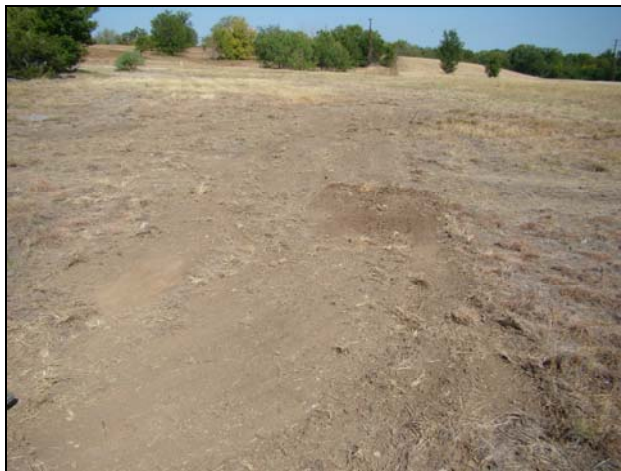
Photo #31
Date: August 3, 2011
Description: Looking Northwest at North
Property Repaired Soil Cover Furrows.

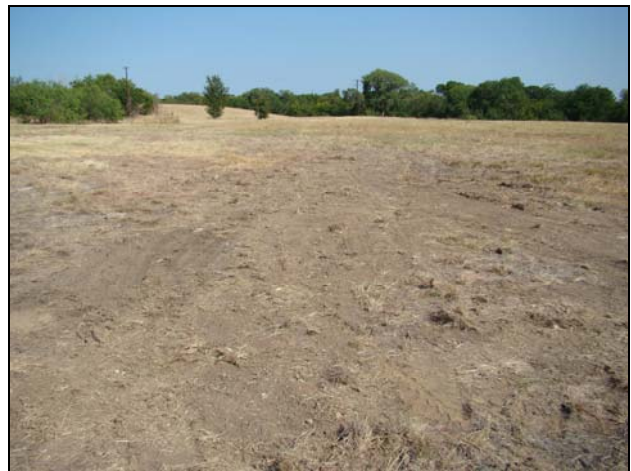
Photo #32
Date: August 3, 2011
Description: Looking Northwest at North
Property Repaired Soil Cover Furrows.

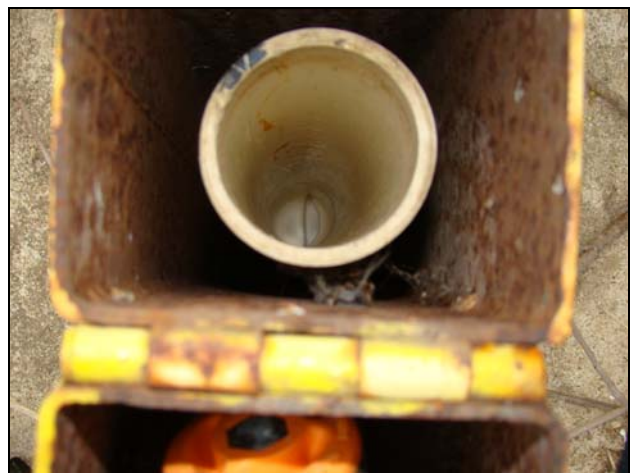
Photo #16
 Date: May 2, 2011
 Description: Looking at Obstruction Located Inside Well Casing at MW-36-90 on the North Property.
