History of the Existing Building

ST. MICHAEL'S PAROCHIAL SCHOOL AND AUDITORIUM

Existing Building

Characteristics of Existing Building

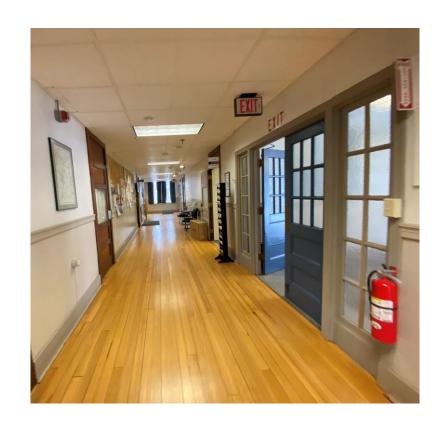
- Three Stories
- 20,070 SF
- Brick exterior with Flat EPDM Roof
- Has two stair towers and elevator
- Renovated School so Large Rooms & Hallways
- Load Bearing Interior Walls (many will need to remain)

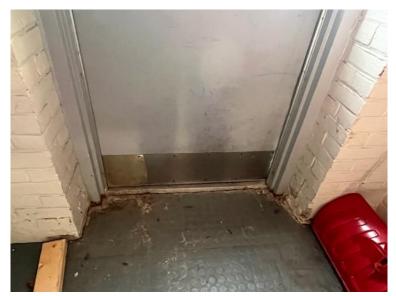
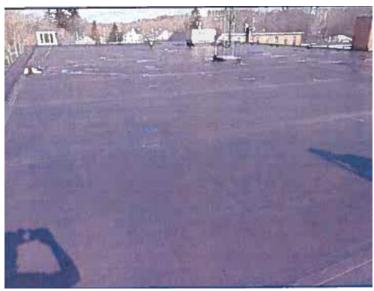
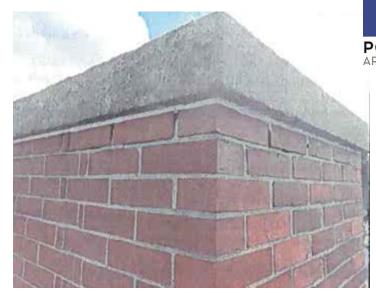
Existing Building – Exterior Façade & Shell

Item: Insulation

There is little to none insulation at the exterior walls

Item: EPDM Roof

EPDM has a 30-year life expectancy, however yours is showing significant wear & tear

Item: Brick

Needs to be repointed in multiple places

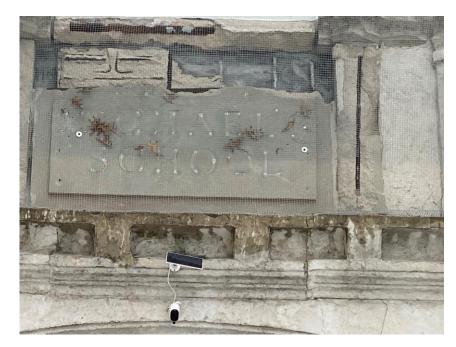
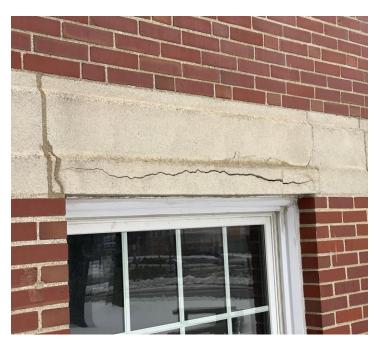
Existing Building – Exterior Façade & Shell

Item: Precast Concrete

The precast concrete is crumbling and needs to be repaired ASAP

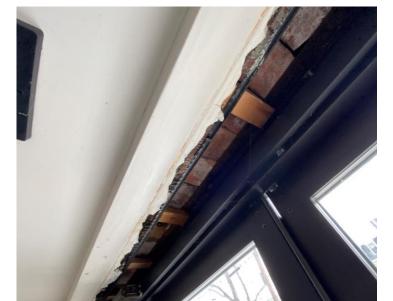
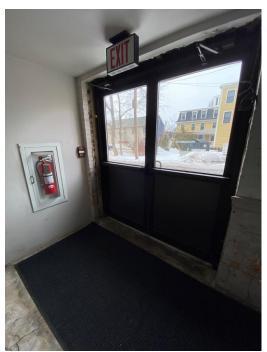
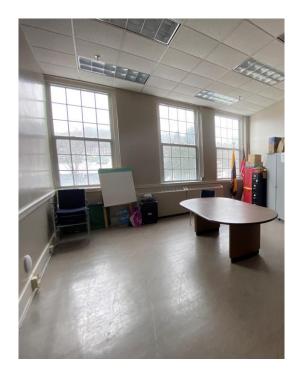
Existing Building – Exterior Doors & Windows

Item: Existing Exterior Doors & Windows

The exterior doors & windows are in bad shape and need to be replaced and trimmed out properly

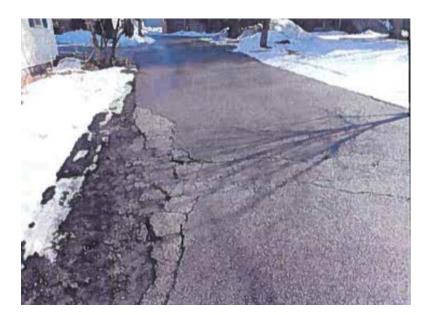
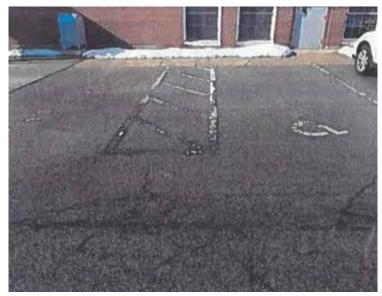
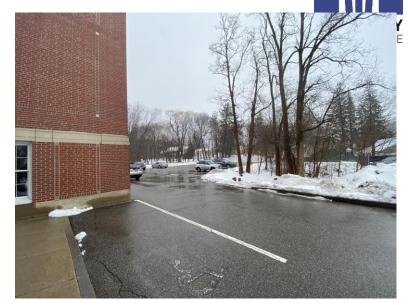
Existing Building – Sidewalks & Parking Lot

Item: Parking Lot

Action: The parking lot is showing sign of wear and needs to be restriped – the walk to the ADA spaces needs to be tilted down to meet ADA code

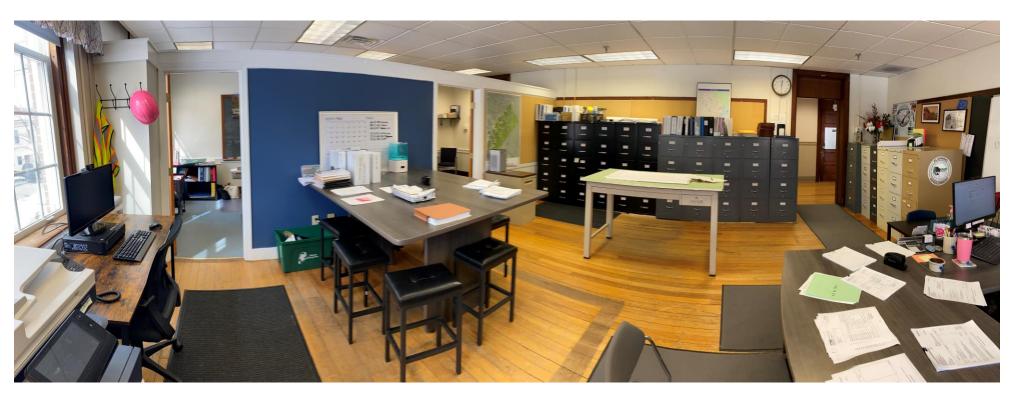
Item: Land Use

There is no counter and the public can wander through out the space

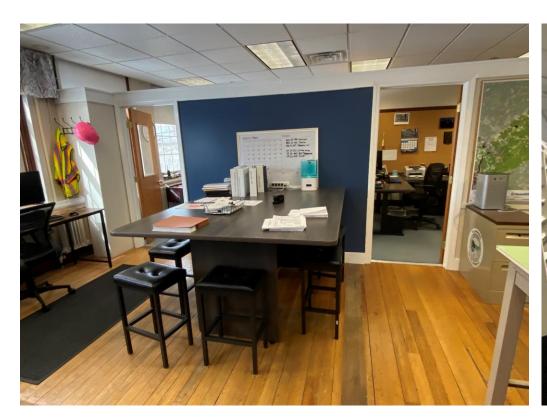
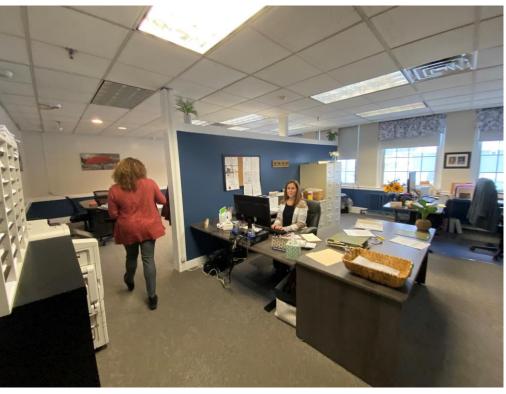
Item: Rooms

Rooms are large & not properly sized & do not have proper walls

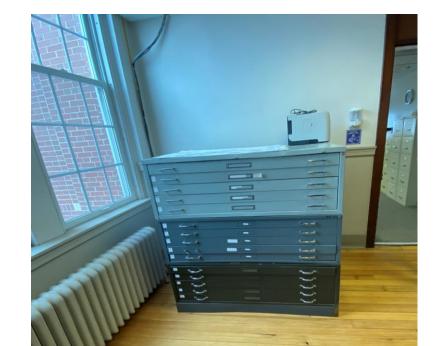
Due to lack of secure space, things are stored in the unsecured areas

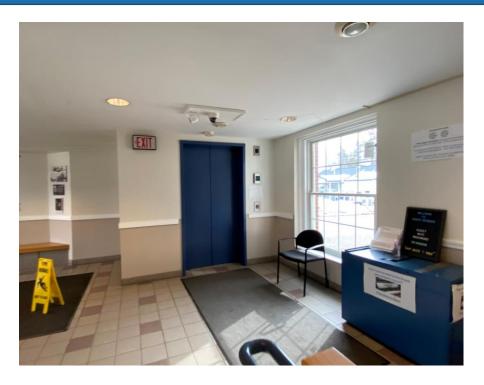
Item: Entry

Lack of monitoring at entry doors by human or monitored cameras

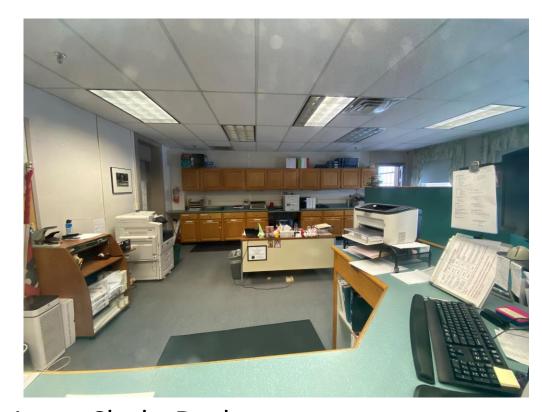
Item: Clerks Desk

Service desks is not ergonomic

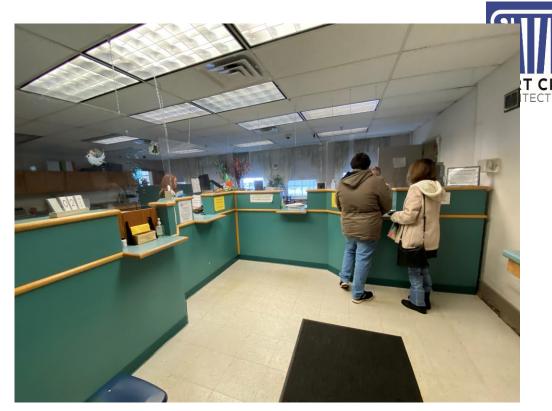
Item: Clerk Queuing

There is no queuing space

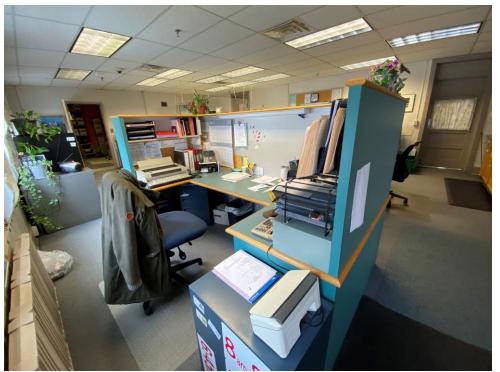
Item: Clerks Desk

The built in Clerk's desk is not adequate

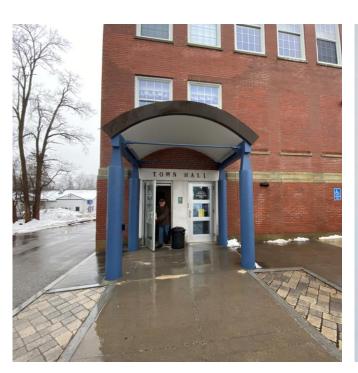
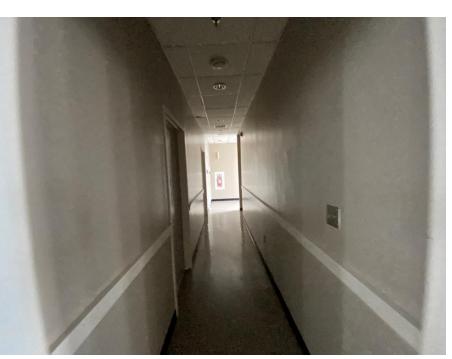
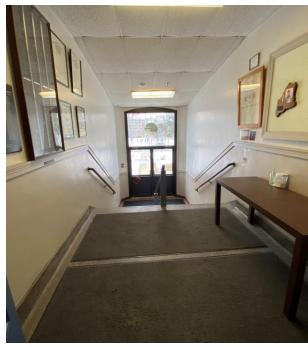
Existing Building – Way Finding

Item: Wayfinding

There are multiple entry doors and it is hard to find your way in building – there are multiple isolated rooms – this can cause confusion and be dangerous

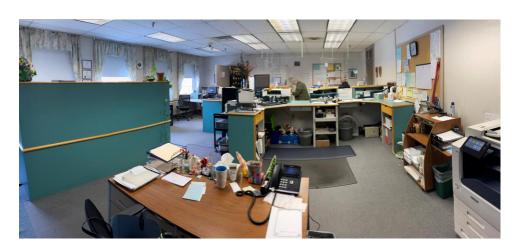
Existing Building – Fire, Health, & ADA Code Issues

Item: ADA Counters / Sinks

There are no ADA counters / sinks throughout the entire facility – these need to be replaced with ADA appropriate fixtures

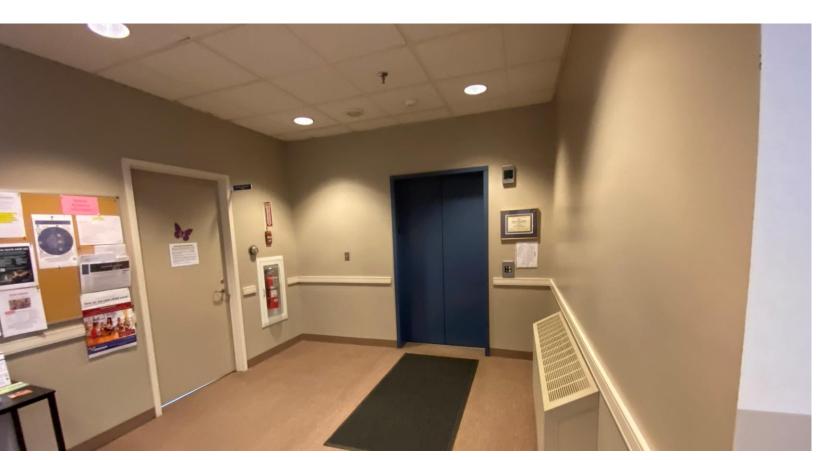
Existing Building – Fire, Health, & ADA Code Issues

Item: Elevator

At the last Elevator inspection, it was noted that the elevator will require major repair / replacement in the next few years due to age

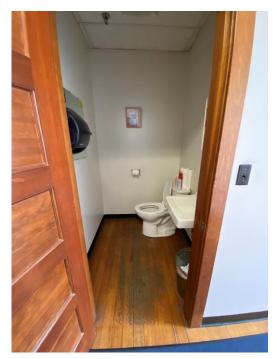
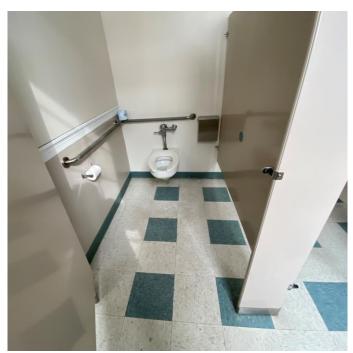
Existing Building – Fire & ADA Code Issues

Item: ADA Bathrooms

None of the existing bathrooms meet current ADA codes and need major renovations

Item: ADA Signage

There is no ADA signage in the building & this should be provided

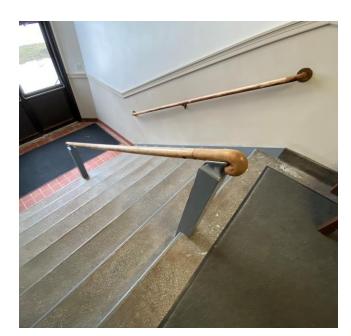
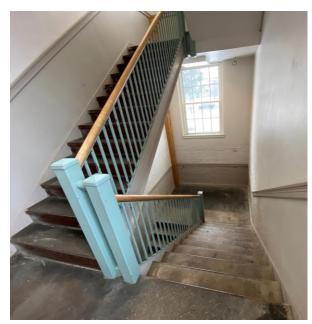
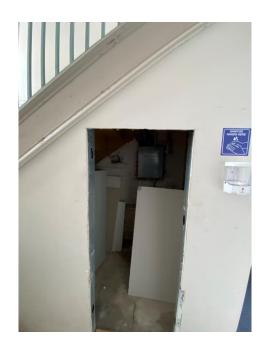
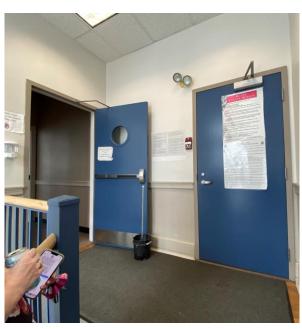
Existing Building – Fire & ADA Code Issues

Item: Stairwell Code Issues

Current stairwells do not meet current codes including: improper handrails; an electrical panels in the stairwell; the stair treads are too narrow; fire doors do not have magnetic hold openers; and guardrails that are too low with wide balusters

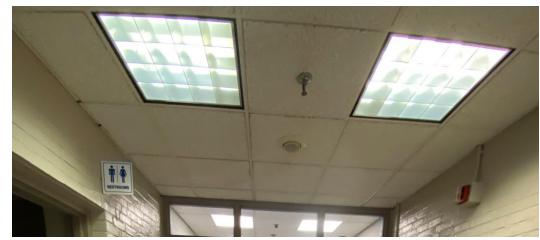
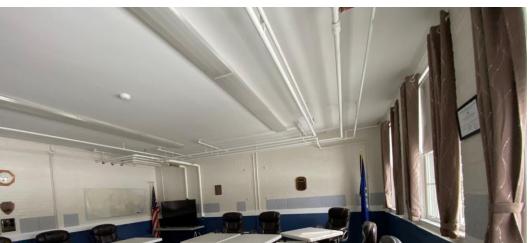
Existing Building – Mechanical & Electric

Item: Existing Lighting

The existing light is florescent and many of the fixtures are cracked or yellow – the lighting systems should be updated through out the entire building with LED

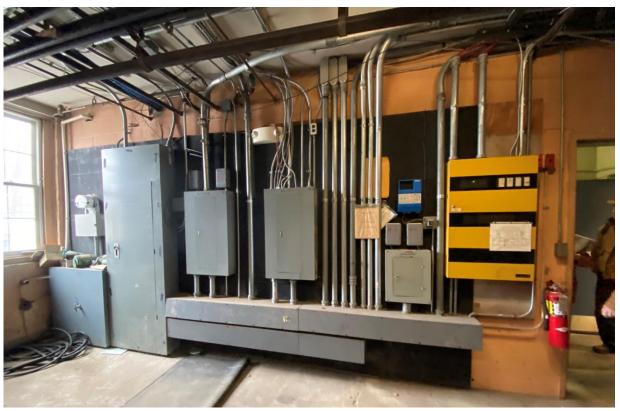
Existing Building – Mechanical & Electric

Item: Electrical System

The generator is old; some breakers that are permanently off; signs of electrical shortages; and oddly placed electrical boxes

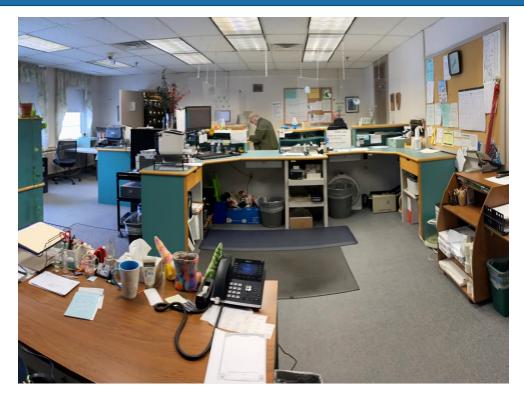
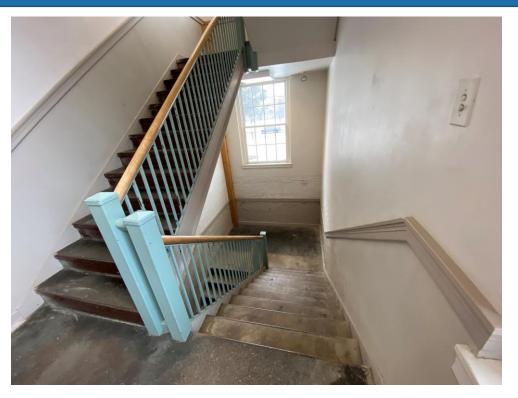
Existing Building – Appearances & Finishes

Item: Finishes

The existing finishes are dated, absent, and/or worn and need to be updated throughout the building – this is included in the renovation estimate

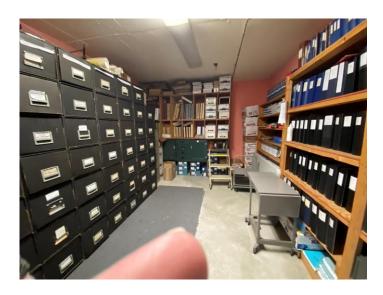
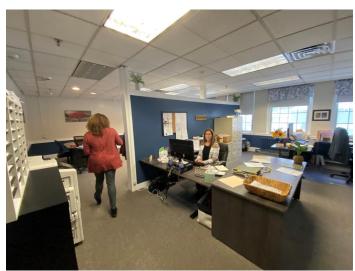
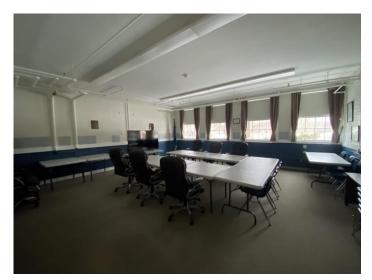
Existing Building – Furniture & Shelving

Item: Furniture

While the desks are great, the shelving systems and meeting furniture needs to be updated
