# City of Big Rapids, Michigan Old Mecosta County Jail

Architectural Assessment

Prepared by  
Preservation Forward, LLC.

August 2024

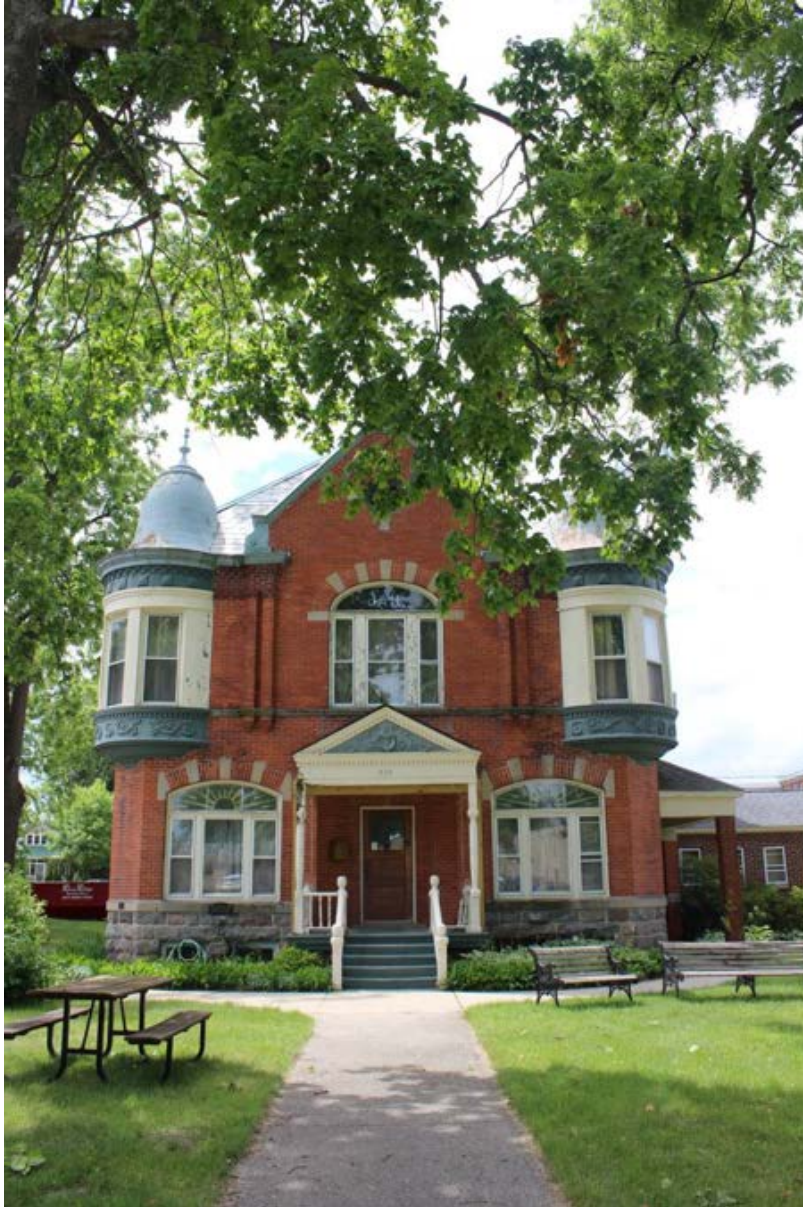
Image 3 Head-on view of the old jail's façade, looking west. Vegetation is growing in areas against the foundation at grade. Vegetation brings moisture against the rock and grows against mortar which accelerates deterioration.

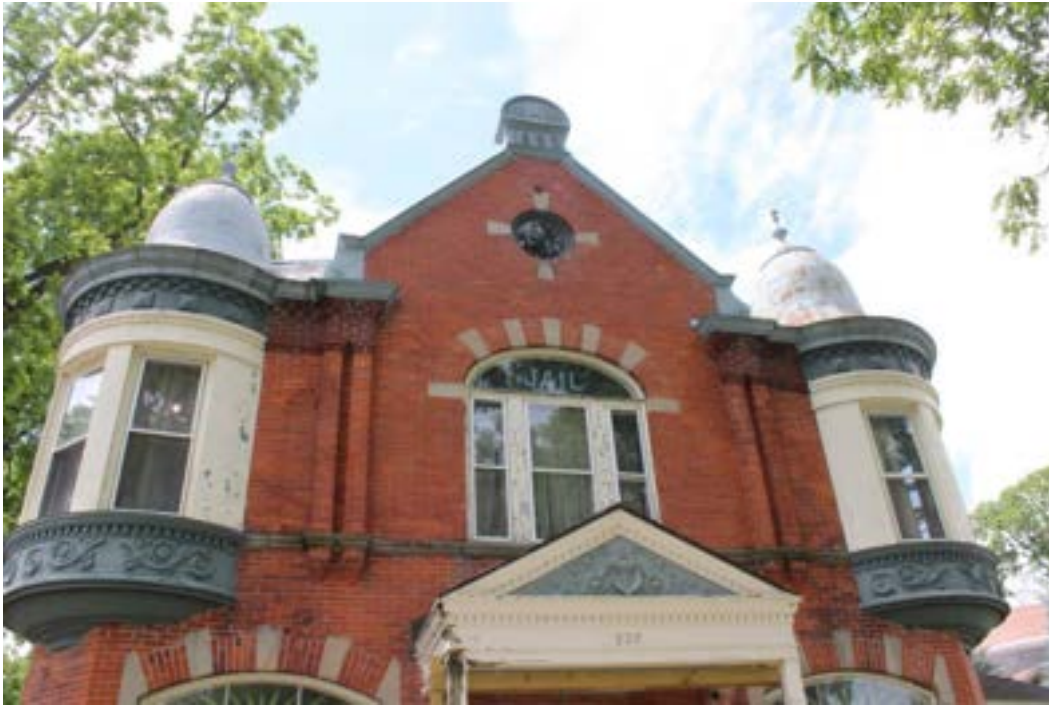
Image 4 Close-up of upper façade, looking west. The portico has structural issues related to moisture penetration. The turrets show paint peeling and deterioration. Metal atop the turret shows signs of age and rust. Some areas of the façade have brick discoloration from water channeling down the brick and not into a water removal (gutter) system.

- *Roof*
  - Install new gutter system with downspouts and catch drains from foundation that go out from structure
  - Assess existing chimney with brick spalling

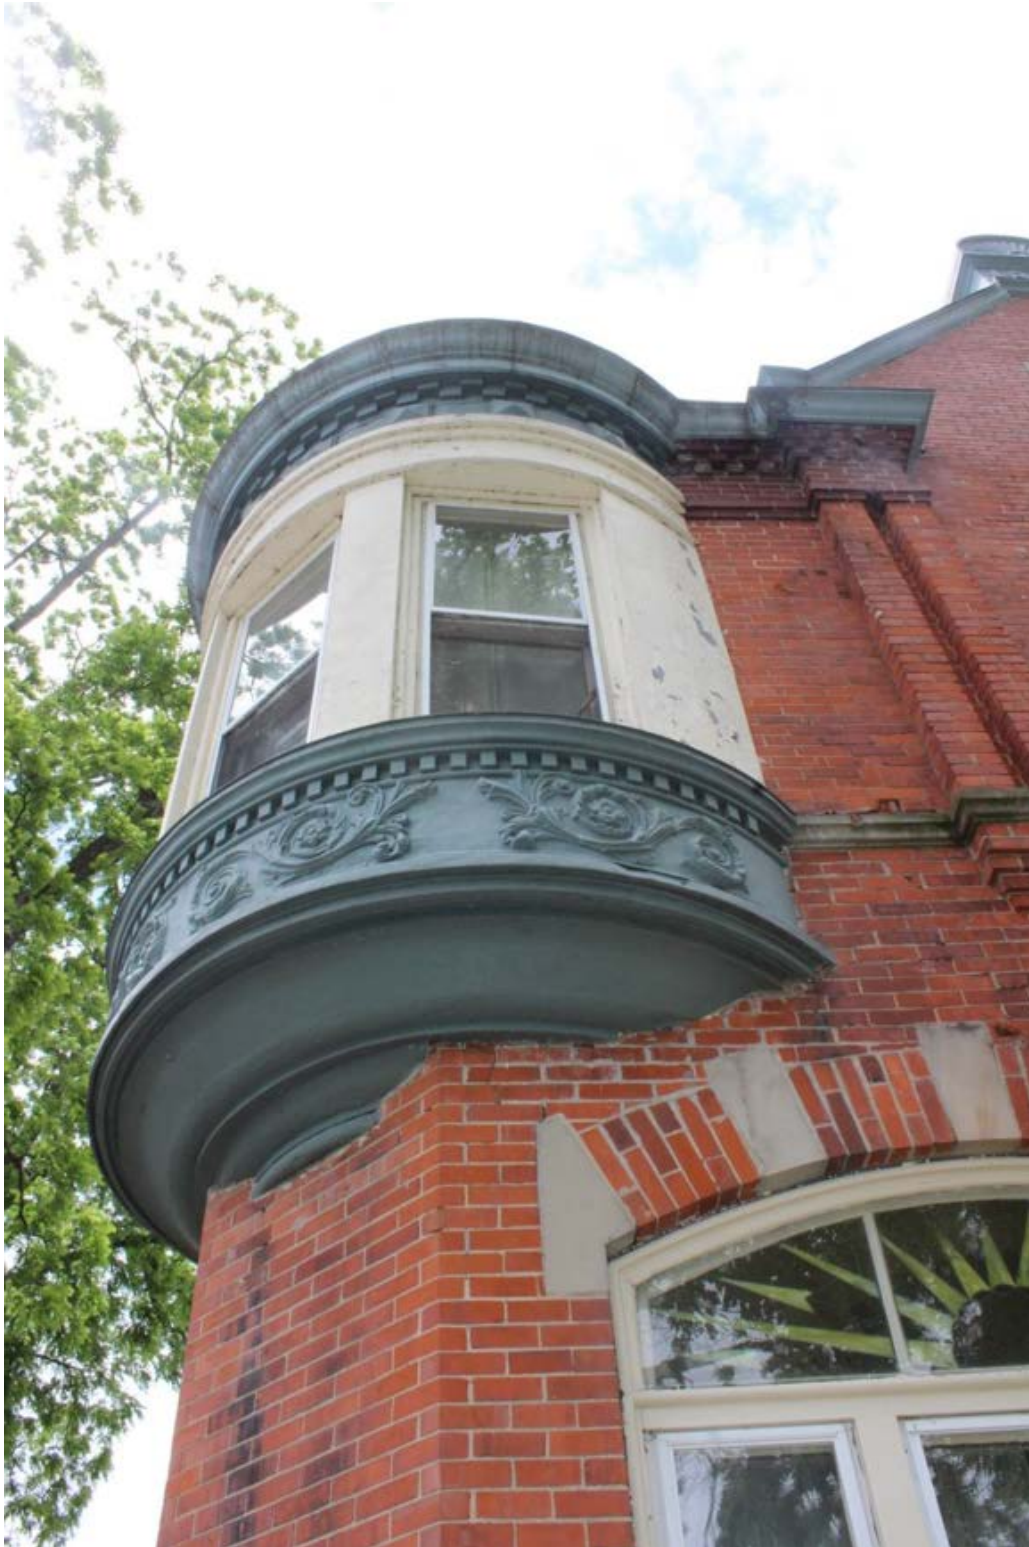
Image 5 South turret on façade, looking west. Brick discoloration is occurring from water infiltration in brick where water is being channeled down the brick due to lack of water (gutter) removal system. Paint is peeling on the turrets. Also, rust is visible on the dome above the turret. Some caulking issues around the turrets and windows that create small fractures in the brick.

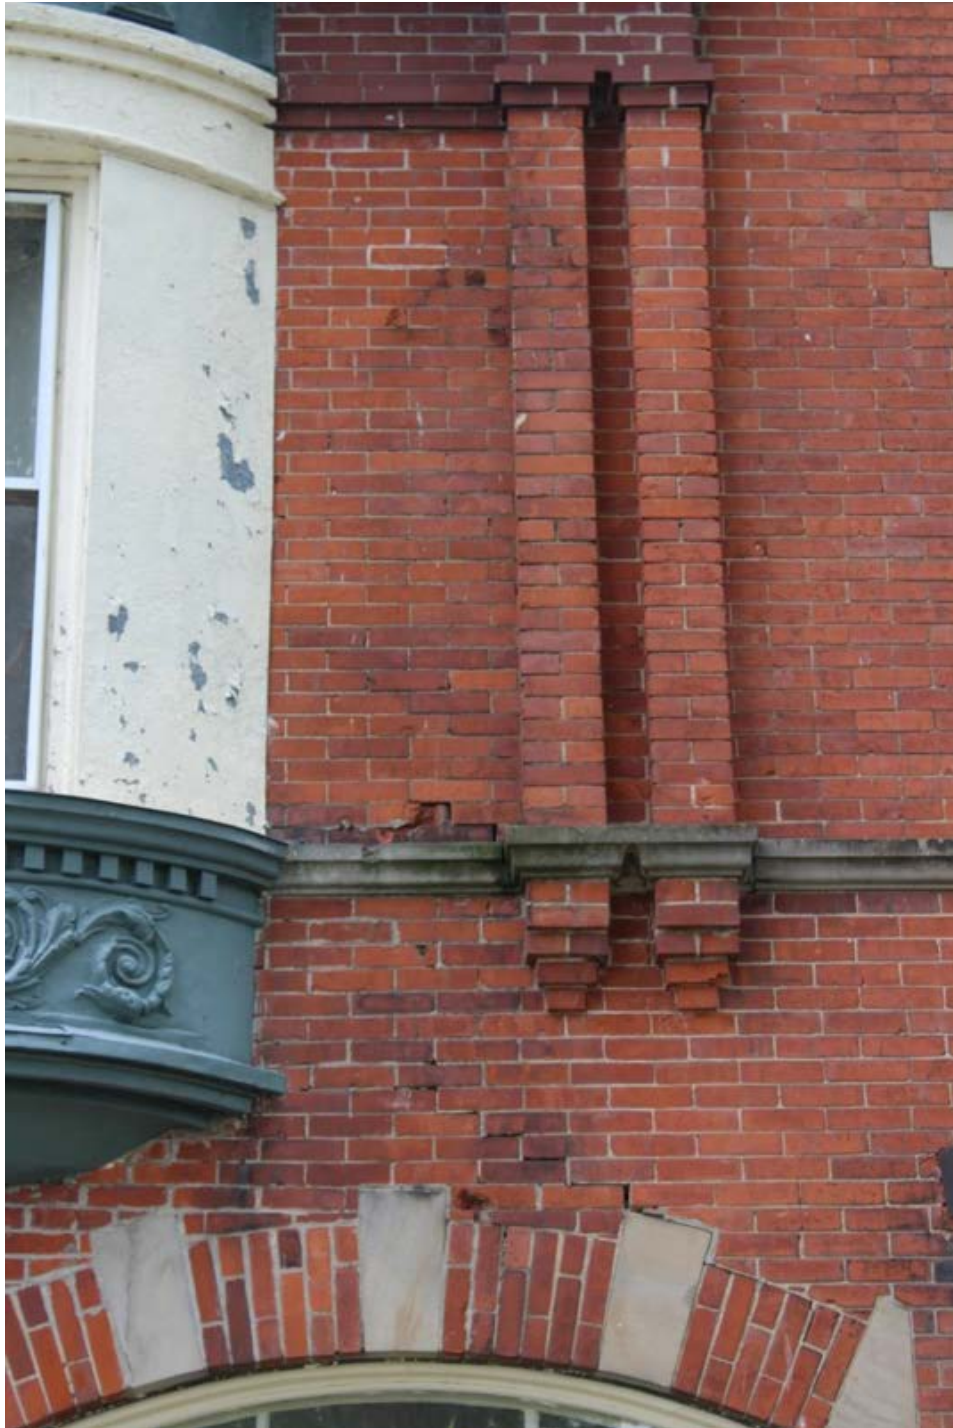
Image 6 Deteriorated brick on south end of façade, looking west. Visible cracking in the mortar joints where mortar is missing and could have water penetration from the inside impacting the brick. Some brick has spalled from the façade where likely water has located behind the wall cavity or incompatible mortar has been placed in the joint. The discoloration of the stone has lichen-like appearance of moisture growth on the belt course of limestone.

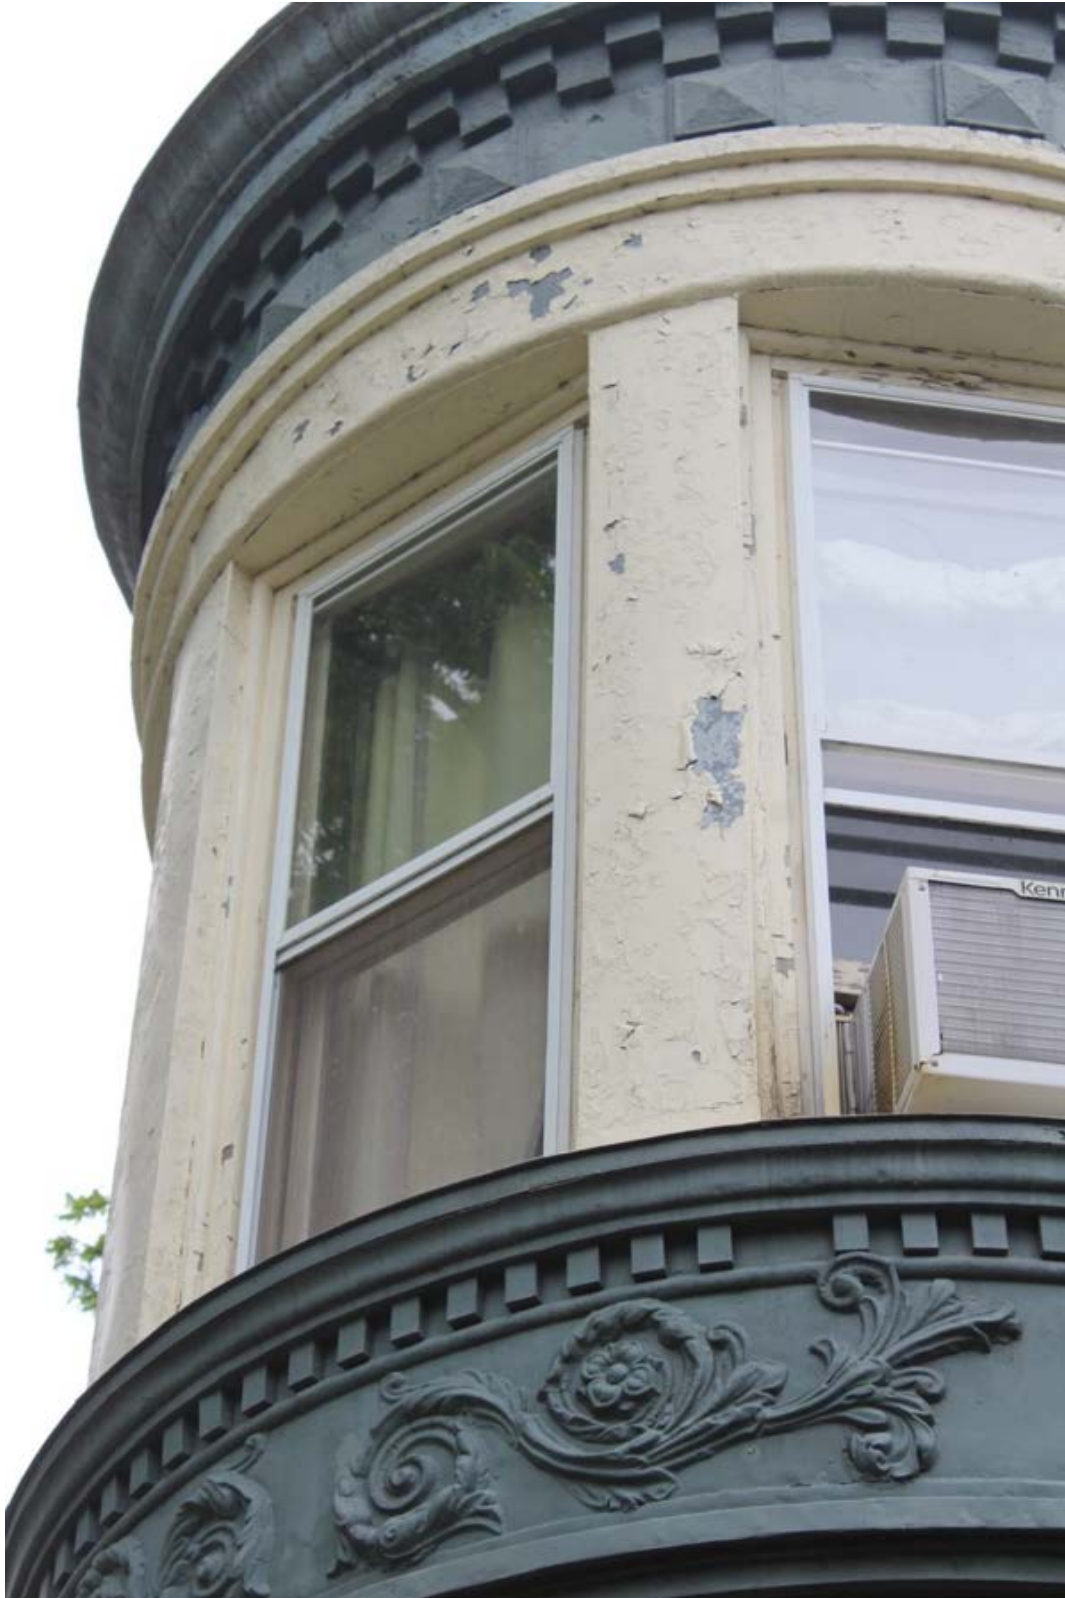
Image 7 Close-up of south turret and its exposed metal material, looking west. Paint failure is visible where paint is peeling and has delaminated from its surface. Rust and water markings on the rim of the dome show that water is penetrating the dome.

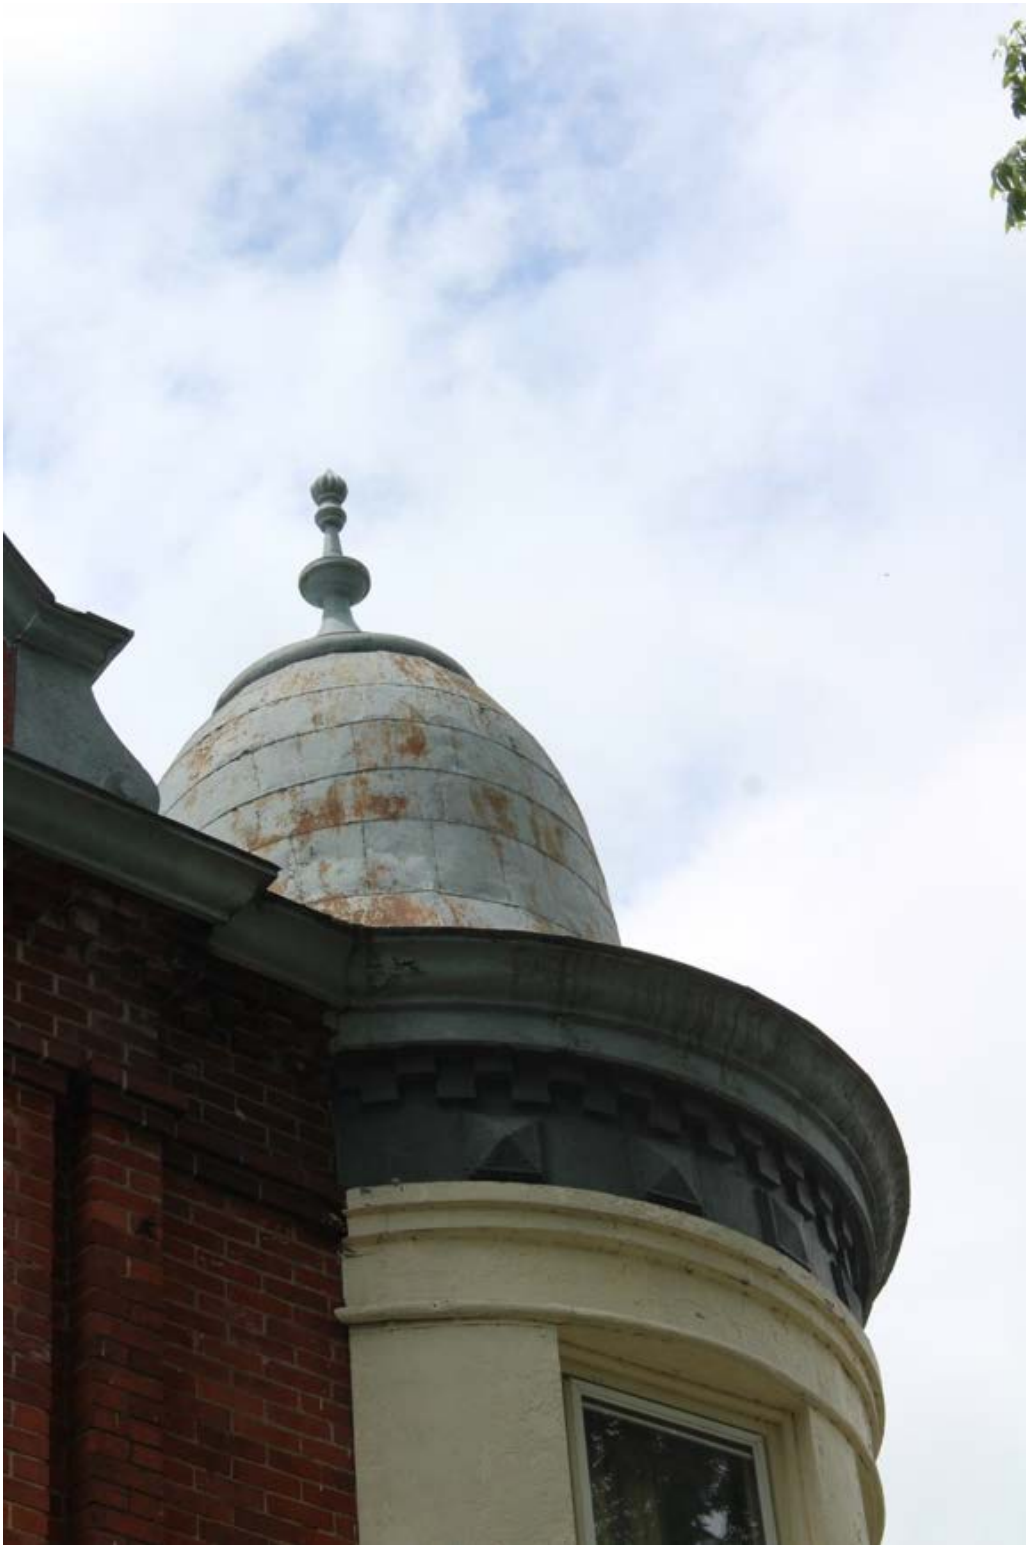
Image 8 View of north turret and its rusted dome, looking northwest Rust and water markings on the rim of the dome show that water is penetrating the dome. The dome appears to be in good condition despite the water infiltration and cosmetic issues.

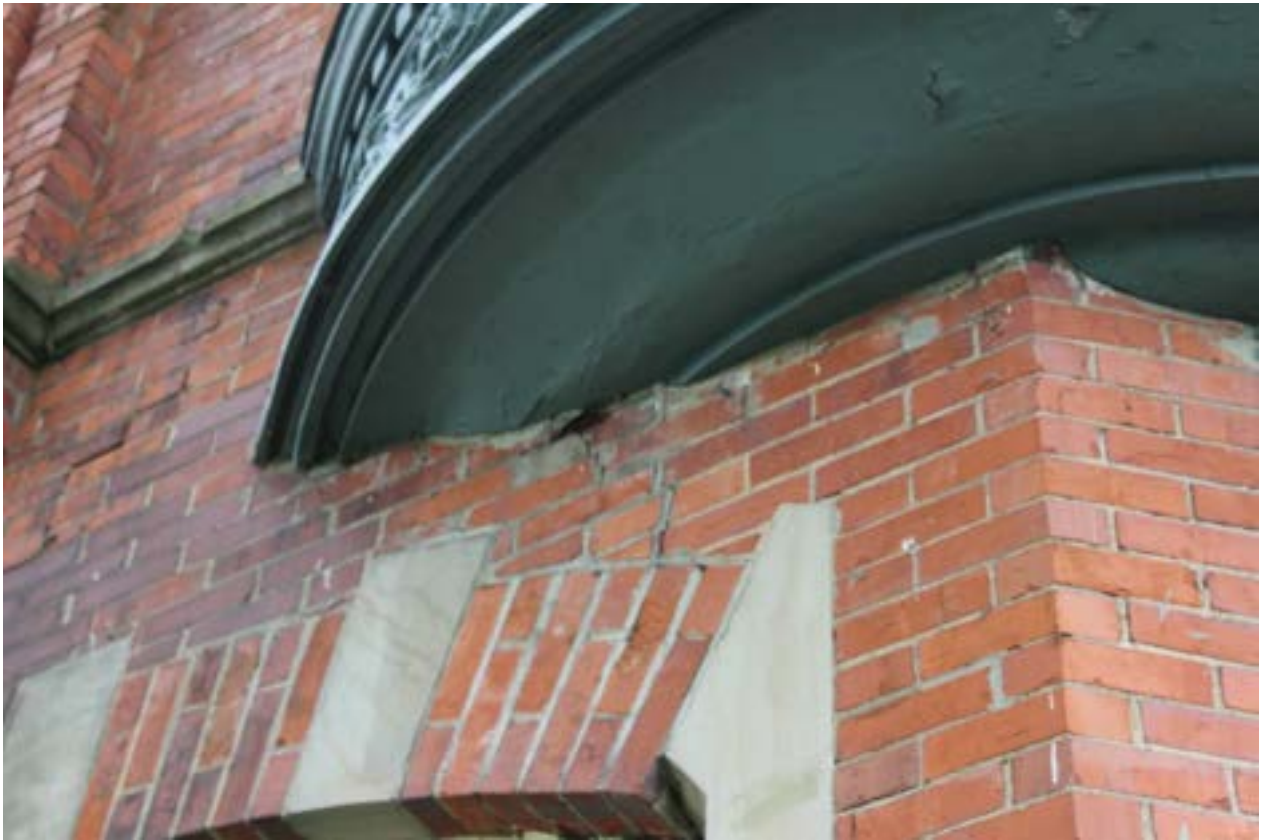
Image 9 View of intersection between north turret and façade brick, looking west. There appears to be mortar that has been inserted in patching locations across the structure. This mortar appears to be a different aggregate mix than the original “mother” mortar mix. This mortar can be stronger than the brick itself and jeopardize the ability for the brick to have an expansion and contraction when temperatures change.

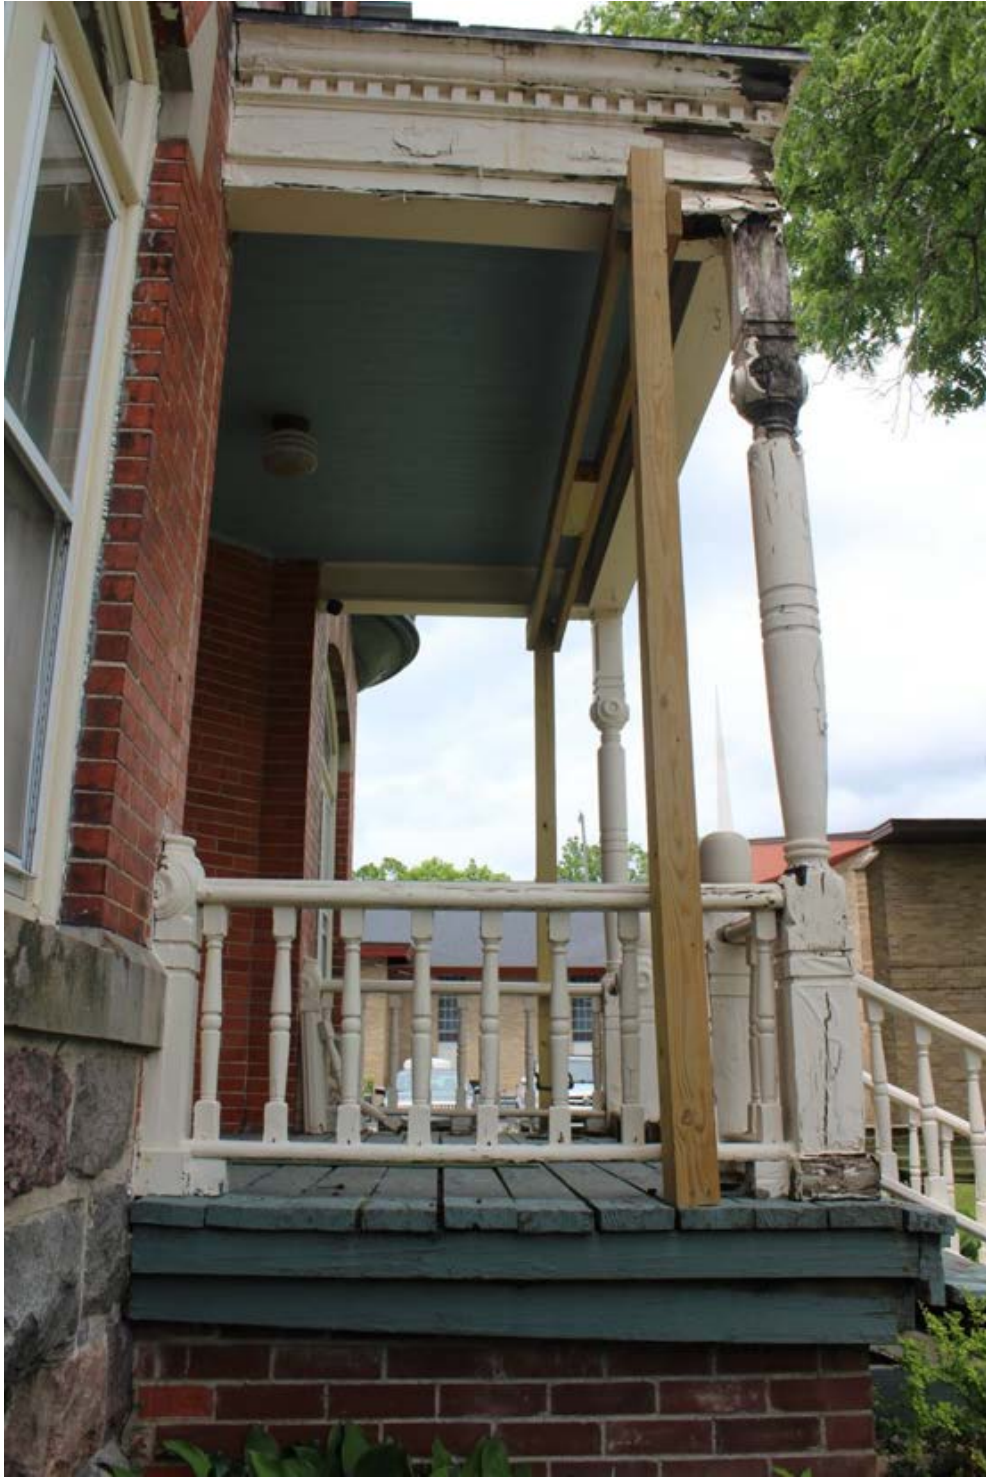
Image 10 View of entryway porch held up by wooden supports, looking north. The portico on the façade has significant damage to due water entering the portico from vacancies/voids and vegetation against the floorboards and foundation of the structure. The two, front columns show wood rot and damage. The porch is later than the original structure. The decorative portico appears to be original, but the columns, flooring, and balustrade are later features. The porch needs immediate attention before further deterioration occurs.

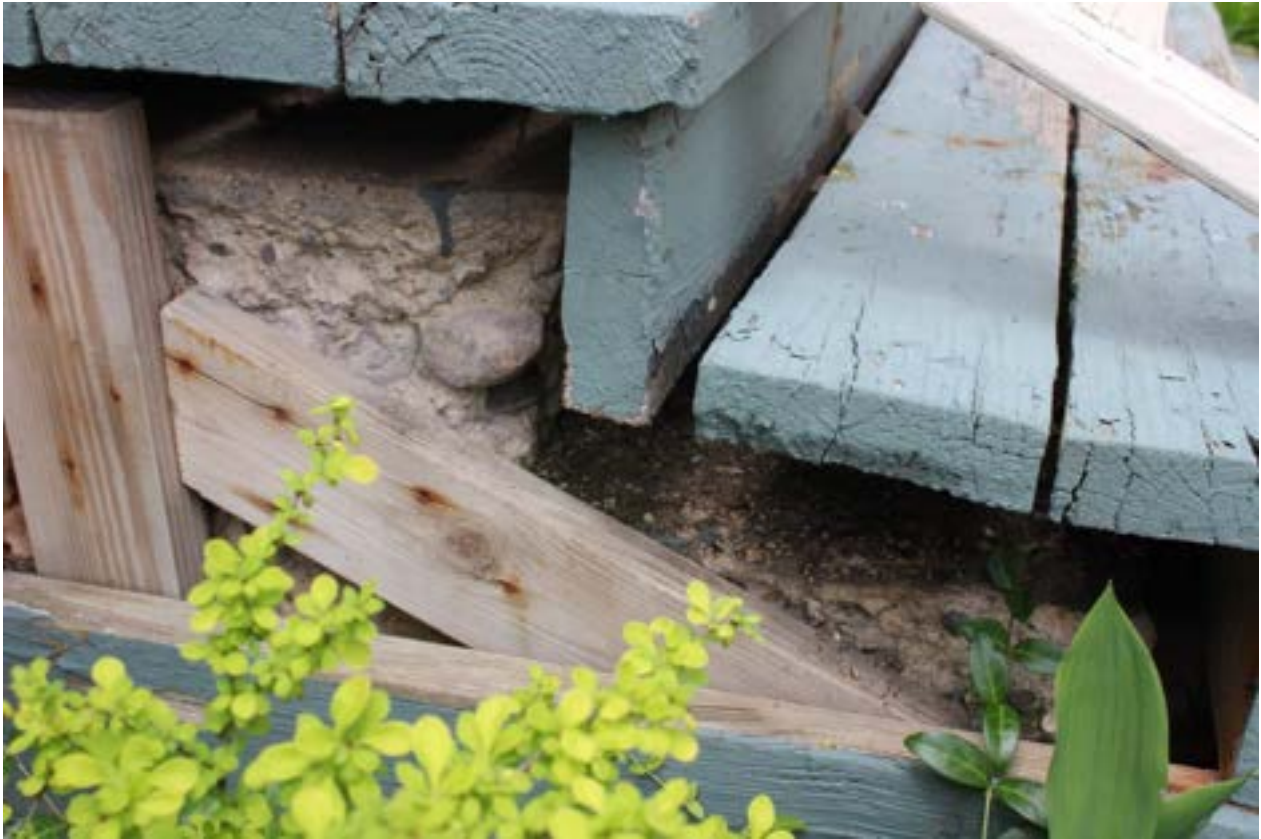
Image 11 View underneath porch staircase to find original stone staircase, looking north. The original structure boasted an aggregate mix for risers and treads. Later, wood boards were added which show visible signs of water damage, wear, and deterioration from vegetation growth.

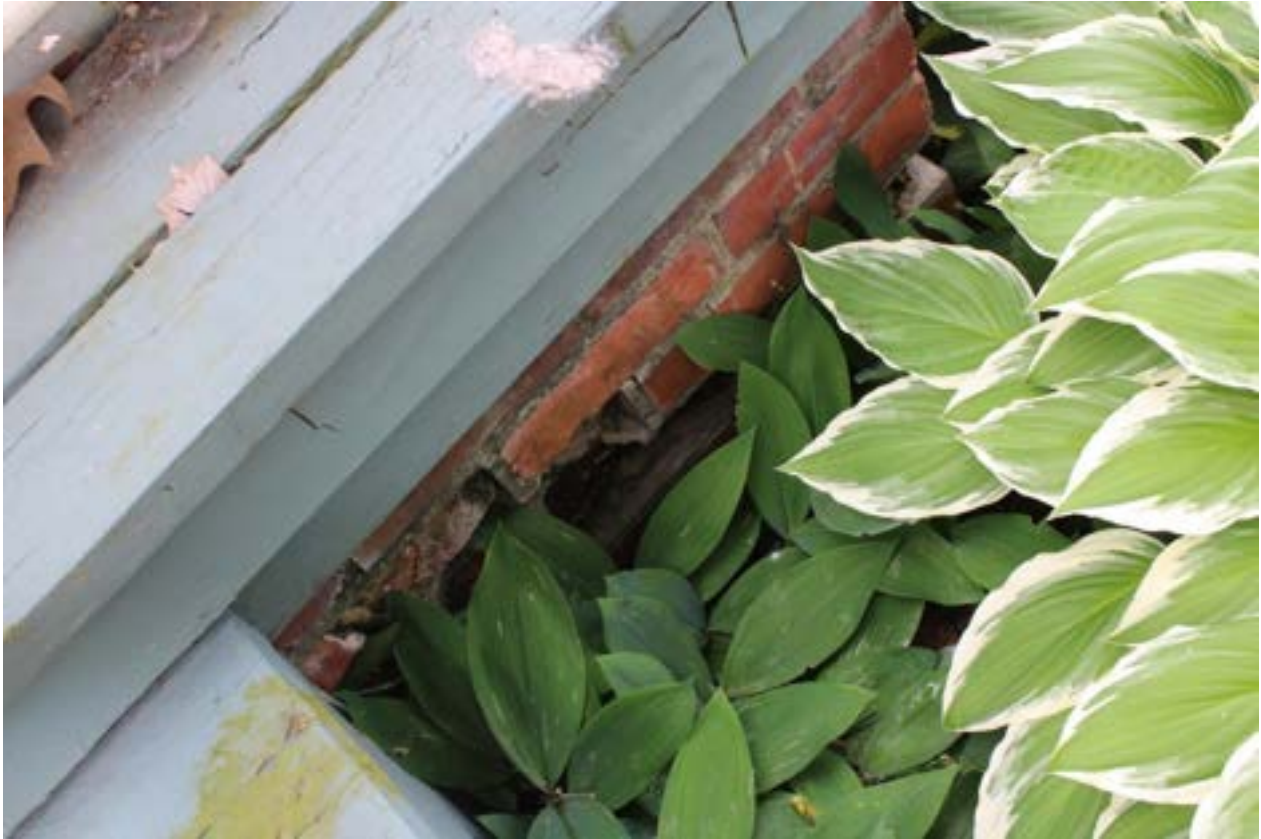
Image 12 Deteriorated brick and mortar underneath north side of porch, looking west. Brick around the porch is deteriorated due to water and moisture against the brick which is causing spalling of the fire skin exterior on the brick. This is problematic. We want to keep water and vegetation away from brick. Mortar joints show discoloration due to lichen, moss, biological growth against the masonry.

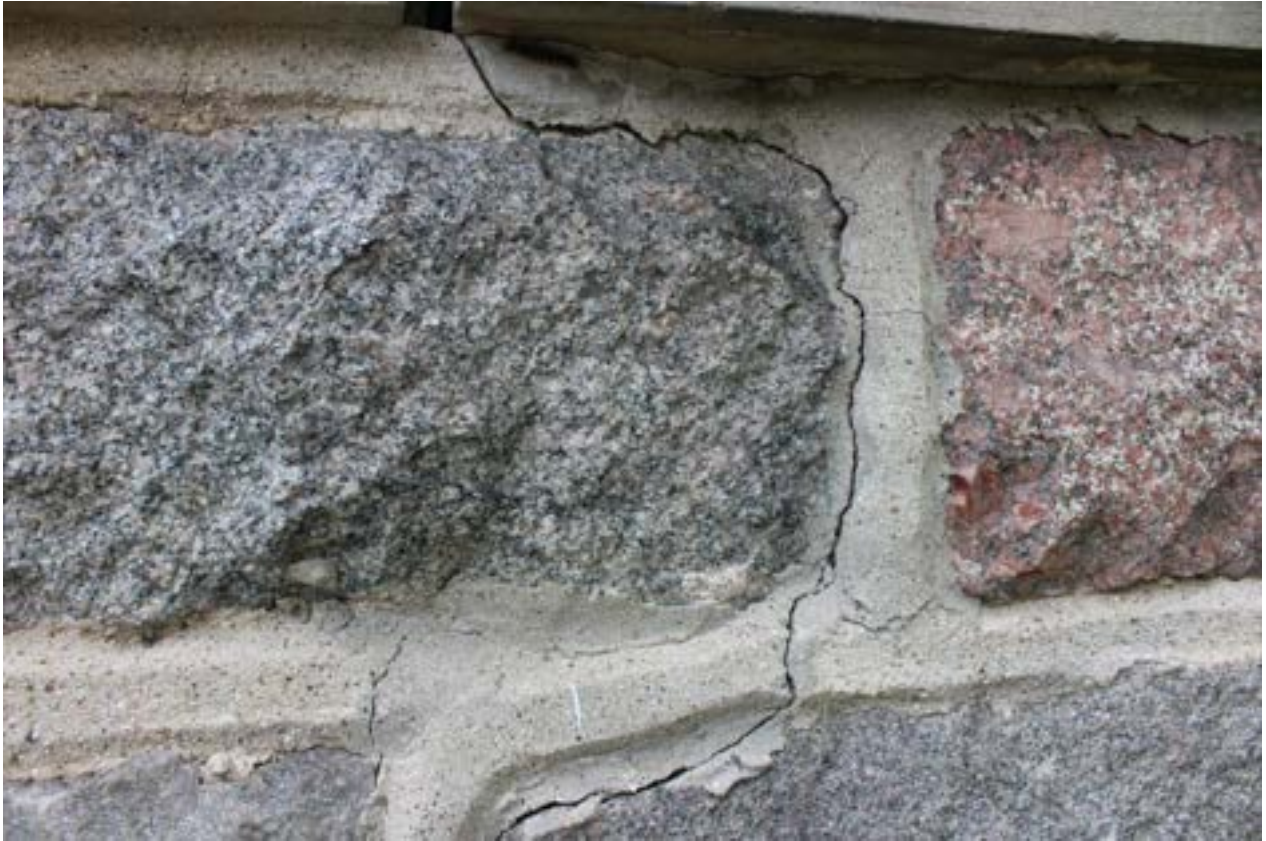
Image 13 Stone foundation on south side of façade and its cracking replacement mortar, looking west. Small, expansion and tensile cracks in the mortar along the foundation.

- Install new fascia and soffit where necessary- look at north and east elevations
- *Foundation*
  - Address cracking and gaps in existing mortar
  - Repoint mortar with mortar that is compatible with original mortar (mortar is evaluated and selected by a mortar analysis test)

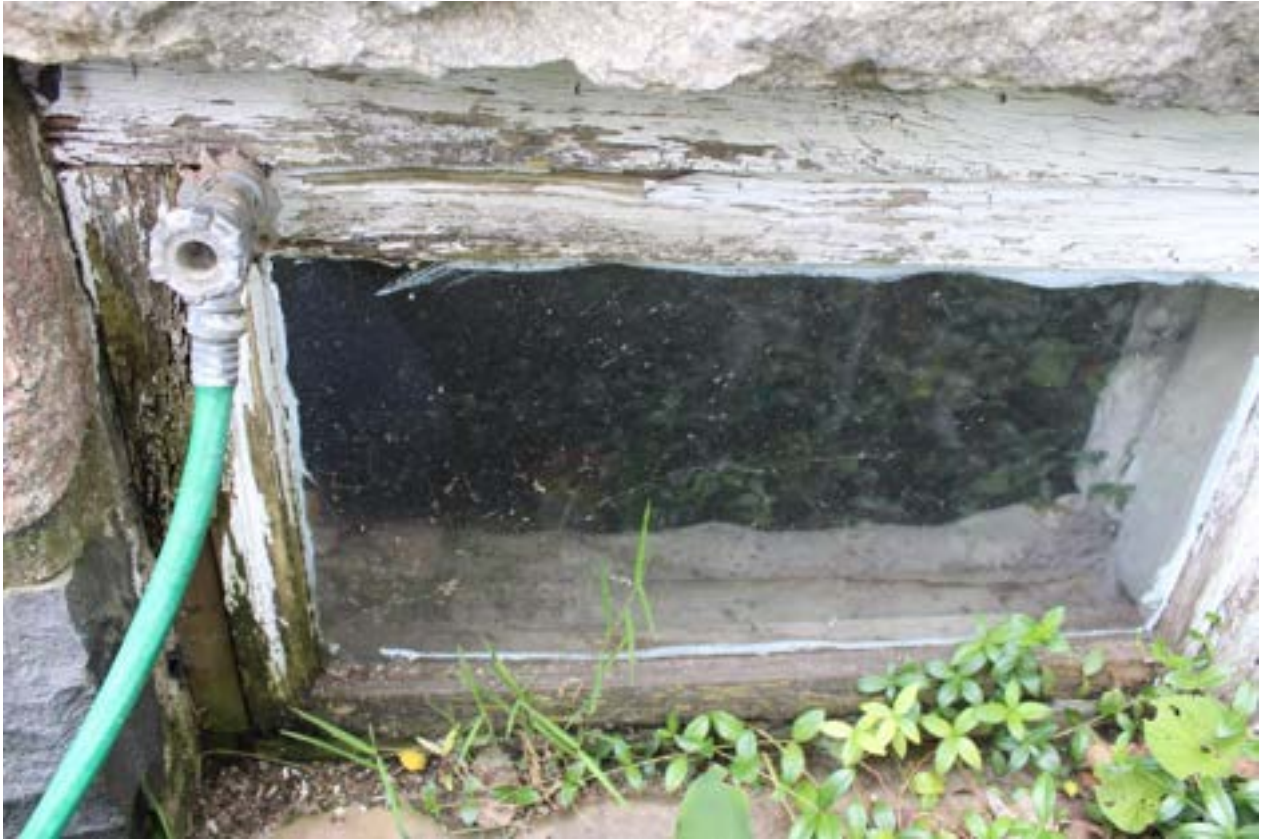
Image 14 Rectangular window to raised basement on south side of façade at the foundation level, looking west. Visible water damage and wood rot. Water could be coming off the hose which is installed against the window sash/casing, because of vegetation against the window, or a combination of both.

At the foundation level, repair the existing basement windows by removing vegetation at the windows and any wood that has rotted or is in disrepair. Existing wood members can be removed, and new wood members can "sistered" in where old members are no longer functional. If repair of existing wood windows isn't possible, replace windows with new egress windows that allow ventilation and accessibility if necessary. Any windows that need to be replaced should be selected to match as close to the original window in materials, size, shape, and pattern as possible. Check window and doors to ensure a tight fit and prevent weather, wind, and moisture from entering the structure. Windows and doors are part of the building envelope of the structure and are an integral part of the building envelope.

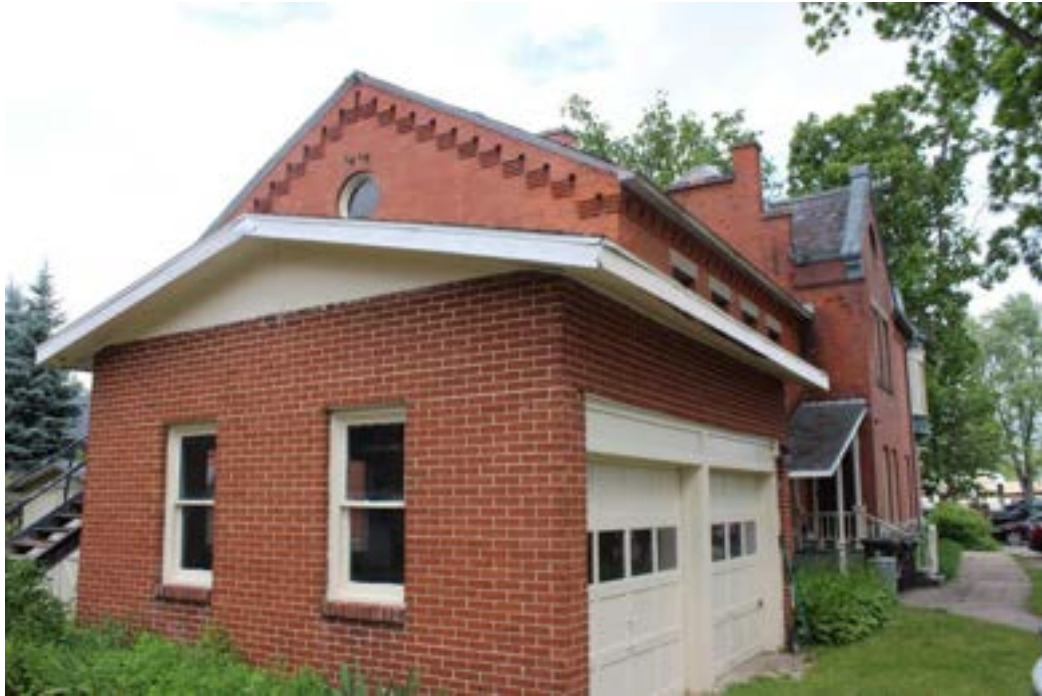
Image 15 Oblique view of circa 1930s garage addition. This addition is adjacent (attached) to the 1893 kit jailhouse which is directly west of the main sheriff's residence that was constructed in 1897. Two, one-over-one windows are located at the west elevation of the garage with side-gabled roof.

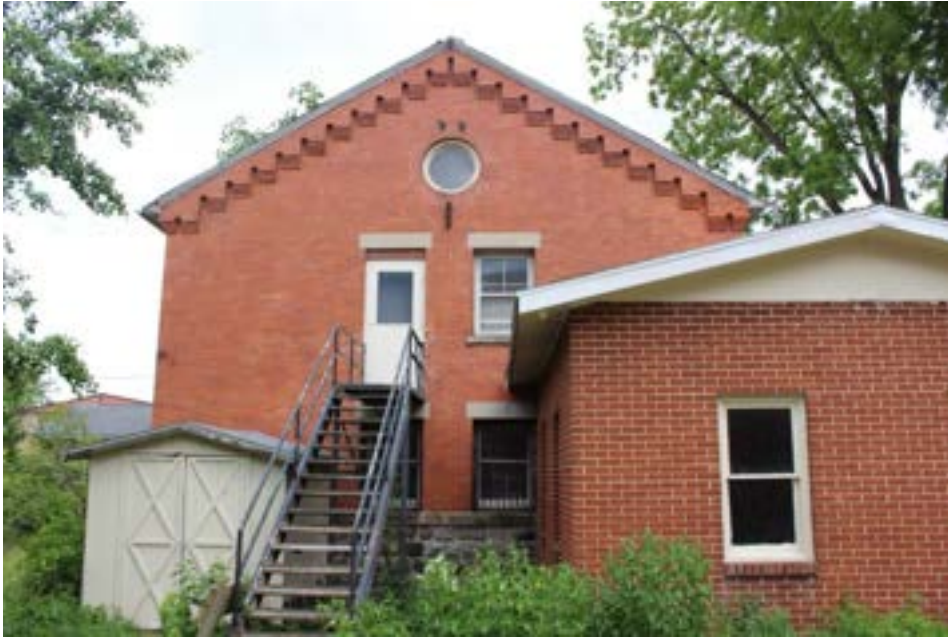
Image 16 Direct view of the jailhouse's west elevation, looking east. There's a significant amount of vegetation against the rear of the structure. Overall, the masonry at this elevation looks to be in good condition. A small shed is located at the northwest corner of the west elevation.

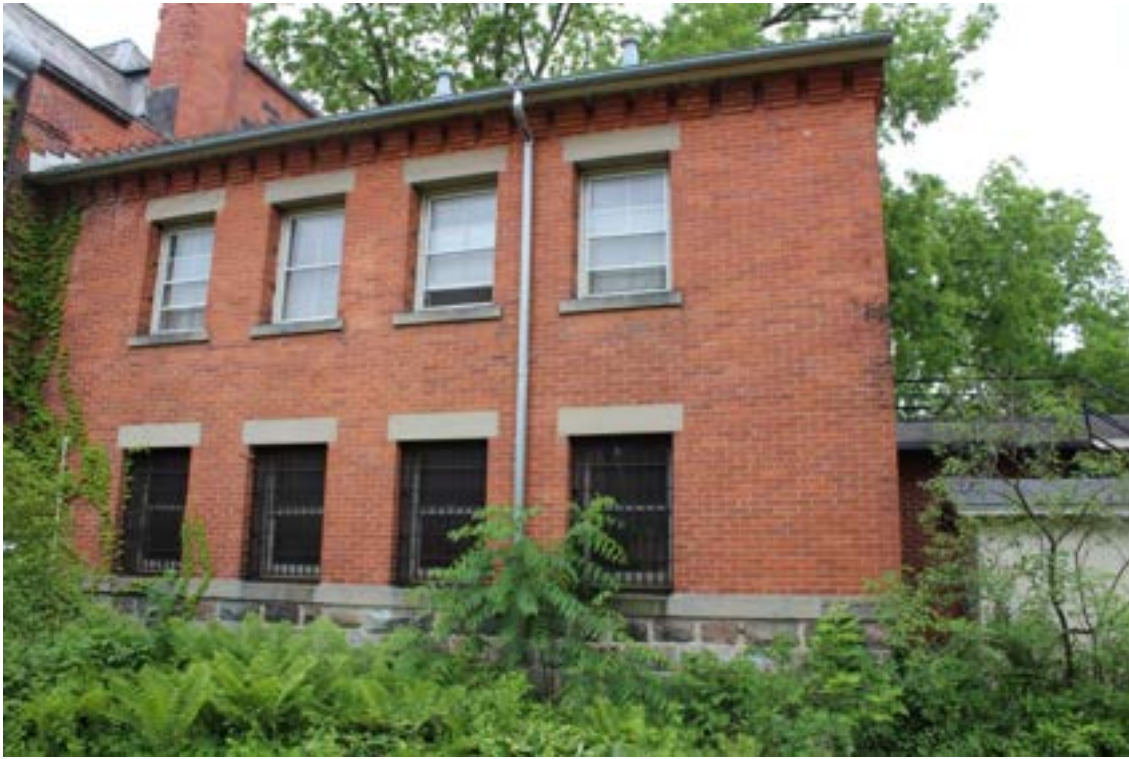
Image 17 The northwest section of the west elevation shows small trees, ivy, ferns, and other biological growth that has spread across this elevation. Vegetation against masonry creates a vehicle for moisture to penetrate brick, stone, and mortar joints.

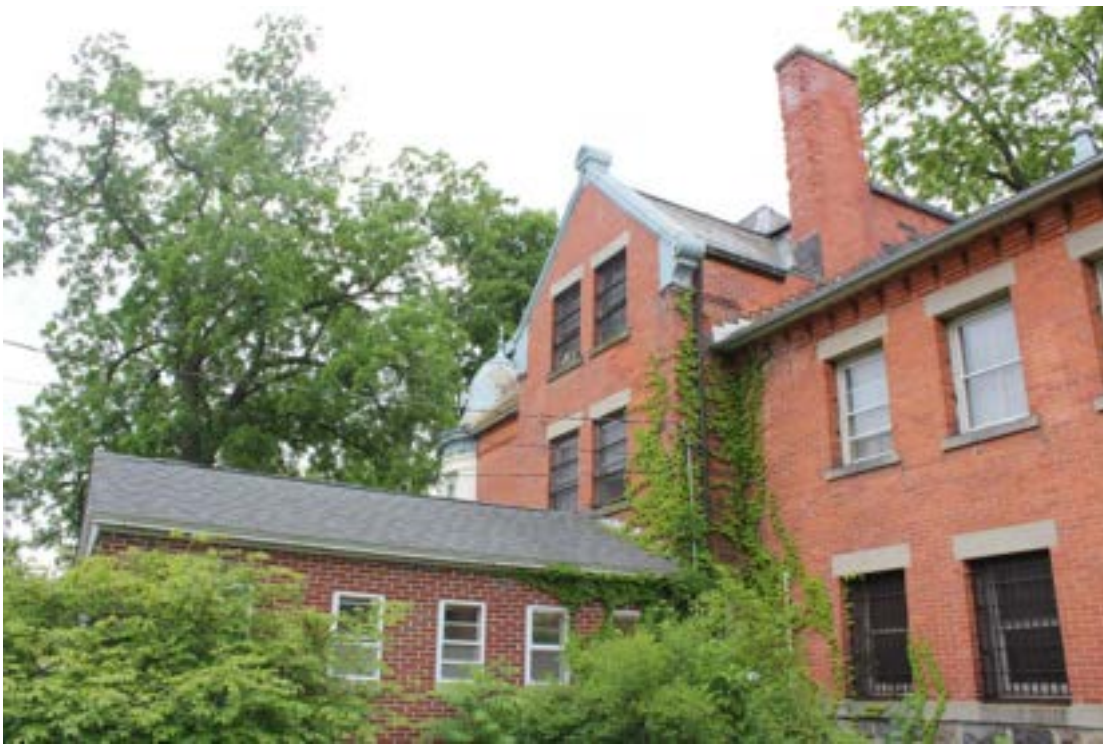
Image 18 Looking east at the 1959 addition located at the center section of the north elevation. This addition has an asphalt-shingled roof with vegetation growing against the flashing and valleys of the roof where the addition adjoins the sheriff's residence. Ivy has spread across the lower and upper stories of this

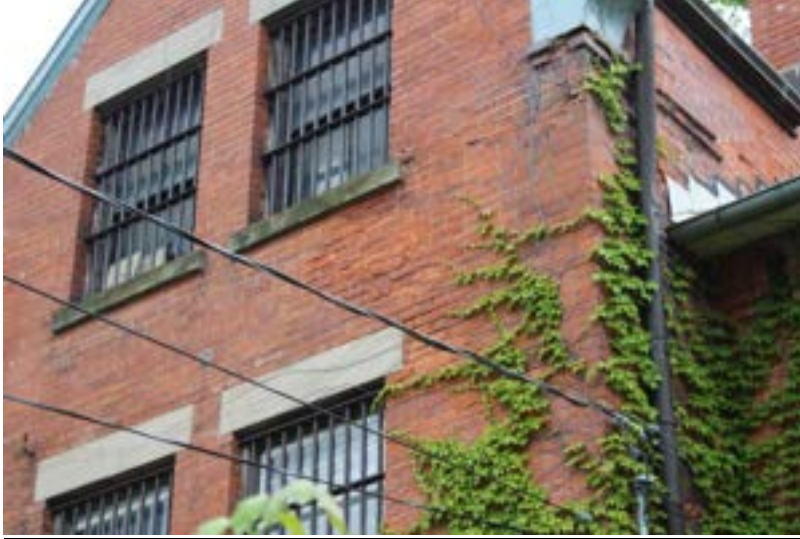
Image 19 Looking south at a detail view of the north elevation at the second and third story. Note the windowsill at the third story has discoloration from vegetation and moisture penetration. Brick below the windows has spalled in areas where the fire skin has spalled off the brick. Vines grow against the upper portion of the elevation.

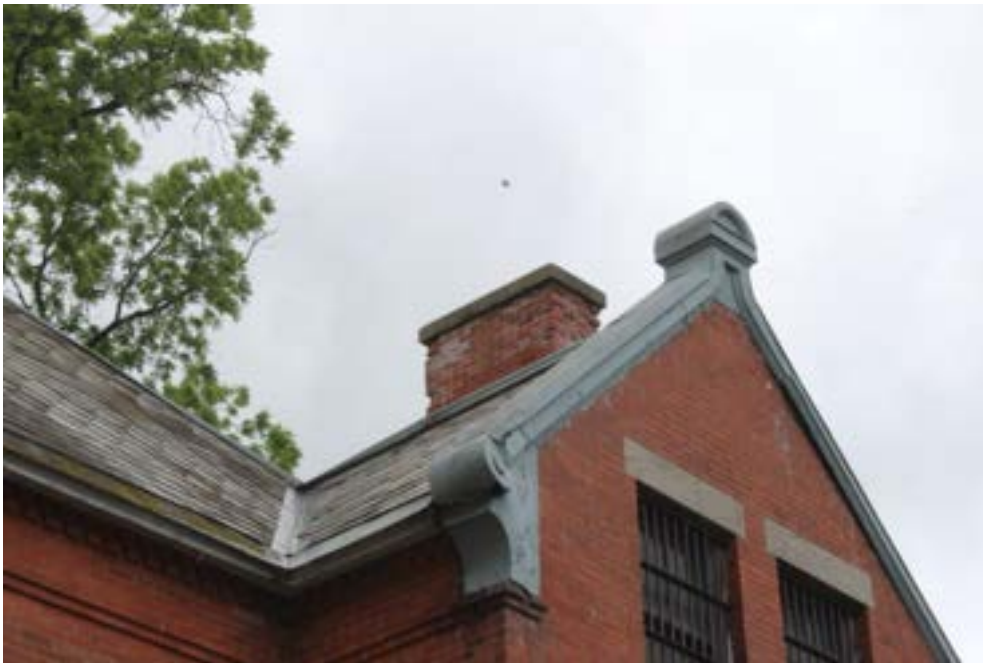
Image 20 Looking southwest at the parapet of the north elevation. Moss and other lichen are visible on the face of the slate roof tiles. Paint has delaminated with peeling at the gable trim and molding. Mortar patching is visible on the east elevation of the chimney. Water has entered areas of the molding and trim

and caused paint to bleed onto brick in areas. Decorative brick dentils and corbelling is visible across the north elevation and is in good condition.

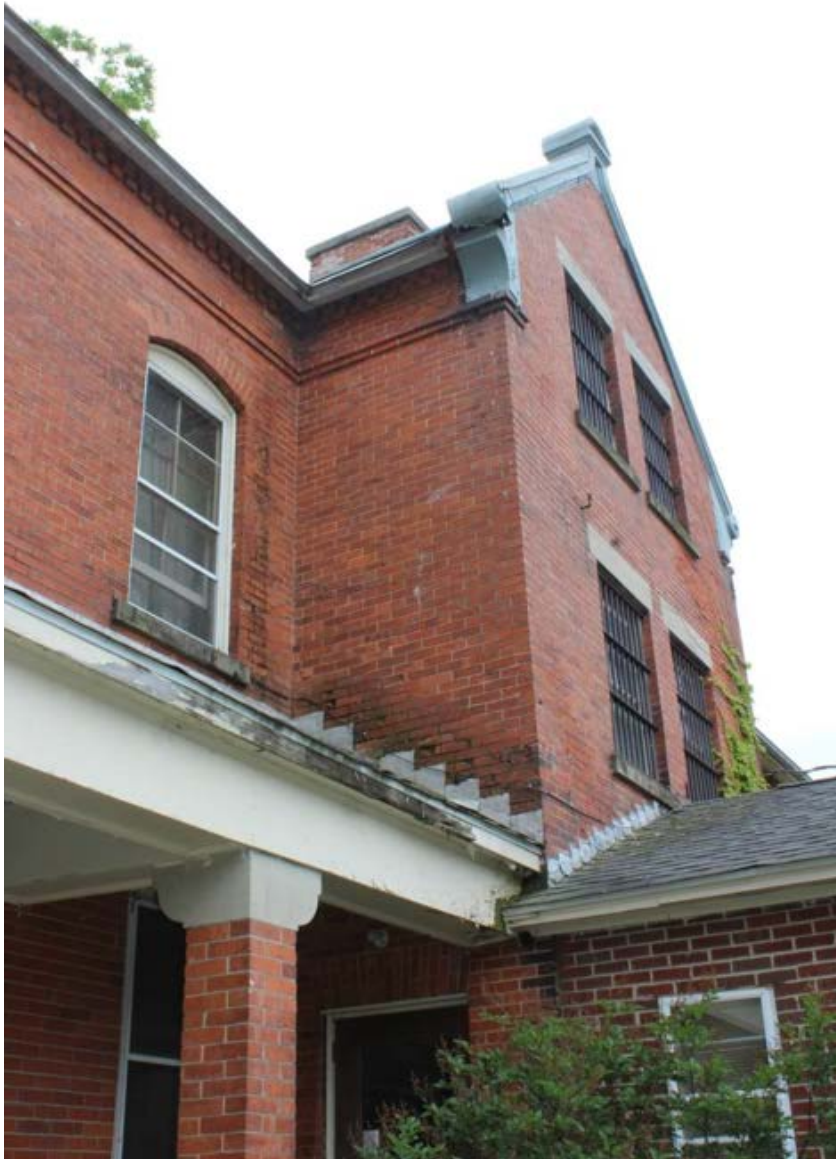
Image 21 The north elevation has a covered portico located at the northeast section of the elevation. There are several areas of concentrated moisture penetration in this area, specifically, flashing at the 1959 addition and the sheriff's residence. Tensile cracking is visible just above the portico, as well as, spalling of the brick and voids in the mortar joints. Brick is discolored in this area from moisture and vegetation. Wood shows paint delamination and peeling. Various areas of wood rot where the roof intersects with wood and water is trapped.

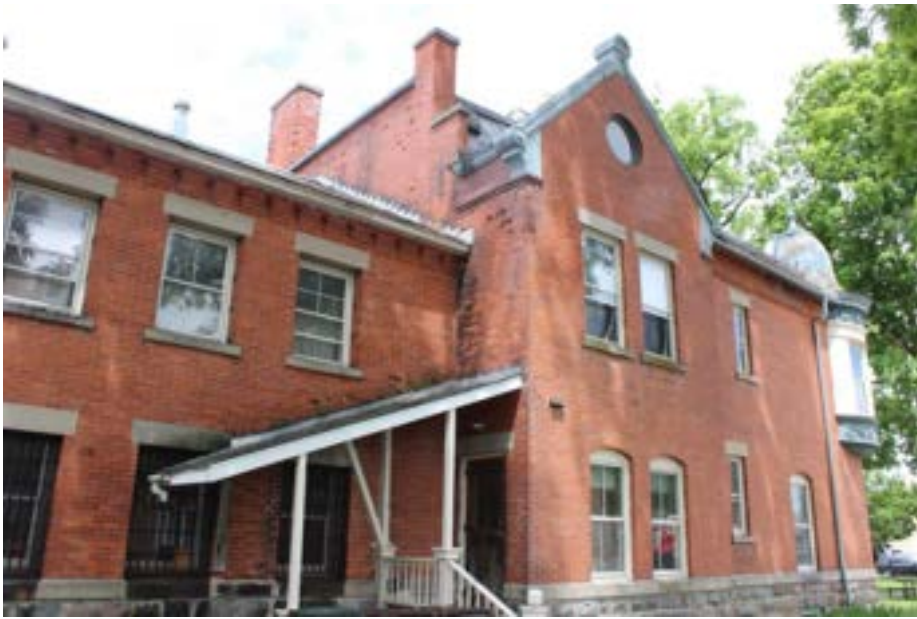
The south elevation encompasses the 1893 jail kit house, the 1897 sheriff's residence, and a 1930's garage at the southwest corner of the elevation. The south elevation has minimal biological growth (vegetation) due to the orientation of this elevation as south facing. The southeast section of the elevation has four windows at the lower level and three windows at upper story. At the lower level, three, two-over-two windows have rounded, arch upper sashes with limestone sills. A small one-over-one window is located between the three, arched windows and has a limestone sill and lintel. At the center section of the south elevation, a narrow portico has a lean-to roof. Just west of this portico is a basement cellar door.

Image 22 Looking northeast at the south elevation. A small portico exists at the rear of the 1897 sheriff's residence where the kitchen is located.
