# City of Big Rapids, Michigan Old Mecosta County Jail

Architectural Assessment

Prepared by  
Preservation Forward, LLC.

August 2024

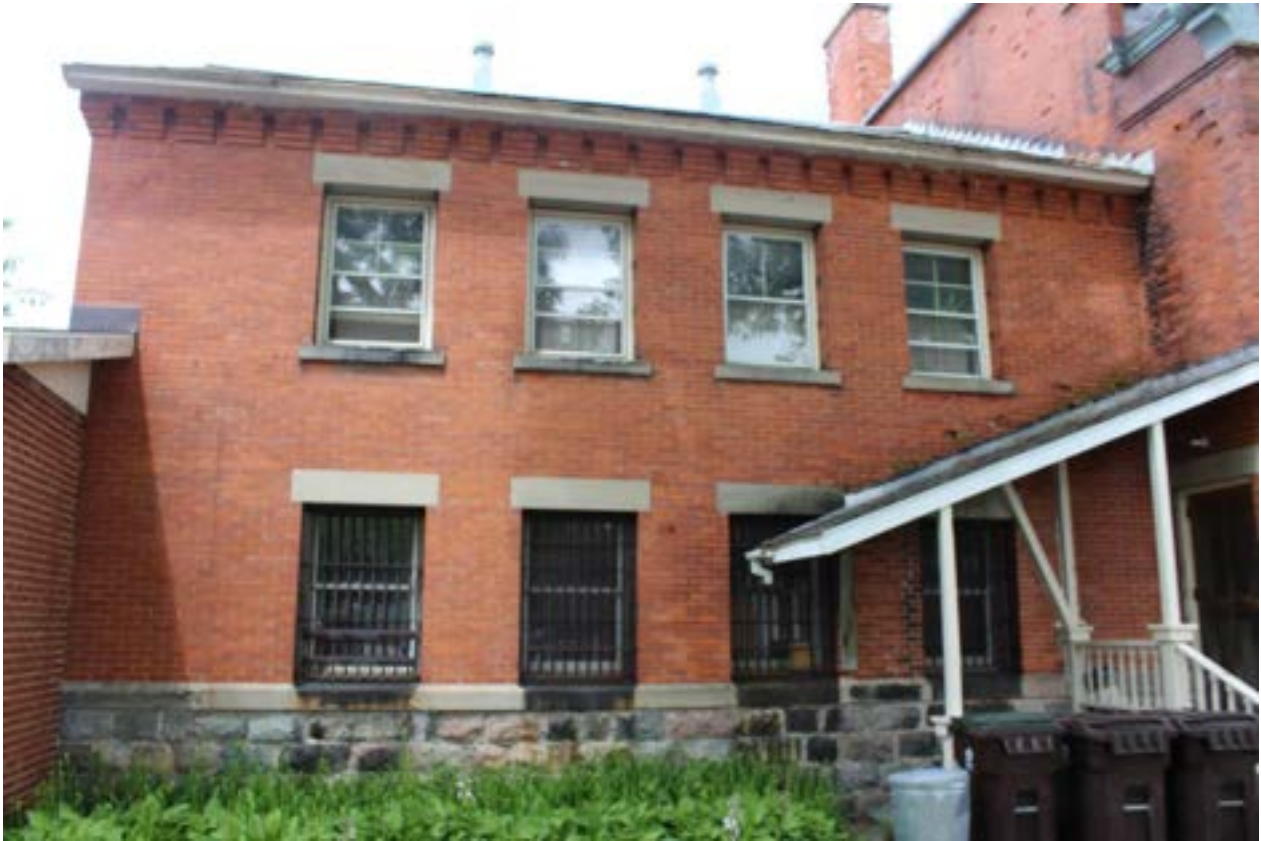
Image 23 Looking north at the south elevation. This is the center of the south elevation where the kitchen is located just off the portico. Also, the first-floor windows are where the jail cells are located. This section of the south elevation boasts two-stories with a series of four, double-hung windows with limestone lintels and sills at both the lower and upper stories. Metal grates cover the first-floor windows and resemble a similar pattern as the north elevation windows at the lower story. Rust has bled onto the limestone belt course at the center section of the south elevation. This rust is visible against the masonry. A gentle/firm bristle brush and soap can clean this from the masonry.

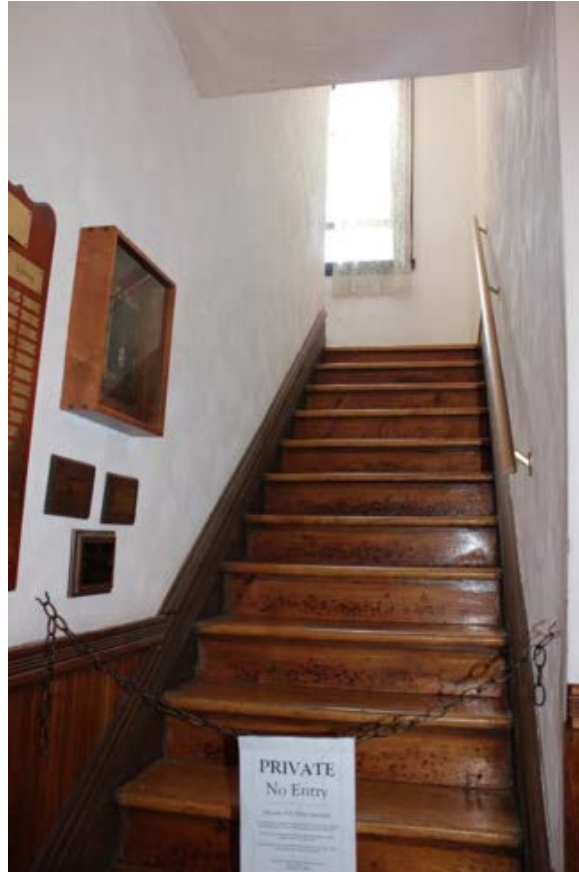
Image 27 Looking north at the stairs that lead to the upper floors of the sheriff's residence. Wood floors, trim, molding, and plaster are all in good condition in this area.

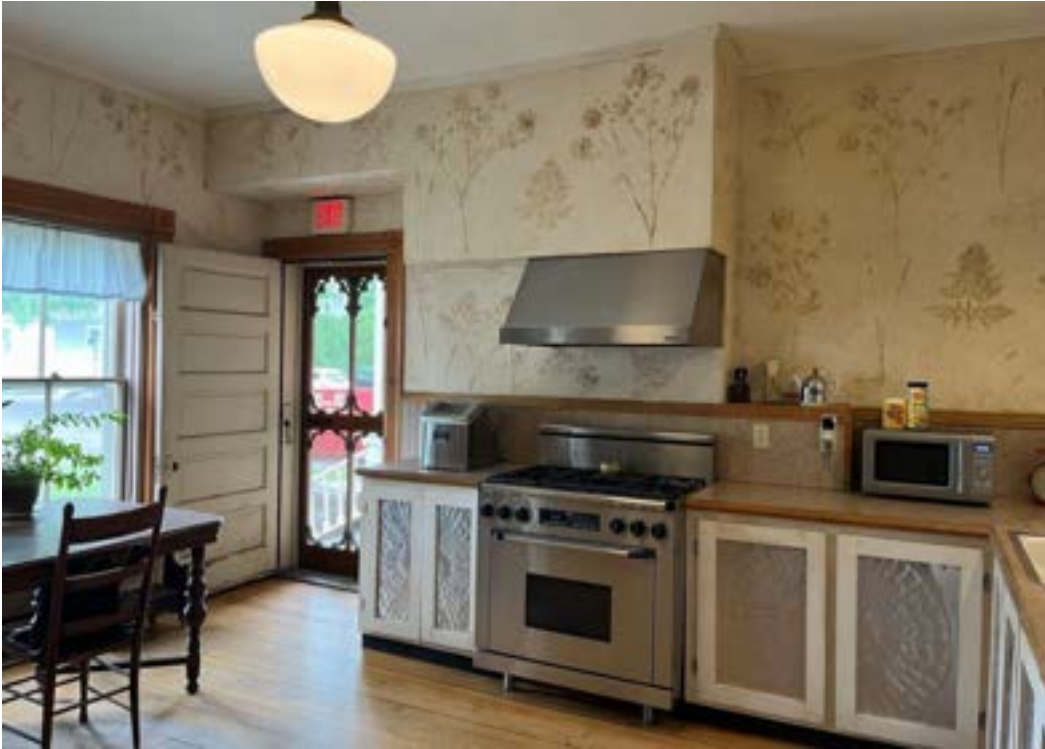
Image 28 Looking west in the kitchen. See egress door to the rear entry near the south-central portico of the sheriff's residence. The kitchen appears to have retained its original floor but looks to have had some modifications with updated appliances, countertops, and finishes.

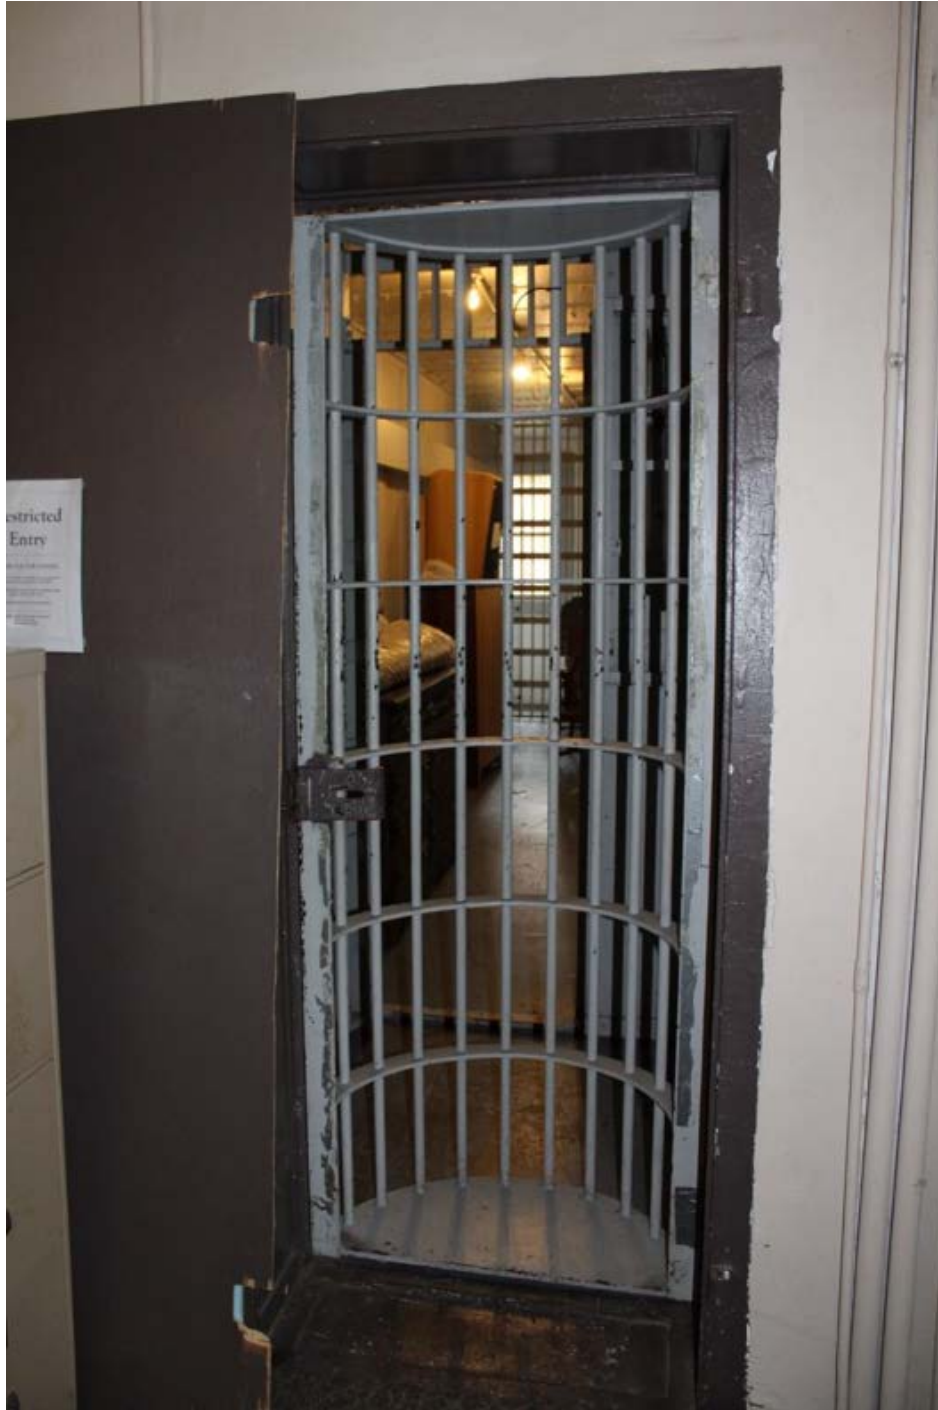
Image 30 Looking north in the jail cell section of the jail kit house. All original jail cells are intact with operable mechanisms.

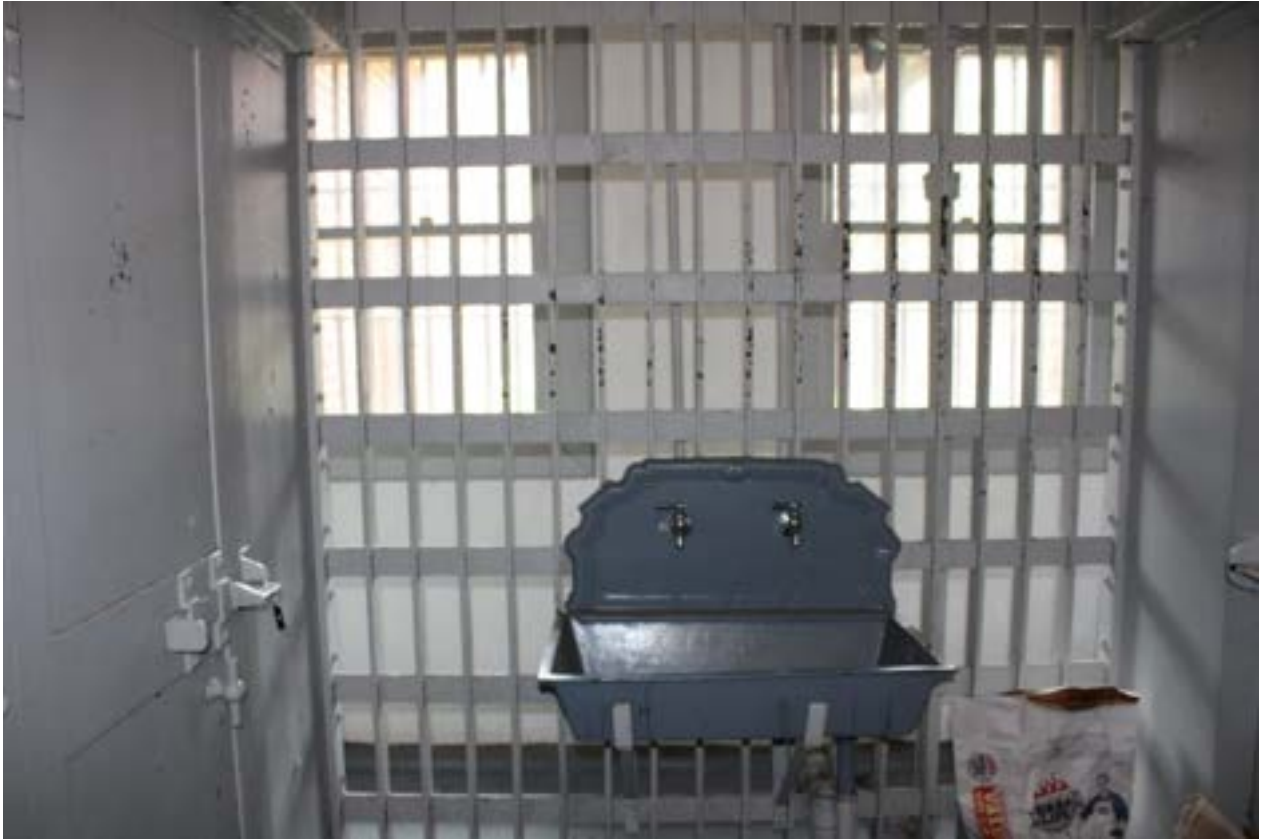
Image 31 Looking south in a jail cell at the original sink.

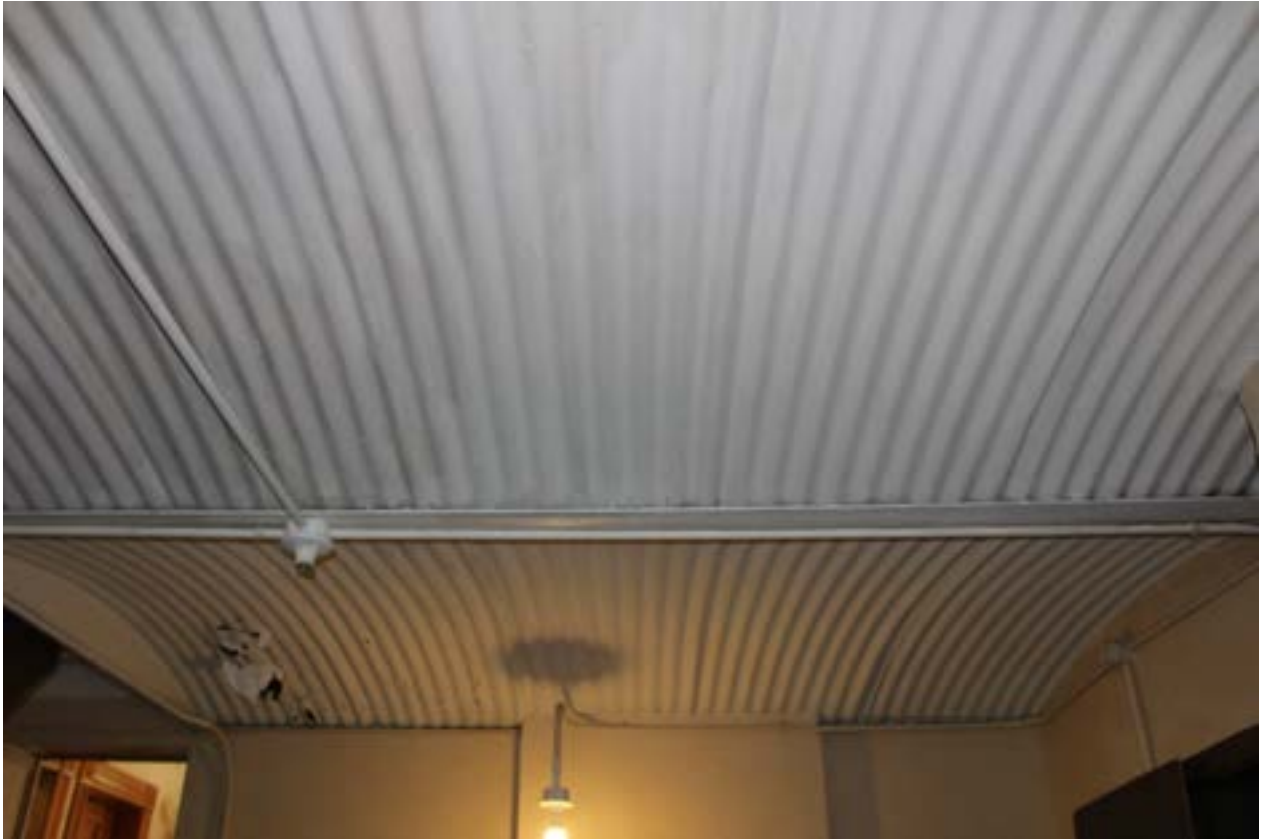
Image 34 Looking south at the ceiling detail in the room adjacent to the kitchen and the jail cells. This ceiling is like a Quonset hut shape with corrugated metal.

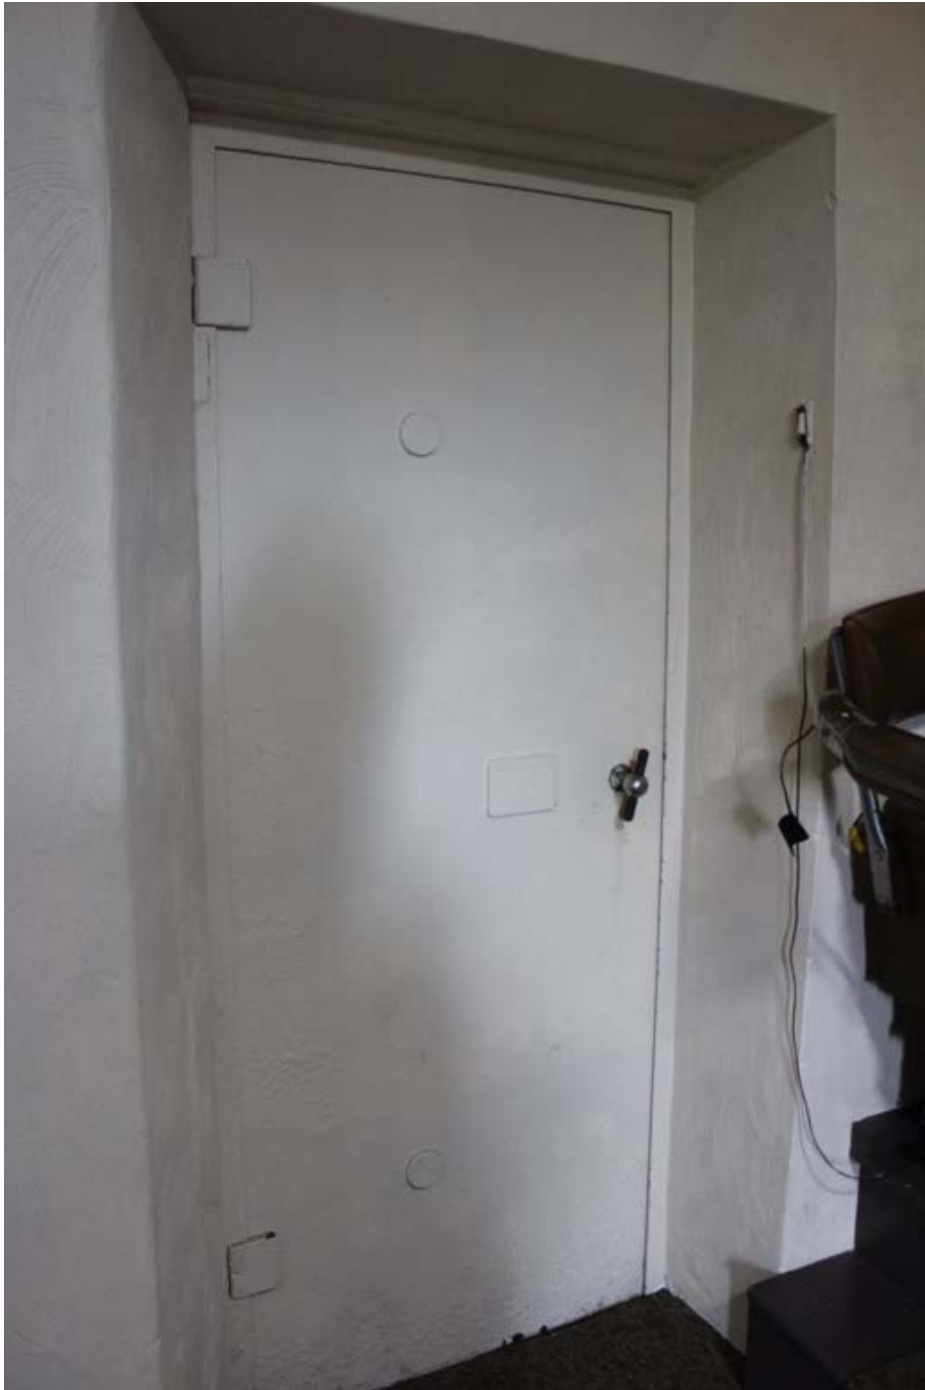
Image 35 Door to a safe in the jail kit house near the jail cells.

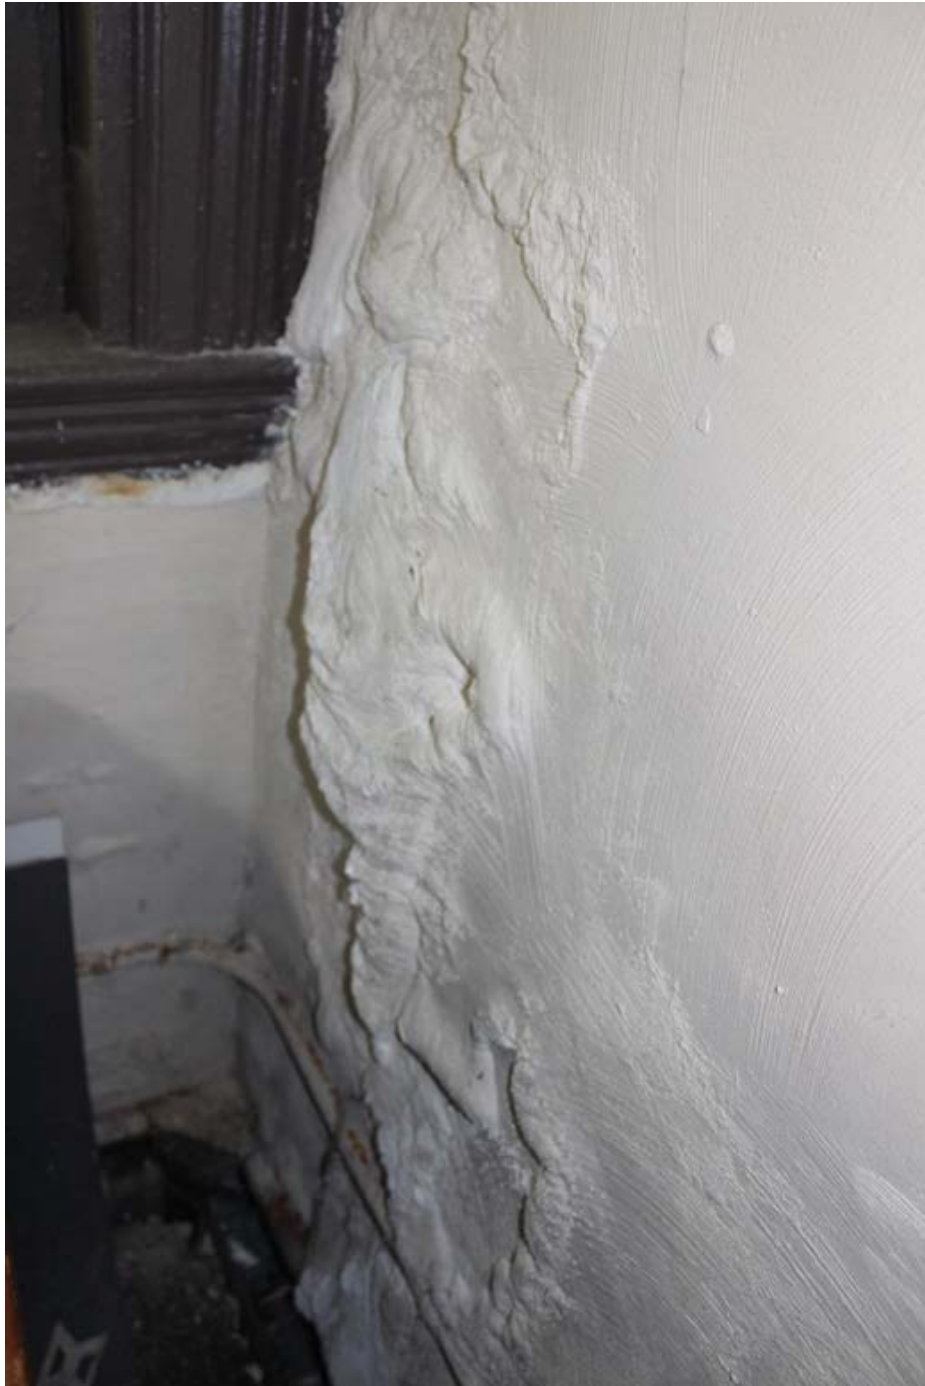
Image 36 Northwest corner of the wall on the first floor of the jail kit house where water has penetrated within the interior of the wall and has resulted in plaster deterioration. Electrical line is rusting along wall from water penetration.

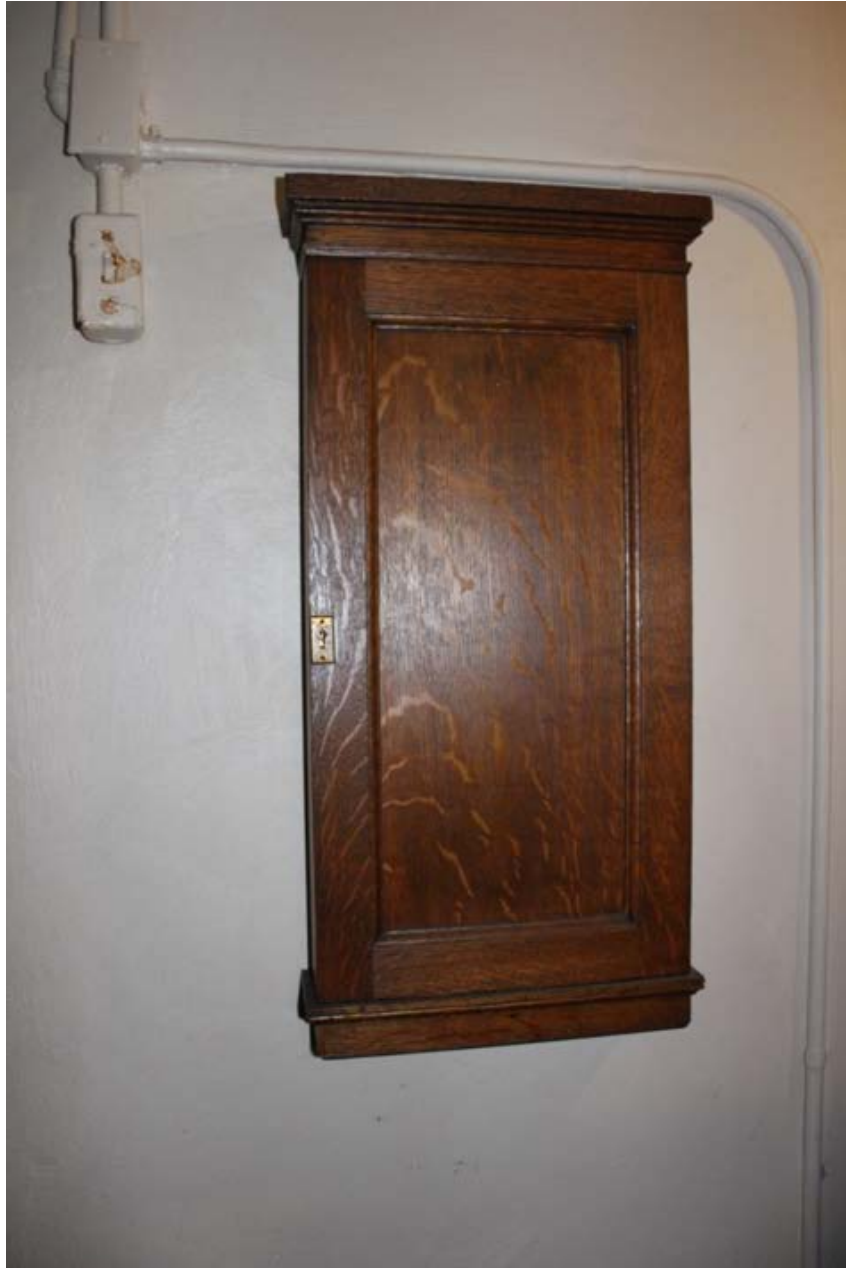
Image 37 Image of original, locked cabinet on wall just adjacent to jail cells that held keys to the cells

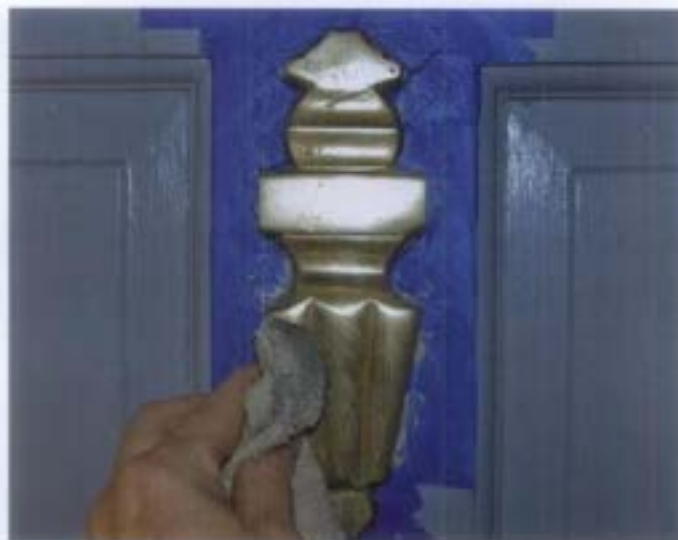
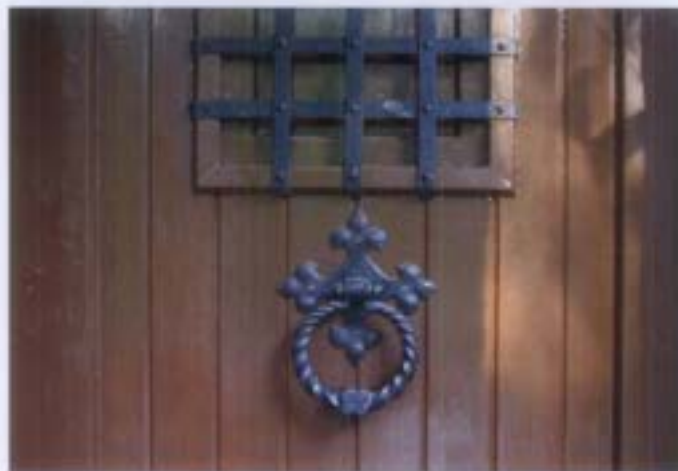
*Figure 1. Maintenance involves selecting the proper treatment and protecting adjacent surfaces. Using painter's tape to mask around a brass doorknocker protects the painted door surface from damage when polishing with chemical compounds. On the other hand, hardware with a patinated finish was not intended to be polished and should simply be cleaned with a damp cloth.*

Original building features and examples of special craftsmanship should be afforded extra care. The patina or aging of historic materials is often part of the charm and character of historic buildings. In such cases, maintenance should avoid attempts to make finishes look new by over-cleaning or cladding existing materials. As with any product that has the potential to harm historic materials, the selection of a cleaning procedure should always involve testing in a discreet location on the building to ensure that it will not abrade, fade, streak, or otherwise damage the substrate (Fig 1).

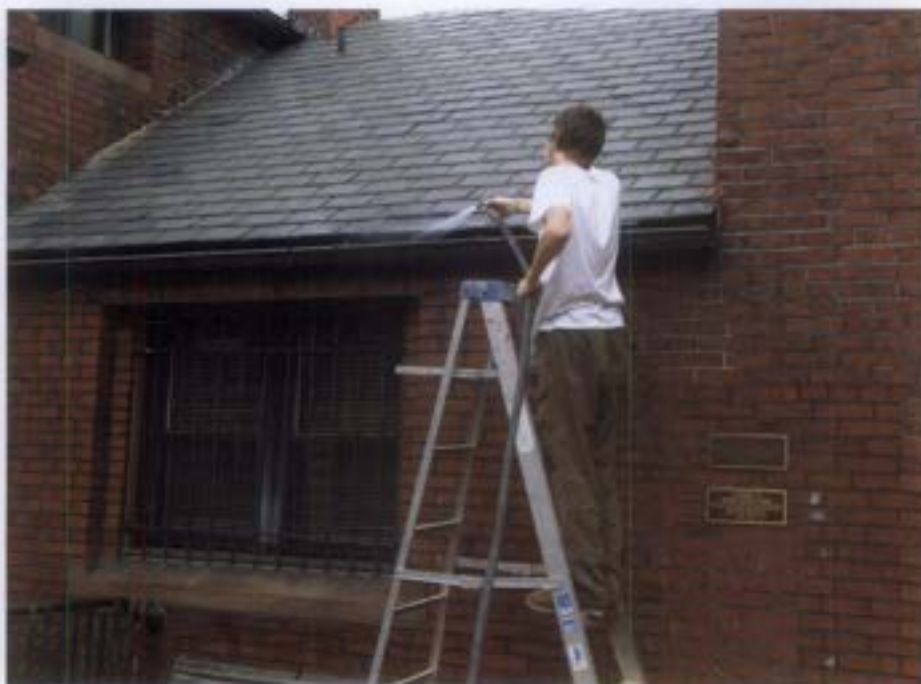
Figure 3. Keeping gutters clean of debris can be one of the most important cyclical maintenance activities. On this small one-story addition, a garden hose is being used to flush out the trough to ensure that the gutter and downspouts are unobstructed. Gutters on most small and medium size buildings can be reached with an extension ladder and a garden hose. Photo: Bryan Blundell.

The functioning of gutters and downspouts can be safely observed from the ground during rainy weather and when winter ice has collected. Binoculars are a useful tool in helping to identify potential roofing problems from the same safe vantage point. Careful observation from grade helps to identify maintenance needs between close-up inspections by an experienced roofer. Observation from the building interior is also important to identify possible leak locations. When access can be safely gained to the roof, it is important to wear shoes with slip-resistant soles and to use safety ropes.

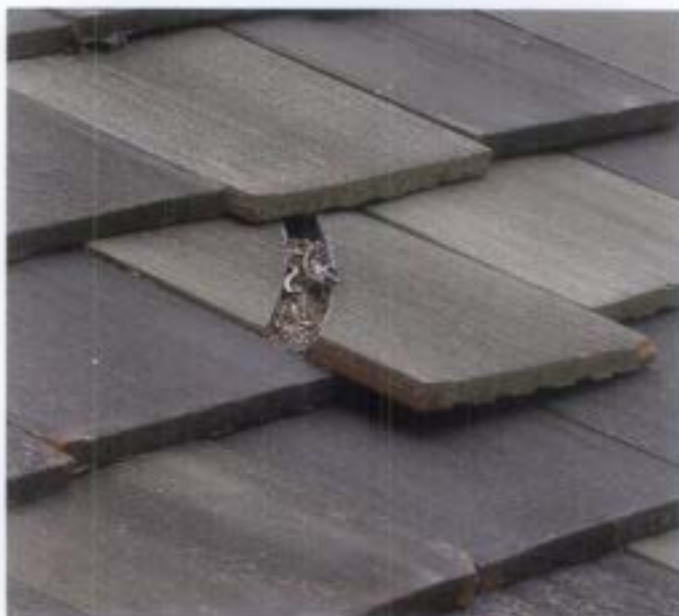
Figure 4. Damage to roofs often requires immediate attention. As a temporary measure, this damaged roof tile could be replaced with a brown aluminum sheet wedged between the existing tiles. Photo: Chad Randl.

- As a temporary measure, slip pieces of non-corrosive metal flashing under or between damaged and missing roofing units until new slate, shingles, or tile can be attached. Repair broken, missing or damaged roofing units with ones that match. Follow roofing supplier and industry guidance on inserting and attaching replacement units (Fig 4). Avoid using temporary asphalt patches as it makes a proper repair difficult later on.

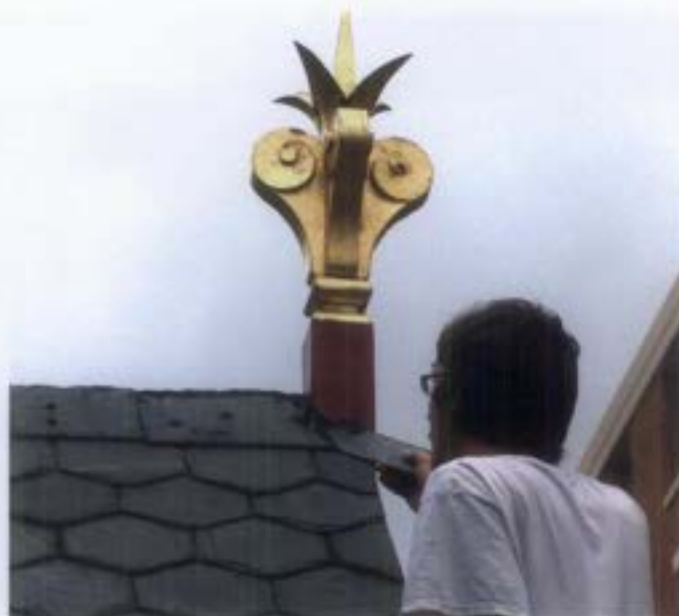
Figure 5. The use of a sealant to close an exposed joint is not always an effective long-term solution. Where this decorative wood element connects to the slate roof, the sealant has failed within a short time and a proper metal flashing collar is being fitted instead. Photo: Bryan Blundell.

- Re-secure loose decorative elements, such as finials and weathervanes. Seek professional advice if decorative elements exhibit considerable corrosion, wood rot, or structural instability. Small surface cracks may benefit from a flexible sealant to keep moisture out; sealants have a limited life and require careful inspection and periodic replacement (Fig 5).

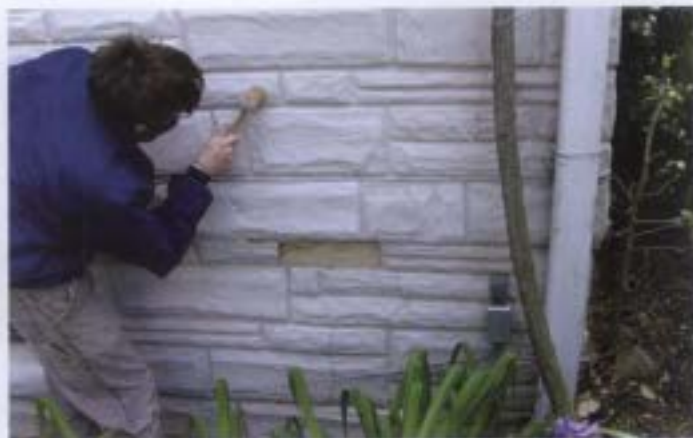
Figure 6. Stucco applied to an exterior wall or foundation was intended to function as a watertight surface. Unless maintained, rainwater will penetrate open joints and cracks that may occur over time. A spalled section of stucco indicates some damage has occurred and a wooden mallet is being used to tap the surface to determine whether the immediate stucco has lost adhesion. Photo: Bryan Blundell.

Exterior walls are designed to help prevent water infiltration, control air infiltration, and serve as a barrier for unwanted animals, birds and insects. The primary maintenance objective is to keep walls in sound condition and to prevent water penetration, insect infestation, and needless decay (Fig 6). Depending on the materials and construction methods, walls should have an even appearance, free from unwanted cracks, and should be able to shed excess moisture. Where surfaces are significantly misaligned or where there are bulging wall sections

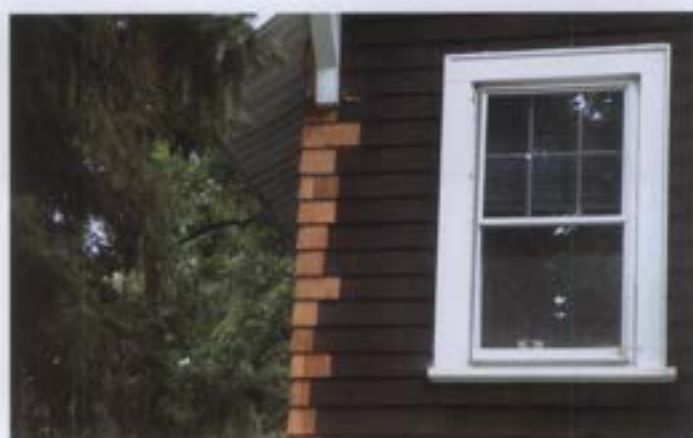
Figure 7. One of the advantages of wood shingles as a wall covering is that individual shingles that are damaged can easily be replaced. On this highly exposed corner, worn shingles have been selectively replaced to help safeguard against water damage. The new shingles will be stained to match the existing shingles.

or cracks indicative of potential structural problems, seek professional guidance as to the cause of distress and appropriate corrective measures. Wood-frame construction generally will require more frequent maintenance than buildings constructed of brick, stone, or terra cotta (Fig 7).

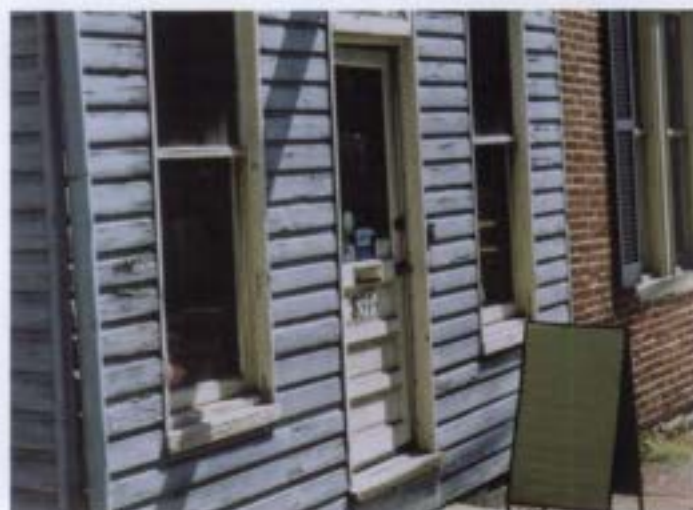
Figure 8. The paint on the siding of this south-facing wall needs to be scraped, sanded, primed and repainted. Postponing such work will lead to further paint failure, require greater preparatory costs, and could even result in the need to replace some siding. Photo: Charles Fisher.

- Misaligned surfaces, bulging wall sections, cracks in masonry units, diagonal cracks in masonry joints, spalling masonry, open joints, and nail popping;
- Evidence of wood rot, insect infestation, and potentially damaging vegetative growth;
- Deficiencies in the attachment of wall mounted lamps, flag pole brackets, signs, and similar items;
- Potential problems with penetrating features such as water spigots, electrical outlets, and vents;
- Excessive damp spots, often accompanied by staining, peeling paint, moss, or mold; and
- General paint problems (Fig 8).

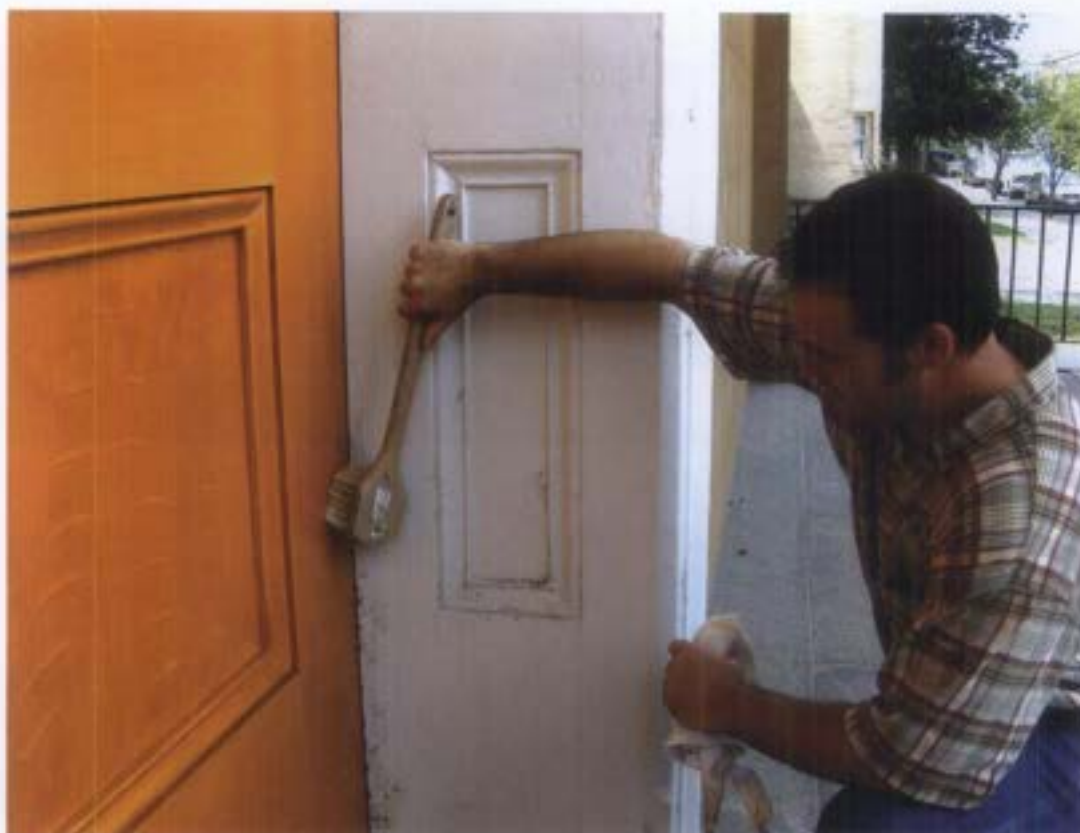
*Figure 9. To help extend a repainting cycle, dirt and spider webs should be removed before permanent staining occurs. In this case, a natural bristle brush and a soft damp cloth are being used to remove insect debris and refresh the surface appearance.*

scheduled times for cleaning for cosmetic purposes to reduce frequency (Fig 9). When cleaning, use the gentlest means possible; start with natural bristle brushes and water and only add a mild phosphate-free detergent if necessary. Use non-abrasive cleaning methods and low-pressure water from a garden hose. For most building materials, such as wood and brick, avoid abrasive methods such as mechanical scrapers and high-pressure water or air and such additives as sand, natural soda, ice crystals, or rubber products. All abrasives remove some portion of the surface and power-washing drives excessive moisture into wall materials and even into wall cavities and interior walls. If using a mild detergent, two people are recommended, one to brush and one to prewet and rinse. When graffiti or stains are present, consult a preservation specialist who may use poultices or mild chemicals to remove the stain. If the entire building needs cleaning other than described above, consult a specialist.

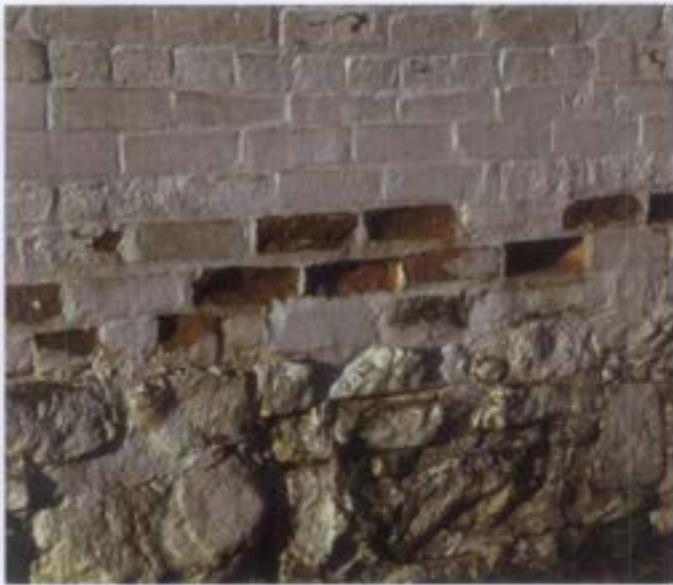
*Figure 10. Repointing of masonry should usually be approached as repair rather than maintenance work in part because of the need for a skilled mason familiar with historic mortar. In this case, a moisture condition was not corrected and the use of a waterproof coating and off-the-shelf Portland cement mortar trapped water and resulted in further damage to these 19th century bricks. Photo: NPS files.*

mortar on vertical masonry wall surfaces, as they are not breathable and can lead to moisture-related damage of the adjacent masonry (Fig 10).

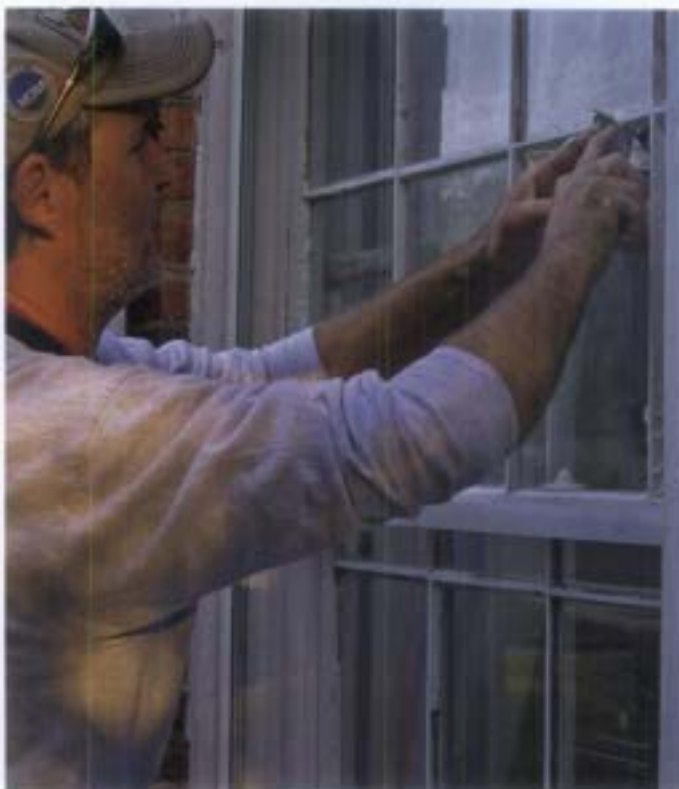
*Figure 11. Glazing putty should be maintained in sound condition to prevent unwanted air infiltration and water damage. New glazing putty should be pulled tight to the glass and edge of the wood, creating a clean bevel that matches the historic glazing.*

- Reputty window glazing where putty is deteriorated or missing. Take care in removing putty so as not to crack or break old glass or damage muntins and sash frames. Re-glaze with either traditionally formulated

oil putties or modern synthetic ones, making sure to properly bed the glass and secure with glazing points (Fig 11).

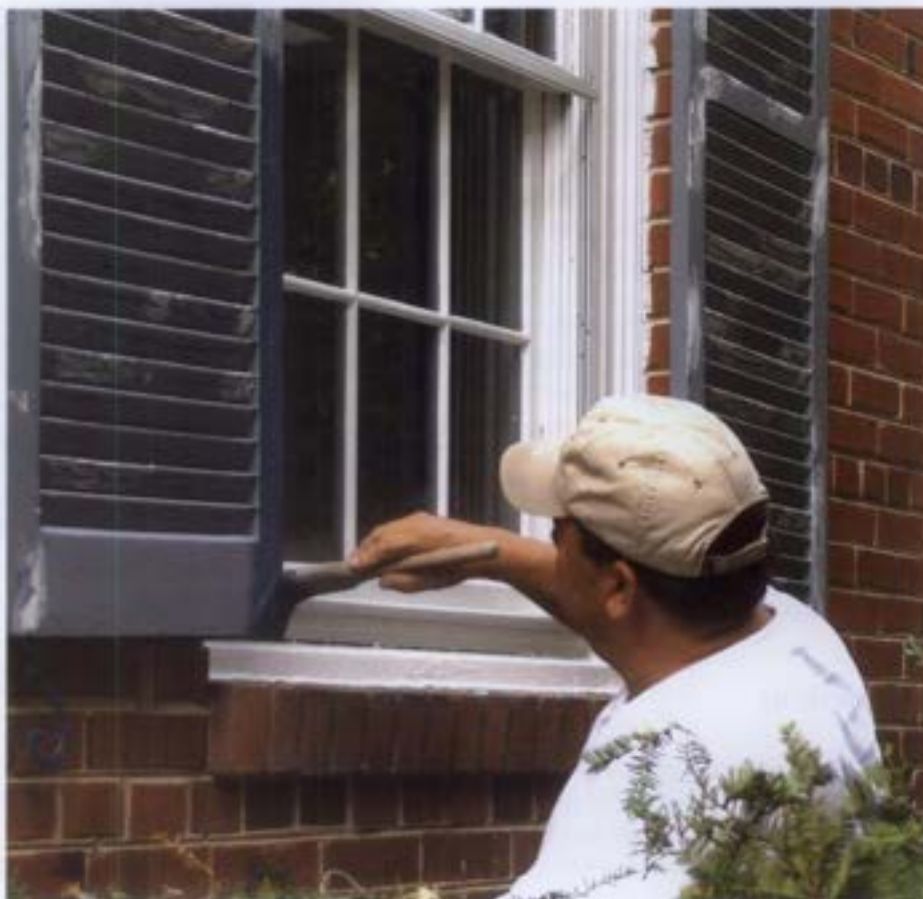
*Figure 12. Good surface preparation is essential for long lasting paint. Scraping loose paint, filling nail holes and cracks, sanding, and wiping with a damp cloth prior to repainting are all important steps whether touching up small areas or repainting an entire feature. Always use a manufacturer's best quality paint. Windows and shutters may need repainting every five to seven years, depending on exposure and climate.*

- Repair, prime, and repaint windows, doors, frames, and sills when needed. Clean out putty debris and paint chips from windows using a wet paper towel and dispose of debris prior to repair or repainting. Take appropriate additional precautions when removing lead-based paint. Sand and prepare surfaces and use material-specific patching compounds to fill any holes or areas collecting moisture (Fig 12). Avoid leaving exposed wood unpainted for any length of time, as light will degrade the wood surface and lead to premature failure of subsequent paint applications. Immediately prime steel sash after paint is removed and the substrate prepared for repainting.

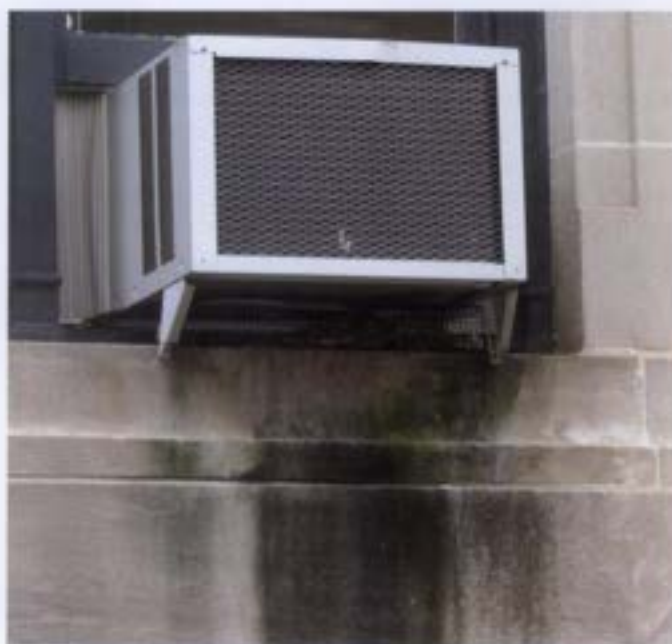
*Figure 13. Window air conditioning units can cause damage to surfaces below when condensation drips in an uncontrolled manner. Drip extension tubes can sometimes be added to direct the discharge.*

- Remove debris beneath window air conditioning units and ensure that water from units does not drain onto sills or wall surfaces below (Fig 13). Removal of air conditioning units when not in season is recommended.

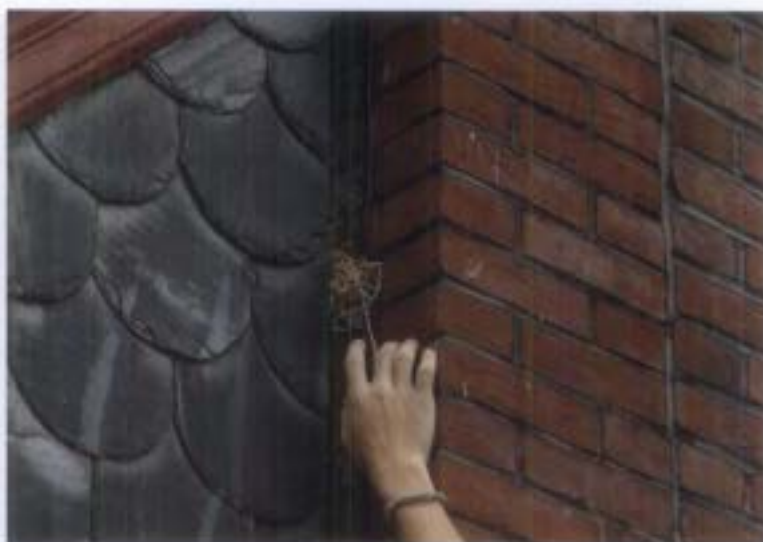
*Figure 14. When inspecting connections between projections and the main building, look for areas where birds, bees and pests may enter or nest. Birds have been nesting in this porch roof and the area is being cleaned of their debris. Where an opening exists, it may be necessary to cover it with a trim piece, screening, or sealant. Photo: Bryan Blundell.*

- damaged flashing or tie-in connections of projecting elements;
- misaligned posts and railings;
- deteriorated finishes and materials, including peeling paint, cupped and warped decking, wood deterioration, and hazardous steps;
- evidence of termites, carpenter ants, bees, or animal pests (Fig 14);
- damaged lamps, unsafe electrical outlets or deteriorated seals around connections;
- loose marker plaques, sign, or mail boxes; and

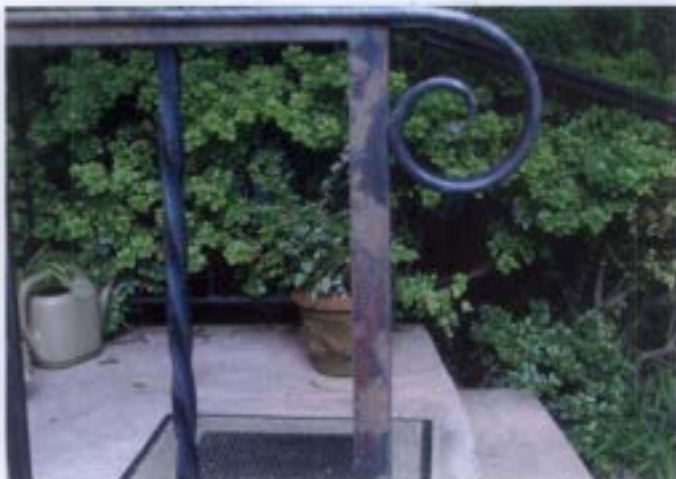
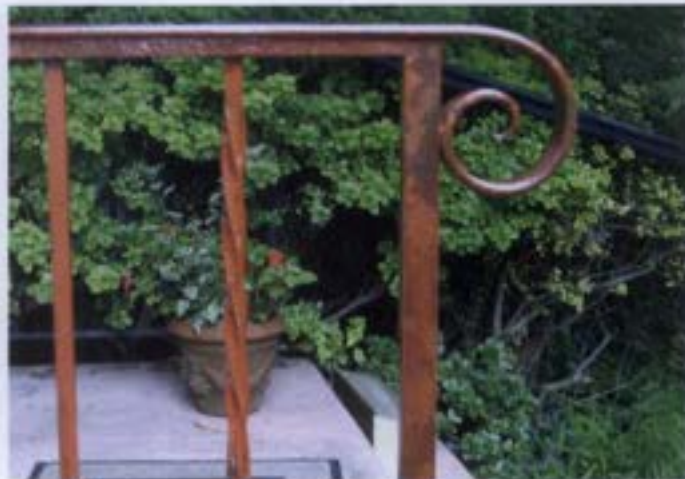
Figure 15. Metal projecting elements on a building, such as sign armatures and railings, are easily subject to rust and decay. Proper surface preparation to remove rust is essential. Special metal primers and topcoats should be used.

- Secure any loose connections, such as on porch rails or fire escapes.
- Maintain ferrous metal components by following manufacturer's recommendation for cleaning and repainting. Remove rust and corrosion from porch handrails, balconies, fire escapes, and other metal features; prepare, prime, and repaint using a corrosion-inhibitive coating system. Apply new primer before new corrosion sets in, followed by new topcoat. Take appropriate safety measures when dealing with existing lead-based paint and in using corrosion-removal products (Fig 15).

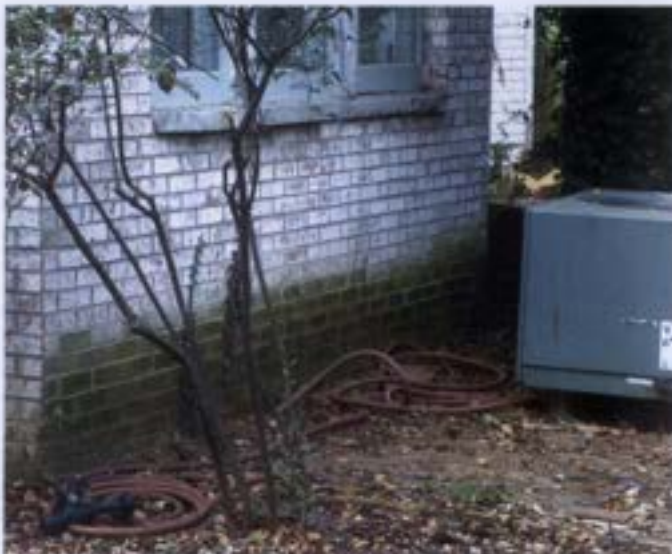
Figure 16. This chronically wet area has a mildew bloom brought on by heat generated from the air-conditioning condenser unit. The dampness could be caused by a clogged roof gutter, improper grading, or a leaking hose bibb.

- material deterioration at or near the foundation, including loss of mortar in masonry, rotting wood clapboards, or settlement cracks in the lower sections of wall;
- evidence of animal or pest infestation;
- vegetation growing close to the foundation, including trees, shrubs and planting beds;
- evidence of moisture damage from lawn and garden in-ground sprinkler systems;
- evidence of moss or mold from damp conditions or poorly situated downspout splash blocks (Fig 16); and
- blocked downspout drainage boots or clogged areaway grates.

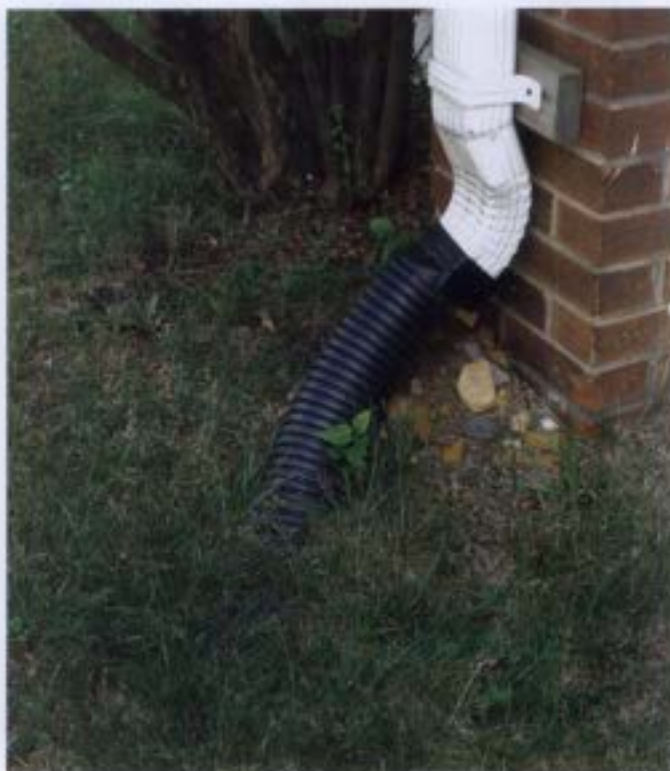
*Figure 17. Extending downspouts at their base is one of the basic steps to reduce dampness in basements, crawl spaces and around foundations. Extensions should be buried, if possible, for aesthetics, ease of lawn care, and to avoid creating a tripping hazard. Photo: NPS files.*

- Reset splash blocks at the end of downspouts or add extender tubes to the end of downspouts as necessary (Fig 17).
- Lubricate operable foundation vent grilles to facilitate seasonal use; paint as needed.
