Tionesta Township – Stitzinger Road

Forest County

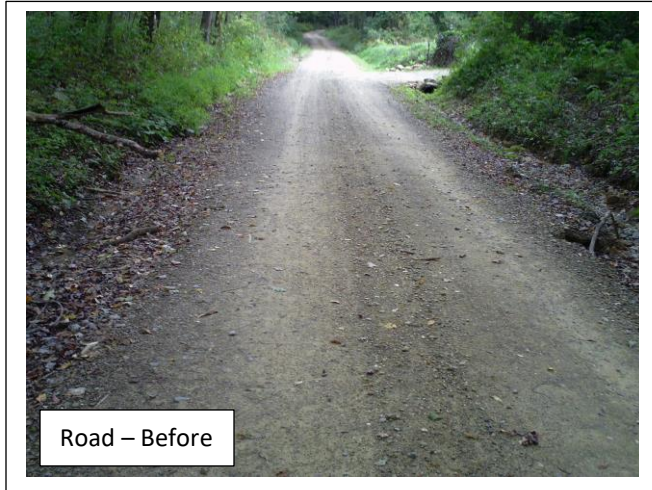
Problem: The road was severely entrenched, with severely eroded ditches. The deep ditches were carrying sediment to the stream. The entire roadway had flooding and erosion problems.
