| Figure 5.1-1 | Silver Lake Watershed – Subwatersheds and Flow Routing ..... | 5.1-17 |

## 5.1 Silver Lake Watershed Management Plan

**SILVER LAKE WATERSHED**  
**CURRENT (2010) AND FUTURE (2030) LANDUSE**  
2015-2025 Watershed Management Plan  
Valley Branch Watershed District

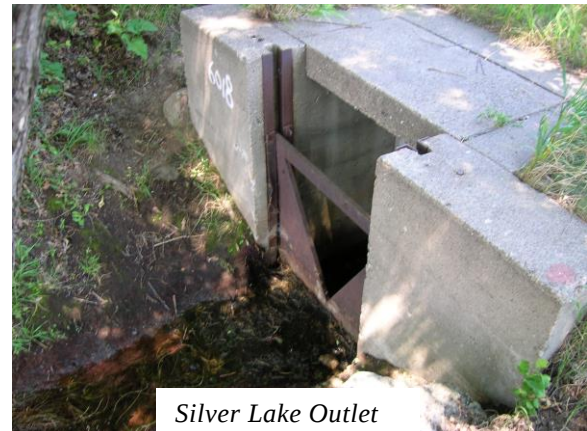
Silver Lake Outlet

Runoff from the Silver Lake watershed enters the lake from storm sewer outfalls and culverts at various points along the lakeshore. The outlet from Silver Lake is a V-notch weir located on the west side of Century Avenue (T.H. 120) on the east side of the lake. The outlet elevation of the lake is Elevation 988.78 (NAVD88 datum, based on a 2008 Ramsey County Survey). Water from the lake flows east under Century Avenue (T.H. 120) to a large DNR protected wetland (#82-0375W) in the Greens of Silver Lake development, located in the City of Oakdale. Silver Lake water level data from 1925 to the present is available from Ramsey County and are shown in Figure 5.1-4 (NAVD88 vertical datum). The MDNR's ordinary high water elevation (OHW) for Silver Lake is 989.84 feet (NAVD88 vertical datum, or 989.57 feet in 1912 datum). The Federal Emergency Management Agency (FEMA) 2010 Flood Insurance Study (FIS) identifies the 100-year flood elevation of Silver Lake as 991feet (NAVD88 vertical datum); note that FEMA rounds to the nearest foot. More recent hydrologic model results (by Oakdale and VBWD) show the 100-year flood elevation of the lake to be approximately 0.5 foot lower.

Since Silver Lake is tributary to the VBWD's flood control project (Project 1007), it is important that the VBWD not allow modifications to the Silver Lake outlet that would negatively affect the proper functioning of the flood control project. It is also important that there be no increases to the Silver Lake flood elevation. As a result, the VBWD has no plans to modify the lake outlet and will manage Silver Lake so that its 100-year flood elevation is maintained at its current level, which is Elevation 991.0, according to the Federal Emergency Management Agency (FEMA) 2010 Flood Insurance Study, or Elevation 990.5, as modeled by the City of Oakdale and the VBWD. The *City of North St. Paul Water Management Plan* (North St. Paul Plan) states that although the Silver Lake outlet is located in the City of Oakdale, the City of North St. Paul has been assuming responsibility for maintenance of the outlet. The City of North St. Paul will continue to maintain the outlet, as the outlet structure is critical to minimizing the impact of flooding on homes in North St. Paul.
