**Historic Building Survey  
Of the Rath Administration Building  
Waterloo, Black Hawk County, Iowa**

October 2005

**City of Waterloo  
Black Hawk County, Iowa**

**Howard R. Green Company  
2550 University Avenue West, Suite 400N  
St. Paul, MN 55114**

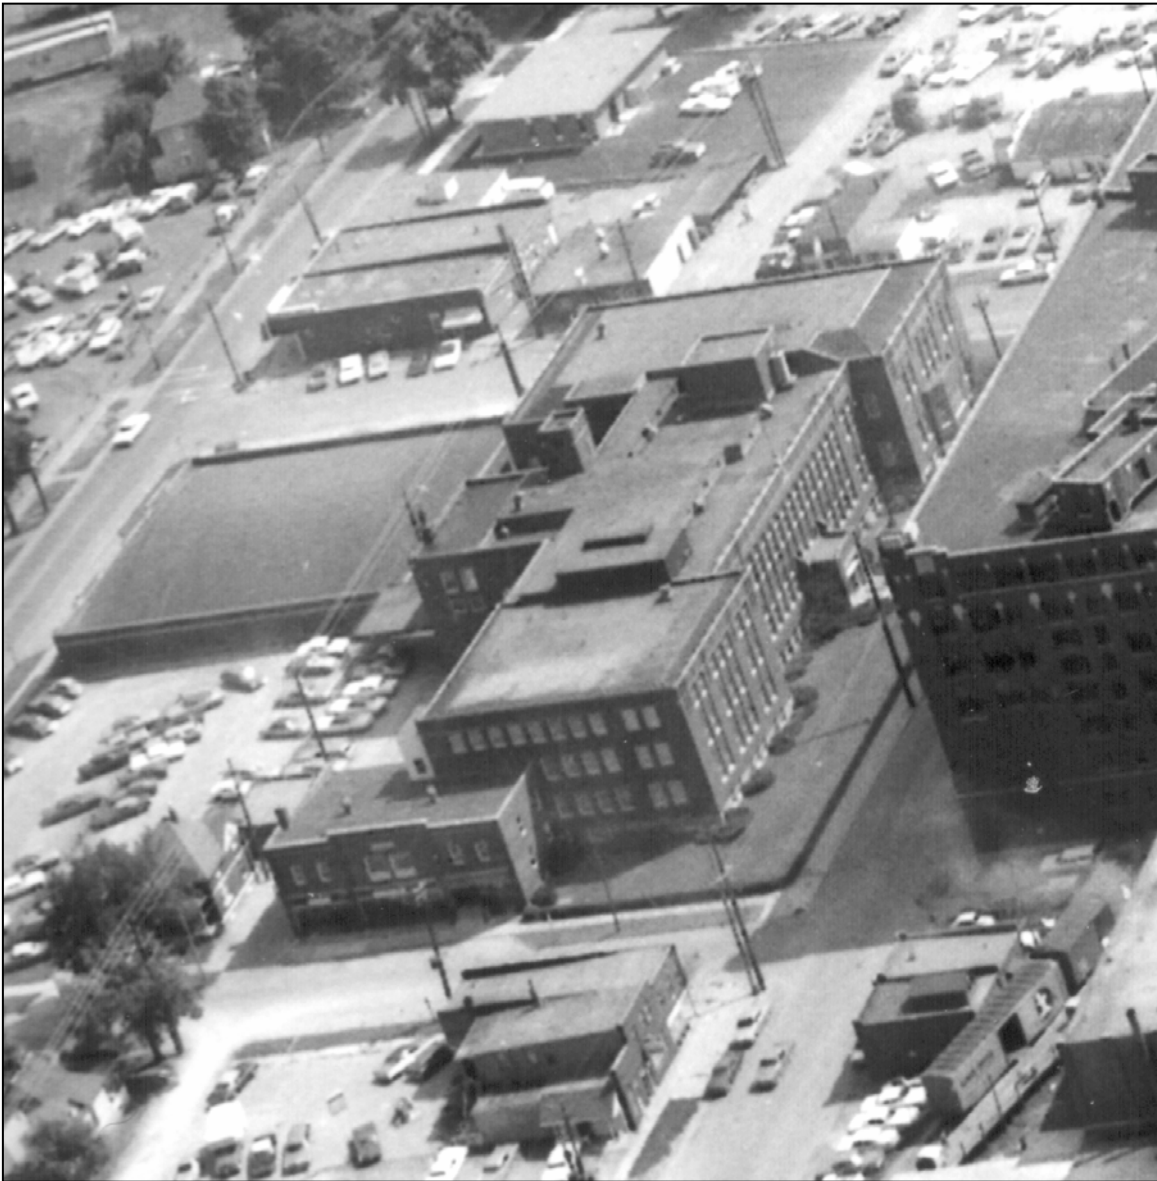
Administration Building, Rath Packing Company, circa 1970, looking southeast. This aerial photograph shows the building as it appeared at a time of full utilization of the entire plant. The original 1925 structure is located in the central portion of the building. Originally, it was a 130-foot by 100-foot two story structure with the main entry doors centered on its front, facing Sycamore Street. The original 1925 building is partially topped by a wooden attic structure that provided space for storage and ventilation equipment. In circa 1940, the overall building size was doubled when a 63-foot by 117.5-foot, two story addition topped by a concrete storage area was added to the southern portion of the original structure along Division Street. In circa 1950, a 63-foot by 75-foot, three story addition was added to the northern portion of the 1925 structure along Elm Street. The 1950s addition also resulted in the incorporation of the 48.5-foot by 70-foot Adams Building into the Administration Building. Photograph courtesy of Walden Photography of Waterloo.

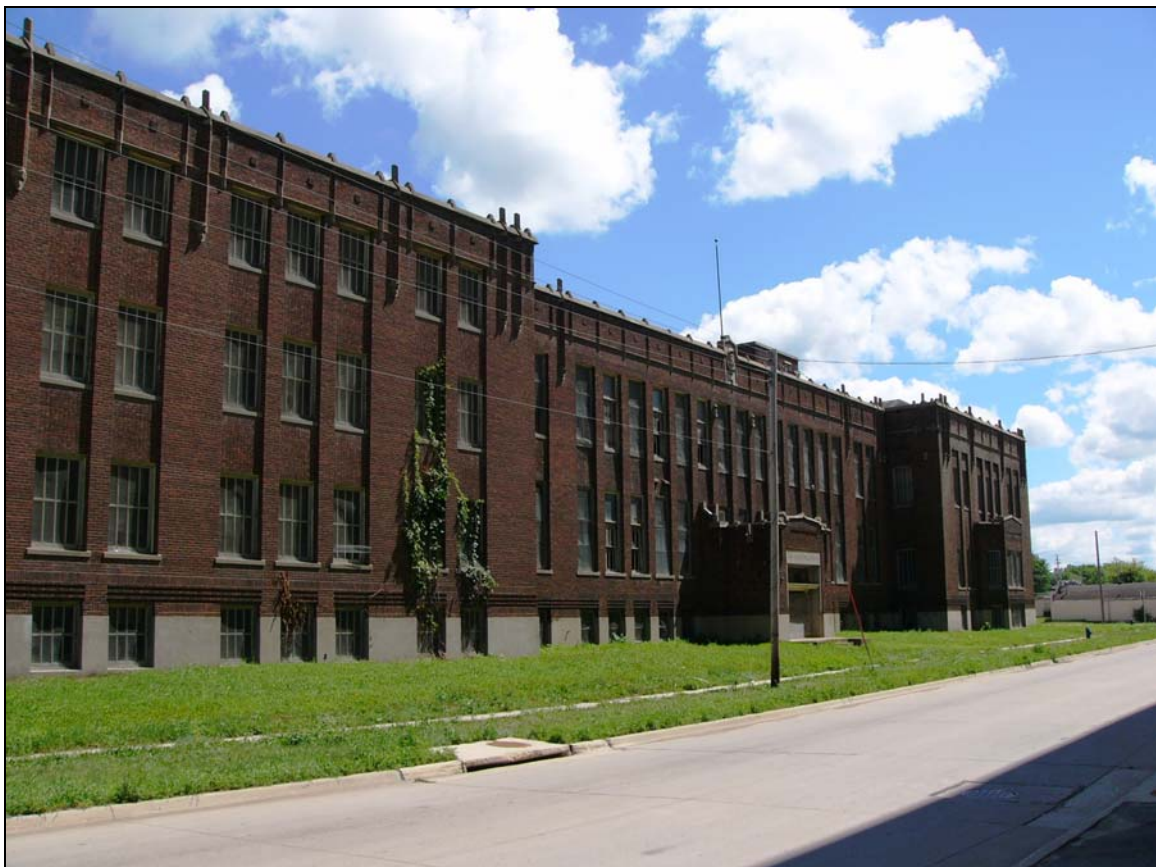
Front façade of the Rath Administration Building as viewed from Sycamore Street near the northwest corner of the building. Building 48A features three bands of 4 over 4 light windows. The original portion of Building 48 features two bands of windows with additional fixed panes above each of the 4 over 4 light windows, resulting in a wide band of windows. Photograph by J. Trnka, July 2005.

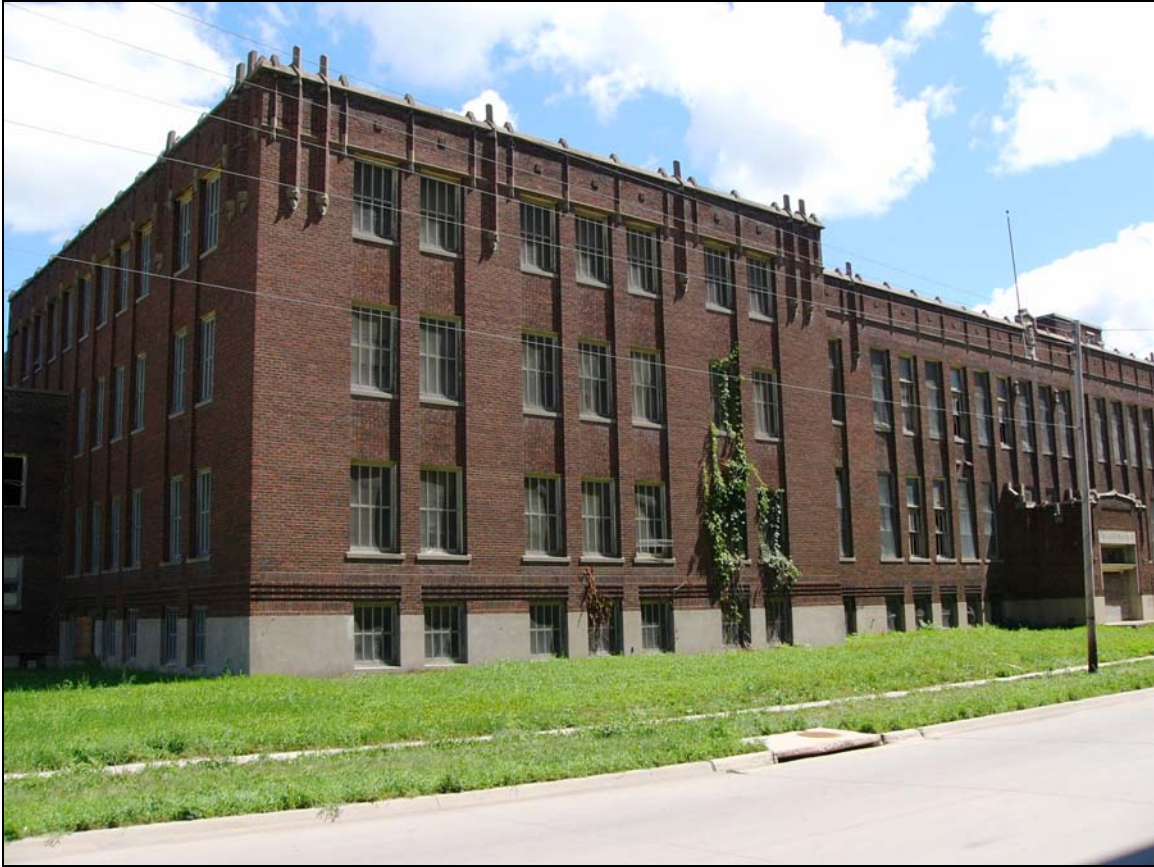
Northwest corner of the front façade of Building 48A and Building 48. This two-story and three-story structure has a footprint of approximately  $\frac{1}{2}$  city block. Constructed of a reinforced concrete or steel frame with brick curtain walls and large windows, its architectural style strongly resembles a public school. While this portion of the Administration Building was constructed outside of the period of significance for the Rath Packing Company, the exterior materials and design are clearly sympathetic to the design of the original 1925 structure. Therefore, the exterior of Building 48A does not significantly impair the exterior integrity of Building 48, the original structure. Photograph by J. Trnka, July 2005.

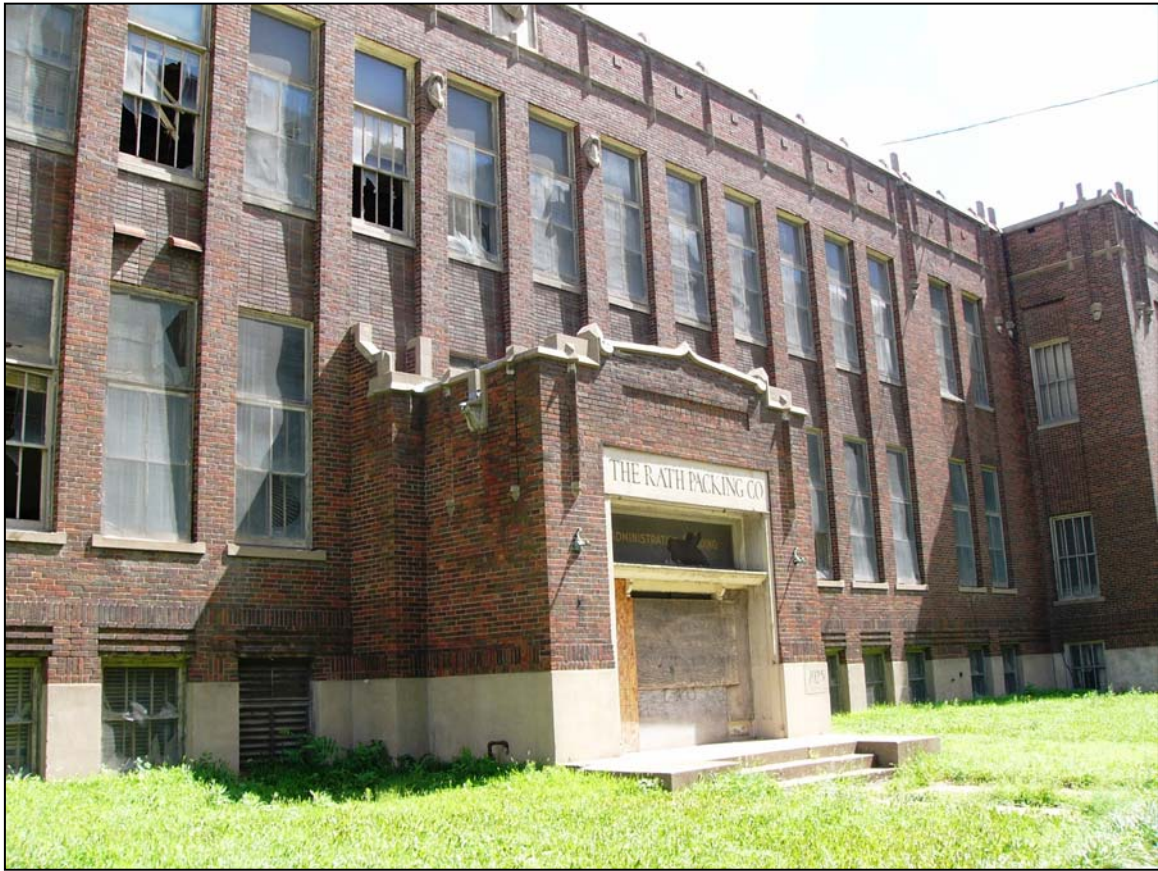
Main entrance in the front façade of Building 48. This is the 1925 portion of the Administration Building. The words, "The Rath Packing Co." are clearly inscribed in the stone lintel that topped the double doors. The vertical scale of this two-story building is exaggerated by the use of fixed sash windows above the bands of main and second floor windows. The difference between the original windows of Building 48 and the circa 1940 addition to Building 48 are shown. The addition features two bands of 4 light over 4 light windows but without the additional rows of fixed panes. Photograph by J. Trnka, July 2005.

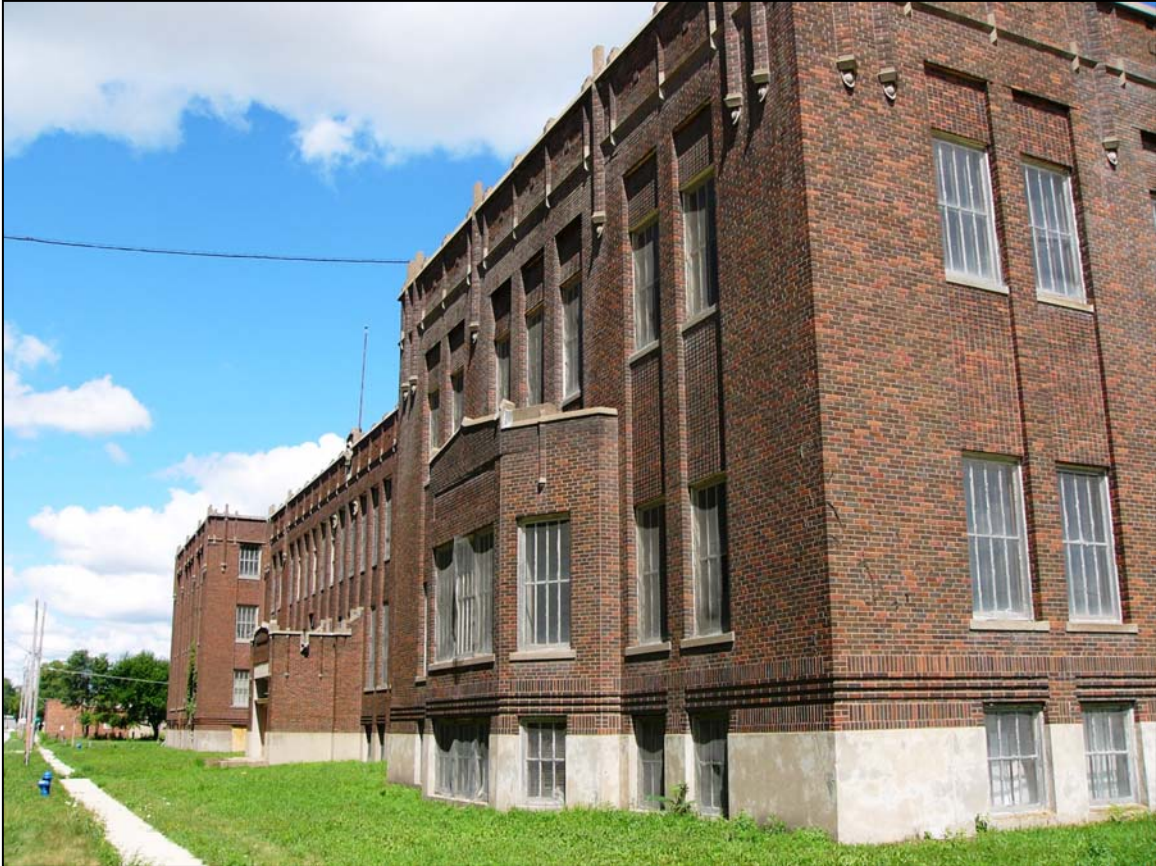
Front façade as seen from the intersection of Sycamore Street and Division Street. The cant bay window in the center of the photograph illuminates the corporate conference room. While this portion of the Administration Building was constructed outside of the period of significance for the Rath Packing Company, it is clearly sympathetic to the design of the original 1925 structure and does not significantly impair the integrity of the original structure. Photograph by J. Trnka, July 2005.

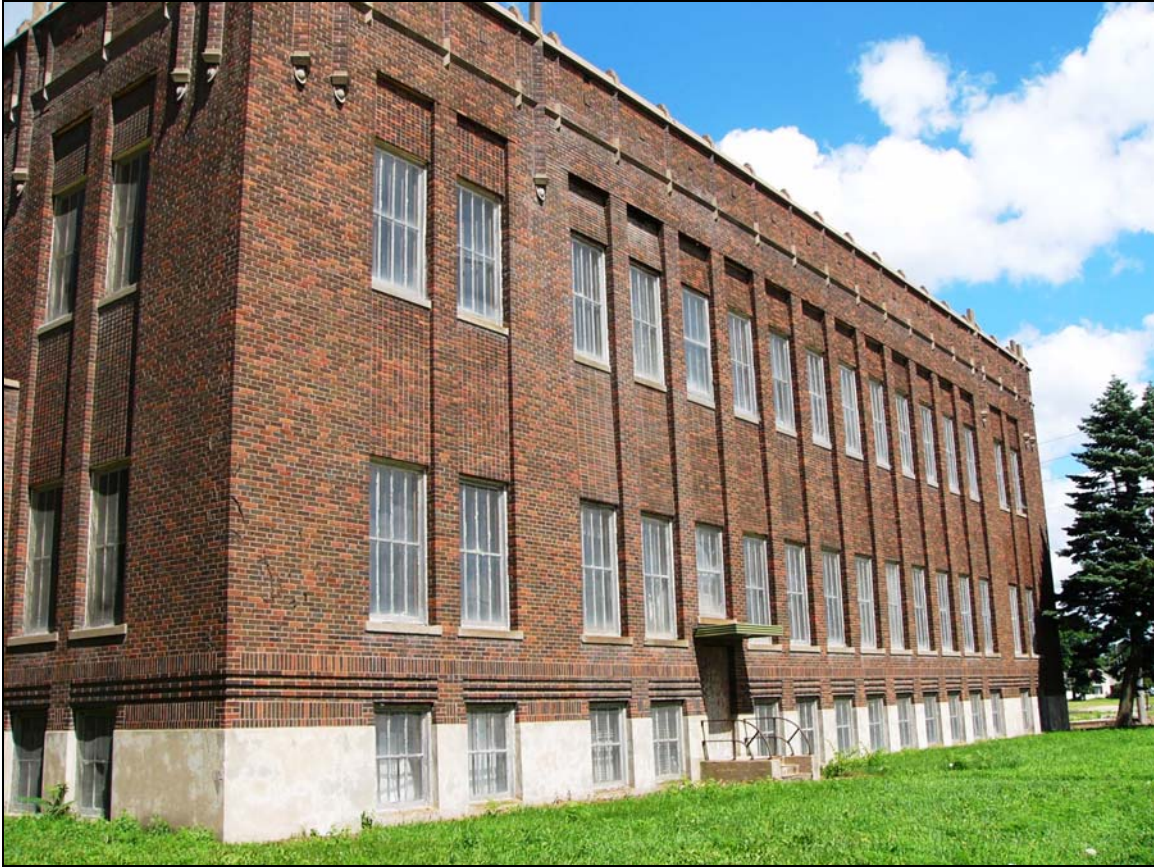
Side façade of Building 48 from the intersection of Sycamore Street and Division Street. The main floor of this corner of the 1940 addition contained the corporate offices, corporate conference room, and has a side entrance that lead a small off-street parking area along Division Street. Photograph by J. Trnka, July 2005.

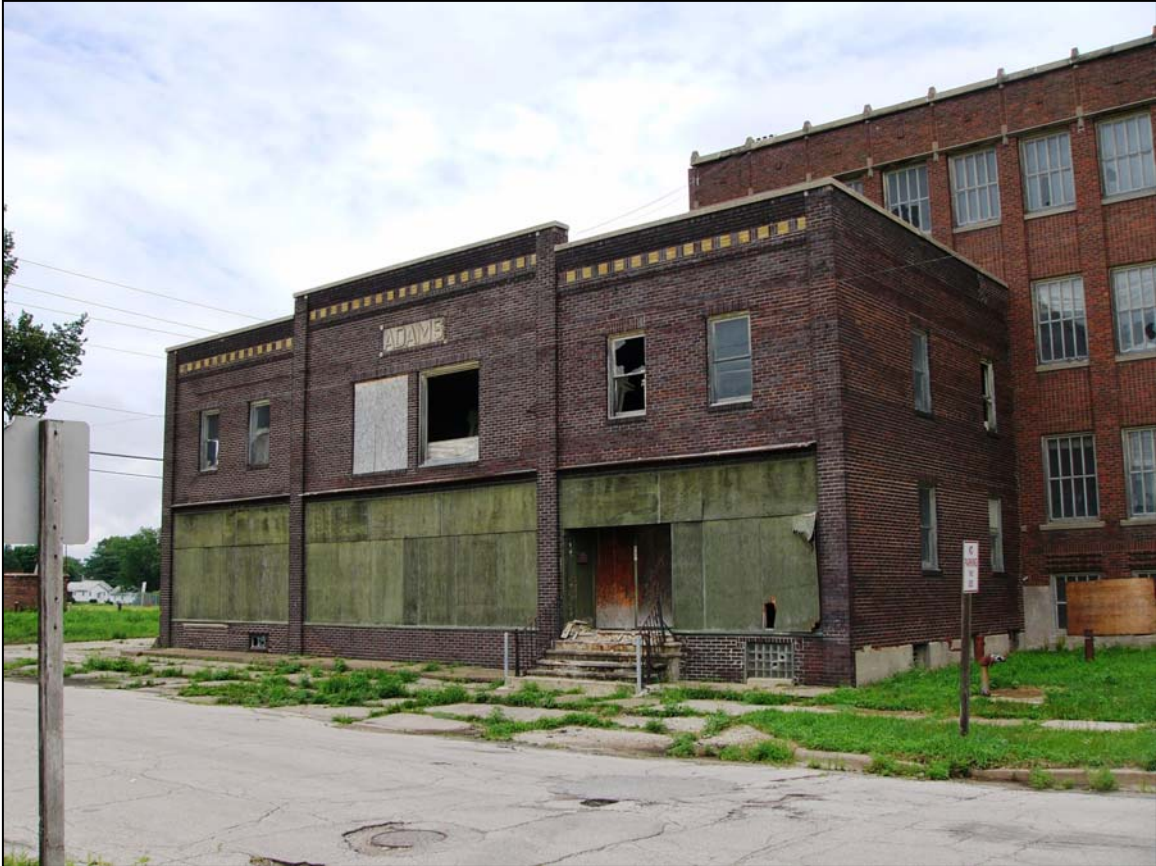
Front façade and side façade of Building 172, the former Adams Building, viewed from near the intersection of Elm Street and Sycamore Street. The three story addition (Building 48A) to Building 48 also resulted in the incorporation of the Adams Building into the Administration Building. However, even after it was incorporated, the Adams section continued to be identified by its own building number. The Adams section is not heated and the majority of its windows have been broken or otherwise compromised, exposing the interior to the elements. The Adams section is expected to continue to deteriorate at an accelerated rate unless the building envelope is immediately stabilized. This portion of the Administration Building was constructed outside of the period of significance for the Rath Packing Company. It is clearly not sympathetic to the design of the original 1925 structure and significantly impairs the overall historic integrity of the original structure. Photograph by J. Trnka, July 2005.

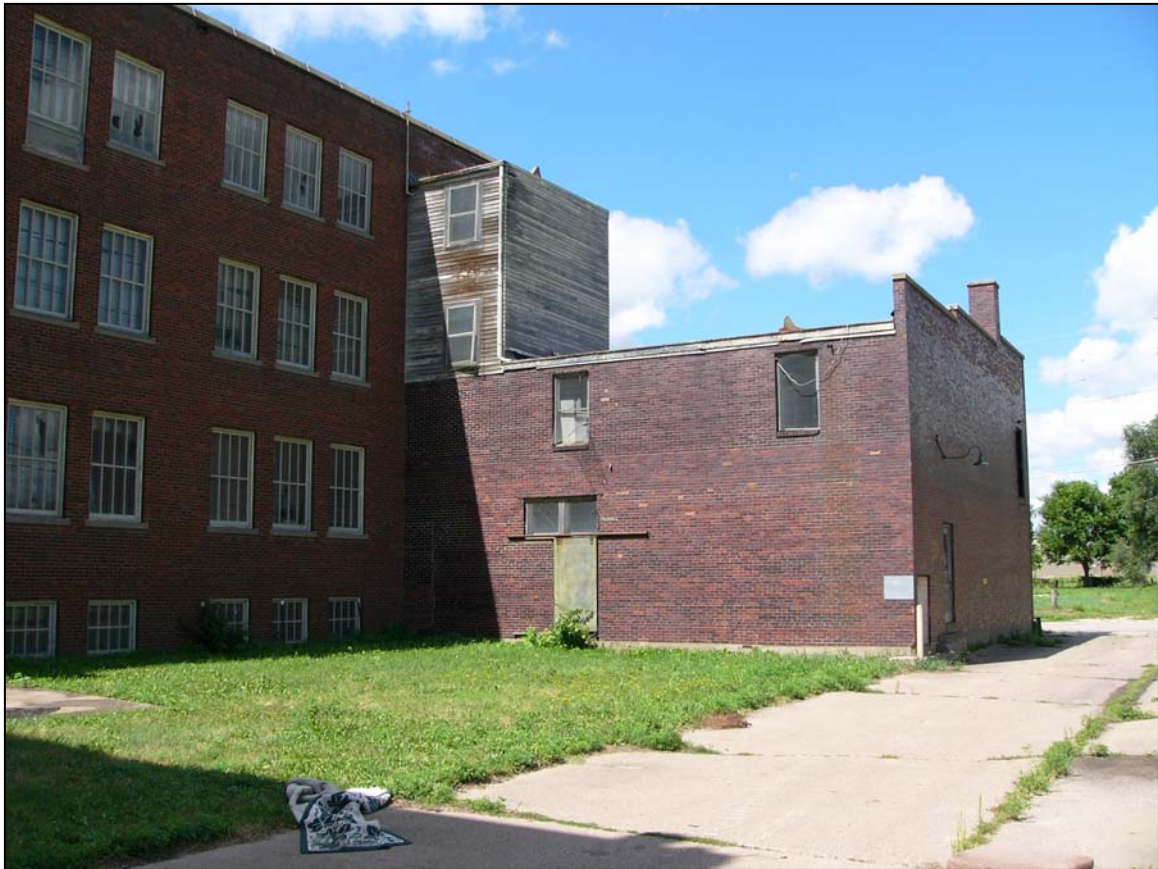
Rear façade and side façade of Building 172 (Adams). The physical relationship between the two buildings is complicated by the fact that the floors of Building 48A do not correspond with the floors of the Adams section. The wooden structure above Building 172 is a stair well that provides access between it and the upper floors of Building 48A. Photograph by J. Trnka, July 2005.

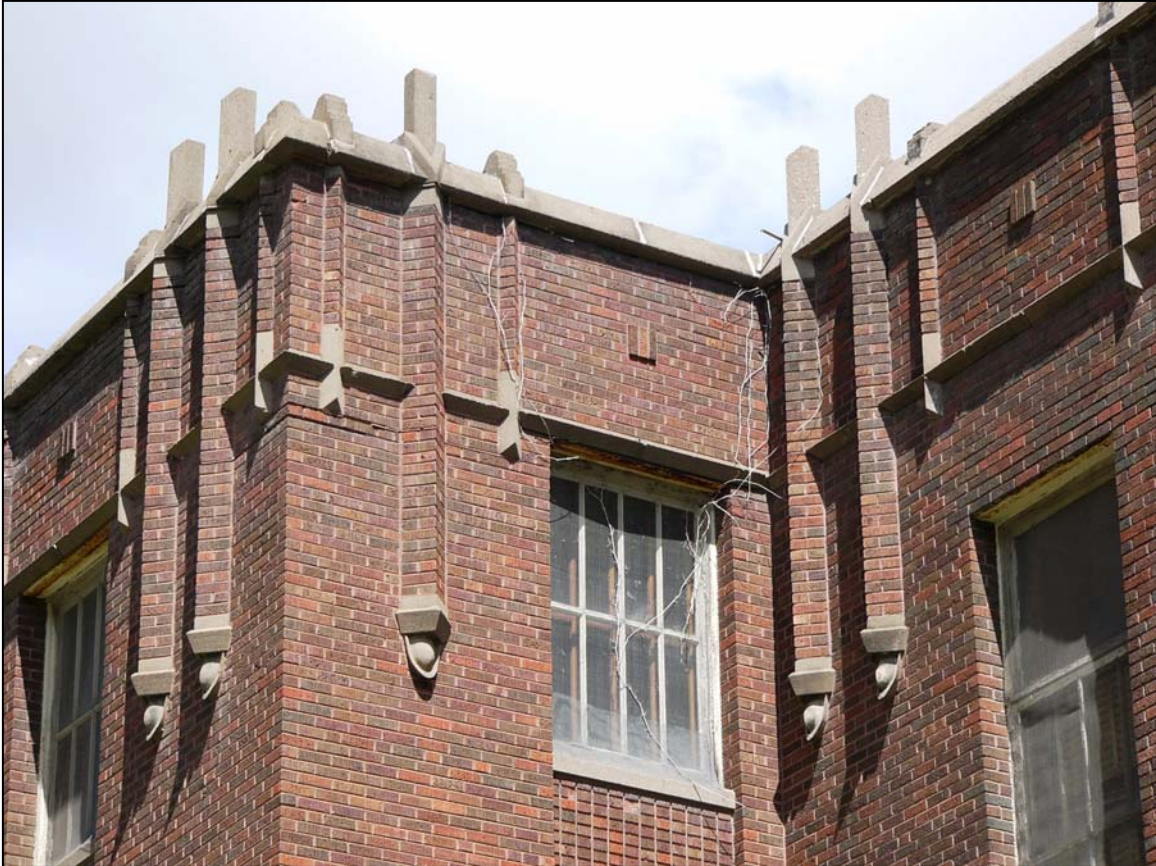
Lavish use of a variety of brick and stone detailing is exhibited throughout the exterior of the Administration Building, especially on the building's front. These corner details are found at the roofline of the southwest corner where the three-story, 1950 section meets with the original two-story, 1925 section. As shown here, the front of the 1950 addition has details that match the original 1925 section. The rear of the 1950 addition does not contain these details. Photograph by J. Trnka, July 2005.

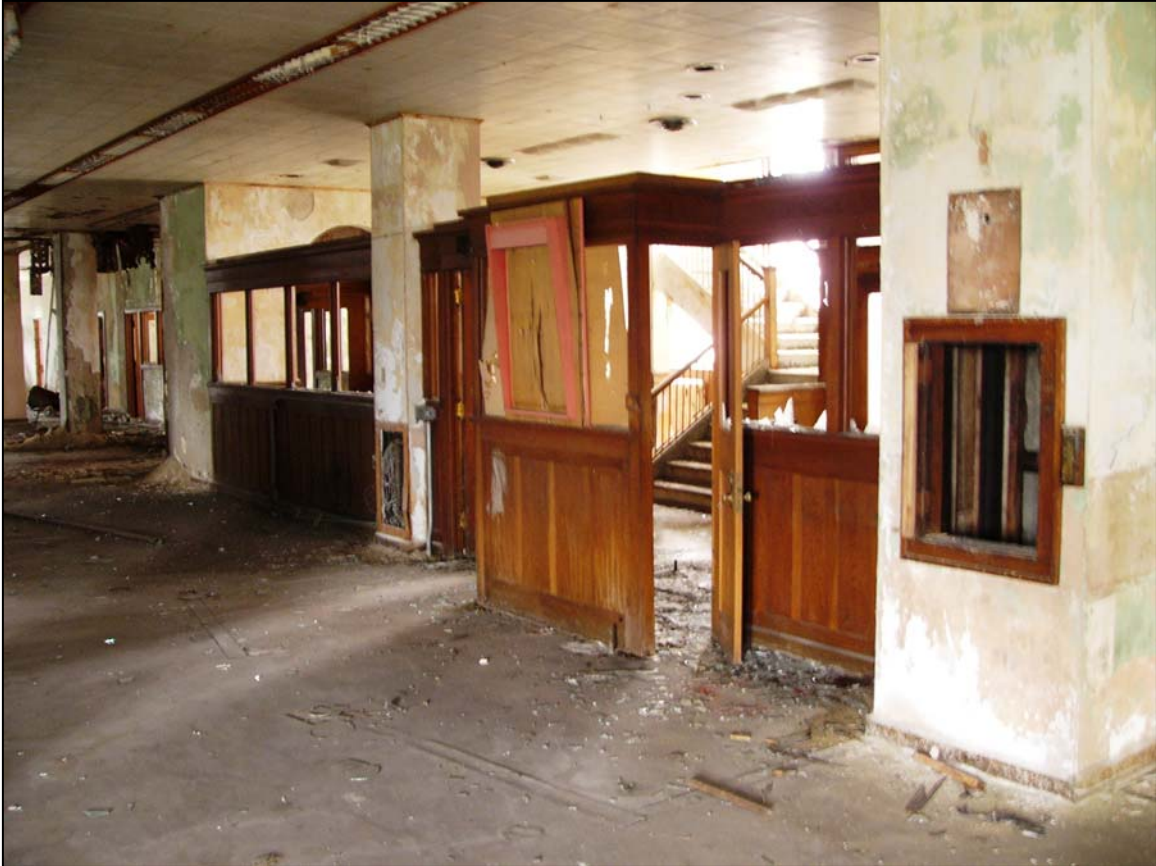
Main floor – entrance to Building 48. The stairway leading up from the main entrance in the front façade ended here. It is clear from the floor and fixture layout that the people that had business with the administrative personnel would have been screened here. The opening in the nearest column is a dumbwaiter that provided access to the 2<sup>nd</sup> floor, attic, and basement. Photograph by J. Trnka, July 2005.

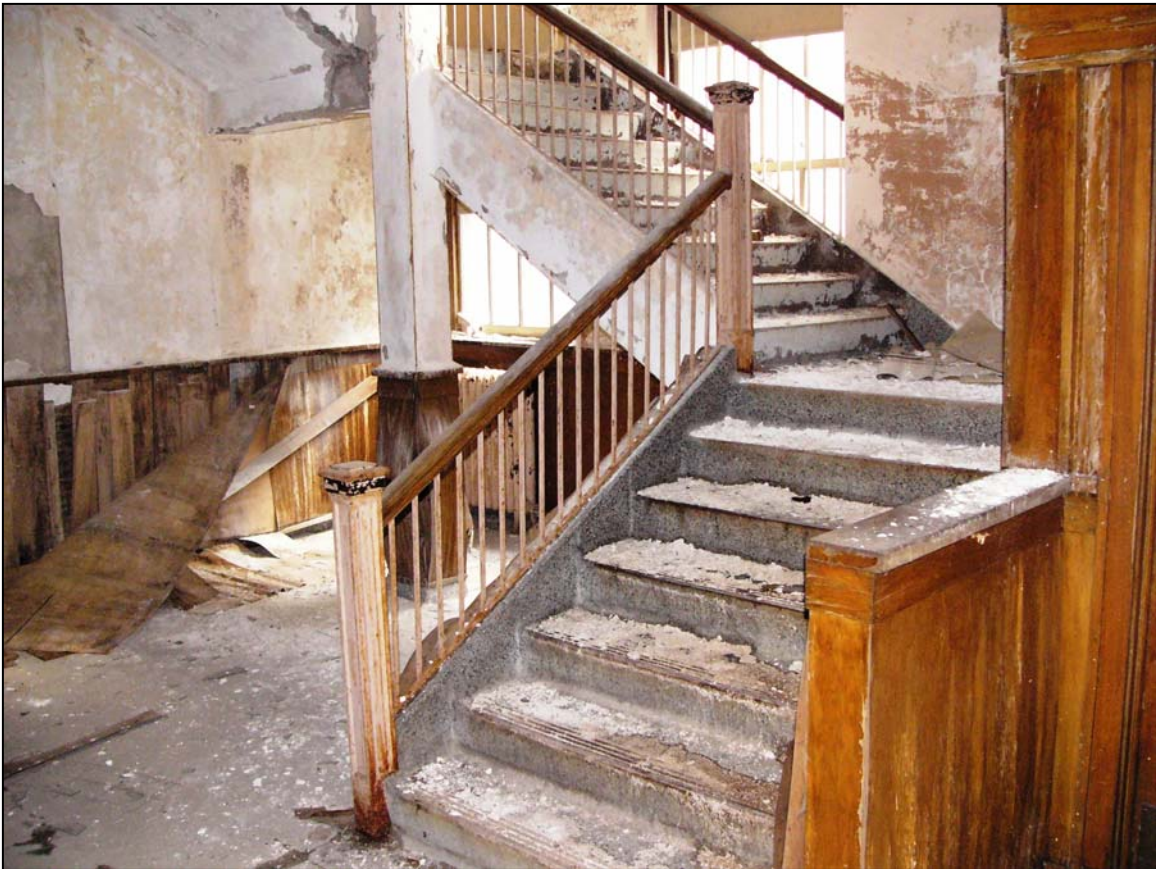
Main stair way. This stairway provided access from the main floor front entrance to the second floor. At one time, this stairway was detailed with painted plaster walls and a wainscot of hardwood paneling. Photograph by J. Trnka, July 2005.

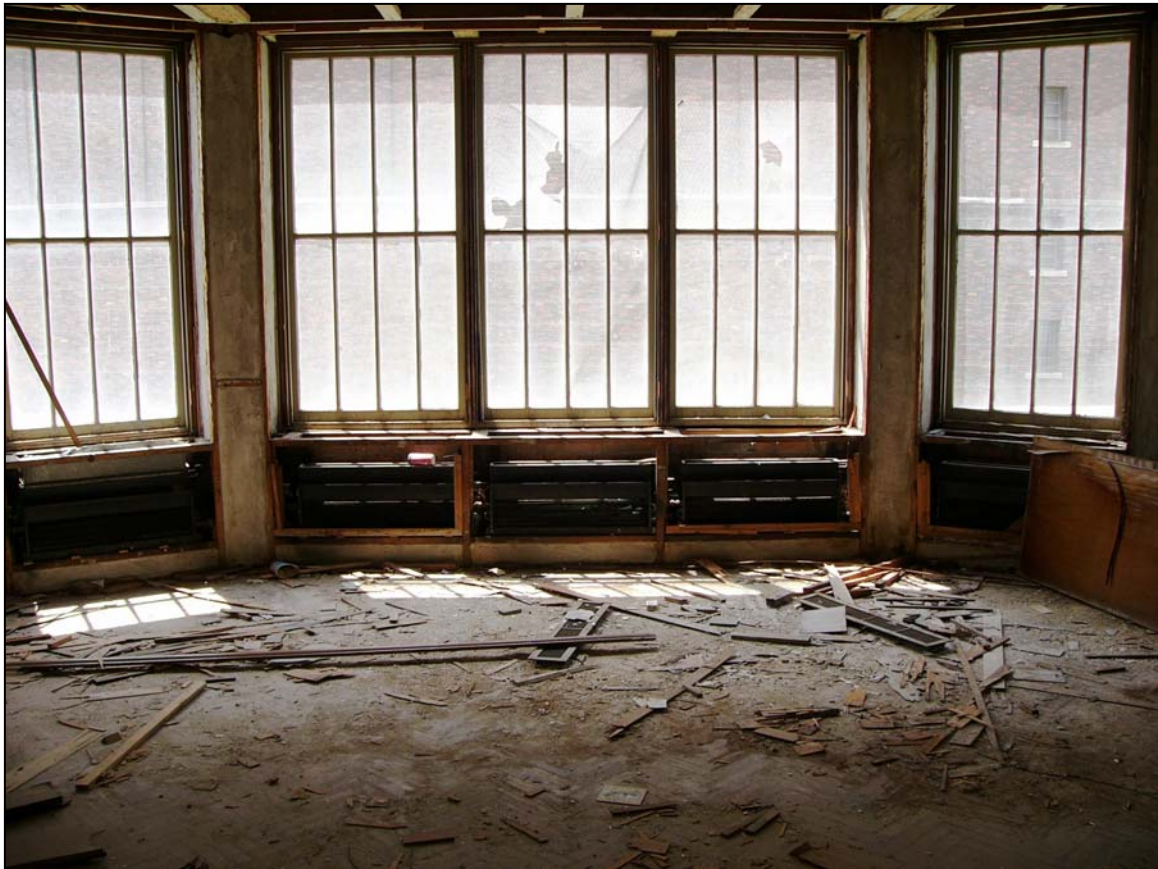
Corporate conference room. This once-lavish conference room once featured hardwood paneling, parquet flooring, a cove ceiling, and the plush setting typical of a successful corporation. Today, only the cant bay windows remain intact to suggest the former glory of the Rath Packing Company. Photograph by J. Trnka, July 2005.

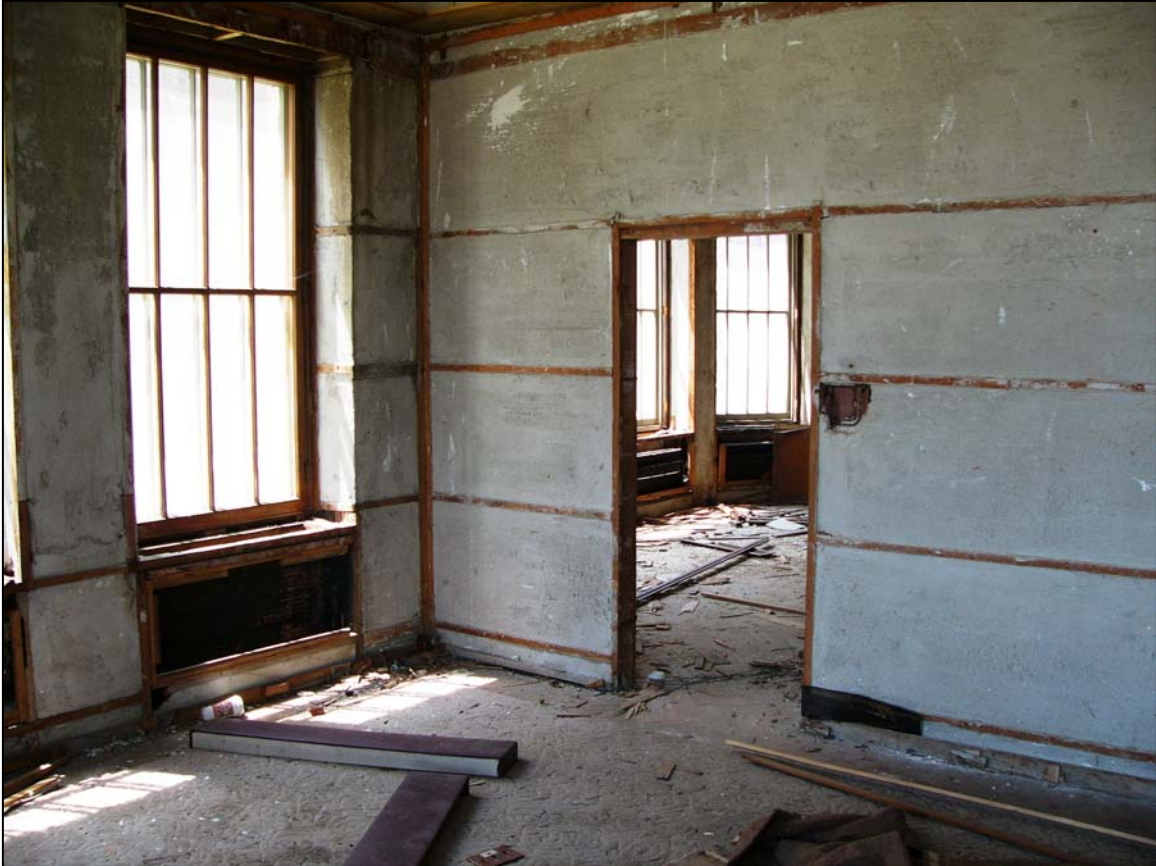
The "Corner Office." This office area, situated at the southwest corner of the main floor of the circa 1940 addition, had a private entrance into the corporate conference room and featured floor-to-ceiling hardwood panel walls, which have been removed. The corporate officers for the Rath Packing Company likely had their offices in this portion of the building, given the materials exhibited in these offices, including private bathrooms, and a separate entrance on the side of the building with its own parking. Photograph by J. Trnka, July 2005.

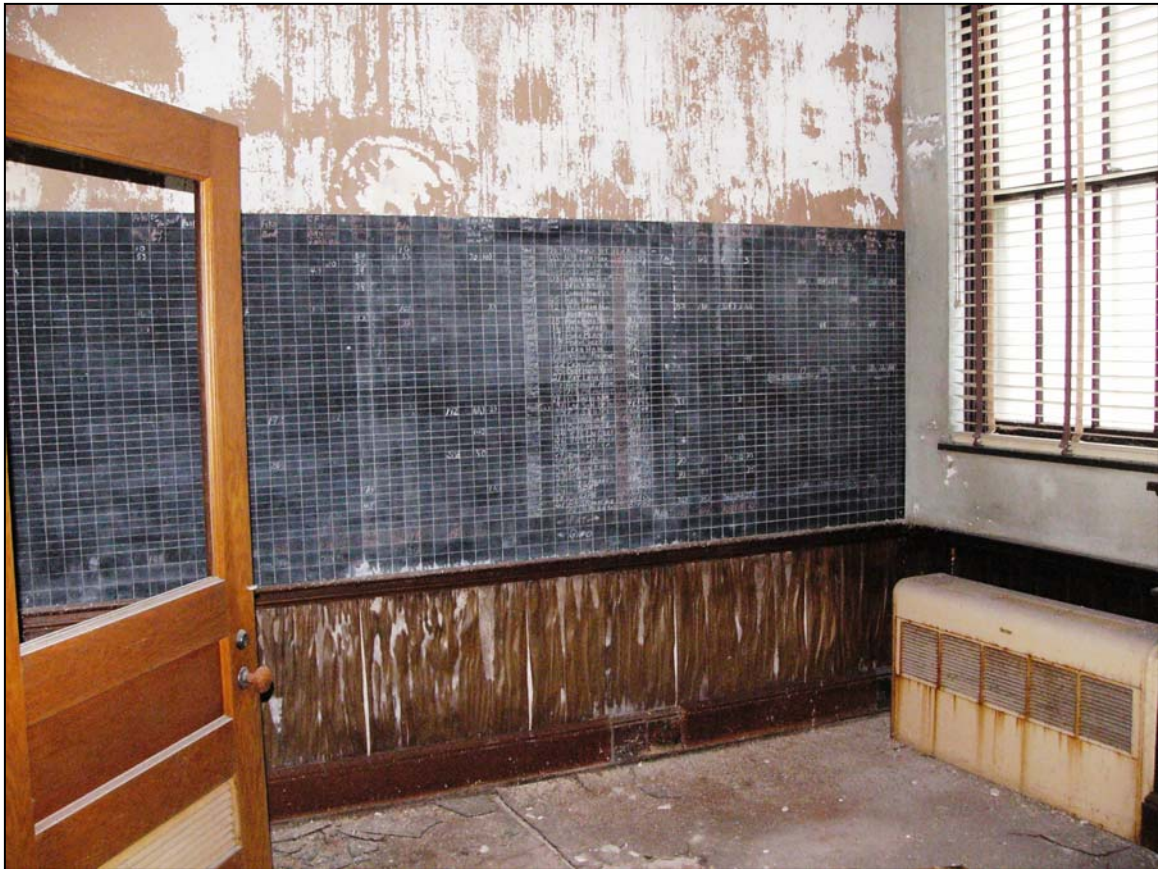
Main floor – chalkboard. This chalkboard is found in an office on the main floor of Building 48 very near the front entrance. Photograph by J. Trnka, July 2005.

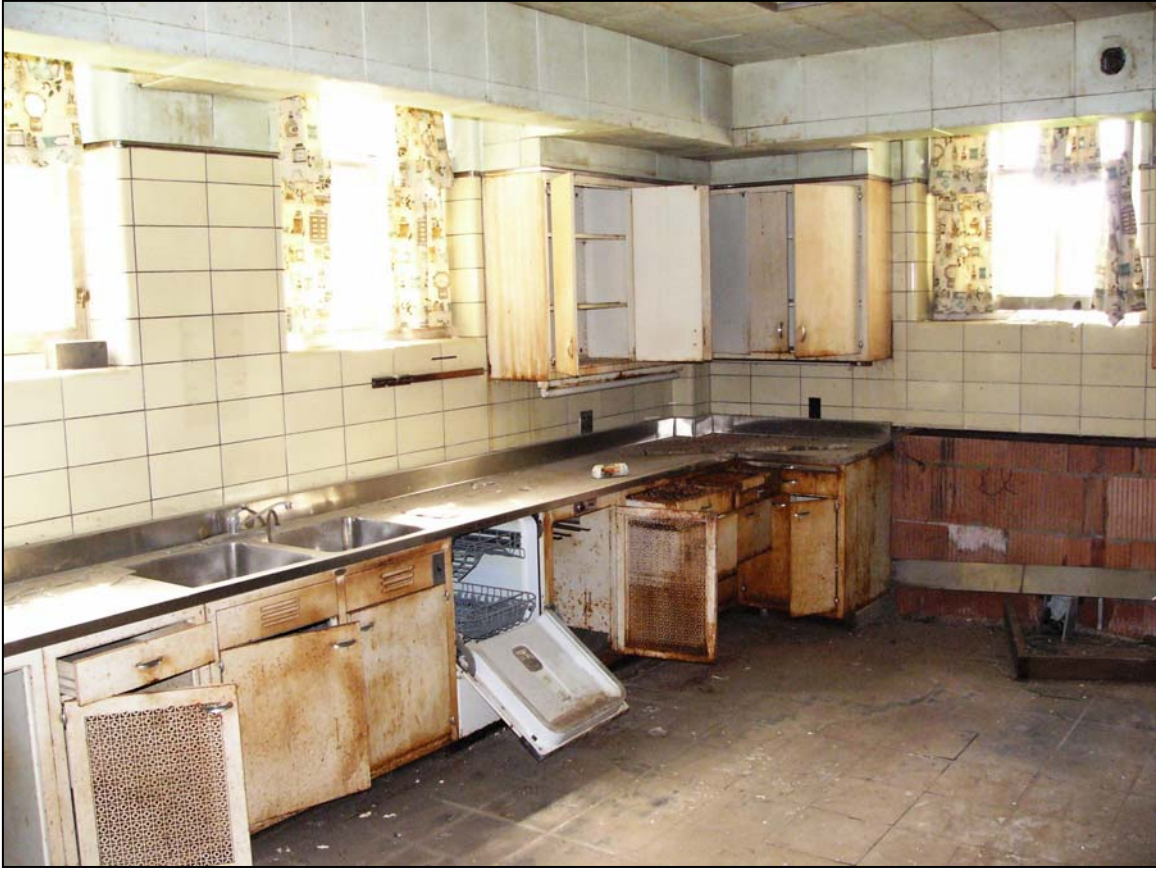
Basement kitchen. This kitchen was clearly large enough to feed up to several hundred people per day. The size of the kitchen suggests that the primary customers were the administrative and management personnel from this building. This kitchen would not have been capable of feeding the thousands of workers employed by this very large meat packing plant. Photograph by J. Trnka, July 2005.

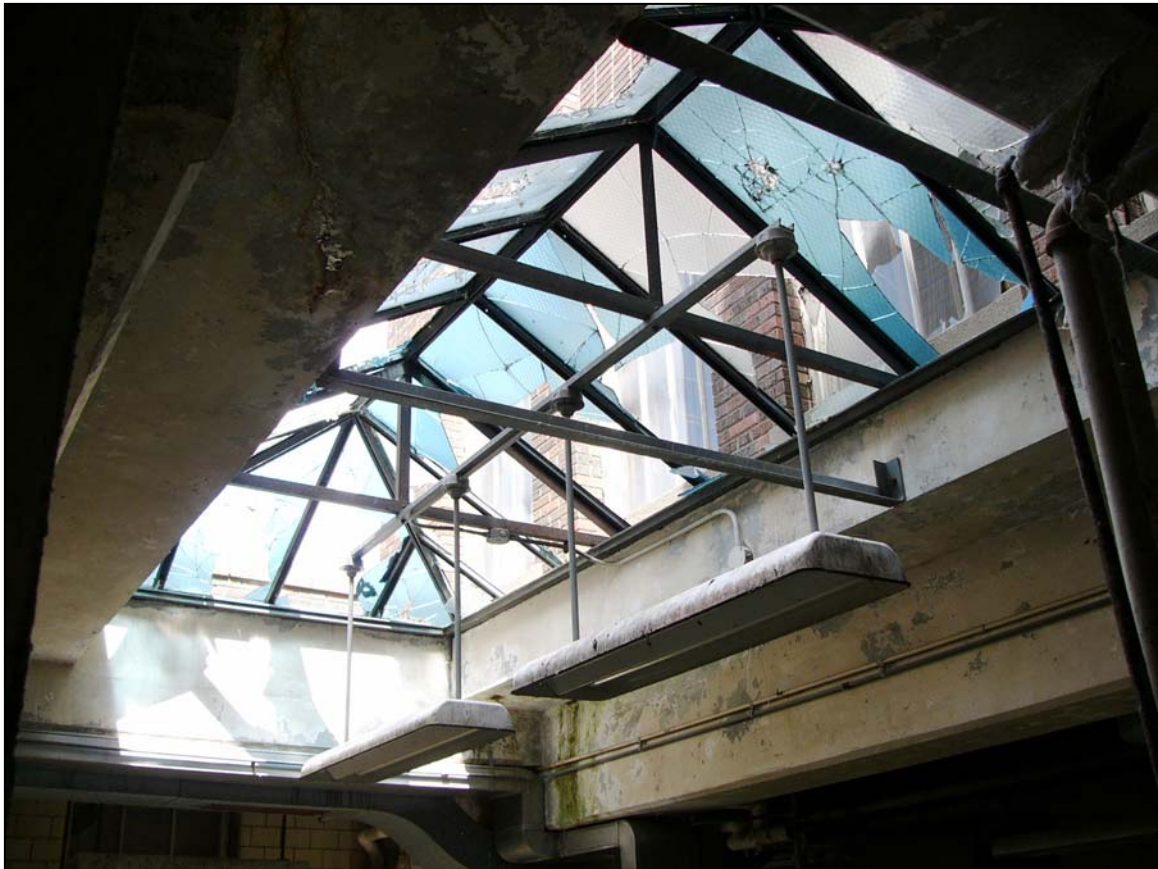
Dishwashing area, basement kitchen. This skylight over the dishwashing area is indicative of the general level of both neglect and destruction that is typical for the Administration Building. Fixtures are broken, either deliberately or due to natural processes, and not repaired. Over the past 20 years, the neglect and deferred maintenance has contributed to an enormous amount of destruction of the historic fabric of this building. Photograph by J. Trnka, July 2005.

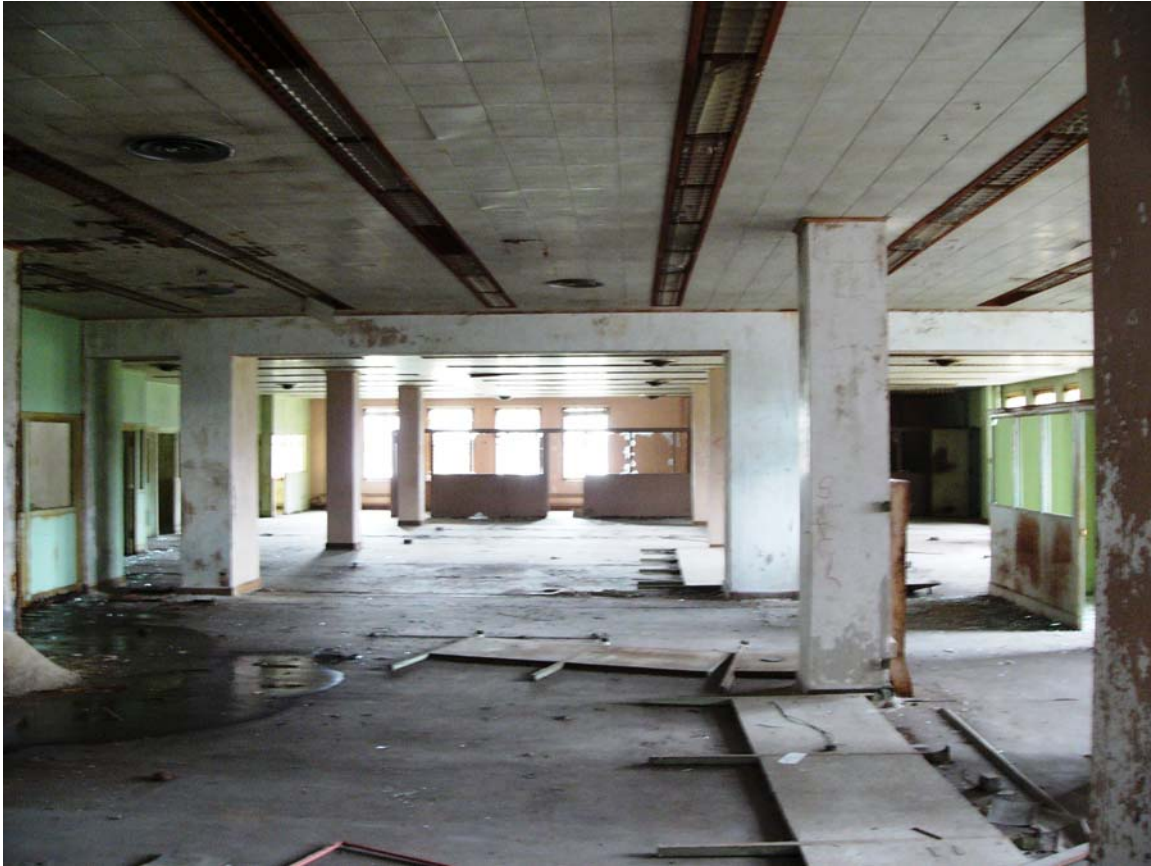
Second floor – open floor area. This photograph was taken from the center of the original section of Building 48 looking toward the additional floor space added by the circa 1940 expansion of this building. The second floor, much like the main floor, features a large expanse of open floor area with offices around the perimeter of part of the building. Photograph by J. Trnka, July 2005.

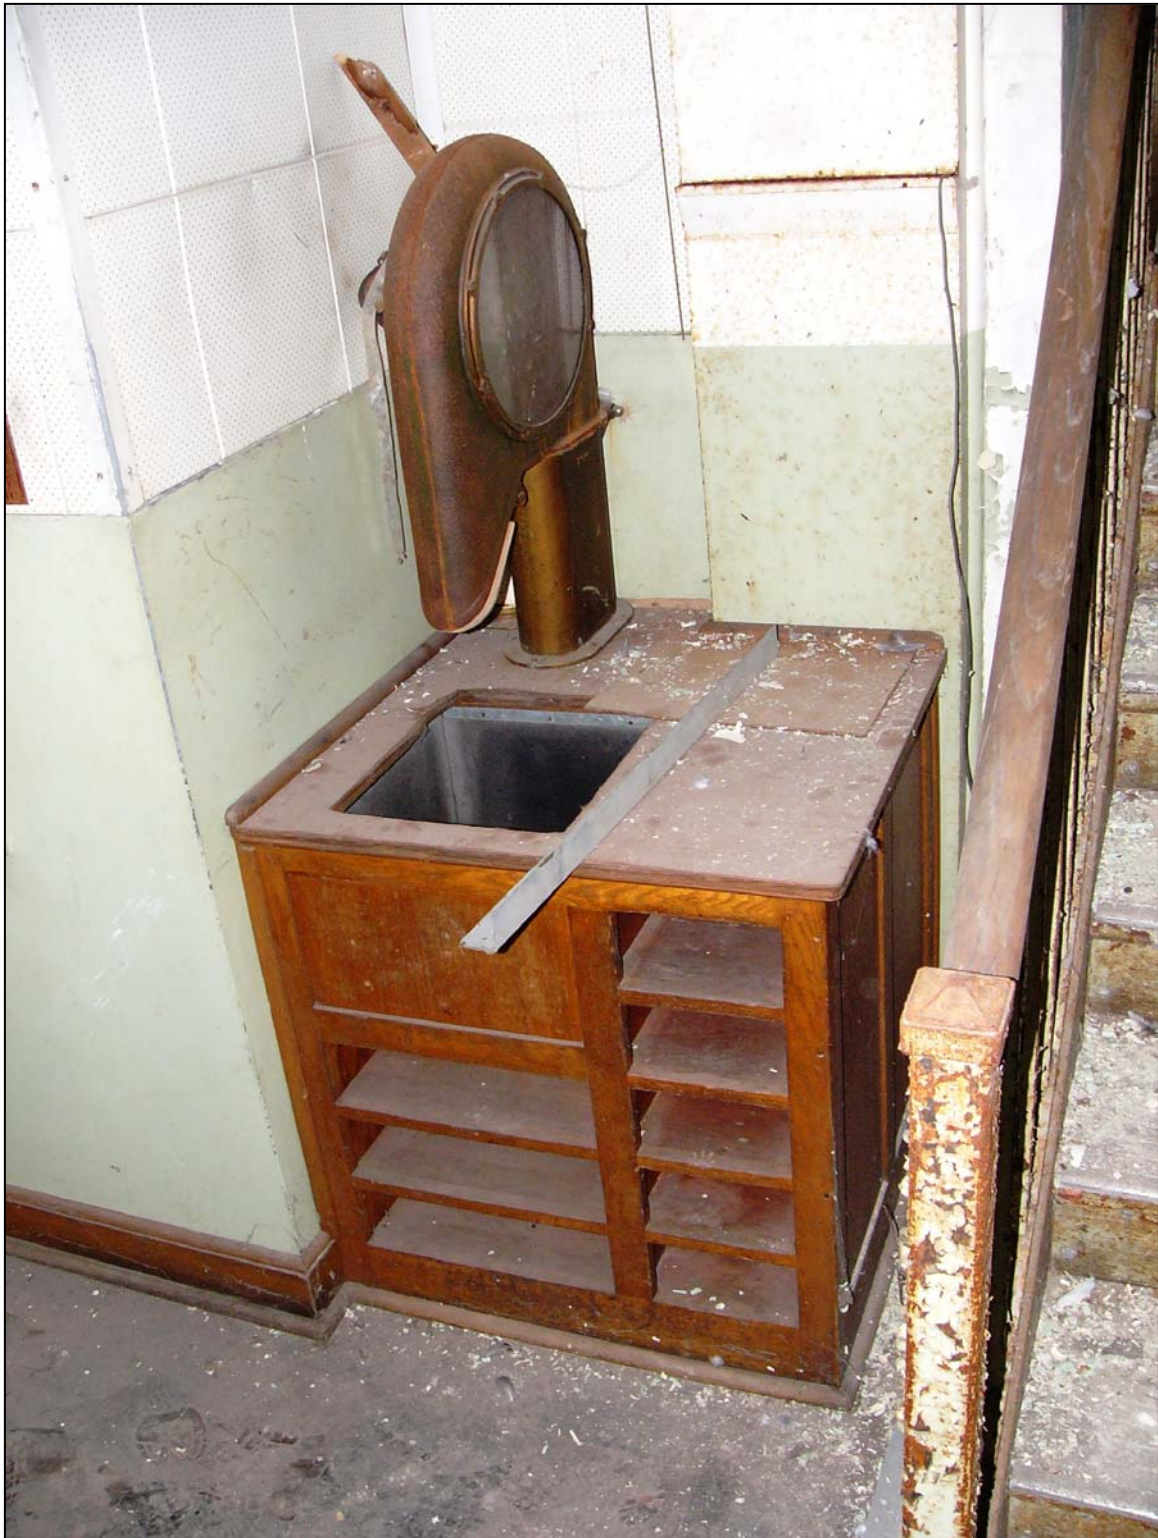
Second Floor, Building 48A. The remnants of a pneumatic tube conveyance system can still be found near the stairs to the second floor of Building 48. Photograph by J. Trnka, July 2005.

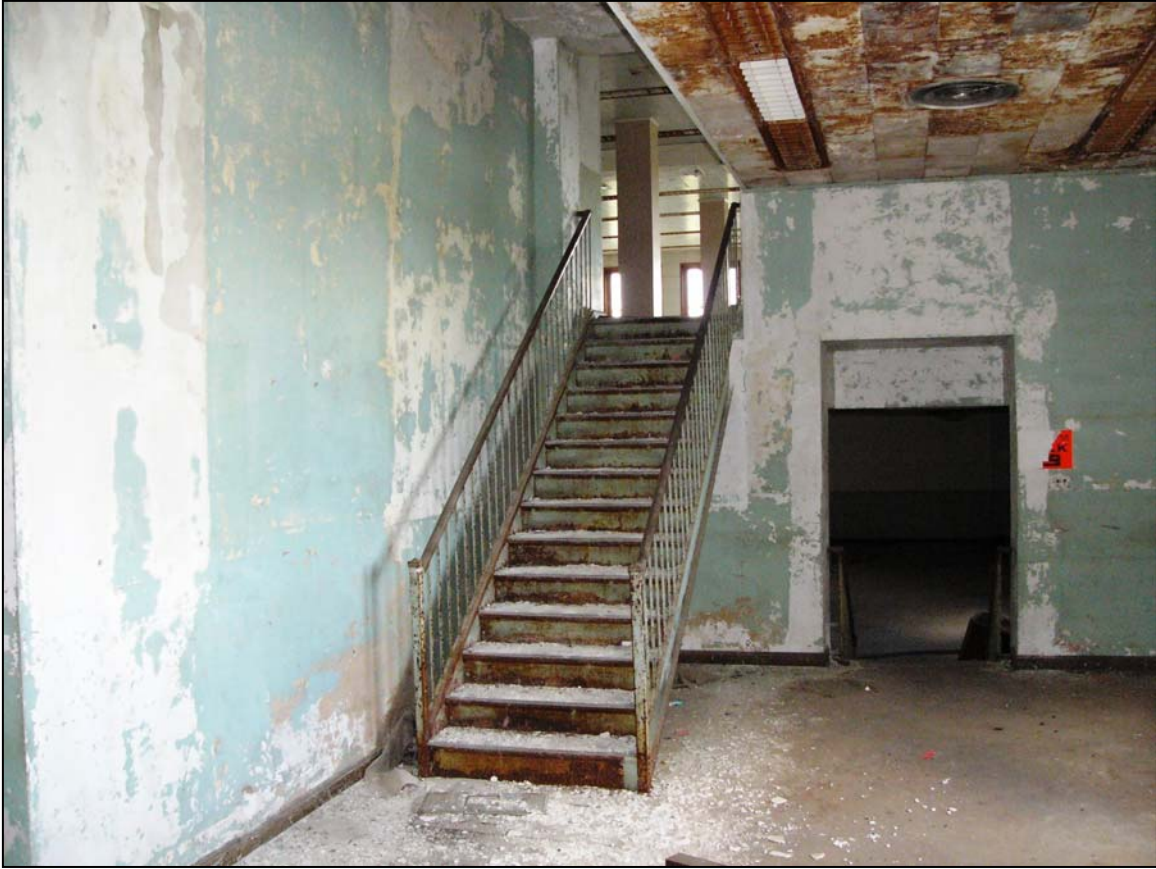
Stairway to the third floor of Building 48A. This stairway connects the second floor of Building 48 to the third floor of Building 48A. The doorway to the right of the stairway connects to the second floor of Building 48A, which is  $\frac{1}{2}$  of a story lower than the second floor of Building 48. Photograph by J. Trnka, July 2005.
