CITY OF WATERLOO
Pavement Management Program
FY 2020-2026

Executive Summary

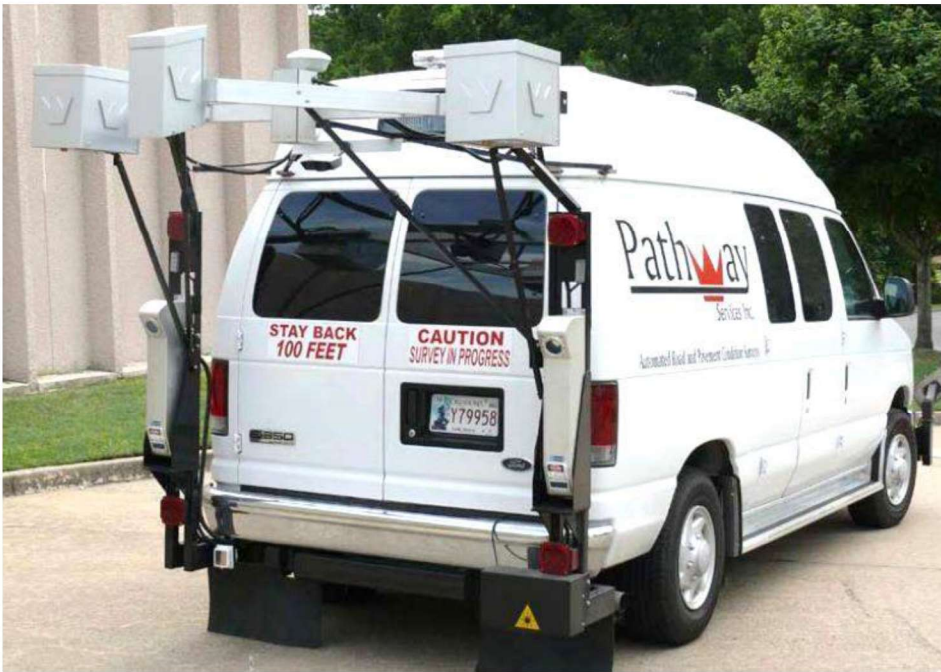
Figure 2: A “Pathrunner” Automated Data Collection Vehicle (Pathways)
This is one of the van’s that a previous data collection vendor used to collect pavement condition in Iowa from 2013-2017.

Roadway pavement condition data were collected by an automated data collection vehicle, like the “Pathrunner” used by Pathways Services Inc., the Iowa DOT’s data vendor. This is a van outfitted with an array of sensors and cameras that automatically collect data on and around the road. These data include, but are not limited to cracking, potholes, faulting, spalling, rutting, etc. Examples of specific pavement distresses can be found in **Section 3.1.3**.

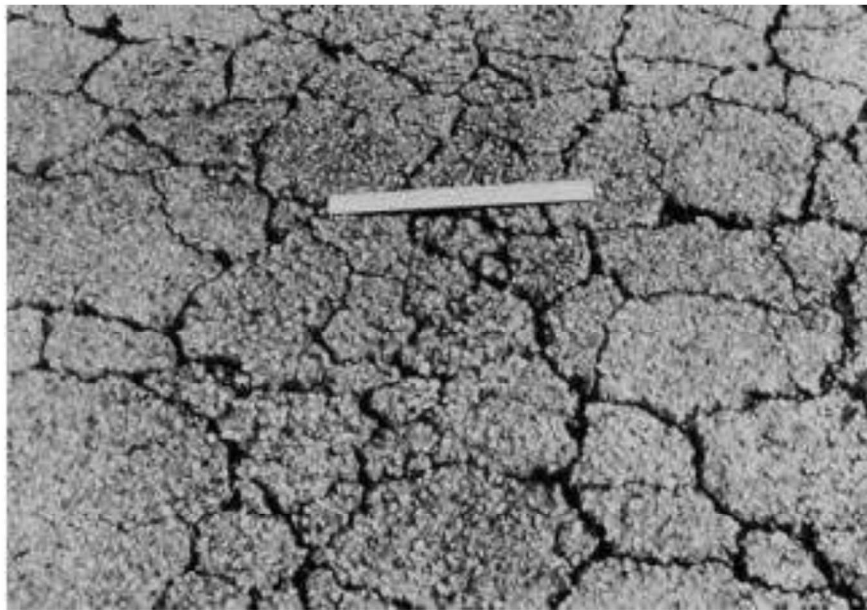
Figure 4: Example of Alligator Cracking (ASTM)
This image is from the ASTM D6433 “Standard Practice for Roads and Parking Lots Pavement Condition Index Surveys.” Alligator Cracks are when pavement breaks into a “scaly” pattern typically caused by fatigue, either from repeated heavy loads, lack of sufficient subgrade support, or weakened material due to drainage issues.

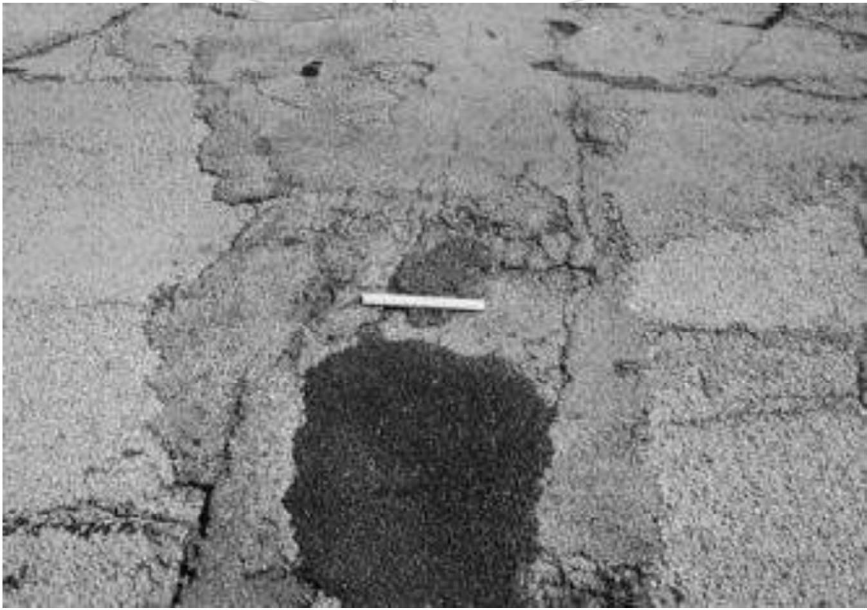
Figure 8: Example of Patching (ASTM)
This image is from the ASTM D6433 “Standard Practice for Roads and Parking Lots Pavement Condition Index Surveys.” Patching is the result of corrective actions already taken and are indicative of underlying issues as well as a common point of failure.

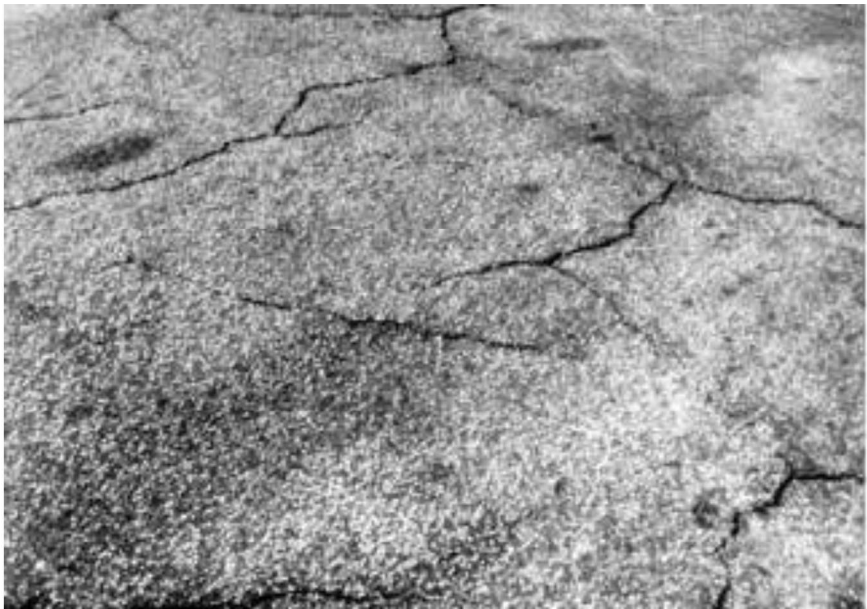
Figure 5: Example of Block Cracking (ASTM)
This image is from the ASTM D6433 “Standard Practice for Roads and Parking Lots Pavement Condition Index Surveys.” Block cracks are when pavement breaks into “chunks” or “blocks” that are roughly rectangular, caused by internal stress from temperature or lack of lateral support.

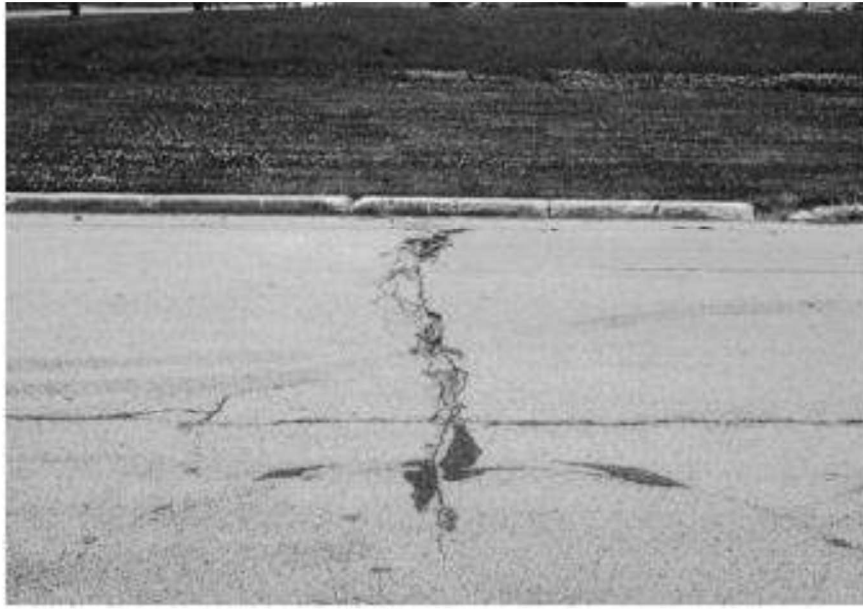
Figure 7: Example of Transverse Crack (ASTM)
This image is from the ASTM D6433 “Standard Practice for Roads and Parking Lots Pavement Condition Index Surveys.” A common distress caused by a wide variety of issues.

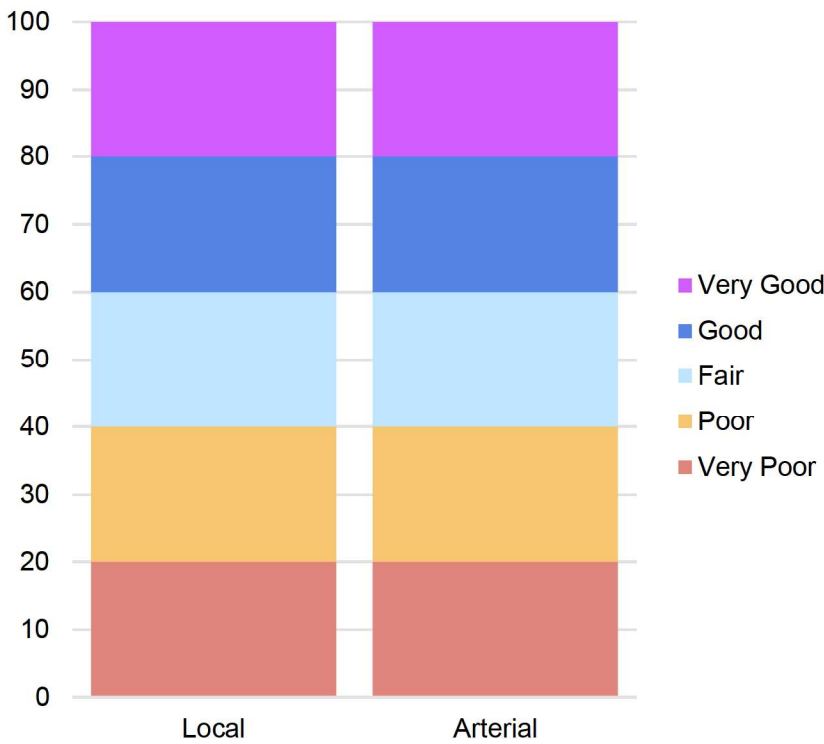
Figure 10: Condition Thresholds
This chart shows the proposed relationship between CityPCI and the condition categories used in this plan.

Instead of using CityPCI literally, condition categories were assigned to each street based on where the value fell on the 0 to 100 scale. For example, pavements with CityPCI ratings below 20 are considered to be “Very Poor” while those above 80 would be “Very Good.” This was done to help with understanding and assessment of the ratings, as well as to allow them to be used in a practical sense

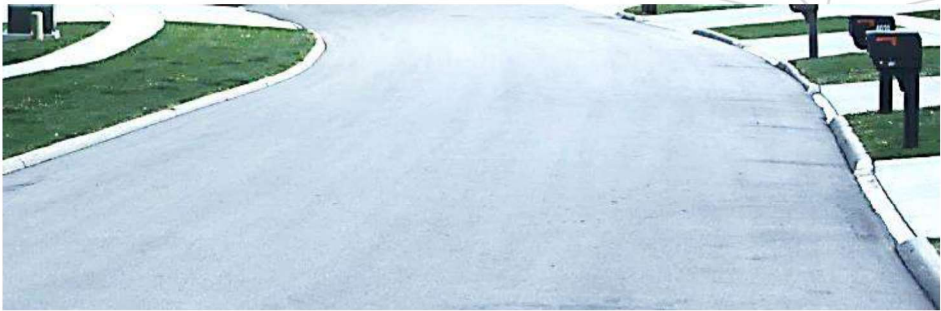
Figure 11: Example of “Very Good” Condition (HMA) – Mourning Dove Dr
This picture was taken from the 2018 data collection records. Mourning Dove Drive, north of Hummingbird Circle has a nearly perfect PCI of 97/100 because it demonstrates no visible pavement distresses.

A score of 80/100 or greater is considered “Very Good.” Roads with pavement in “Very Good” condition exhibit very few surface distresses, if any, and those that are apparent will be very low in severity. Most often, these pavements will be very new. The average age of “Very Good” pavements in Waterloo is less than 10 years, meaning they were either recently constructed or rehabilitated with an overlay in the past few years. As such, it may not be feasible to expect every street in a city to be “Very Good” because it would be prohibitively expensive resurface every street in 10 years’ time.

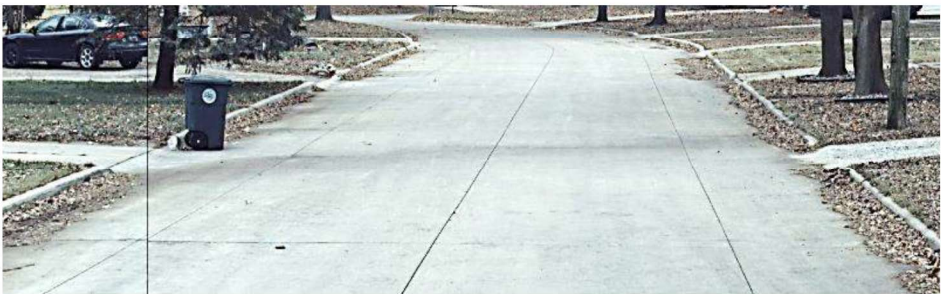
Figure 12: Example of “Very Good” Condition (PCC) – Seneca Ave
This image shows Seneca Avenue from the 2018 data collection, in which it was rated as 86/100 and would be considered “Very Good” for a PCC pavement.

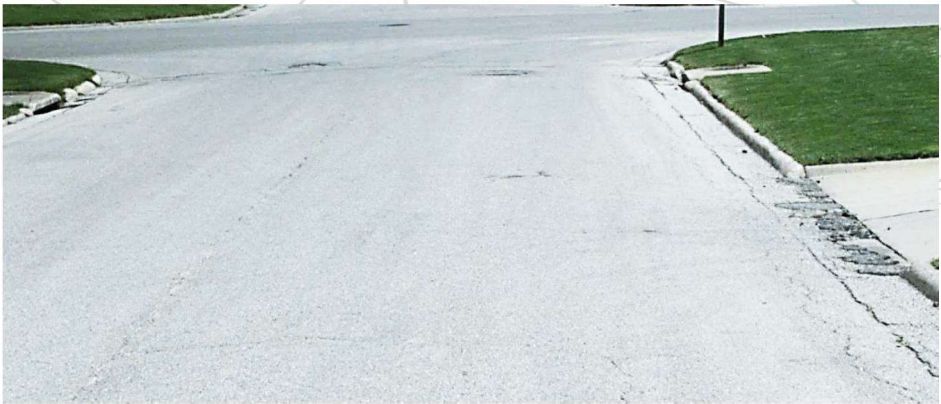
Figure 13: Example of “Good” Condition (HMA) – Liberty Ave
This picture of Liberty Ave between Oregon and Minnesota. It was rated as 75/100, which would be considered good for an HMA pavement. Low severity cracks and small distortions can be found, but nothing that impacts drivers.

Pavements with CityPCI scores between 61 and 80 are considered to be in “Good” condition. The distresses on these streets are more noticeable but do not cause much concern because they are minor and infrequent. Most drivers will not even notice the few cracks and distortions. Regular maintenance activities like crack sealing can help prevent the spread of these deficiencies and preserve these pavements for quite some time for low costs. The majority of Waterloo’s streets would be considered to be in this category.

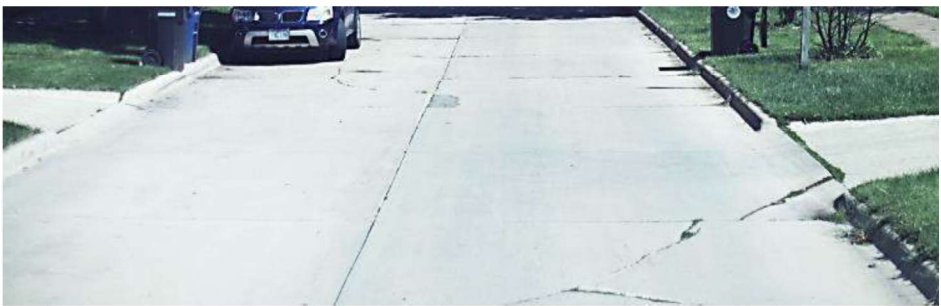
Figure 14: Example of “Good” Condition (PCC) – Kingsley Ave
This image shows an example of a PCC pavement in “Good” condition. Kingsley Avenue between Fletcher and Lawnhill is rated as 69/100, because of a few cracked panels and small patches in decent repair.

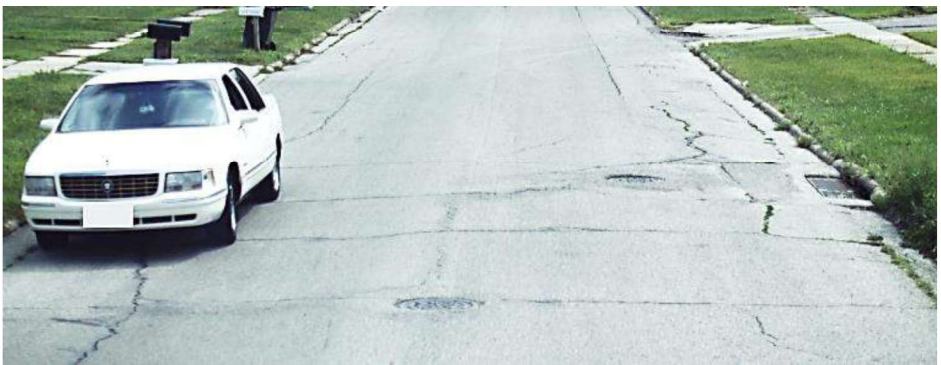
Figure 15: Example of “Fair” Condition (HMA) – Oleson Road
This image of Oleson Road between Hammond and Bethel is an example of HMA pavement in “Fair” condition, with a PCI of 48/100. There are very noticeable distresses but they only impact drivers slightly.

“Fair” streets (CityPCI 41-60), have quite noticeable distresses. Either many low severity distresses, or a few high severity distresses. These will still not impact drivers very much, however.

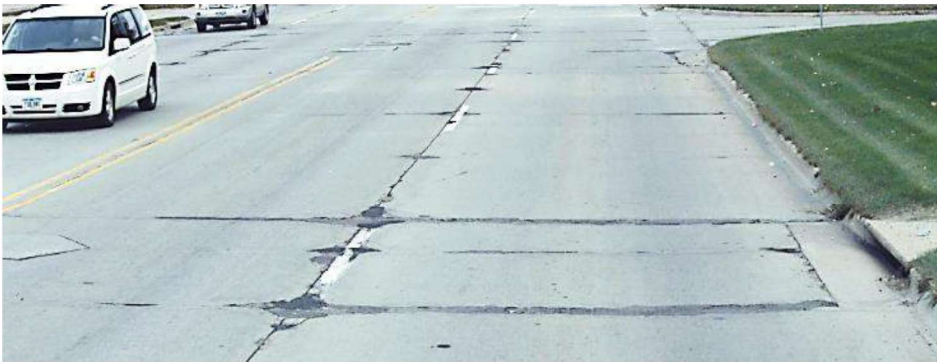
Figure 16: Example of “Fair” Condition (PCC) – Ansborough Ave
This picture of Ansborough Ave between Stratford and Upton is an example of a PCC pavement that was rated as 51/100 which would be considered “Fair.”

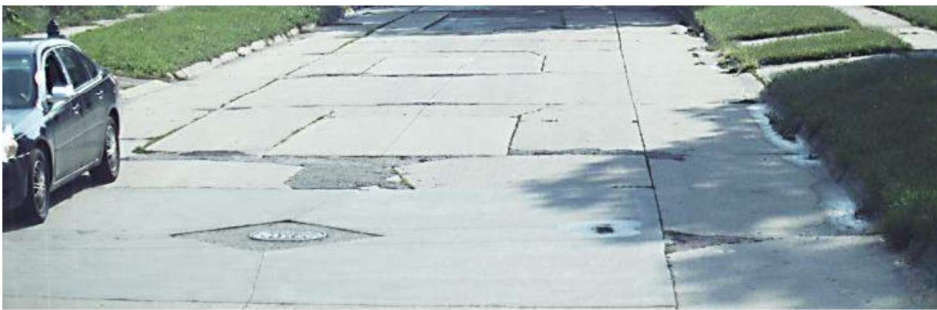
Figure 18: Example of “Poor” Condition (PCC) – Webster St
This image is an example of a PCC pavement in “Poor” condition. Webster street between Linn and North Barclay was rated as 26/100 due to uneven joints and numerous point failures that would certainly impact driver experience.

At this point in a pavement’s life, it is about 75% of the way through its expected serviceability. It will begin deteriorating much more quickly and fall into “Poor” (21-40) or “Very Poor” (1-20) in only a few years, if neglected. However, because the distresses on “Fair” streets are still minor, this is often the ideal time to Rehabilitate them affordably. On the other hand, pavements that deteriorate further, into the “Poor” and “Very Poor” categories, will likely require Reconstruction, which is very costly.

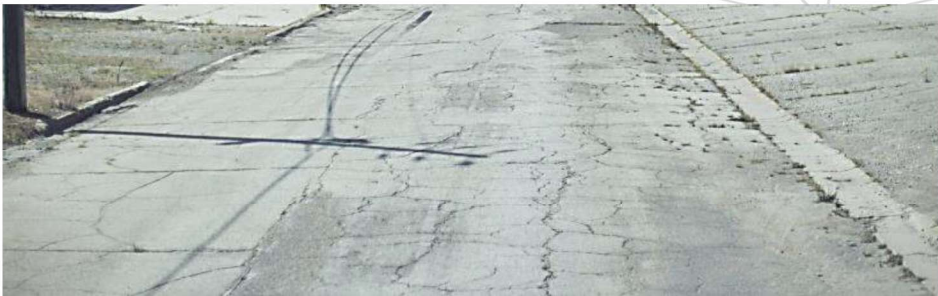
Figure 19: Example of “Very Poor” Condition (HMA) – 10th St East
This picture of 10th Street East, to the southwest of Sycamore street is one of the few HMA pavements in Waterloo considered to be in “Very Poor” condition. Rated as 17/100, this road’s pavement exhibits distresses across the entirety of the street and even has grass growing through the cracks.

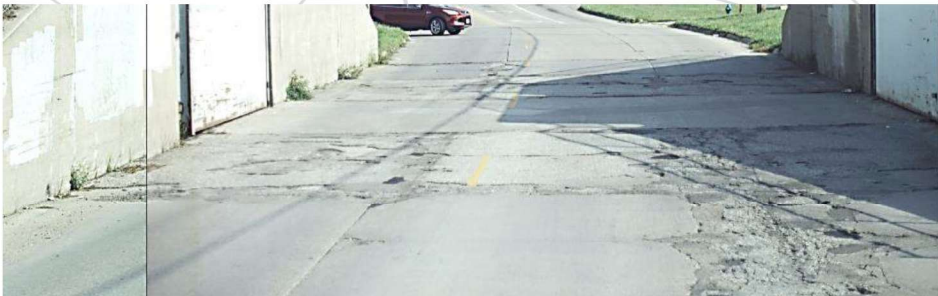
Figure 21: Example of “Very Poor” Condition (PCC) – Fletcher Ave
This picture of Fletcher Street south of Black Hawk Road is the only PCC pavement of “Very Poor” condition in Waterloo. Rated as an 8/100 in 2018, it exhibits multiple points of severe distress that could not be addressed through any means other than rebuilding the road from the base up.

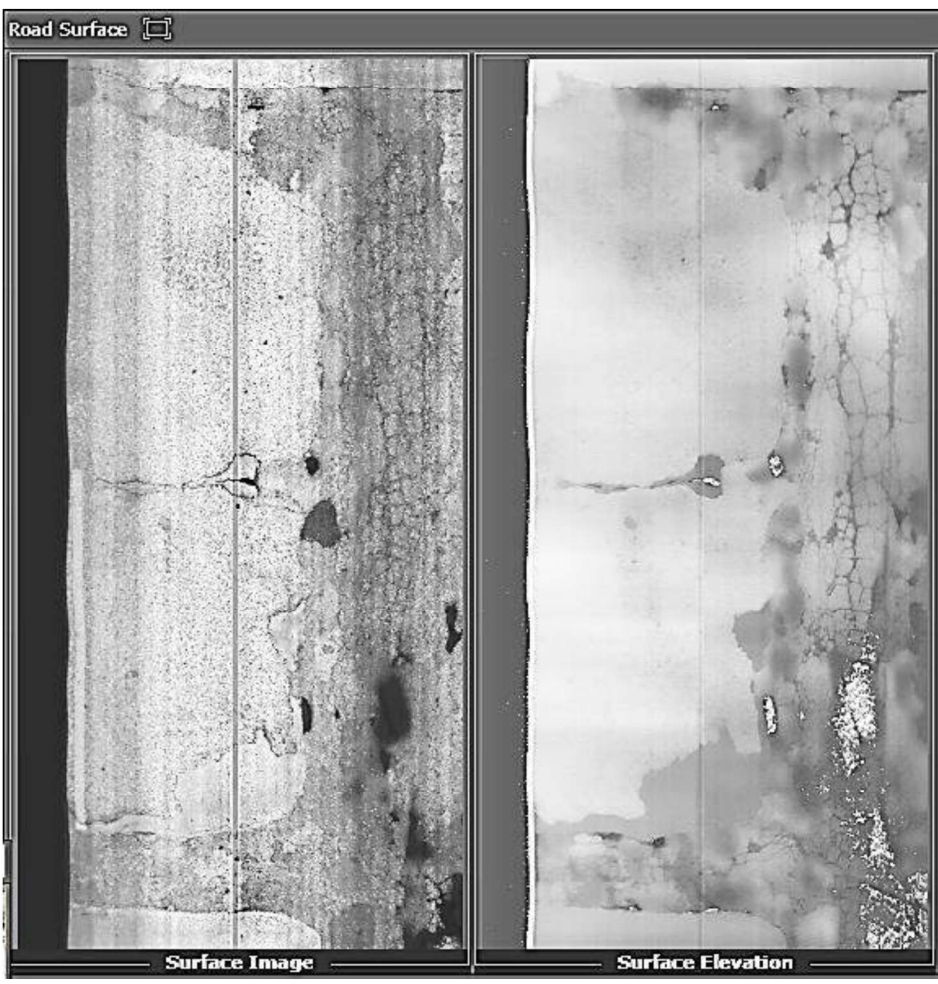
Figure 22: Roadway Imagery of a “Very Poor” PCC Pavement
This image is from the section of Fletcher shown in Figure 21. These were captured by the data collection vehicle’s downward facing camera (left) and LIDAR array (right). These are one of the key resources used in evaluating pavement condition.
