South Berwick Town Hall Evaluation and Recommendations

August 20, 2023

Port City Architecture and their consultants have been commissioned to provide a facility assessment for the existing South Berwick Town Hall building including physical condition; structural integrity; mechanical, electrical, and plumbing system; site conditions; overall appearance; overall function; and code compliance. As part of our inspection, we highlighted any workplace safety issues, potential hazard, and building functionality pertaining to a modern-day town hall administration that incorporates current technology and practices.

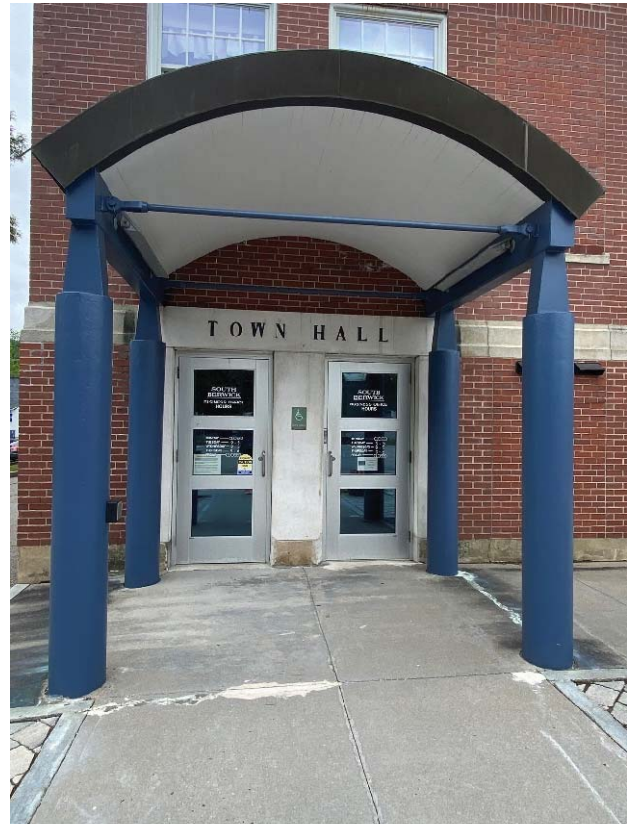
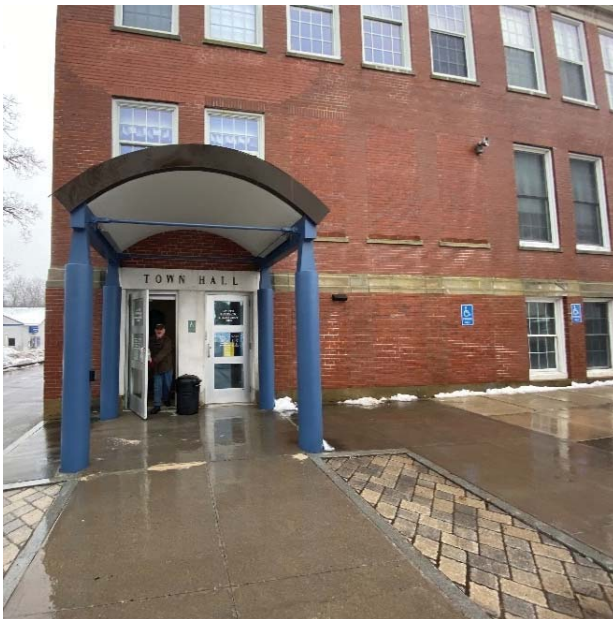
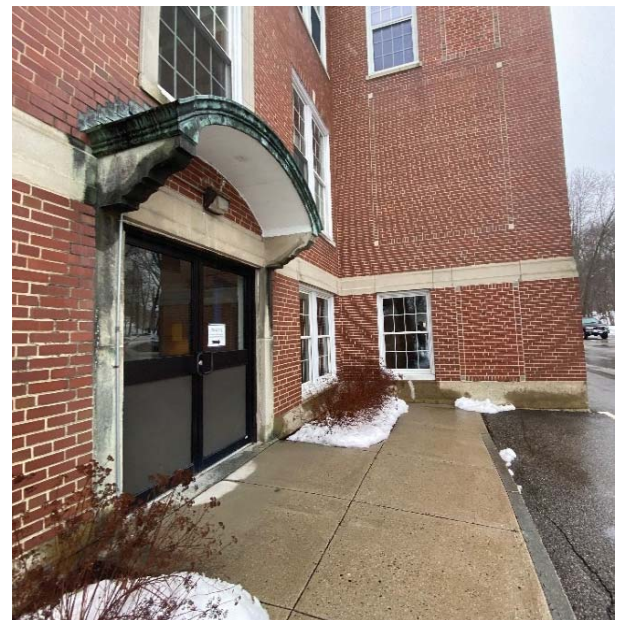
- The main entry facing the street is infrequently used by the public or staff since the parking lot is at the rear of the building.
- The primary public entry with a canopy and an automatic door opener and faces the parking lot.
- A door on each side of the building which provides direct egress for each of the stair towers as required by code.
- Two doors at the rear of the building that access directly to the ground floor.

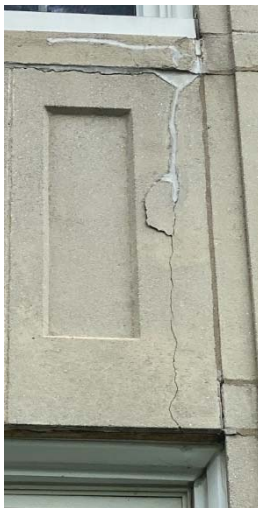
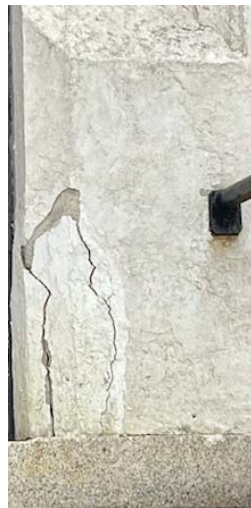
- There is precast concrete throughout the exterior façade and the precast concrete is starting to fail in many locations. Refer to the next few pages for specific examples of failure at the windows, tablets, and pediment. This issue needs to be addressed now before an injury occurs.
- Refer to in Appendix A for more information.

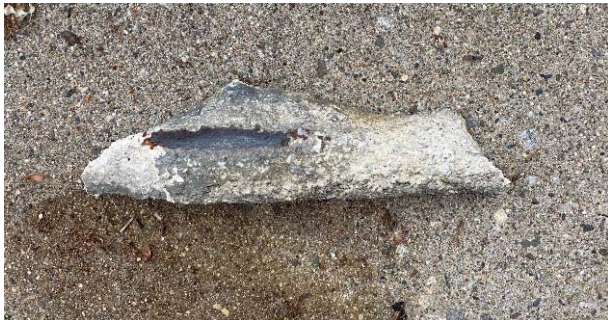
- A piece of concrete sill that has fallen and can be seen on the sidewalk below.

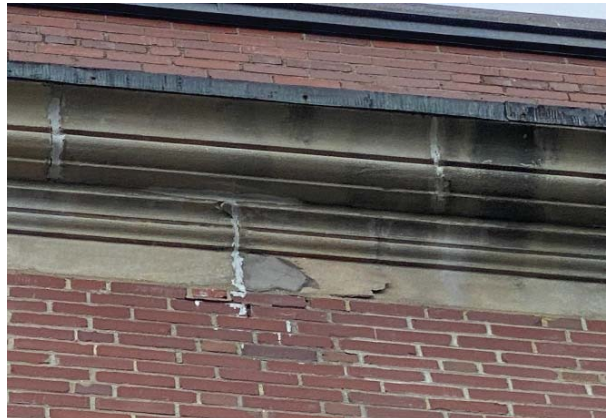
Precast Concrete Pediment:

- The pediment is starting to deteriorate, and a small portion of precast concrete has fallen.
- After further inspection from the ground, there was limited cracking but a large quantity of staining. From the ground and without selected demolition, we are unable to inspect if the break-metal cap is allowing water into the building's masonry facade, but we suspect that it might be. If it is, this will greatly accelerate the deterioration process. Either way, the pediment needs to be thoroughly inspected and remediated as soon as possible.

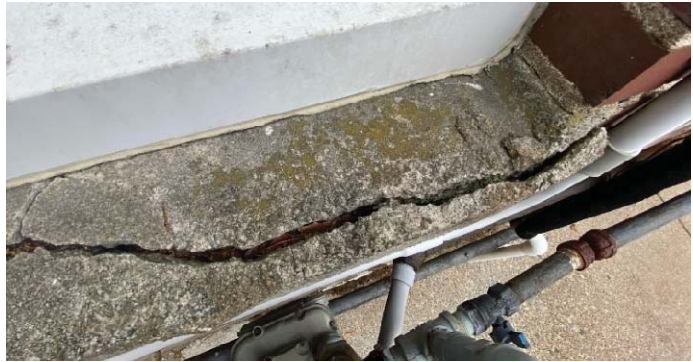
Windowsills:

- The existing windowsills are precast concrete and do not have flashing or other material to prevent water from sitting on them; subsequently water penetrates into the concrete sill and causing extensive cracking.
- Many sills are cracked, and some have pieces that have broken off.
- We were only able to inspect the windowsills on the ground floor. Not all sills could be inspected from the ground level, and we were not able to open windows to look at the sills on the second and third floors because the windows are failing and thus inoperable. A further inspection should be made with a lift bucket to ensure that there are not more significantly damaged sills that may have lose concrete that we were not able to assess from the ground level.

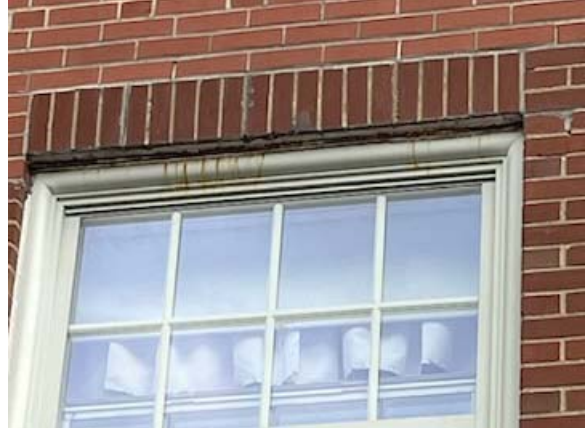
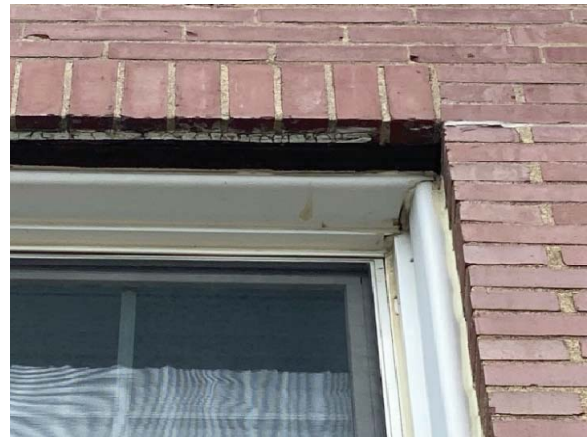
Window Lintels:

- The steel windows are rusting. Though this is normal, they should be regularly scraped and painted.
- At some point, somebody caulked between the brick and the lintel blocking water from draining properly. The blocked water is freezing and expanding causing damage to the brick. This caulk needs to be removed.

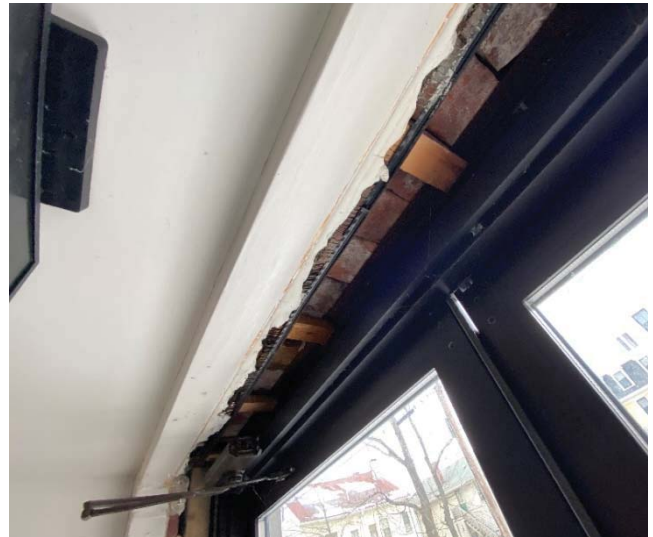
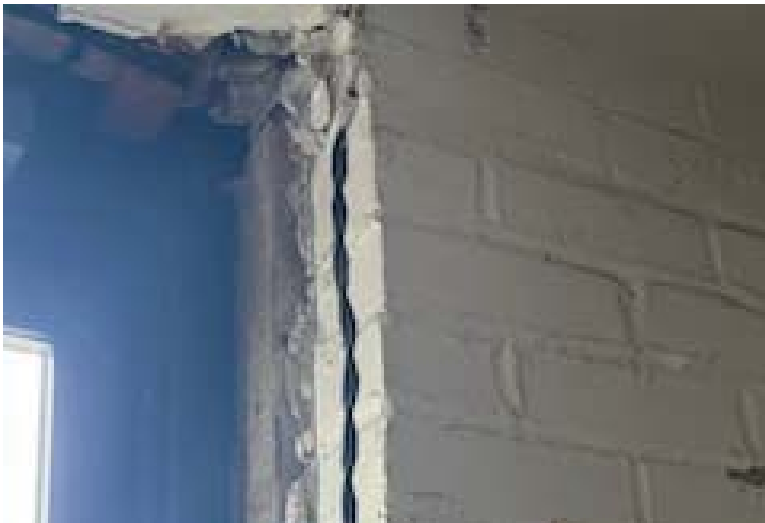
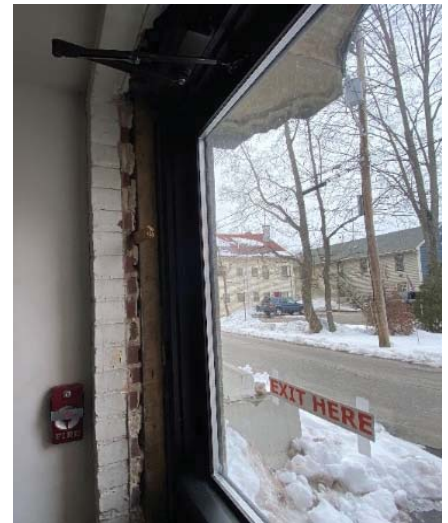
Insulation Issues:

- There is little to no insulation at the exterior of the building. This allows heat to escape and is costly for the town to heat and cool the building. In most places, there is only exposed brick on the interior. Additionally, this affects the comfort of the occupants of the building. While this building is grandfathered from the existing energy codes, if any major renovation occurs, the building will need to meet the energy code and thus require insulation.
- In some places the finishes, such as existing dry wall, will need to be removed to be able to provide insulation.

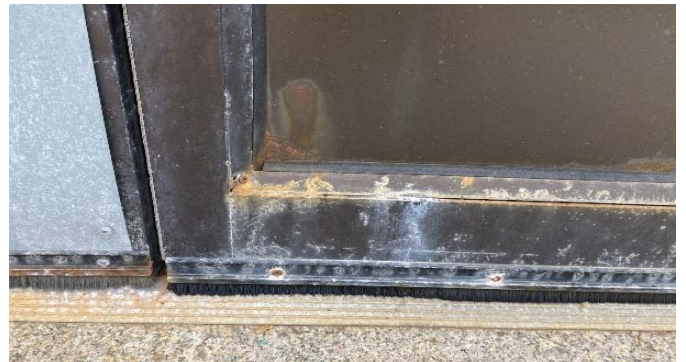
- The aluminum storefront front doors are deteriorating, a panel has corroded, and the door should be replaced.

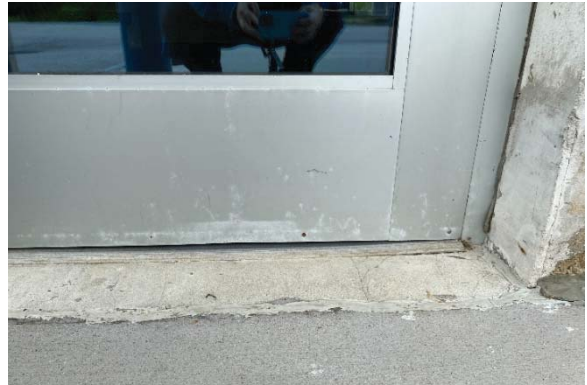
Aluminum Storefront Entry Doors:

- The entrance canopy funnels rainwater to the side and the water is damaging the building. Gutters or other water control should be added.
- The rear entry doors are ADA and have an automatic door opener. However, the thresholds are starting to curl and should be replaced. See Threshold note above.

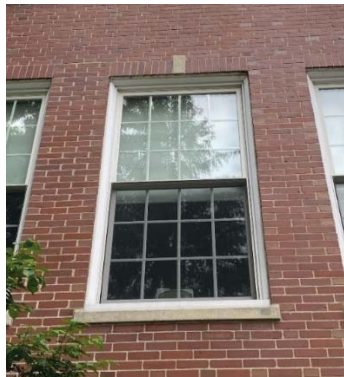
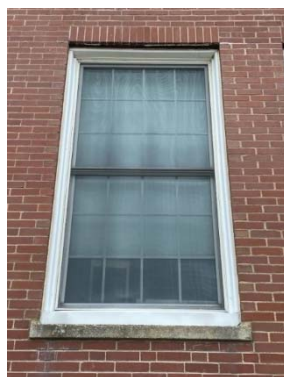
Windows:

- Windows were replaced approximately 25 years ago and vinyl windows of this size have a lifespan of ten years. Many of the windows are failing. These need to be stabilized now and replaced in the next year.
- In our exploration, we encountered the window sashes are falling out and the top sashes will not stay up in many locations. Both issues pose a significant risk for personal injury and need to be addressed now. Please see Port City's letter of June 14, 2023, refer to **Appendix C – Letter to South Berwick about Windows and Precast** for the full letter.

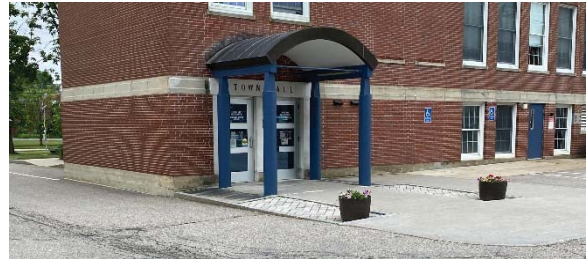
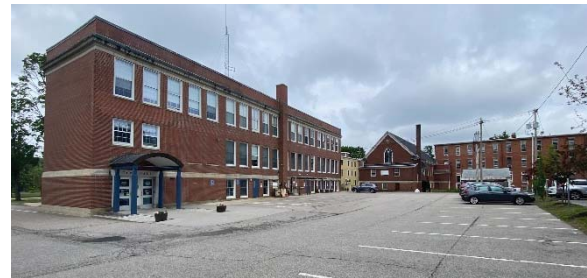
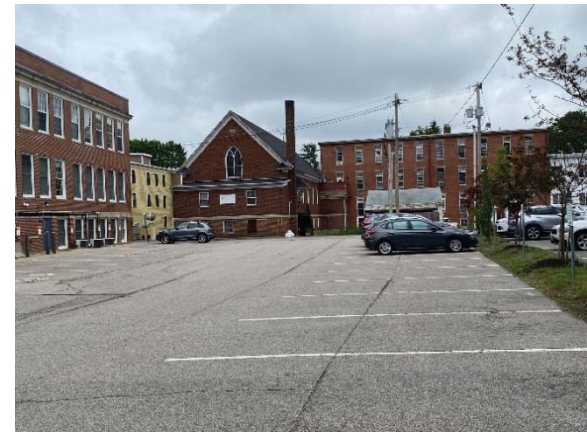
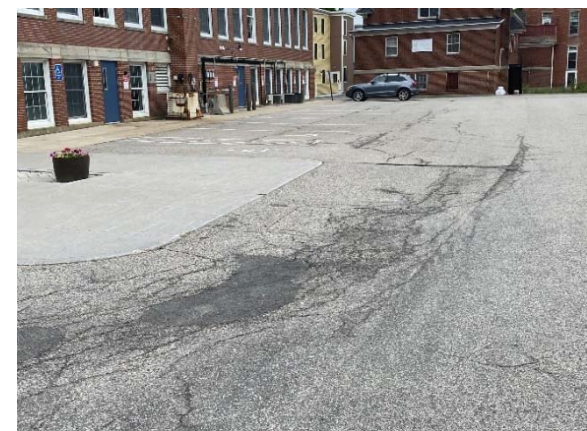
General Parking Lot

- There is ponding and broken areas of pavement indicating the subbase is failing. The parking lot should be regraded and paved.
- The parking lot needs to be restriped.
- The entrance and exit could use better signage.

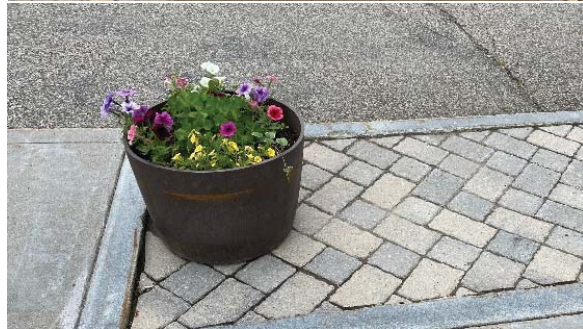
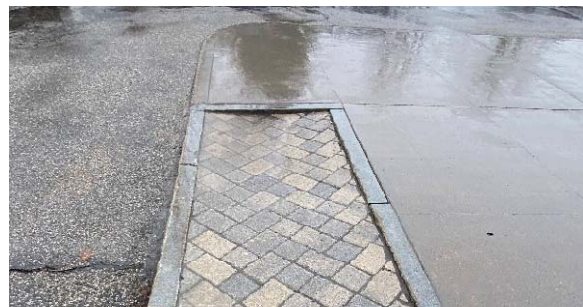
Entry Sidewalk

- The planting beds at the main entry were filled in creating a tripping hazard since the pavers shifted / sunk. These need to be repaired.

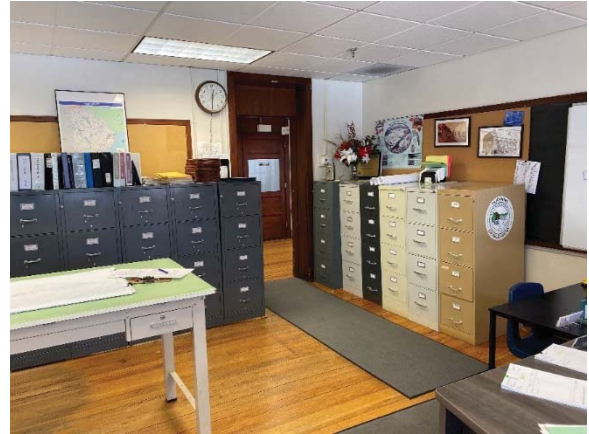
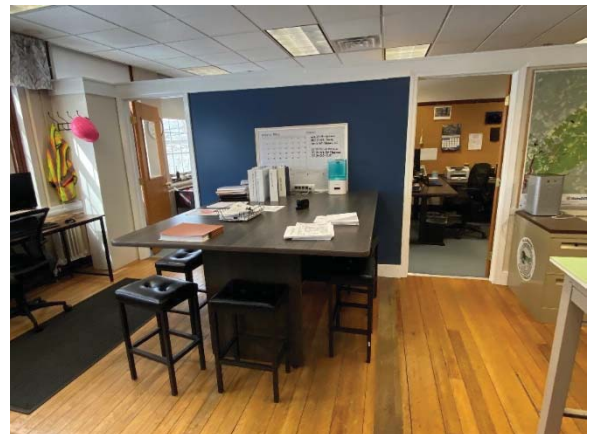
- The offices partitions do not reach the ceiling causing a lack of adequate privacy for the occupants.

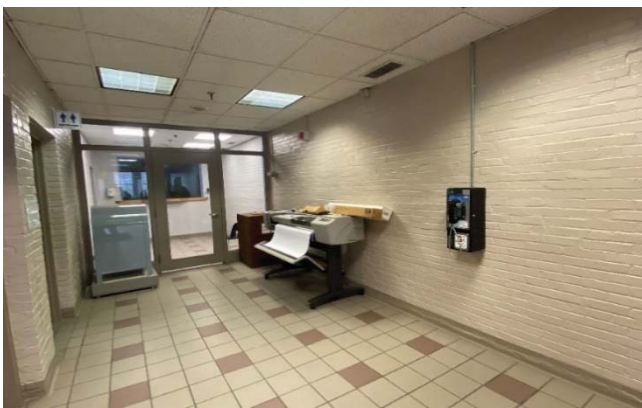
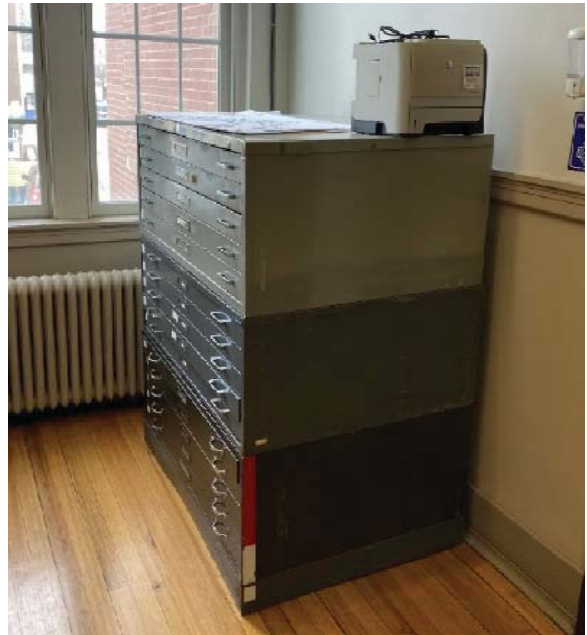
- Land Use lacks adequate storage. Additionally, much of the current storage and equipment is in the hallways, lacking the security needed for confidential files and equipment. There is a flat folder in the second-floor hallway and a plotter in the first-floor hallway. Either additional square footage should be allocated for storage, and/or the town can reduce file storage space requirements by implementing a sliding filing system for compact storage.

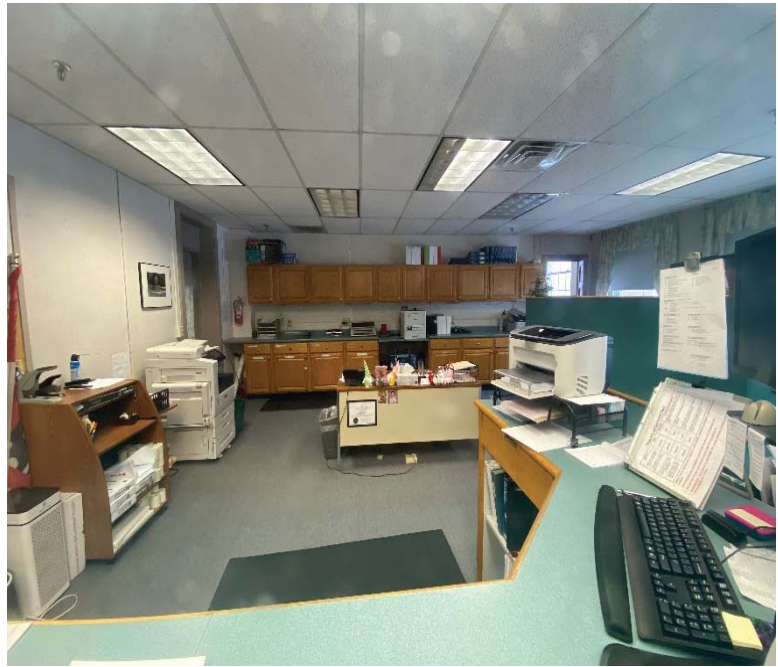
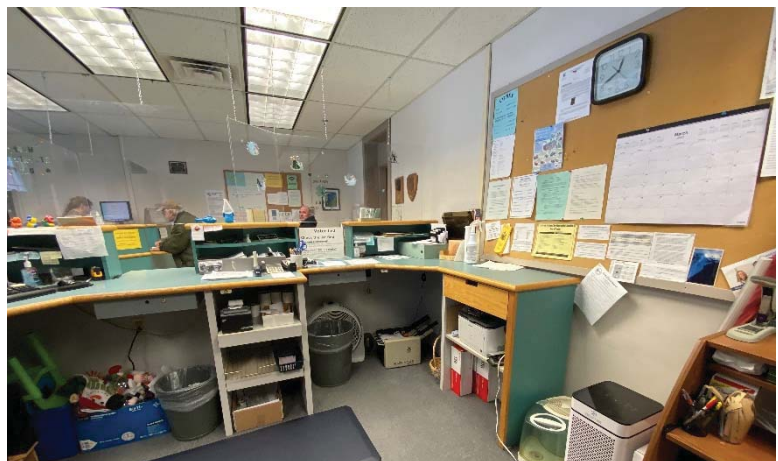
Clerk's Office:

- The clerk's office is on the second-floor and has the highest level of customer service.
- The clerk's office lacks queueing space for the public who line up in the hallway and in the stairway on busy days.
- The materials that staff share frequently are not located next to staff work space counters. This inefficient use of space causes service delays.
- The lighting within the office is inadequate and is likely causing eye strain.
- There is no space or opportunity for counter staff to do training remotely (this is required by the state). There should be a small space or private desk where staff can conduct business separate from the service counter.

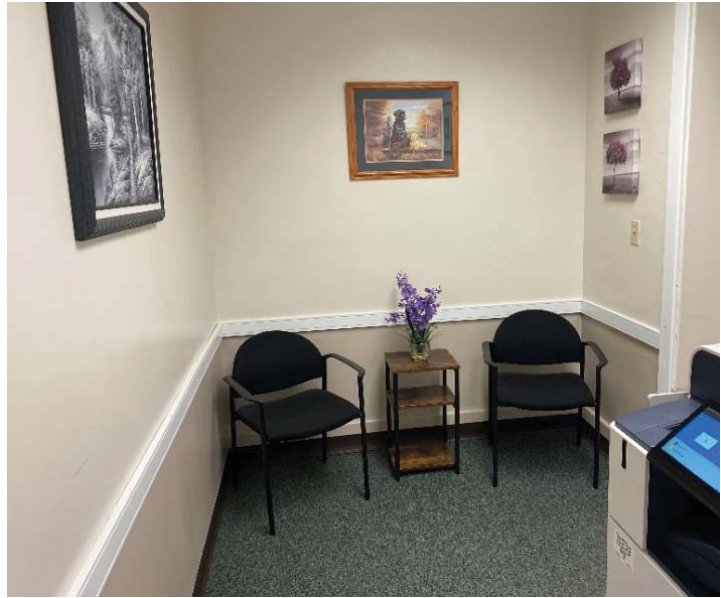
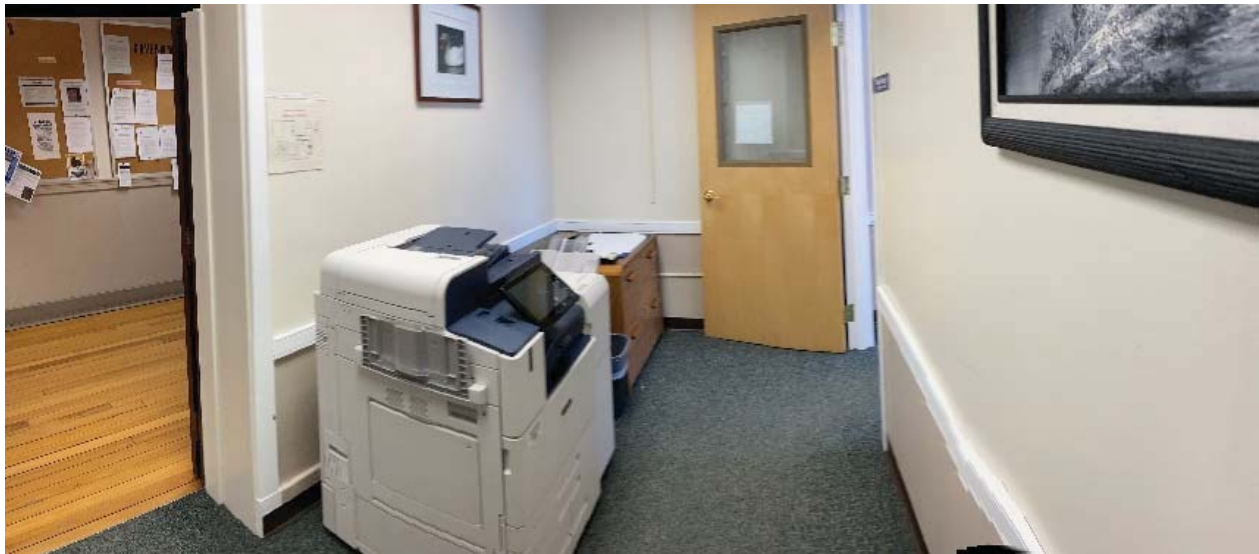
Town Manager's Office Waiting:

- The only waiting is located in front of the Town Manager's suite. The area only has two chairs and a large copier. This space is not comfortable and is unwelcoming.
- The space is not visible to any office making it awkward for people to be noticed while allowing visitors access to potential confidential information on the copier.
- A dedicated waiting area should be created to avoid mixing the office functions with public waiting areas.
- Additionally updated furniture should be implemented into the space for comfort and aesthetics.
- Finishes are worn and should be updated.

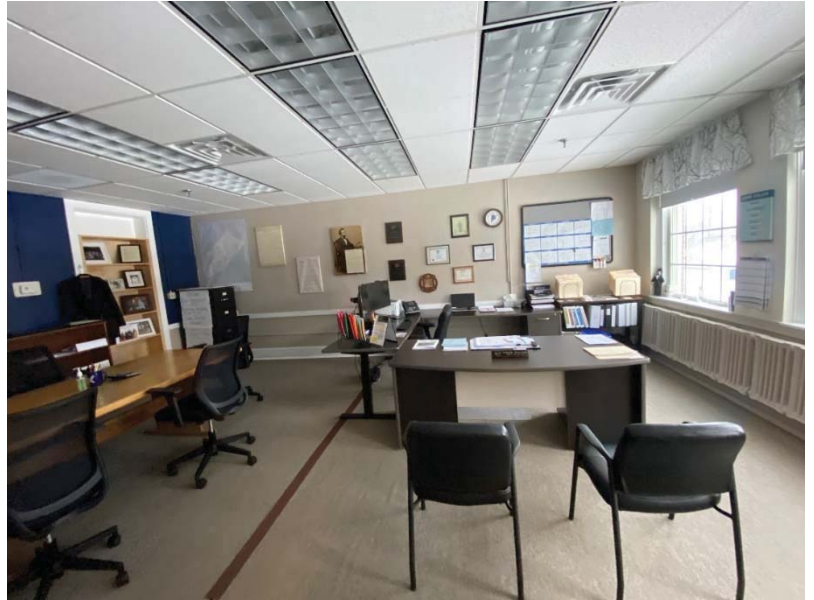
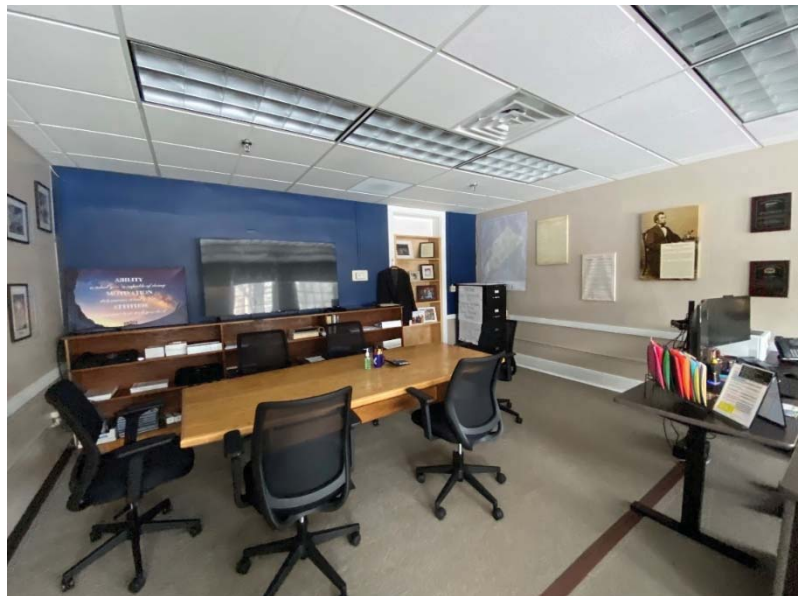
Town Manager's Office:

- The Manager's office is large enough and the furniture is fairly new. The office has proper walls unlike several of the other administration offices.
- The finishes are in bad shape including the carpet which is old. It has become unglued and is ripped. This should be replaced.
- The lights are fluorescent and can cause eye strain and should be upgraded to LED lights.

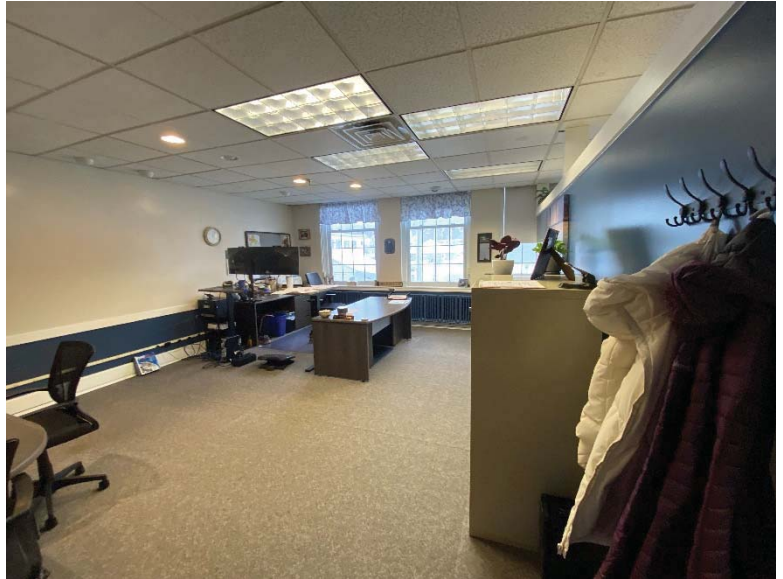
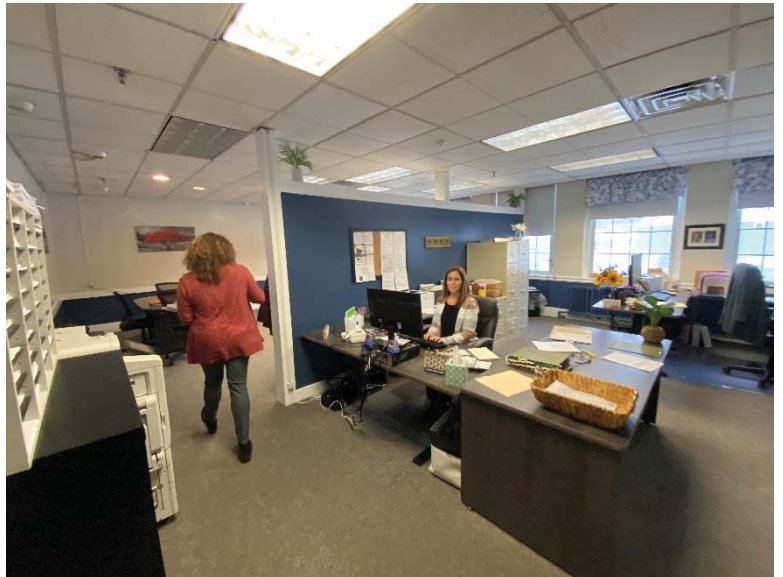
Assistant Town Manager's Office:

- The Assistant Manager's Office is too large and does not have full walls but only an approximately 7'-0" high partition between her and two administrators. Because of this, the Assistant cannot have private conversations in her own office.
- They are newer than the town manager but have a dull appearance because of the fluorescent lighting. If the lighting is changed to LED, the finishes would look better.

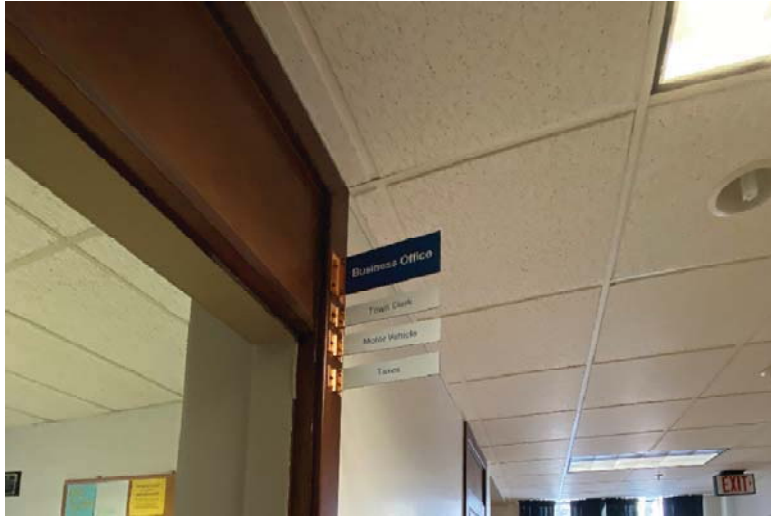
Hallway Signage:

- There is inadequate signage. The signage should be upgraded and oriented to help the public locate where they want to go.
- Signage does not meet ADA code requirements for visibility / accessibility and need to be replaced with code complying signage.

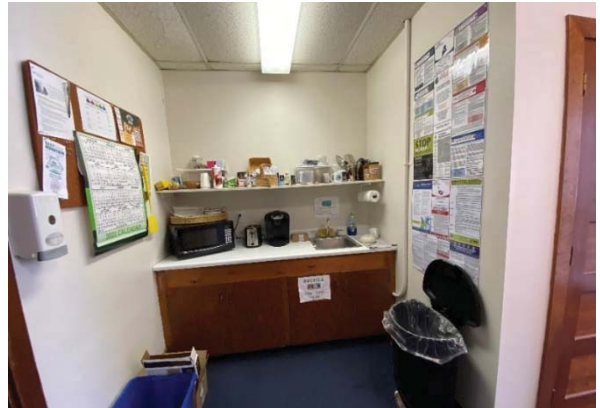
Second Floor Staff Kitchenette:

- The kitchenette has inadequate space to meet the needs of the staff who use it.
- The kitchenette does not meet ADA code because counter height is too high and lacks space to roll under the sink.
- The finishes are failing, making the kitchenette hard to clean.

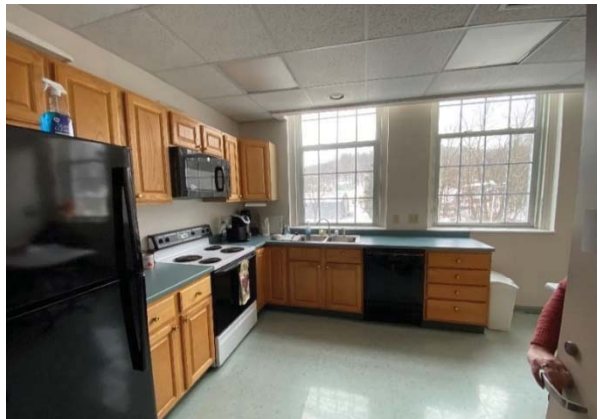
Full Kitchen on Third Floor:

- Does not meet ADA code because counter height is too high and lacks space to roll under the sink.
- Stove lacks NFPA Hood, which is required by code. Either the stove should be removed now or a hood needs to be provided.
- The counter finishes are failing, making the kitchenette hard to clean.

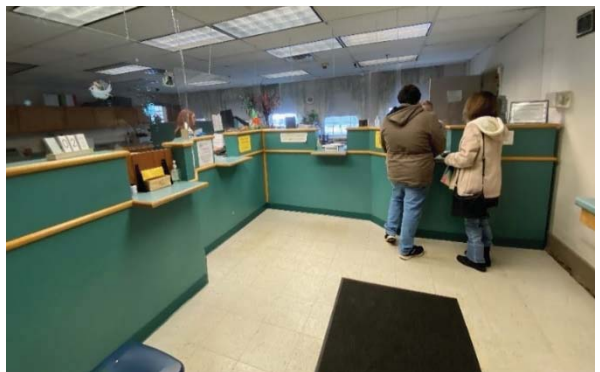
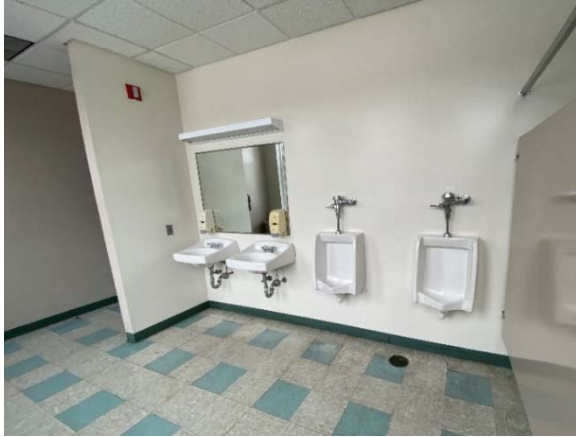
Clerk Service Counter:

- The service counter on the second floor does not meet ADA requirements for either staff or public because it is too high for the height required by ADA code and should be modified or replaced.
- The side counter is too high and extends too far into the space to meet ADA requirements. This should be removed, replaced, or reworked to meet current codes.

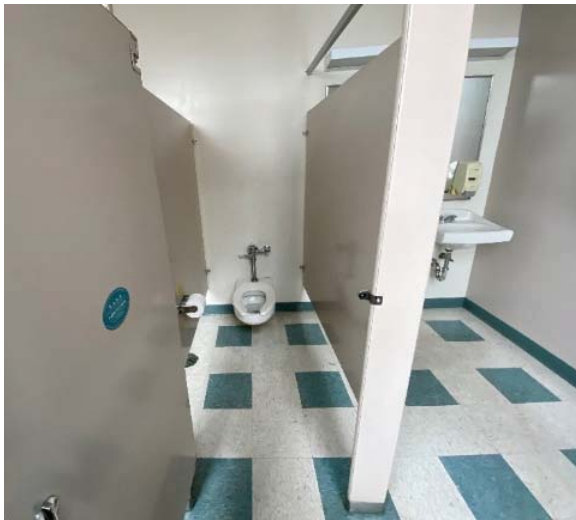
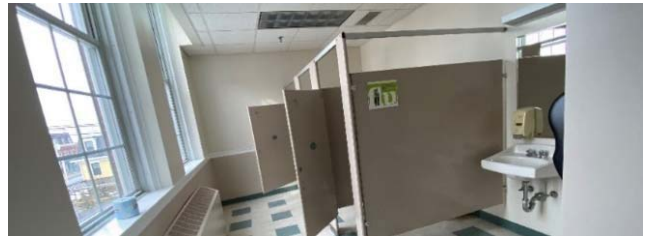
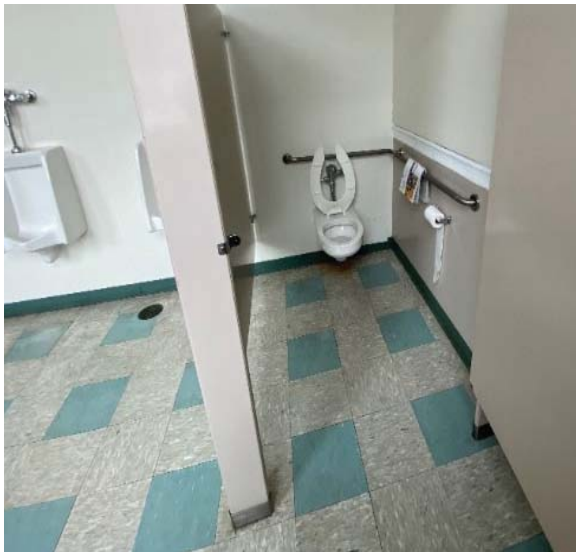
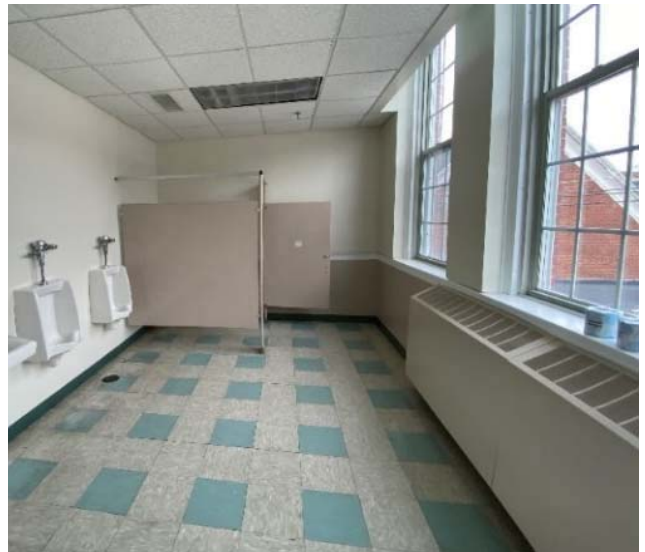
Third Floor Bathrooms:

- There are male and female multi – stall bathrooms.
- None of these bathrooms meet ADA code in multiple ways.
 - The sink and mirrors are too high for accessibility requirements.
 - The sinks need LAV guards on them.
 - Urinals are too high per ADA.
 - ADA stall does not meet required clearance and lack all the grab bars required.
- Finishes throughout are faded and the tiles are making the bathroom absorb odors causing unpleasant smells.

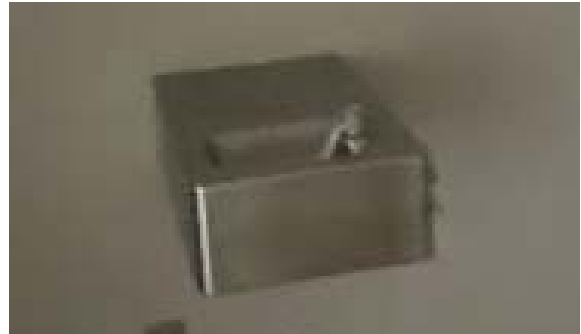
Third Floor Water Fountain:

- The water fountain exists on the third-floor outside of the bathrooms.
- Does not meet ADA height.
- Plumbing code requires an ADA water fountain in public buildings.

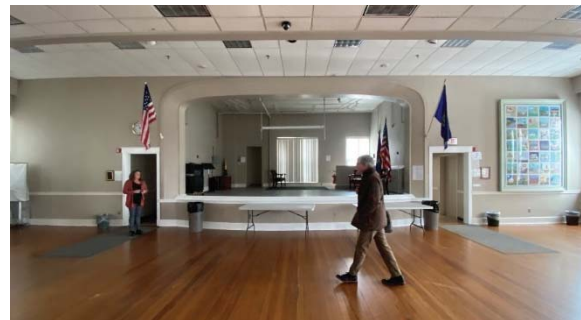
**Auditorium and Stage:**

- The stage is not ADA accessible and needs to be.

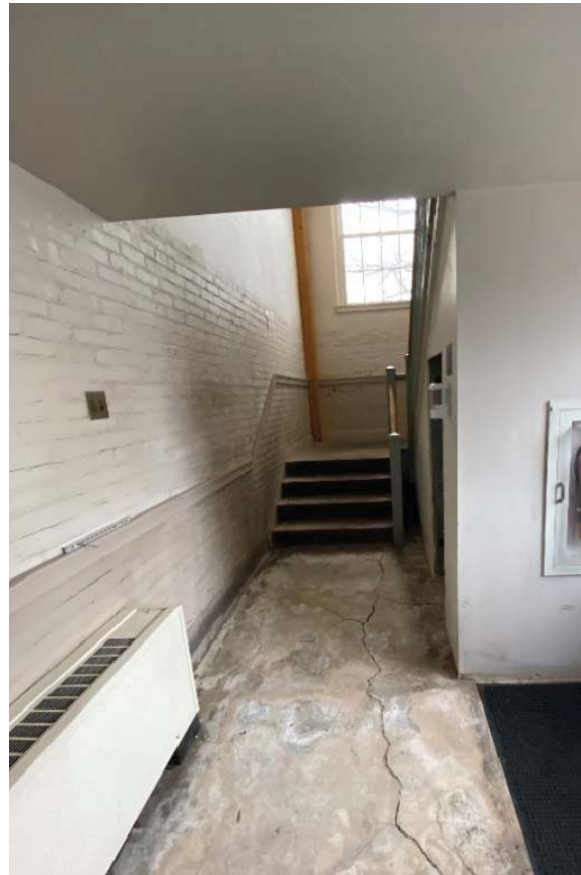
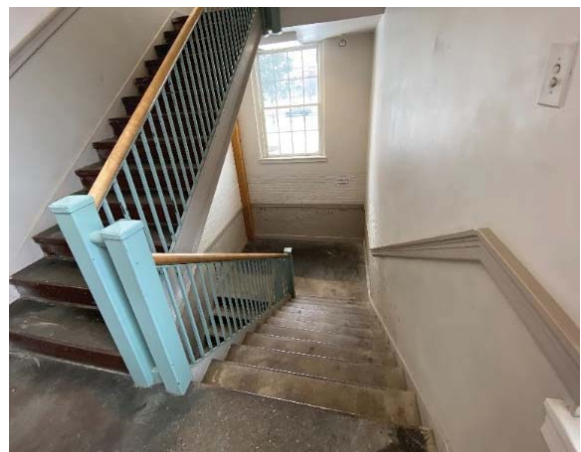
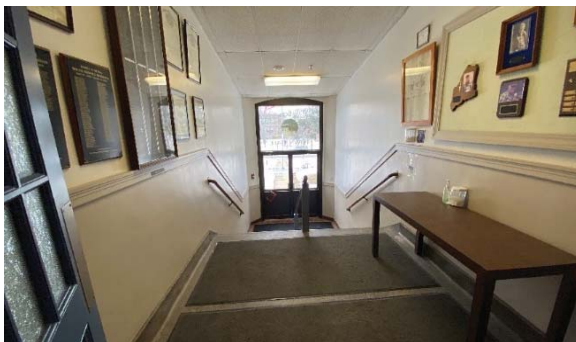
Stairs:

- The stair rise and run does not meet the current code. The metal pan stairs should be removed, and proper stairs installed.
 - There is an electrical panel in the stairwell that needs to be removed now.

- There is enclosed storage under the stairs but the enclosure is not fire rated. This is not allowed and needs to be removed now.
 - There are no tread finishes but only bare concrete finish. These are slippery especially when they are wet. Treads need to be added to prevent falls.

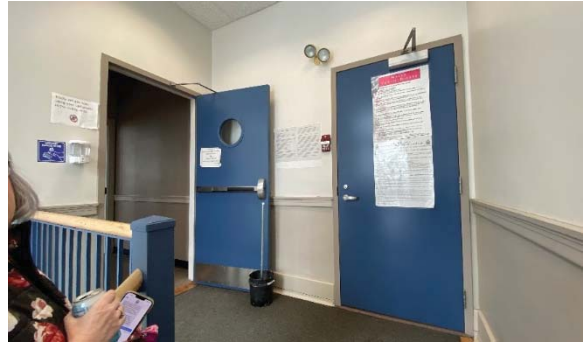
Fire door in staircase:

- Fire doors are propped open, and they are required to be closed or on electrical hold openers to meet the Life Safety Code. If the town wants to continue this practice, hold openers are required.

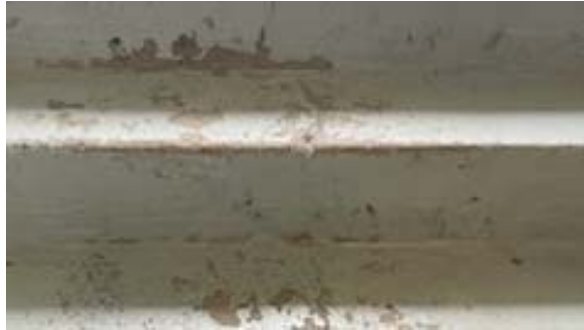
**Damage to stair treads:**

- This staircase in the old police station is chipped and is a tripping hazard. These need to be repaired as this poses a safety hazard.

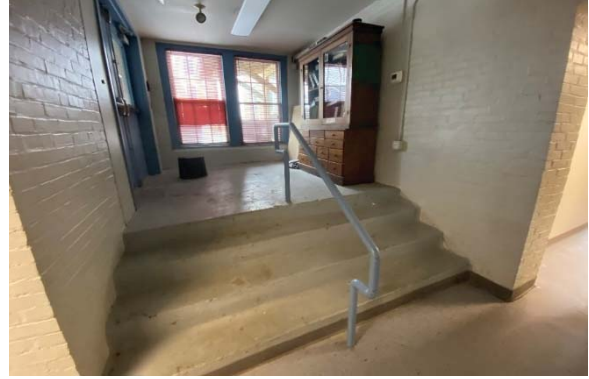
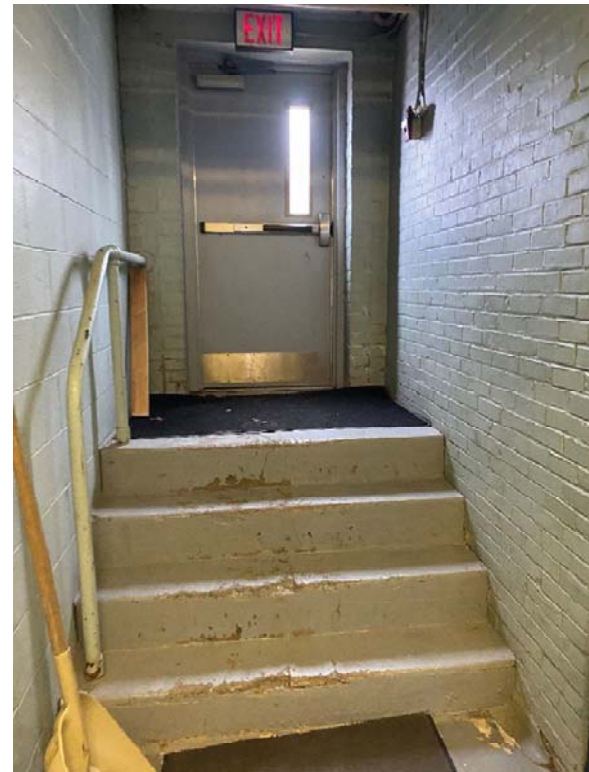
First-Floor Stairs

- All of the stairways in the old police station staircases lacks handrails on both sides as required by code. Additionally, this staircase should have rubber treads added to prevent people from slipping.

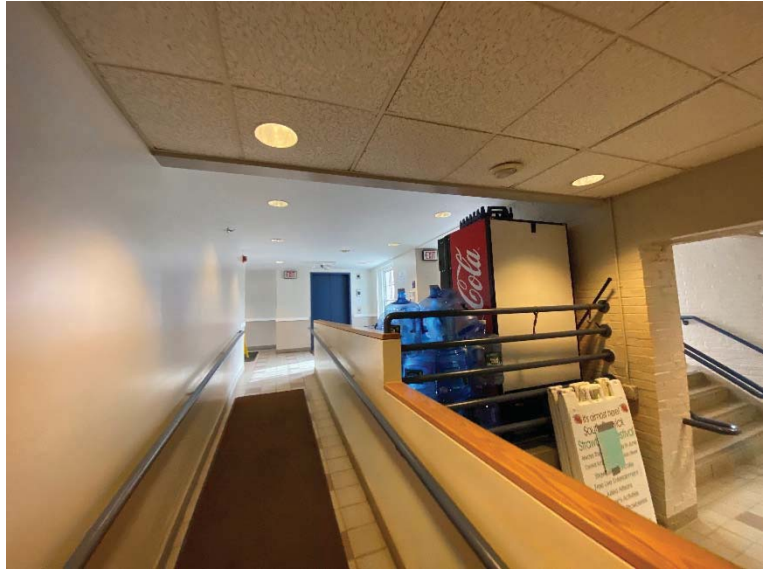
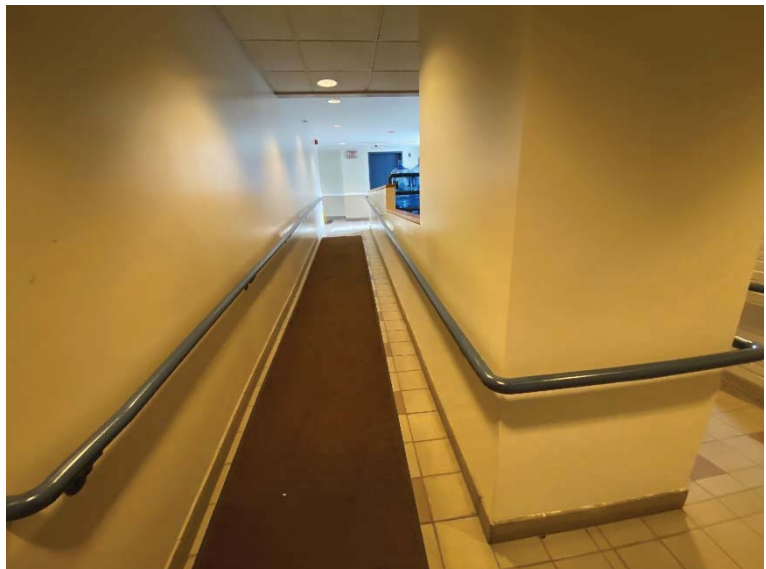
First-floor Ramp:

- There is a ramp from the entry to the first-floor to provide ADA access. The ramp is in good shape and appears to meet current code requirements.

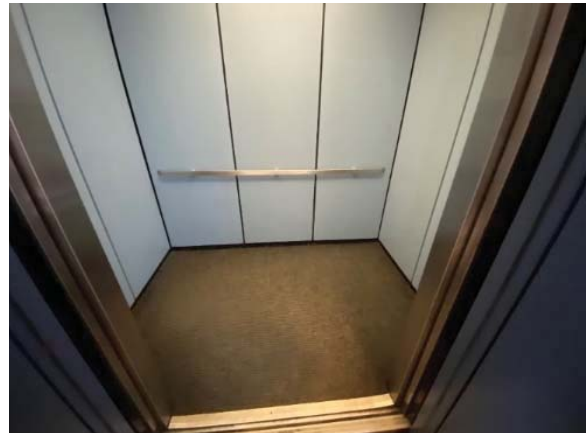
Elevator:

- The elevator has been in existence for many years and is reaching the end of life on several components.
- The leveler is failing so the elevator does not always line up with each floor. It is anticipated that the elevator will need to be replaced in the near future. It is possible that the elevator will fail its next annual state inspection and will need to be replaced at that time.
- The existing elevator shaft should be grandfathered and not need to be made larger. However, that is up to the local jurisdiction, and they may require the town to enlarge the elevator shaft to meet current code requirements.
- The flooring appears to be class A, and this meets code.

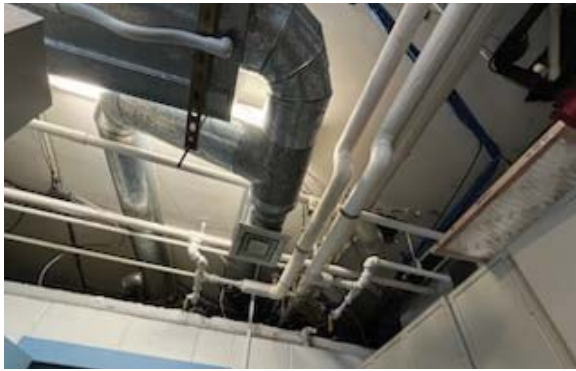
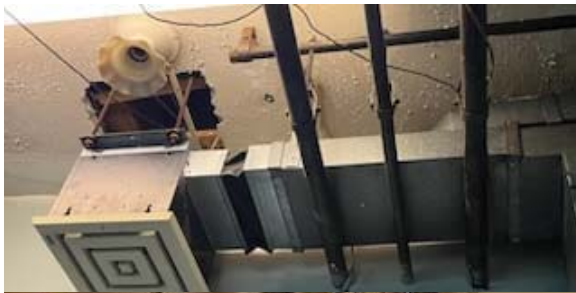
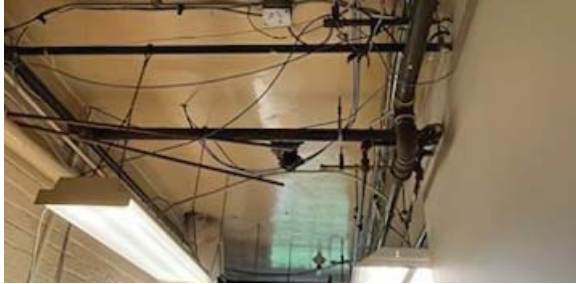
Mechanical, Electrical, and Plumbing General:

- The MEP has been retrofitted over the years. The walls are in disarray from renovations. There are scattered equipment, pipes, and wires, as well as holes and dents in the walls. These need to be repaired.
- All hard walls and ceilings with cuts need to be patched and all penetrations in fire walls need fire caulk to provide fire rated systems as required by code.
- Electrical wires when exposed should be in conduit to make sure they are not damaged.

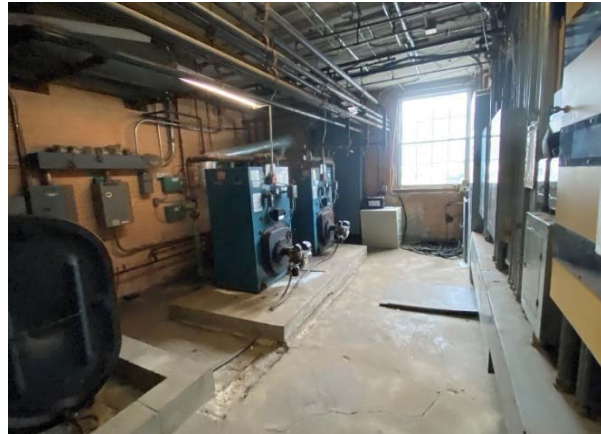
Mechanical Room.

- The mechanical room houses boilers, oil tanks, and the main electrical panels.
- The boilers were recently replaced because they were failing.
- All wall and ceiling penetrations need to be fire caulked because the space needs to be fire rated.

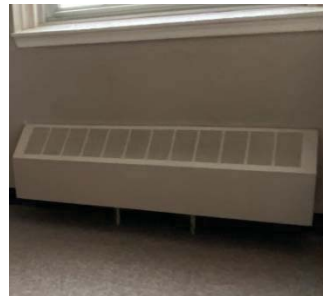
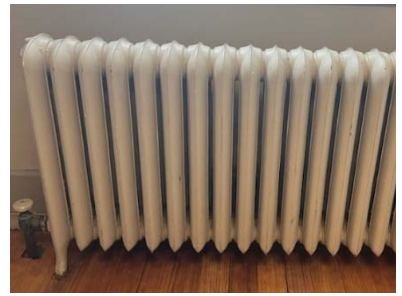
Heating & Ventilation Systems:

- The heating system is steam, which is inefficient and does not modify well. It would be more cost-effective to provide a different heating system both initially and to run it. This should be replaced if any major renovations are done.

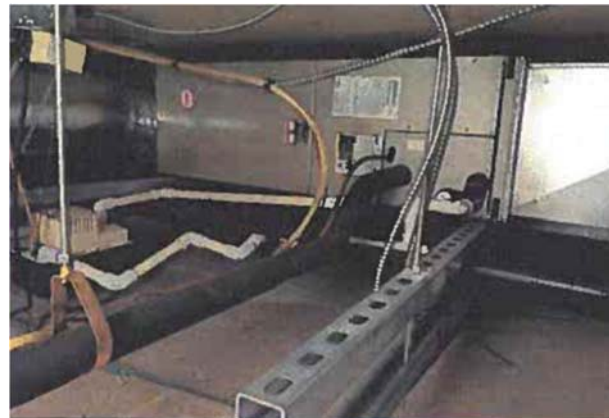
Air Handlers

- The expected life of an air handler is 25 years and the town's air handlers are over 20 years old – they **do not provide cooling**. These air handlers could start failing at any time.
- The air handlers should be replaced if the building is renovated, and the town should expect to replace them in a few years if they remain in the existing building without major upgrades.
- The air handlers and ducts should be professionally cleaned because of dust and dirt buildup over the last 20 plus years.
- The air quality should be checked to make sure there is no air quality issues.
