South Berwick Town Hall Evaluation and Recommendations

August 20, 2023

Port City Architecture and their consultants have been commissioned to provide a facility assessment for the existing South Berwick Town Hall building including physical condition; structural integrity; mechanical, electrical, and plumbing system; site conditions; overall appearance; overall function; and code compliance. As part of our inspection, we highlighted any workplace safety issues, potential hazard, and building functionality pertaining to a modern-day town hall administration that incorporates current technology and practices.

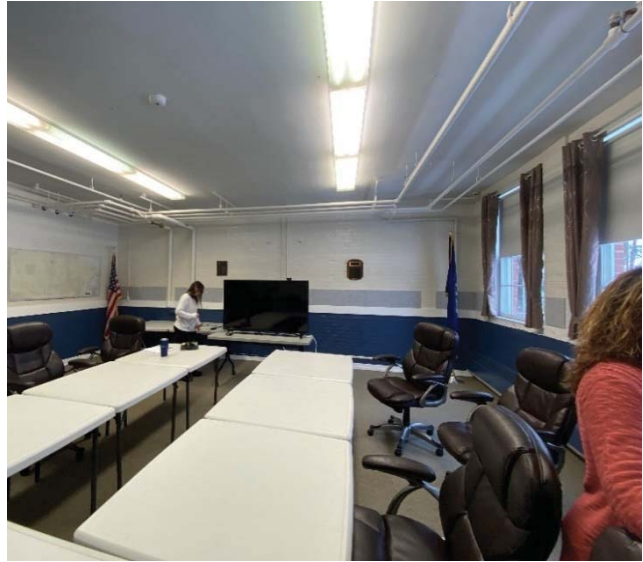
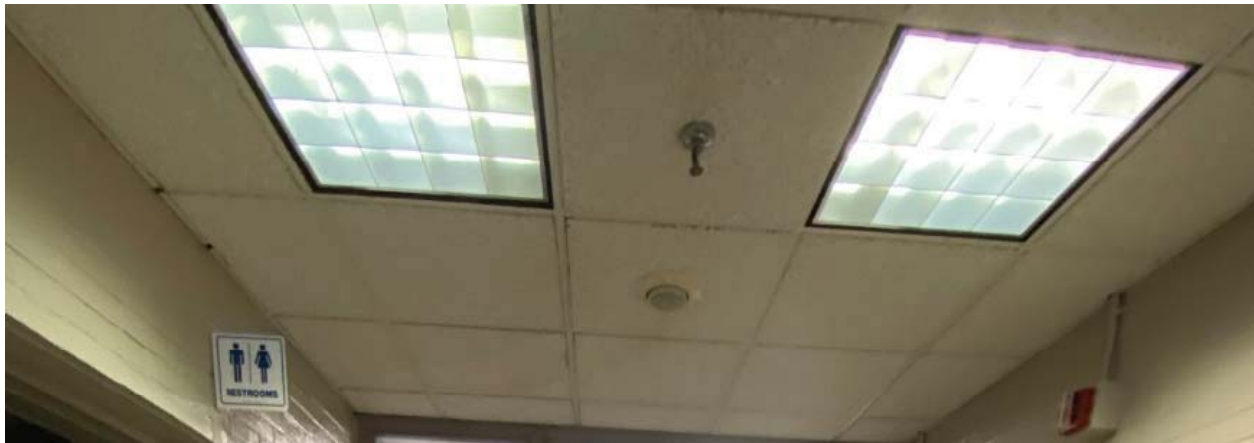
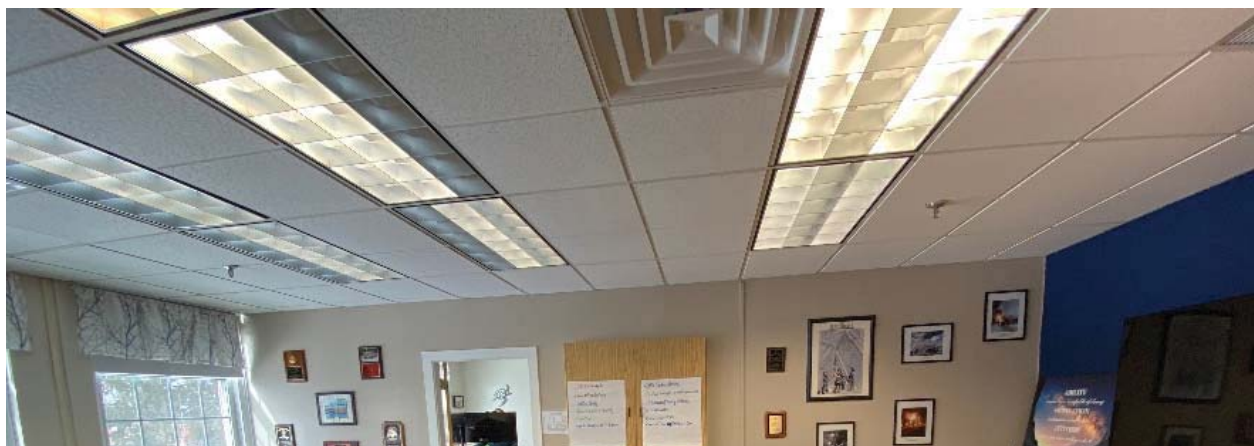
Existing Lighting:

- Lights are primarily fluorescent. The lighting in many of the spaces has a white or yellow hue which causes eye strain and LED lights are more cost effective to run. All the lights in the building need to be replaced.
- Signs of yellow and cracking lens are present on fixtures throughout making the building look less appealing and less professional. These should be replaced.

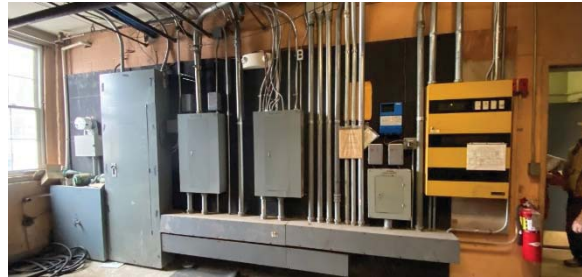
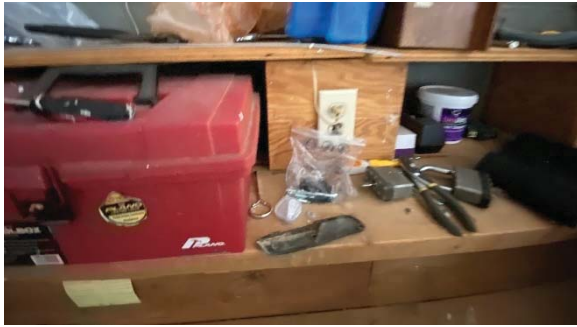
- At least one outlet has flash burns indicating there were not proper surge protectors.

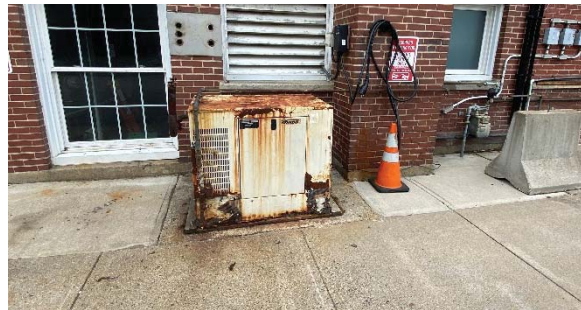
- The generator is outdated and past its current life. It should be replaced.

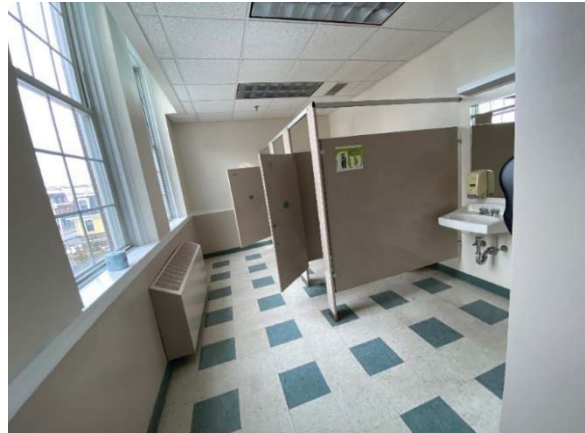
Plumbing:

- The bathroom plumbing fixtures appear to be functioning adequately, but they do not meet current code requirements for water flow. If the bathrooms are renovated, these fixtures need to be replaced throughout. However, these fixtures are grandfathered and can remain until there is renovation work to the bathrooms.
- None of the sinks, toilets, or urinals meet ADA. See ADA section.
- At least one plumbing vent terminates in the attic instead of outside. This should be fixed now to meet code requirements and to prevent excessive moisture in the attic.

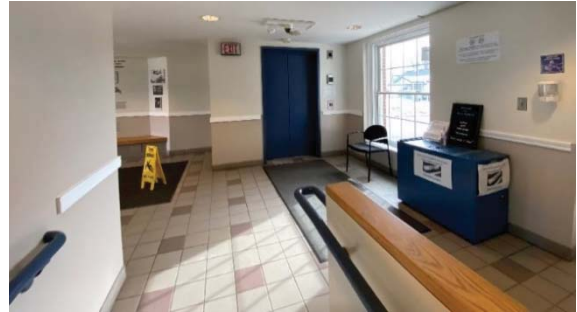
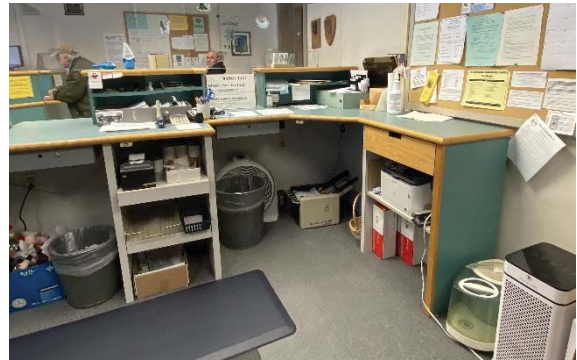
Finishes:

- The building's last major renovation was in the 1990s.
- The finishes are aged and show major wear. In many places, the finishes are beyond repair.
- The finish selections are dated.
- The finishes are no longer able to be cleaned sufficiently due to stains and wear.
- The plastic laminate is chipped and delaminating in some places making the entire office look unprofessional.

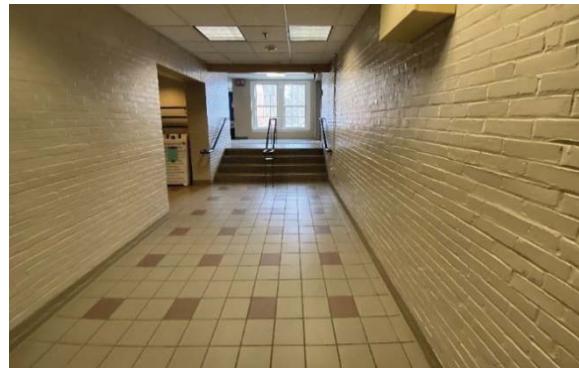
- The quarry tile on the first-floor is holding up.

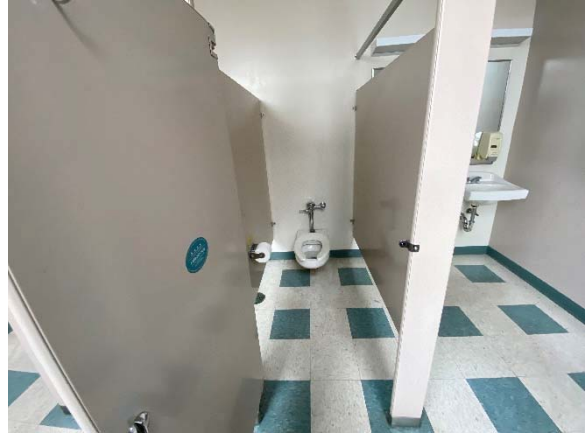
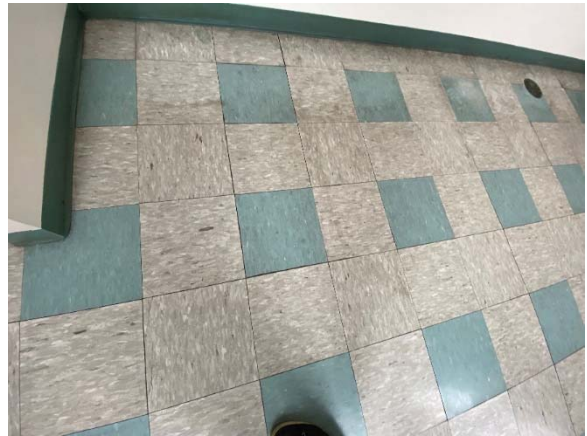
Bathroom Finishes:

- The floors are Vinyl Composite Tile (VCT) which allows liquids to flow through the seams and soak into concrete or wood below making it nearly impossible to remove bathroom smells.
- The ceilings are acoustical ceiling tiles which also absorb bathroom smells.
- The partitions are metal with cardboard cores which also absorb bathrooms smells.
- All these finishes should be replaced with contemporary finishes that will be easier to clean and will not absorb smells.

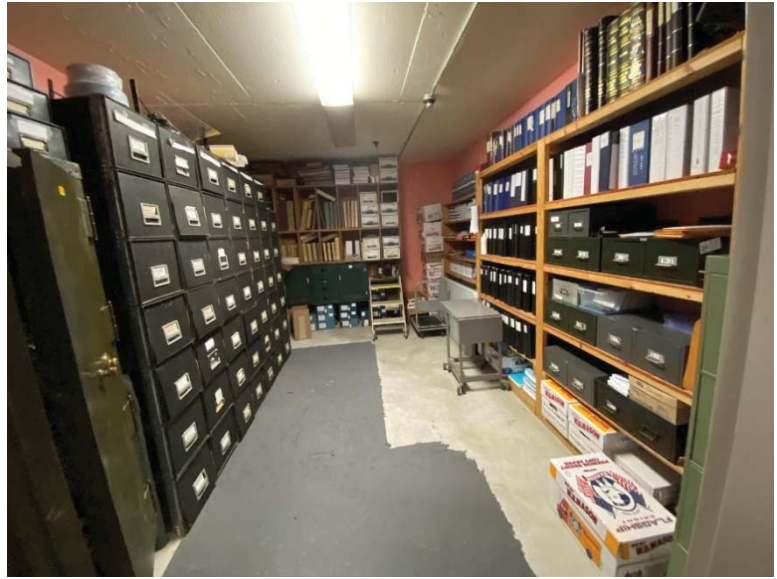
Clerk's Office Vault:

- The vault is attached to the clerk's office workspace as it should be.
- The Clerk's vault has plywood shelves. The acid in plywood can damage documents and should be replaced.
- The large drawer system is a cardboard system and should be replaced with a more permanent systems it will fail.
- Switching to a slider storage system will increase the amount of storage the vault could hold without damaging the documents. However, before this can be done, a structural analysis should be done to make sure the floor is strong enough to support.
- A leak in the roof has damaged the shelving and vault materials in the past and may occur again so should be monitored.
- If the building is renovated a fire inspection must be conducted on the vault to confirm the fire rating of the room. Because this requires selected demolition, this inspection could not be conducted at this time.

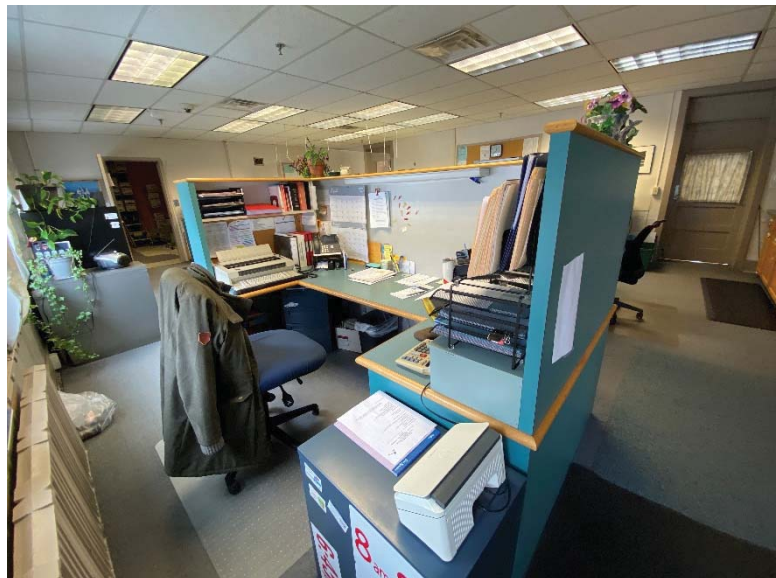
Clerk's Office Desk.

- While most staff have been provided a new desk set-ups in the past 18 months, there is not enough space in the clerk's area for a new desk. This is still the 1990's built in. It is not ergonomic, private, adequately sized, or adjustable and it needs to be all of these.

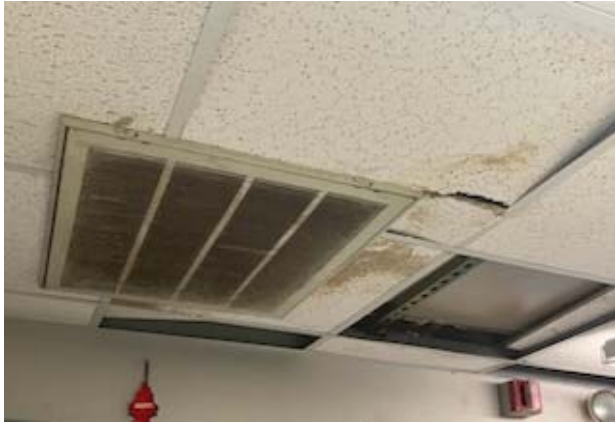
Ceilings:

- Ceilings throughout are dated, worn, and water damage is present throughout.
- In many places the ceiling frame is starting to turn yellow from age. These should be replaced.
- The ceilings systems need to be replaced throughout the building.
