## CIVIL CONSULTANTS MEMORANDUM

**SUBJECT: South Berwick Town Hall – Exterior Masonry Inspection**

**DATE: OCTOBER 3, 2023**

**PROJECT: EXTERIOR REVIEW – TOWN HALL / COMMUNITY CENTER**

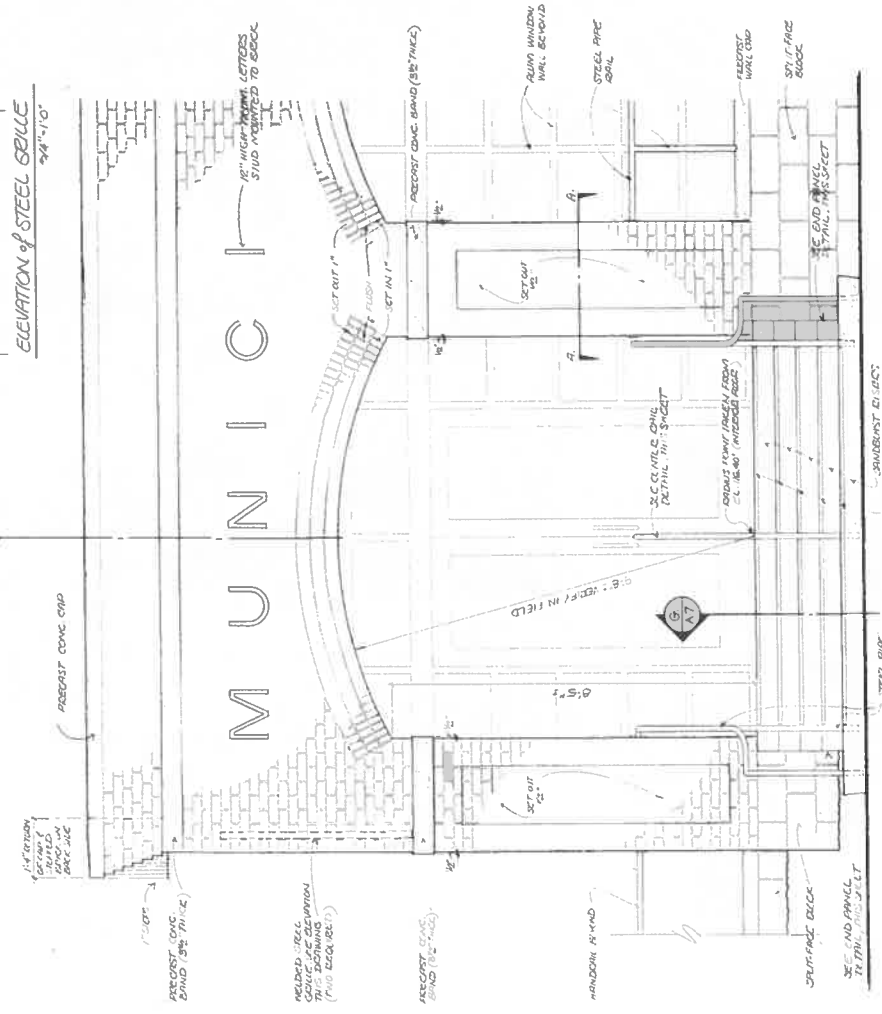
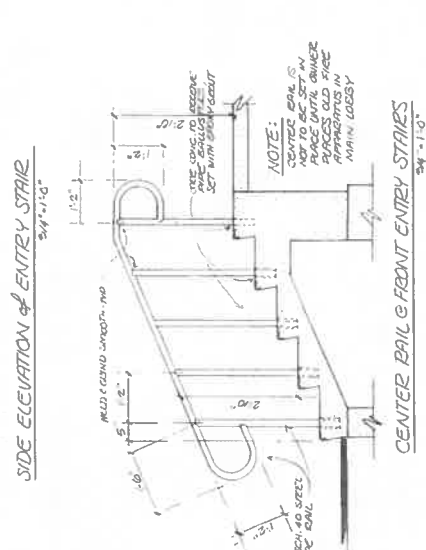
I WALL SECTION

arch is supported by concrete block masonry. The block details were designed by the project architect during the renovation, not the project structural engineer. The details on the plan do not indicate how the arch of brick veneer is supported. It is our recommendation that some destructive testing and removal of finishes be completed to determine the damage to the existing masonry support. The work should be conducted by a mason with engineering oversight. Moisture is entering the brick veneer and causing the leaks and staining. The investigation will reveal if there is damage to the veneer supports. We recommend that this be completed sooner rather than later.
