LANDMARK COMMISSION REPORT

APPLICATION FOR COMPREHENSIVE EXTERIOR POST STORM RENOVATIONS TO 125 E WATER STREET

Reference Number: LC-09-18

REPAIR NARRATIVE

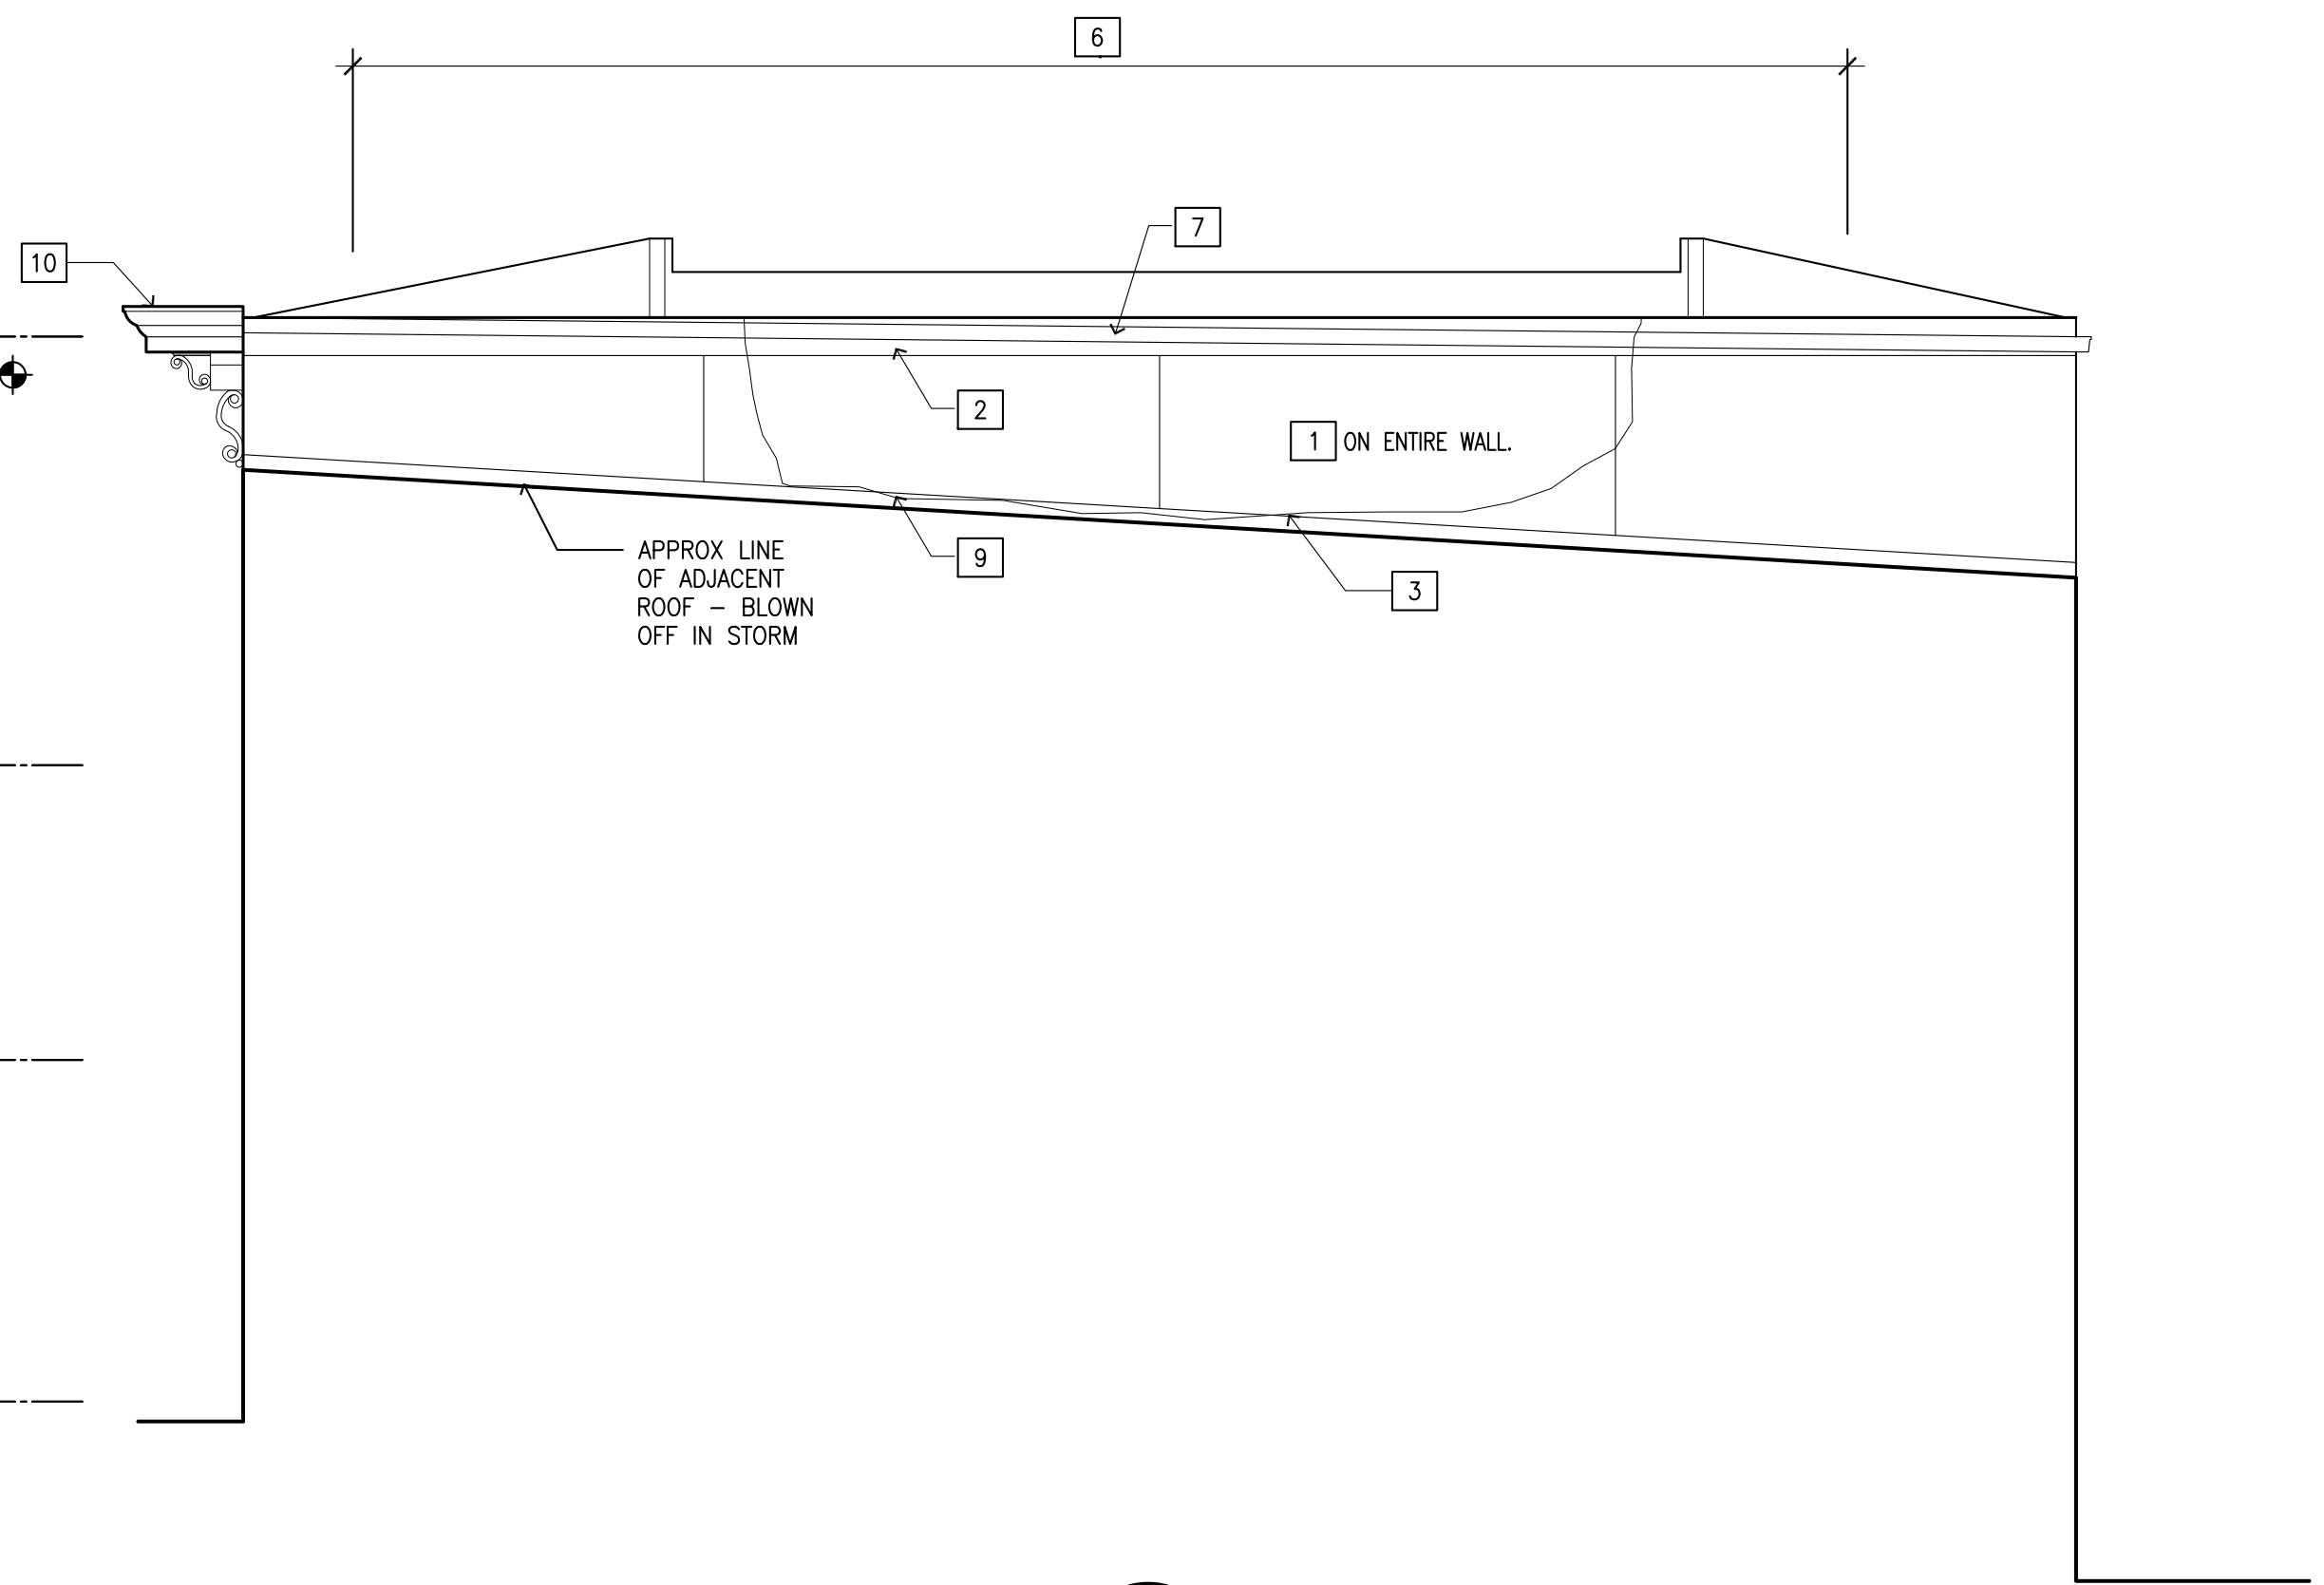
2 EAST ELEVATION
A200 SCALE: 1/8" = 1'-0"

The east wall of the building continues to serve as a party wall condition. The total surface area of this wall is 4,000 sf with 594 sf of wall extends above the adjoining building, which is not visible from the ground level primary elevation. This was entirely covered with an EIFS system pre-storm damage. The storm damage resulted in a loss of 240 sf (6%) of the entire east wall. The proposed new condition is consistent with this pre-damage condition, with the exception that the color of the replacement EIFS system will be more compatible with the brick colors.

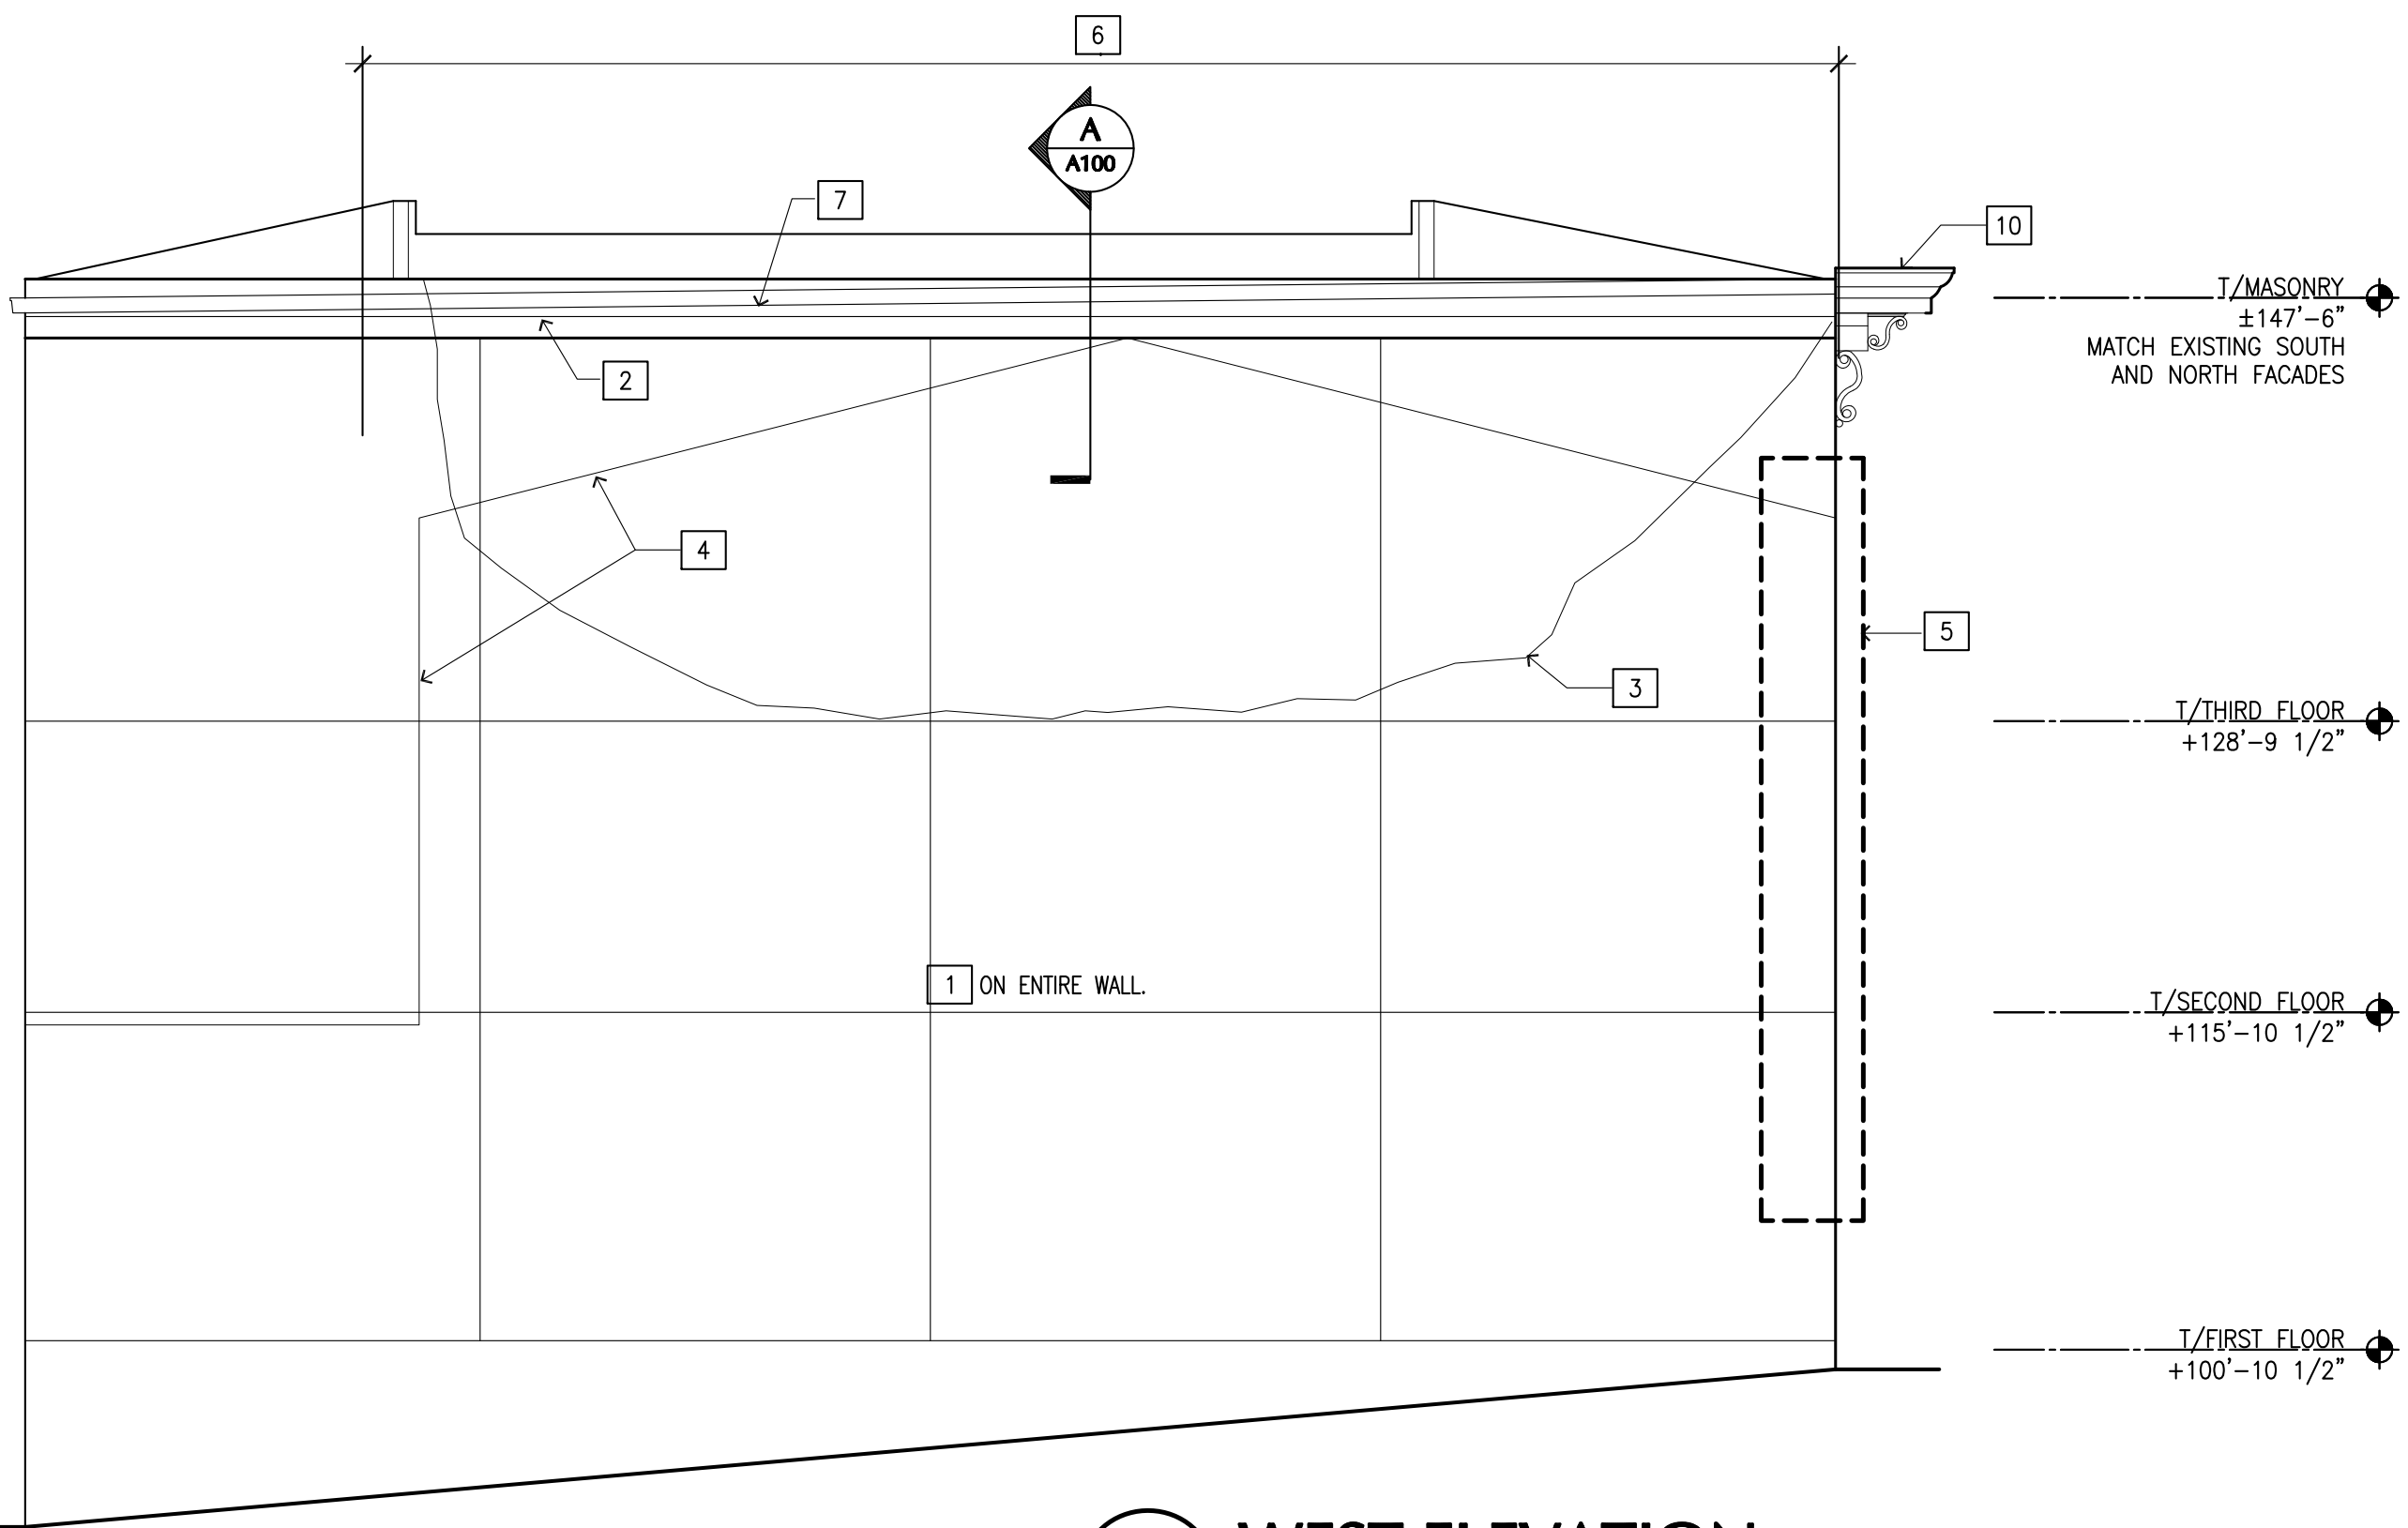
1 WEST ELEVATION
A200 SCALE: 1/8" = 1'-0"

In recent years, the building to the west was demolished due to neglect, thus exposing what was never intended to be, and is not capable of being a wall exposed to the elements. The wall was constructed with bricks that do not have a severe or moderate (SW or MW) facing, making them excessively porous for single or double wythe construction. By leaving these exposed, the interior of the building becomes susceptible to the negative effects of moisture infiltration as well as freeze thaw conditions. With the wall not having any insulating properties and the wall varying between 2 and 3 wythes of thickness, it does not have enough mass to allow for the dew point to land outside the interior space, thus creating a condensation issue within the building.

As noted above, the existing west wall is also not consistent in its thickness and dimension. The thickness varies from 2 to 3 wythes thick along its length. Thus the repairs are limited to a width dimension of 2 brick wythes or 8" nominally, to accommodate the necessary reinforcing and anchoring. This thickness does not allow for the exterior application of a veneer brick face.

TOTAL WALL AREA THIS ELEVATION: 4,175 SF
AREA OF PREVIOUSLY EXISTING EIFS: 1,352 SF

The entire surface area of the west facing walls is 4,000 sf. Prior to the storm damage, there was 872 sf of EIFS on this wall (22%), 383 sf of limestone (10%) with the balance being the exposed brick listed above. The storm damage resulted in the loss of 900 sf of this wall (22%.) With the proposed repairs, the exposed limestone will remain and the balance will be covered with EIFS. The color of the EIFS will be similar to the overall color of the brick and have a moderately textured finish. This will create a compatible color scheme to the pre-storm damage condition.
