**Subject: Quantification of Asbestos Containing Materials and Lead-Based Paint
Former Illinois State Mental Institution (Tinley Park Mental Health Center),
7600 West 183rd Street, Tinley Park, Illinois 60477
Project No. 103P3304**

**QUANTIFICATION OF ASBESTOS CONTAINING MATERIALS
AND LEAD-BASED PAINT**

**FORMER TINLEY PARK MENTAL HEALTH FACILITY
TINLEY PARK, ILLINOIS**

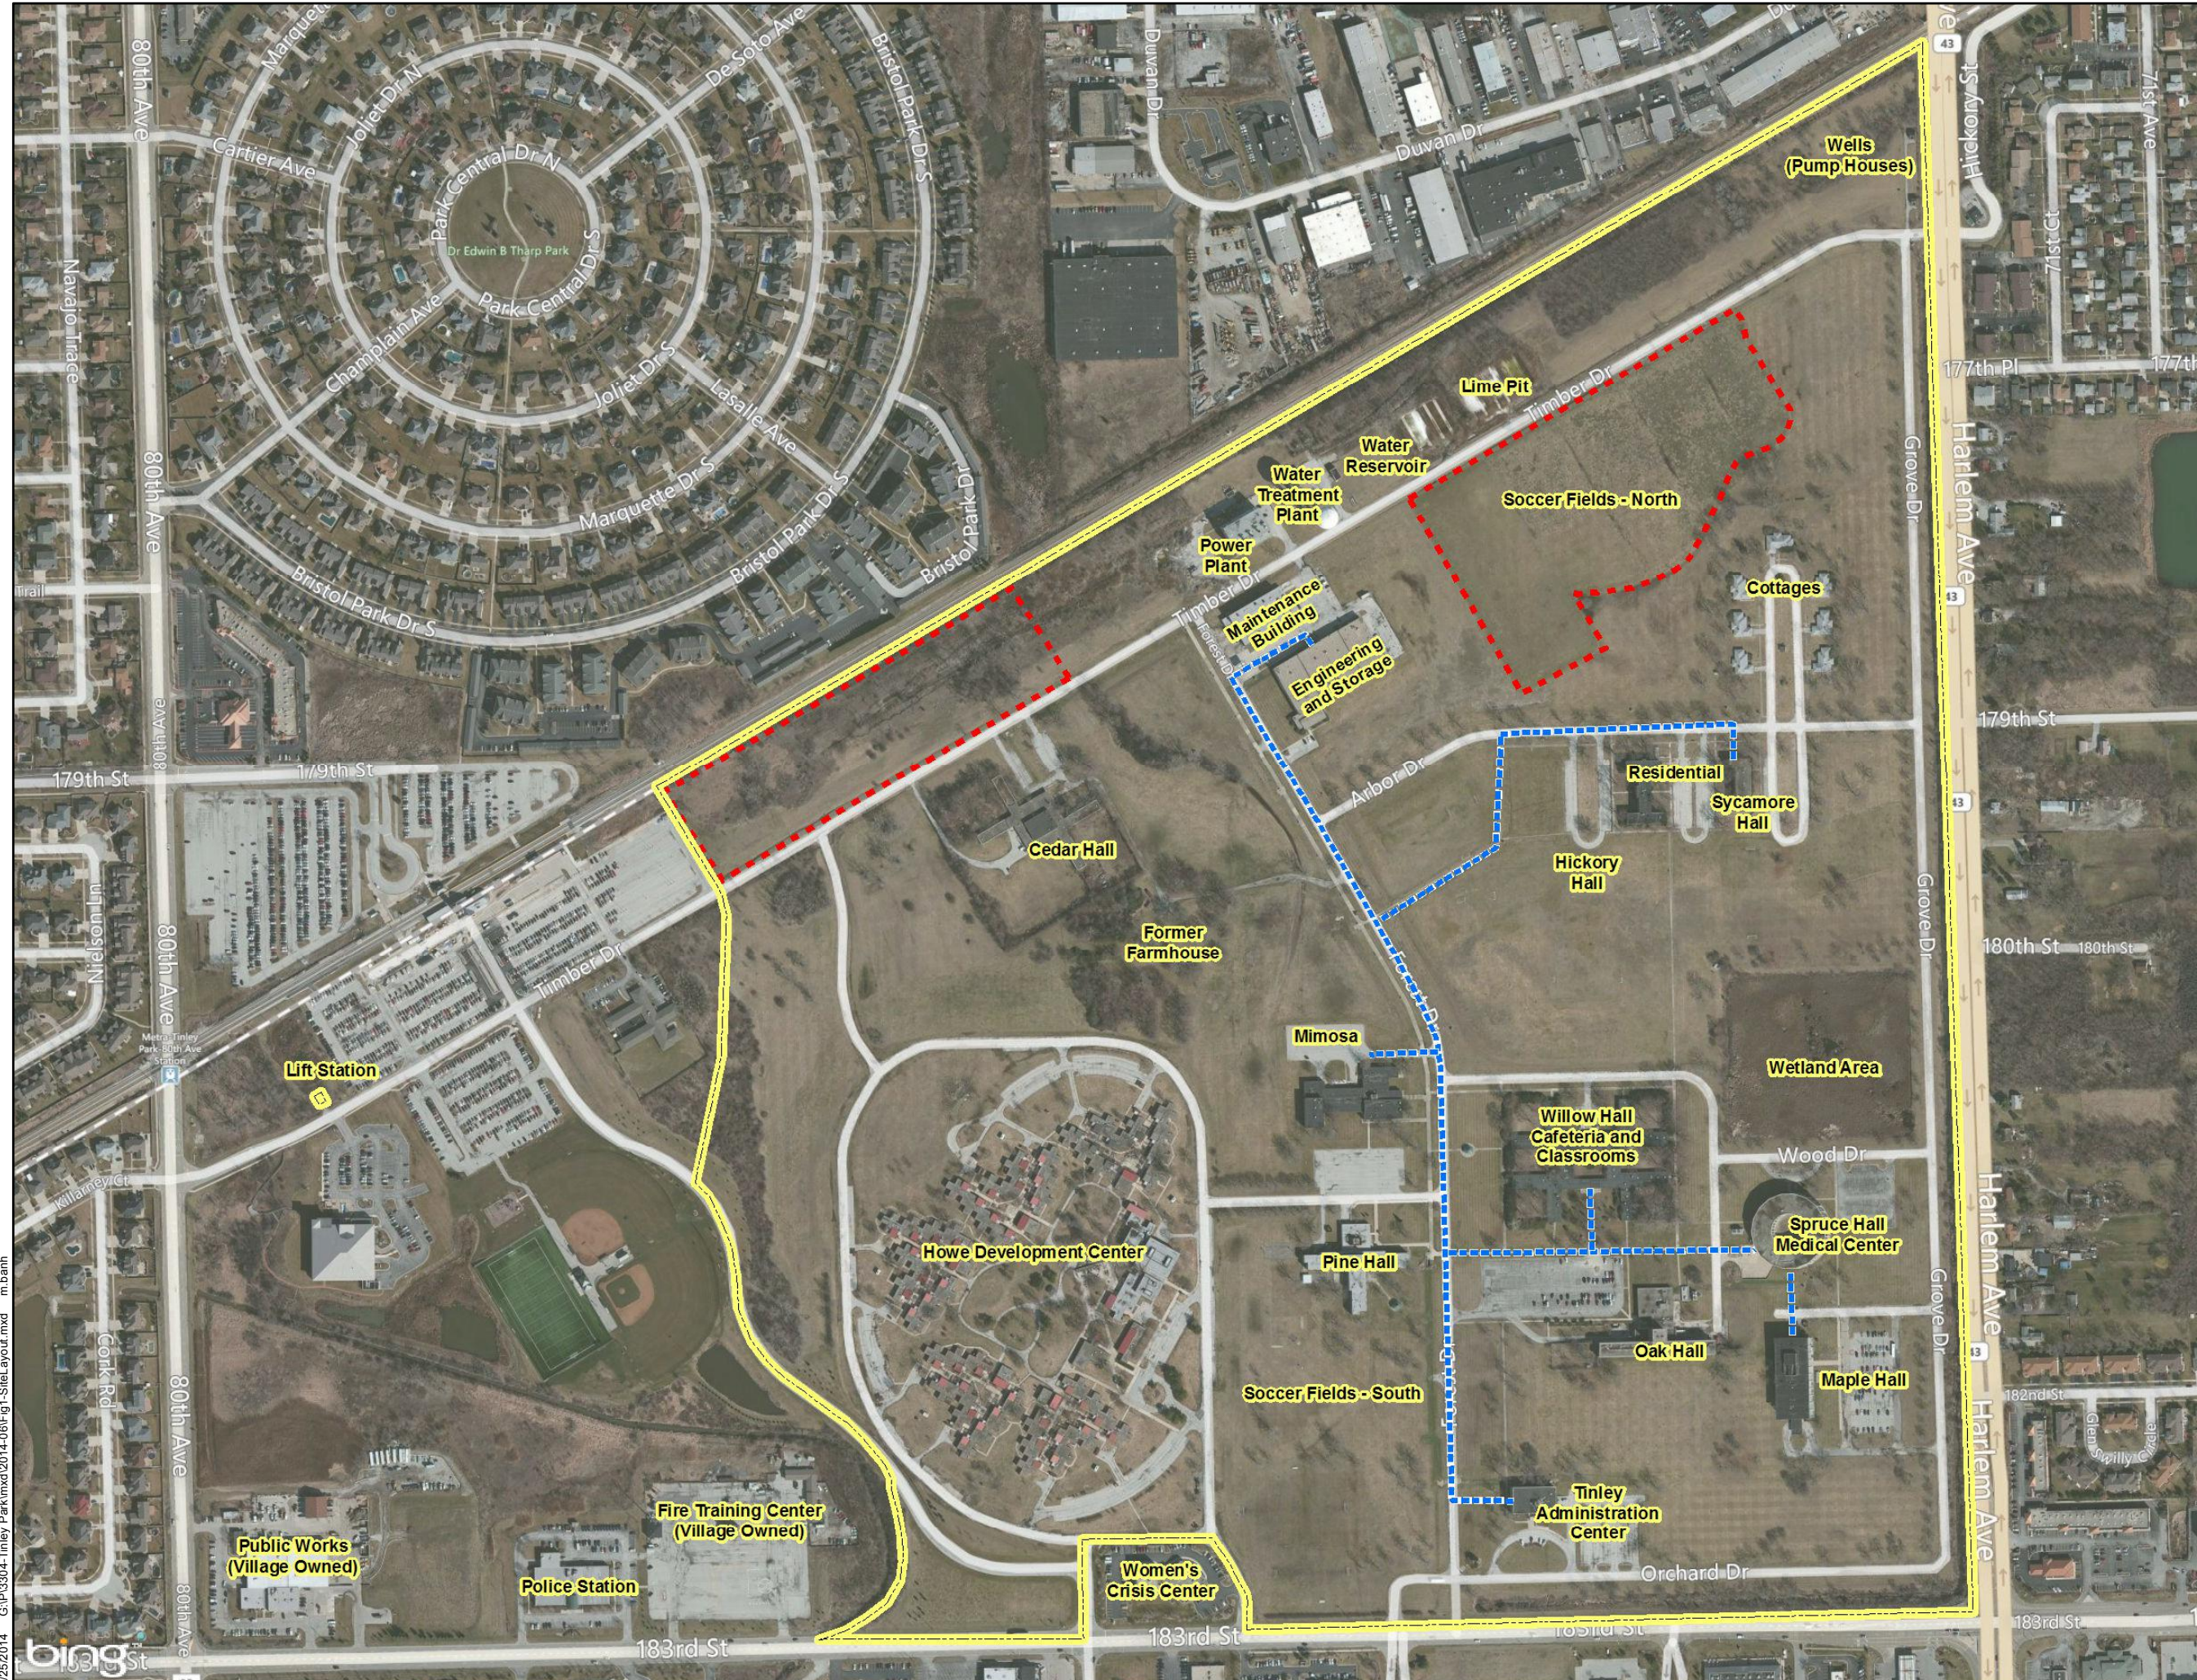
FIGURE 1
SITE LAYOUT MAP

- Legend**
- Approximate Tunnel Location
 - Approximate Outline of Suspected Fill Area
 - Approximate Site Boundary
 - Text** Building structure or significant site feature
