West Collingswood Preservation Plan

A Guide for the Neighborhood's Property Owners

Prepared for the Borough of Collingswood, New Jersey with funding from the Certified Local Government Program of the U.S. Department of the Interior, National Park Service, administered by the State of New Jersey, Department of Environmental Protection, Division of Parks and Forestry, Office of New Jersey Heritage.

August 1989

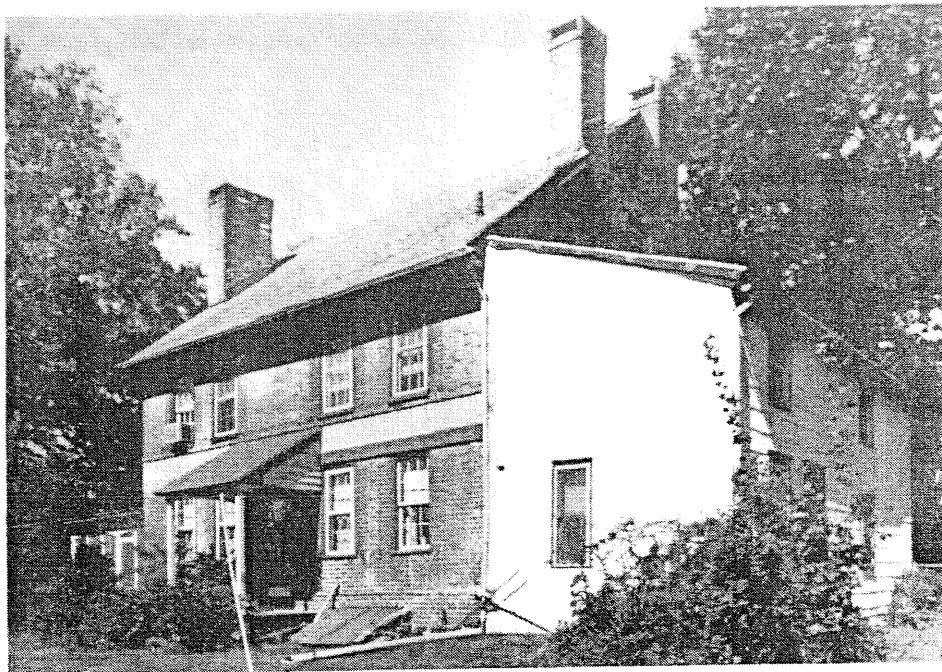
THACKARA HOUSE
912 Eldridge Avenue

Built in 1754, the Joseph Thackara House is the oldest dated structure in the Borough of Collingswood. A traditional, colonial Quaker farmhouse, this building fronts Newton Creek which was the primary source of transportation in the mid-eighteenth century. This front facade was laid in Flemish bond brickwork and features: a central raised-panel entrance door; six-over-six sash windows; segmentally arched-head basement window openings punctuating a molded brick watertable above a coursed fieldstone foundation; an added bulkhead access; and a simple wood box cornice. The portico has been added - originally there was a pent roof at the stuccoed area below the brick beltcourse.

- Bargeboard** A decorative board attached under the projecting portion of a gable roof.
- Bay** The portion of a facade between columns or piers providing regular divisions and usually marked by windows. For example, the Thackara House at 912 Eldridge Avenue has a three-bay elevation facing the street.

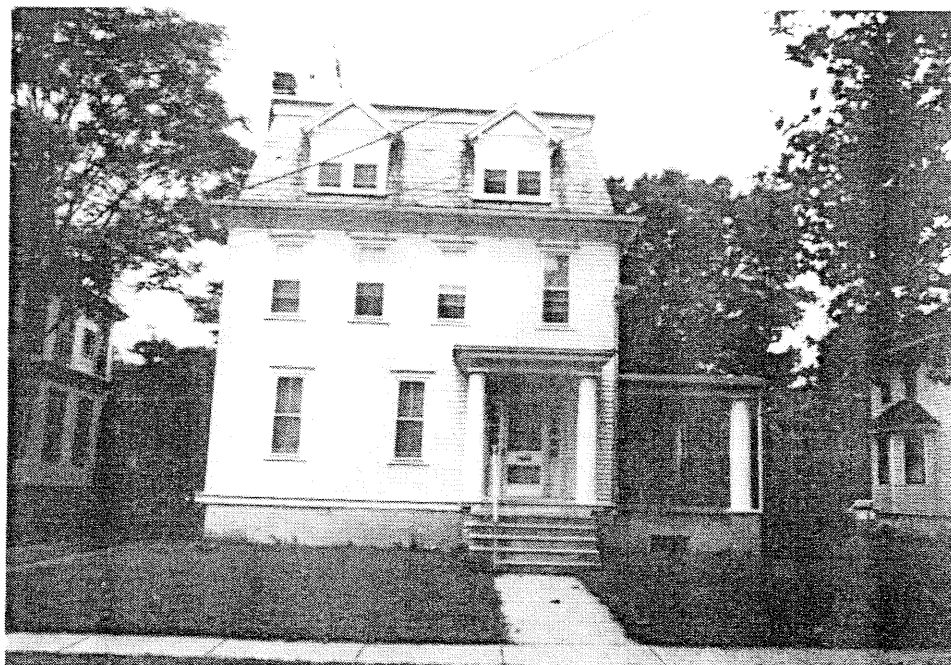
Built as one of seven speculative houses by E.C. Knight's Collingswood Land Company in 1888-89, 811 Collings Avenue is a freshly-repainted building of the Second Empire Style. It displays decorative wooden cresting on a slate mansard roof with gabled dormers. An intricate bracketed cornice tops a clapboarded facade fenestrated with two-over-two windows. The entrance door is set within a transomed and sidelighted opening sheltered by a circa 1920s portico. Originally the house would have had a full-width front porch. The building was purchased in 1901 by John Daughton, a lumber merchant, and his wife, Amelia, who used the structure as a boarding house.

Scored Stucco Stucco which has been tooled with shallow grooves before drying to simulate blocks of stone such as on the foundation walls of 811 Collings Avenue.

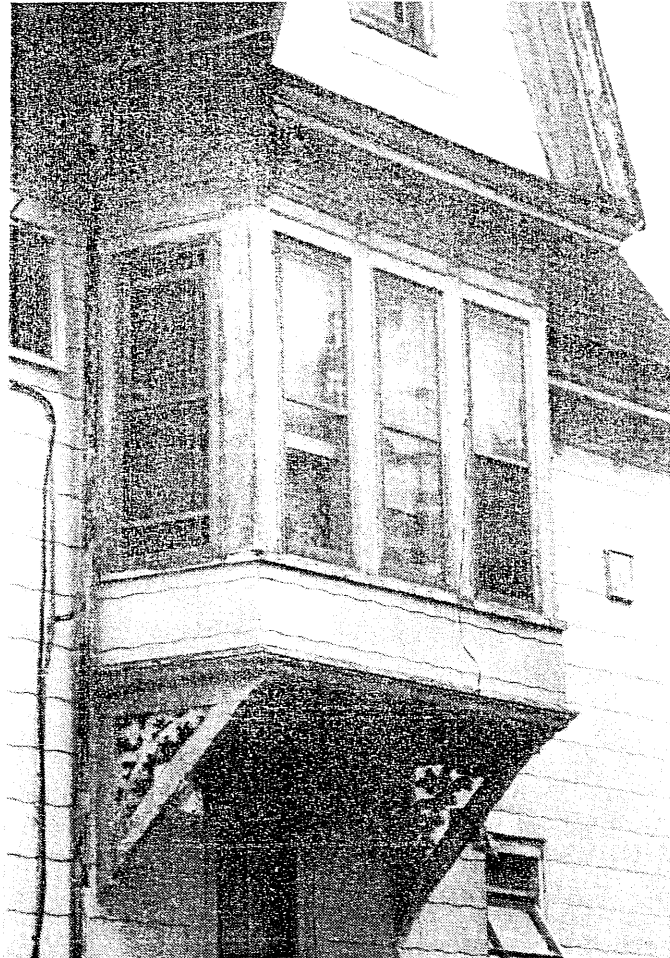
1021 Collings Avenue

Built in 1888-89, this building is studied in the Rehabilitation Guidelines section. Its vernacular plan-type and massing is augmented by eclectic finishing details including paired arched-head attic windows, two-over-two sash windows, an intricate bracketed Eastlake cornice, jigsaw knee braces on a projecting second floor bay, and a wrap-around porch that originally featured jigsaw brackets and a decorative wooden balustrade.

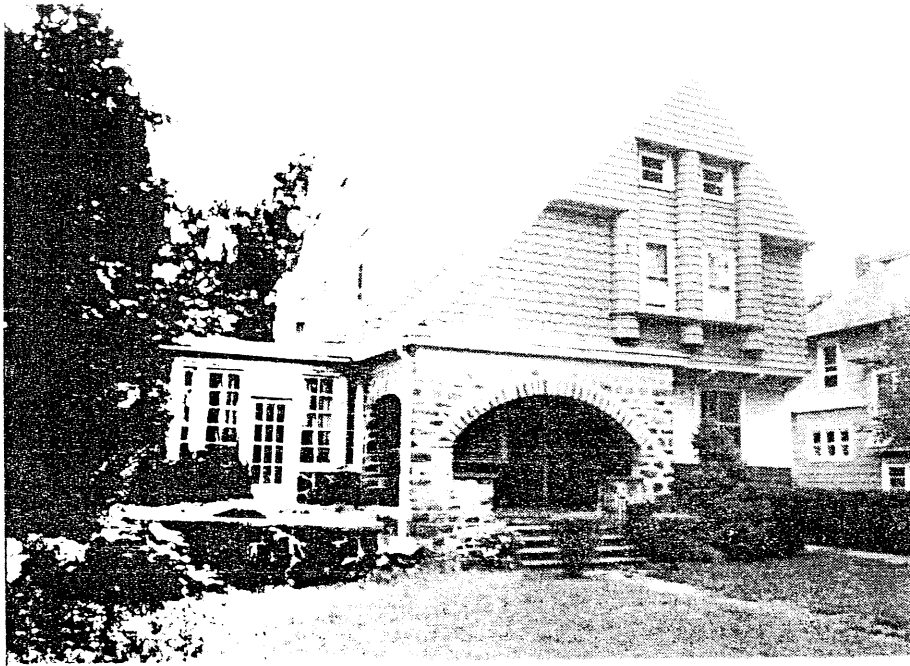
Listed in the 1900 directory as the home George F. and Lotti L. Wielland, 916 Collings Avenue is an architecturally sophisticated building executed in the Shingle Style. With the low segmental arch at the entrance porch, the design is reminiscent of the late-nineteenth century work of Philadelphia architect Frank Furness. The atypical massing includes an asymmetrical roof carried over an open stone porch, and a composition of stepped vertical wall planes.

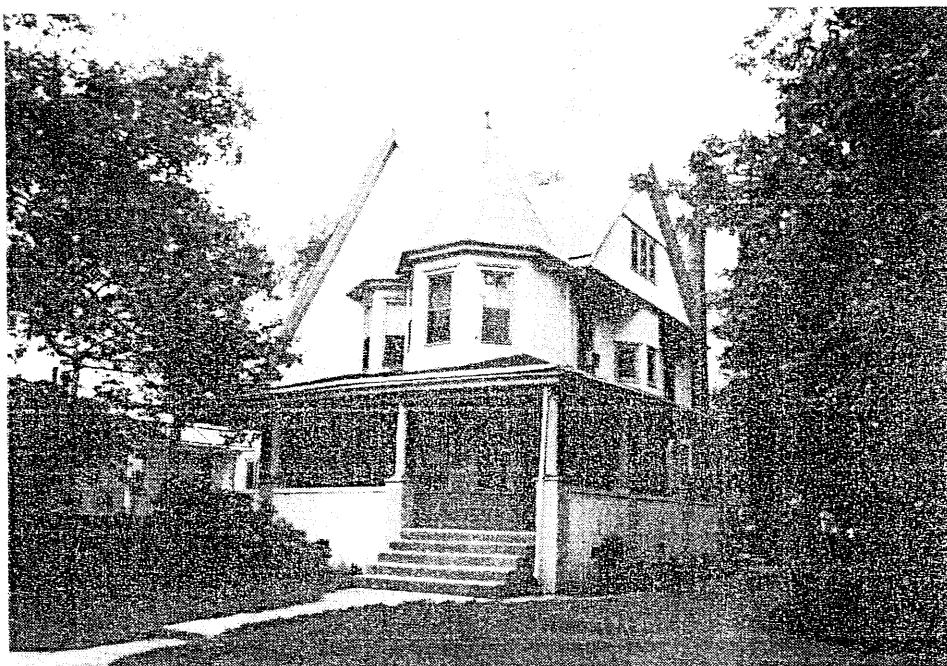
1001 Grant Avenue

This house was erected in 1901 by J. P. Davis, a Camden cabinet maker. It features the picturesque massing typical of the Queen Anne Cottage Style of architecture, expressed through the octagonal turret, oriel windows, steep roof slopes, and wrap-around porch. Note the simple cast finial at the top of the turret's peak.

Turret A small tower with a steep pointed roof, usually found at one corner of Queen Anne Style buildings such as 1001 and 1016 Grant and 913 Collings Avenues.

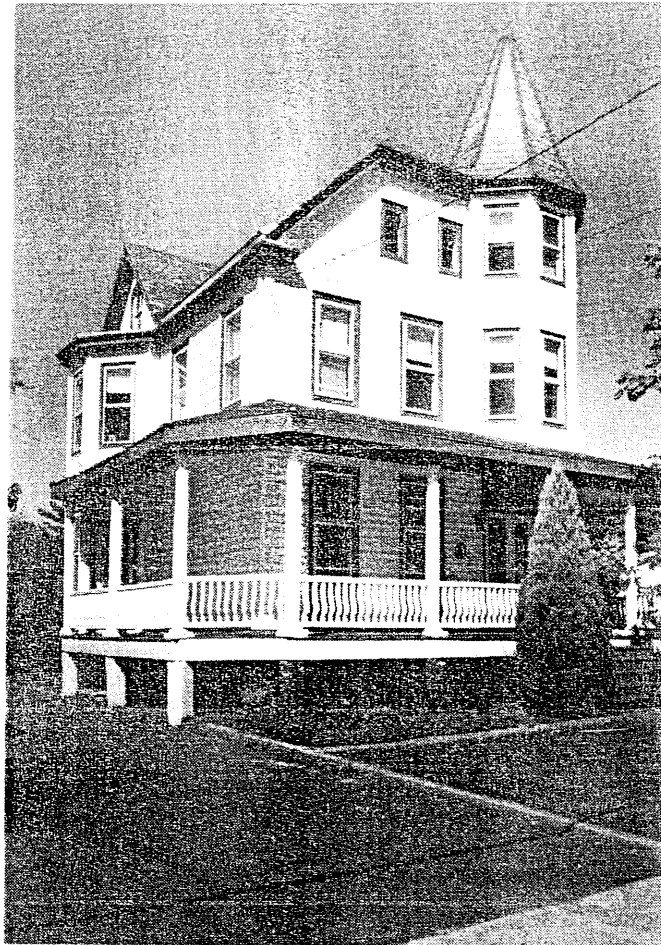
911 Collings Avenue

Built by Howard H. Peacock, a machinist, in 1903, this building is noteworthy for its octagonal corner turret with steep slate roof, clipped gable end, and wrap-around porch with attenuated Doric columns and bowed balustrade.

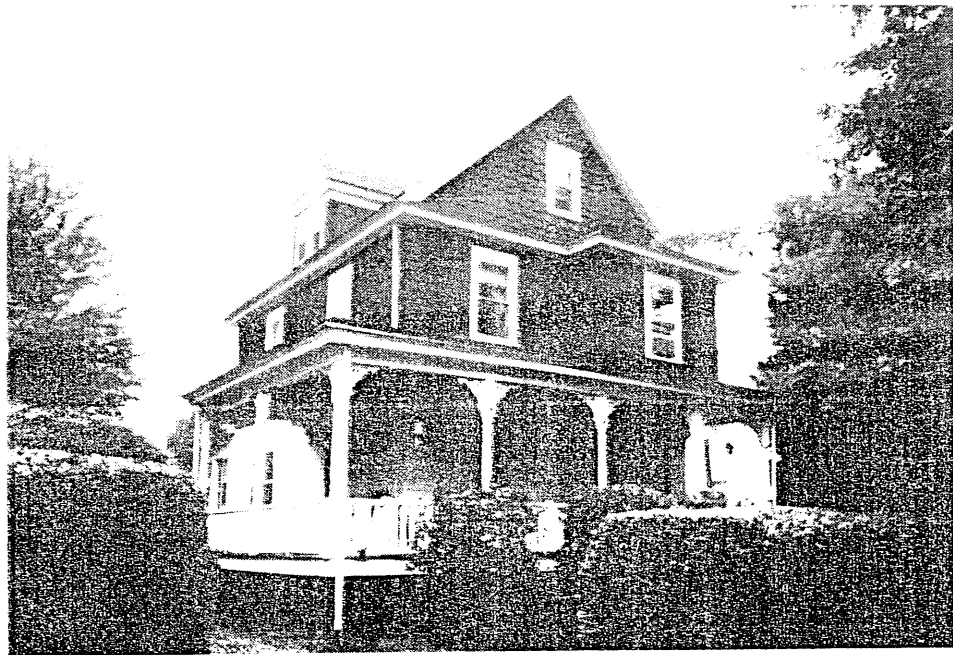
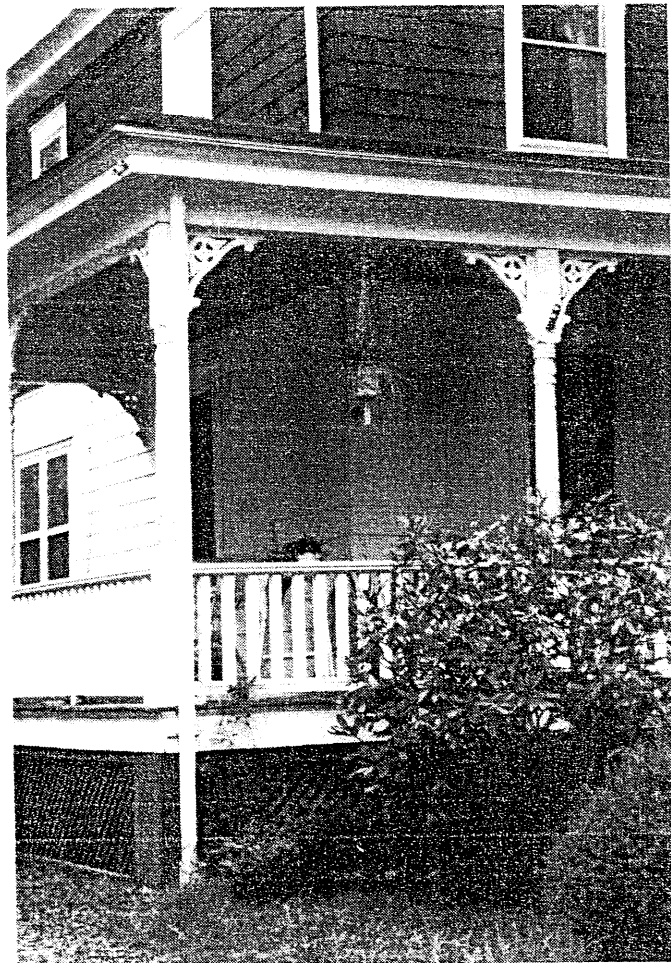
416 Taylor Avenue

This early American Foursquare Style house (the term "four-square" refers to the rough division of the house plan into quadrants of entrance hall, living room, dining room, and kitchen.) was built before 1907 and displays sawtooth shingling in its gable end and straight shingling on the second floor. Although covered with artificial siding, the first floor is probably clapboarded underneath. The wrap-around porch is one of the area's finest with intact pole gutters, turned columns, jigsaw brackets, wooden balustrade, and diagonal lattice panels.

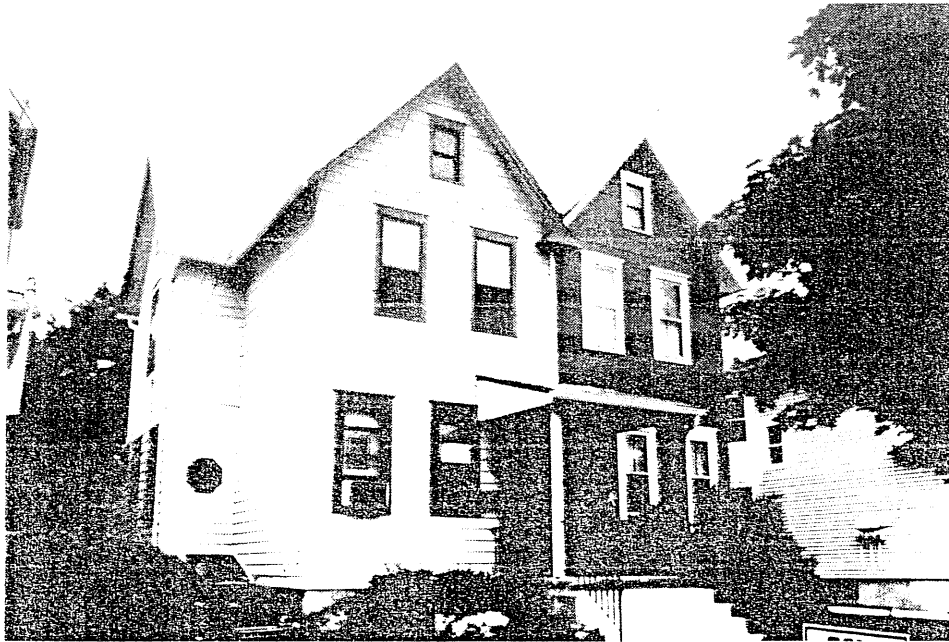
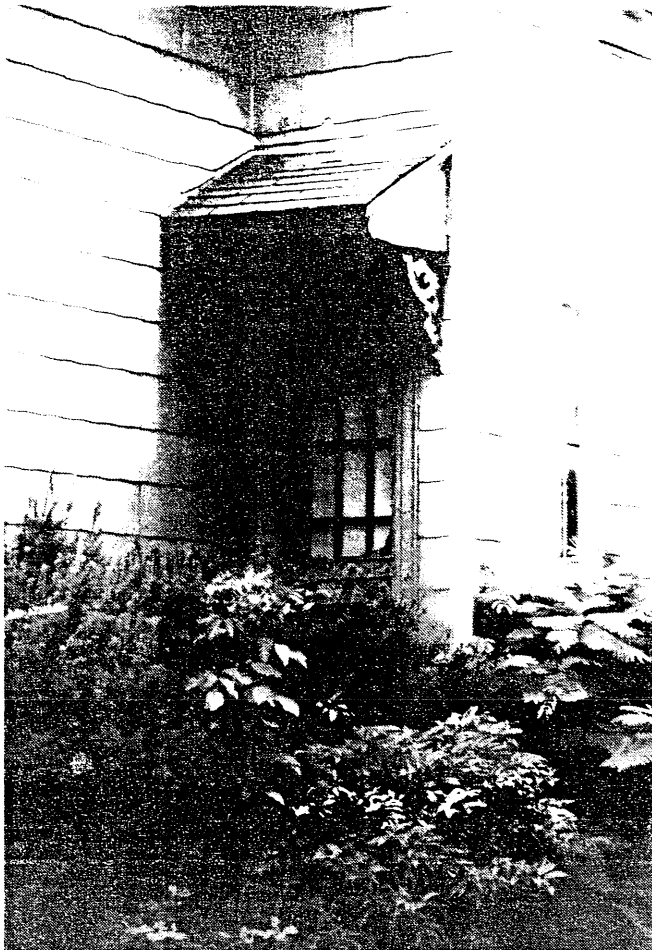
1013-1015 Eldridge Avenue

This double house with paired gable ends was the only twin on the south side of Collings Avenue when the 1907 Hopkins map was drawn. The house on the left, 1015, retains its original wooden shingle cladding while the house on the right has been covered with asbestos shingles. However, it is this resurfaced half which retains its original side door with roof jigsaw bracket (providing important evidence if the original front porch was ever to be rebuilt.)

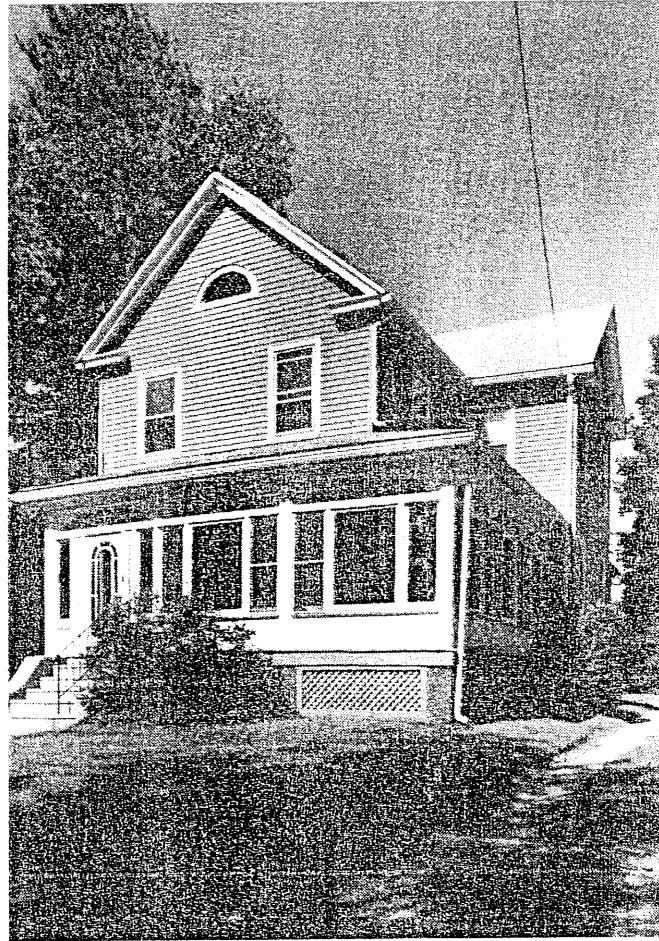
805 Eldridge Avenue

This L-shaped two and one-half story house is shown on the 1907 map. It is included here to show the glazed porch with multi-light segmentally arched transoms, tripartite sash and base panel configuration, and delightful arched-head sash pattern of the door. The lunette window in the gable end is also of note, although the sash has been altered.

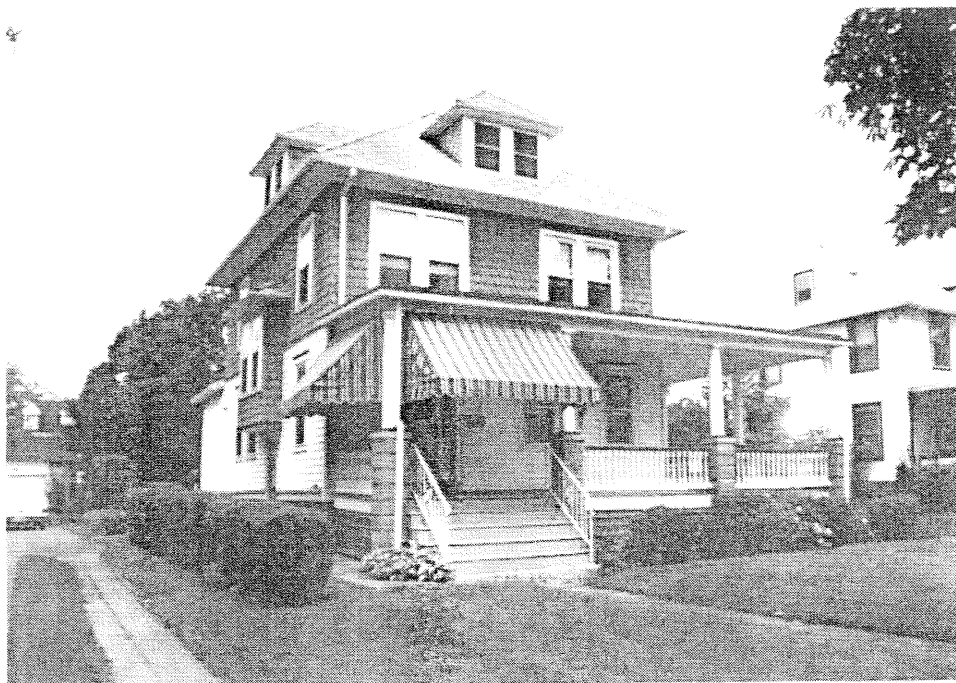
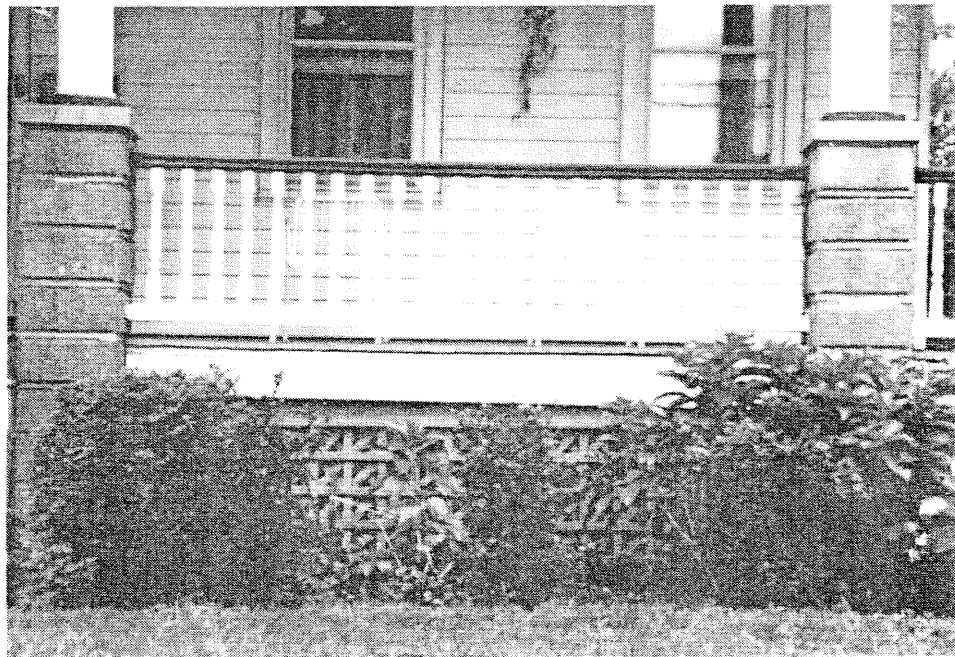
805 Collings Avenue

This American Foursquare Style house is featured as a case study in the Rehabilitation Guidelines section. These photographs illustrate the immaculate porch details - Doric columns on raised faceted CMU piers, turned spindles, compound lattice panels - and the fishscale shingling of the projecting stair landing bay window.

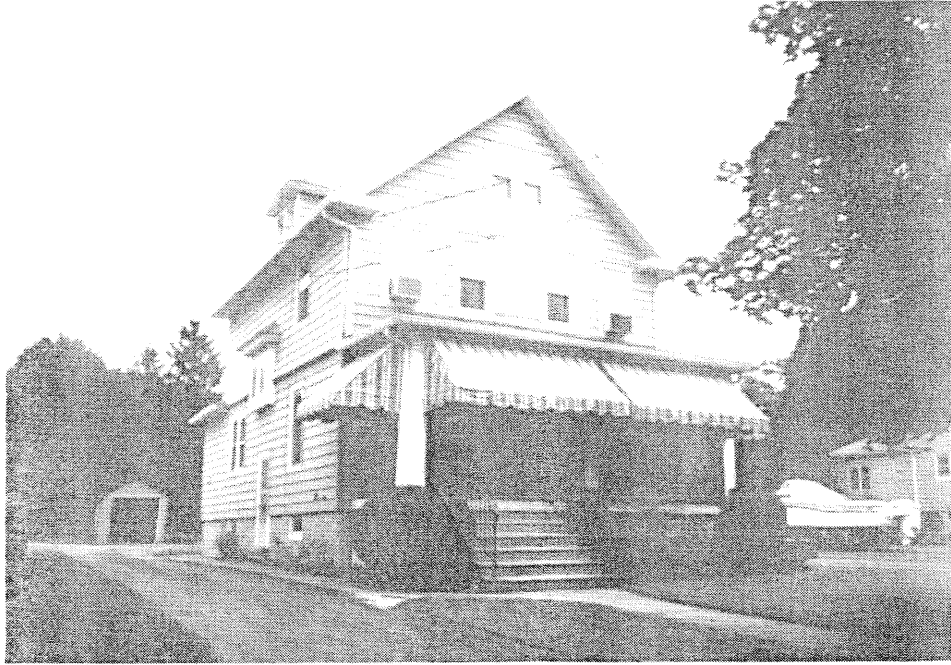
315 Cattell Avenue

This archetypical early twentieth-century house with gable end to the street is noteworthy for its historical use of cloth awnings. Upon close inspection, the original awning hardware can still also be seen at the second and third floor front windows.

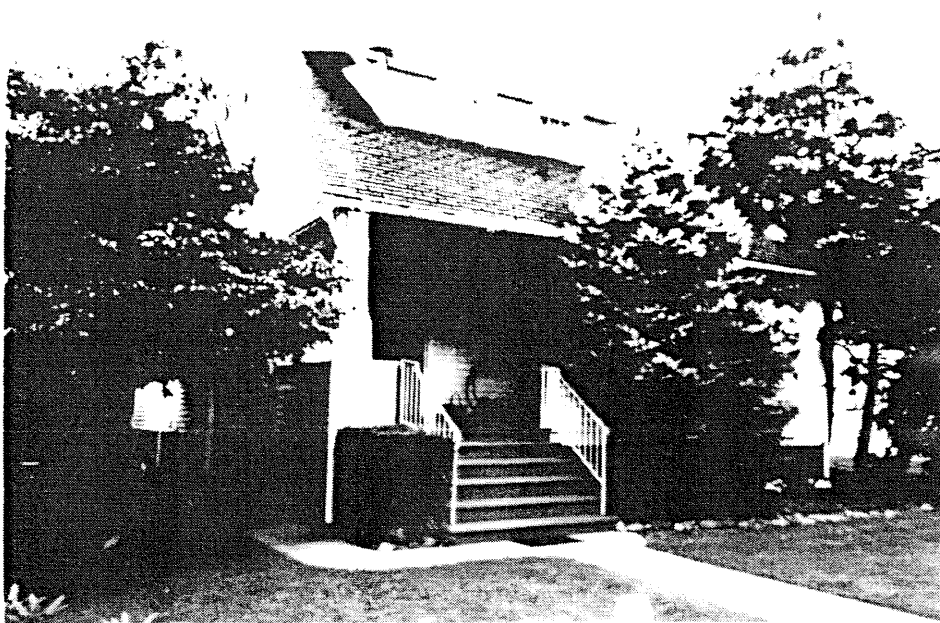
907 Collings Avenue

This neat Bungalow Style house is one of the district's most intact and well maintained buildings. Although the evergreen tree unfortunately hides the buildings full impact, the distinctive features include a low shed dormer with projecting rafter ends and knee braces, second floor sawtooth shingling, first floor clapboards which are carried around to create a half-wall on the porch, and half-round gutters with cylindrical downspouts.

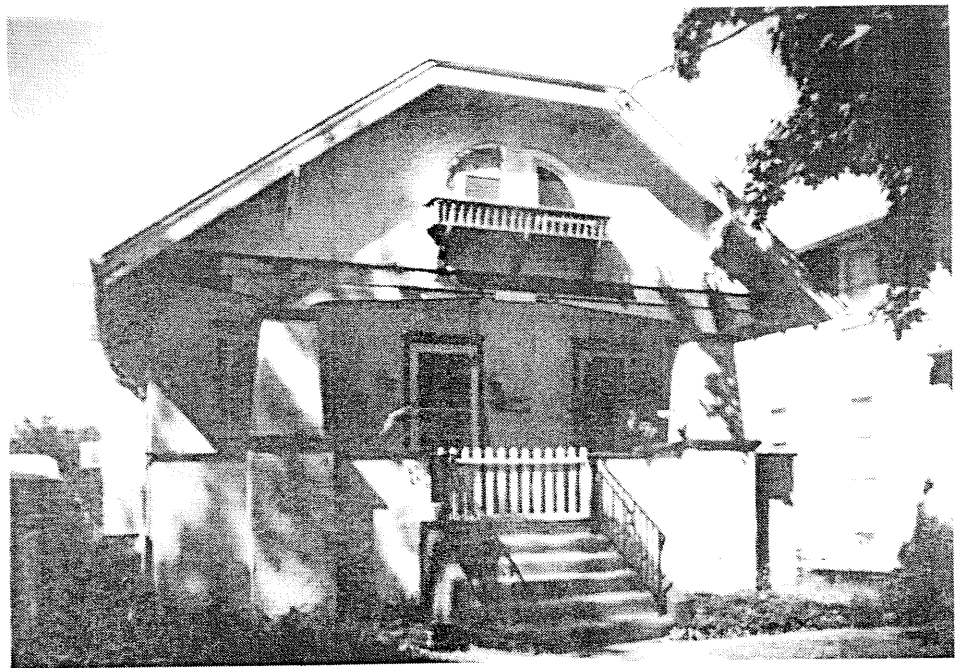
911 Magill Avenue

This unusual Bungalow style house displays two unique elements: a balconette below a split arched head window in the clipped gable end; and elephantine columns above a stuccoed porch half-wall.

- Backpriming** The coating of unexposed surfaces of exterior wooden members with primer paint to protect against deterioration.
- Balconette** A small, projecting, decorative balcony such as on the second floor of 911 Magill Avenue.

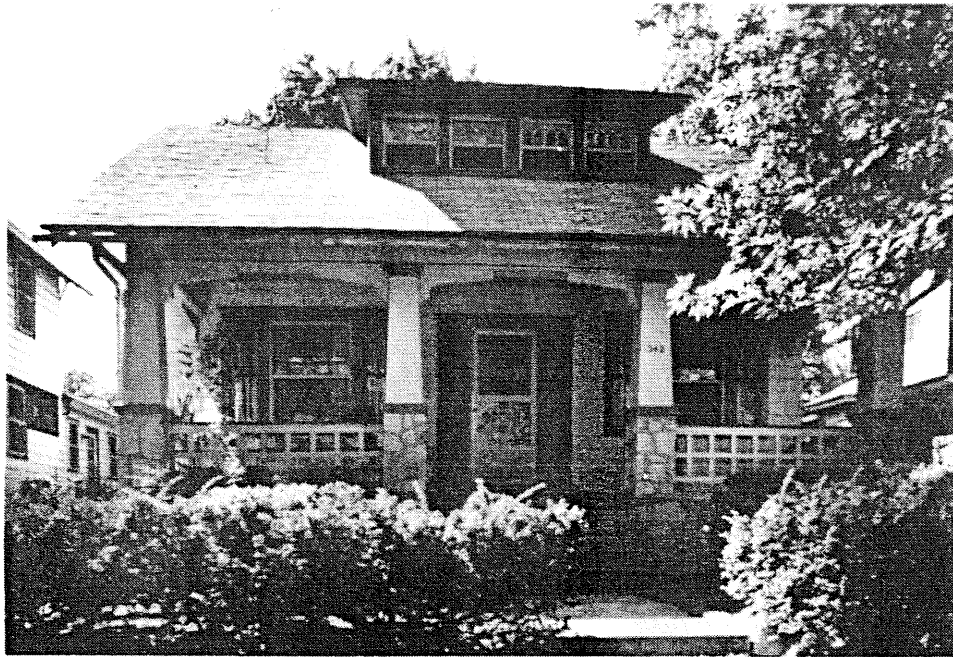
342 Richey Avenue

This shingled Craftsman Bungalow is introduced by a remarkable front porch which displays an atypical porch balustrade with intermediate rail, tapered square columns holding understated sawn porch brackets, and uncoursed stone porch piers and stair cheek walls.

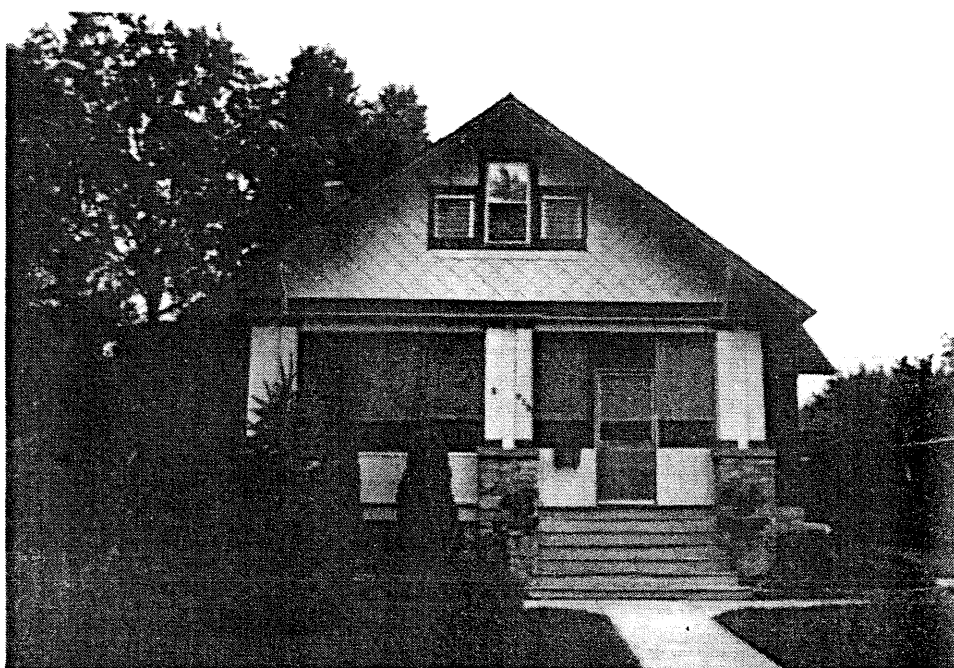
920 Eldridge Avenue

Another variation on the Bungalow theme, this building features a diamond shingle pattern in its gable end and paired pilasters on the porch.

A decorative pattern of wall shingles laid in staggered horizontal rows where the corners of the wooden shingles have been cut off at the bottom to create a diamond shape, as in the gable end of 920 Eldridge.

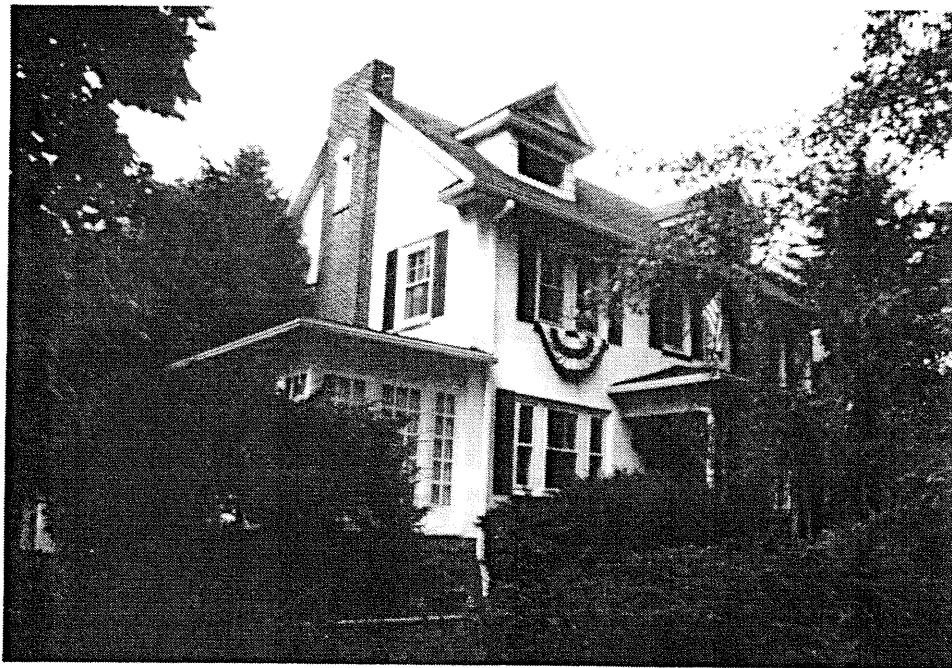
1023 Grant Avenue

This two and one-half story stuccoed building is executed in the Colonial Revival Style. Although largely hidden from the street by shrubs and trees, the house in this oblique view displays pedimented dormers, a fenestrated end chimney, six-over-one window sash, an entrance portico, and multi-light glazed side porch.

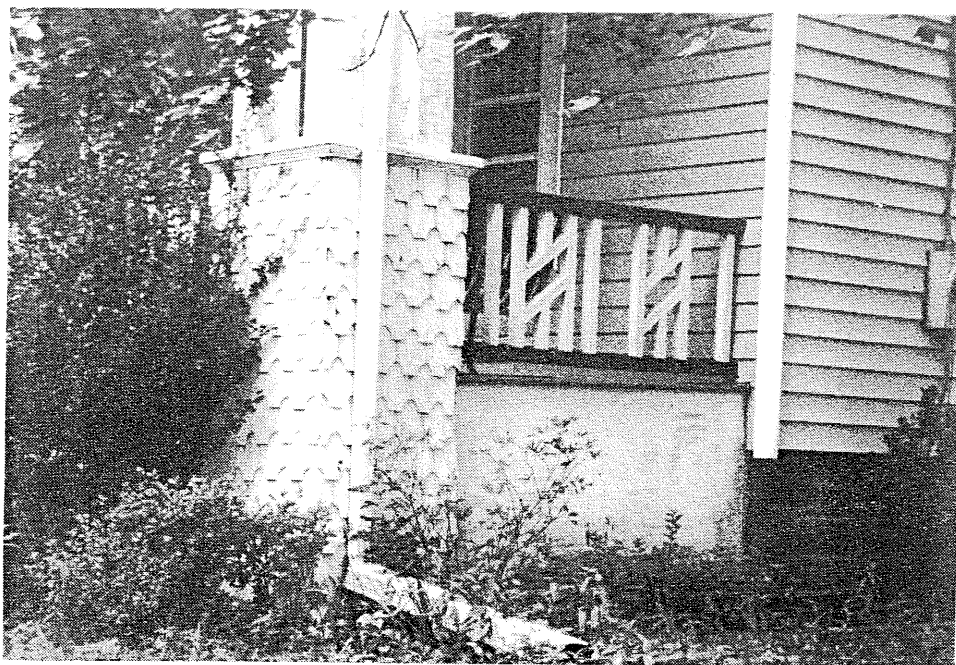
400 Sloan Avenue

This porch detail at the corner of Sloan and Magill Avenues is unique. The triple corner column cluster rests on a raised pier clad in unusual sawn shingles with segmentally clipped corners. Furthermore, the wooden balustrade features a staggered diagonal articulation pattern.

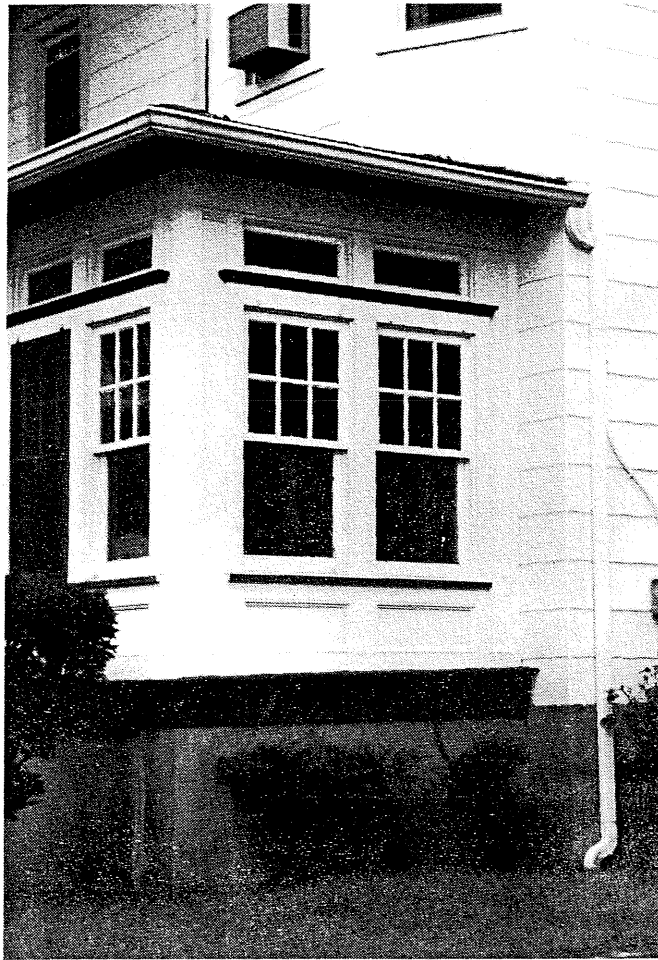
328 Sloan Avenue

This glazed porch enclosure takes a typical design approach toward claiming a transitional interior/exterior space, but incorporates special features such as paired six-over-one sash, transoms, and recessed base panels.

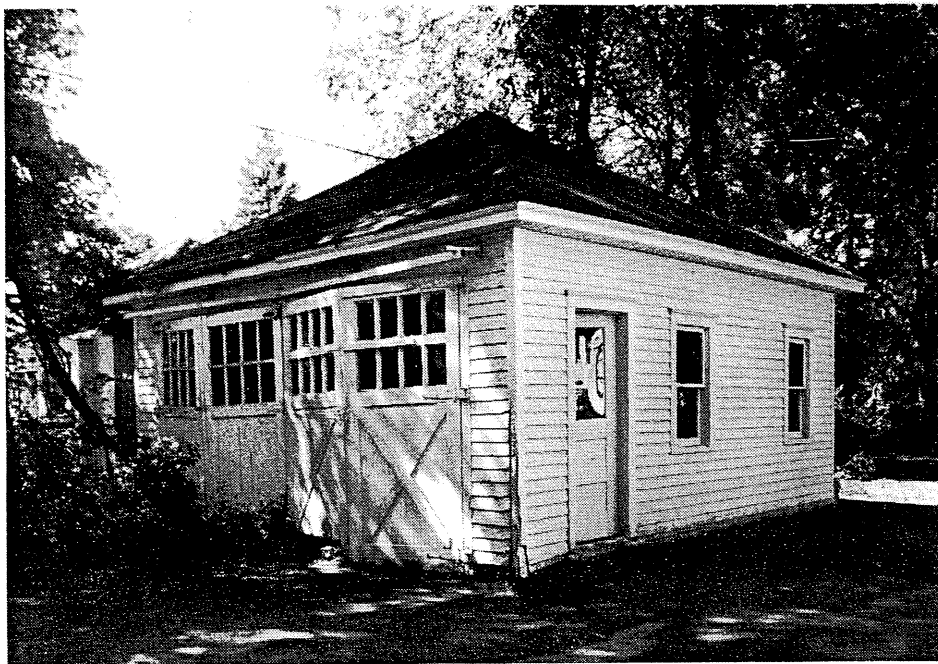
322 White Horse Pike Garage

Original garages greatly contribute to the overall character of West Collingswood. The design of these outbuildings usually responded to that of the main house, picking up the same roof forms, wall materials, and a simplified version of the woodworking details. Often when the main house has been heavily altered, the garage will provide evidence of the original style. This garage behind 322 White Horse Pike displays a hipped roof, wooden clapboards with cornerboards, paired double-leaf garage doors with multi-light sash, a sash entrance door, and one-over-one sash windows

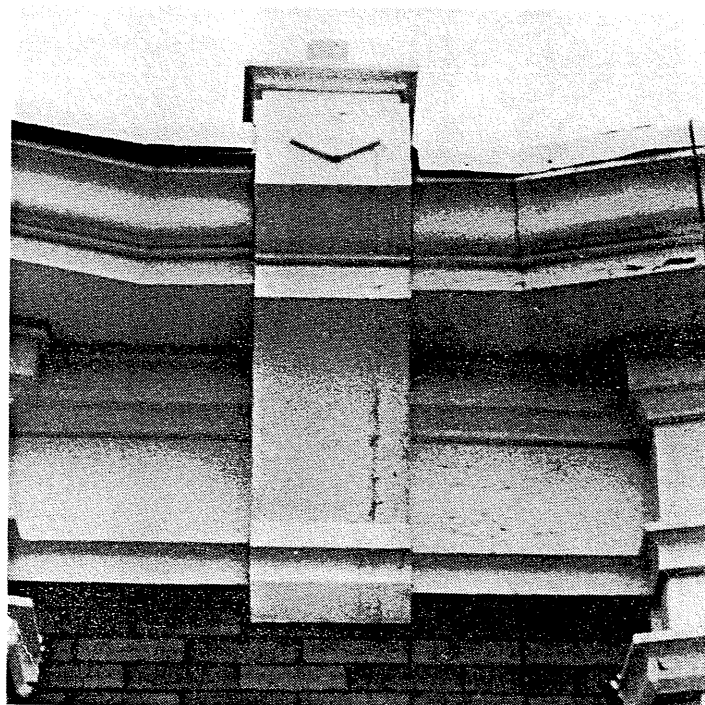
Corbelling Successive brick courses projecting beyond the face of the wall to form a decorative bracket or cornice, as seen below the cornice consoles of 1001-1007 Magill and 716-718 Richey Avenues.

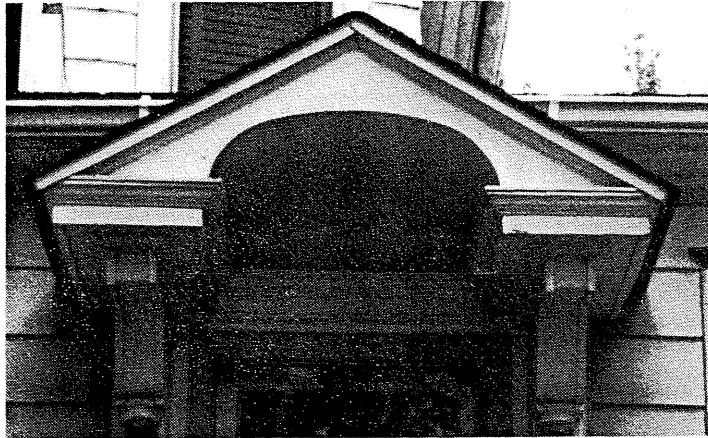
Door Hood

A decorative and functional projecting pediment above the door, such as that of 608 Eldridge Avenue.

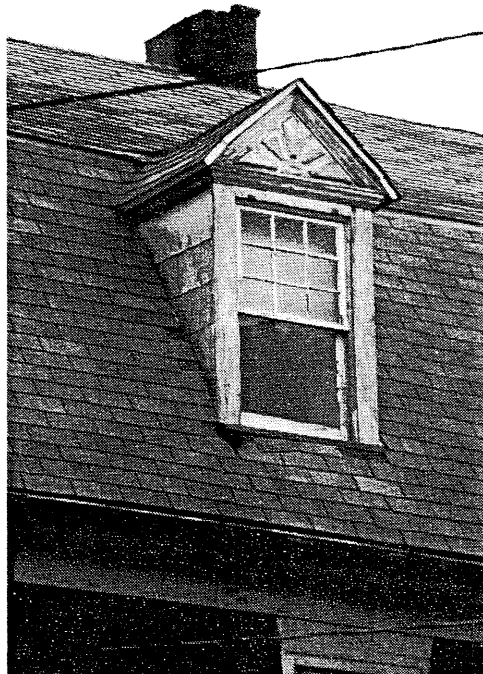
Dormer

A projecting vertical structure on the slope of a roof which provides light and headroom to the interior space. Illustration shows a gabled dormer at 408 White Horse Pike.

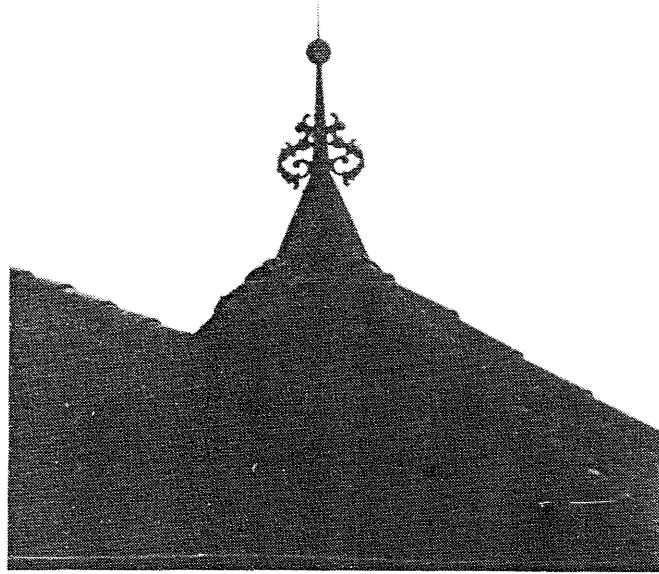
Finial A projecting decorative element, usually of metal, at the top of a roof turret or gable such as on those of 816 Collings and 1001 Grant Avenues.

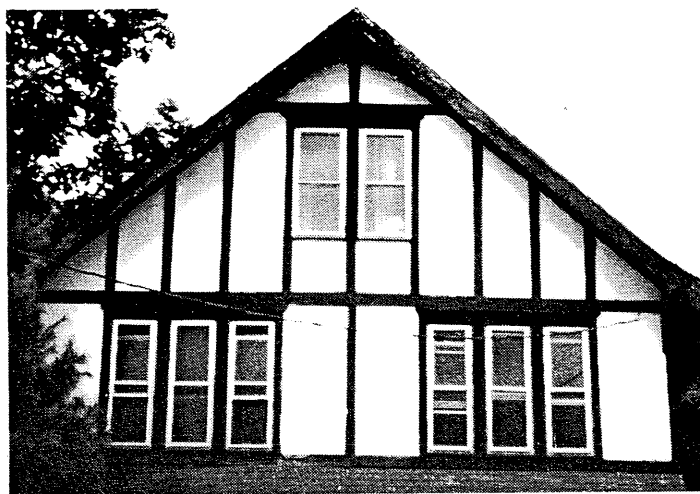
Half-Timbering	A decorative treatment on stucco-covered buildings where vertical, diagonal, and horizontal wooden members divide the stucco into panels such as on the portico and dormer of 1008 Collings Avenue and the second floors of 724 Grant and 925 Magill Avenues. Originating in England during the Elizabethan period when the wooden members were actually structural, this treatment characterizes houses of the Tudor Revival style of architecture.

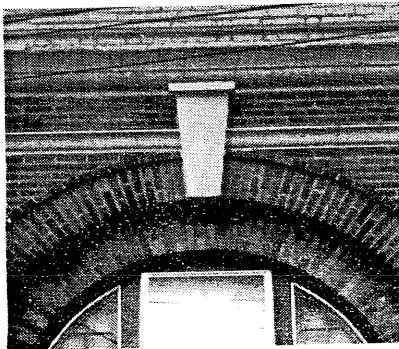
Keystone The uppermost wedge-shaped element at the center of an arch, such as at the second floor of 701 Collings Avenue.

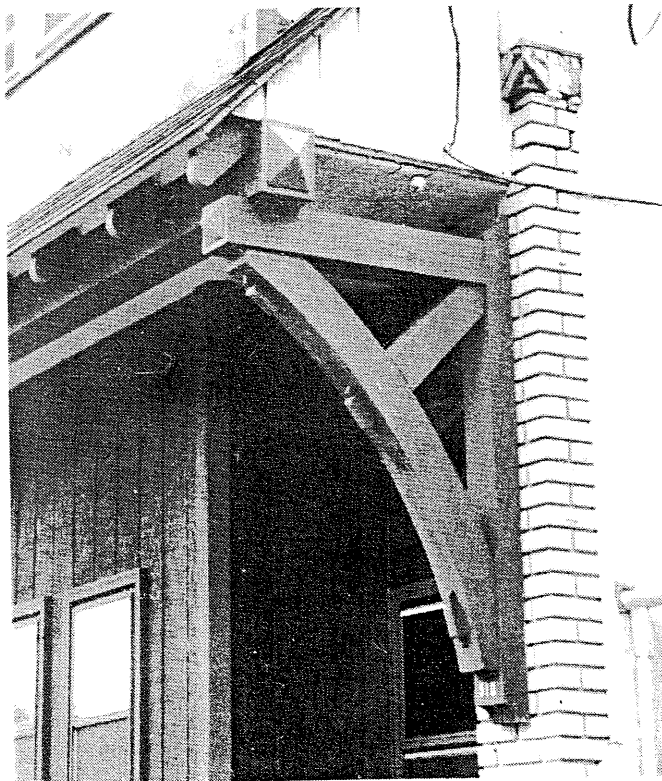
Knee Brace An oversized bracket supporting a cantilevered or projecting element such as the pent roof at 510-512 Richey Avenue, and the dormer overhang on 907 Collings Avenue.

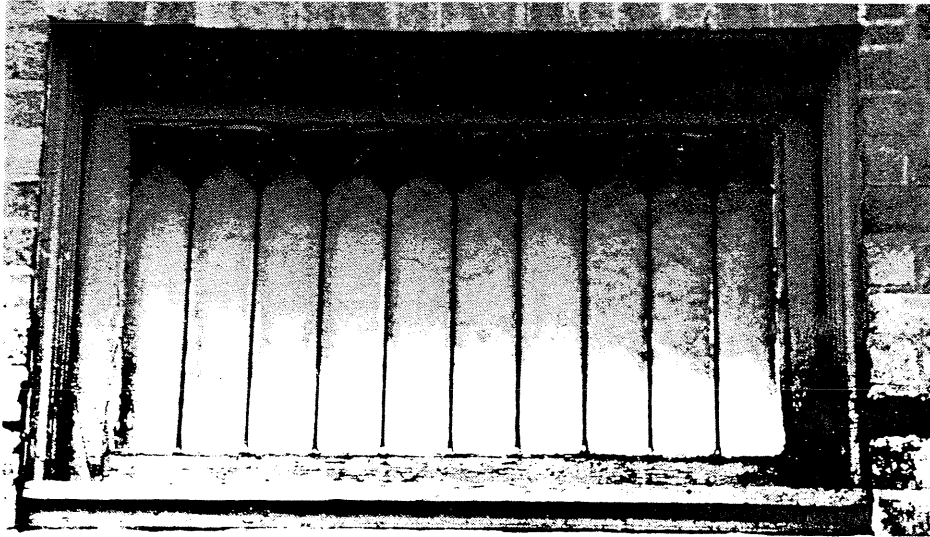
Leaded Glass Glass, whether clear or stained, set in lead comes, such as in the transom of 701 Collings Avenue.

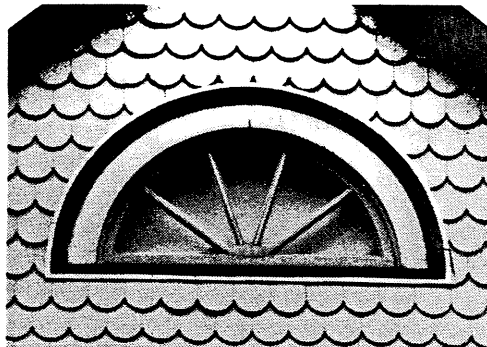
Lunette Window An arched, elliptical window, as in the gable end of 600 Eldridge Avenue.

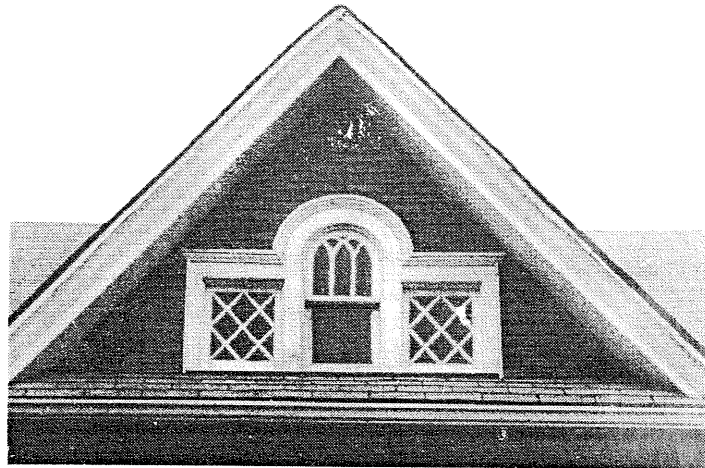
Palladian Window

A tripartite opening with central arched-head window flanked by smaller square-head windows which share the same sill, such as at the second floor of 508 White Horse Pike and the gable ends of 706 Magill and 416 Richey Avenues.

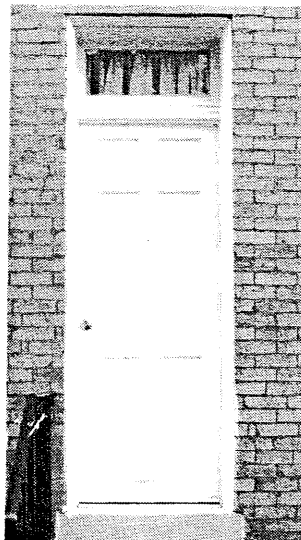
**Panelled Door**

A door composed of solid panels(whether raised or recessed) held within a framework of rails and stiles, such as the side entry of 628 Collings Avenue.

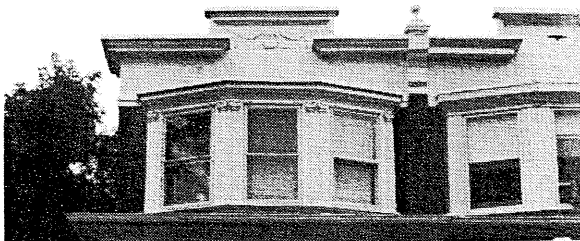
Parapet A low, horizontal wall at the edge of a roof, such as on 716-730 Richey, 1001-1007 Magill, and 701 Collings Avenues.

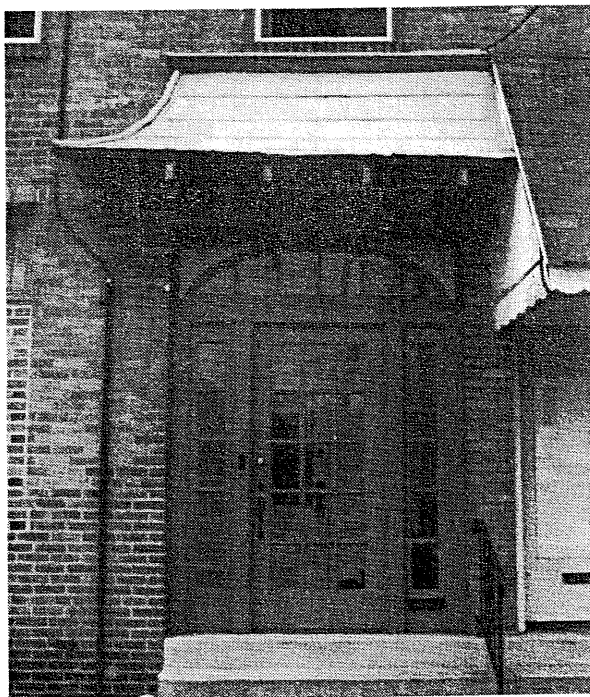
Pent Roof A continuous, horizontal shed roof projecting from the wall between the first and second floor windows, such as that of 530 Richey Avenue. Very common elements in colonial architecture, pent roofs were originally featured on the Thackara House at 912 Eldridge Avenue.

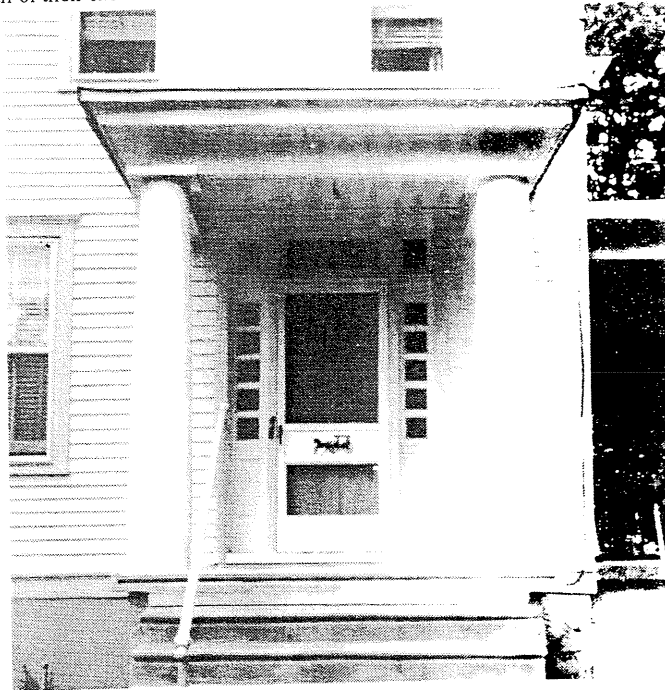
Portico

A porch at an entrance, as at 811 Collings and 1013-1015 Eldridge Avenues, although both of these buildings originally featured porches across the full width of their facades.

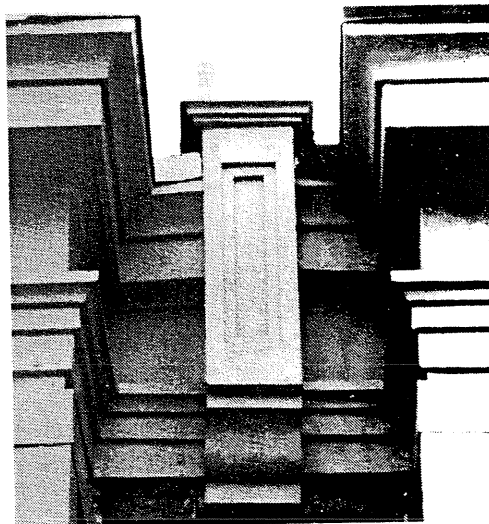
Pressed Tin

Decorative, as well as functional, metalwork made of molded tin and used to sheath roofs, bays, and cornices such as the roof of 701 Collings Avenue, and the bay windows of 622-628 Collings and 327-329 Sloan Avenues.

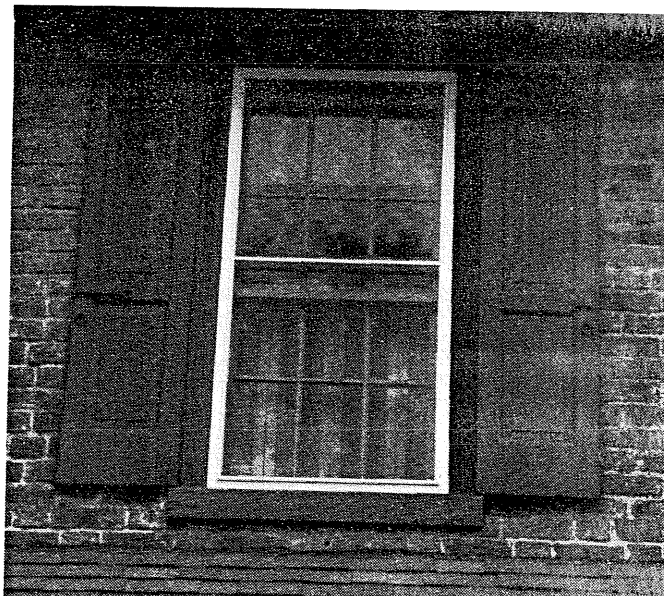
Six-over-Six Window

A double-hung window with six panes of glass in each sash such as those of the Thackara House, 912 Eldridge Avenue.

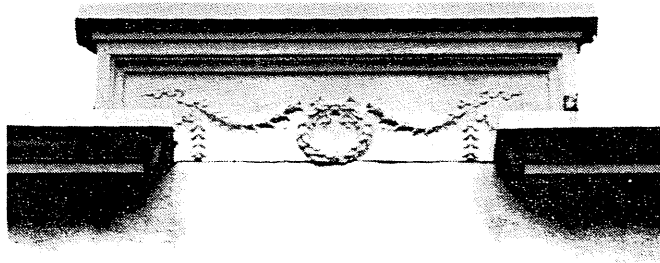
Swag A curved, foliated garland or draping cloth design used as an applied decorative treatment on flat vertical surfaces such as the parapets of 718 Richey and 1001-1007 Magill Avenues.

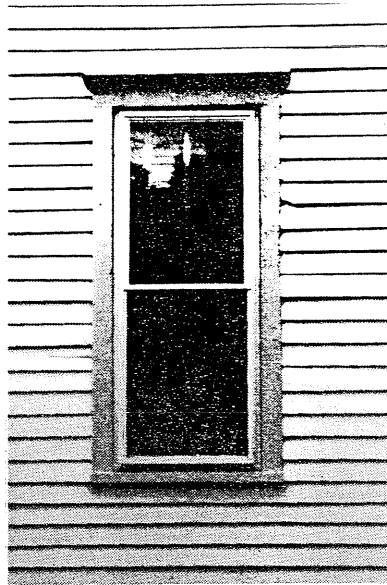
Two-Over-Two Window

A double-hung window with two panes of glass in each sash such as those of 811 and 1021 Collings Avenue.
