West Collingswood Preservation Plan

A Guide for the Neighborhood's Property Owners

Prepared for the Borough of Collingswood, New Jersey with funding from the Certified Local Government Program of the U.S. Department of the Interior, National Park Service, administered by the State of New Jersey, Department of Environmental Protection, Division of Parks and Forestry, Office of New Jersey Heritage.

August 1989

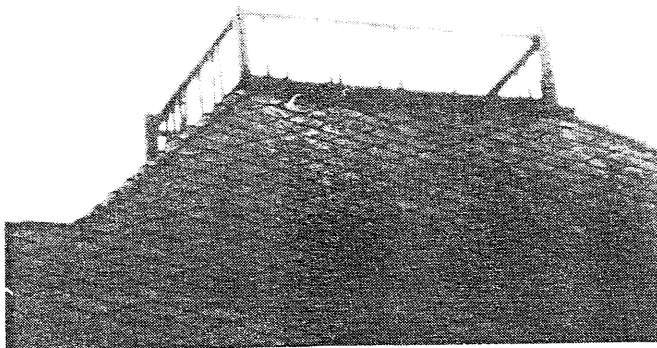
Widow's Walk

A decorative balustrade at the top of a hipped roof, the only surviving Collingswood example of which is on 816 Collings Avenue (also called a "captain's walk").

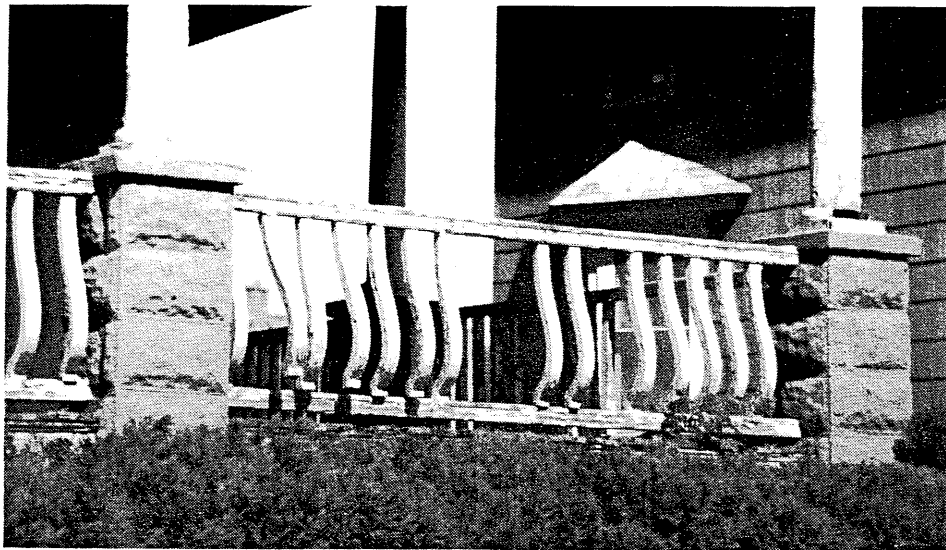
Porches are particularly susceptible to deterioration.

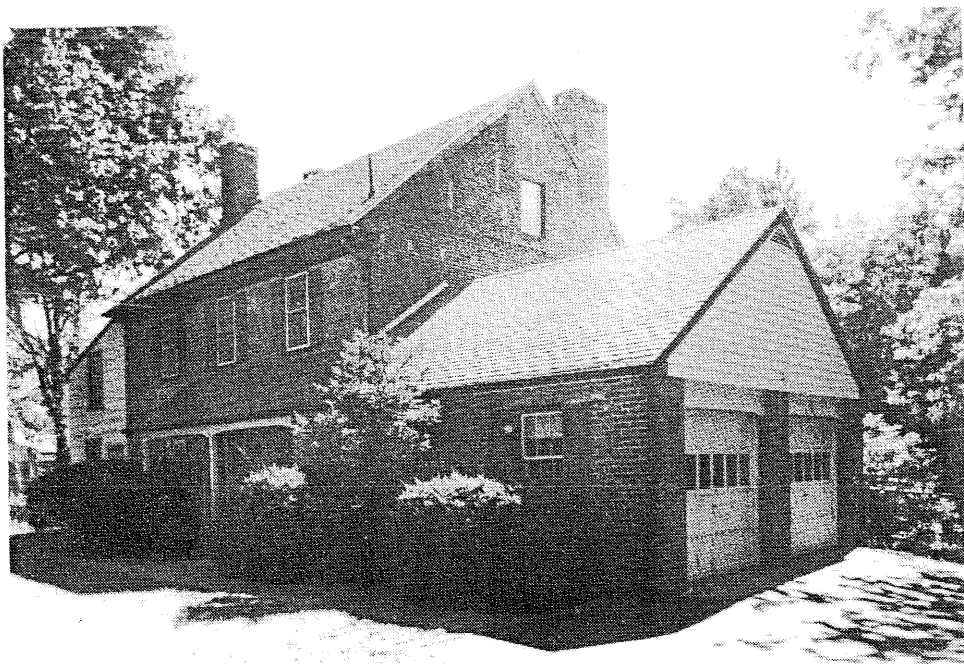
1754 Thackara House with modern garage addition

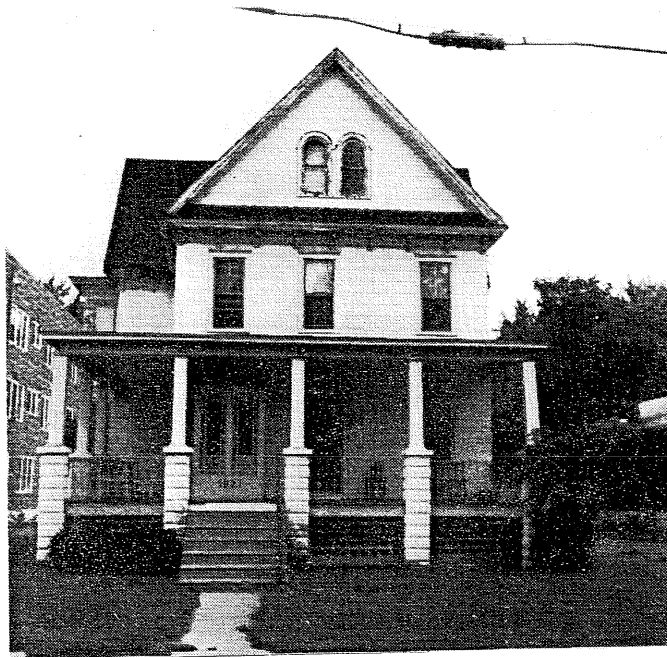
1021 Collings Avenue

This two and one-half story frame house was built by the Collingswood Land Company in 1888-89. The first occupant was David Shriner who was renting the building when the 1893 directory was published but who owned it by 1897. The 1907 Hopkins map shows the house with a drive back to a garage. The 1909 directory lists milk dealer Joseph C. Eldridge and his wife, Lidie, who had moved to this house from their farm near the Mt. Ephraim [Black Horse] Pike (see the 1877 map). His son, J. Cooper Eldridge, Jr., owned the house in 1914 after his father's death. By 1950, the house was a rental property owned by H. Pontius, an accountant living on Virginia Avenue. It is probable that the house was converted to a duplex during this period.

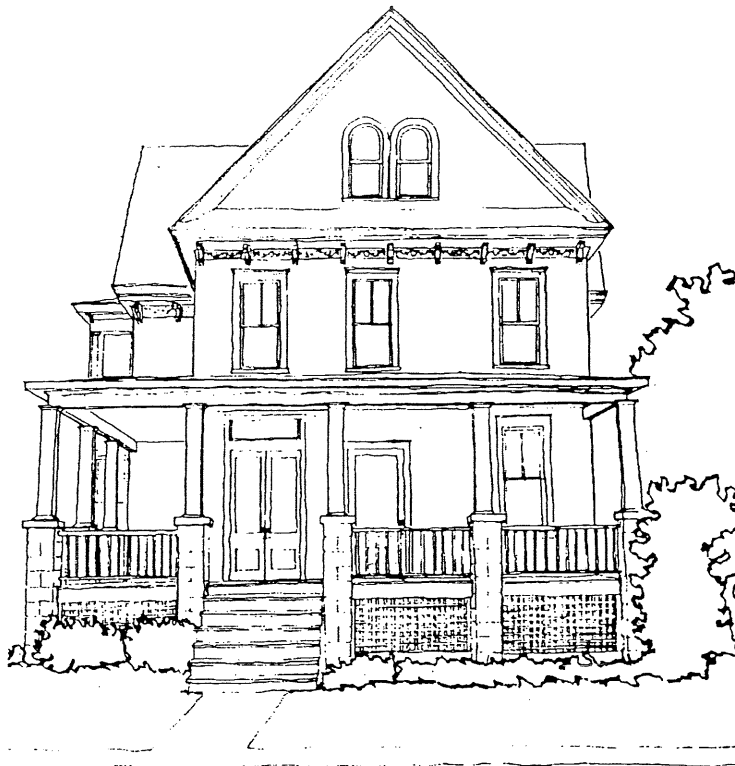
The building features a gabled roof with cross gables to the sides and the gable end to the street, paired arched-head attic windows, an ornate Eastlake cornice, jigsaw side bay brackets, two-over-two double-hung window sash, transomed double leaf sash doors, and a wrap-around porch with square columns on raised, faceted block piers. The original wooden clapboards have been covered with asbestos shingles, a vestibule and second entrance added, and the original porch railing, brackets, and steps have been removed.

- ☐ When reroofing, use an architectural Fiberglas asphalt shingle responding to the original appearance of wood shingles.
- ☐ Replace missing section of cornice molding on side bay.

- ☐ Replace missing porch cornice molding and porch balustrade.
- ☐ Remove added vestibule without damaging original sash entry doors and transom.
- ☐ Replace modern door with new panelled sash door, painted to match woodwork. Remove and restore opening when added entrance is no longer required.

- ☐ Replace lattice with new, smaller-scale lattice to match original, and paint.

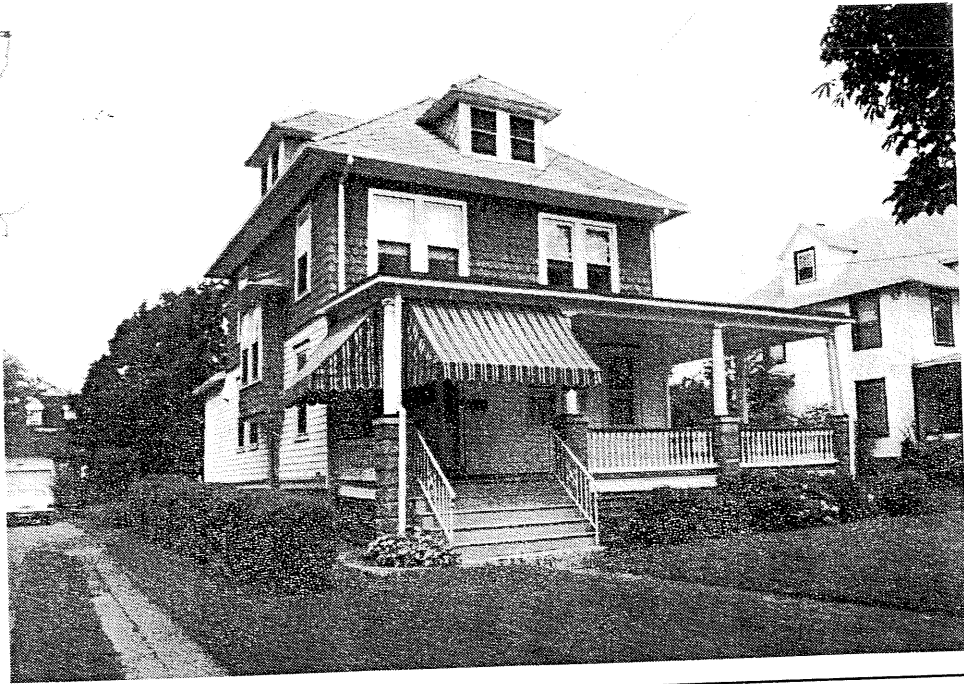
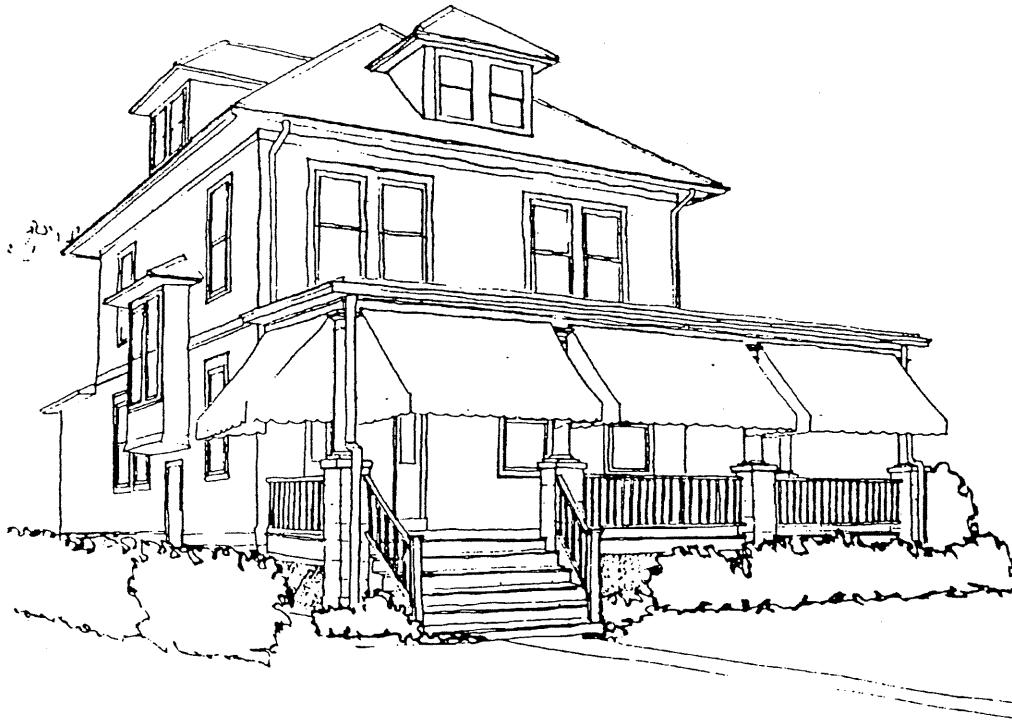
805 Collings Avenue

This American Foursquare Style house was in place by 1907 when it is shown with the three neighboring houses as owned by David Evans on the Hopkins map. Evans was a real estate investor who owned at least seven properties in West Collingswood at that time. He had sold the property by 1912 to Alan Bemis and his wife. The house is best known, however, as the residence of H.K. Reiss Holston who headed the History Department at Collingswood High School in the 1950s. The property is still owned by the Holston family.

The building features a hipped roof with hipped dormer, paired one-over-one sash double-hung windows, sidelighted entry with stained glass above raised panels, fishscale second floor wall shingles, projecting side bays, and an open front porch complete with all the original details: Doric columns on raised piers; turned wooden spindles; wooden steps; compound lattice work; and, historically appropriate awnings. The first floor clapboards have been covered with aluminum siding. In the rear yard is a matching hipped-roof garage.

- ☐ When reroofing, use an architectural Fiberglas asphalt shingle responding to the original appearance of wood shingles.
- ☐ Reattach any loose wall shingles.
- ☐ Replace the few shingles which are broken or missing with new shingles to match.
- ☐ Stabilize or rebuild, if necessary, the end porch pier which is leaning.
- ☐ Add identical awnings on the other two porch bays.
- ☐ Remove aluminum siding from first floor clapboards and repaint wood after proper surface preparation.
- ☐ Replace stair railings with wooden balustrades to match the rest of the porch.

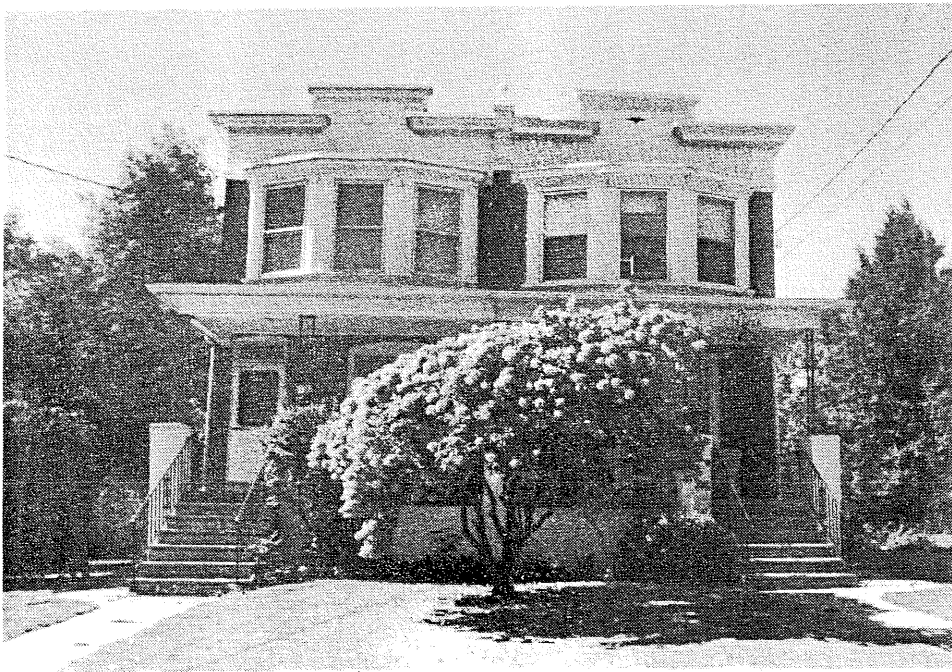
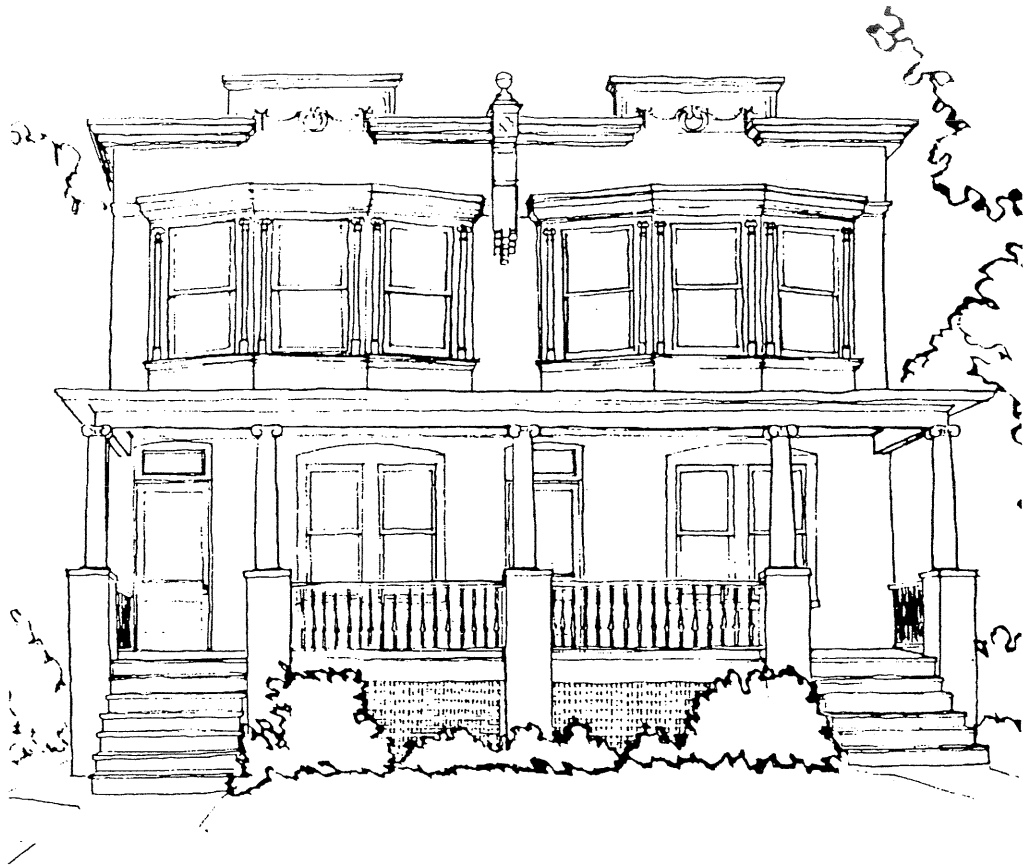
716-718 Richey Avenue

This brick twin is one of six pairs of nearly identical houses built in West Collingswood in the 1910s. The other twins are located at 722-724 and 728-730 Richey Avenue, 1001-1003 and 1005-1007 Magill Avenue, and 327-329 Sloan Avenue. 716-718 Richey and the neighboring twins were built in 1912 by David Evans and assessed at \$225 for the land and \$1,200 for the house on each lot. By 1914, 716 Richey was the home of Margaret Doughty, a designer, and Howard N. Walker, a bookkeeper, and his wife, Emily. The original owner of 718 was Nathan Ergood, a master carpenter and foreman. His family appears in the directories at this address until 1950 when the building is the home of Thomas Turner, a water meter repairman employed by the Borough of Collingswood.

Each of these twelve houses was executed in running bond red brick with red mortar joints. The slope of the gable roof is hidden behind parapet walls featuring a decorative wreath-and-swags motif and molded tin cornices with corbelled consoles. Projecting second floor bays are sheathed in tin and punctuated by one-over-one sash windows flanked by attenuated pairs of Ionic pilasters. A transomed entry and paired one-over-one sash windows are set within segmentally-arched head openings on the first floor. The original open-air porches have replacement columns on all but the Sloan Avenue houses. There the original Ionic columns on brick piers are apparent between the glazed infill panels of later porch enclosures. A historic postcard view from 1912 of this twin clearly shows the original turned balustrade, wooden steps, and lattice panels between the piers.

- ☐ Remove aluminum siding from parapet and bay of 716, restoring tin below.
- ☐ Replace porch columns with Ionic columns to match the original columns which survive on 327-329 Sloan Avenue.
- ☐ Replace porch balustrades.
- ☐ Install lattice panels to match the original latticework between the porch piers. Paint the infilled stucco behind the latticework a dark color to recreate the original open feeling.
- ☐ Relocate tree further from the front wall of the porch.

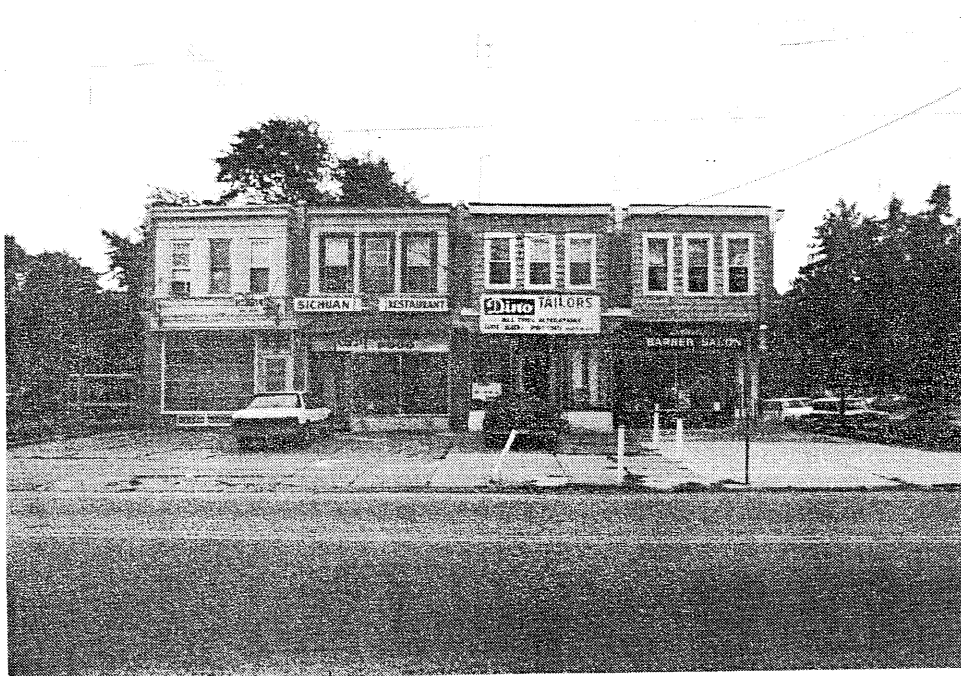
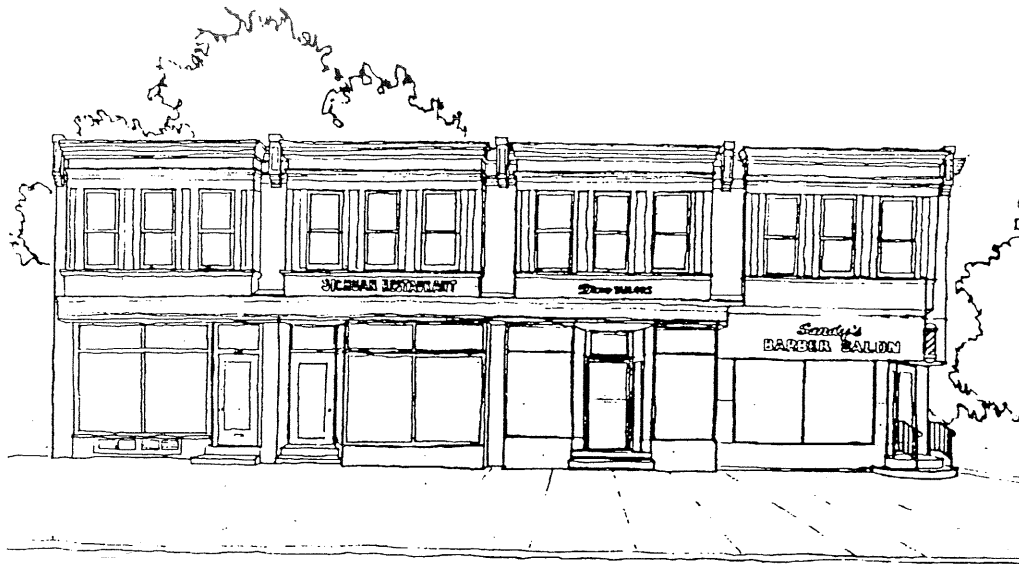
622-628 Collings Avenue

This two-story brick commercial row probably dates to circa 1920. Long-time residents of the area will remember G.W. and C.C. Fortune, Paperhangers, the original business located at 622 Collings until 1950. Fred Fischner is listed with a bakery at 624 Collings in the 1920 directory. It is most likely that this was an outlet store for his other bakery on the east side of town. Surprisingly, there are no listings for 626 or 628 Collings in the 1920 directory. It is possible that these stores were not occupied at that time as the construction of the row clearly dates from the same period.

Each building originally featured a storefront at the first floor and living quarters at the second level. The facades are topped by molded tin cornices with intermediate consoles at the party walls. Tin bays with one-over-one sash windows project from the second floor. The first floor storefronts at 622-626 originally had recessed off-center entry doors flanked by transomed plate glass windows. The original storefront still survives at 624 Collings, although it is hidden by overscaled signage and an added pent. The end building, 628, has an original double-leaf diagonal corner entry and is clad in pigmented structural glass from a later modernization. This pigmented structural glass is an example of an alteration that has gained significance over time and should not be removed.

- ☐ Remove aluminum siding from the cornice, consoles, and second floor bays of 626 and 628.
- ☐ Paint all second floor bays and cornices the same color to unify the row. Express individual color schemes, if desired, at the storefront level.
- ☐ Replace the signage on 624 and 626.
- ☐ Although three of the four storefronts have been substantially changed, it is not necessary to reconstruct the original storefronts to integrate the designs. Replacing the glazing pattern of 622 will help unify the row.
- ☐ Do not allow parking in front of the buildings. Create a pedestrian area with benches, planters, and outdoor seating for the restaurant.

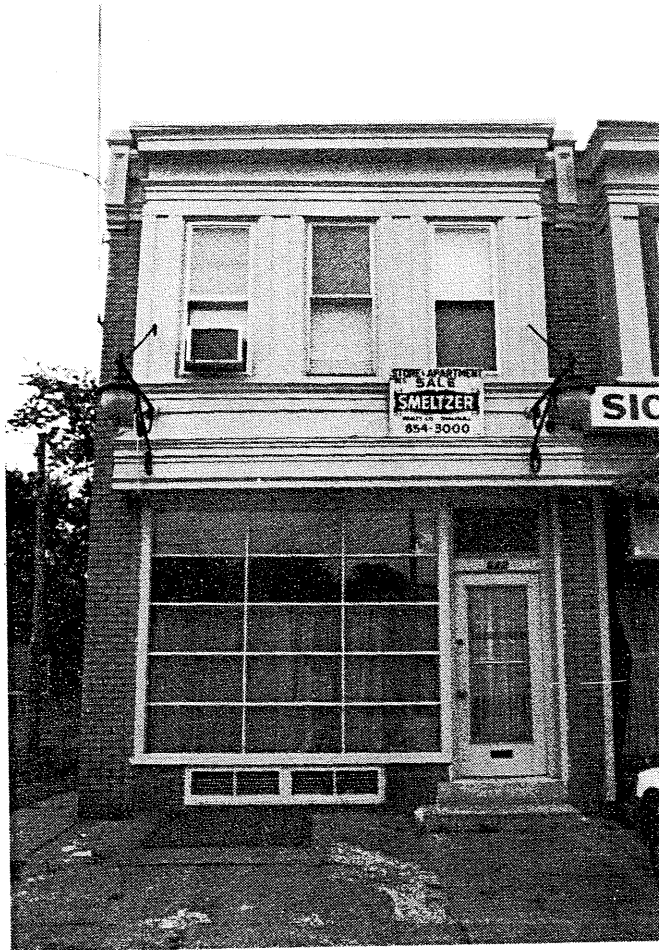
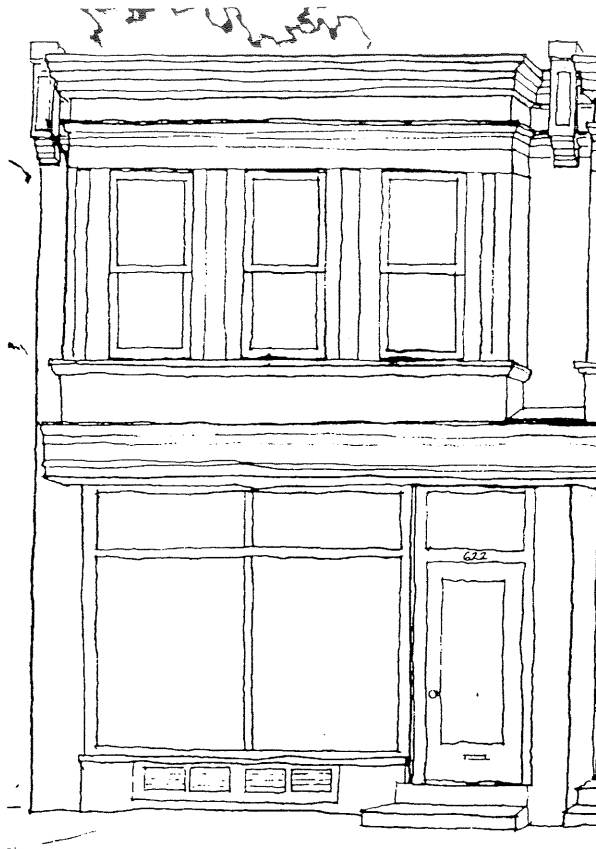
622 Collings Avenue

- ☐ Reattach edge of loose cornice console.
- ☐ Remove lighting sconces and surface-mounted conduit from the storefront cornice. If artificial lighting is necessary, install below cornice soffit.
- ☐ Replace the glazing pattern of the storefront window to pick up the line of the transom windows.
- ☐ Place new signage in signage band.

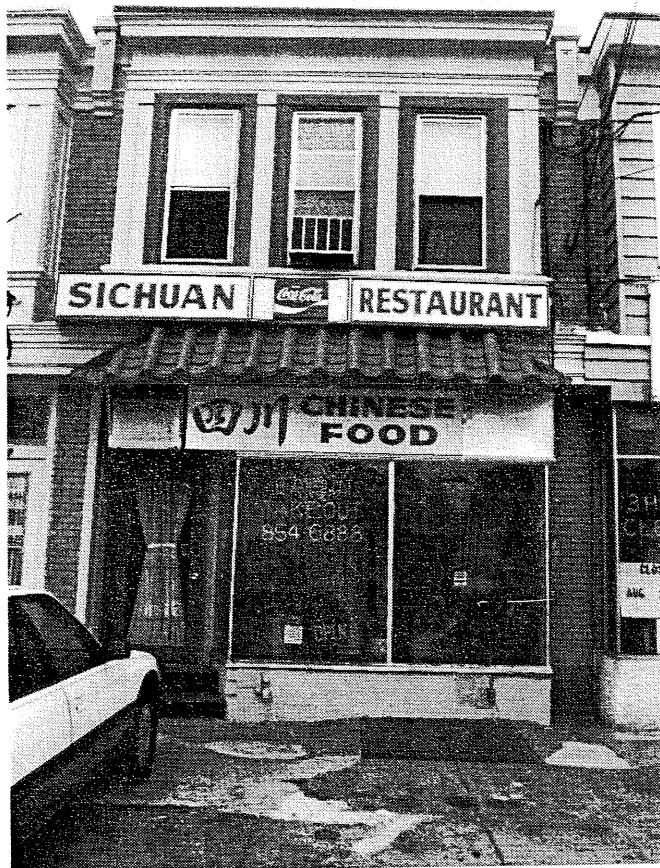
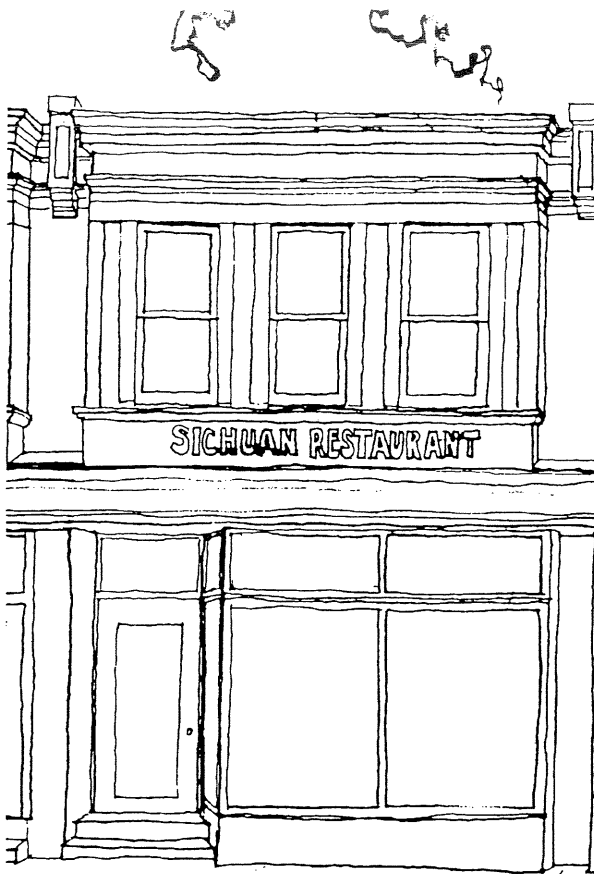
624 Collings Avenue

- ☐ Replace signage, locating new advertizing in signage band.
- ☐ Remove added pent.
- ☐ Reopen transoms.
- ☐ Relocate lighting to storefront cornice soffit.
- ☐ If possible, relocate air conditioning units to rear elevation or remount the units within the existing openings so that the units do not project.

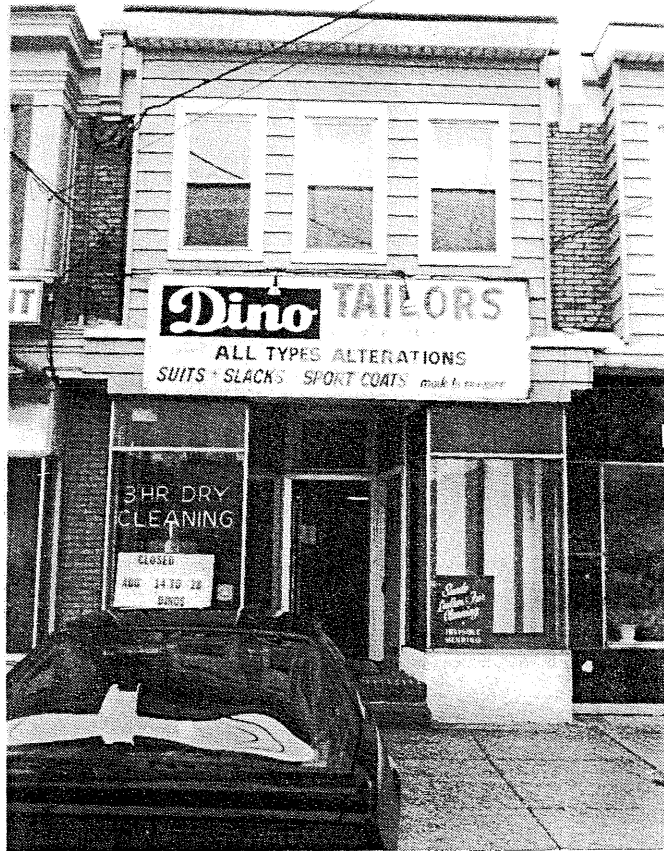
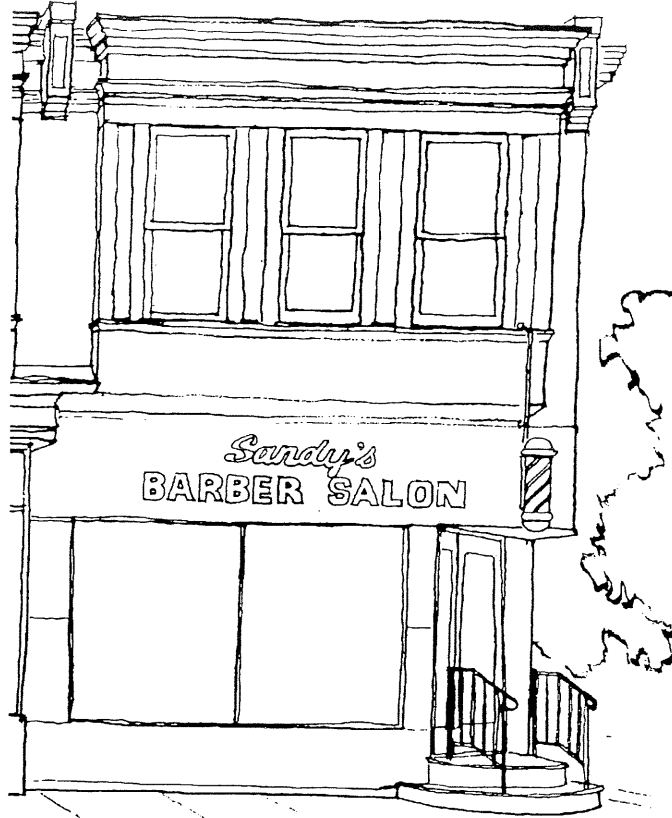
626 Collings Avenue

- ☐ Remove aluminum siding from cornice and second floor bay.
- ☐ Replace missing top element of storefront cornice above pigmented structural glass.
- ☐ Patch pigmented structural glass where damaged with flexible caulk, colored black to match the glass.
