Re: Operations and Maintenance Inspections Letter Report Rockwool Industries, Inc. Federal Superfund Site 1741 Taylors Valley Road, Belton, Bell County, Texas. TCEQ Site Identification Number SUP033

This letter summarizes the operations and maintenance (O&M) inspections performed in January 2015, March 2015, and June of 2015 by Daniel B. Stephens & Associates, Inc. (DBS&A) in order to complete the assigned tasks outlined under Texas Commission on Environmental Quality (TCEQ) Contract 582-14-40670, Work Order # 327-0040 at the Rockwool Industries, Inc. (RWI) Federal Superfund Site located in Belton, Bell County, Texas. Specifically, DBS&A performed the work in accordance with the February 11, 2011 Rockwool Industries, Inc. Superfund Site O&M Plan (DBS&A, Feb 2011); the January 17, 2014 Addendum Numbers 2 and 3 to the April 26, 2011 Rockwool Industries, Inc. Federal Superfund Site Field Sampling Plan (FSP2 and FSP3) for Operations & Maintenance Activities (DBS&A, January 2014); and the Wilder Construction Company MatCon® Operation and Maintenance Plan for Rockwool Superfund Site (Wilder, 2006). The site inspection and maintenance activities have been developed in accordance with Tex

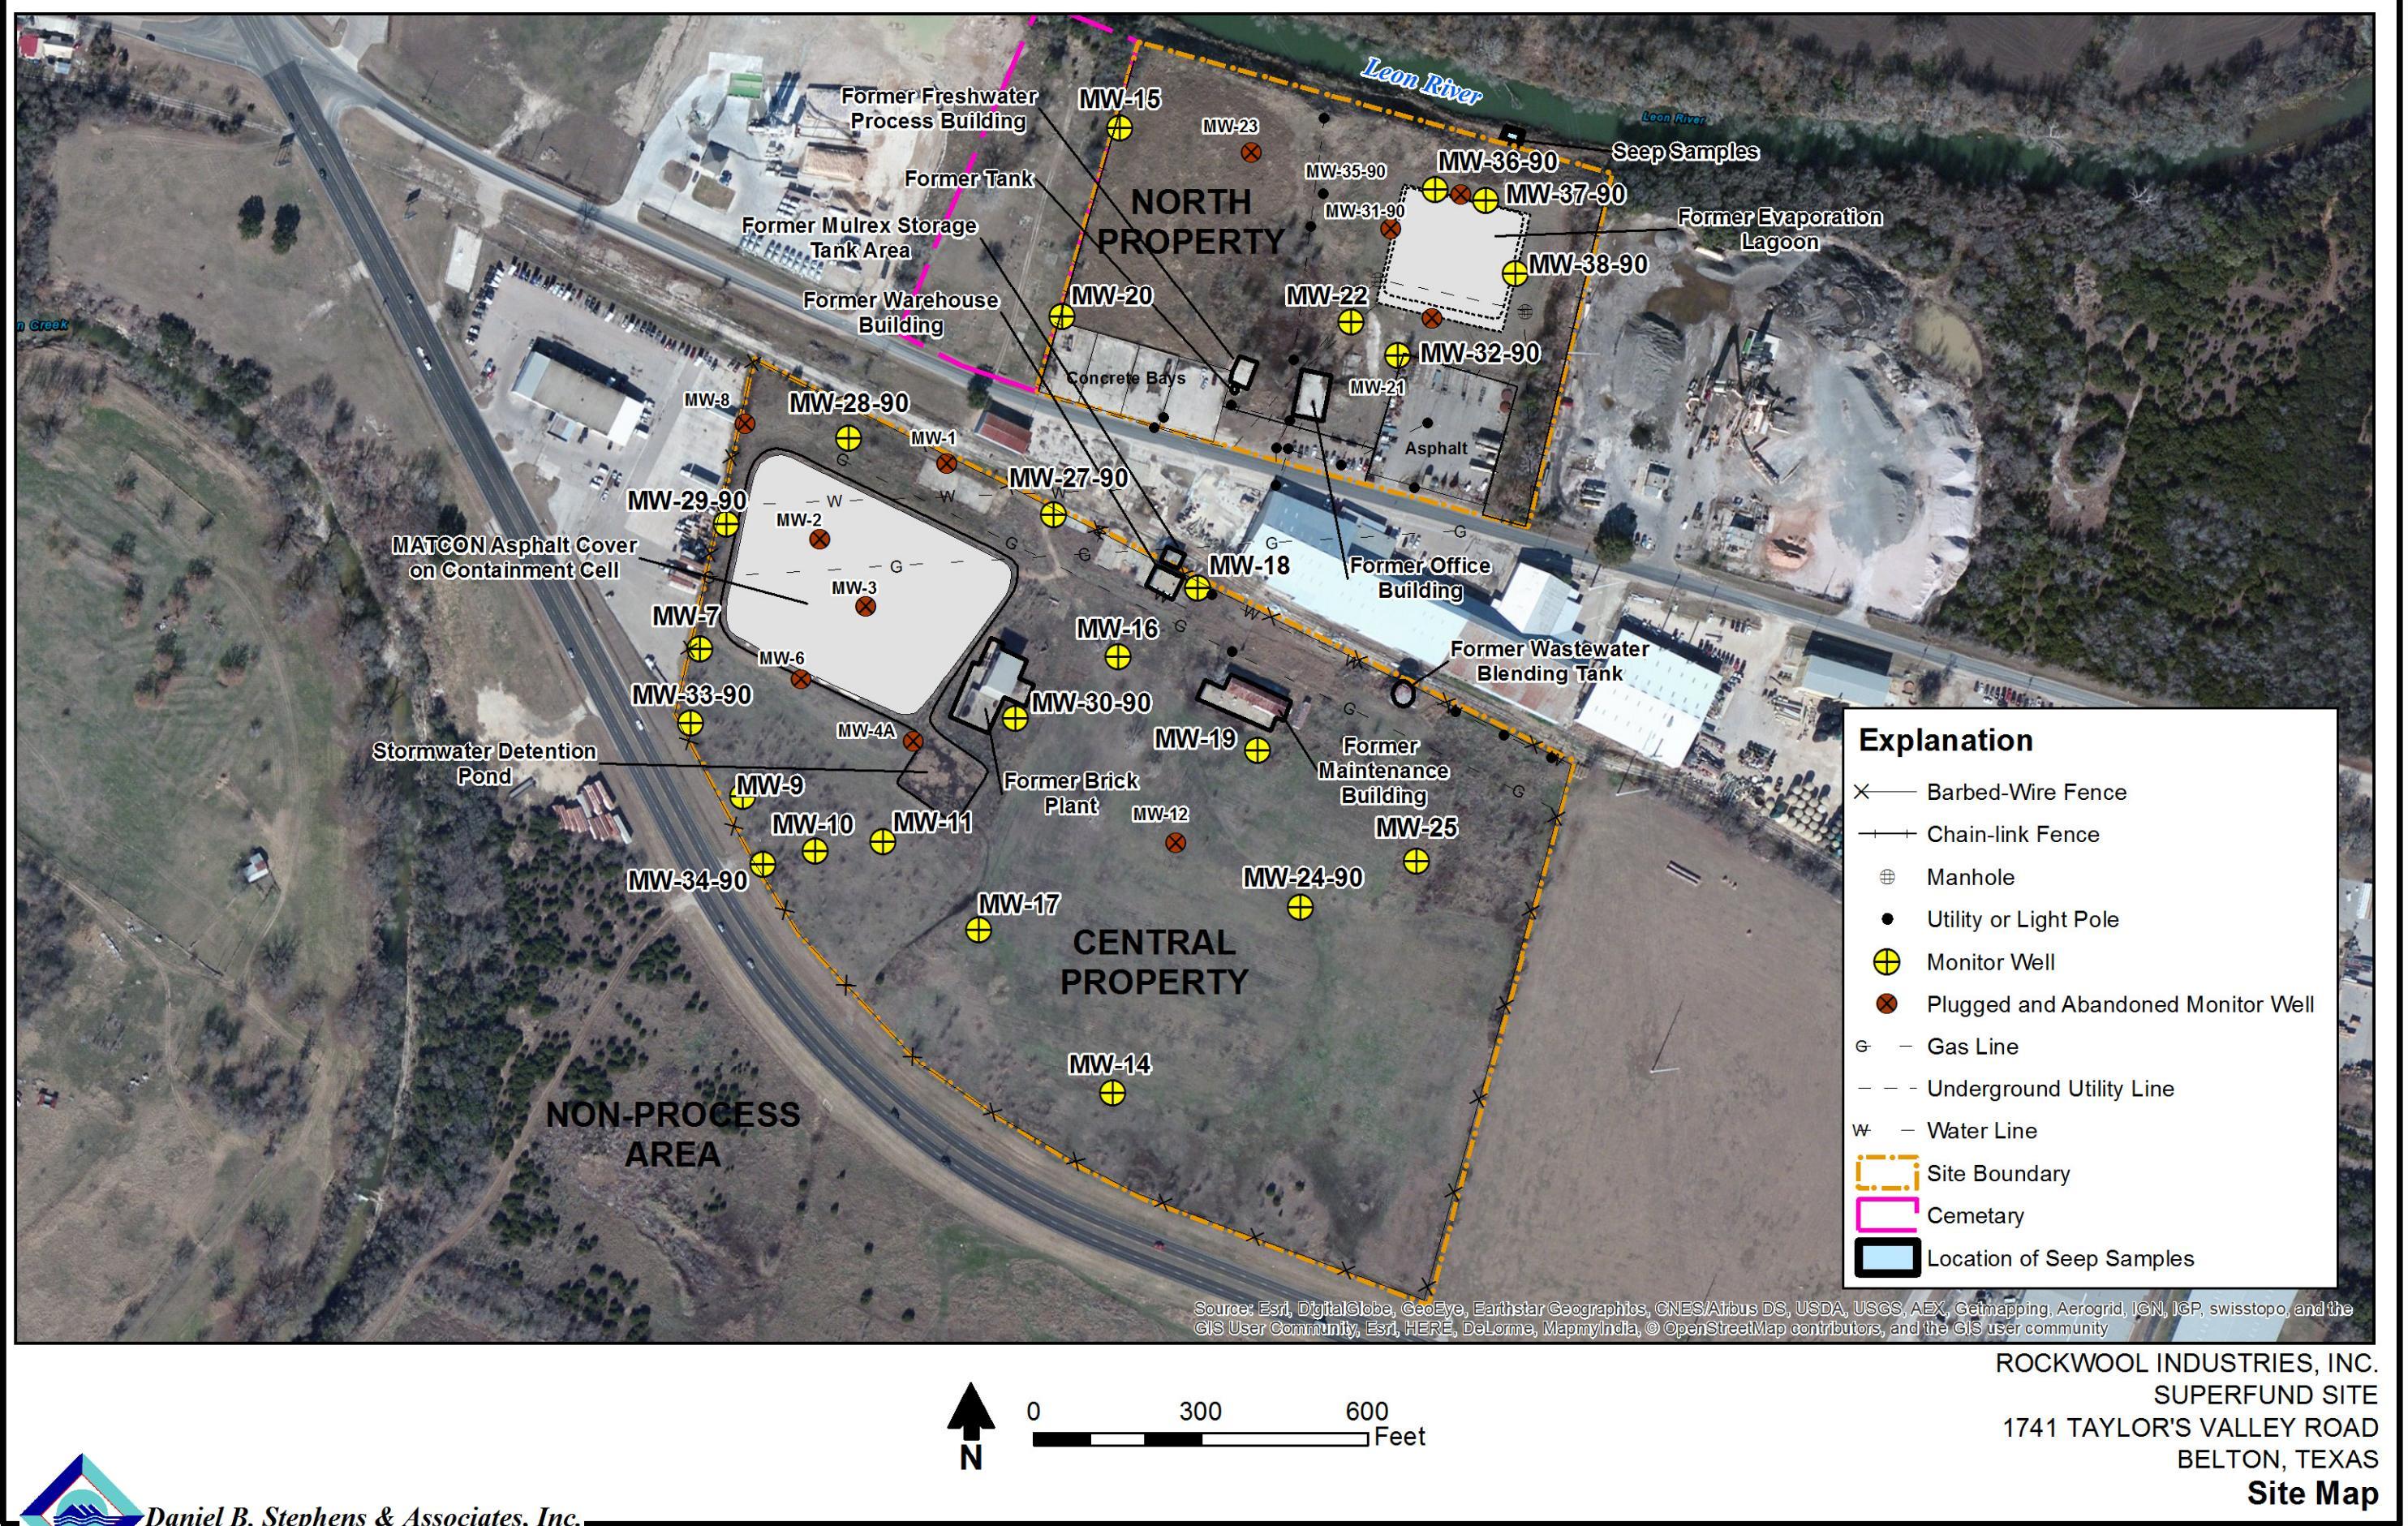
The RWI Site is broadly divided into two main areas; the North Property and the Central Property as illustrated in **Figure 2** (Site Map). The North Property and adjoining Geer Property-Cemetery area constitute a 14-acre tract of land on the north side of Taylor's Valley Road. The Central Property includes Operable Unit 2 (OU2) and forms a 47-acre tract of land south of Taylor's Valley Road extending to FM-93. Historically, the RWI Site included a Non-Process tract that covered approximately 40-acres of land located south of FM-93, which traversed southwest to Nolan Creek. During prior remedial investigations, the Non-Process tract was determined to be free of contaminant impacts; therefore, this 40-acre tract of land is no longer considered part of the RWI Site.
