MILAN COMMUNITY WATER SYSTEM
NM3525533

Subject: Customer survey to determine service line pipe materials

Customer Service Line Material Identification Guide

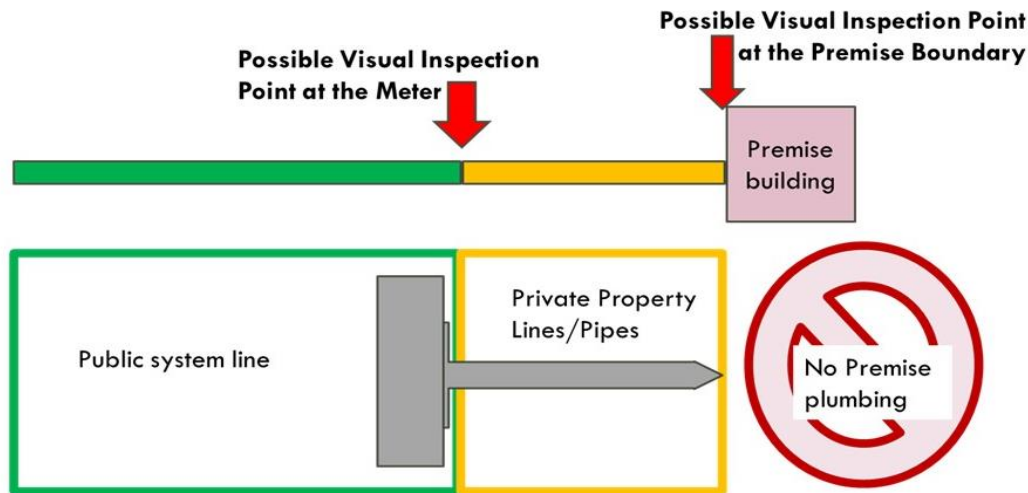
The water utility owns the public pipes that lead up to the what the property title determines is a private water line. In New Mexico, that is usually the property line. The image below indicates what your water service line might look like and the points you may visually inspect to determine the materials of the water pipe.

A water service line is the pipe that carries water underground from a water main or well into a building. Water service lines can be made of a variety of materials: copper, plastic, galvanized or lead. The service line could also be a mix of several types, especially if repairs have been made to the line at different times in the building's history.
