A Red Light Running (RLR) Photo Enforcement System was installed at the intersection of US Rte. 20 (Lake St.) at JF Kennedy Dr. on November 20, 2012 (northbound/eastbound) after finding limited success with other attempted measures to promote safer driving and improve compliance with traffic laws. As a condition of use, both Illinois law and the Illinois Department of Transportation require periodic statistical analyses/evaluations be conducted.

US Rte. 20 (Lake St.) at JF Kennedy Dr.
Addison, IL

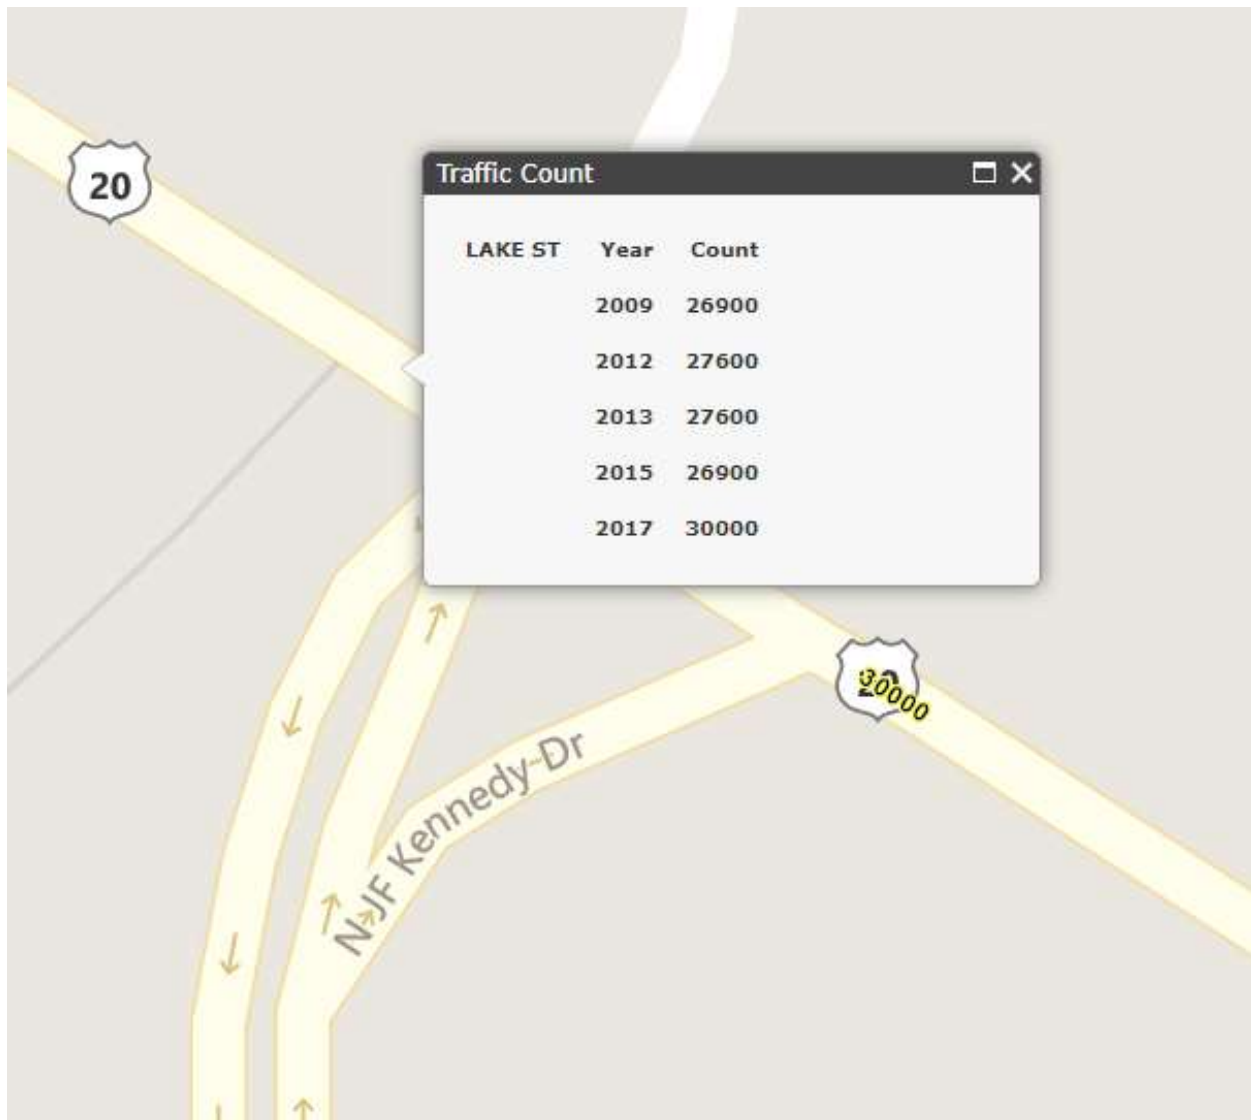
US Rte. 20 (Lake St.) at JF Kennedy Dr. (Eastbound/Westbound)

- 26,900 (2009)
- 27,600 (2012)
- 27,600 (2013)
- 26,900 (2015)
- 30,000 (2017)
