Jenks Township – Lamonaville Road

Forest County

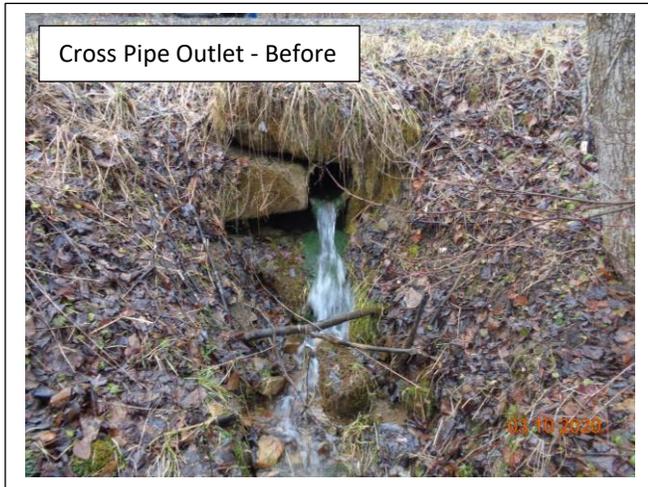
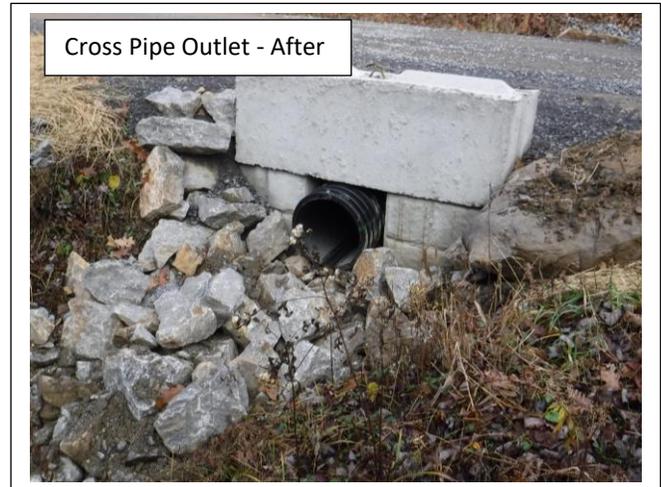
Problem: The existing cross pipes were too small, causing erosion at the outlet of the pipes. Standing water in some of the roadside ditches was causing water to saturate the road base, creating potholes. The lack of head and end walls on the existing cross pipe was causing the road bank to erode.

Solution: The six existing 15-inch diameter pipes were replaced with 18-inch diameter pipes. An additional 18-inch diameter cross pipe was also installed. 246 feet of underdrain was installed. Head and end walls were installed on all of the cross pipes. Bank support was provided with large stone. Six turnouts were added to direct runoff away from the roadway and into stable, vegetated areas. Disturbed areas were seeded and mulch.
