PUBLIC WORKS STATUS REPORT

By Nicholas Bryan
Public Works Supervisor

Month of August 2021

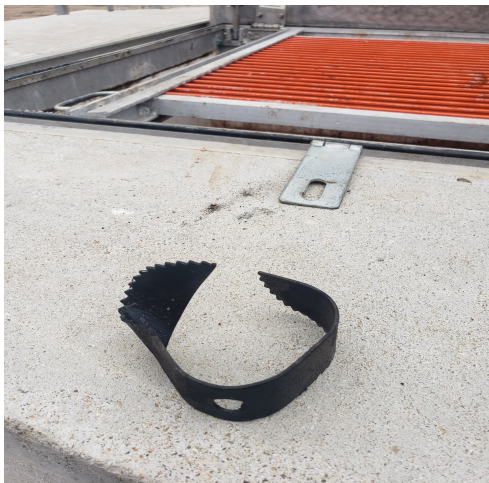
this picture shows the sewer snake cutter that damaged pump #2

This month was routine for the most part but we did have to change out a pump that failed at the San Jaun Hollister rd sewer lift station. Gil our collections system operator was performing his routine pump station maintenance and found Pump 2 main breaker tripped and not resetting upon further inspection this required to pull the Pump out of the wet well to inspect during the inspection Gil found a sewer snake cutter had lodged into the pump impeller causing the pump to overheat that lead to failure of the pump. Gil swapped out the damaged pump with a loaner pump this brought the station back to full capacity allowing the Microvi skid to go back into operation. This station is scheduled for future much needed improvements. I almost forgot this month we also had to replace a float switch at our Lang St sewer lift station the float switches control the pumps turning them on and off depending on the current demand. The switches are vital to the operation of the station we order spares because the switches are not failure proof as you never know when they can go out. August 23rd we had a alarm call at 8:44 am that the backup generator was turned on at our waste water treatment plant this was unusual as the rest of the town still had electricity. Justin from Cypress Water services found a lack of power at the waste water plants main electrical panel? Public works called out PG&E. PG&E responded about 2 hours later and they replaced a fuse at the power pull that supplies the plant. The good news is that the backup generator started up and maintained power until it was restored. This is why its so important for the city to keep moving forward to install emergency backup generators at our most important infrastructure. I also have great news before the new fiscal year started we budgeted to purchase a portable emergency generator this generator is capable to produce 3 phase 480 volts this is whats needed to power up our pump stations along with the generator we also installed transfer switches to Well 5 ,well6 and San Juan Hollister sewer lift station this allows the hookup from a backup generator. There has been a need to purchase a generator for a long time and am pleased to say that the current administration is doing a great job adding resiliency to our aging system this is a group effort with Management, EGINEERING, Public works.

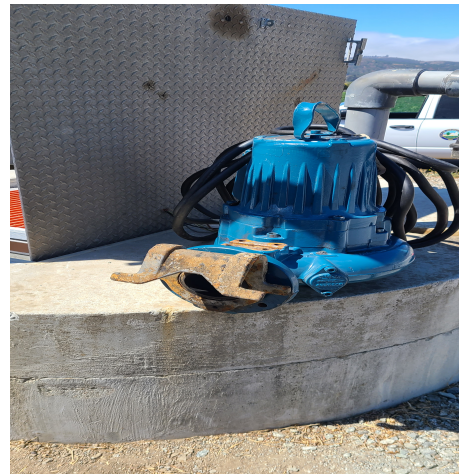
This was a loaner pump that we installed as a backup for pump #2
