PUBLIC WORKS STATUS REPORT

By Nicholas Bryan
Public Works Supervisor

Month of February 2022

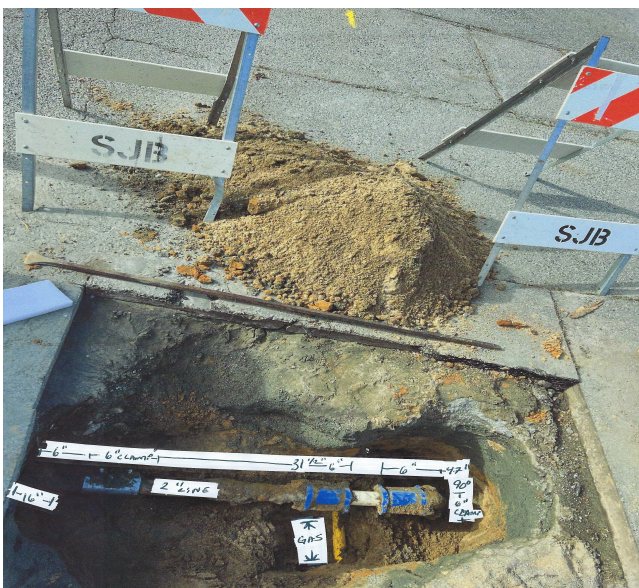
Water Main Repair North St / Second St. You can see the PG&E gas main right below the water main this is why we call USA North 811 to have other organizations utilities located so we can avoid hitting hazards with our equipment. We also found some previous repairs this section of pipe will be replaced during the valve replacement work.

The month of February was a dry month this didn't help to bring any relief towards our current drought. Water conservation will be a continued topic in the near future. There were some repairs made to our aging water system. The first repair was to a 2 inch ductile iron water main located at the intersection of North St / Second St the repair was completed with the pipe under pressure as the water was impossible to slow down due to a broken control valve. Public Works is working on replacing the valve this will allow more system control also helping to make future repairs more manageable. Public works also changed a broken wharf head fire hydrant located at 4th and Monterey St this will help improve the fire safety in this area.

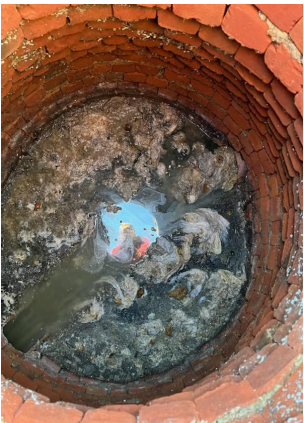
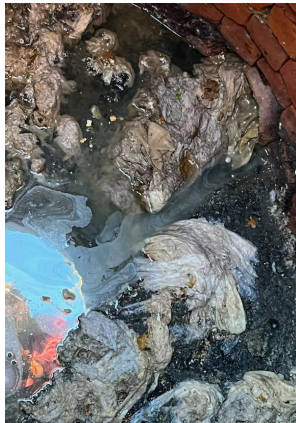
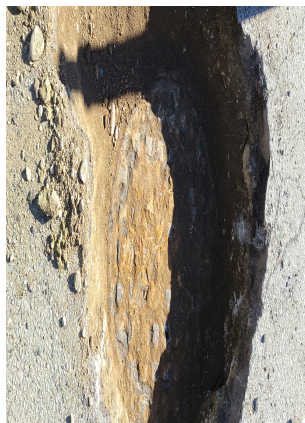
This manhole was found with our sewer camera and we went forward with excavating and installing a new frame and cover for future access for maintenance. This is located at the intersection of Merentis Circle / Monterey St

The past months we have had sewer draining problems located on Monterey St between 4th to Church St. There was a decision made to perform a camera inspection for this portion, upon inspection we found a old covered brick Sewer manhole we located the manhole and excavated the manhole down to the lid and we pulled the lid off and found the manhole was full of wipes, swifter sweepers and other debris that does not belong in the sewer these items need to be discarded in the trash Public Works did send out a notice to the residents that live in this area after delivering notices we still found little improvement in the prevention of flushing illicit items this is alarming. The manhole was cleaned out and we installed a new frame and cover to allow better access for future maintenance. This area is still being inspected as it appears that we are still having problems with the sewer flow. The Ahwahnee sewer lift station needed a sewer pump pulled and cleaned as some wipes clogged up the pump. The pump has a worn wear ring this wear ring sits in the pump between the volute and the impeller. Changing this wear ring could help eliminate future problems with the pump.

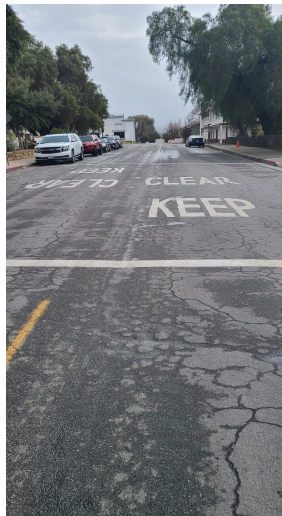
Not to much to report just the regular month to month maintenance this includes pot hole repair as needed and street sweeping . Public works did refresh some red curb also refreshing the keep clear striping on Second st at the Fire house . Armando did a great job this was painted free hand with out stencils .
