PUBLIC WORKS STATUS REPORT

By Nicholas Bryan
Public Works Supervisor

Month of June 2022

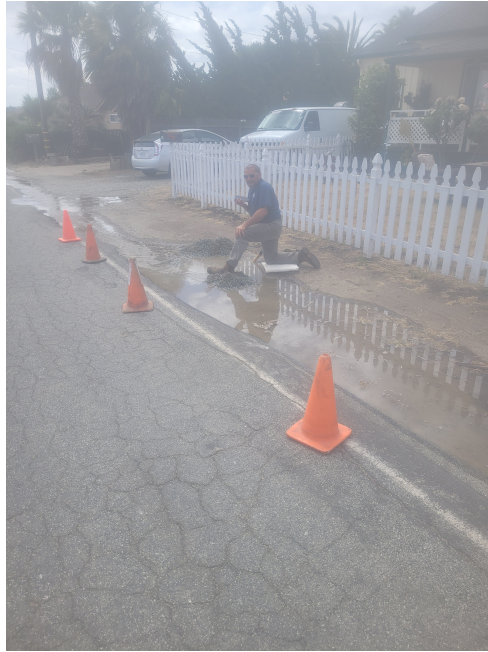
Mission Vineyard Rd water repair

There was some notable water repairs . There is a 2inch galvanized water main located on Mission Vineyard Rd this water main is undersized and extremely old and corroded it has sprung leaks a couple times a year . There is a 4inch water main installed I recommend that the properties that are being serviced from the 2inch line be connected to the existing newer 4inch line this would eliminate future leaks by allowing the 2inch line to be abandoned . Public Works also responded to a water lateral leak located on the older section of 5th st the water lateral appeared to be extremely rusted and corroded . I can forecast future leaks in this area as this area is in need of all new underground utilities same as allot of other older areas of town as the utilities have reached the end of there lifespan .

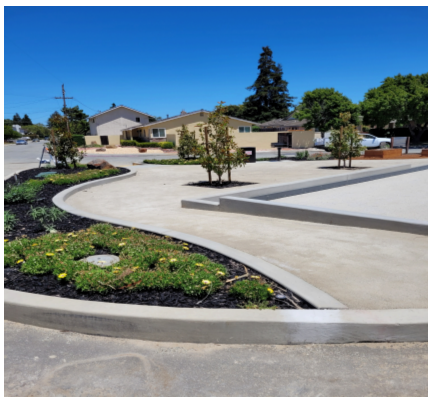
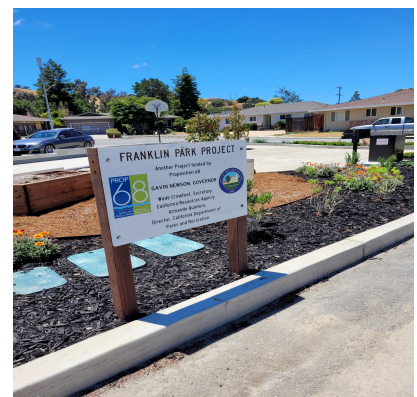
New Franklin Park

The Franklin Park project is 98% complete the fencing has been removed and ready for some bocce ball to be played . There are some last finishing touches to be addressed the benches , tables and the community succulent garden still need to be finished . The supply chain issues have caused long lead times for the tables and benches . The Verruti Park restroom installation has been off to a slow start the electrical trenching has been completed also some demolition and rough grading has taken place . I'm not sure when this project is going to be completed . Public Works has also made adjustments to our grounds irrigation schedule . The city and residents are currently only allowed to irrigate landscaping to 2 days a week Monday and Thursday before 9am and after 5pm the water restrictions have been put in place due to the current drought .
