PUBLIC WORKS STATUS REPORT

By Nicholas Bryan
Public Works Supervisor

Month of January 2023

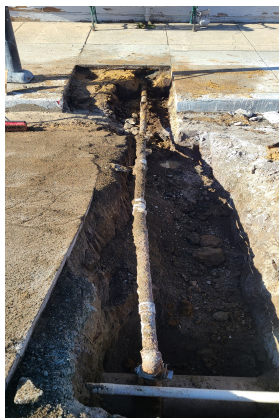
Polk St
Water
line

What a way to start off the New Year . Public Works was a busy during the month of January there was 4 water main repairs . The first repair was located across from 451 San Juan Hollister rd we have a 8 inch Transite main that delivers water from well 5 to the Iron and Manganese water treatment plant . This water main is very important without repairing this water main we could not produce water for the town. The second repair was located at the intersection of San Jose and First st this main is a old 2inch iron main that has required multiple repairs through the years this line is on the replacement list. The third repair was located on 5th St between Polk St and Washington St this is a 4inch Transite main that the saddle had become corroded and was leaking the saddle needed to be replaced and the service line reattached this is the second saddle replacement in the last 2 years on the same water main , its likely that more will start failing and we will develop more leaks. The final repair towards the end of January was located on Polk St between Second St and Third St . The contractors completing the street and sidewalk improvements hit a shallow water line during saw-cutting . Public Works replaced the saddle tap and service line lowering the line in the process to avoid future damage.

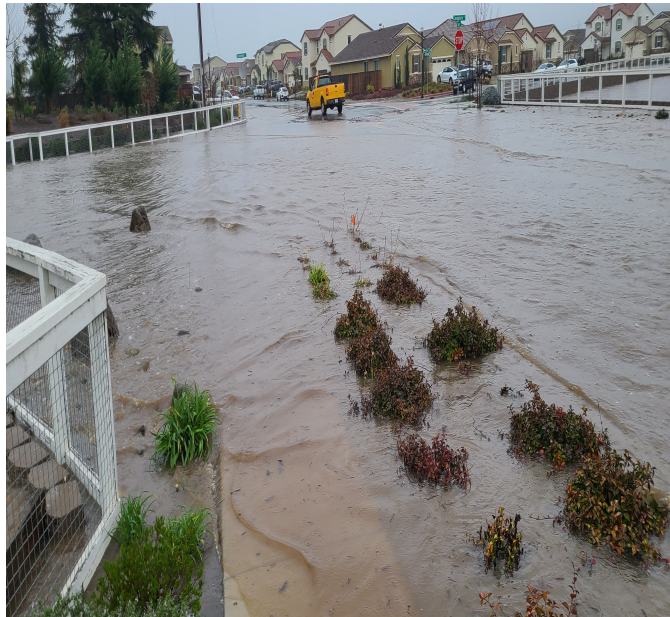
During the month of January Public Works responded to flooding located in the area of the Rancho Vista sewer lift station. Public Works installed sand bags to surround the wet well hatch to help prevent storm water intrusion. This is extra reassurance as the door hatch seal is in good shape keeping intrusion at bay. Public Works also during the heavy rains responded to the San Juan Hollister Rd sewer lift station, this station receives sewer from the industrial district located on the south end of town. There was a property that had missing sewer clean out lids. This led to a large amount of storm water intrusion. On-call staff met with property owner and found the clean outs with missing caps and recapping the clean-outs reduced the intrusion, allowing the sewer lift station to not be overwhelmed and pump as usual. This could have led to a sewer overflow but thankfully staff was able to correct the issue.

Flooding in the Rancho Vista Subdivision
The sewer lift station is located towards
the top of the photo.

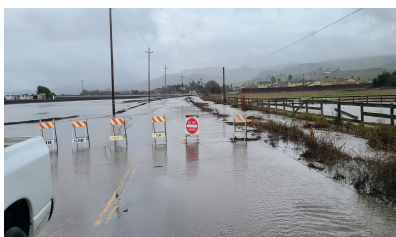
First
Street
Flooded

Flooding was the big topic for January . Public works spent quite a few hours responding to local flooding these hours were spent cleaning drainage ditches , clearing drain inlets , constructing berms to direct flood waters to protect properties , cleaning up storm debris and putting out traffic control devices for advance warning these include signs and barricades and we also utilized the message trailers that the County has kindly has lent the city. During the last 5 years this year we have had the most severe flooding this flooding also showed us where all the trouble spots are located . The majority of the flooding from what I have noticed is storm water runoff coming from the county out of city limits towards the outskirts of town this runoff is muddy and full of debris . The Rancho Vista development could not handle all the runoff this caused extensive flooding . We have documented the areas of concern keeping record will help us develop a plan on areas that we need to concentrate on for preventative maintenance operations ahead of the rainy season .
