Meeting Date: 11/14/2023	NB #1
Agenda Item: Air Quality Testing Report for Town Hall	
Informational:	
Sevee & Maher Engineers was hired to do an air quality test on all three floors of the Town Hall. The Report shows that nothing was found to be at an unhealthy level despite the lack of air handling systems. Recommendations were also made in the report.	
Town Manager's Recommendation:	
To make a motion to accept the report from Sevee & Maher Engineers, for the air quality report the Town Hall.	
Requested Action:	
To make a motion to accept the report from Sevee & Maher Engineers, for the air quality report the Town Hall.	
Vote

Town Hall

180 Main Street, South Berwick, Maine

INDOOR AIR QUALITY/MOLD ASSESSMENT
SOUTH BERWICK TOWN HALL
180 MAIN STREET, SOUTH BERWICK, MAINE

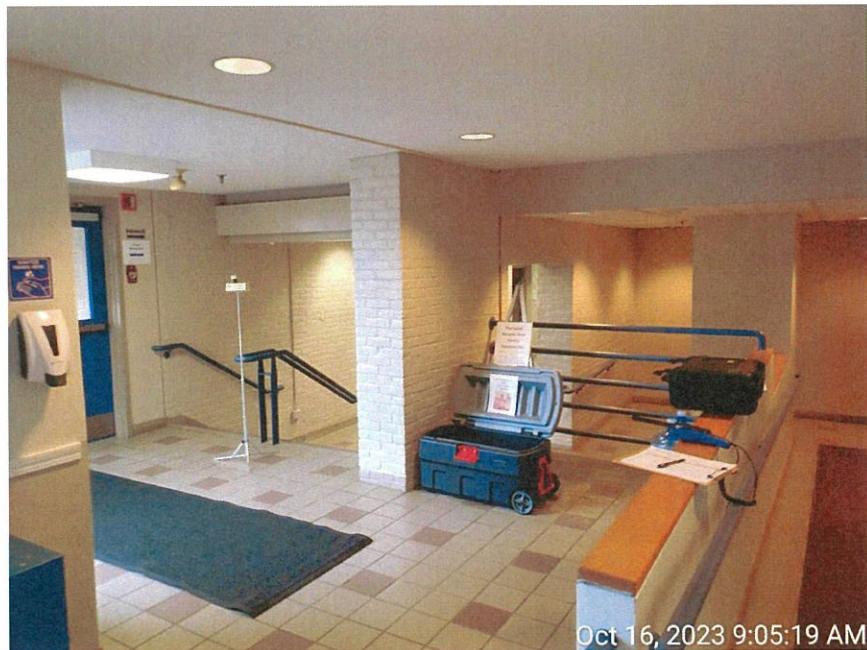
Air sample ST-2 collected in first floor entry/elevator area.

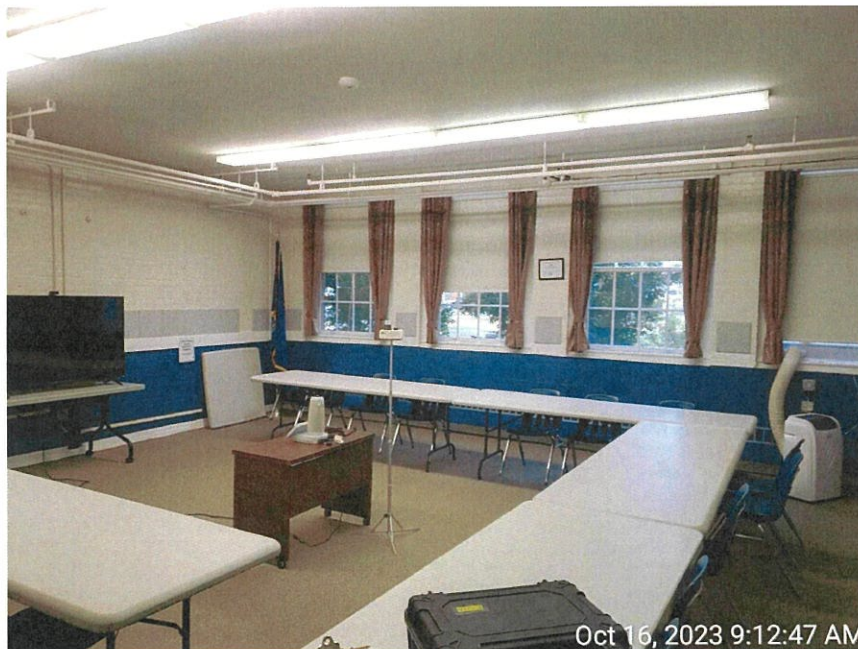
Air sample SI-3 collected in first floor meeting room (former Public Works).

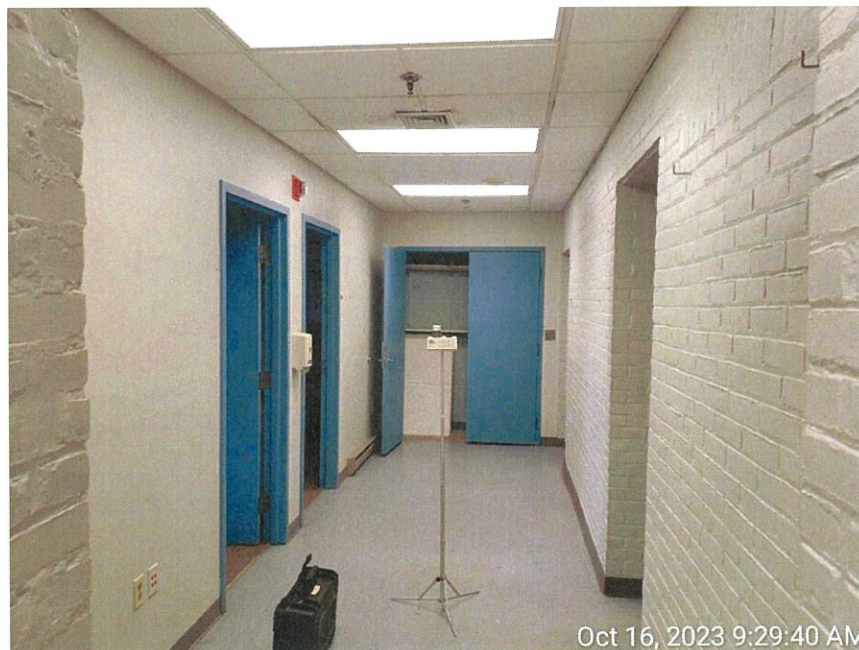
Air sample ST-4 collected in first floor hallway near former Police Dispatch/Locker Room area.

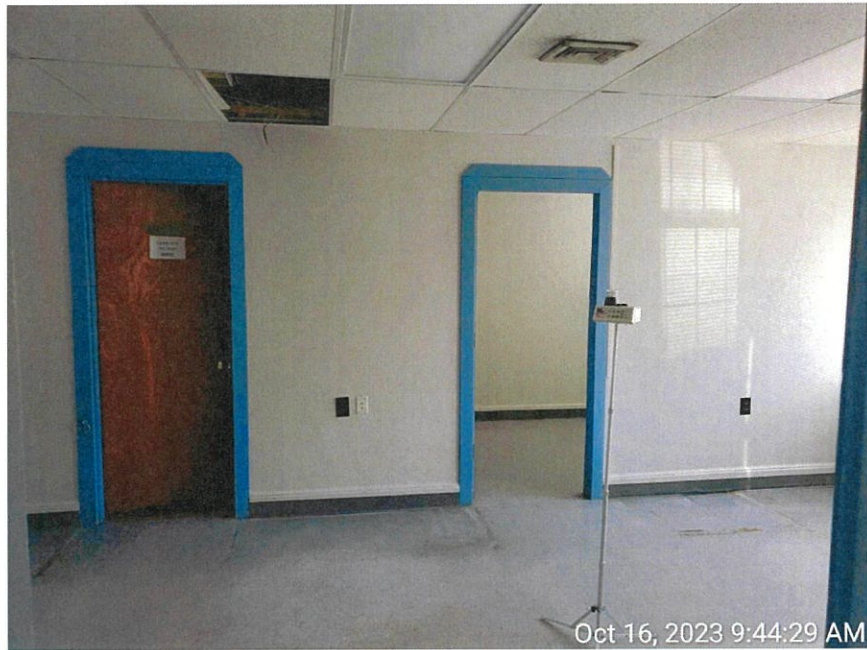
Air sample ST-5 collected on first floor in former Police Patrol Office.

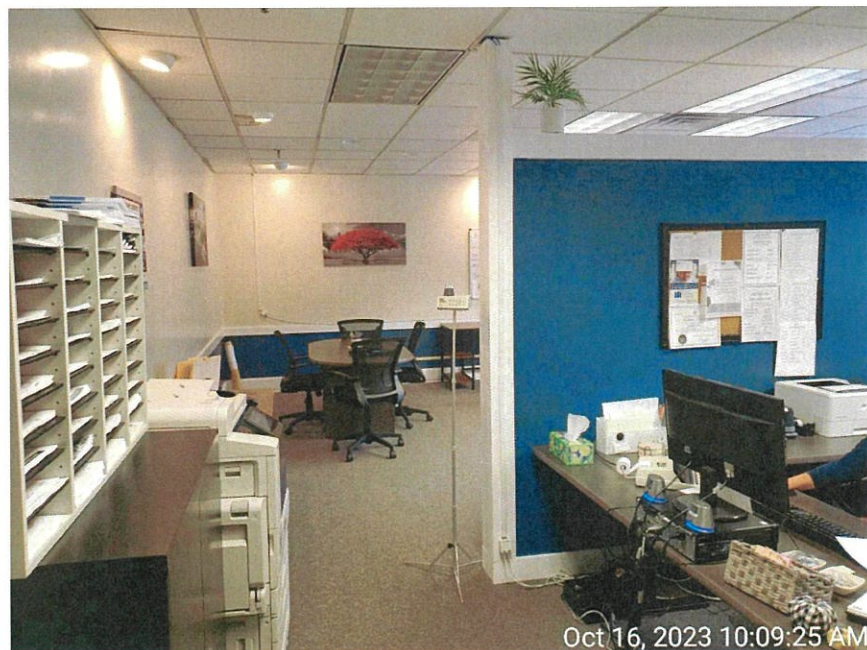
Air sample ST-6 collected on second floor in Asst. Town Mgr./HR/Finance Offices.

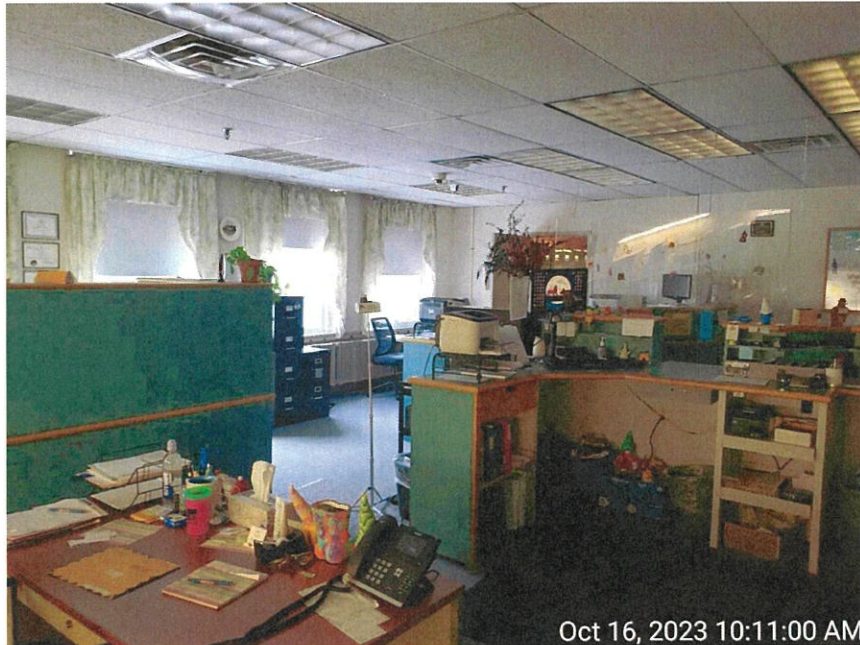
Air sample ST-7 collected on second floor in Assessing Offices.

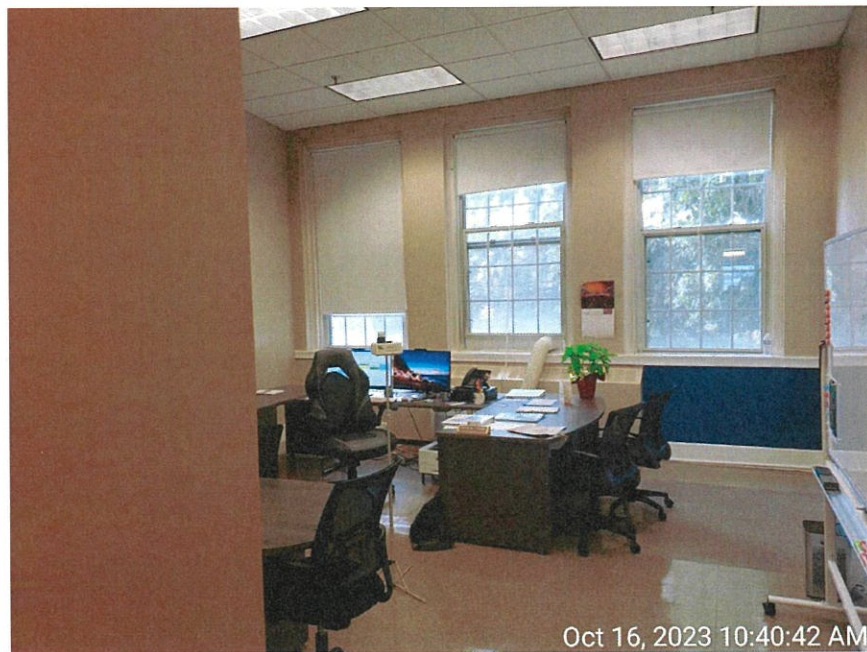
Air sample ST-10 collected on third floor in Economic & Community Development Office.

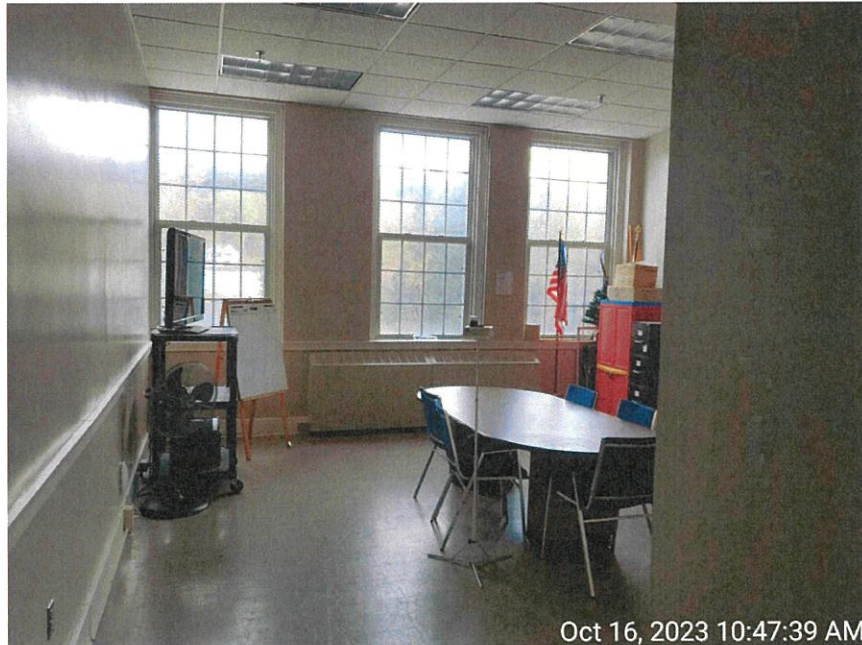
Air sample ST-11 collected on third floor in Meeting Room #2.

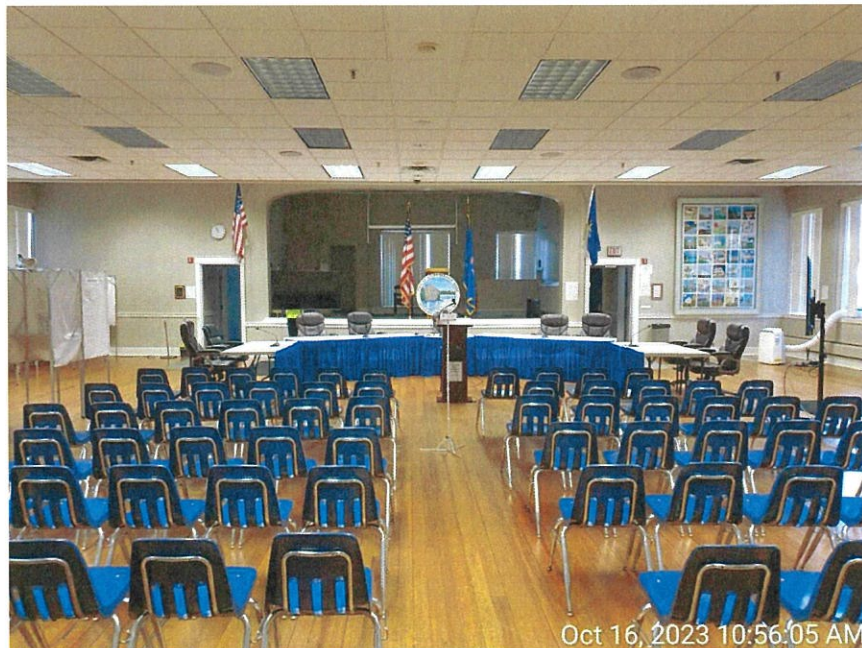
Air sample ST-12 collected on third floor in Auditorium.

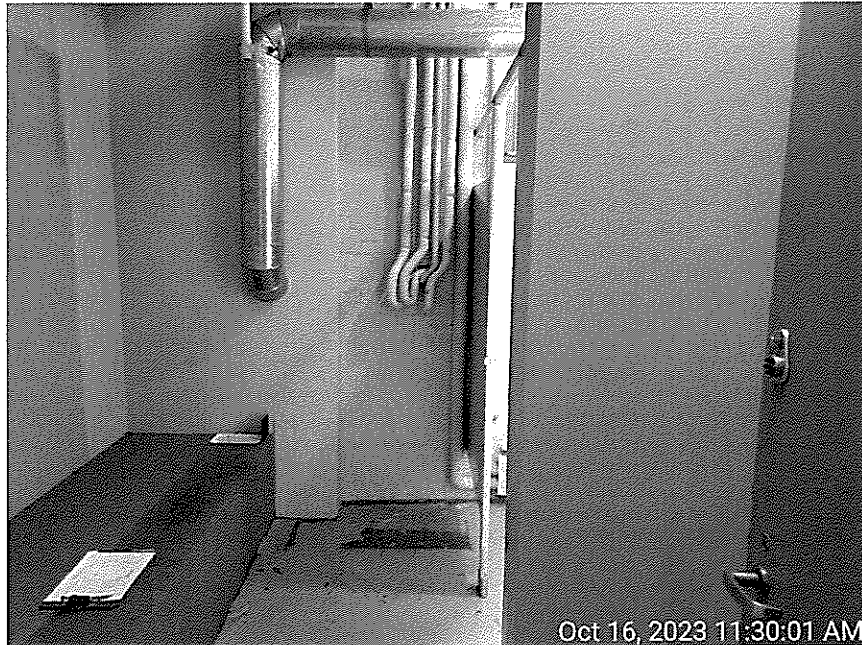
Insect infestation in first floor former Police locker room.

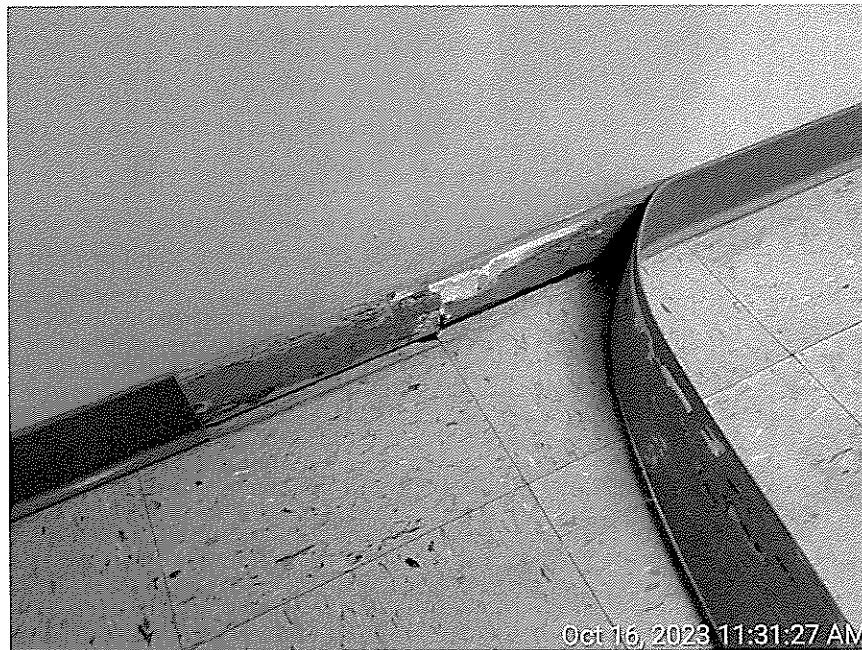
No mold growth issues observed for lower drywall on first floor.

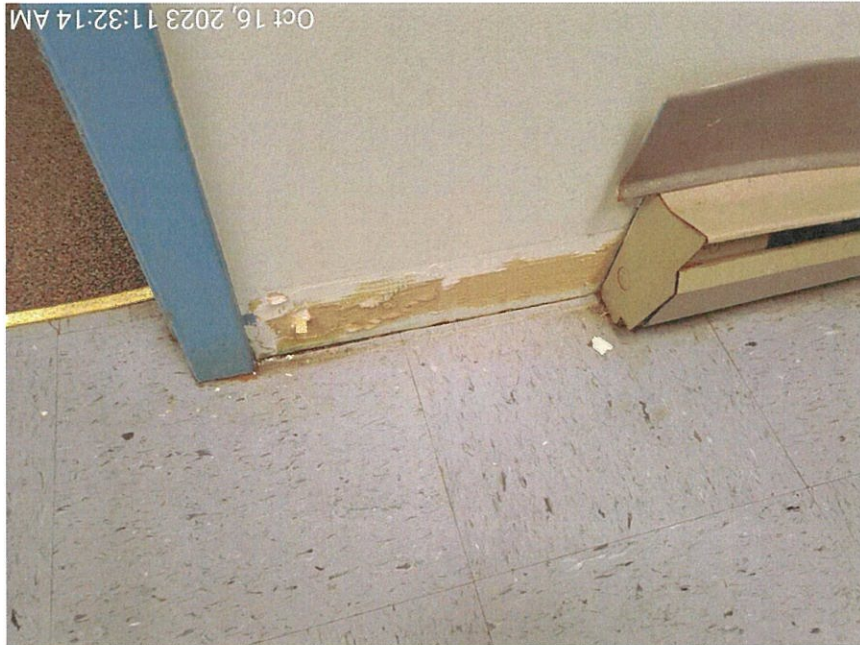
No mold growth issues observed for lower drywall on first floor.

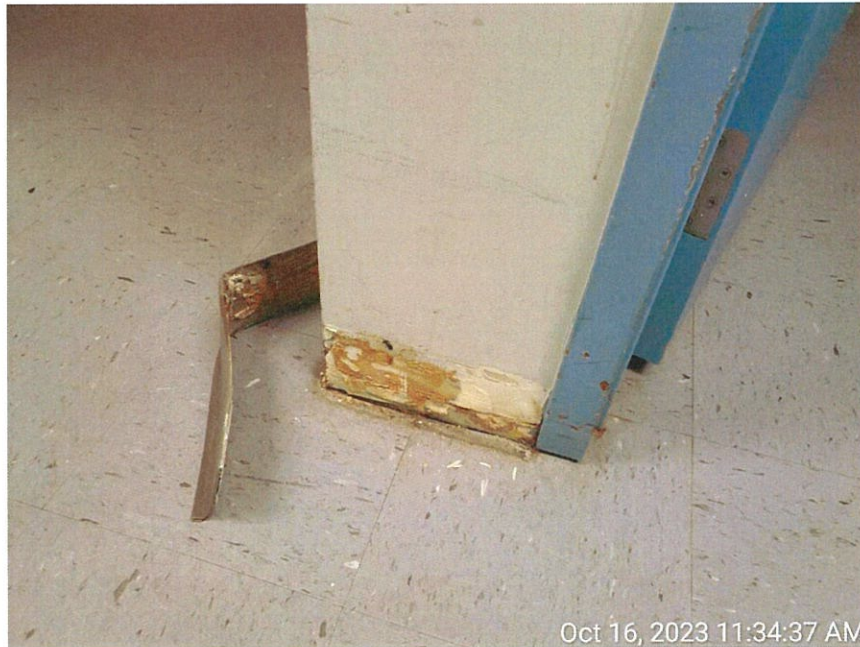
No mold growth issues observed for lower drywall on first floor.

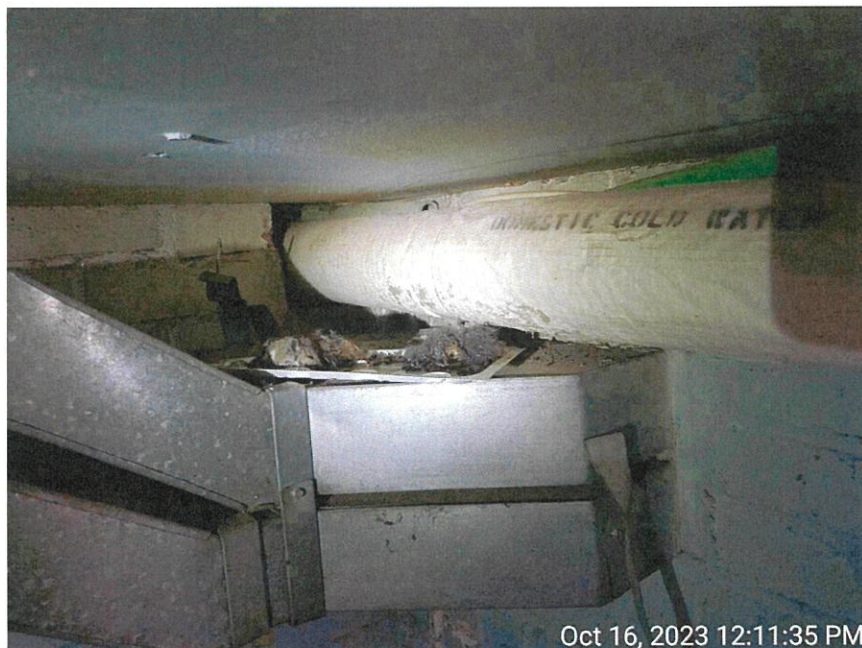
Rodent carcasses in first floor sprinkler room.

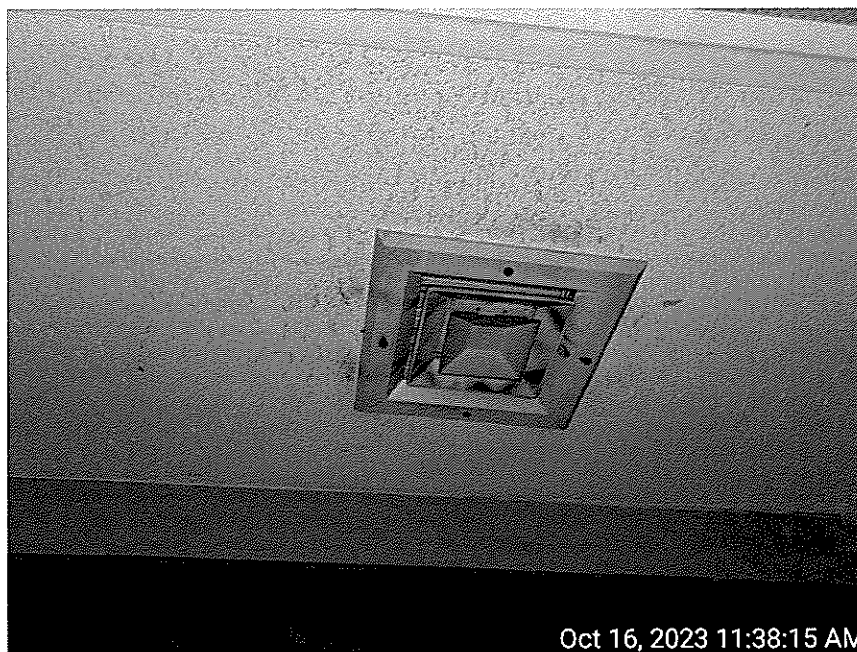
Dirty supply diffuser and ductwork on first floor in Utility Room near former Police Patrol Office.

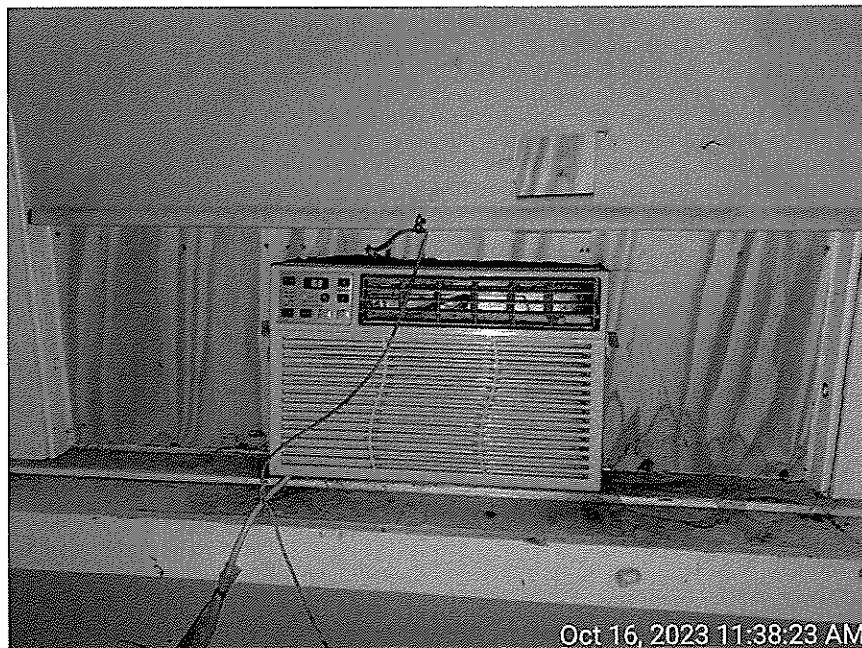
Dirty/mold compromised portable window A/C unit on first floor in Utility Room near former Police Patrol Office.

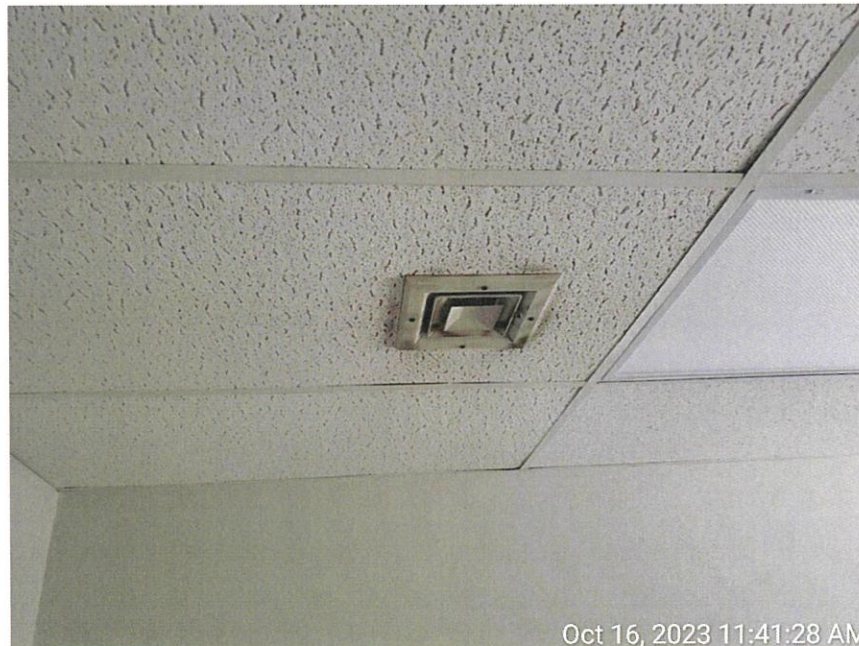
Dirty supply diffuser and ductwork on first floor in former Police Interview Room.

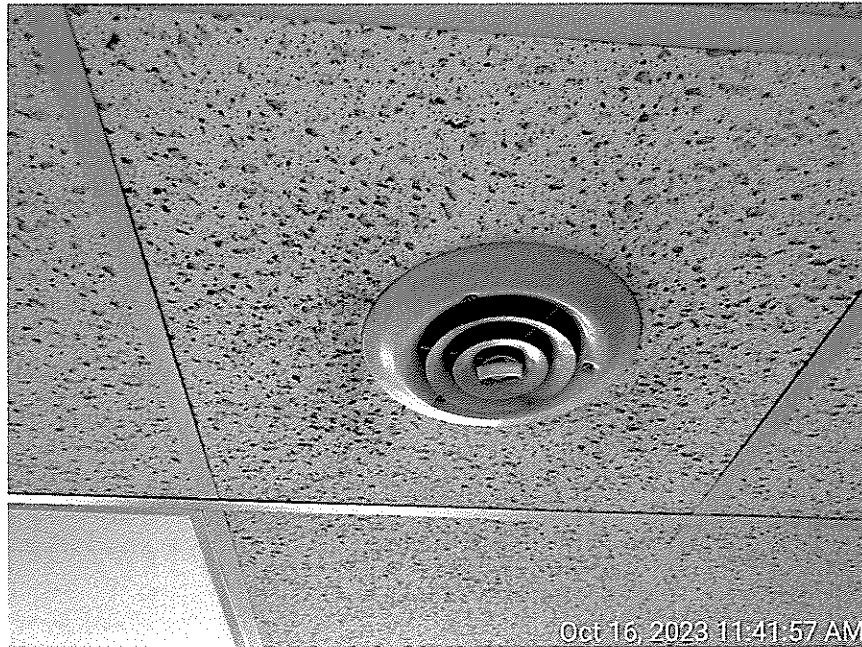
Dirty supply diffuser and ductwork on first floor in former Police Lieutenant & Sergeant Office.

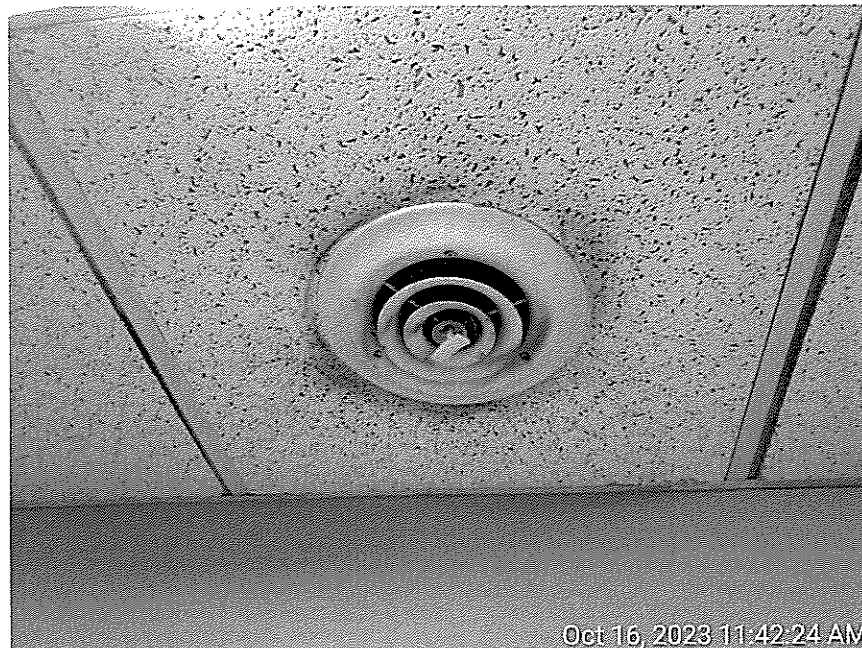
Dirty supply diffuser and ductwork on first floor in former Police Storage Room.

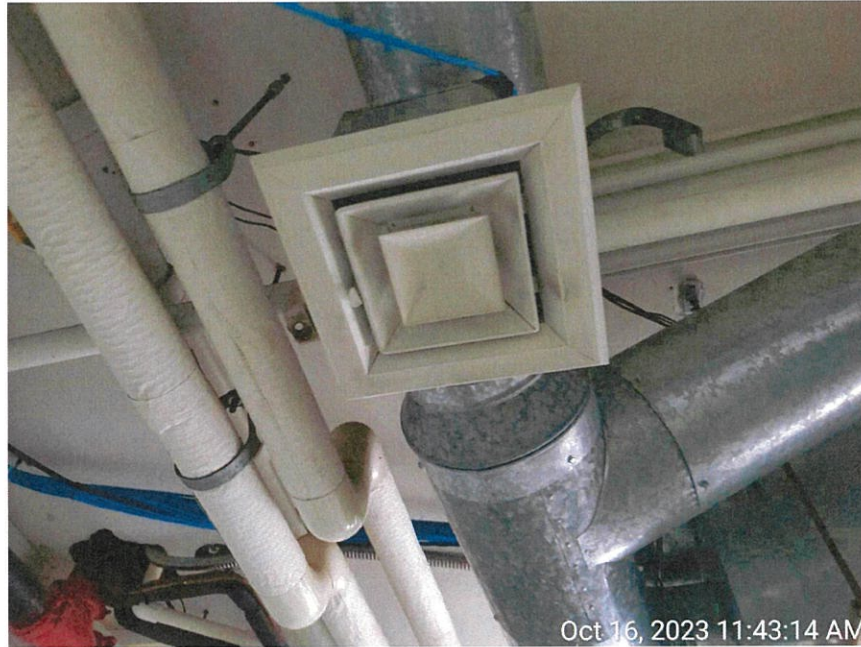
Dirty supply diffuser and ductwork on first floor in former Police Locker Room.

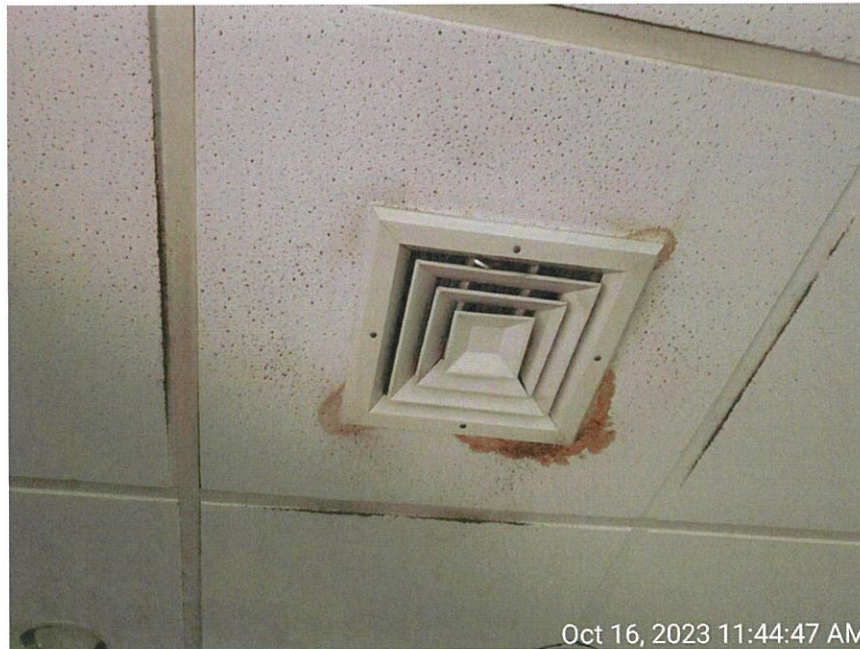
Dirty supply diffuser and ductwork on first floor in former Police Dispatch Office.

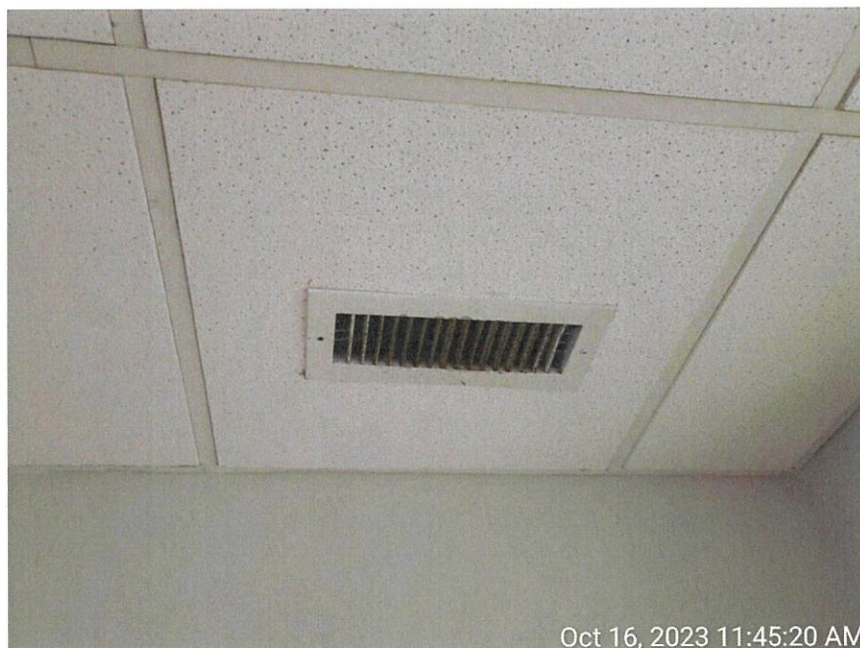
Dirty return diffuser and ductwork on first floor in former Police Dispatch Office.

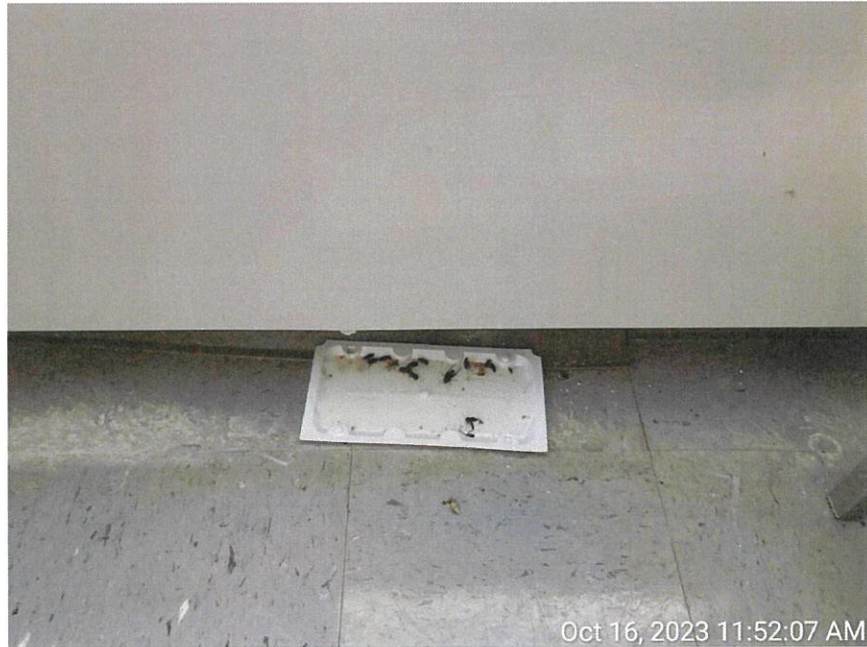
Insect activity on first floor.

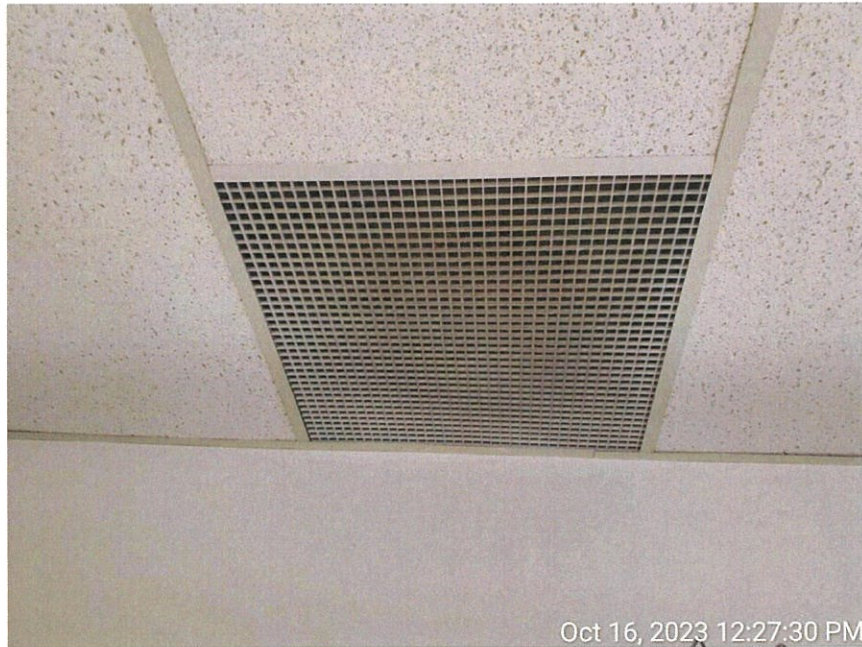
Dirty return diffuser and ductwork on second floor in Town Clerk Offices.

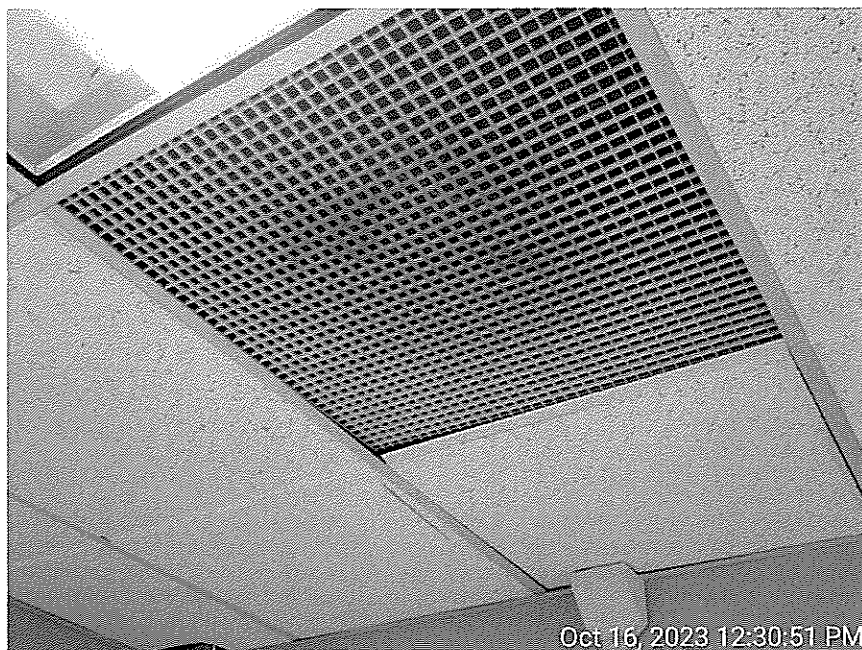
Dirty return diffuser and ductwork on second floor in Assessing Offices.

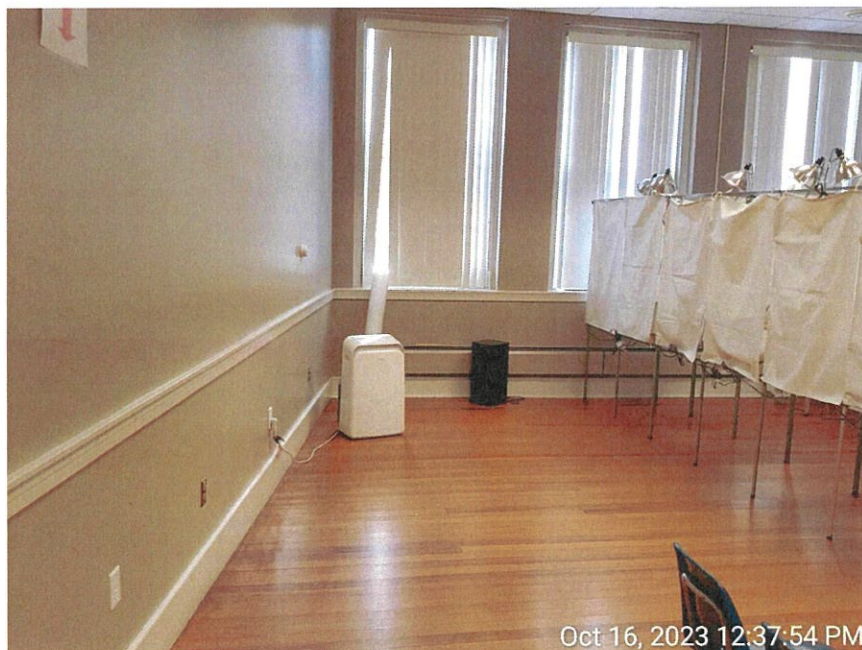
Air purifier (black) on third floor with ionizing setting - Ozone producing.

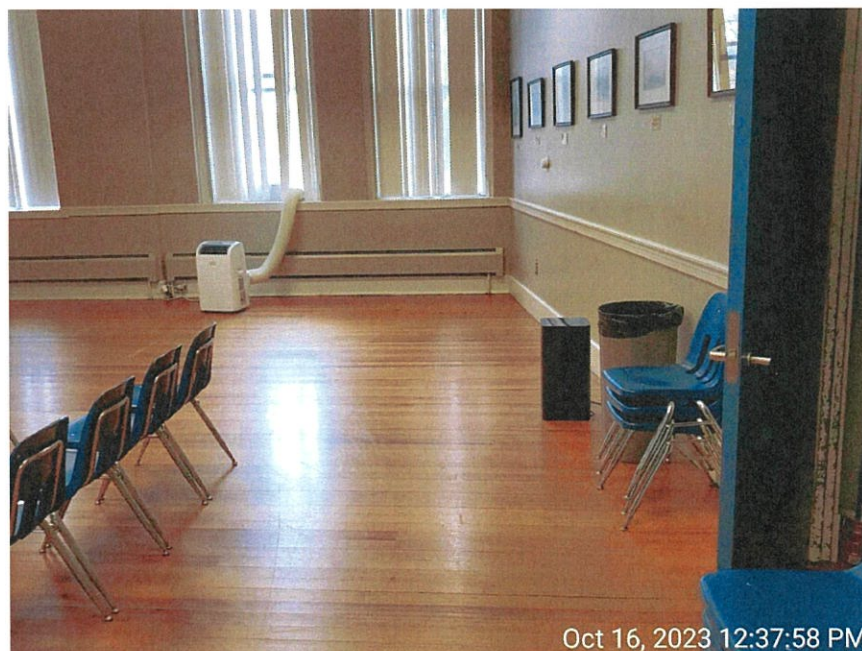
Air purifier (black) on third floor with ionizing setting - Ozone producing.

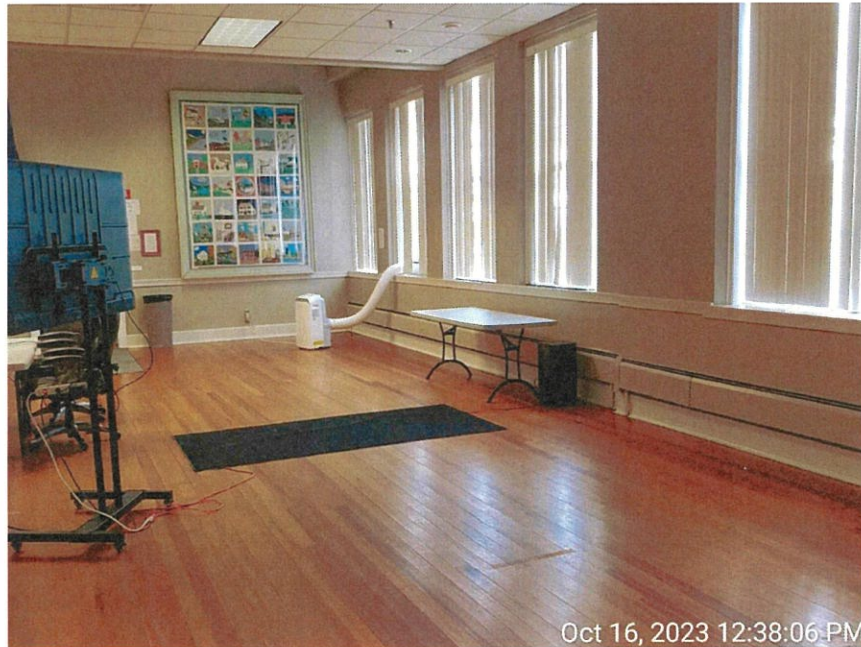
Air purifier (black) on third floor with ionizing setting - Ozone producing.

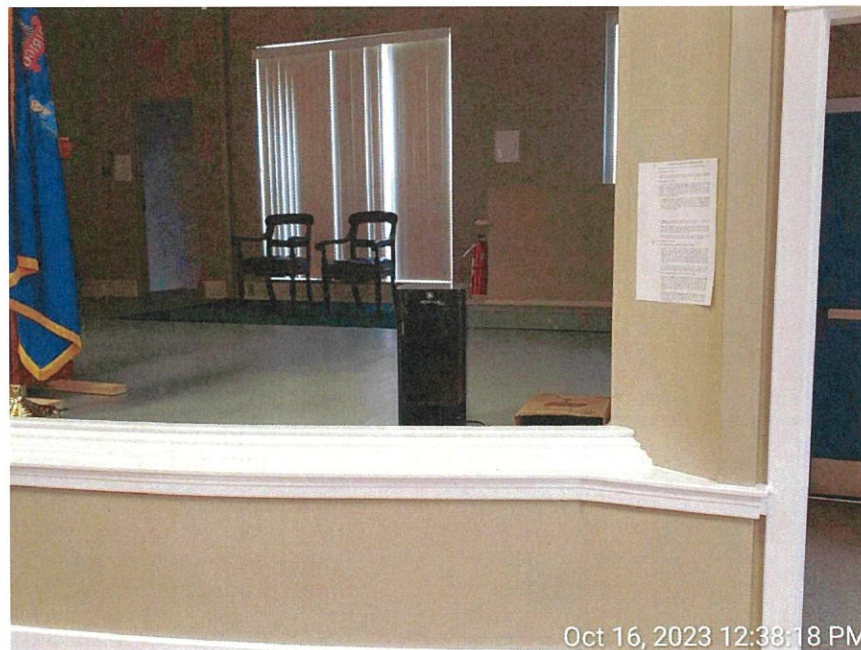
Air purifier (black) on third floor with ionizing setting - Ozone producing.

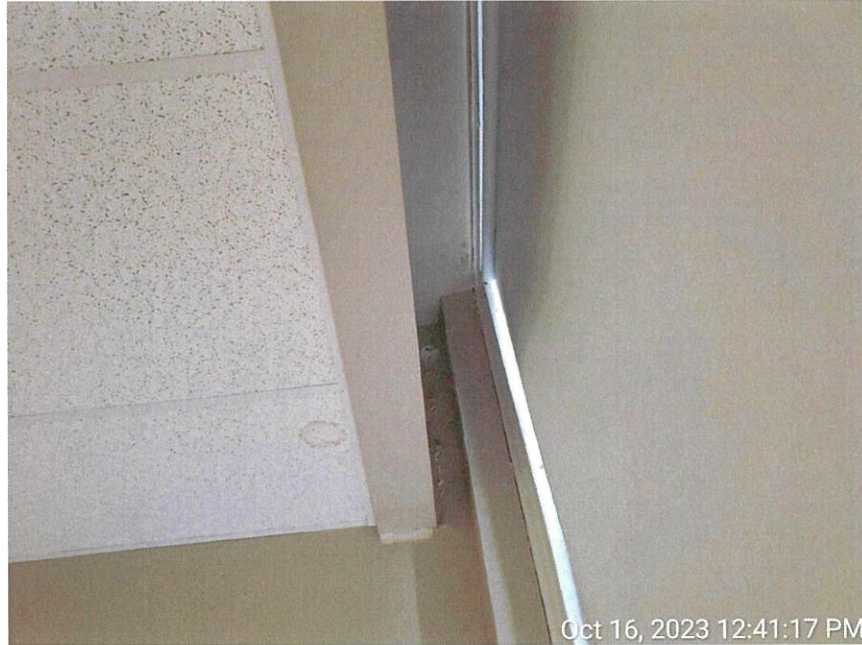
Water intrusion impact for window header on thirld floor In electlon storage room.

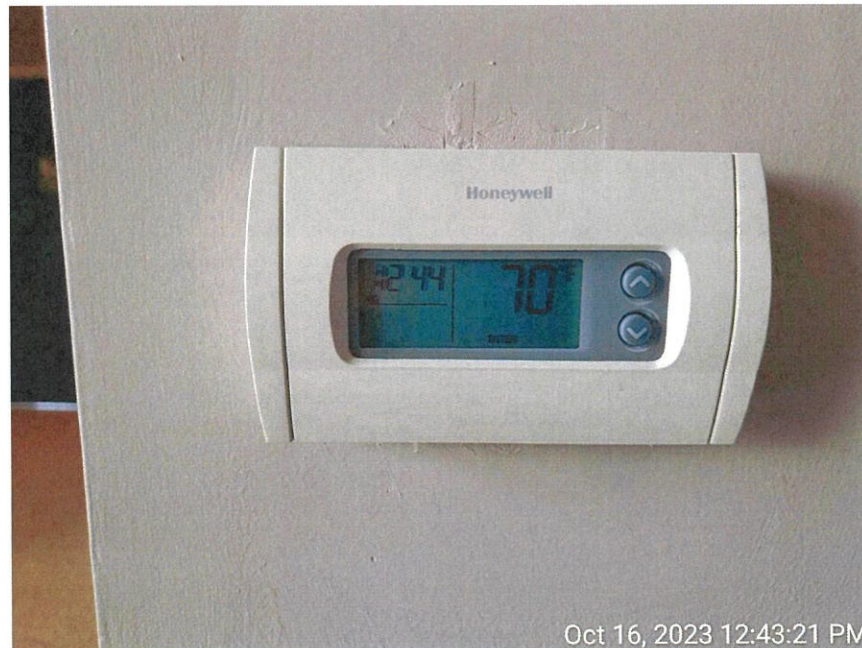
Thermostat on third floor with filter issue message.

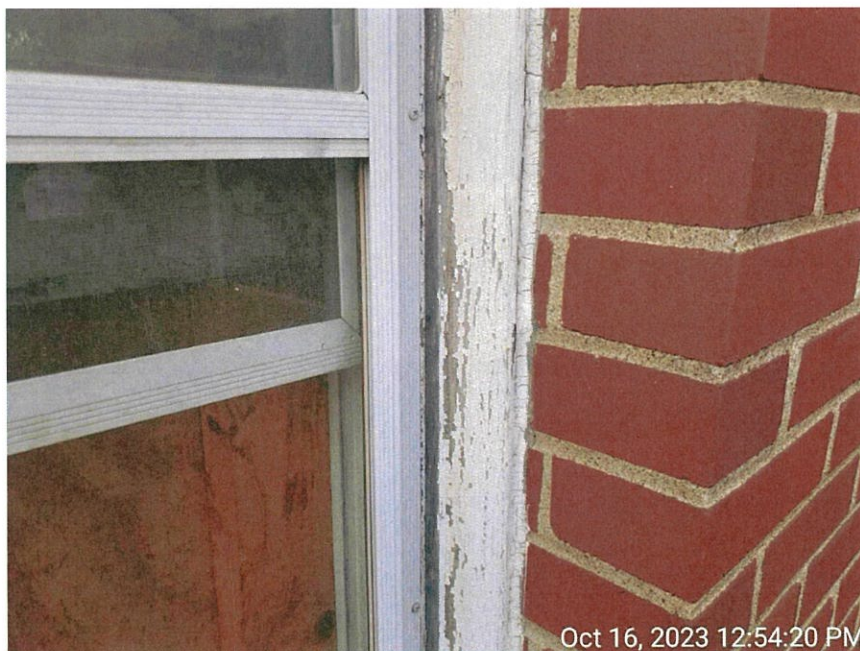
Possible lead-based paint for uncladded window trim.

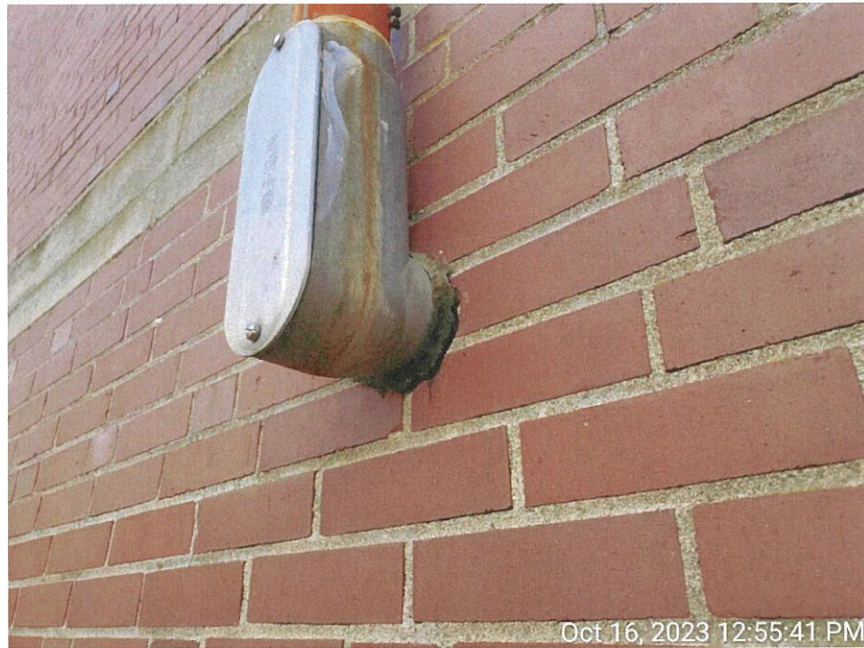
Unsealed perimeter penetrations.
