INDOOR AIR QUALITY/MOLD ASSESSMENT SOUTH BERWICK TOWN HALL 180 MAIN STREET, SOUTH BERWICK, MAINE

October 2023

John M. Boilard, RIHT, CMC Senior Industrial Hygiene & Safety Specialist

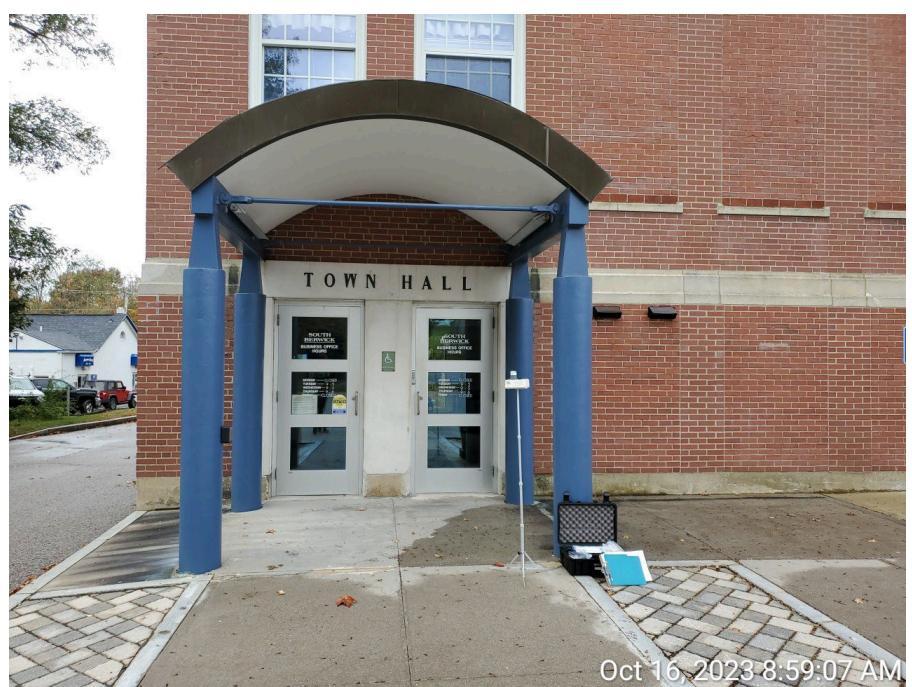
Air sample ST-1, outdoor control.

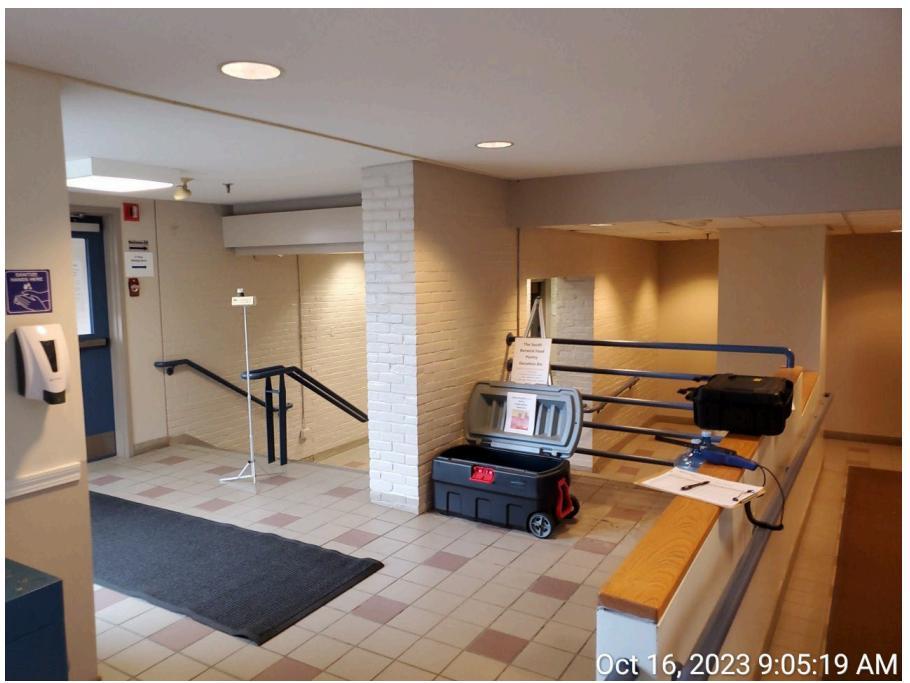
Air sample ST-2 collected in first floor entry/elevator area.

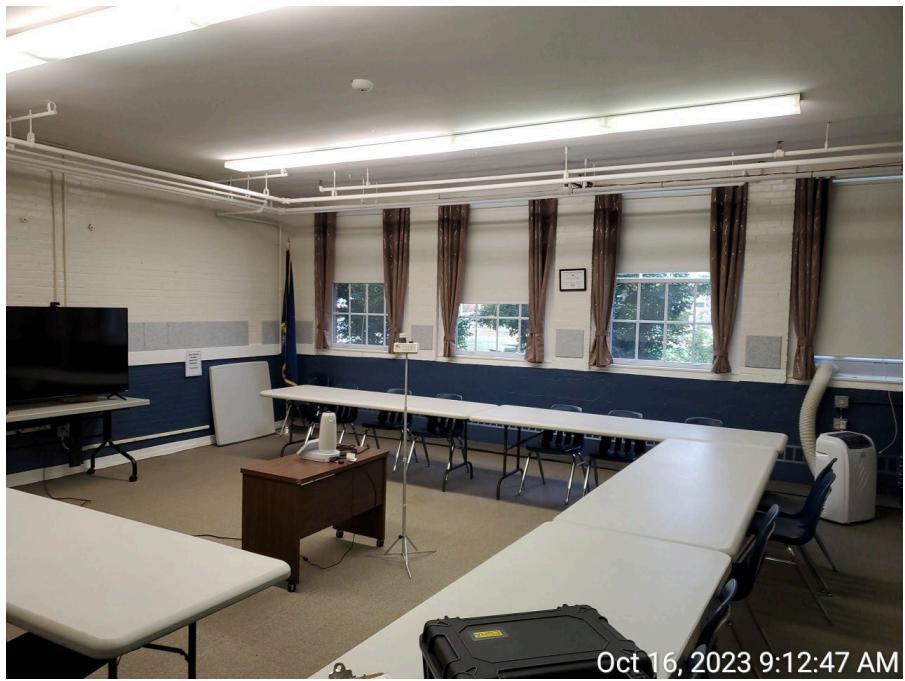
Air sample ST-3 collected in first floor meeting room (former Public Works).

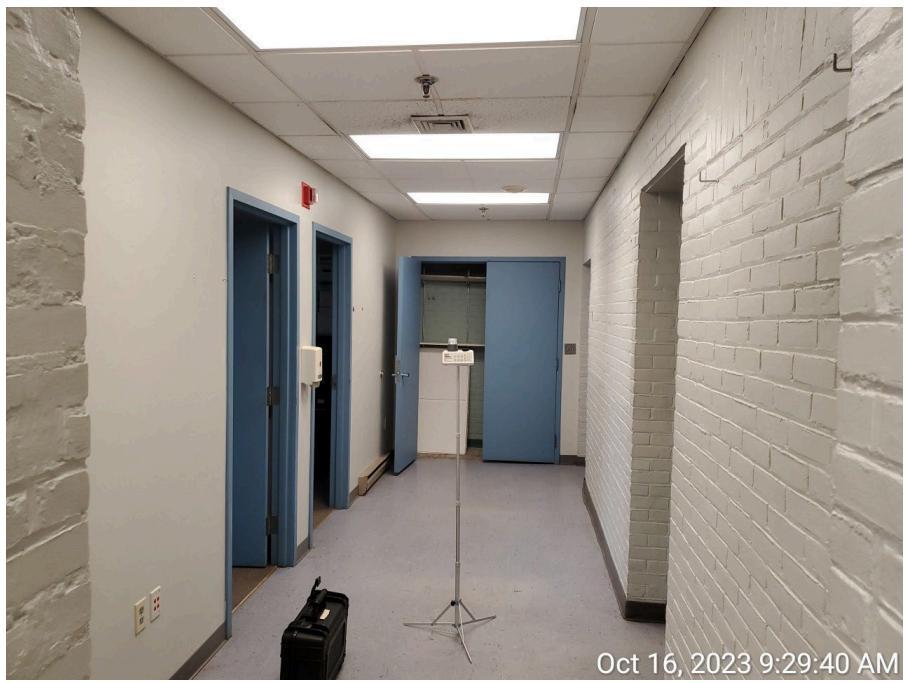
Air sample ST-4 collected in first floor hallway near former Police Dispatch/Locker Room area.

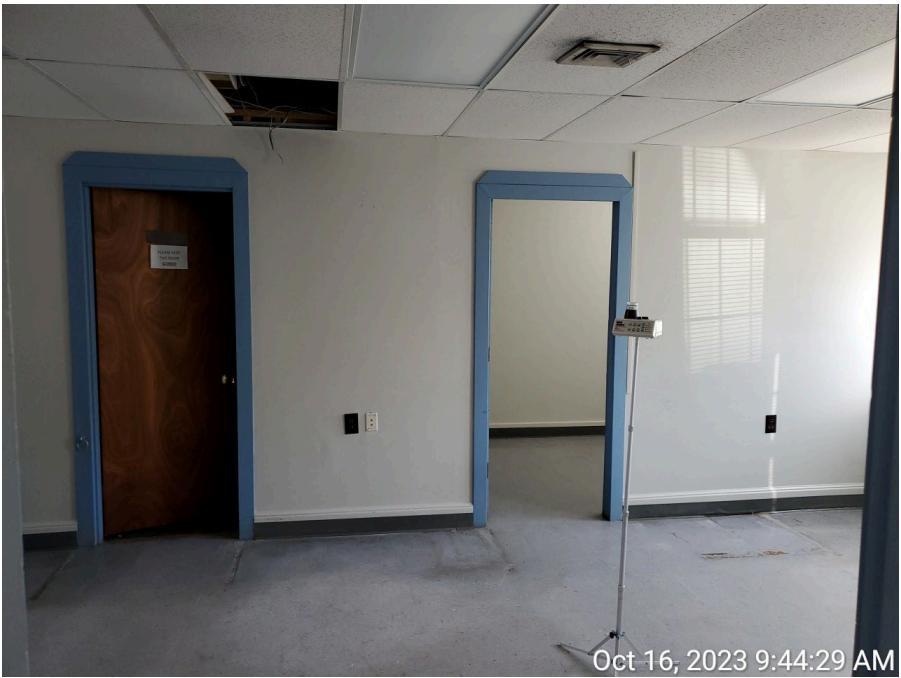
Air sample ST-5 collected on first floor in former Police Patrol Office.

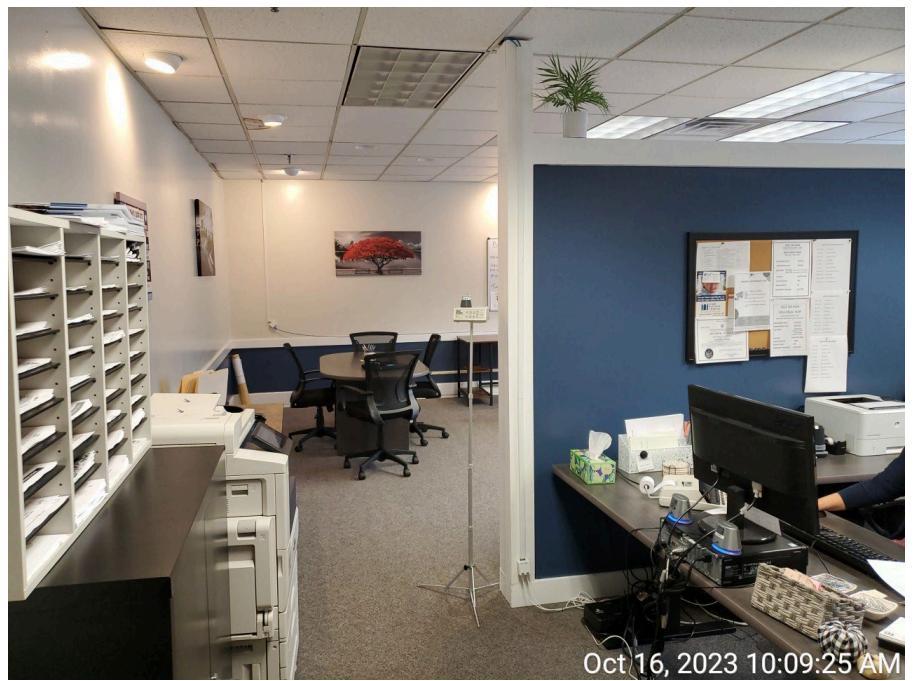
Air sample ST-6 collected on second floor in Asst. Town Mgr./HR/Finance Offices.

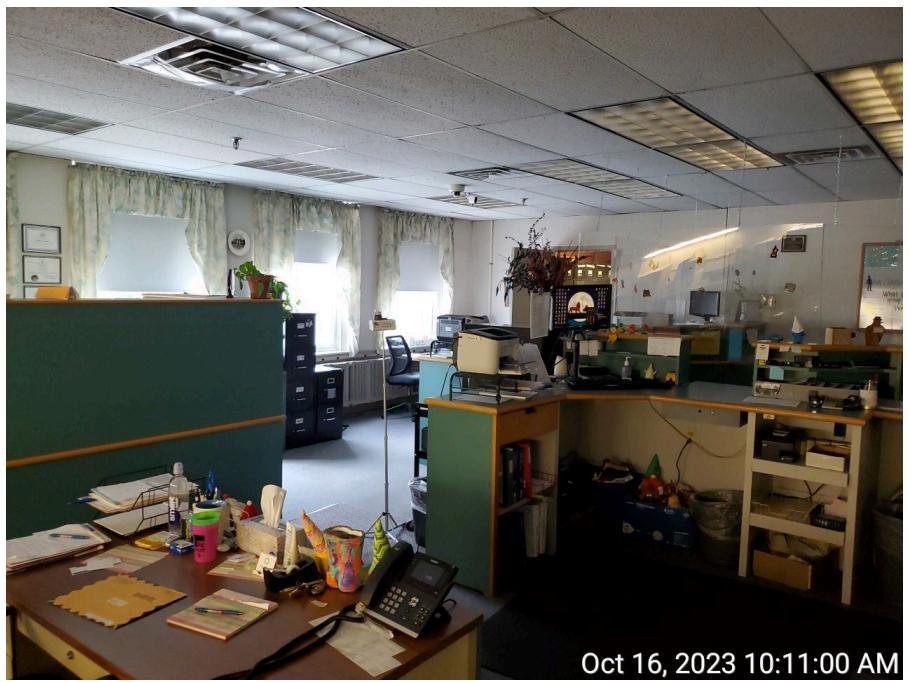
Air sample ST-7 collected on second floor in Assessing Offices.

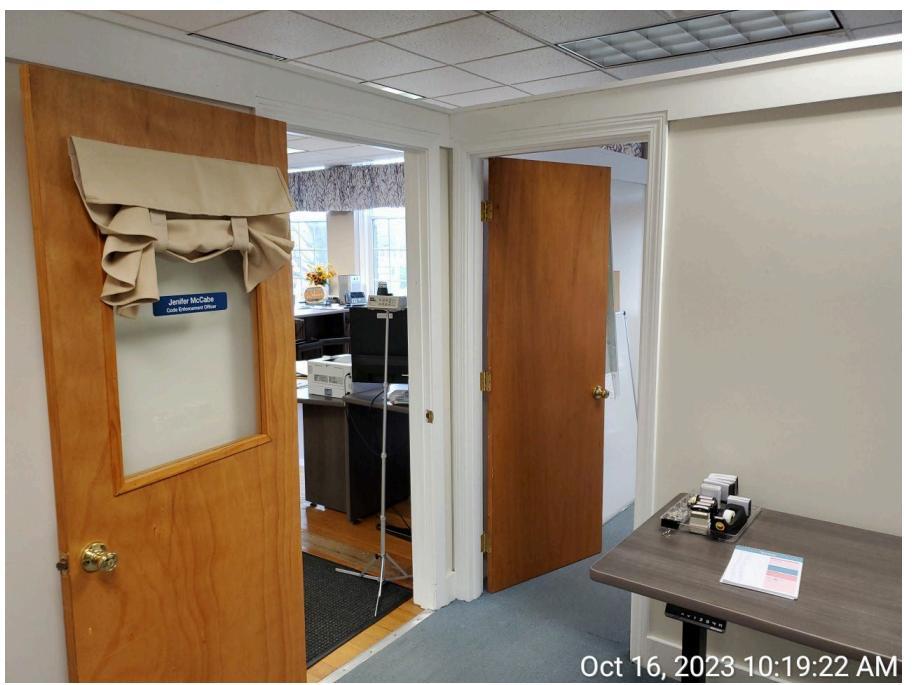
Air sample ST-8 collected on second floor in Code & Assessing Offices.

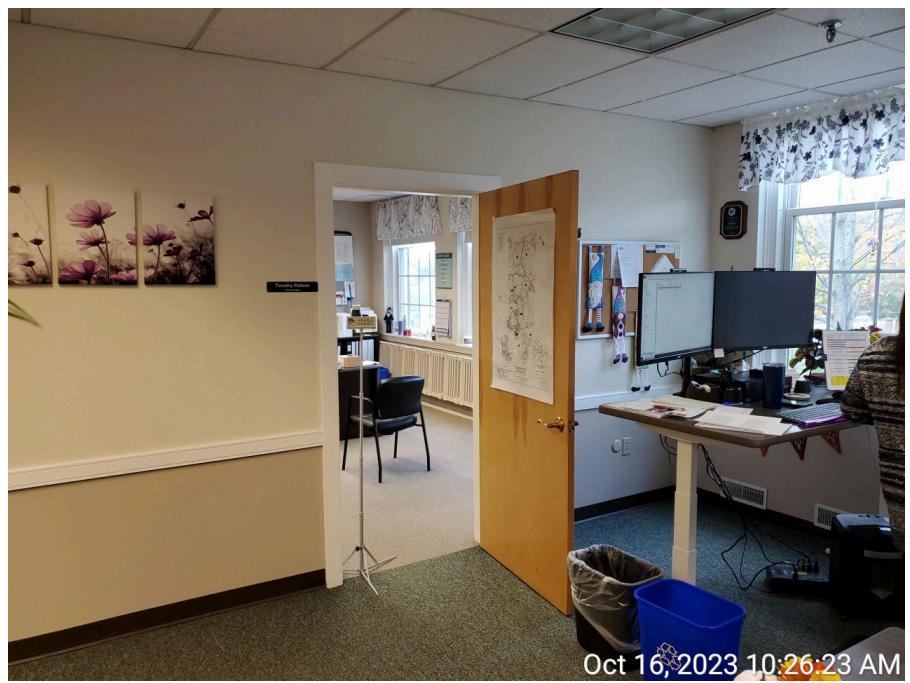
Air sample ST-9 collected on second floor in Town Manager Office area.

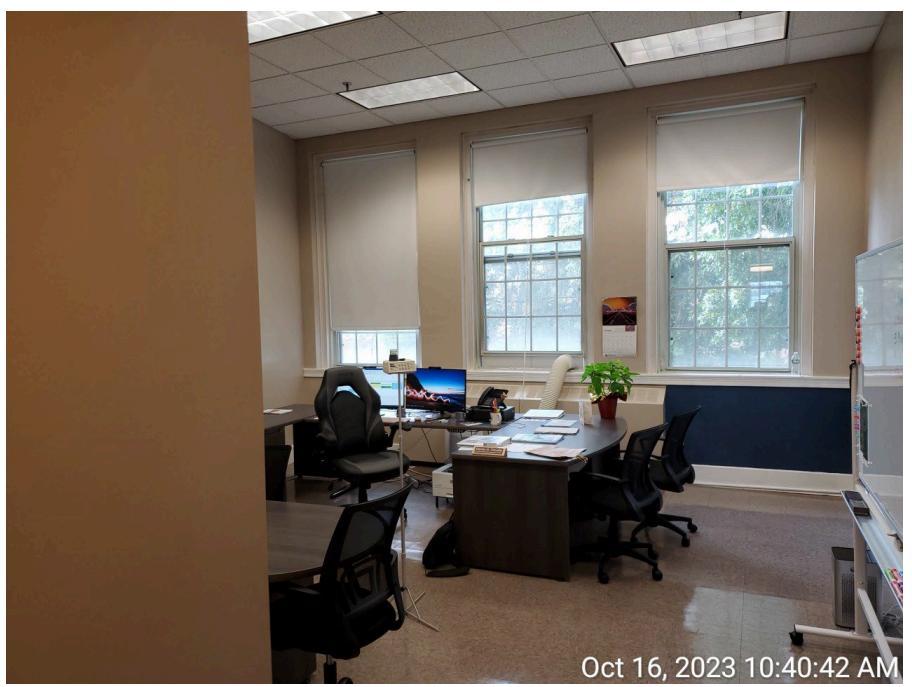
Air sample ST-10 collected on third floor in Economic & Community Development Office.

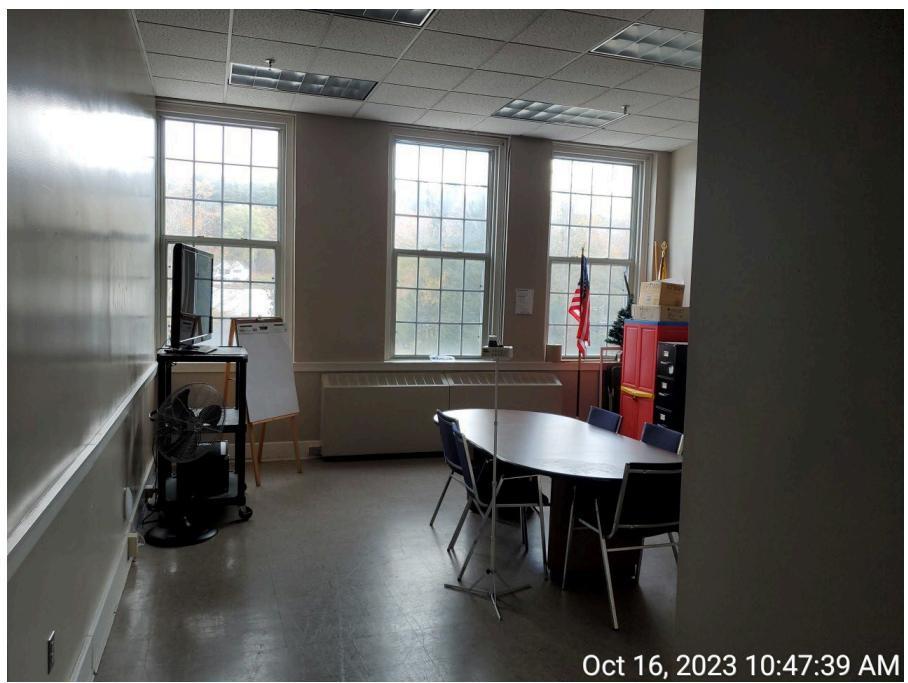
Air sample ST-11 collected on third floor in Meeting Room #2.

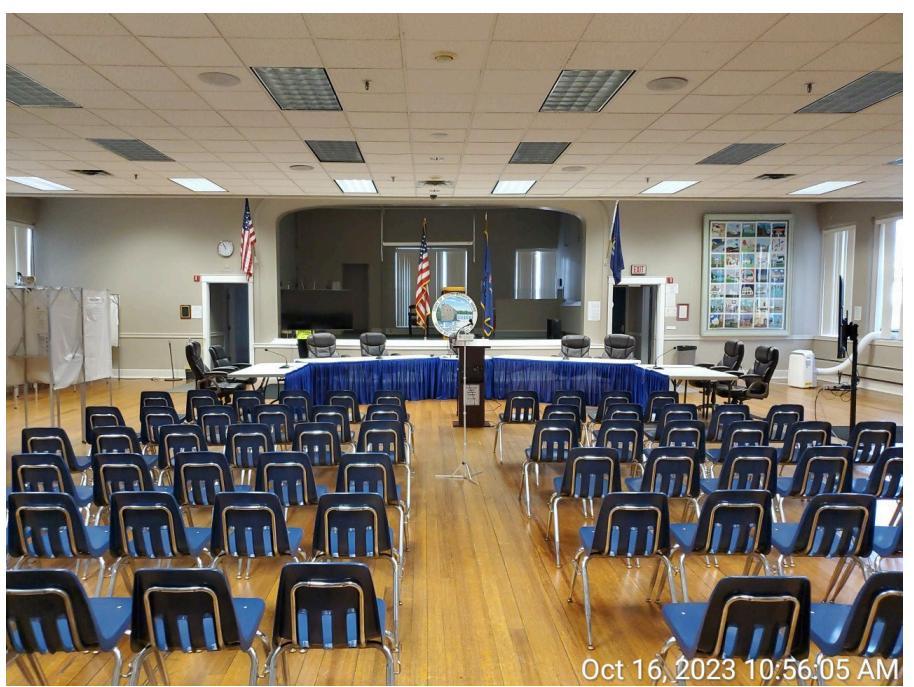
Air sample ST-12 collected on third floor in Auditorium.

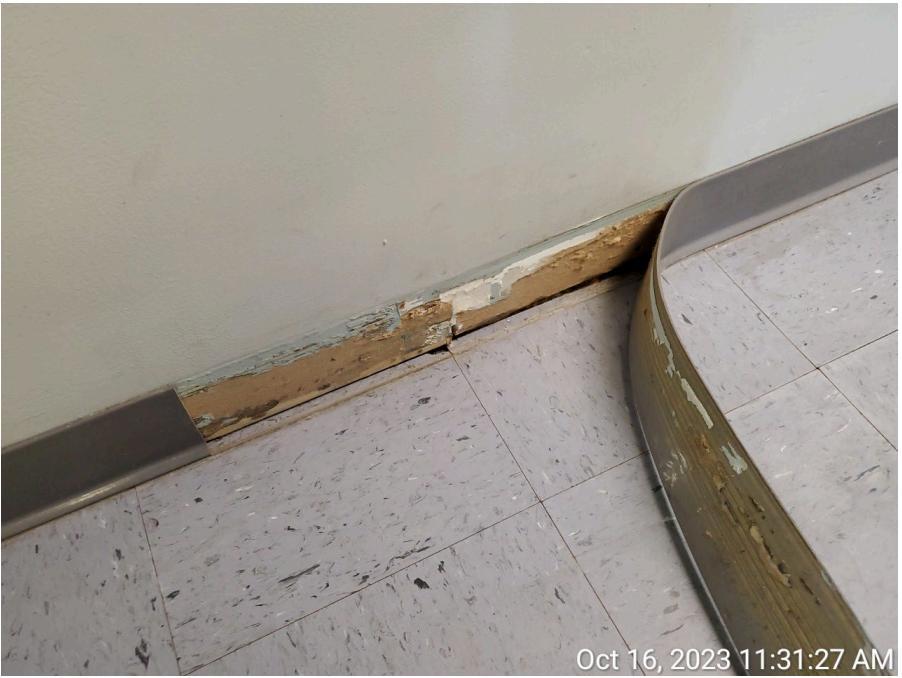
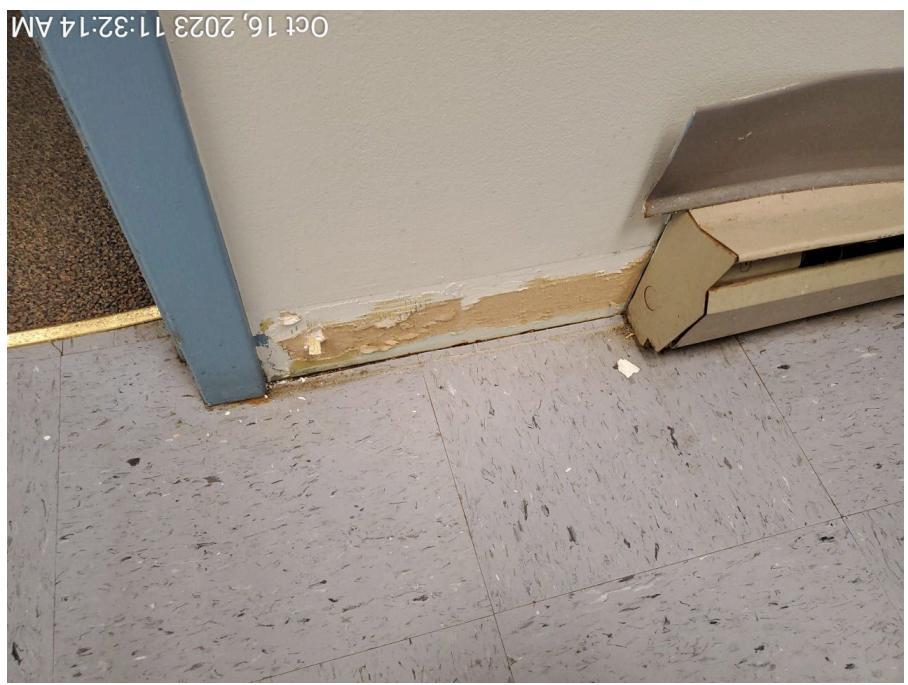
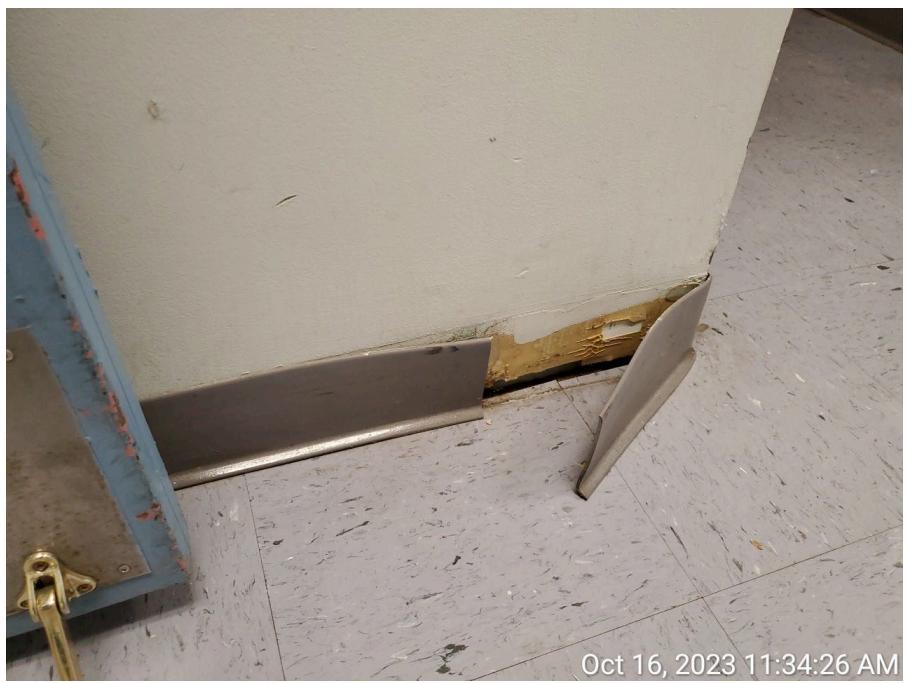
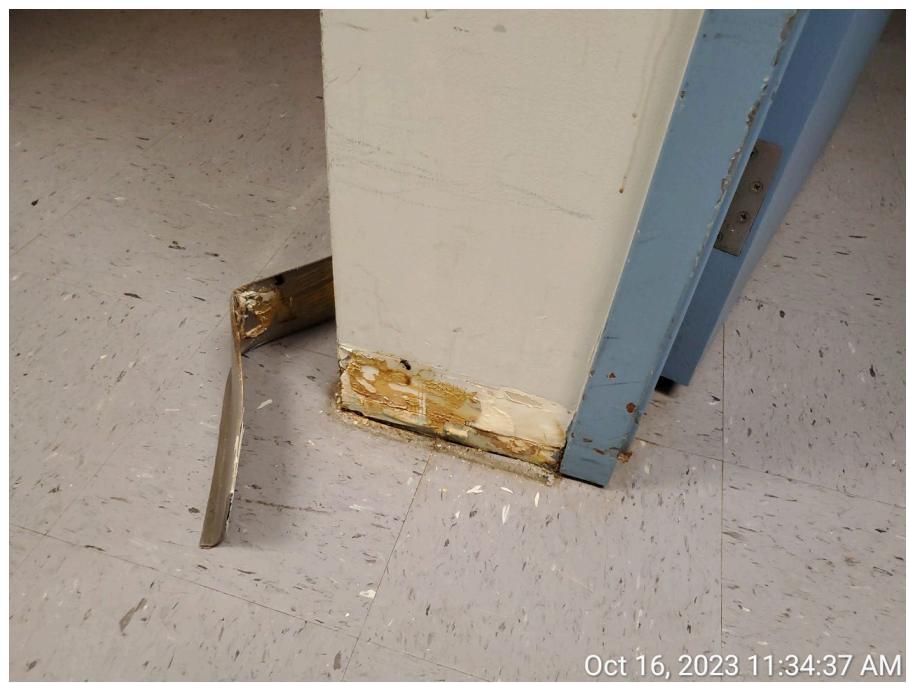
No mold growth issues observed for lower drywall on first floor.

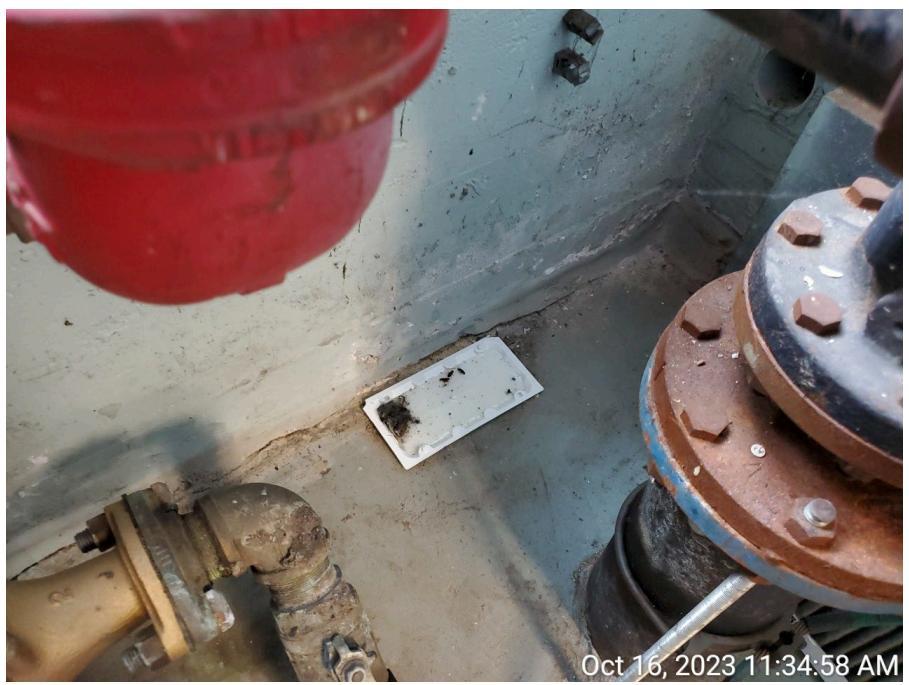
Several dead rodents were present in the first-floor sprinkler utility room.

Rodent carcass in first floor sprinkler room.

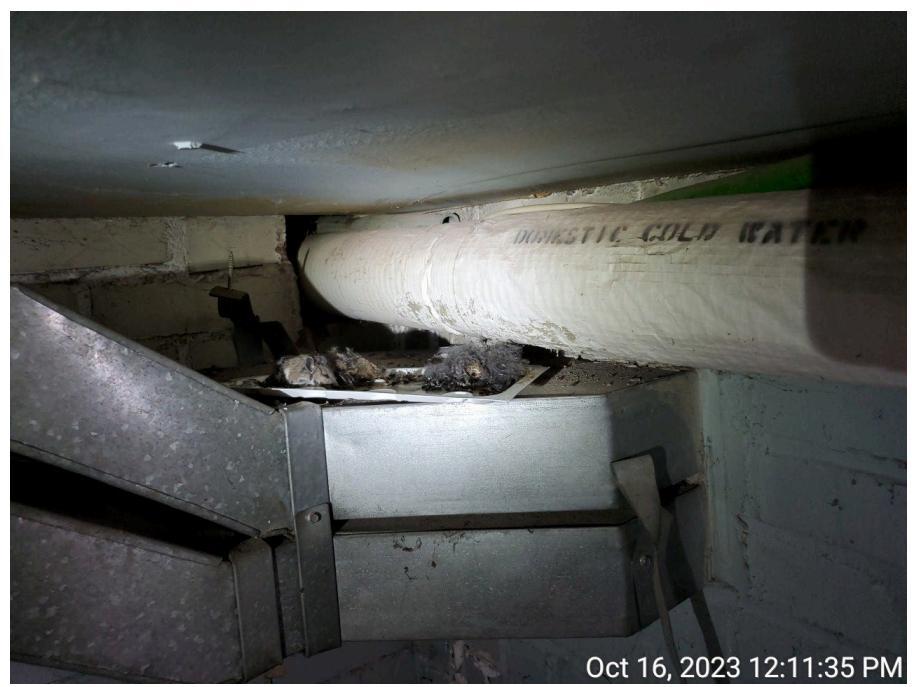
Rodent carcasses in first floor sprinkler room.

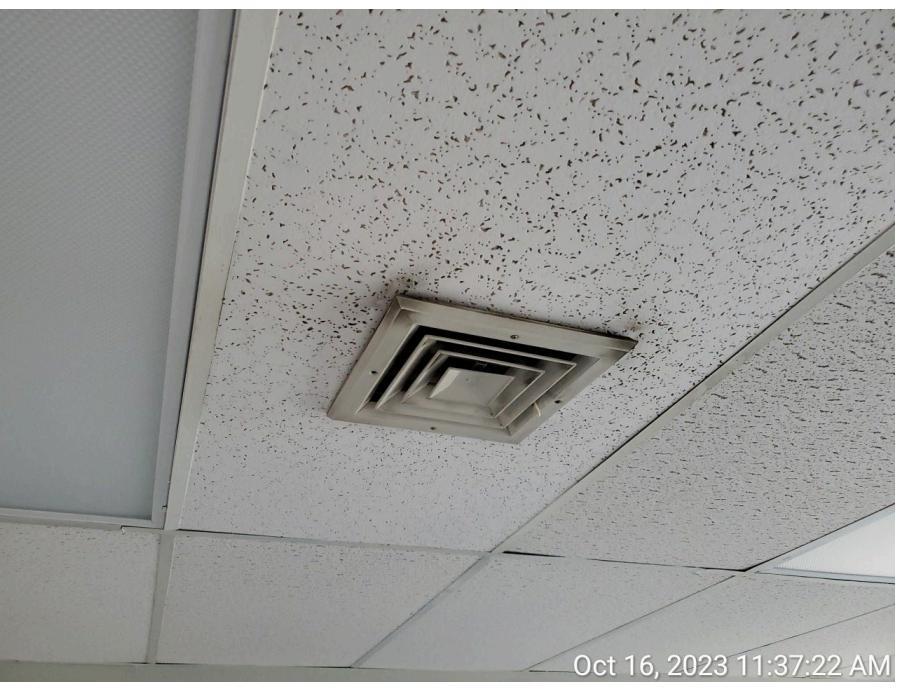
Dirty supply diffuser and ductwork on first floor in former Police Patrol Office.

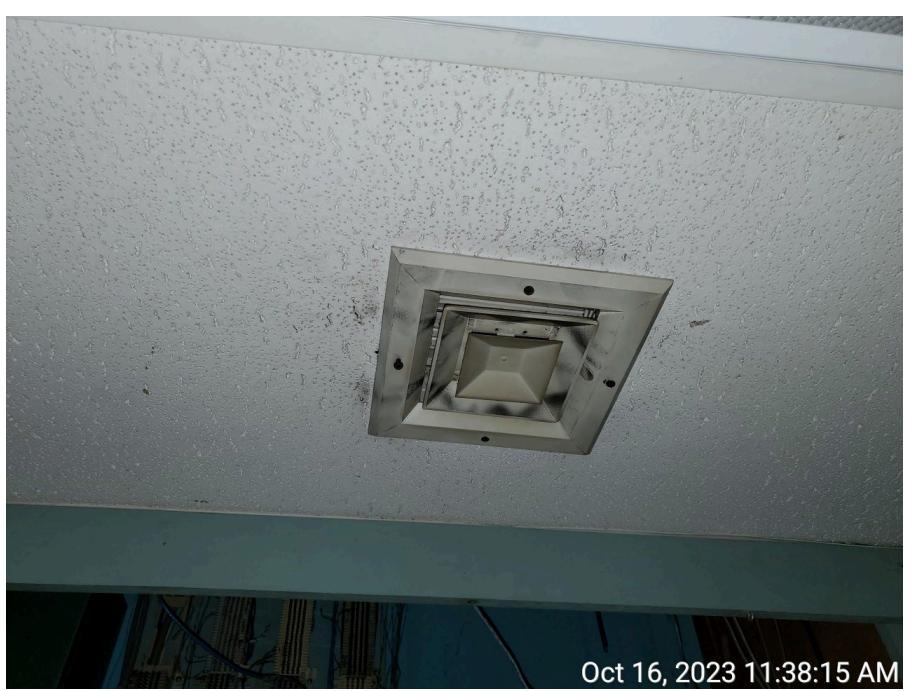
Dirty supply diffuser and ductwork on first floor in Utility Room near former Police Patrol Office.

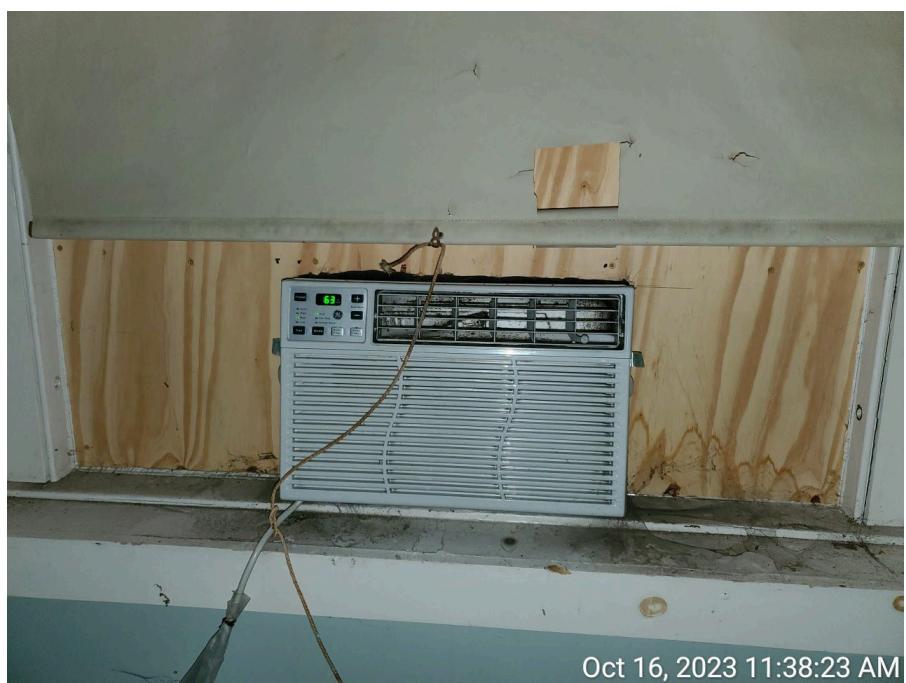
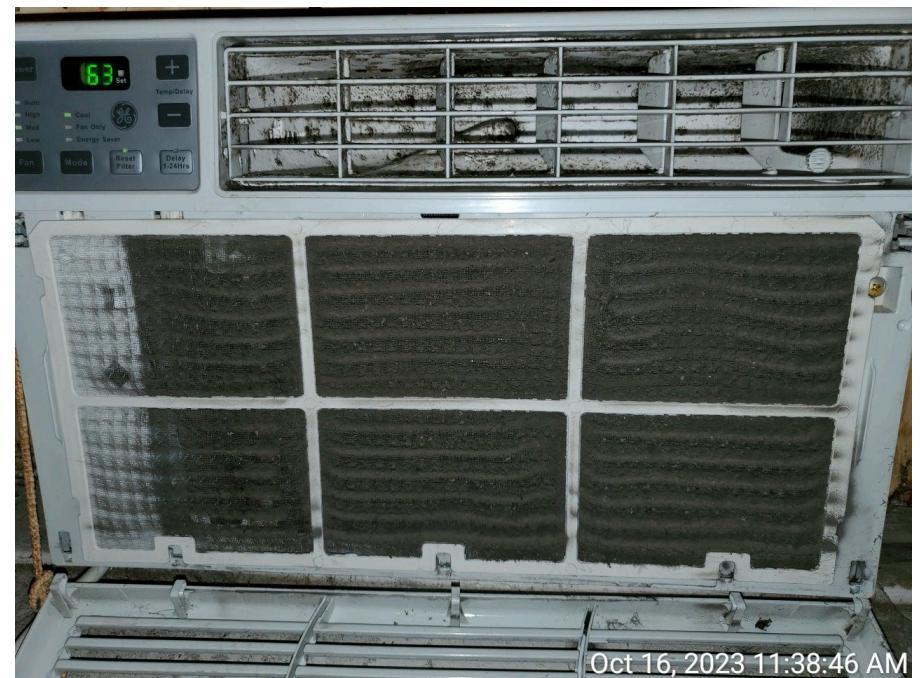
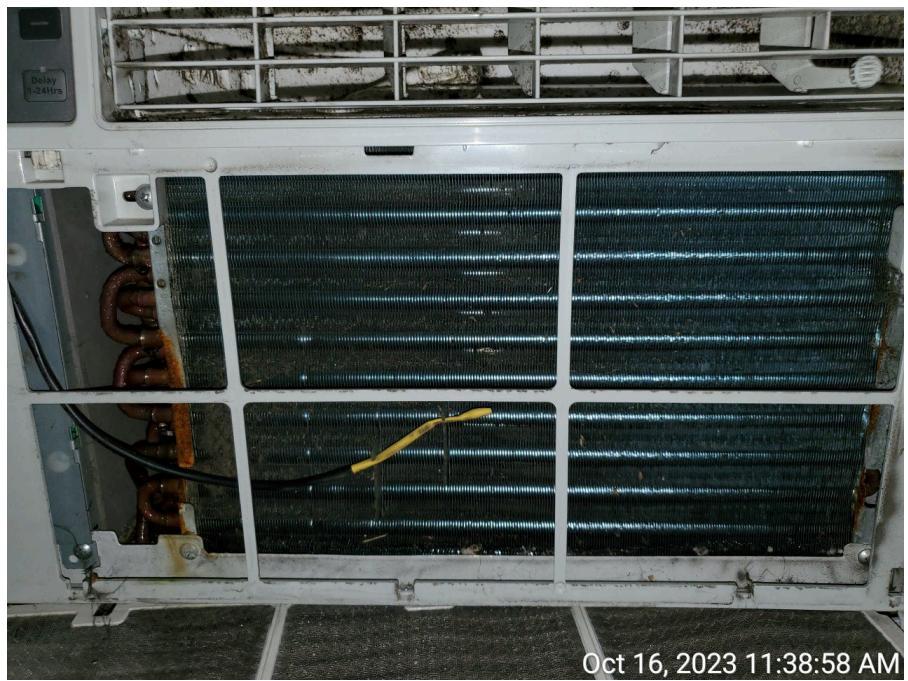
Dirty/mold compromised portable window A/C unit on first floor in Utility Room near former Police Patrol Office.

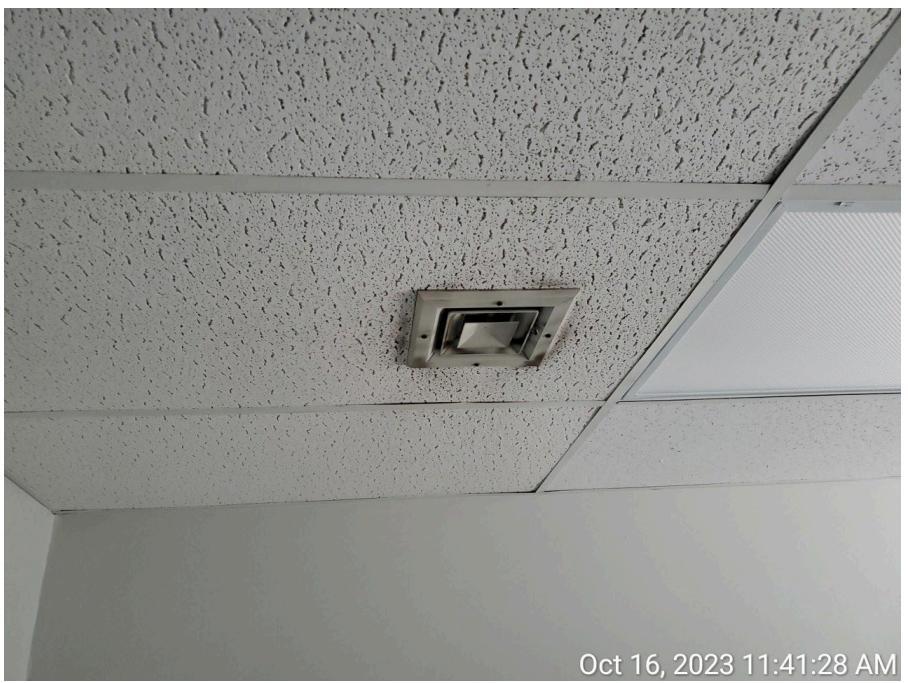
Dirty supply diffuser and ductwork on first floor in former Police Interview Room.

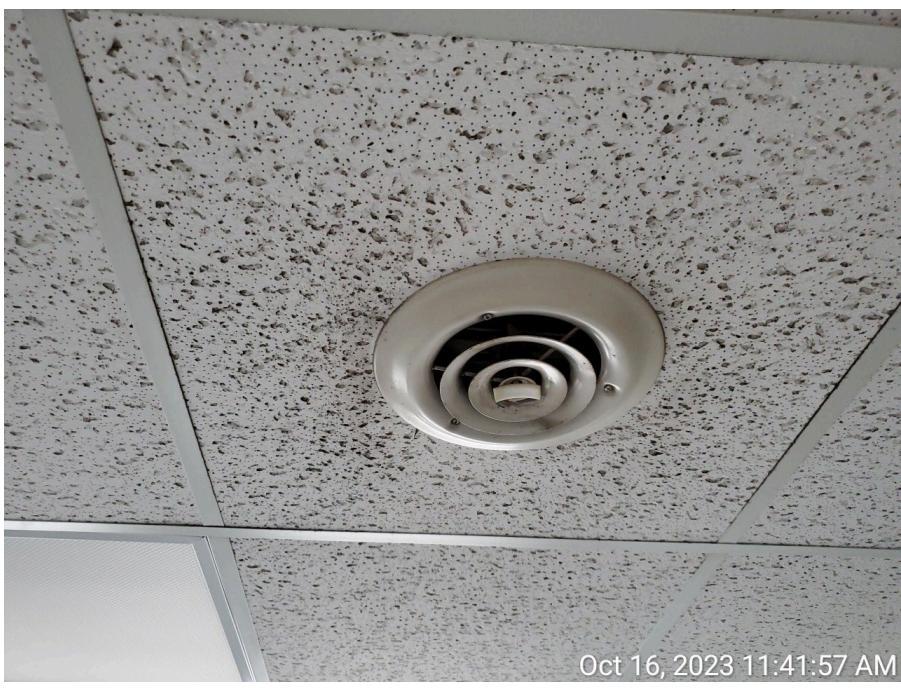
Dirty supply diffuser and ductwork on first floor in former Police Lieutenant & Sergeant Office.

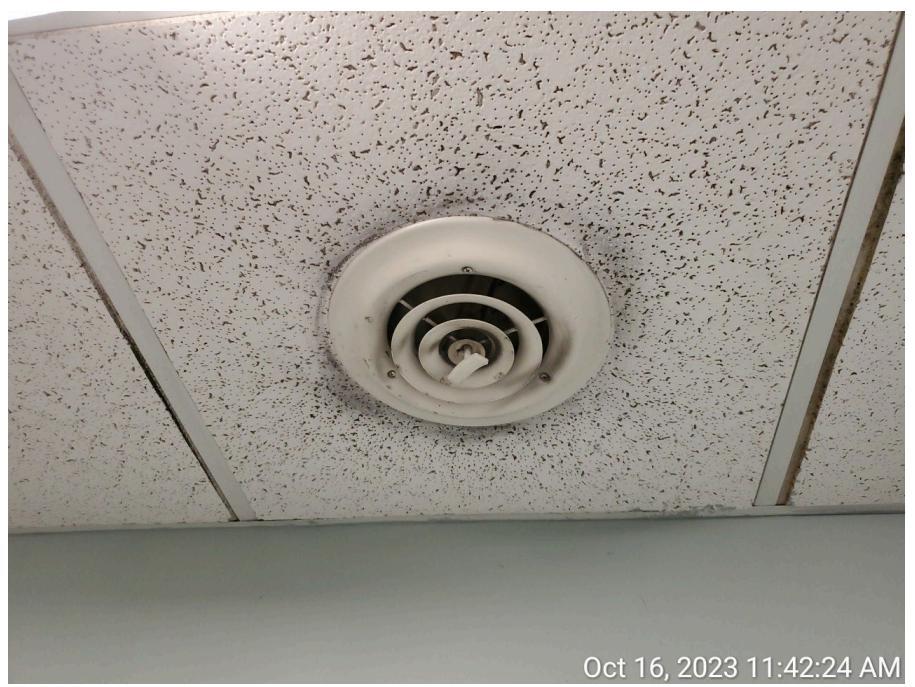
Dirty supply diffuser and ductwork on first floor in former Police Storage Room.

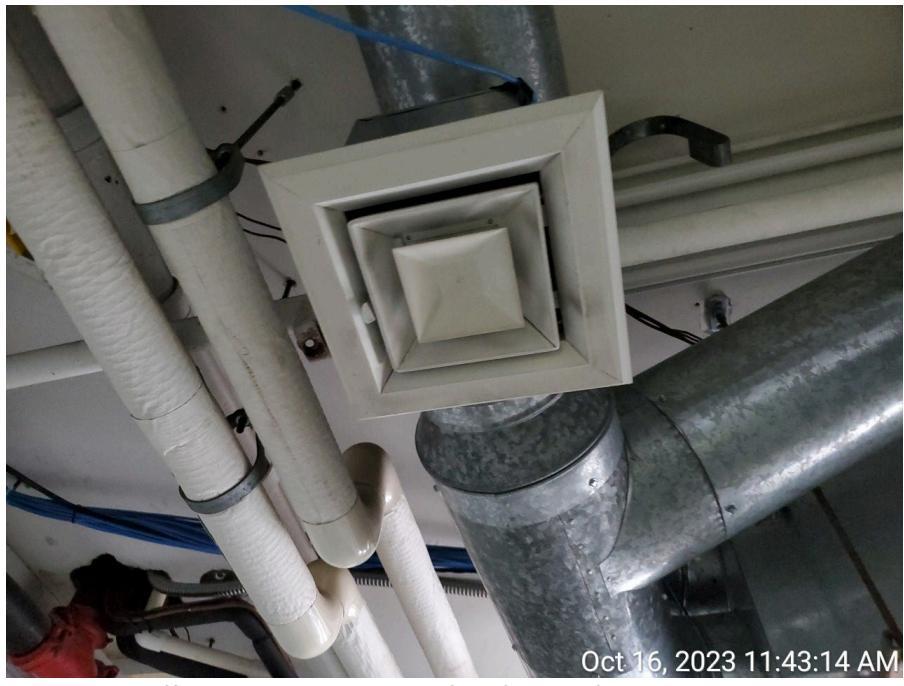
Dirty supply diffuser and ductwork on first floor in former Police Locker Room.

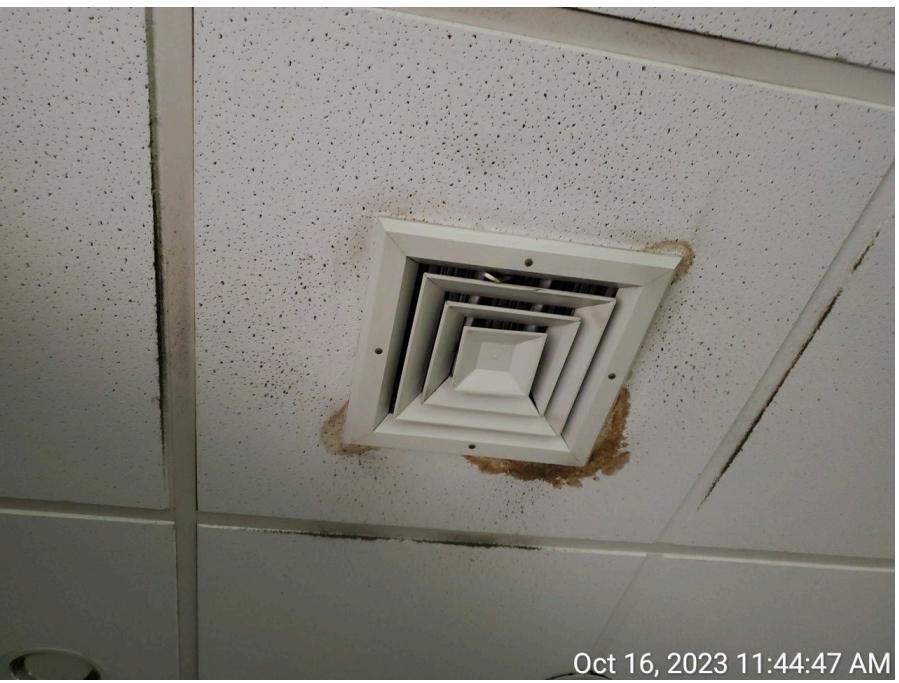
Dirty supply diffuser and ductwork on first floor in former Police Dispatch Office.

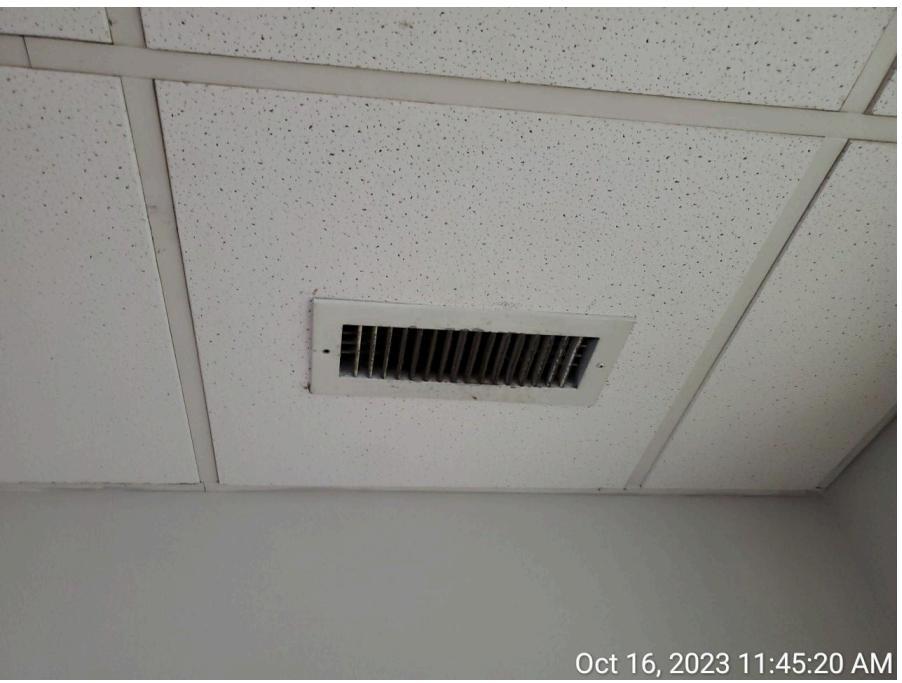
Dirty return diffuser and ductwork on first floor in former Police Dispatch Office.

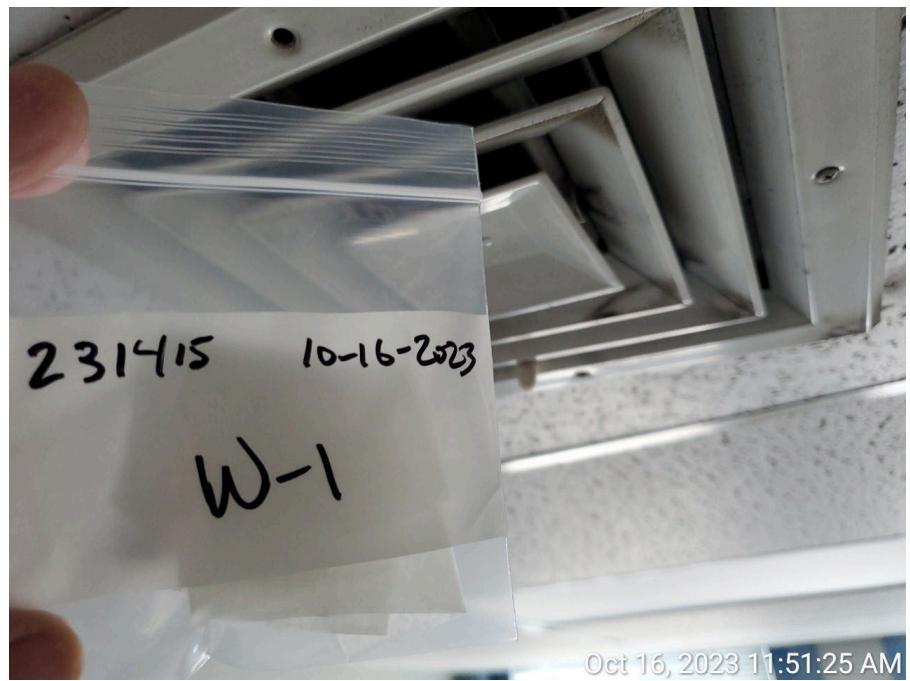
Wipe sample W-1 collected from supply diffuser on first floor in former Police Patrol Office.

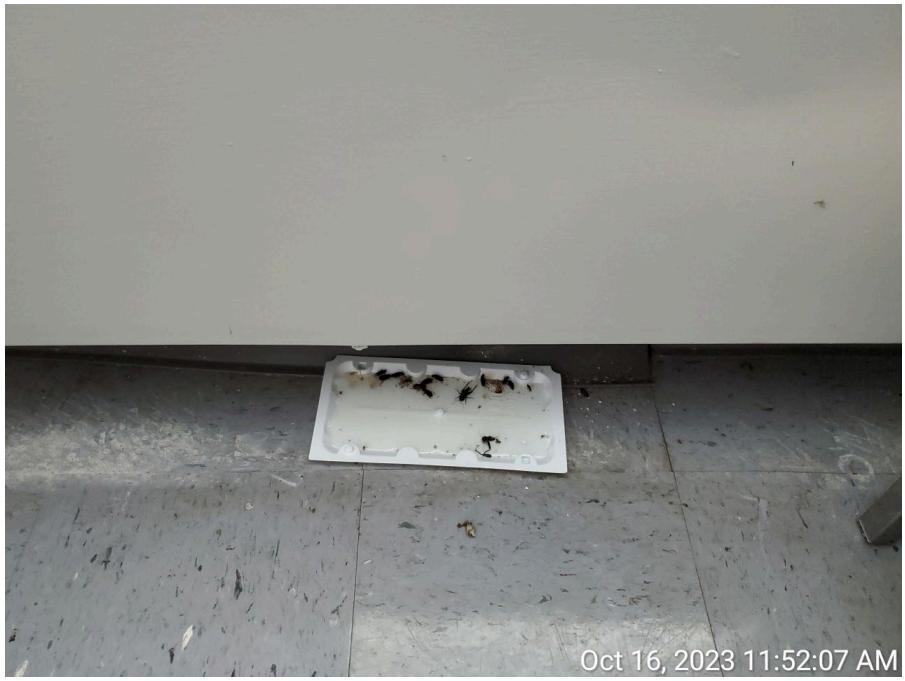
Insect activity on first floor.

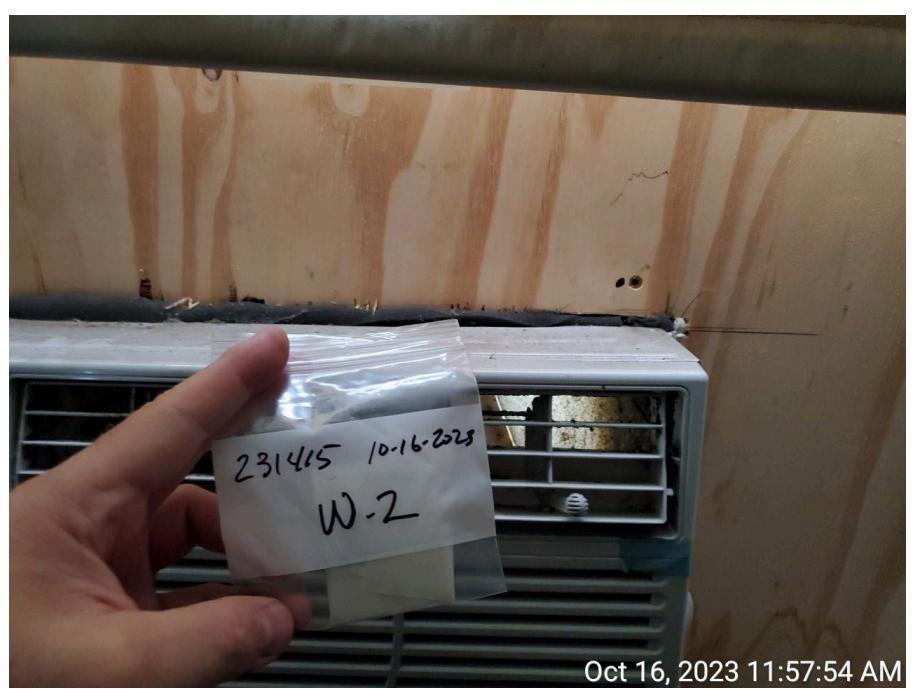
Wipe sample W-2 collected from air discharge plenum for portable window A/C unit on first floor in Utility Room near former Police Patrol Office.

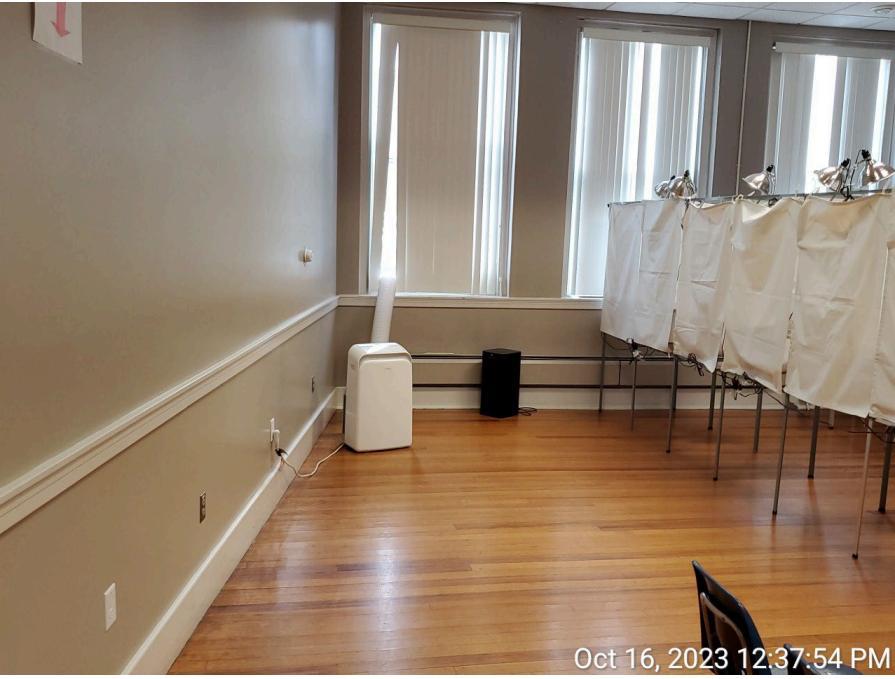
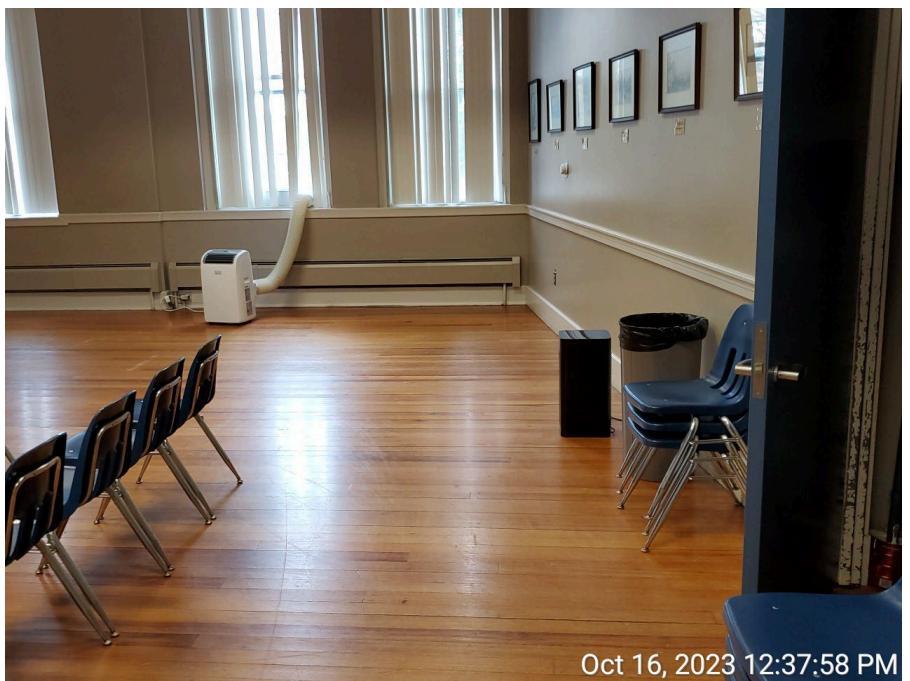
Air purifier (black) on third floor with ionizing setting - Ozone producing.

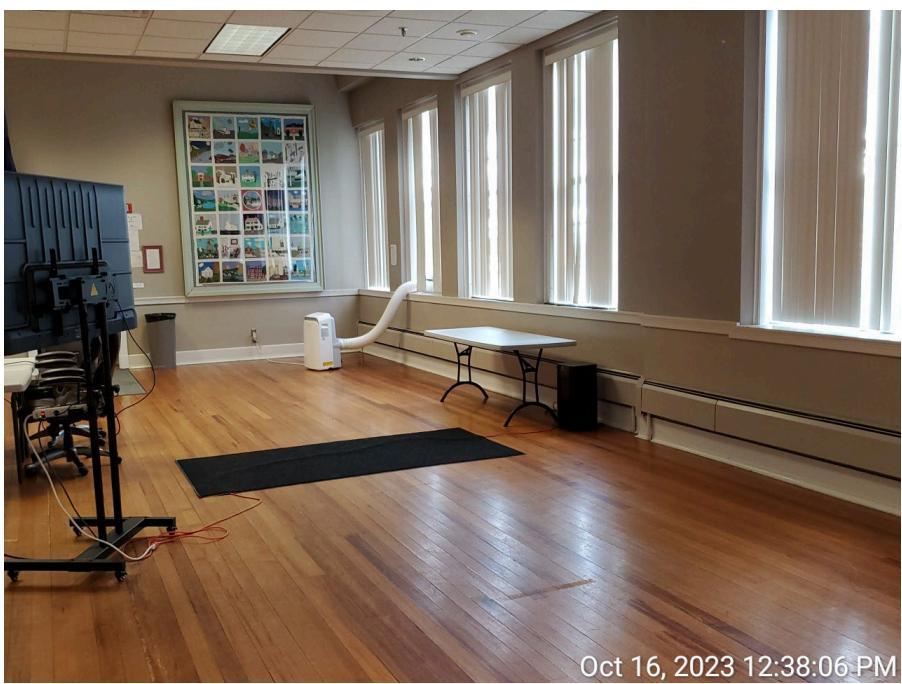
Air purifier (black) on third floor with ionizing setting - Ozone producing.

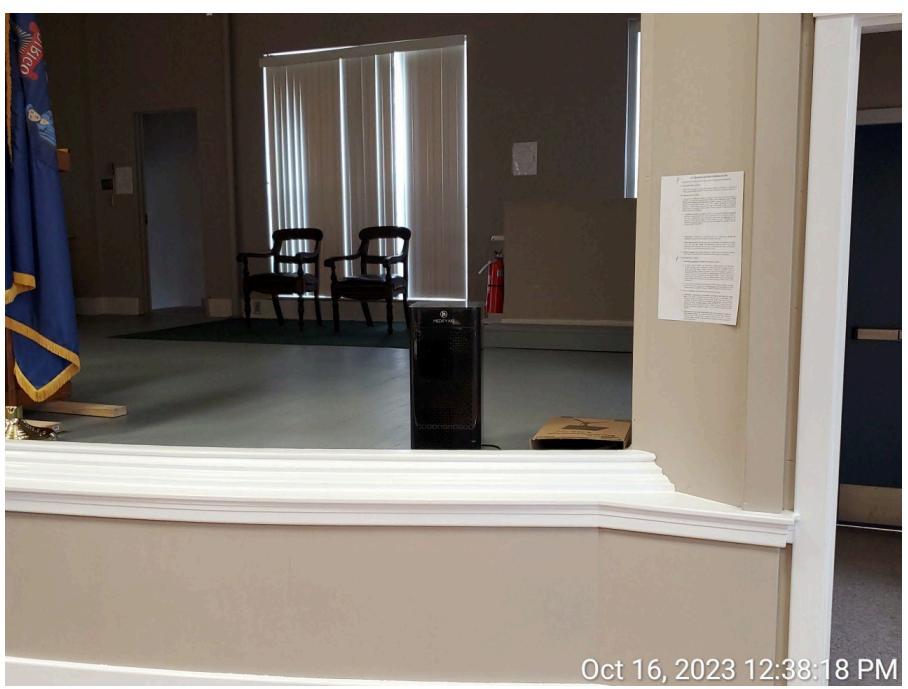
Air purifier (black) on third floor with ionizing setting - Ozone producing.
