INDOOR AIR QUALITY/MOLD ASSESSMENT SOUTH BERWICK TOWN HALL 180 MAIN STREET, SOUTH BERWICK, MAINE

October 2023

John M. Boilard, RIHT, CMC Senior Industrial Hygiene & Safety Specialist

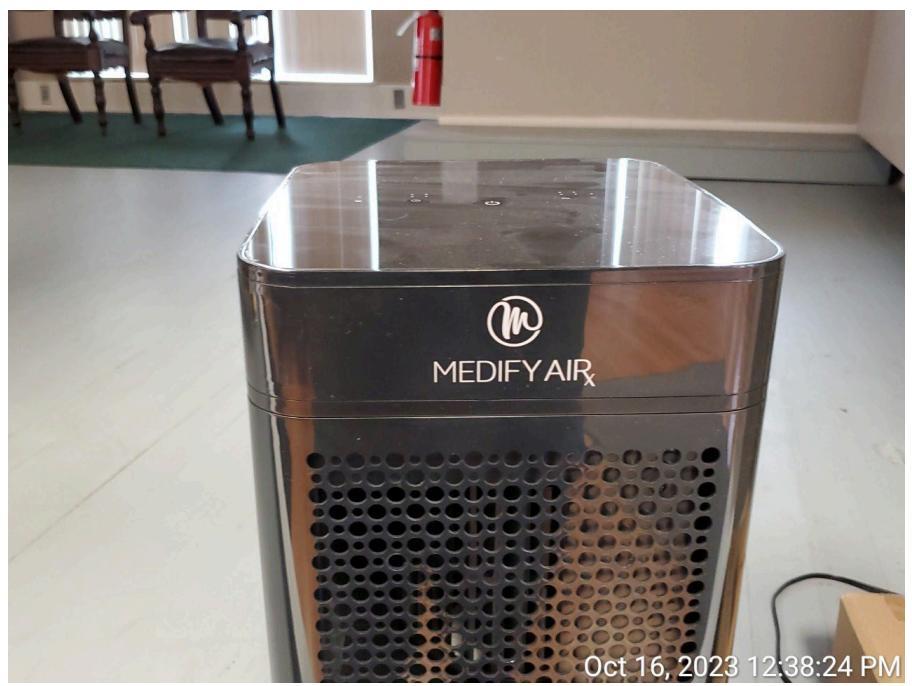
Air purifier on third floor with ionizing setting - Ozone producing.

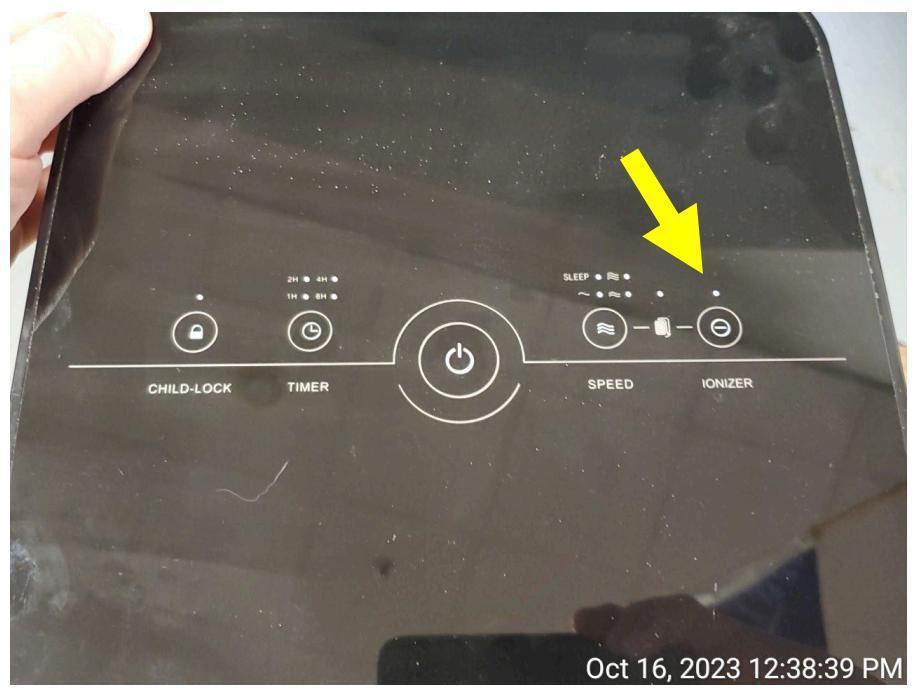
Air purifier on third floor with ionizing setting - Ozone producing.

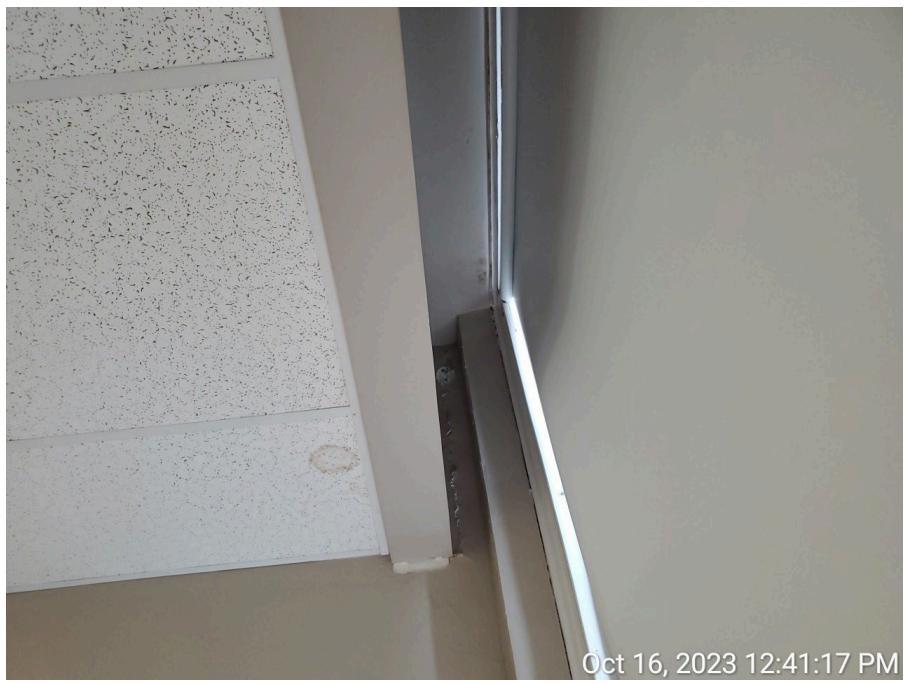
Water intrusion impact for window header on third floor in election storage room.

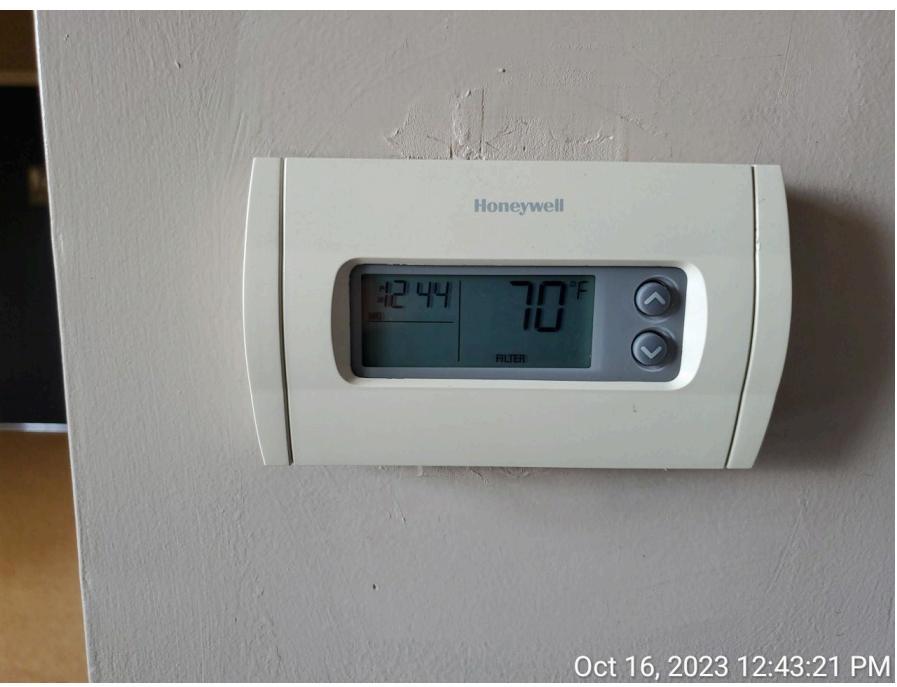
Thermostat on third floor with filter issue message.

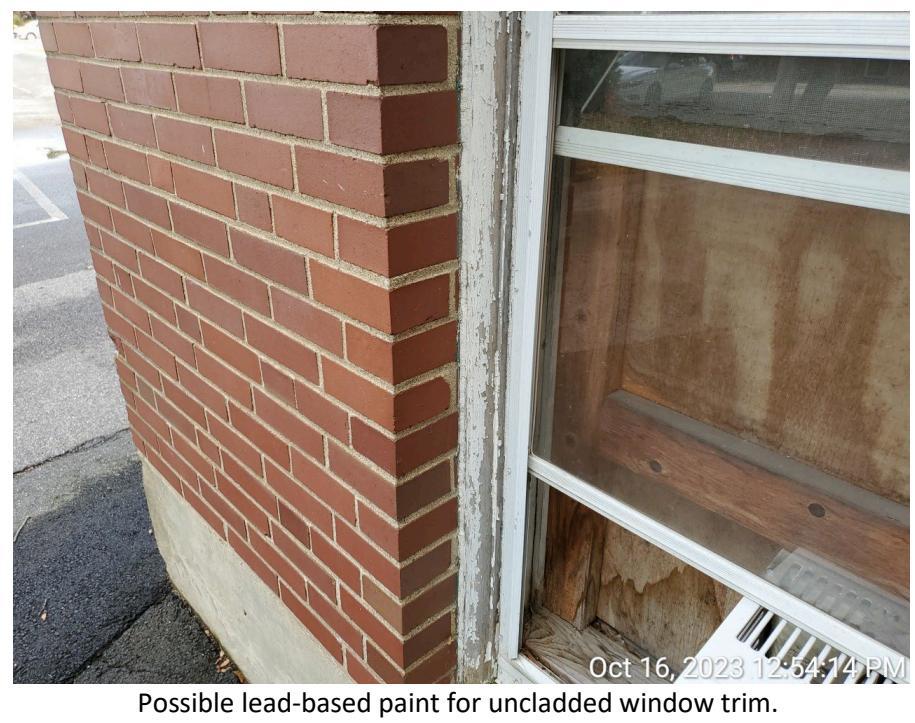
Possible lead-based paint for uncladded window trim.

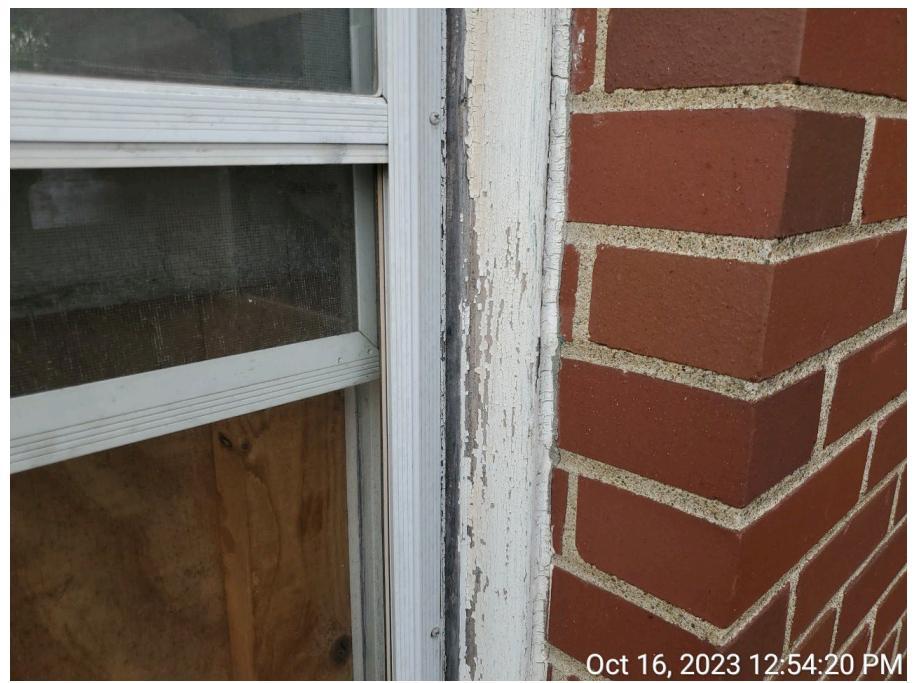
Possible lead-based paint for uncladded window trim.

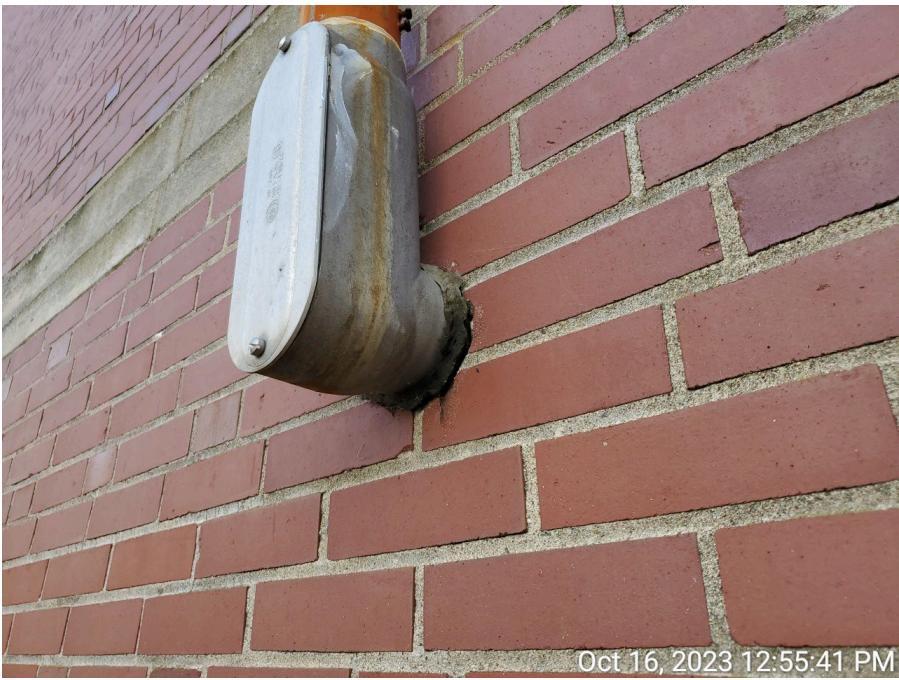
Unsealed perimeter penetrations.
