Alpha Home & Commercial Building Inspections

Property Inspection Report

180 Main St, South Berwick, ME 03908
Inspection prepared for: Perry Ellsworth
Real Estate Agent: -

Date of Inspection: 2/23/2021 Time: 10:00 AM
Order ID: 12304

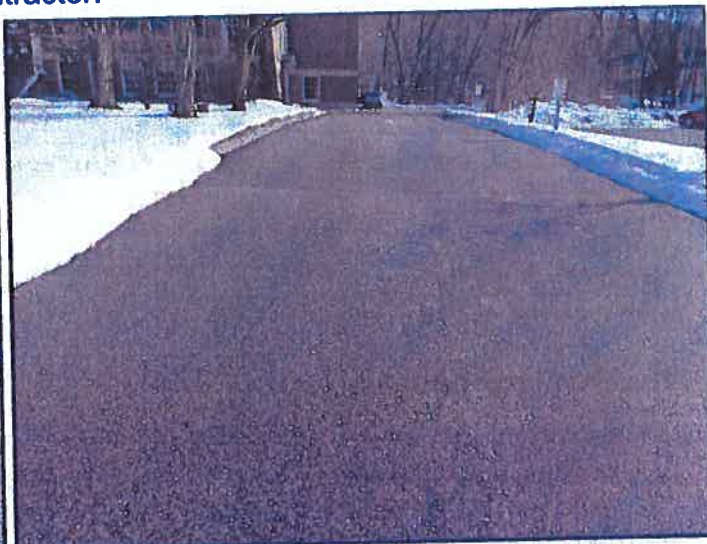
1.3. Excessive deterioration and cracking was observed at the asphalt surfaces. Recommend assessment and repairs by a qualified asphalt contractor.

Cracks in asphalt at right side driveway.

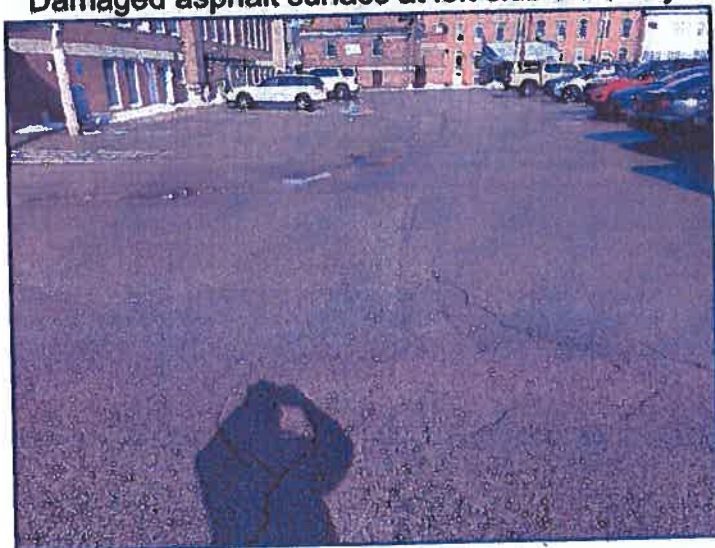
Damaged asphalt surfaces at rear parking

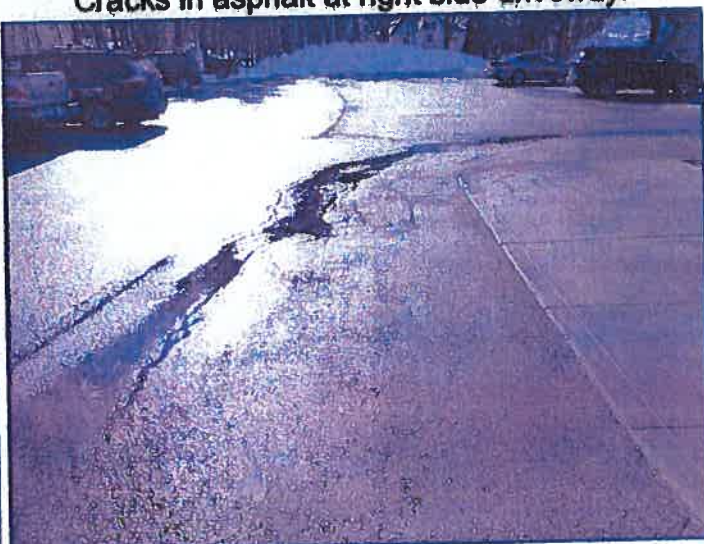
Damaged asphalt surfaces at rear building.

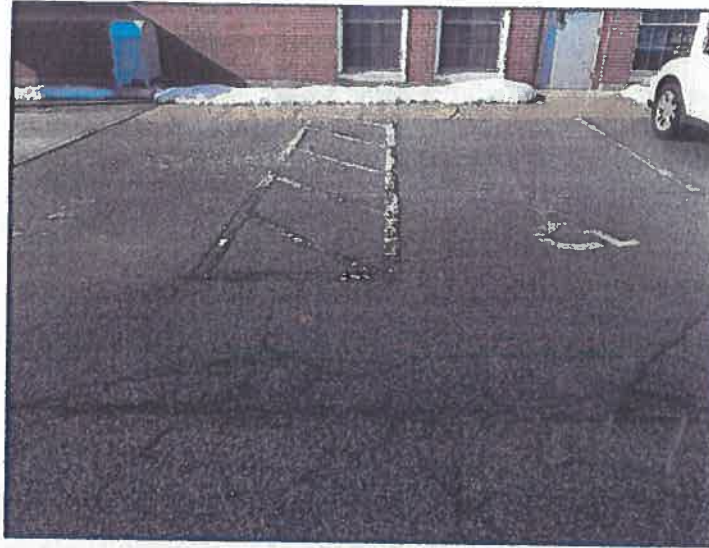
1.2. Striping is faded, recommend re painting parking lot markings by a qualified contractor.

Faded paint at parking lot markings.

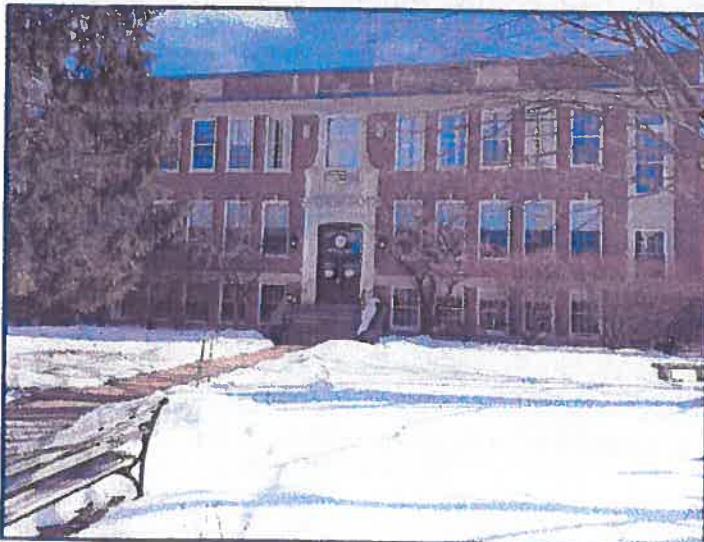
2.3. Grading at one or more area of property has neutral slope, this may be conducive to ponding of water against foundation, recommend monitoring condition and take measures to divert water away from this area as needed.

Neutral grading

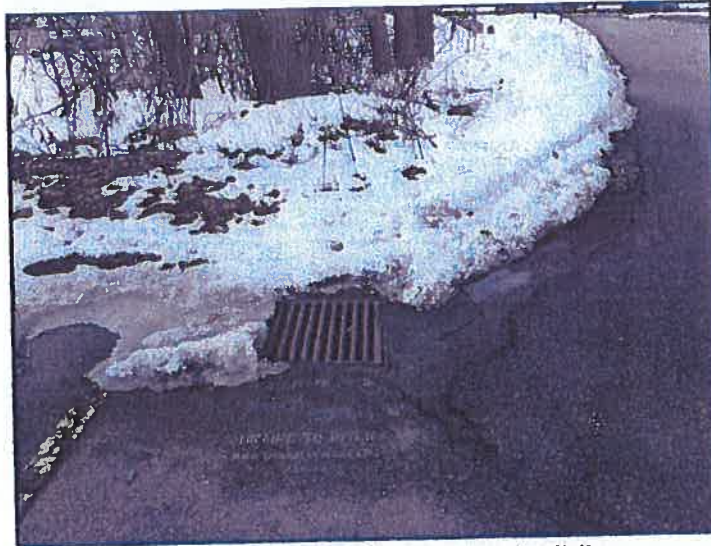
2.4. There is one or more surface drain at exterior of building, recommend monitor for proper drainage, keep clear of snow / ice / debris and have cleaned and serviced as needed.

Surface drain at right side of building

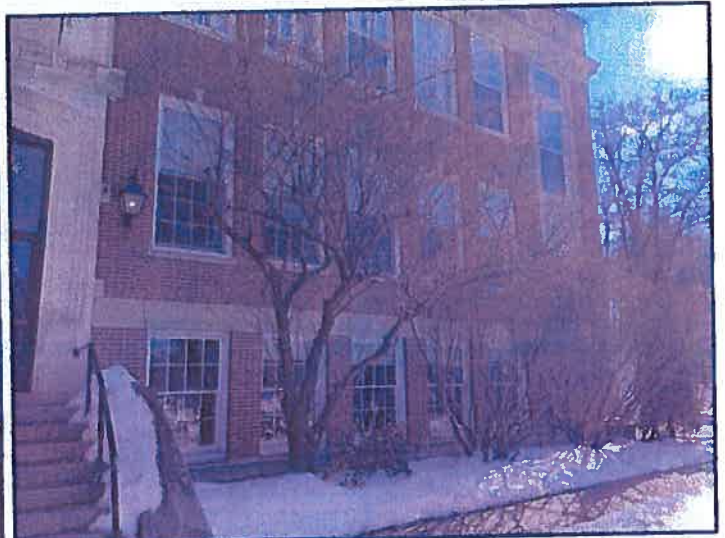
3.1. Vegetation such as trees, shrubs and/or vines are in contact with or less than one foot from the structures exterior. Vegetation can serve as a conduit for wood destroying insects and fungal growth and may retain moisture against the exterior after it rains. Vegetation should be pruned and/or removed as necessary to maintain a one foot clearance between it and the structures exterior.

Vegetation in contact with building should be cut back or removed.

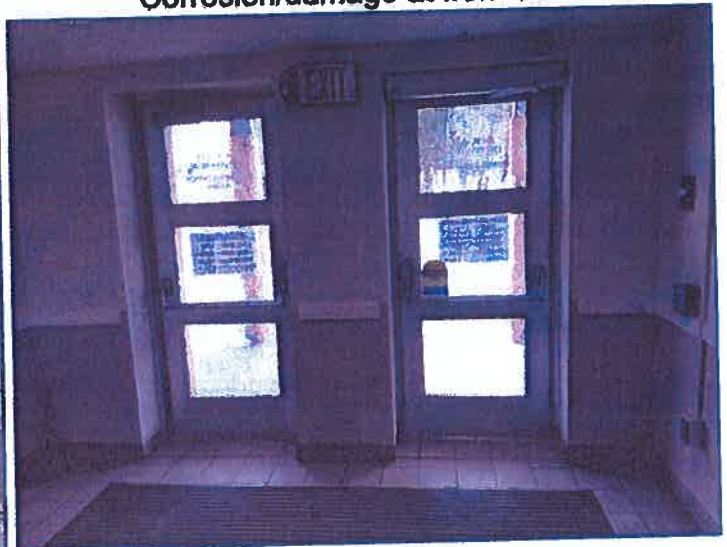
1.3. One or more exterior door does not seal well. This can be an energy drain and allow vermin into building. Recommend repair / adjustment by a qualified contractor.

Rear doors do not seal well

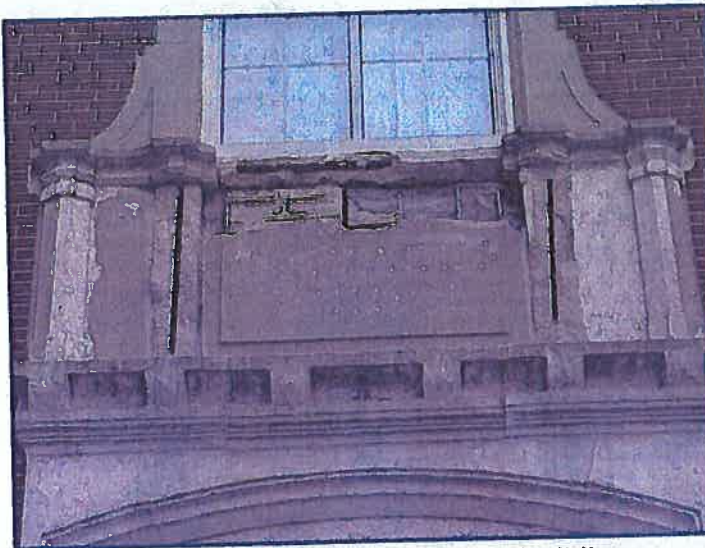
2.2. One or more areas of damage to exterior wall surfaces, recommend full assessment and repairs by a qualified contractor.

Damaged surfaces at front of building

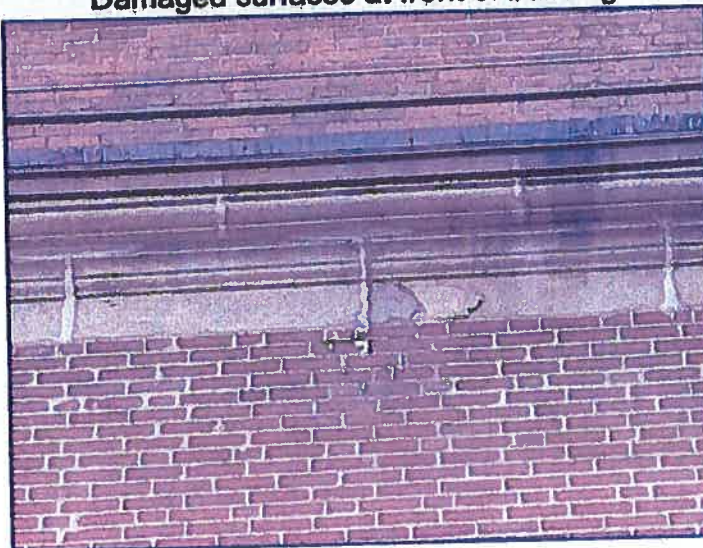
Damage at left side

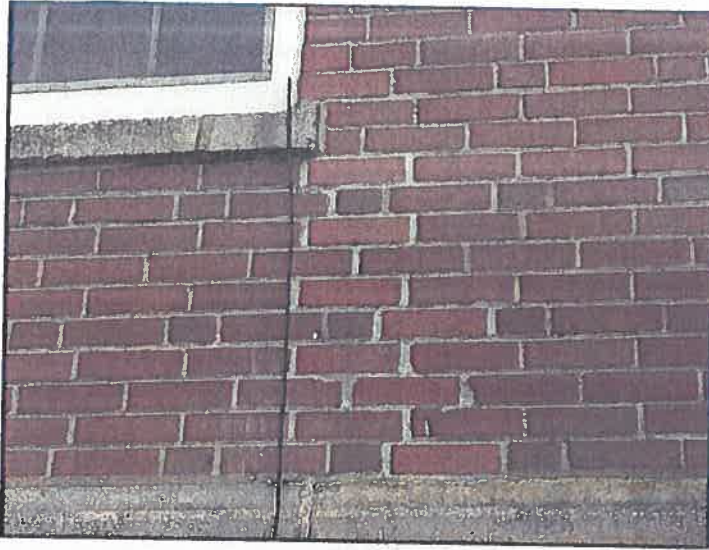
2.3. The exterior brick and stone masonry walls are in fair to poor condition. There are many areas of loose and receding grout, there are several areas of vertical and/or step cracks in walls. Recommend full inspection and repairs by a qualified masonry contractor.

Step cracking at rear

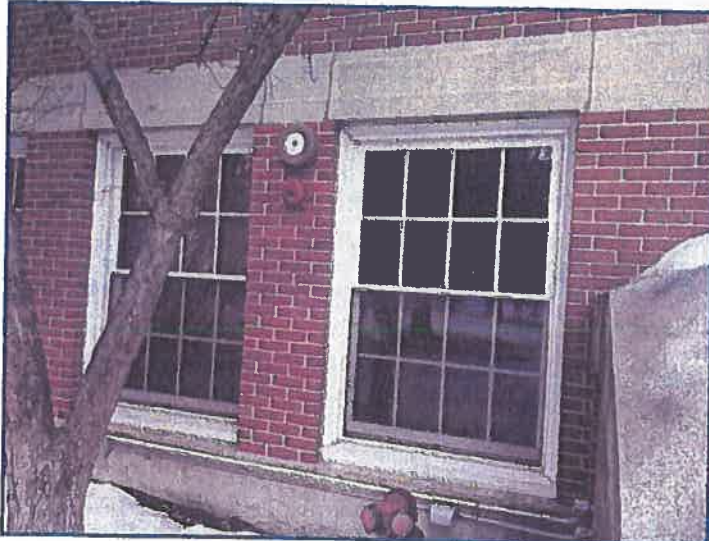
3.2. Deterioration of glazing and caulking at one or more window. Recommend assessment and repairs by a qualified contractor.

Older single pane wood windows with peeling paint and glazing

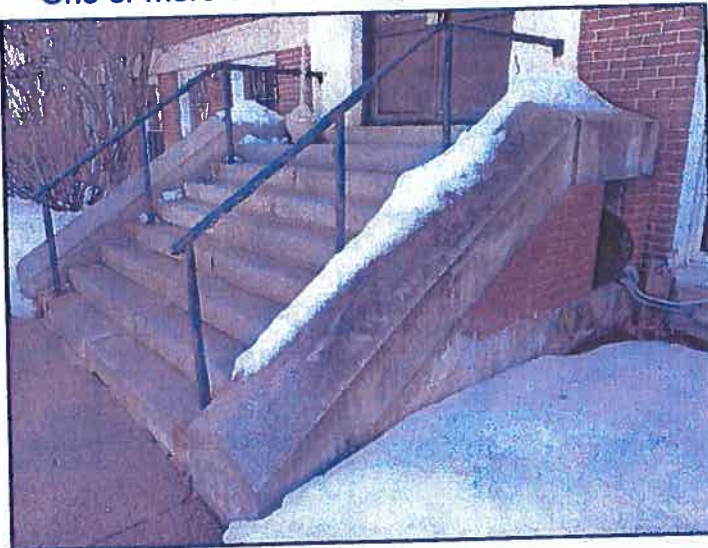
- Exterior stairs were inspected for any areas of damage, missing or improper hand rails or guard rails and for any areas of improper installation.
- Stair rail openings exceed 4" spacing, recommend installing vertical balusters for safety, no greater than 4" apart to prevent children from falling or getting stuck between balusters.
- One or more stair hand rail is damaged or loose, recommend repair by a qualified contractor.

Rail openings exceed 4"s.

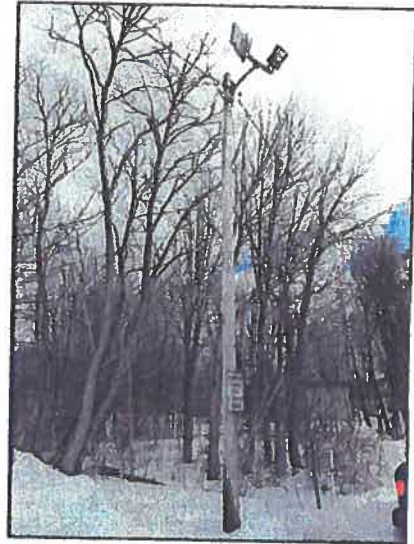
5.1. Exterior lights were not tested. Outside lights on commercial properties are typically controlled by timer and or photo sensors. Recommend confirming proper operation at night prior to closing.

Exterior lighting was not observed illuminated

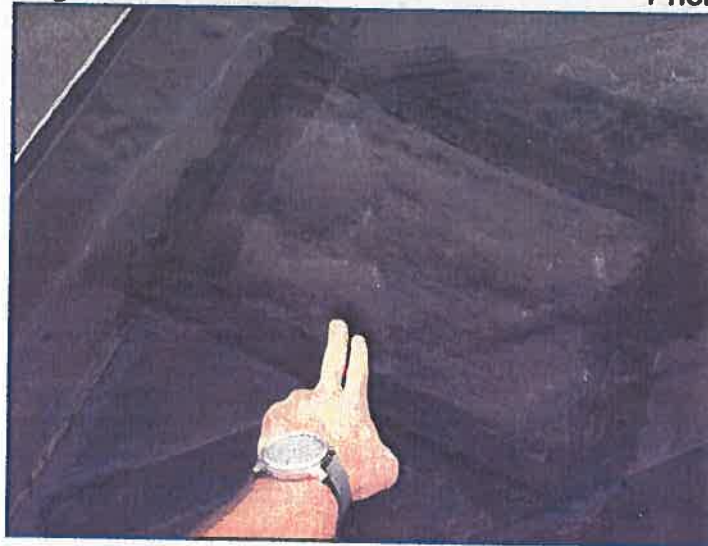
1.3. There area areas of lifting and or damage to roof surfaces, recommend assessment and repairs as needed by a qualified roofing contractor.

Areas of lifting at patches and seams

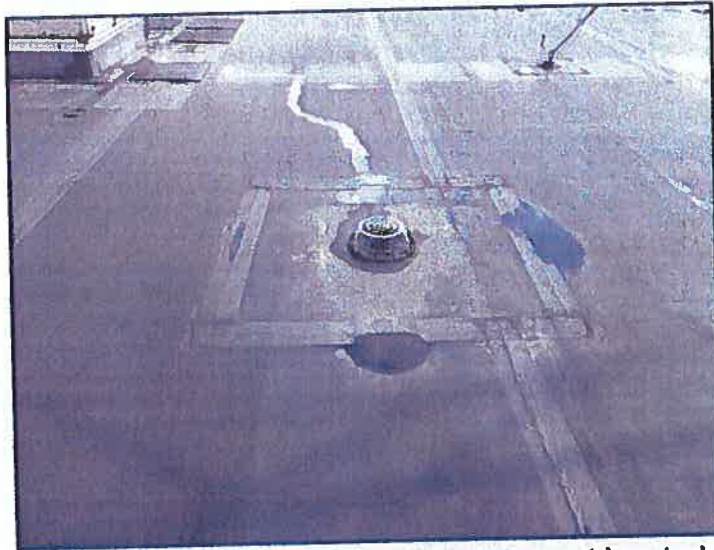
2.1. It is important that all gutters properly divert water outside of and away from building to prevent water intrusion. The final termination of internal gutters were not located. Recommend asking property owner where and how well gutters drain and making corrections if needed.

Internal roof drains. Termination was not located.

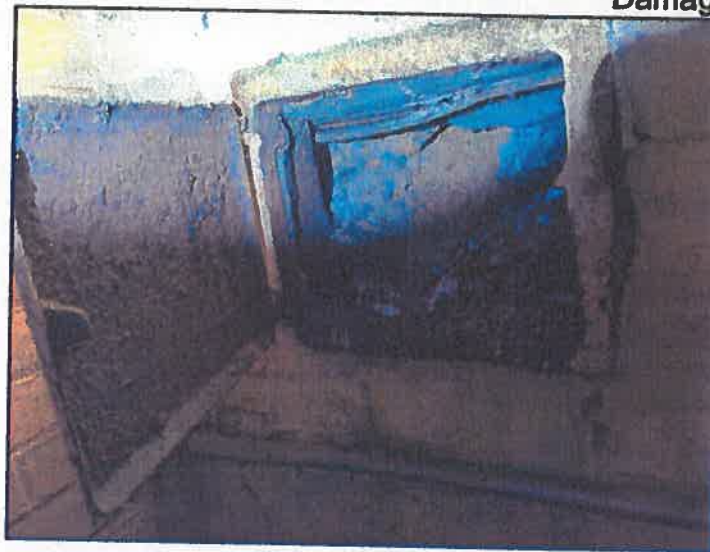
- 3.2. Limited visibility to some upper areas chimney and or flashing due to height and pitch of roof.
- 3.3. Chimney(s) are over 95 years old and will require inspection and maintenance from time to time.
- 3.4. Flue is not included in this inspection, recommend having flue inspected by a qualified masonry / chimney contractor.
- 3.5. Chimney mortar and brick have areas of deterioration or cracking. Recommend having assessed and repaired as necessary by a qualified masonry contractor.
- 3.6. Chimney clean out is full recommend cleaning.

Chimney clean out is full.

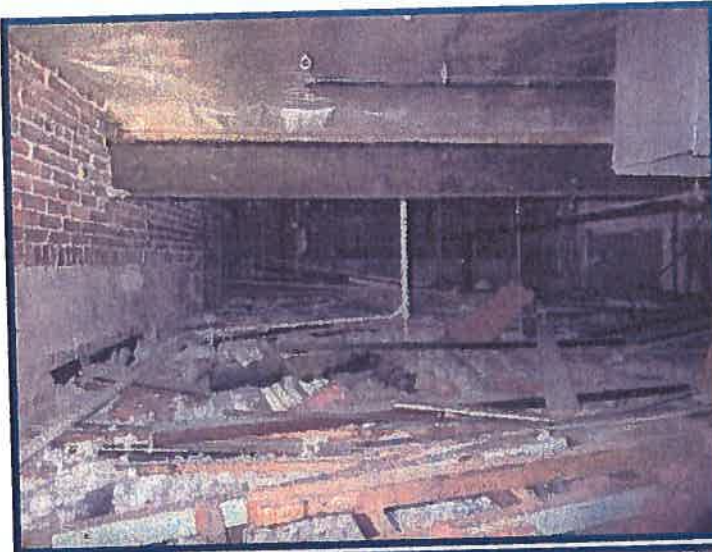
2.4. Stains were found in one or more attic surface areas, no elevated levels of moisture were found. The stain(s) may be due to past or present roof and/or plumbing leaks. Recommend asking the property owner about history of water intrusion and or assessment of any affected areas by a qualified contractor and repairs as necessary.

water staining above vapor barrier, dry at the time of inspection

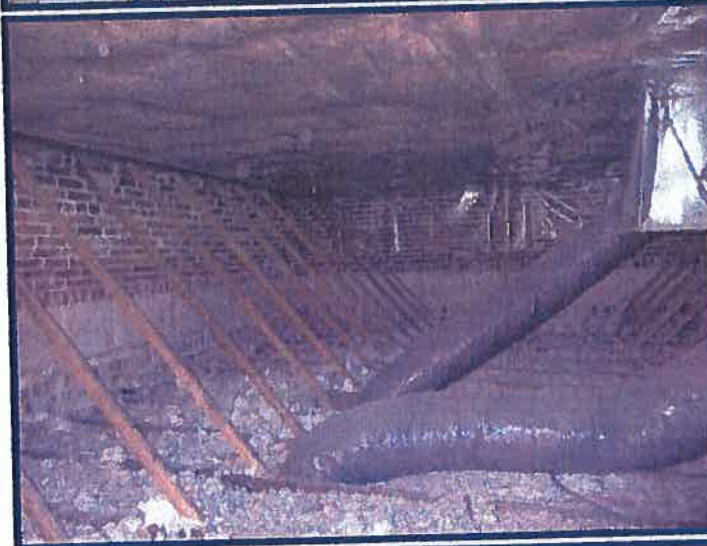
2.5. The exterior brick masonry walls have areas of horizontal cracking and step cracking on walls. Recommend full inspection and repairs by a qualified masonry contractor.

horizontal cracks throughout attic space

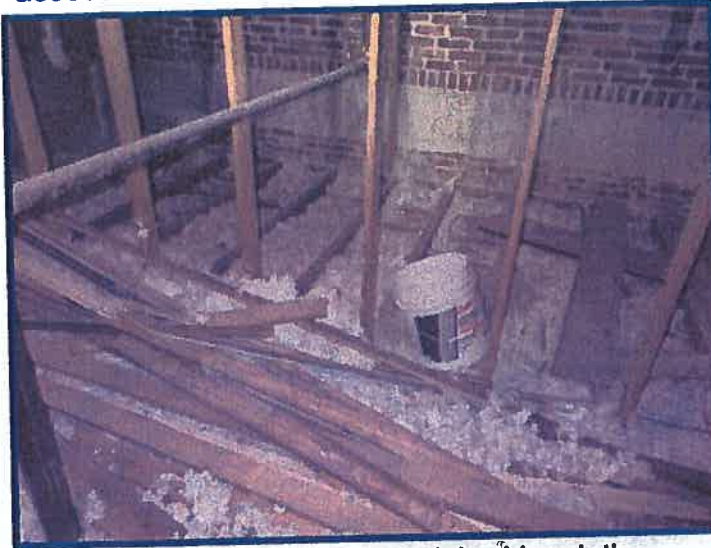
4.2. Areas of missing or compressed insulation. Missing insulation can be a contributing factor to condensation, fungal growth, ice damming, and energy loss. Recommend installing additional insulation where needed by a qualified tradesman.

Areas of disturbed / diminished insulation.

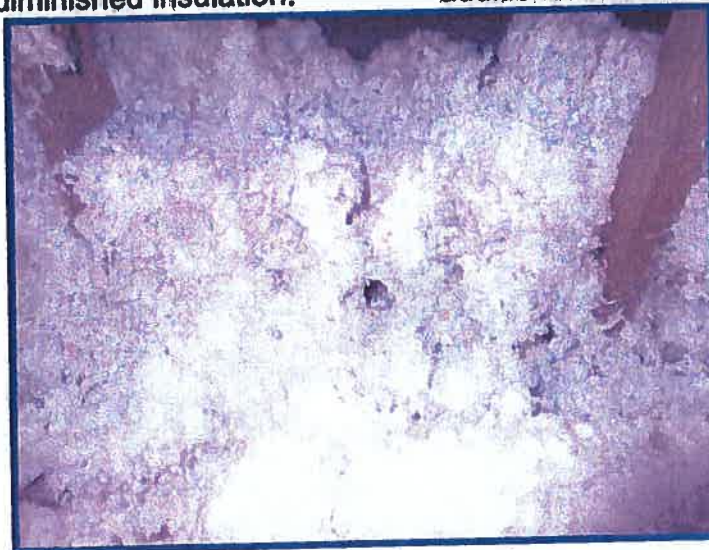
4.3. Animal droppings or activity observed in the attic. Vermin can damage insulation & electrical wiring. We do not identify the droppings. If squirrels or bats are present it can be more difficult and costly to treat. When animal droppings are observed a qualified pest company should always assess. Recommend a professional pest contractor evaluate for treatment.

animal tunnels in insulation

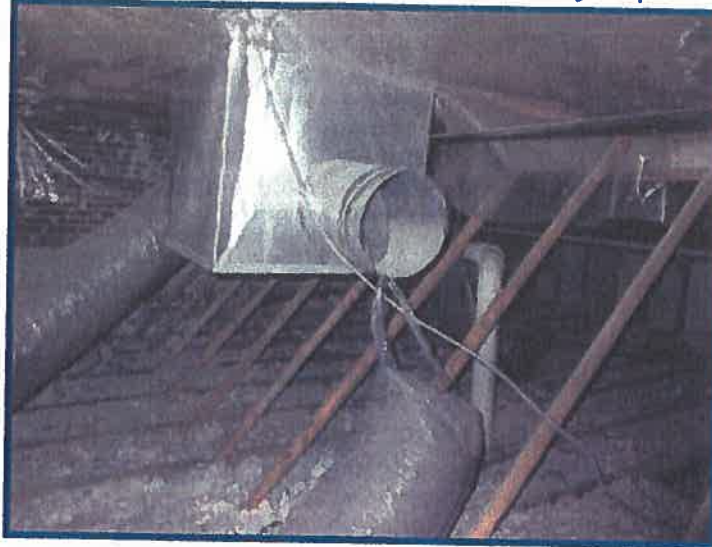
5.1. Ducts are loose or damaged at one or more area, this can contribute to energy loss, ice damming, moisture and mold growth, recommend assessment by a qualified HVAC contractor.

disconnected ducts in attic space

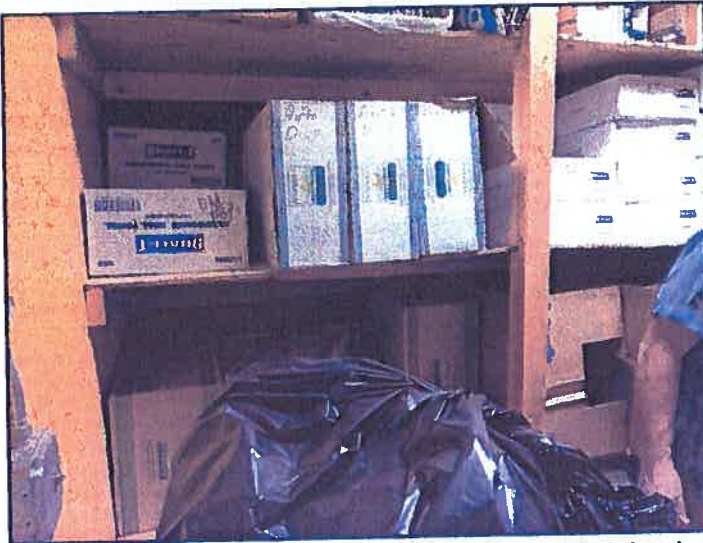
1.6. Limited visibility due to finished basement space and or stored items or cluttered conditions.

Limited visibility due to stored goods / finished space.

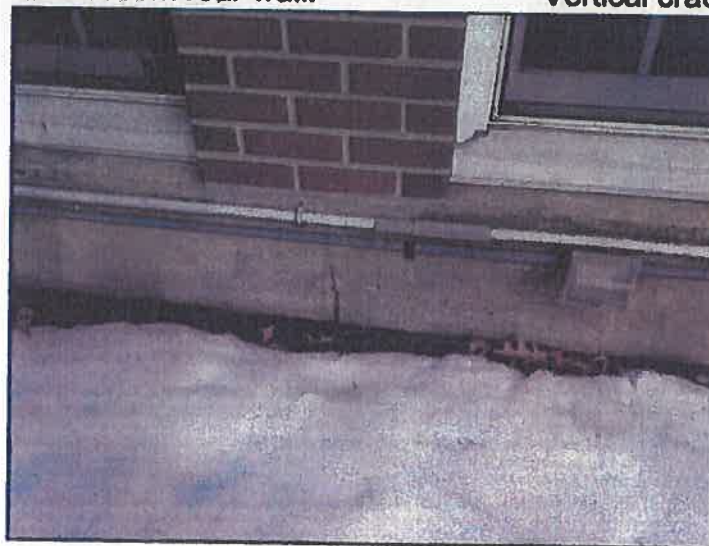
1.8. Vertical cracks noted on foundation wall at one or more location, recommend monitor for further movement and or water intrusion and sealing / repairs as needed.

Vertical crack at front wall

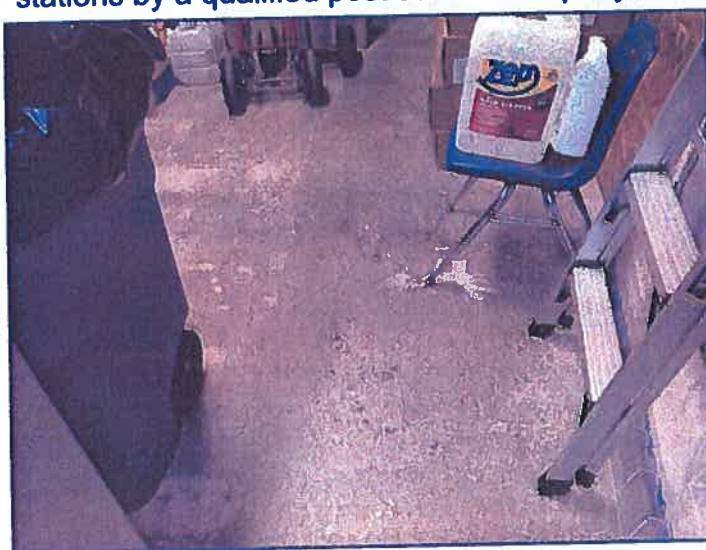
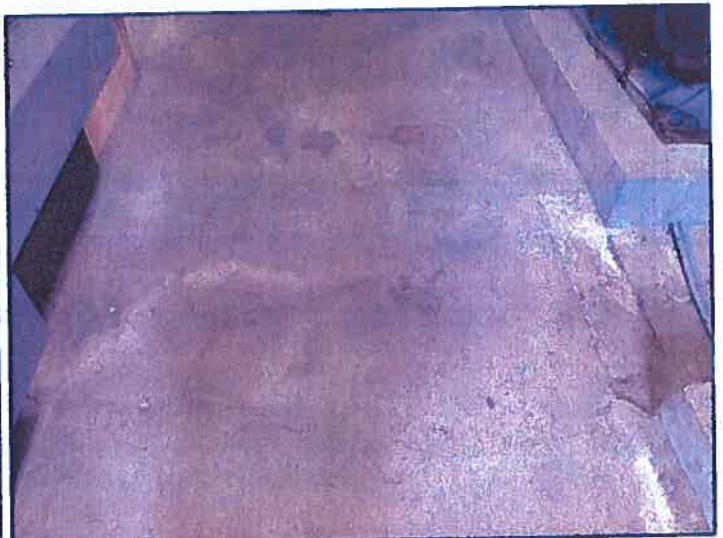
3.3. Typical settlement cracks, recommend monitor for further movement and water intrusion and repairs by a qualified contractor as needed.

Typical cracks

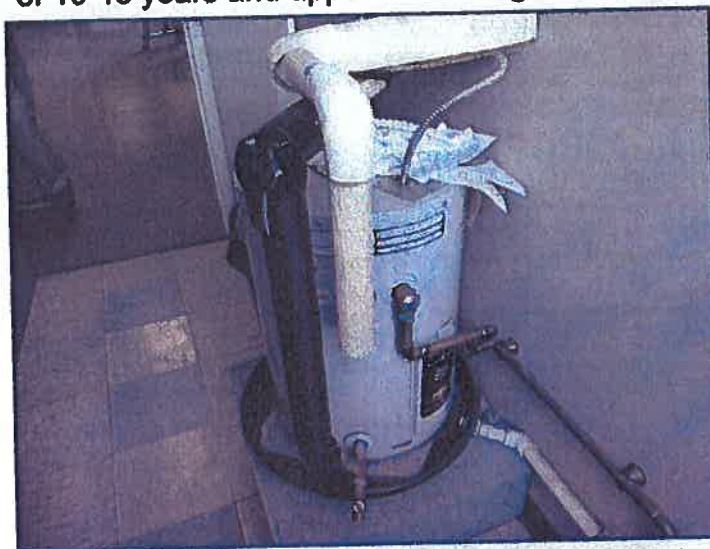
Electric water heater at third floor janitors closet, 4 years old.

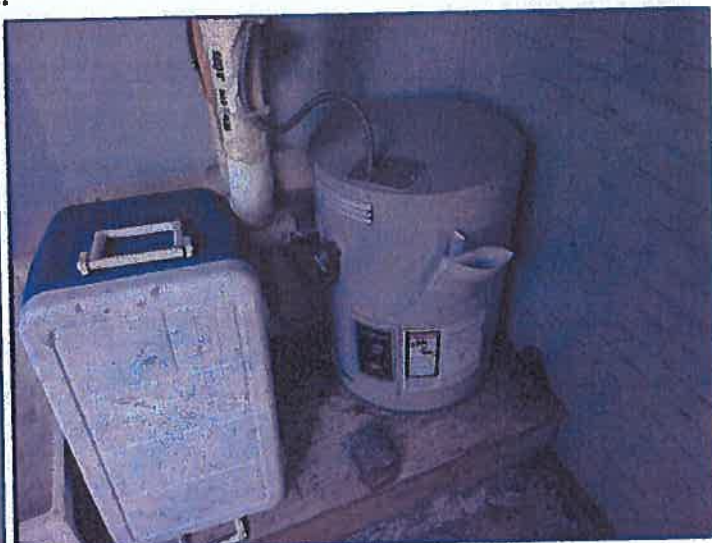
Electric water heater at lower level front room/sprinkler room, 8 years old.

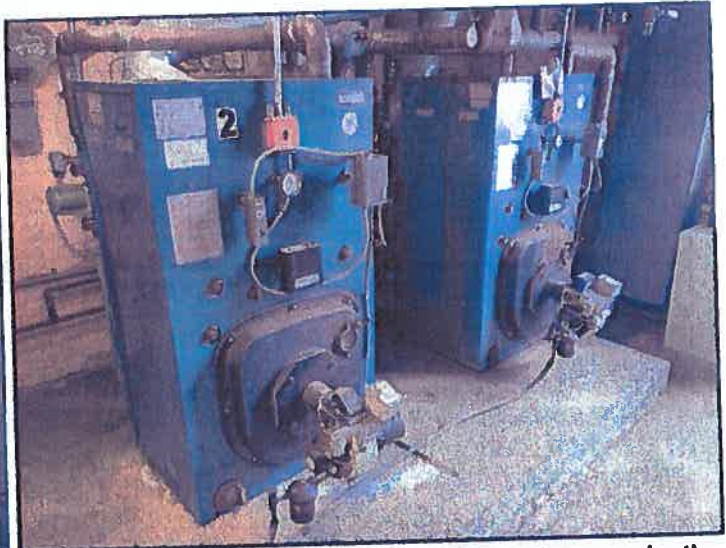
Two boilers in basement mechanical room, both approximately 24 years old.

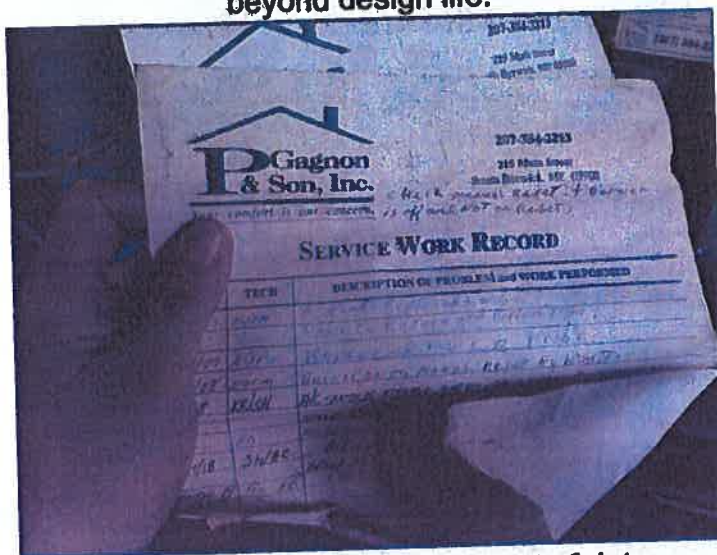
- 1.7. Oil boilers and furnaces require annual maintenance. Last maintenance recorded is 9-9-18. Recommend inspection of oil tank and oil lines during each annual oil burner service. For systems with service tag older than one year recommend service and inspection by a qualified oil heating company.

Most recent service tags are out of date.

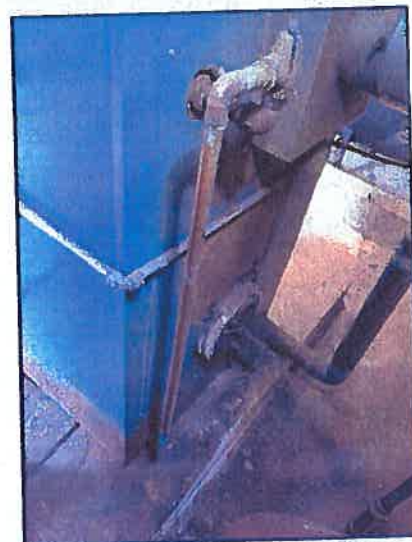
- 1.6. Temperature & Pressure relief pipe is leaking at one or more boiler, there is corrosion at end of pipe, recommend repair by a qualified plumber.

Corrosion at TP valve.

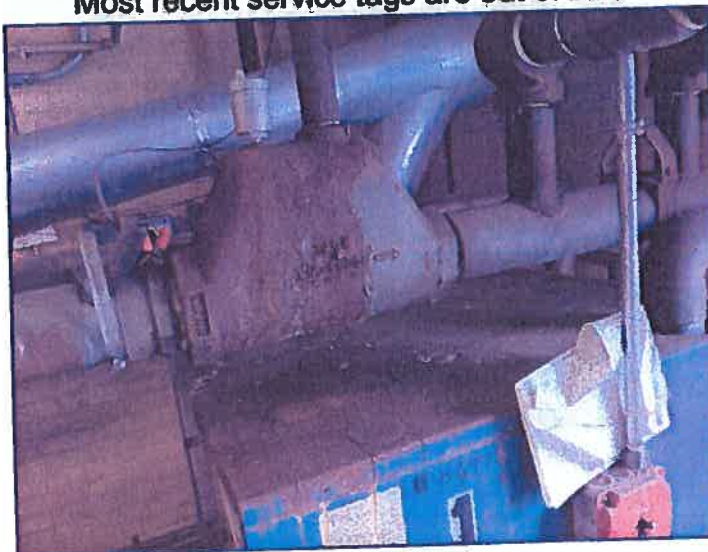
- 1.5. There is corrosion on plumbing fixtures and or outside cabinet surface, this is an indication of leaks, of age or improper combustion. Recommend full inspection and repairs if needed by a qualified heating contractor.

Corrosion at boiler

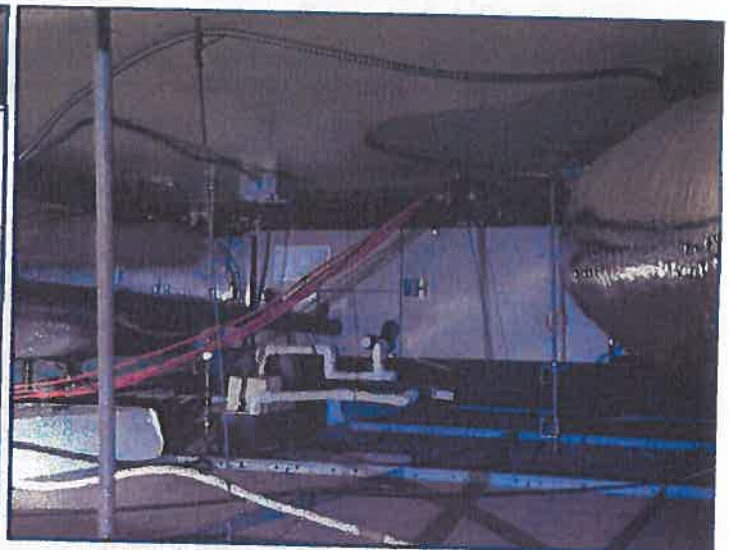
Conference room air handler, 16 years old

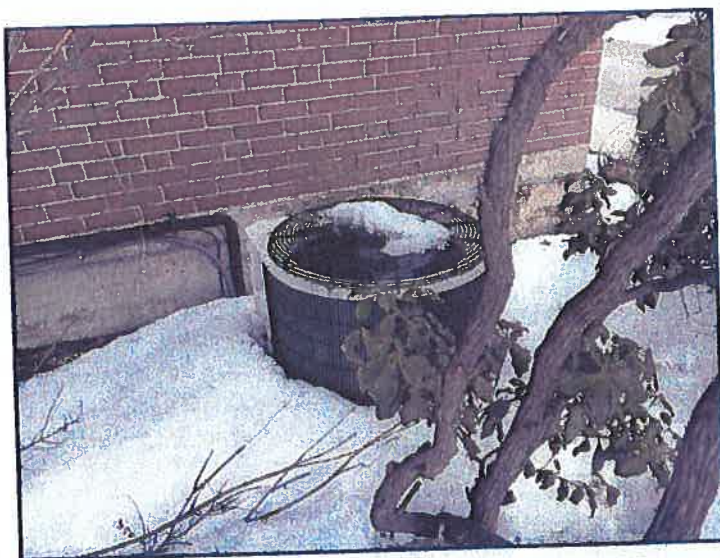
Front right AC compressor / town managers,
2004/17 years old

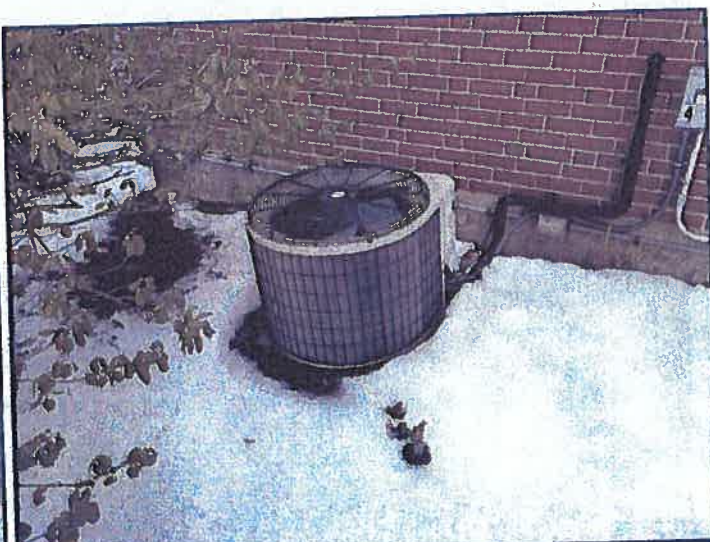
Front left AC compressor/code enforcement,
2005/16 years old

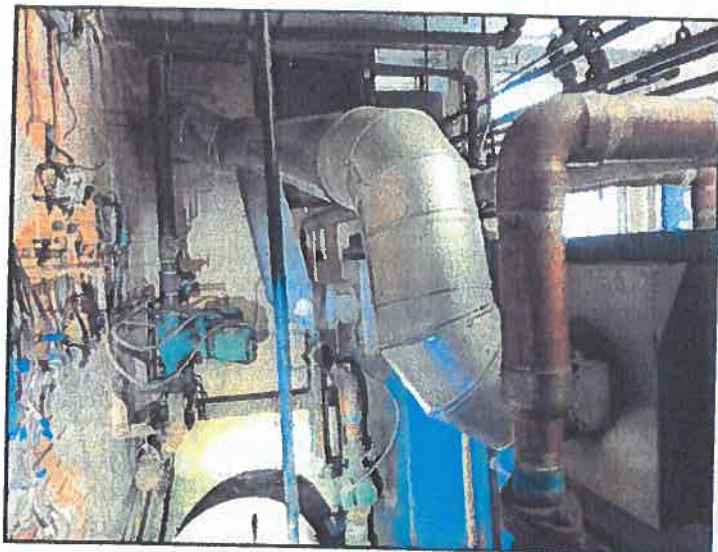
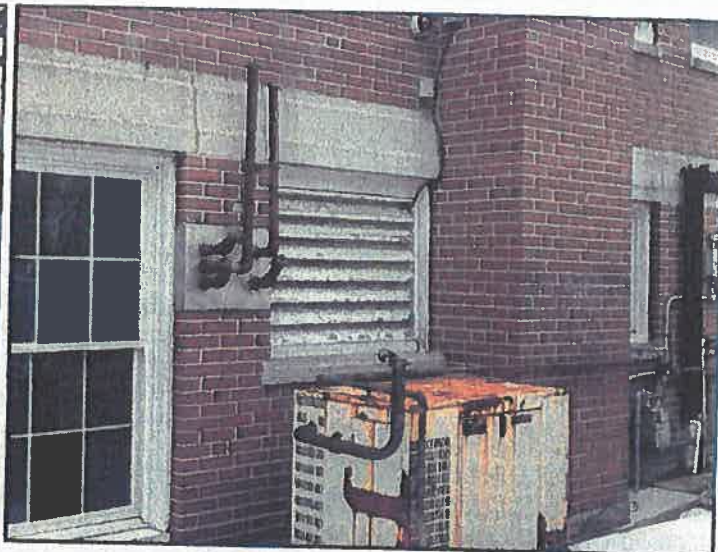
Boiler/mechanical room makeup air vent.

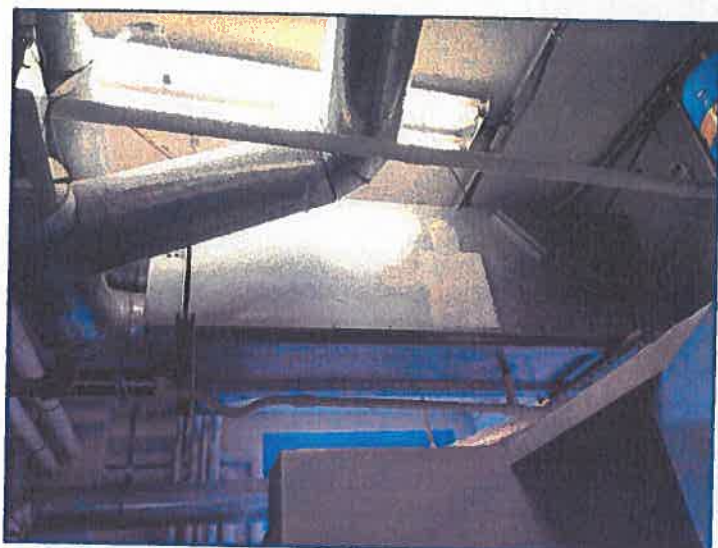
ERV at police station bathroom / locker room

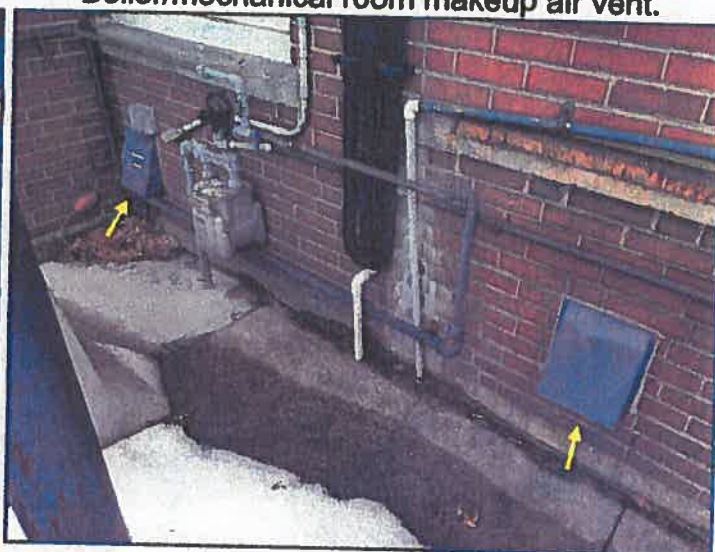
ERV vent terminations at rear of building.

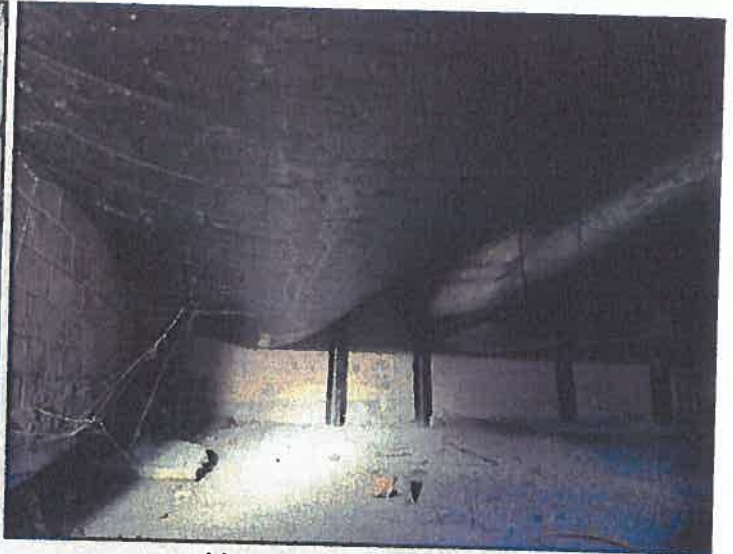
Underside of oil tanks

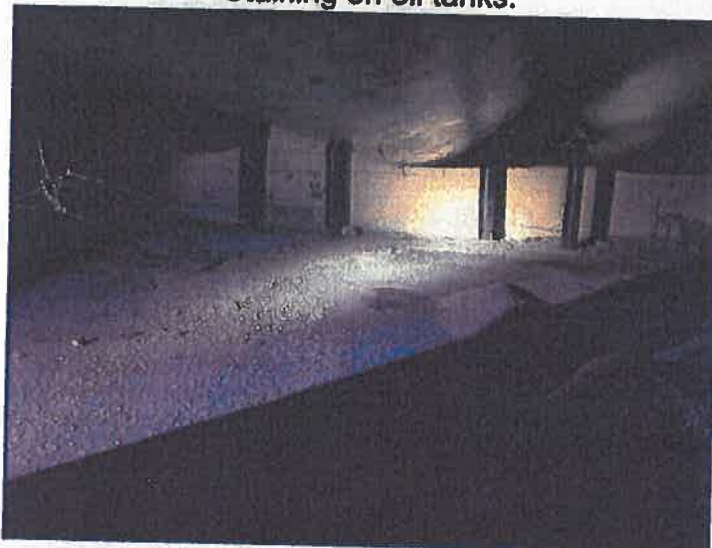
3.5. Corrosion or staining on oil tank, recommend inspection by a qualified oil burner company. A leaking oil tank can create environmental hazardous conditions. Oil tank should be inspected for evidence of leaking by a qualified oil burner company and replaced or repaired as needed.

Oil staining at underside of tank and on floor below oil tanks.

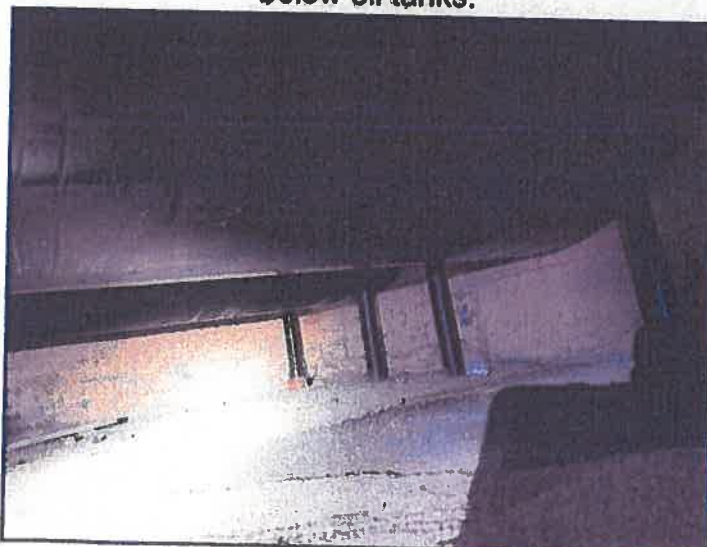
3.6. There is oil staining, wet oil on tank and or floor. Oil tank should be fully inspected by a qualified oil burner company and replaced or repaired as needed.

Oil leak / wet oil staining on tank and floor below oil tank.

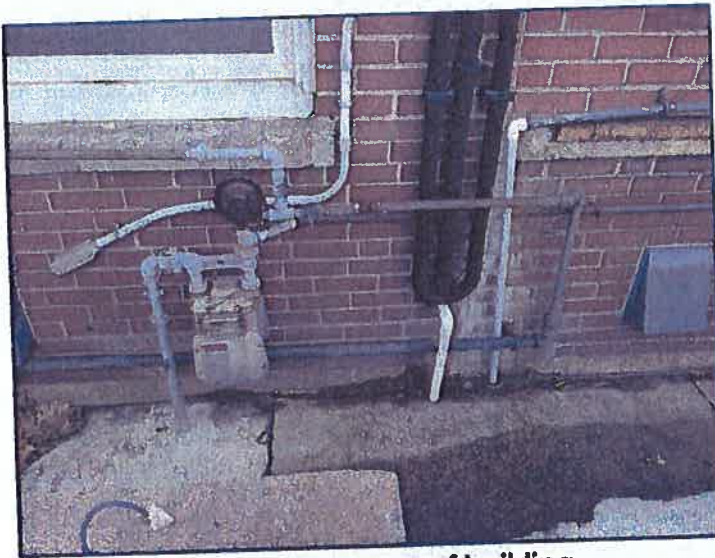
Gas meter at rear of building

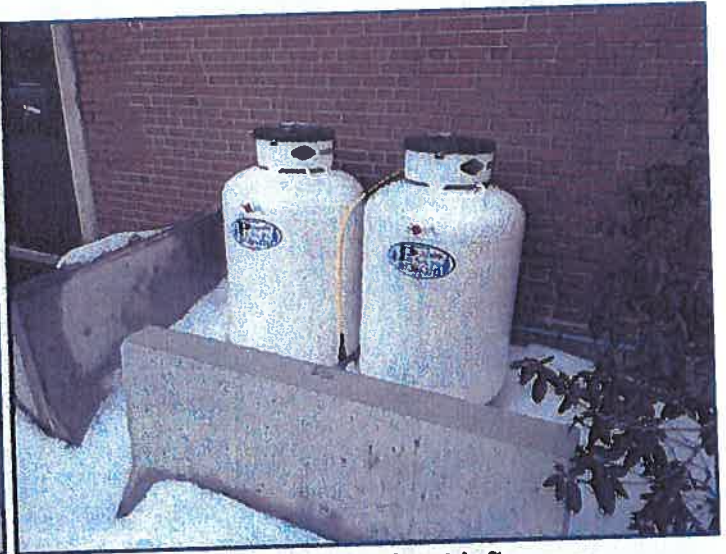
Propane bottles at front left corner.

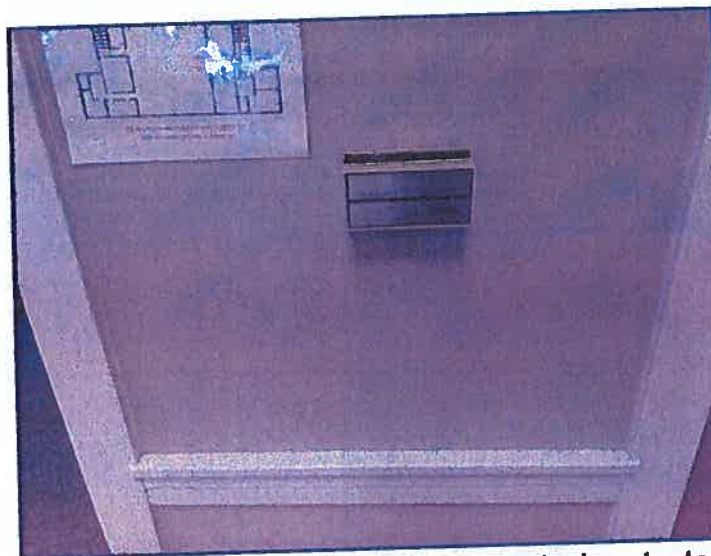
5.1. Thermostat does not appear to start unit, have furnace fully inspected by a licensed HVAC technician.

Third floor rooftop furnace did not start when tested.

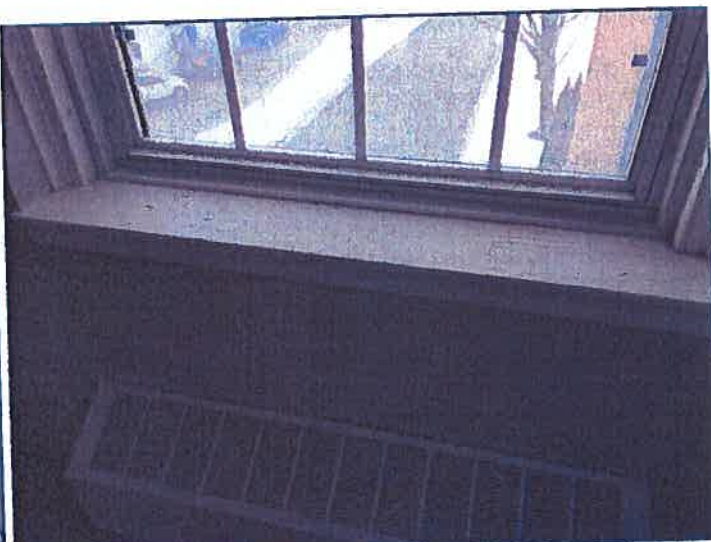
Water staining on window sills tested dry.

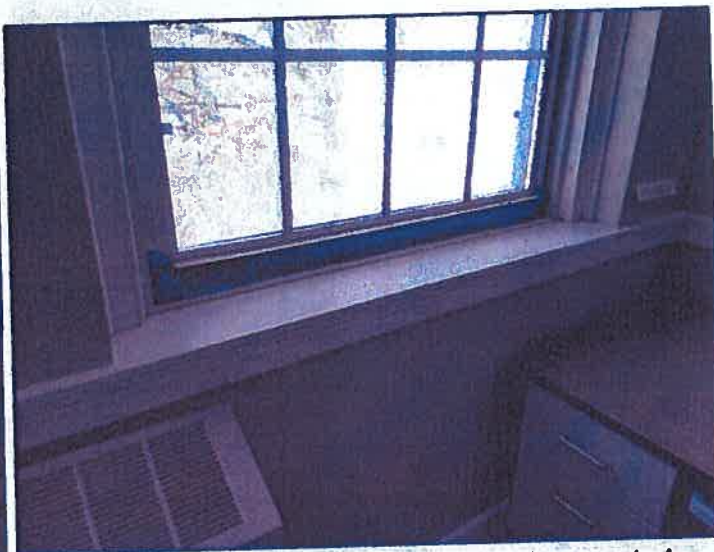
Window at third floor front left room does not close properly.

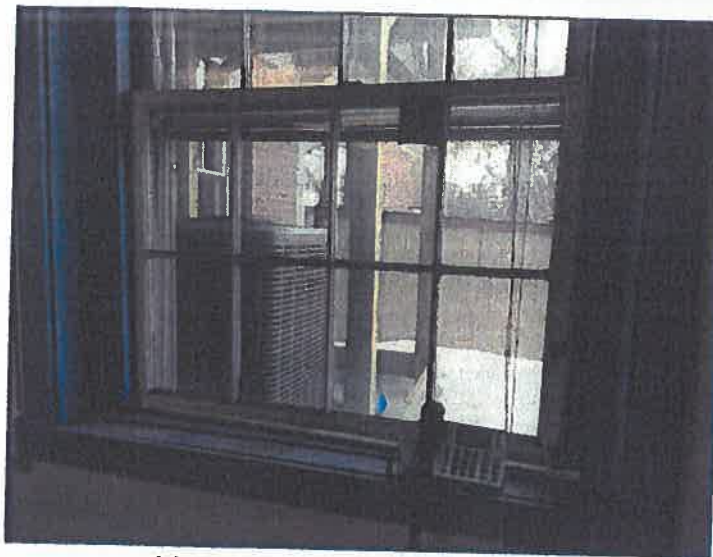
older single pane wood window

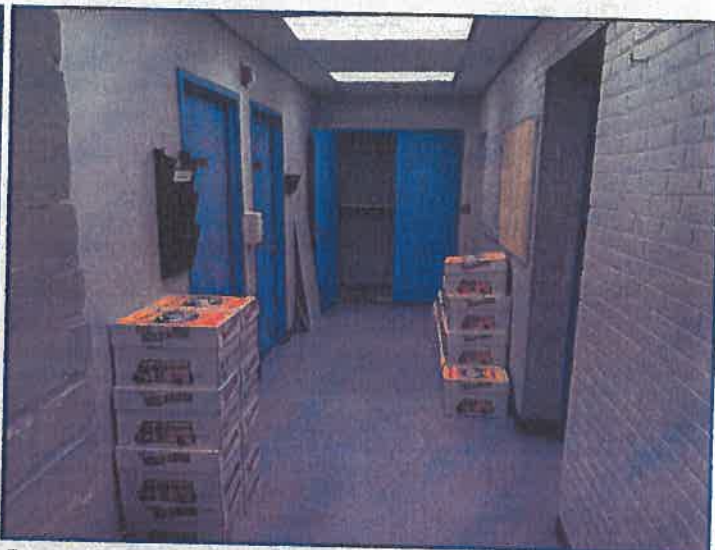
Damaged wall and wet conditions at rear entry. General disrepair throughout former police station.

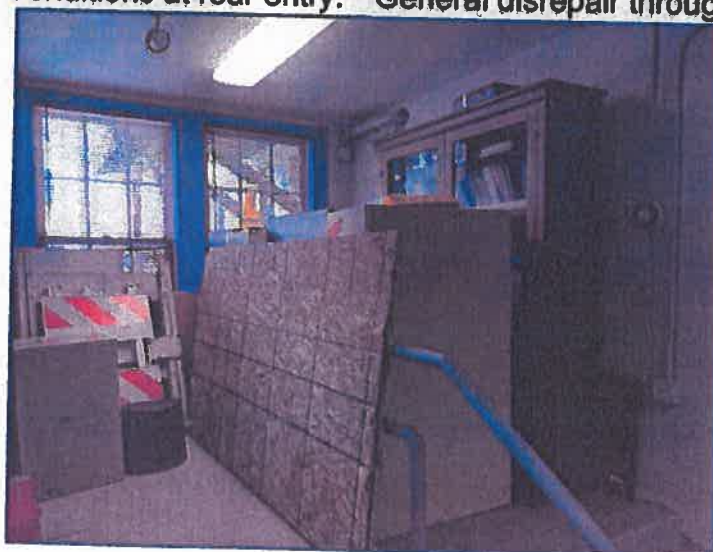
- 3.3. Cluttered conditions in one or more area of the building limiting visibility and access to interior surfaces and components.
- 3.4. Stains on walls at one or more area of building, tested dry at time of inspection, recommend checking with current property owner about history of water intrusion or leaks, repairs by a qualified contractor and monitor for future water intrusion.

Cluttered conditions at former police station.

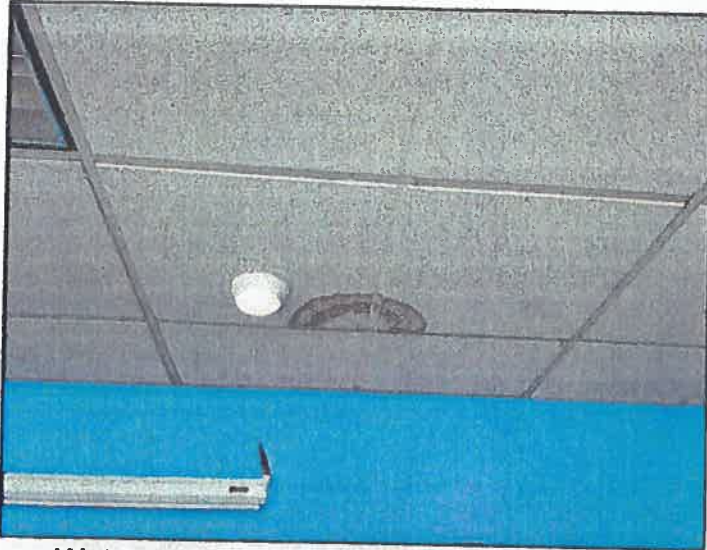
4.2. Stains noted on ceilings in one or more area of building. This is evidence of past or present leaks. They tested dry at the time of the inspection. Recommend asking current building owner for the source and history of any leaks or water intrusion, assessment and repairs by a qualified contractor of any affected areas and monitor for further water staining.

Water staining at conference room ceiling.

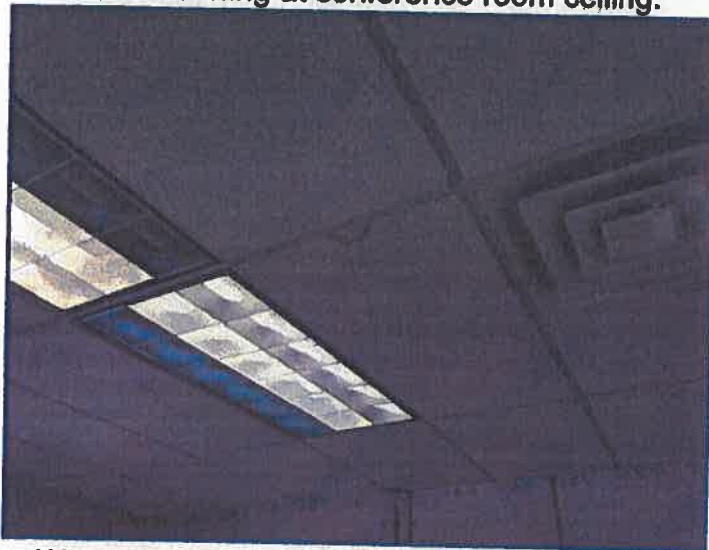
Water staining at second floor / finance room.

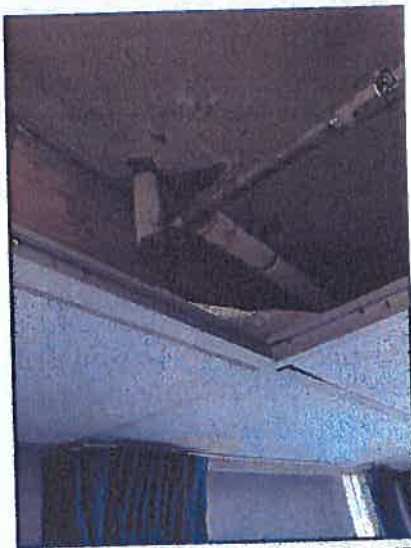
Water staining at town manager's office tested dry.
