Alpha Home & Commercial Building Inspections

Property Inspection Report

180 Main St, South Berwick, ME 03908
Inspection prepared for: Perry Ellsworth
Real Estate Agent: -

Date of Inspection: 2/23/2021 Time: 10:00 AM
Order ID: 12304

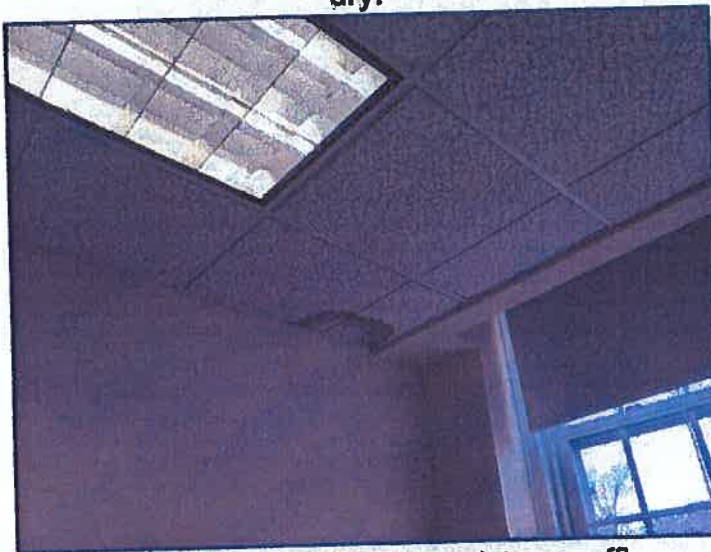
Water staining at general assistance office.

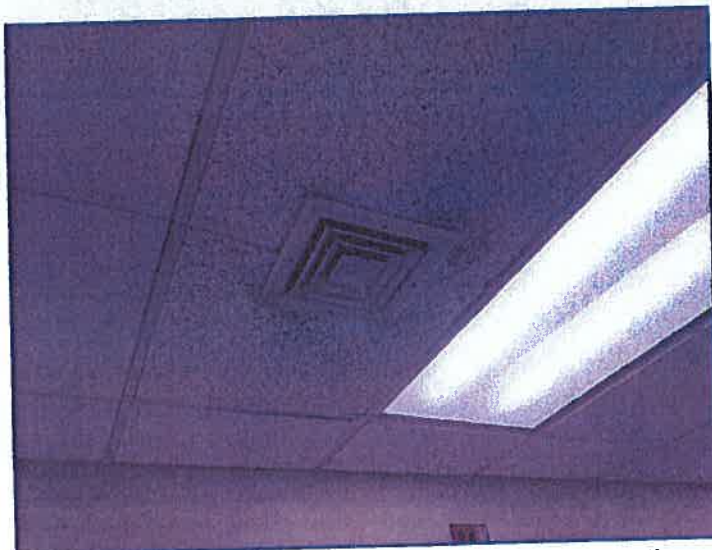
Water staining throughout former police station tested dry.

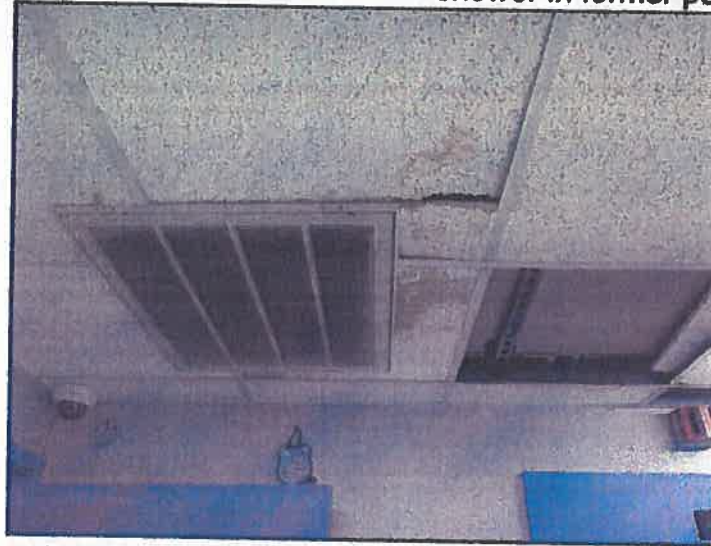
Damaged ceiling tiles and water staining at former police station. Area tested dry.

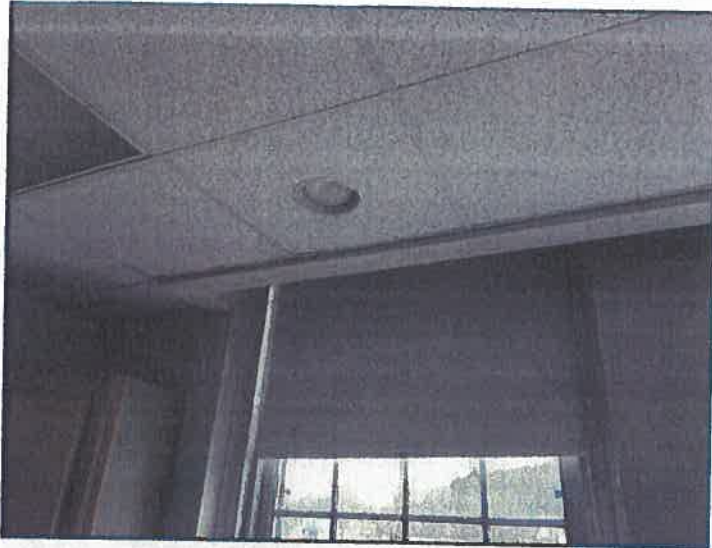
Light out at the third floor kitchen.

- 6.2. One or more ceiling light fixtures not working at time of inspection. Recommend changing bulb and repair/ replacement by a qualified electrician as needed.

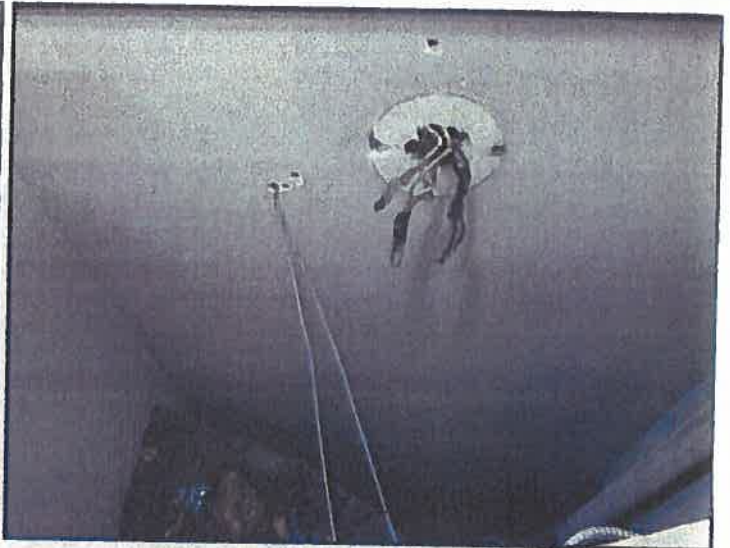
Open splice at roof access / above drop ceiling was not live at the time of inspection.

- 6.3. One or more outlet / switch cover plates missing. Recommend repairs for safety.
- 6.4. Open splices were observed. This is a "Safety Concern". Whenever an electric wire is cut and reconnected, the "splice" should be encased in a covered "junction box" to prevent shocks and separation of the splice. Client is advised to consult with a licensed electrician prior to closing for repairs/replacement as needed to ensure safety.

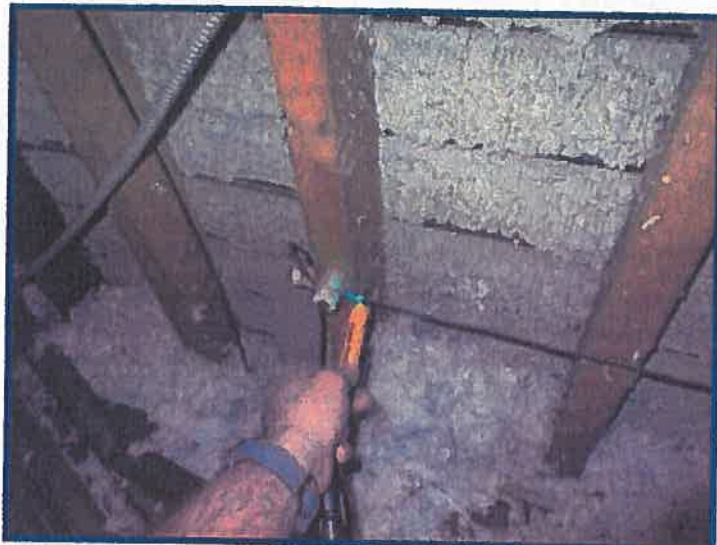
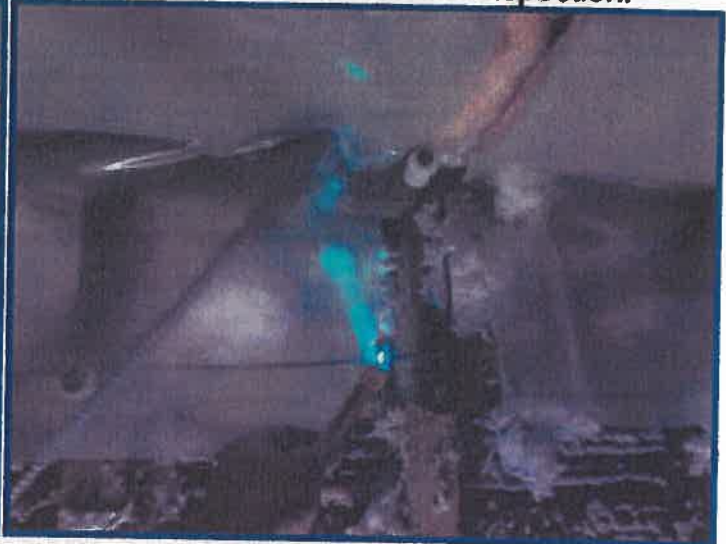
- 6.7. This property has "knob and tube" wiring which was commonly installed prior to 1950. It is ungrounded, and considered unsafe by today's standards. Over time, the wire's insulation becomes brittle and falls apart, resulting in exposed conductors and a risk of shock and/or fire. This wiring is also easily damaged by covering it with insulation (a common practice), and incorrectly tapping new wiring into it. No energized knob and tube wiring was found during the inspection. It is not within the scope of this inspection to determine what percentage of this property's wiring is of the knob and tube type or to determine what percentage of the knob and tube wiring is energized vs. abandoned. A qualified electrician should evaluate this wiring and make repairs or replace wiring as necessary.

Knob and tube wiring.

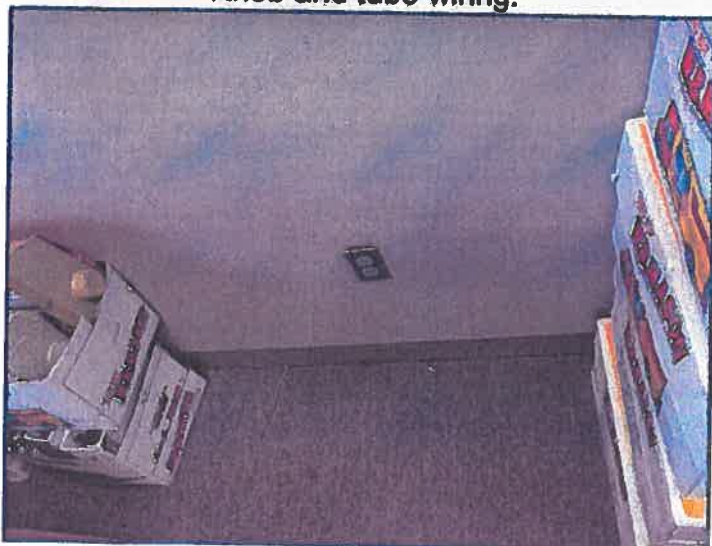
Loose outlet at third floor rear right room.

- 6.8. One or more loose outlet noted, recommend repair by a licensed electrician.
- 6.9. One or more damaged outlet noted, recommend repair by a licensed electrician.

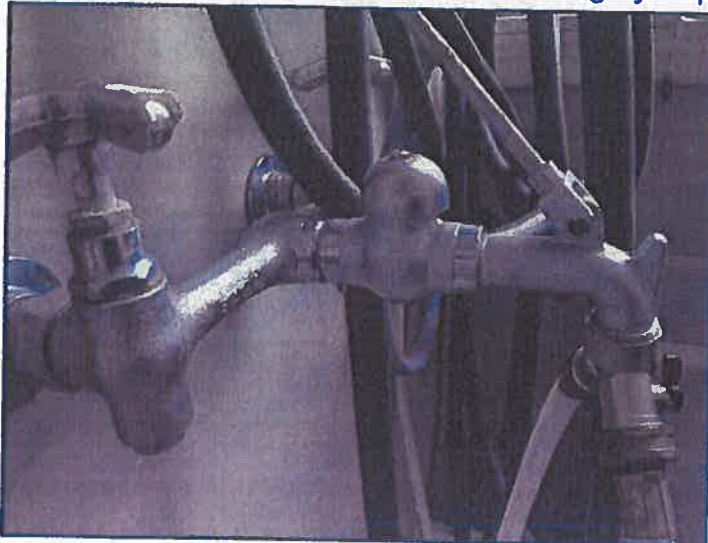
Faucet is leaking at third floor janitor closet.

7.3. Sink faucet in one or more location leaks. Recommend repair/ replacement by a qualified plumber.

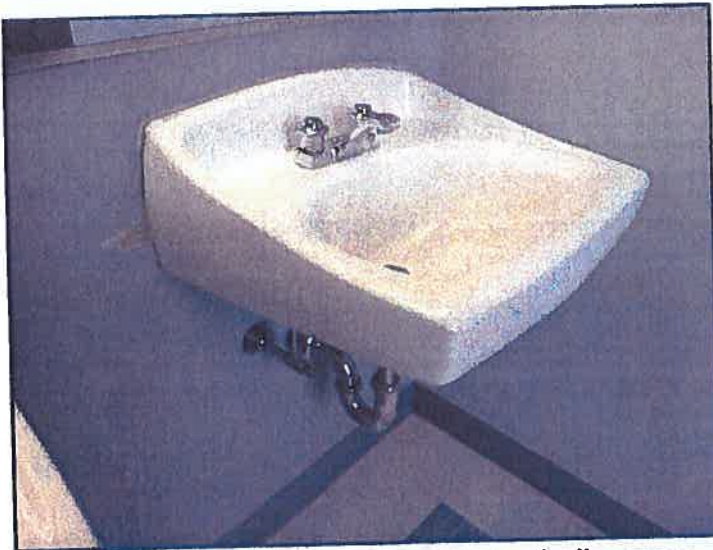
Loose sink / gap at wall at third floor ladies room.
Corrosion on plumbing below sink.

7.5. Sink is loose or damaged at one or more location, suggest repairs as needed by a qualified contractor.

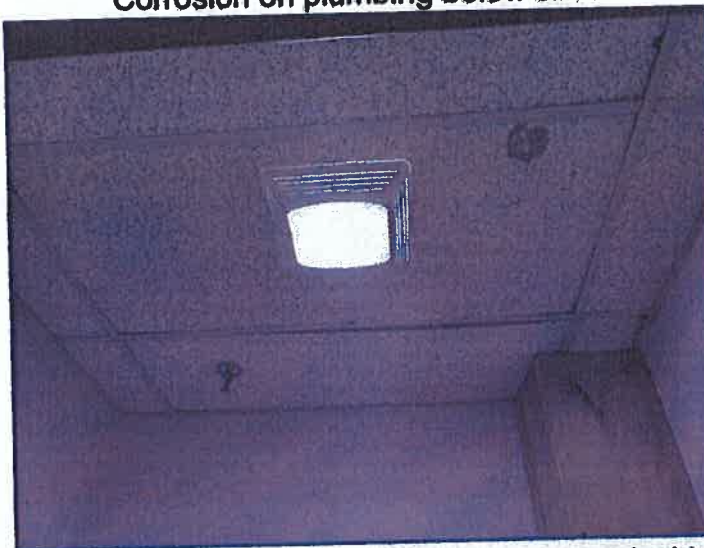
Second floor bathroom vent fans terminate inside building.

7.6. One or more bathroom vent does not extend to the exterior. Termination of venting should be to the exterior with a proper hood or roof cap equipped with a backdraft damper. Recommend terminating all vents to exterior of building by a qualified tradesman.

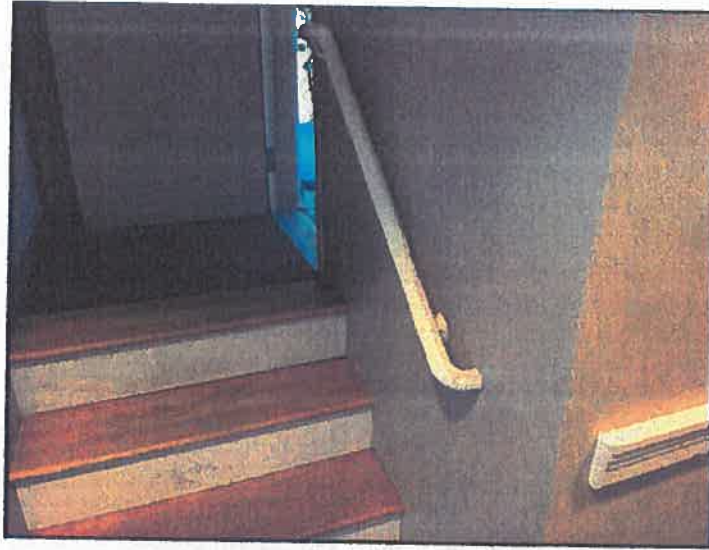
Loose railing at stage rear stairway.

8.2. Stair handrail is loose. Recommend repairs for safety.

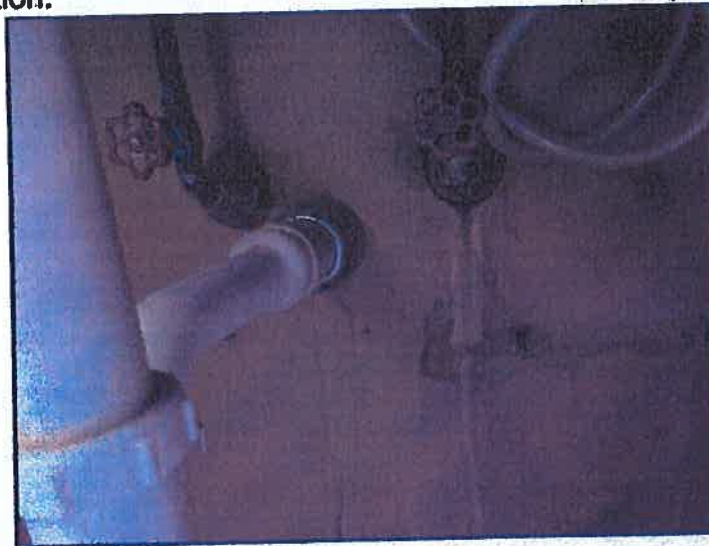
Staining tested dry

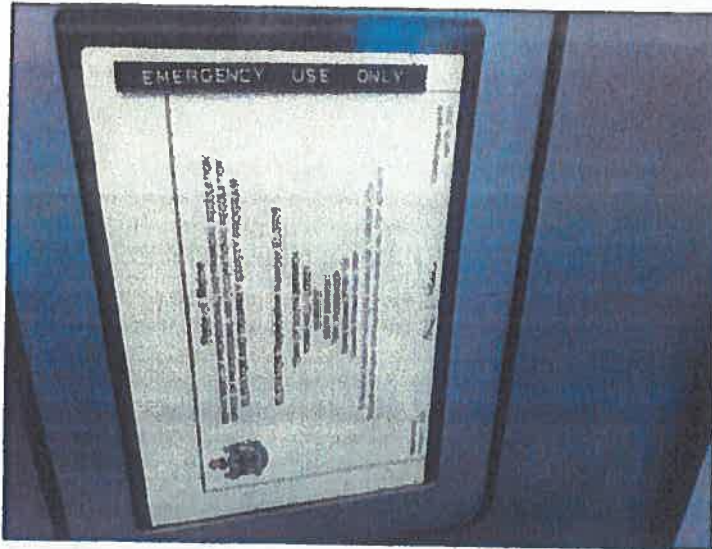
10.1. Elevators require minimum annual state inspection and regular maintenance. Last state inspection expires 4-30-21. Last service tag is 7-14-20.

Most recent service log (7-14-20).
